### 3.4 Detailed Descriptions of Principal Buildings - Homestead Group

#### 3.4.1 The Homestead Group Generally

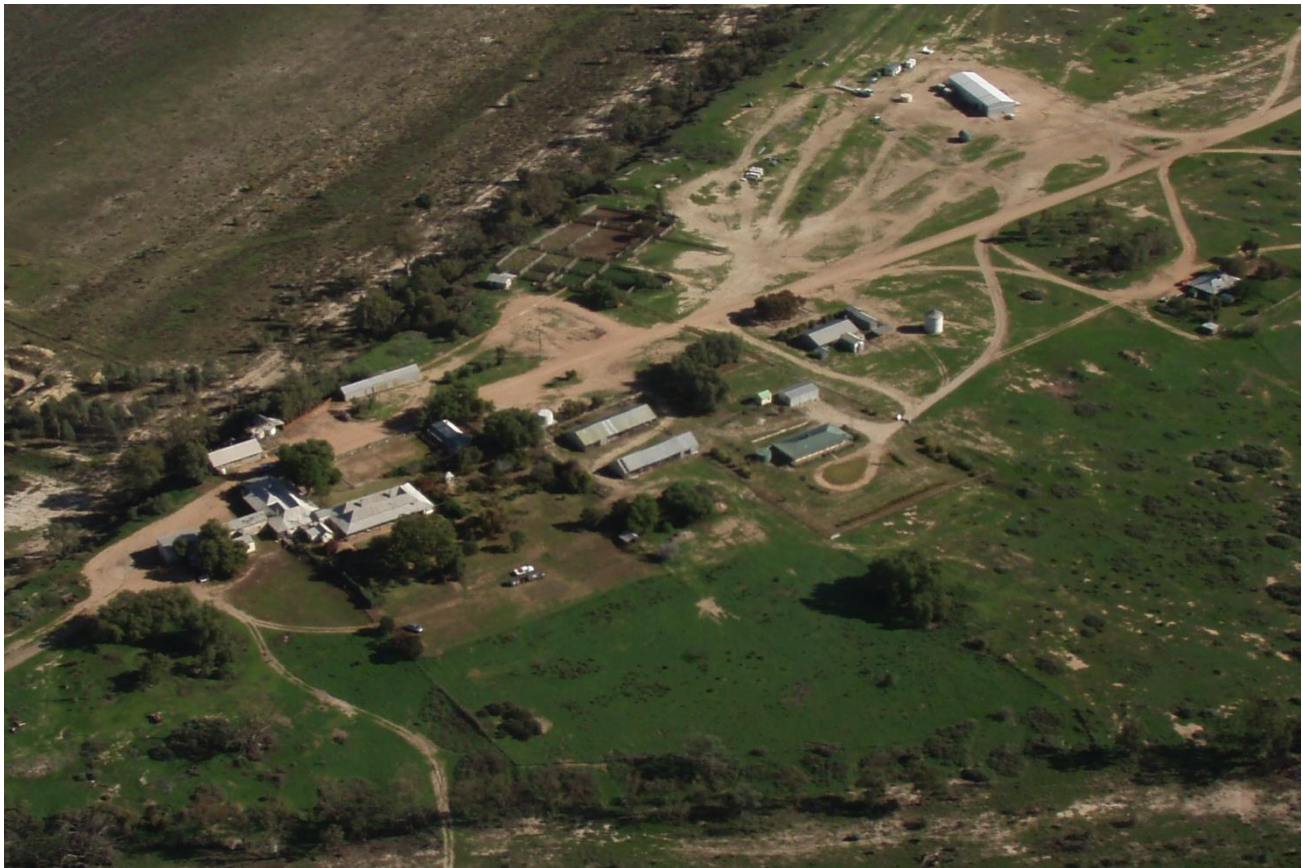
Figure 3.4.1 Aerial view of the Yanga Homestead Group from the southeast. The Homestead is at the left of the photo. A second machinery shed has since been built adjacent the shed at the top right. NPWS asset survey 2007

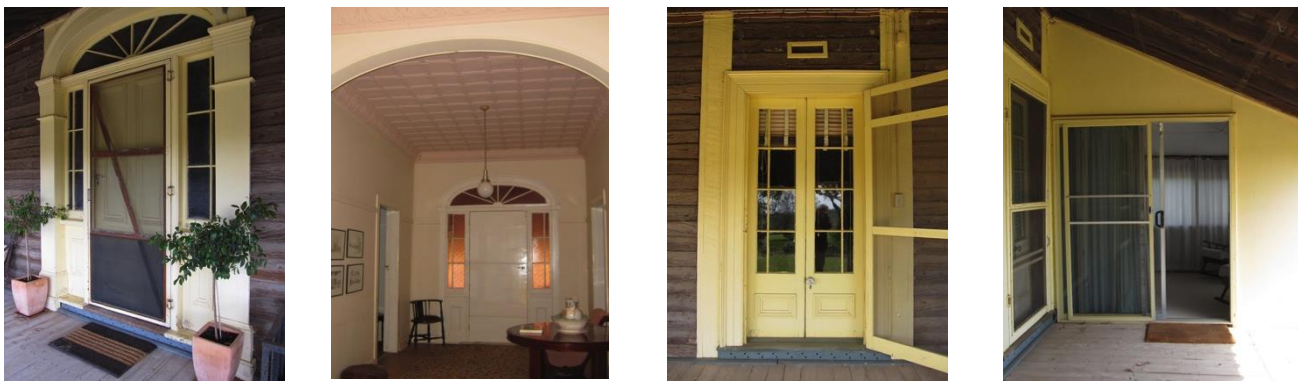
Figure 3.4.6 Front doorset with elliptical fanlight and sidelights - outside and interior views. Typical French door with margin glazing bars and intrusive aluminium door to the Flat. Photos by CMP authors, 2009

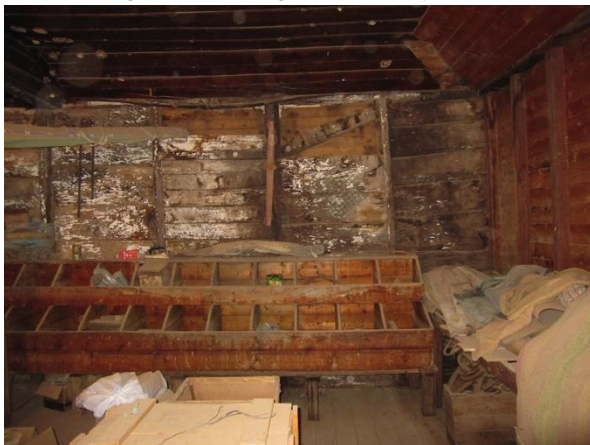
North wall of Store, deteriorated under central valley.

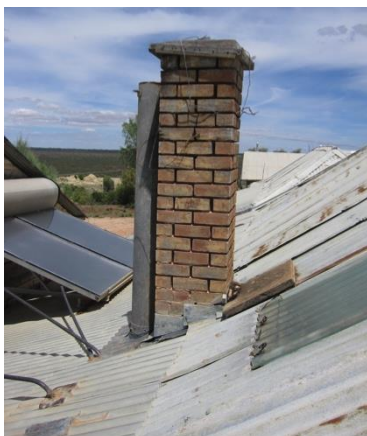
*Kitchen chimney with capping slab on roof to right. Corrugated glass skylight to right or photo.*

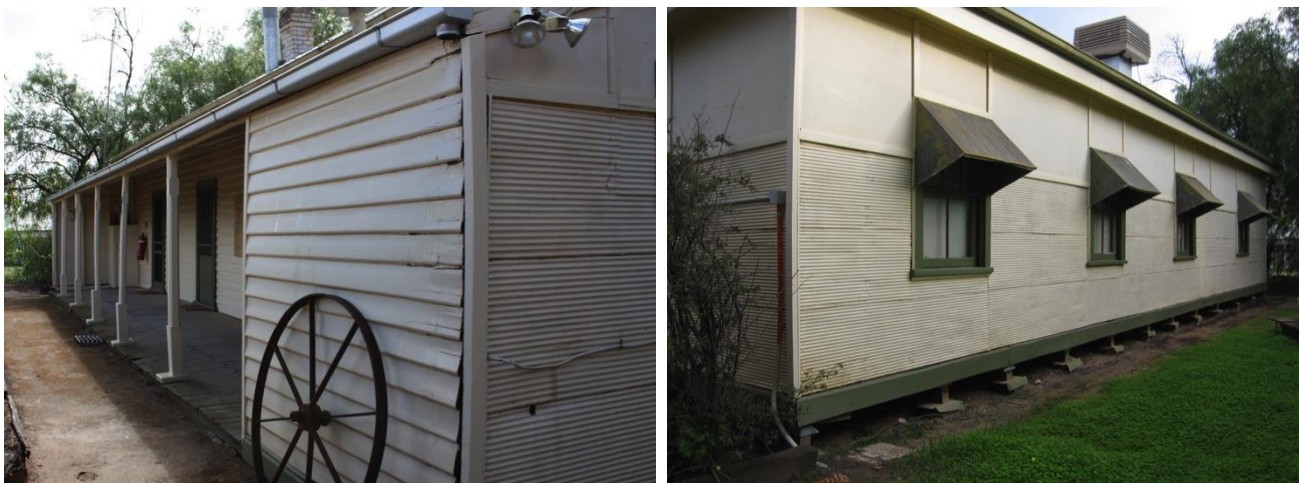
Figure 3.4.21 Views of Cooks Cottage. South side on left and north side on right. Photos by CMP authors, 2009

The building is generally in good condition and has recently been renovated to house the an exhibition. The brick chimney is badly cracked on the north side and should be strapped or rebuilt and some flashing is missing. The mesh enclosing the subfloor space is loose and needs refixing. The ridge capping is also loose and needs refixing and some roof sheet fixings. The downpipe at the south-east and north-east corners are missing and the gutter is split at this corner. The gutters have seedlings growing in them in some places. There is a redundant flue in the south roof slope near the centre of the building and an evaporative cooler on the north face of the roof. The exterior and interior are recently painted. Several fibro sheets on the exterior are cracked but still in place.

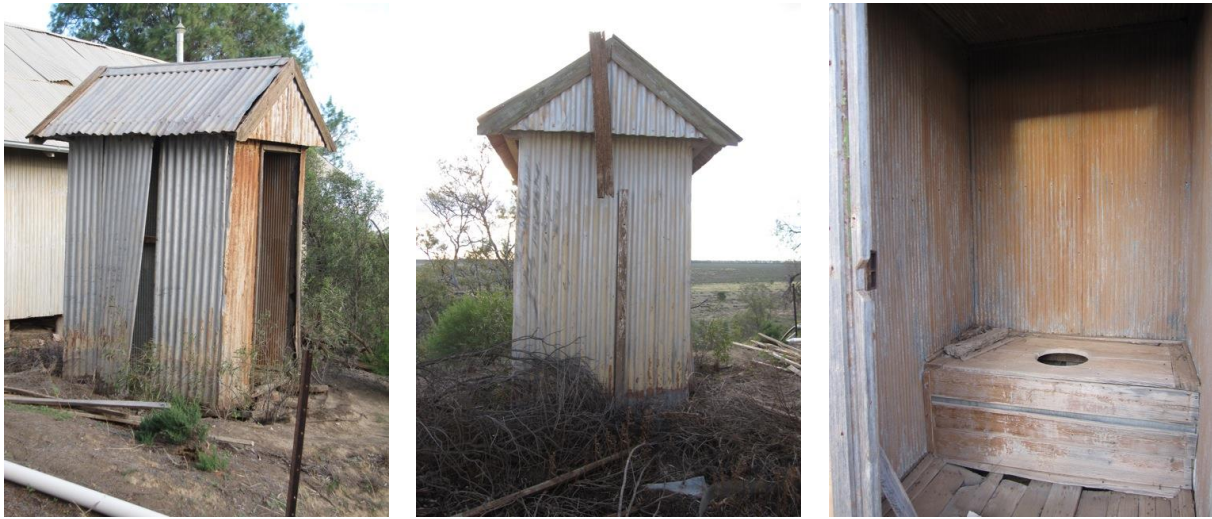
Figure 3.9.30 Views of Stores Outhouse. CMP authors, 2009.

The outhouse is a simple timber framed, cgi clad structure with a gabled roof. The ridge runs east west. It is sited to look over the lake and away from the Store. There is a timber boarded floor and the whole structure is on large section timber sleepers to enable it to be moved. Internally the walls are lined with ripple iron and there is a timber seat. The structure is now undermined, some of the cgi cladding is loose and the door is missing.
