BARRENJOEY HEADLAND CONSERVATION MANUAL

Prepared by GAO Heritage Group
May 2012

This Conservation Management Plan was prepared by the Government Architect's Office,
NSW Public Works for the Office of Environment and Heritage.
Report No. 11090

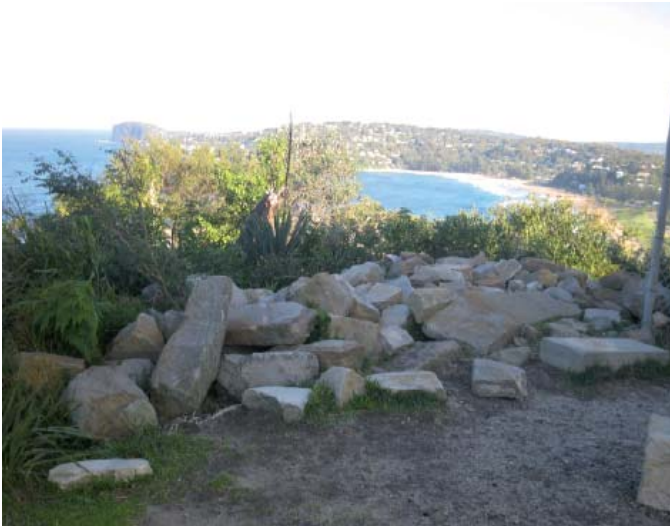
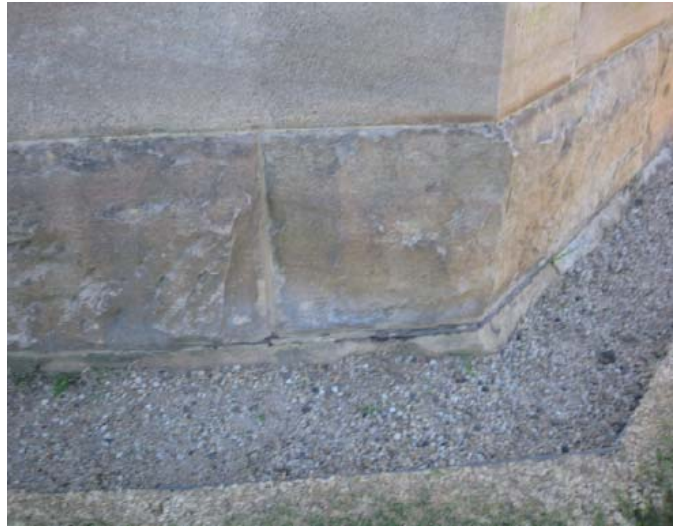
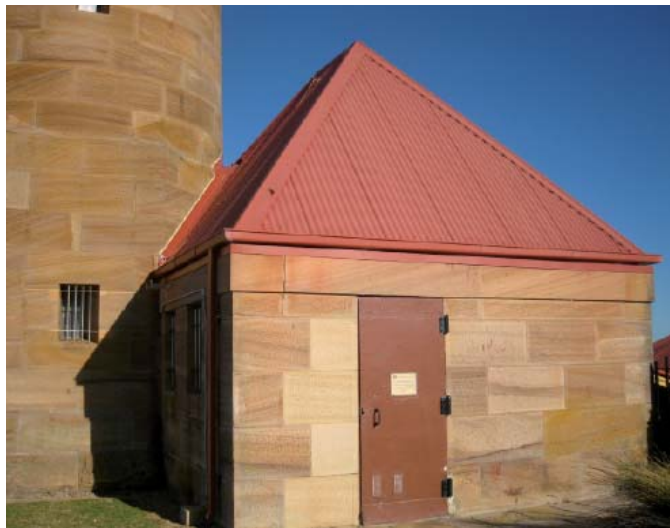
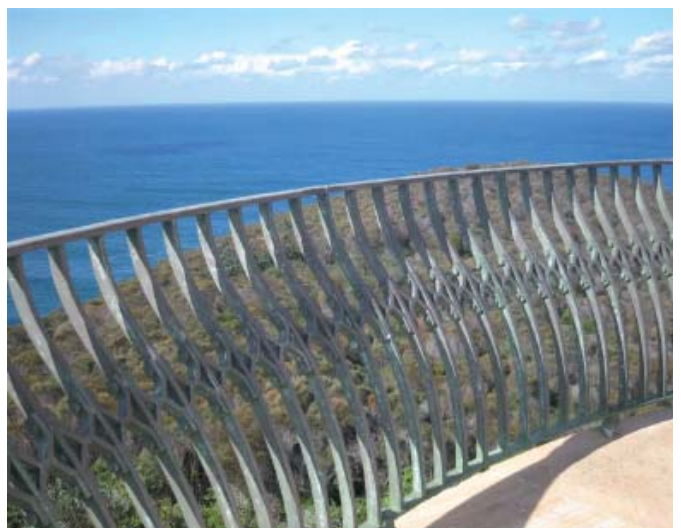
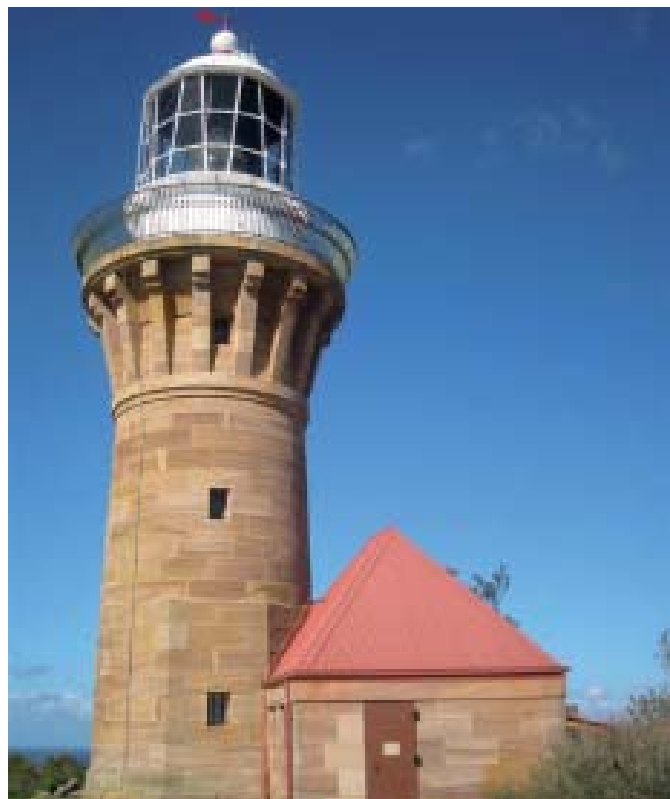
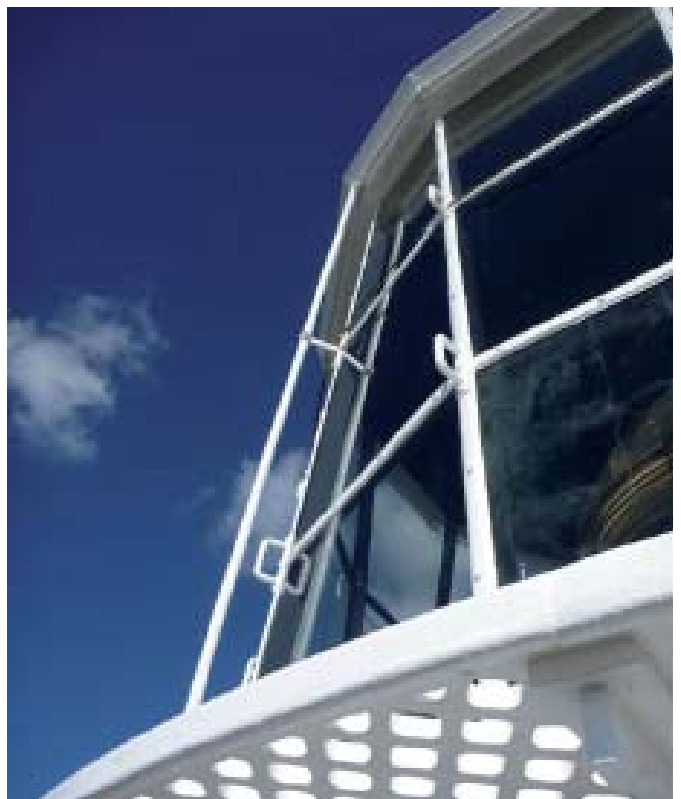
PHOTOGRAPHIC RECORD - EXTERNAL CONDITION

Overall the lighthouse and associated oil room are in moderate to good condition however it has been noted by NPWS staff, Col Brown, that water ingress occurs below the top gallery level following inclement weather. The sandstone fabric and metal elements generally appear to be in sound condition.

Overall the lighthouse and associated oil room are well maintained and in good condition. However corrosion is observed to part of the iron shelving to the perimeter of the lantern.

WORKS	LOCATION	PRIORITY
<p>Immediate surroundings to Lighthouse Perimeter</p> <p>a) Remove grass growing around perimeter of lighthouse</p> <p>b) Remove sandstone rubble and rubbish</p> <p>c) Investigate water leak in external copper tank. Provided tank is superfluous, disconnect.</p> <p>d) Clear debris from existing downpipes and ensure rainwater drains away from building</p>	<p>Adjacent to sandstone walls</p> <p>Just south of lighthouse</p> <p>Just south of lighthouse</p> <p>Perimeter of Lighthouse</p>	<p>1</p> <p>1</p> <p>1</p> <p>1</p>
<p>External Fabric</p> <p>a) Repoint open/defective sandstone joints using lime mortars to address water ingress problem; Specialist heritage advice to be sought to confirm lime mortar mix design and application. Re-pointing of bed joints to be completed by experienced stonemason or masonry restoration specialist.</p> <p>b) Treat corrosion to metal window frames; Remove and treat frame corrosion by removing rust to bright metal, applying protective paint system, where removal is not possible treat in-situ using same method</p> <p>c) Repaint dome, repair dome wind vane, treat corrosion to external catwalk, repaint catwalk and re seal lantern room top sill plate, remove lantern door skin; treat corrosion, rust proof, service lock mechanism and paint.</p> <p>d) Consider extending subsoil drainage for downpipe on NE corner of oil room.</p> <p>e) Consider installing lead flashing with a lip to encourage run-off on parapet above the slit openings to slow down deterioration of stonework below.</p> <p>f) Discuss feasibility with mason and/or glazier of replacing glazed openings to Head Keeper's stair in order to slow down deterioration of surrounding stone; Clean out existing glass remnants from openings and retain for sampling. Glass size must be smaller than total width of opening including recesses to allow fitting – do not remove any stonework to fit glass. Replace with 12mm laminated glass as per original. Putty into position; do not silicone into position.</p>	<p>Upper lantern level</p> <p>Throughout Lighthouse</p> <p>Upper lantern level</p> <p>Adjacent to Oil Room</p> <p>Adjacent to Oil Room</p> <p>Adjacent to Head Light Keeper's stair</p>	<p>1</p> <p>1</p> <p>1</p> <p>2</p> <p>2</p> <p>2</p>

<p>Internal Fabric</p> <p>a) Treat corrosion to shelving, and repaint; Engage stonemason to remove stone from around corroded cast iron on the top step/landing. Treat corrosion by removing rust to bright metal, applying protective paint system and then providing a new block of stone to match original</p> <p>b) Complete works to light house lantern room including reseal glazing, paint glazing astragals, paint blocking plates, repaint floor, de-mould room.</p>	<p>Lower lantern level</p> <p>Lower lantern level</p>	<p>1</p> <p>2</p>

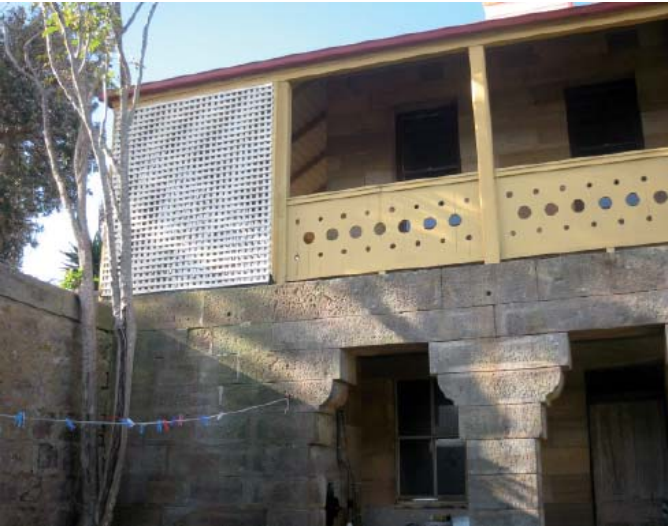
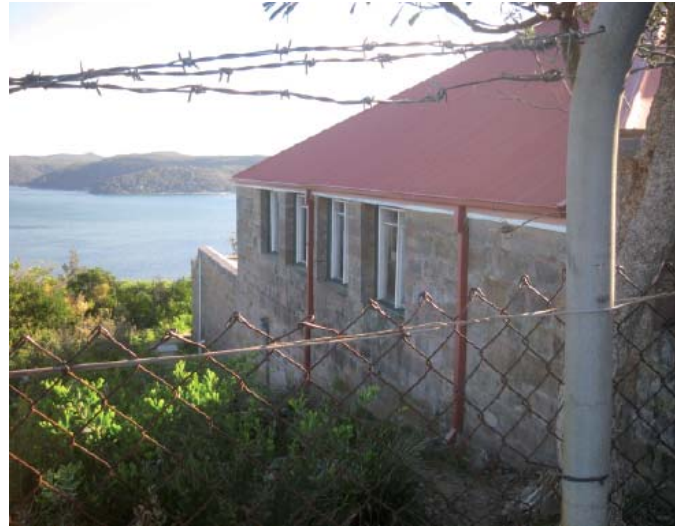
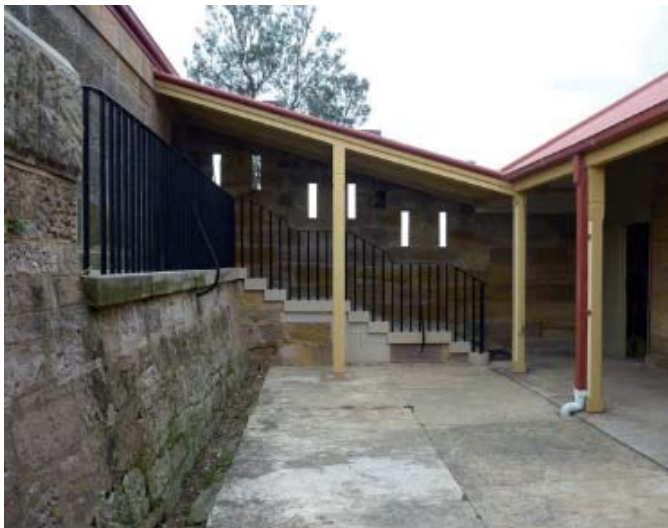
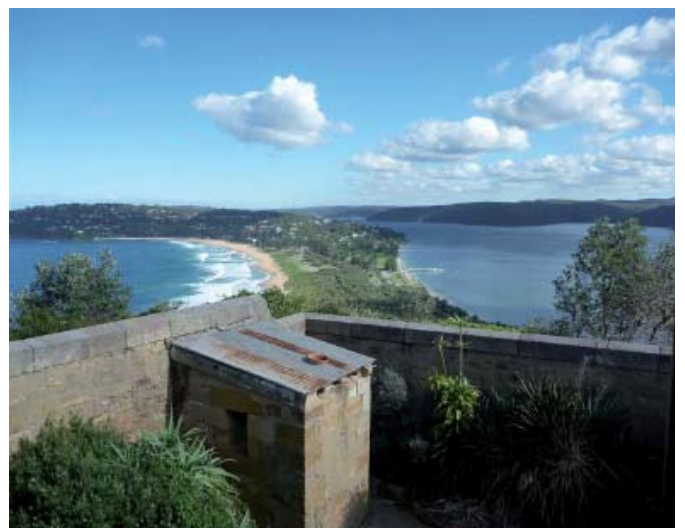
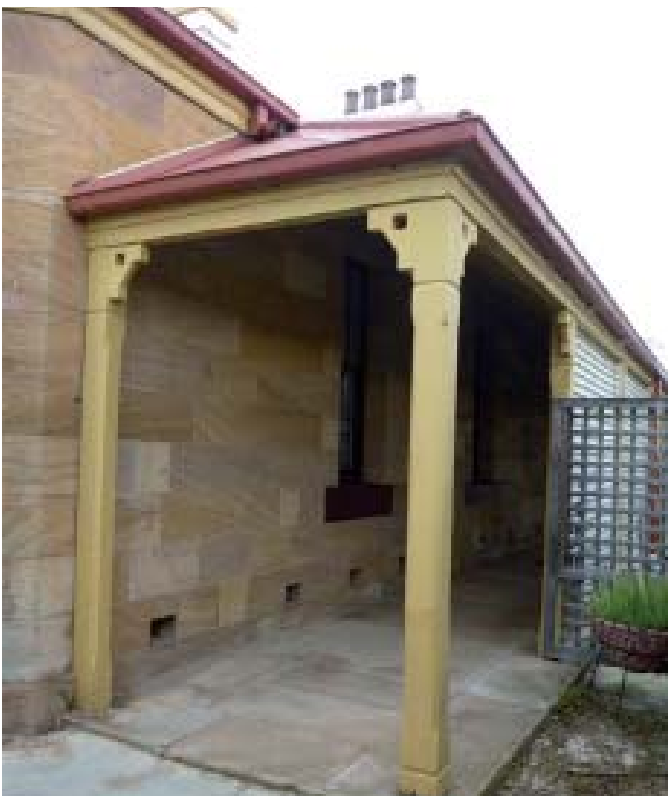
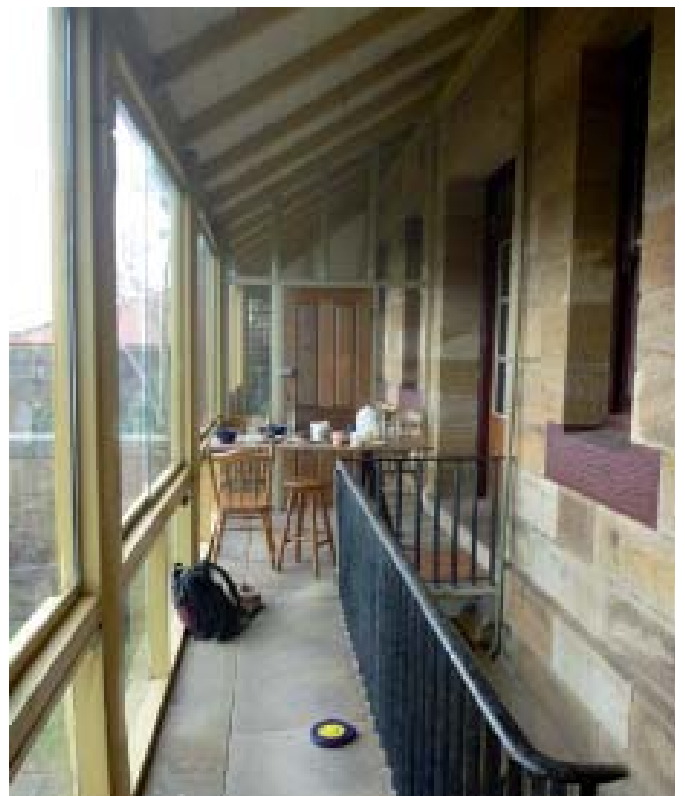
PHOTOGRAPHIC RECORD - EXTERNAL CONDITION

Overall the cottage is in moderate condition and appears to be watertight. The sandstone and timber fabric generally appear to be in sound condition, although there is one crack in the sandstone wall and movement to the south corner of the cottage that is of some concern. The external staircase is corroded and a number of works are required to reinstate missing elements and remove intrusive elements to the cottage.

The outdoor privy appears to be in poor condition with repairs required to the roof.

Overall the cottage to the main level is in moderate condition, however the basement level is in poor condition with a number of repairs required to the walls, floors and windows.

WORKS	LOCATION	PRIORITY
<p>Front and Rear Courtyard</p> <p>a) Clean out all surface water drains ensuring correct operation; Drains to be cleaned by hand using hand tools only ie. shovel / broom.</p> <p>b) Remove vegetation growing from sandstone wall mortar joints, carefully remove to protect stone joints and mortar. Re-instate northern courtyard surface drainage system by removing garden located in this area. Cut back ficus and other vines as close as possible without damage to stone, remove all new growth; Hand remove stems and attachments to stonework, where roots are firmly embedded in joints, cut and poison, do not pull from wall removing excessive mortar.</p> <p>c) Structural Eng. to assess crack in boundary wall and movement in southern corner Note: Check standard exemptions for permissibility of any ground disturbance under the Heritage Act and seek approval as required.</p>	<p>Front and rear courtyard</p> <p>Adjacent to sandstone walls</p> <p>Rear courtyard</p>	<p>1</p> <p>1</p> <p>1</p>

<p>External Fabric</p> <p>a) Remove leaf litter from gutters</p> <p>b) Roof flashing (above living room) north / west corner - complete the sealing of zincalume flashings into stonework; Application of lime mortar or polyurethane sealant to seal flashing to be confirmed by specialist heritage consultant.</p> <p>c) Remove open/defective pointing and repoint using a lime based mortar of the cottage.</p> <p>d) Cut back the vegetation to the access way and remove the vine growing on the structure; Removal of vine to be carefully undertaken to protect stone joints and mortar. Cut back vine as close as possible without damaging stonework, remove all new growth, hand remove stems and attachments to stonework, where roots are firmly embedded in joints, cut and poison, do not pull from wall removing excessive mortar.</p> <p>Remove defective roof sheeting, white ant damaged fascia boards, roof sheeting battens and roof rafters; Replace roof rafters and battens with new seasoned hardwood timbers to match original timber section sizes. Supply and install new fascia board in new materials to match original fascia section & profile. Stainless fixings to be used in connection of all timbers. Roof battens to be fixed to new rafters in accordance with AS 1684 Light Timber Framing Code.</p> <p>e) Replace missing scotia timber mould under eaves around bay window removed to fit guttering.</p> <p>f) Stabilise retaining wall where Coral tree was removed</p> <p>g) Remove lattice enclosing part of the verandahs where missing and current domestic entry door and replace with new security lattice and/or glazing panels that is sympathetic to building architecture. Extend the timber balustrade from the rear verandah around to the side verandah</p> <p>h) Reinstall missing corner frieze details to verandah posts</p> <p>i) Reinstall missing sections of skirting to match existing</p> <p>j) Repair joinery and repaint 3 windows to exterior wall of verandah</p> <p>k) Repair top of balustrade where timber has deteriorated as discreetly as possible to match existing profile and timber grade</p> <p>l) Replace window with new window to match existing size, type and profile</p> <p>m) Replace timber baserail under glazed screen to verandah matching existing profile and timber grade.</p>	<p>Gutters</p> <p>Roof</p> <p>To sandstone joints (particularly to rear facade)</p> <p>WC</p> <p>Above W1 to W3</p> <p>Front courtyard</p> <p>V3 & V4</p> <p>V1, V3 & V4</p> <p>Living</p> <p>V2</p> <p>V4</p> <p>W24</p> <p>V2</p>	<p>1</p> <p>1</p> <p>1</p> <p>1</p> <p>2</p> <p>2</p> <p>2</p> <p>2</p> <p>2</p> <p>2</p> <p>2</p> <p>2</p>

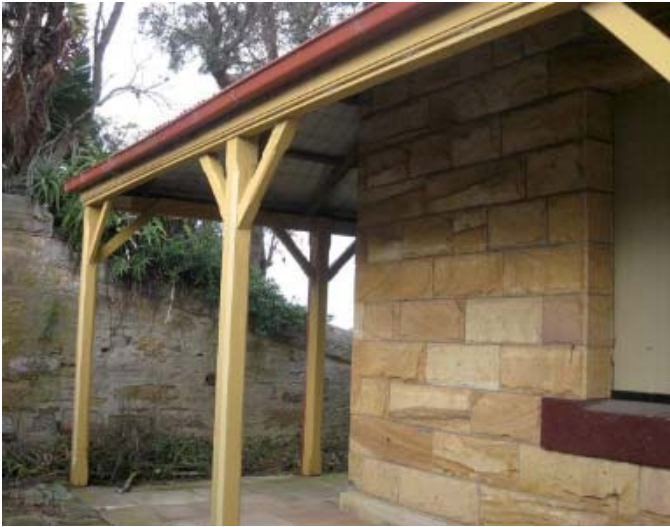
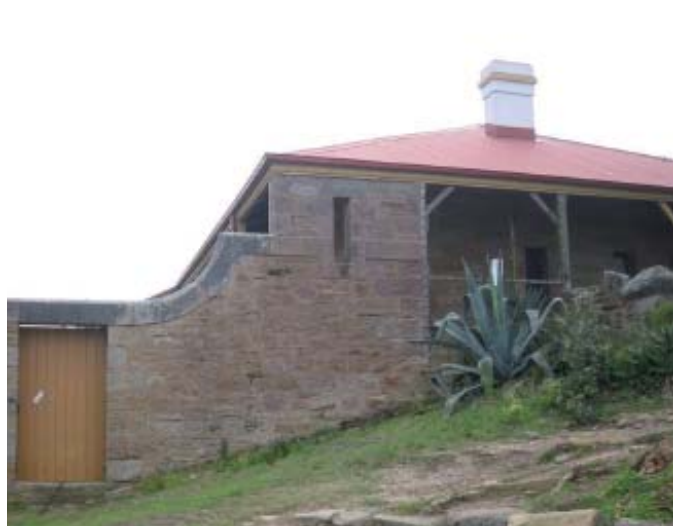
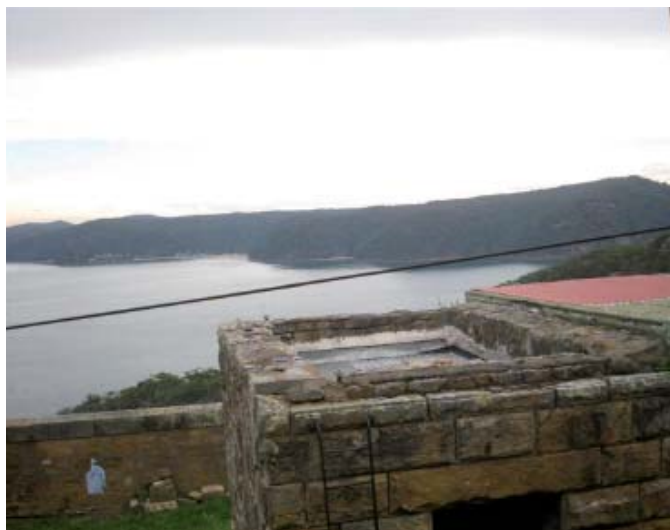
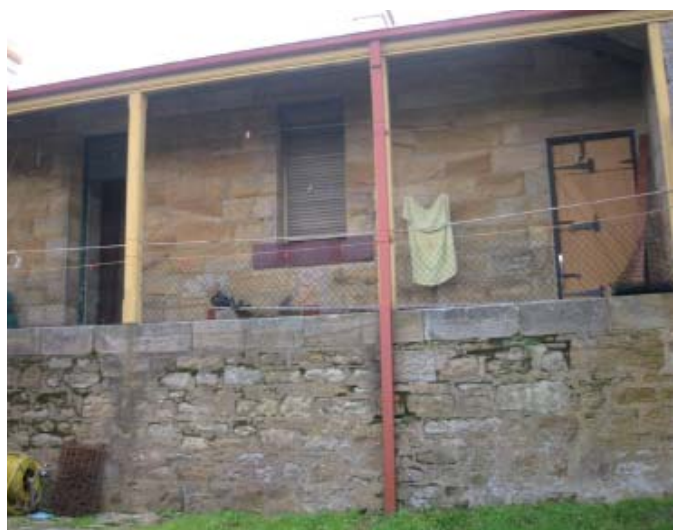
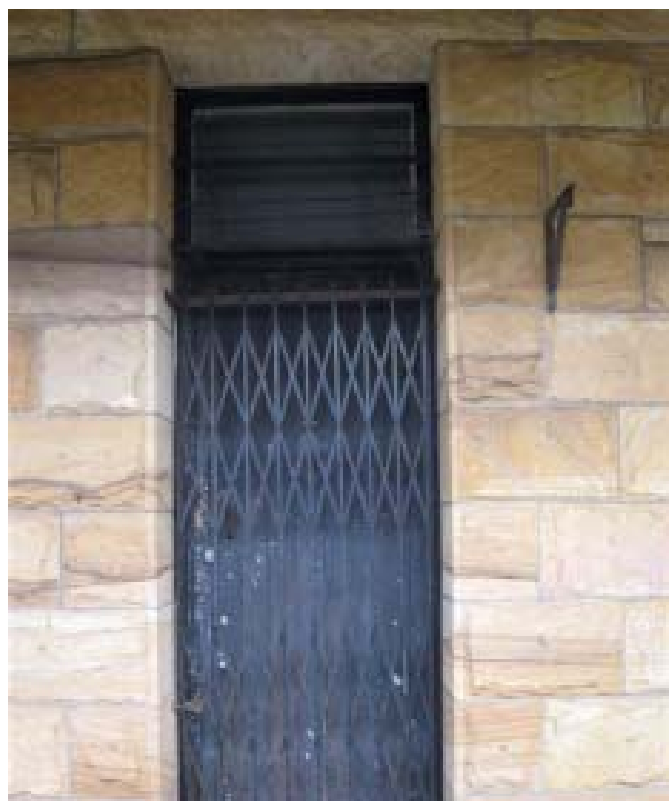
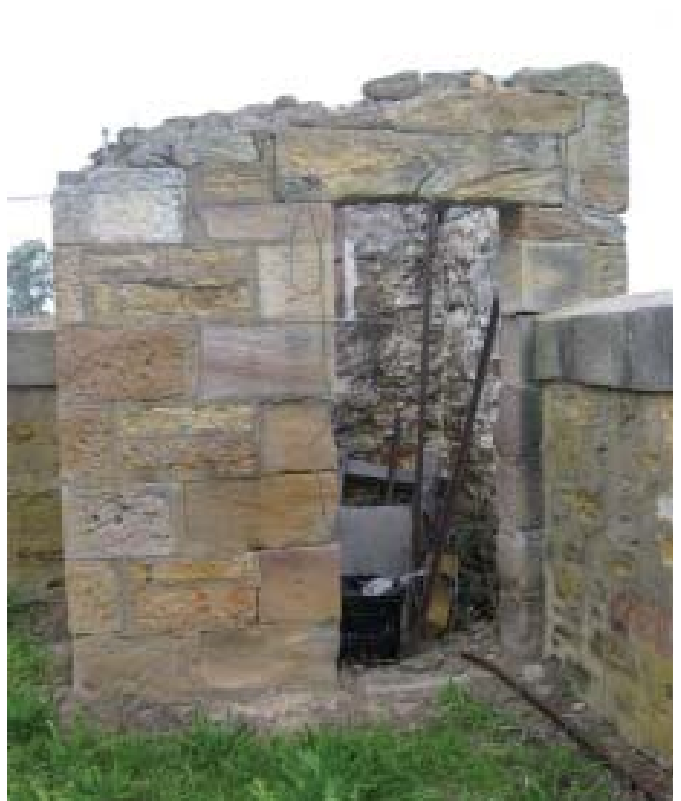
PHOTOGRAPHIC RECORD - EXTERNAL CONDITION

Overall the cottage is in moderate condition and appears to be watertight. The sandstone and timber fabric generally appear to be in sound condition although the balustrade is missing to the rear verandah and repairs are required to the external staircase. The outbuilding appears to be in poor condition although it requires a new roof and drainage system. The outdoor privy is in a semi-ruinous state.

Overall the cottage and outbuildings are in moderate condition. Some of the internal sandstone walls are painted and there are a number of more recent modifications made by more recent residents.

WORKS	LOCATION	PRIORITY
<p>Front and Rear Courtyard</p> <p>a) Remove vegetation growing from sandstone wall mortar joints, carefully remove to protect stone joints and mortar. Cut back ficus and other vines as close as possible without damage to stone, remove all new growth, hand remove stems and attachments to stonework, where roots are firmly embedded in joints, cut and poison, do not pull from wall removing excessive mortar.</p> <p>b) Remove rubbish and debris</p> <p>c) Clean out all surface water drains ensuring correct operation</p> <p>d) Treat for rust and repaint hand water pump and lid to ground water tank</p> <p>e) Remove redundant pipework to exterior</p> <p>f) Ease and adjust courtyard entry gates ensuring 5 mm clearance below door. Treat exposed timber with oil based primer and recoat complete timber gate in paint system to match existing on completion.</p>	<p>Adjacent to sandstone walls</p> <p>Rear courtyard & Outbuilding</p> <p>Rear courtyard</p> <p>Rear courtyard</p> <p>Rear courtyard</p> <p>Front courtyard</p>	<p>1</p> <p>1</p> <p>1</p> <p>1</p> <p>2</p> <p>1</p>

<p>External Fabric</p> <p>a) Install lining to underside of cottage verandah and above external staircase to match existing timber paneling with v-joint finish</p> <p>b) Extend end of downpipe and ensure stormwater drains away from verandah post. Consider installing subsoil drainage if needed.</p> <p>c) Remove leaf litter from cottage gutters</p> <p>d) Remove defective pointing and repoint using a lime based mortar of the cottage wall</p> <p>e) Remove roofing and stormwater drainage system to the outbuilding and install a flat roof similar to that of the adjacent duplex with gutter installed to the western facade</p> <p>f) Remove downpipe attached to the eastern facade of the outbuilding and divert the drainage from the covered area over the staircase to the new outbuilding roof (refer (d)).</p> <p>g) Reinstate missing glazing bar to top sash</p> <p>h) Pin and repair the top two treads of the external staircase</p> <p>i) Reinstate corrugated roof to former privy and stabilise structure</p> <p>j) Repair defective verandah post to south elevation by either cutting and removing defective section of post and installing new scarfed section of timber to match existing section size and profile or completely replace post with new hardwood post that is similar in section size and profile to original item. Replace or repair end verandah post and introduce a new balustrade between the two posts to match existing in size, profile colour and timber grade. Balustrade may need amendment to meet current BCA standards eg a higher rail above recreated timber balustrade.</p> <p>l) Remove steel reinforcement mesh (security screen) and replace with new security lattice and/or glazing panels sympathetic to building architecture</p> <p>m) Treat the metal fixture adjacent to the main entrance</p> <p>n) Treat metal grill to windows</p> <p>o) Refix the loose metal fixing used to hold window shutter into mortar joint</p> <p>p) Treat as per stairs in Head Keepers cottage A2 above, external fabric - n).</p> <p>q) Remove all flaking/defective paint coatings of all external timber building elements. Prepare timber surfaces in accordance with Australian Standard 2311 and on completion apply timber primer and two coats of finishing paint.</p>	<p>V1 to V3 & above staircase</p> <p>V1</p> <p>Gutters</p> <p>To sandstone joints</p> <p>Outbuilding</p> <p>Outbuilding</p> <p>W9</p> <p>External staircase</p> <p>Privy</p> <p>V2, V3</p> <p>V1</p> <p>D1 & D2</p> <p>W1 & W2</p> <p>Adjacent to W9</p> <p>External staircase</p> <p>To exterior throughout</p>	<p>2</p> <p>1</p> <p>1</p> <p>1</p> <p>1</p> <p>2</p> <p>1</p> <p>2</p> <p>2</p> <p>1</p> <p>1</p> <p>2</p> <p>2</p> <p>2</p> <p>2</p> <p>1</p> <p>2</p>

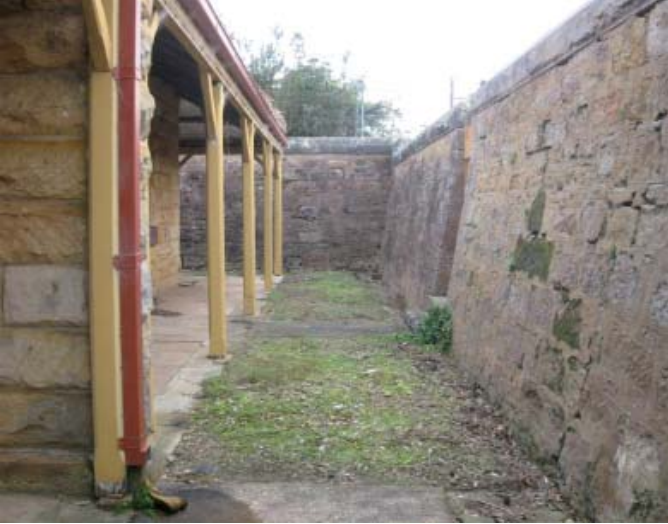
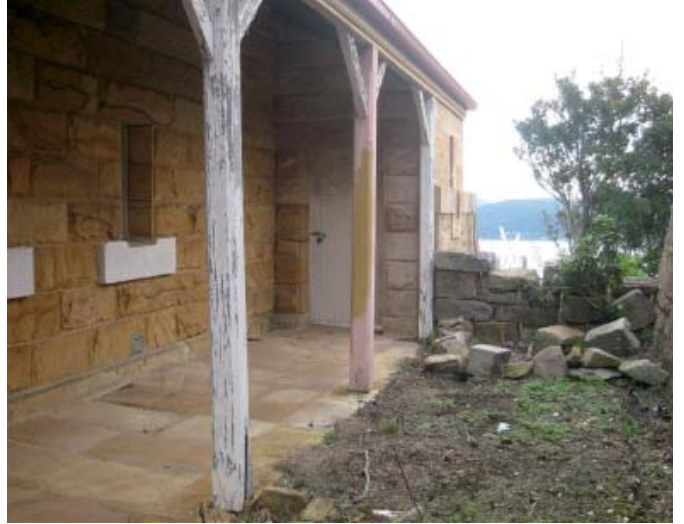
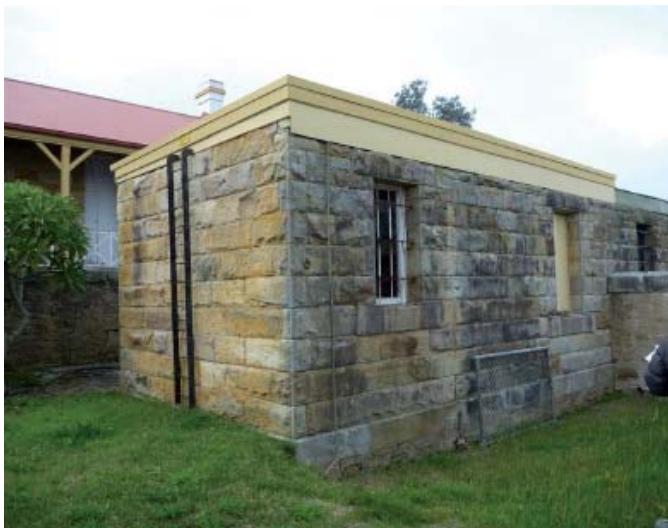
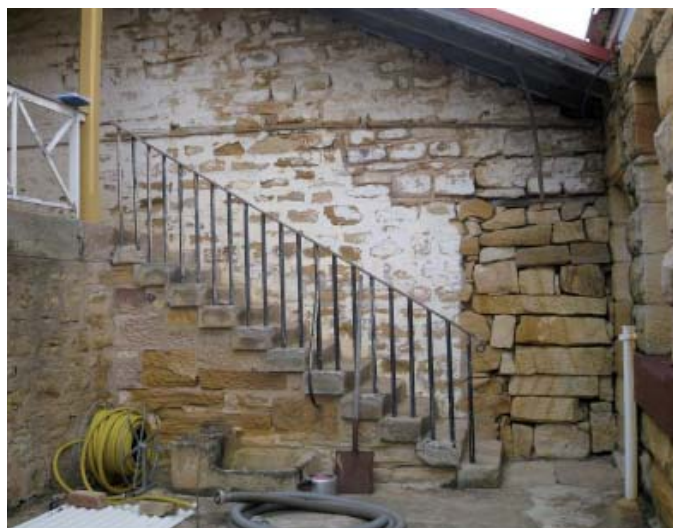
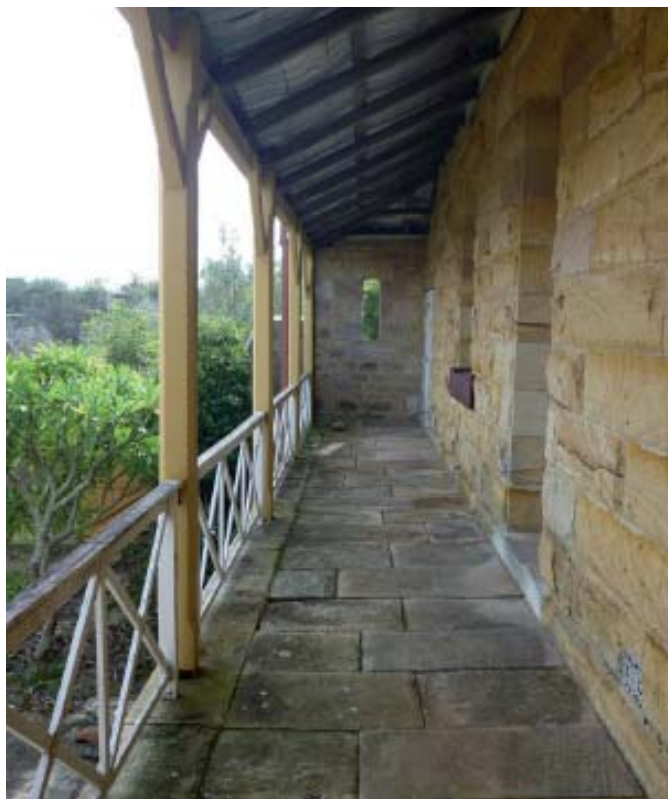
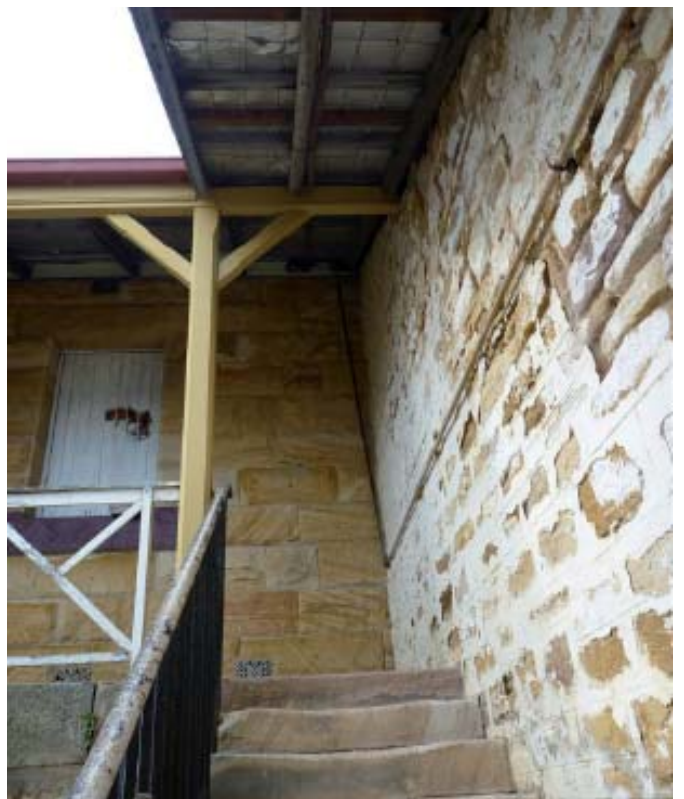
PHOTOGRAPHIC RECORD - EXTERNAL CONDITION

Overall the cottage is in moderate condition and appears to be watertight. The sandstone and timber fabric generally appear to be in sound condition although repairs are required to the sandstone treads to the external staircase. The outbuilding appears to be in moderate condition and the outdoor privy is in poor condition (although difficult to assess due to the amount of rubbish stored within it).

Overall the cottage and outbuildings are in moderate condition. Some of the internal sandstone walls are painted and there are a number of more recent modifications made by more recent residents.

WORKS	LOCATION	PRIORITY
<p>Front and Rear Courtyard</p> <p>a) Remove vegetation growing from sandstone wall mortar joints, carefully remove to protect stone joints and mortar. Cut back ficus and other vines as close as possible without damage to stone, remove all new growth, hand remove stems and attachments to stonework, where roots are firmly embedded in joints, cut and poison, do not pull from wall removing excessive mortar.</p> <p>b) Remove rubbish and debris</p> <p>c) Even out grassed area</p> <p>d) Clean out all surface water drains ensuring correct operation</p> <p>e) Treat for rust and repaint hand water pump and lid to ground water tank</p> <p>f) Remove redundant pipework to exterior</p> <p>g) Ease and adjust courtyard entry gates ensuring 5 mm clearance below door. Treat exposed timber with oil based primer and recoat complete timber gate in paint system to match existing on completion.</p>	<p>Adjacent to sandstone walls</p> <p>Rear courtyard & Outbuilding</p> <p>Rear courtyard</p> <p>Rear courtyard</p> <p>Rear courtyard</p> <p>Rear courtyard</p> <p>Front courtyard</p>	<p>1</p> <p>1</p> <p>2</p> <p>1</p> <p>1</p> <p>2</p> <p>1</p>

<p>External Fabric</p> <p>a) Install lining to underside of cottage verandah and above external staircase to match existing timber paneling with v-joint finish</p> <p>b) Remove leaf litter from cottage gutters</p> <p>c) Remove defective pointing and repoint using a lime based mortar of the cottage wall</p> <p>d) Rebuild and stabilise end stone wall adjacent to D7</p> <p>e) Install downpipe to the eastern facade of the outbuilding to divert the drainage from the covered area over the staircase.</p> <p>f) Repaint joinery to verandah</p> <p>g) Reinstate missing elements and repaint joinery to balustrade</p> <p>h) Install new window</p> <p>i) Treat as per stairs in Head Keepers cottage A2 above, external fabric, m)</p> <p>j) Treat metal grill to windows</p>	<p>V1 to V3 & above staircase</p> <p>Gutters</p> <p>To sandstone joints</p> <p>Adjacent to D7</p> <p>External staircase</p> <p>V2</p> <p>V3</p> <p>W11</p> <p>External staircase</p> <p>W11</p>	<p>2</p> <p>1</p> <p>1</p> <p>1</p> <p>1</p> <p>2</p> <p>2</p> <p>1</p> <p>1</p> <p>2</p>

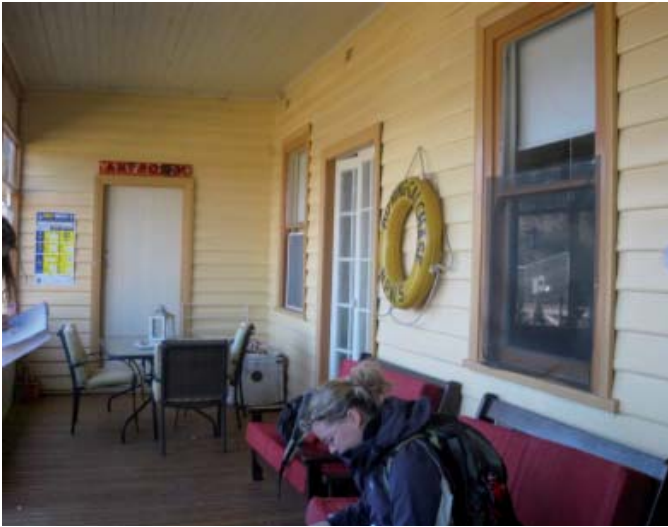
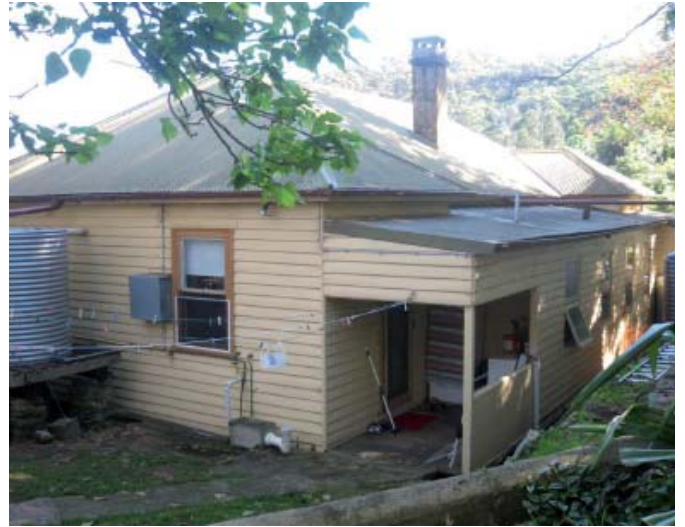
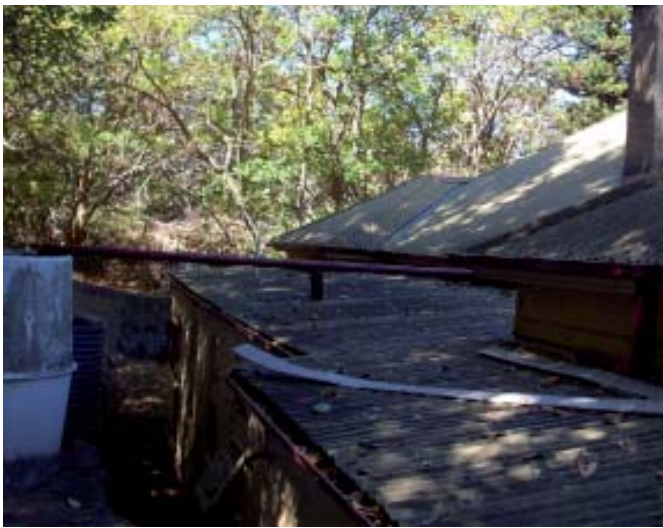
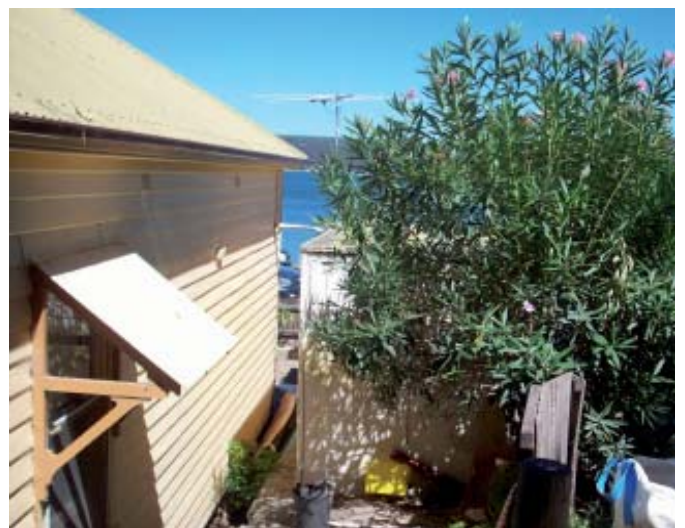
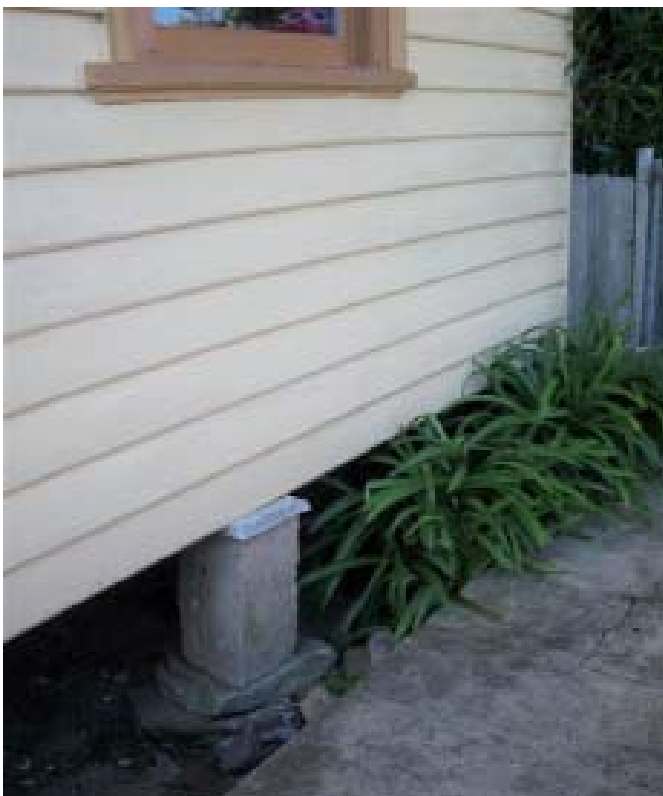
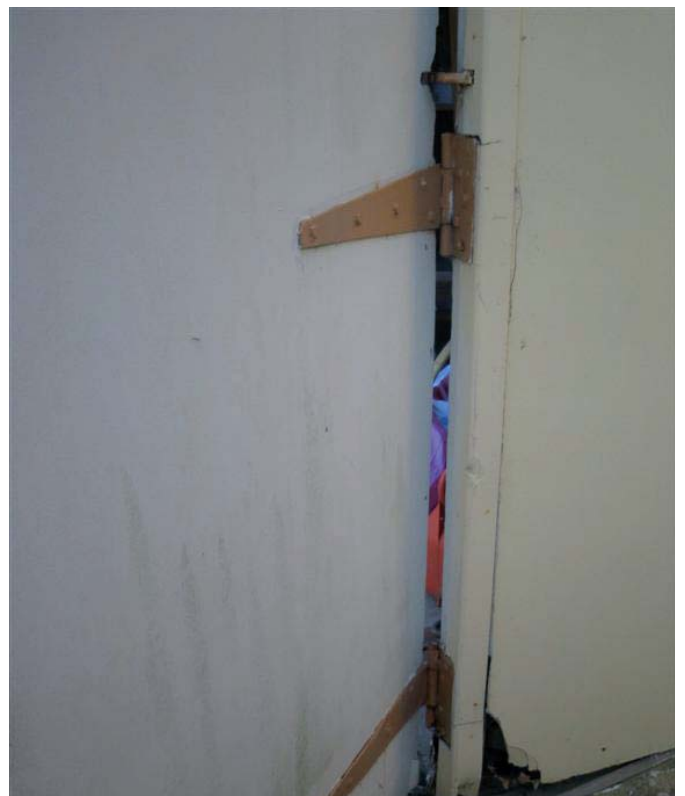
PHOTOGRAPHIC RECORD - EXTERNAL CONDITION

Overall the cottage is in good condition and appears to be well maintained as it is currently tenanted to a NPWS staff member. The building appears to be watertight and the joinery is generally in sound condition.

Overall the cottage is in good condition, however the shed is in moderate condition.

WORKS	LOCATION	PRIORITY
<p>Front and Rear yard</p> <p>a) Replace fallen sections of timber paling fence</p> <p>b) Remove rubbish and debris</p> <p>c) Stabilise retaining wall to rear of property and consider volume upgrade of rainwater tank</p> <p>d) Remove build-up of wind and tide-borne sand at regular intervals, back to original levels</p> <p>e) Remove coral trees from Customs House precinct beyond the yard that are having a negative impact on archaeological or natural heritage values of the site. Poison the stumps rather than removing them to avoid damage to archaeological deposit(s). Note that excavation in the front yard requires approval under section 90 of the NPW Act as it may have an impact on an Aboriginal midden in the vicinity.</p>	<p>Front yard north west</p> <p>Front & rear yard</p> <p>Rear yard</p> <p>Rear yard</p> <p>Front & rear yard</p>	<p>1</p> <p>1</p> <p>2</p> <p>2</p> <p>2</p>

<p>External Fabric</p> <p>a) Chock the swandstone blocks on isolated piers where there is minor subsistence in order to stabilise the timber sub-floor frame</p> <p>b) Remove leaf litter from cottage gutters, install guards to rear skillion and level gutters to ensure water is draining away from roof. Refix gutters as required.</p> <p>c) Repair gutter/downpipe to shed and ensure water drains away adequately</p> <p>d) Remove redundant conduits to rear facade</p> <p>e) Repair missing section of window hood.</p> <p>f) Investigate condition of all existing windows including sashes and make appropriate repairs</p> <p>g) Verandah</p> <ul style="list-style-type: none"> - Replace rotten boards with hardwood and replace defective timbers to match existing. - Replace decking with 65mm x 18mm pencil round hardwood decking with a gap of 3mm between each board. - Replace masonite boards on the verandah wall with 800mm high fibre cement/ blue boards. Reinstall framework by putting studs back in and then replace boards. Install a back cover sheet and paint boards. - Install shutters on verandah for sun protection using existing brackets and rope holders. 	<p>Under cottage</p> <p>Gutters</p> <p>Shed</p> <p>Rear facade</p> <p>W12</p> <p>All</p> <p>Verandah</p>	<p>1</p> <p>1</p> <p>1</p> <p>2</p> <p>1</p> <p>2</p> <p>1</p>

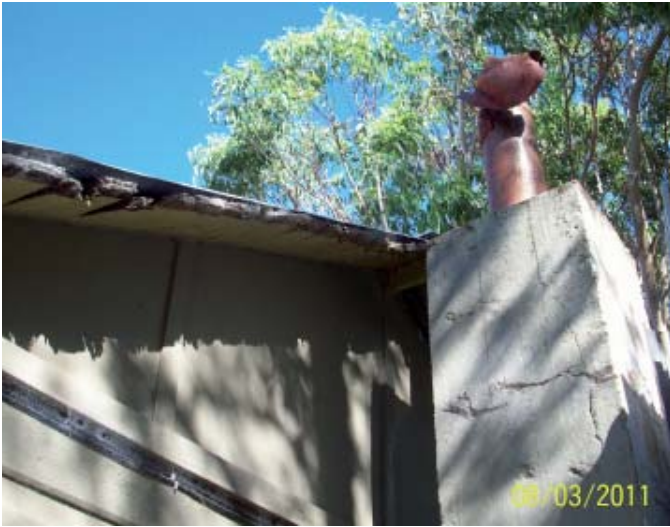
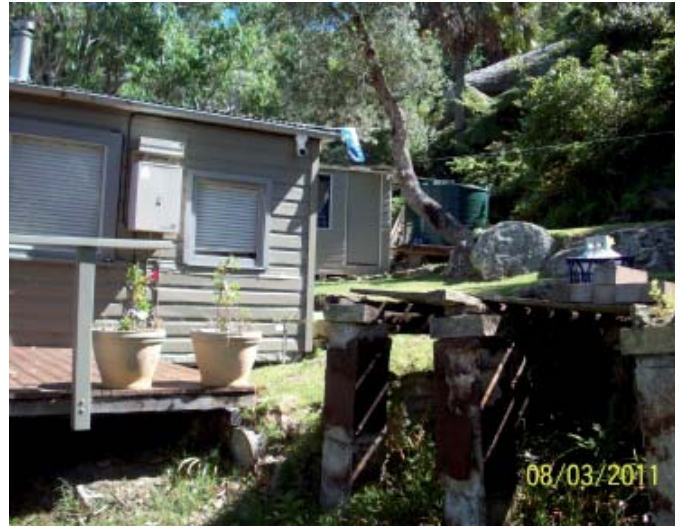
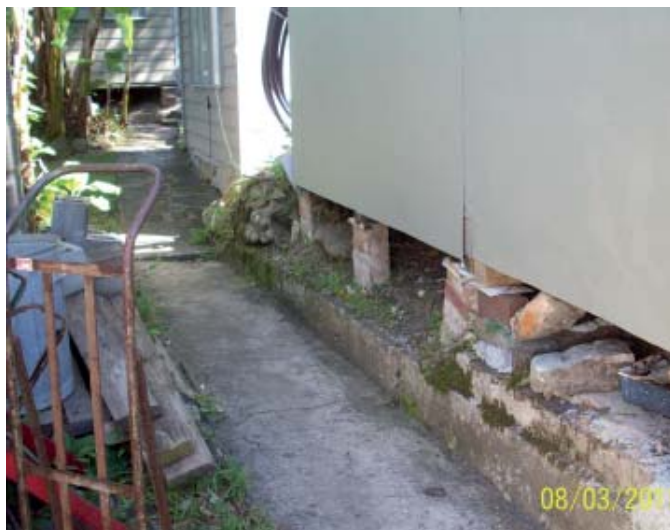
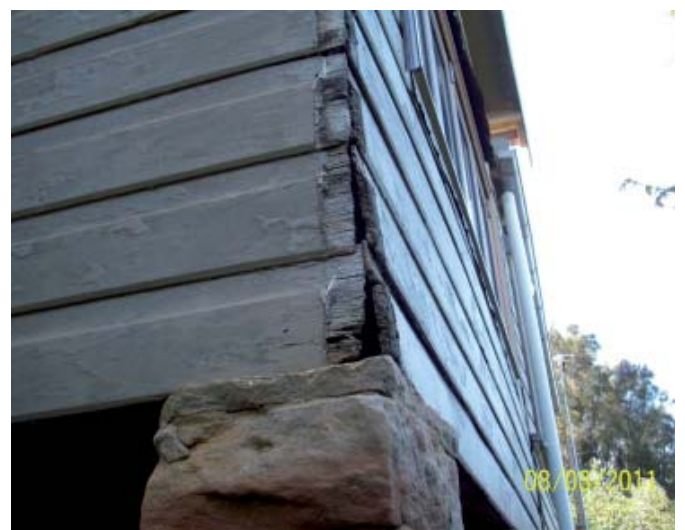
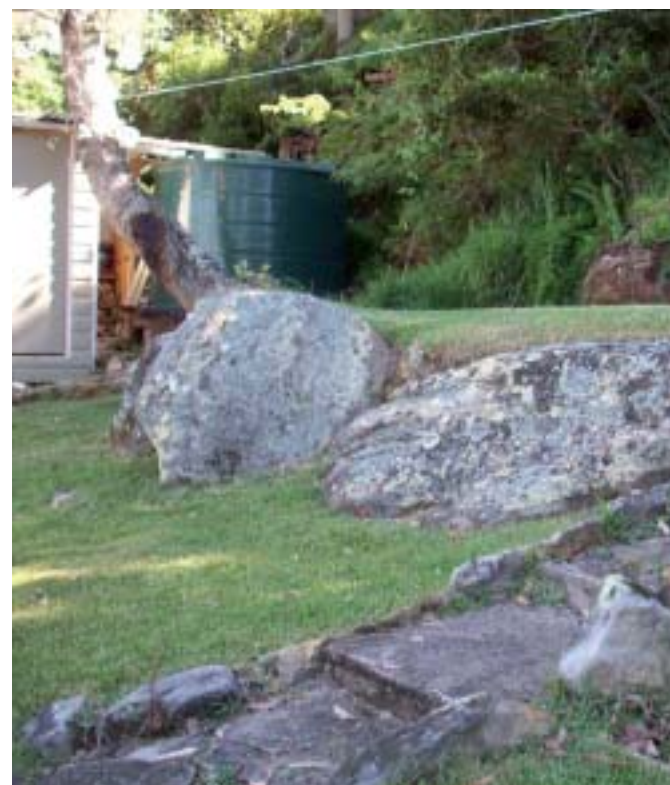
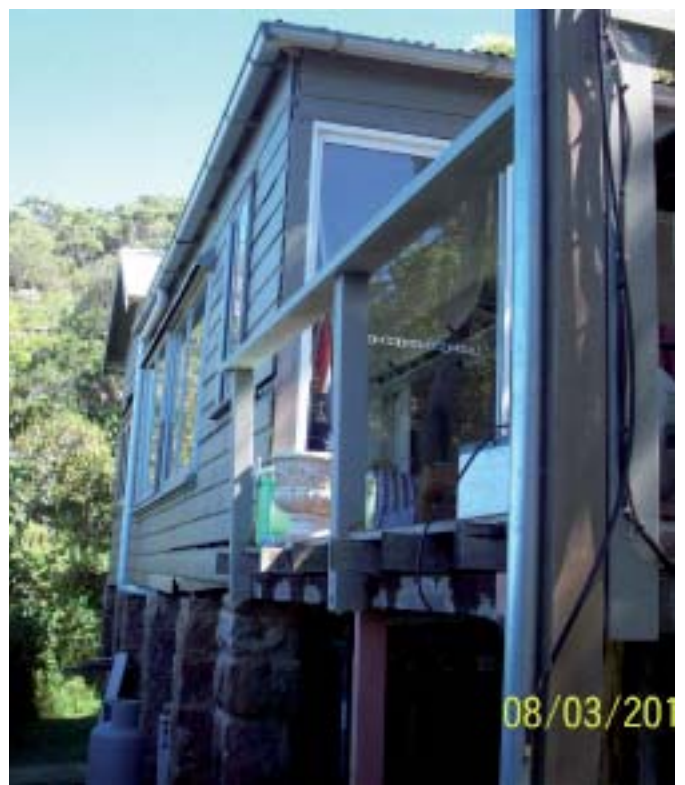
PHOTOGRAPHIC RECORD - EXTERNAL CONDITION

Overall the cottage is in moderate to good condition and appears to be watertight. The weatherboard has rotted in some instances and requires repair, as do some of the roofing sheets/gutters which appear to be dropping to some elevations.

Overall the cottage interior appears to be well maintained and outbuildings are in good condition.

WORKS	LOCATION	PRIORITY
<p>Front and Rear Courtyard</p> <p>a) Carefully remove weeds and overgrowth</p> <p>b) Remove rubbish/debris</p> <p>c) Implement sand removal strategy to address sand build up at the front of the cottage</p>	<p>Around the property</p> <p>Around the property</p>	<p>2</p> <p>2</p>
<p>External Fabric</p> <p>a) Remove leaf litter from cottage gutters</p> <p>b) Refix roofing sheets/gutters and ensure that water is adequately diverted away from the cottage.</p>	<p>Gutters</p> <p>Gutters</p>	<p>1</p> <p>2</p>
<p>Internal Fabric</p> <p>None identified as access was not permitted.</p>		
<p>Joinery</p> <p>a) Repair ends to timber boarding underneath roof sheets and install fascia board to gable end</p> <p>b) Install ends to weatherboard where required and install edge corner trims to the cottage where missing</p> <p>c) Reinstate missing window architrave to the exterior of the small bedroom window</p>	<p>Gable to north facade</p> <p>To exterior</p> <p>Western facade</p>	<p>1</p> <p>1</p>

<p>Metal</p> <p>a) Replace vent to chimney</p>	<p>To bedroom chimney</p>	<p>2</p>
