BARRENJOEY HEADLAND CONSERVATION MANUAL

Prepared by GAO Heritage Group
May 2012

This Conservation Management Plan was prepared by the Government Architect's Office,
NSW Public Works for the Office of Environment and Heritage.
Report No. 11090

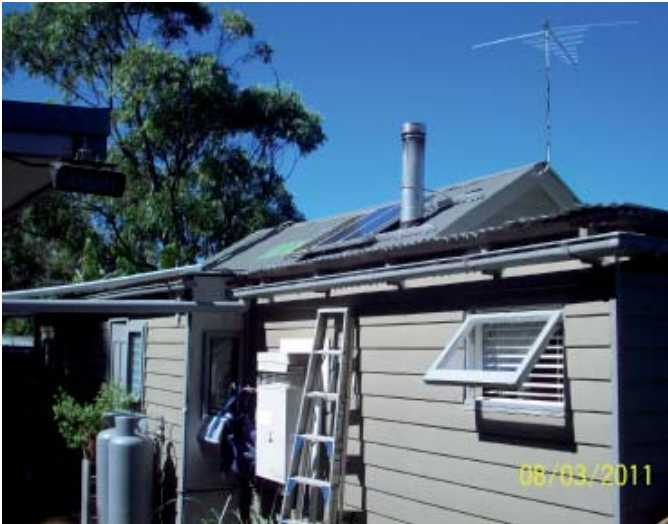
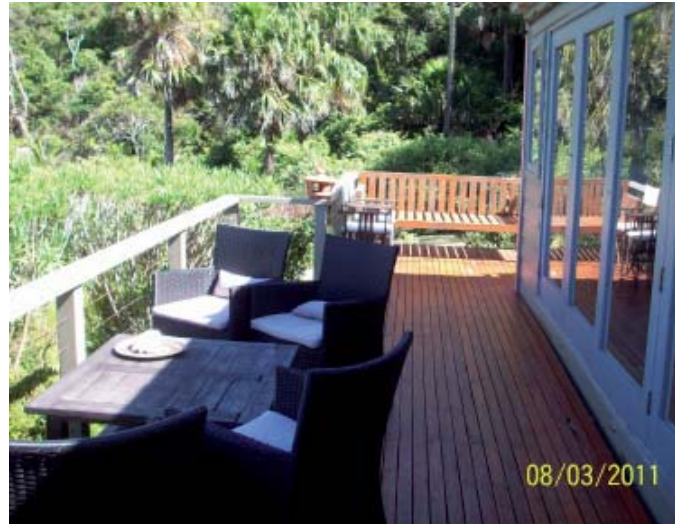
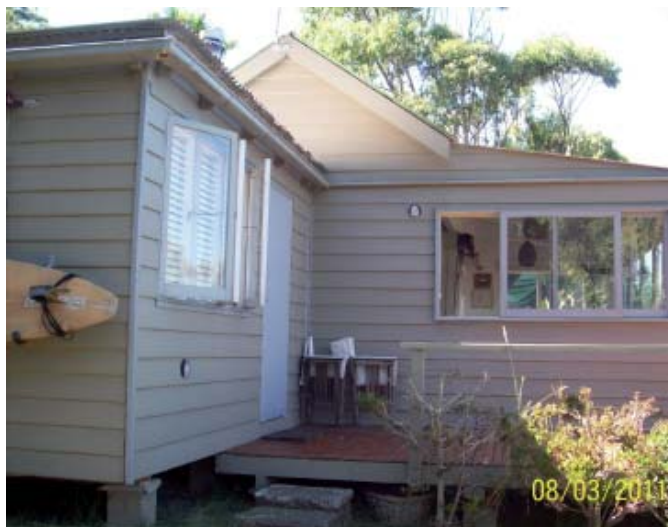
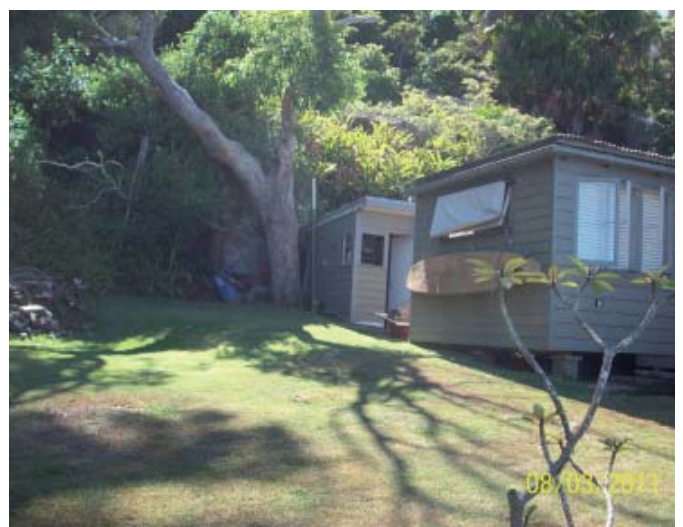
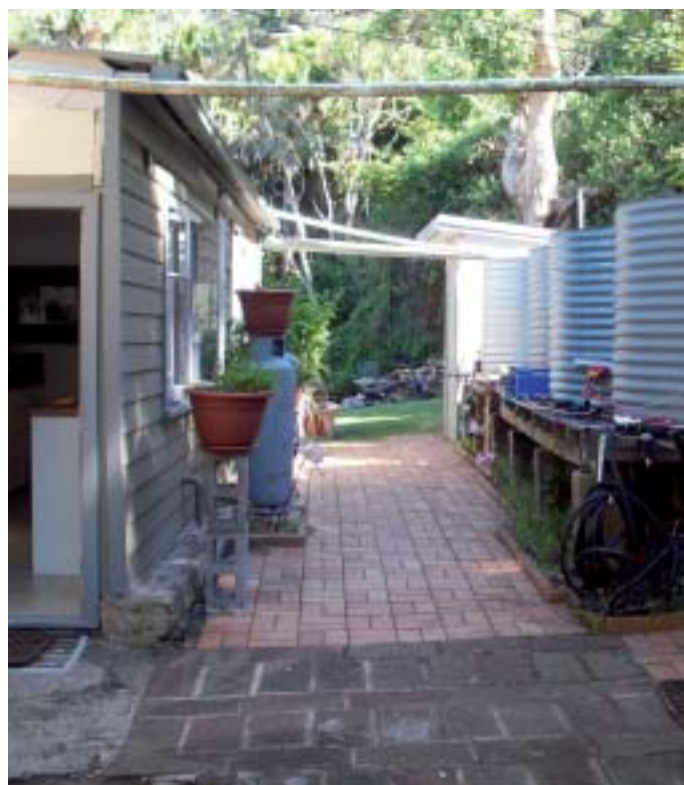
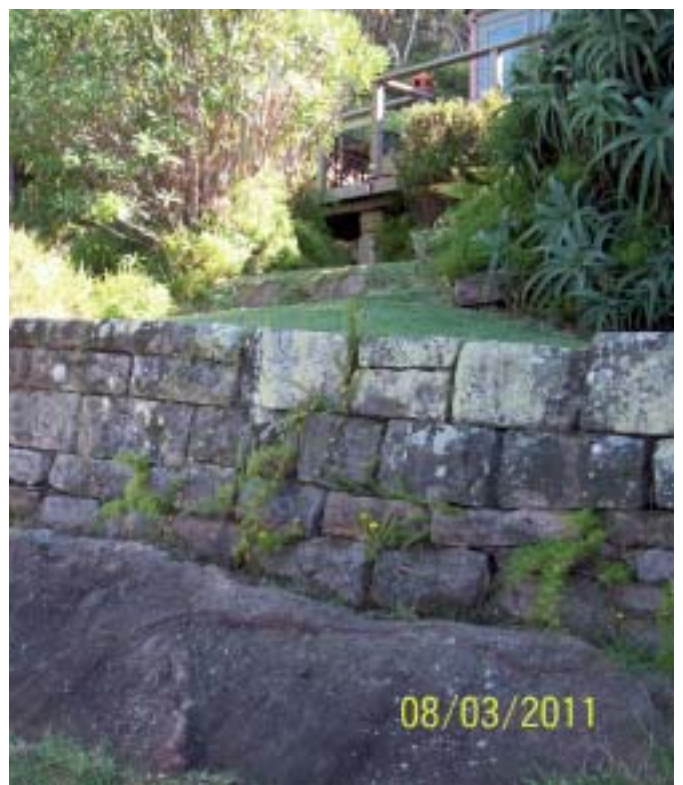
PHOTOGRAPHIC RECORD - EXTERNAL CONDITION

Overall the cottage is in moderate to good condition and appears to be watertight. The weatherboard has rotted in some instances and requires repair, as do some of the roofing sheets/gutters which appear to be drooping to some elevations.

Overall the cottage interior appears (from photographs) to be well maintained and outbuildings are in good condition.

WORKS	LOCATION	PRIORITY
<p>Front and Rear Courtyard</p> <p>a) Carefully remove weeds and overgrowth</p> <p>b) Remove rubbish/debris</p>	<p>Around the property and to sandstone retaining wall</p> <p>Around the property</p>	<p>2</p> <p>2</p>
<p>External Fabric</p> <p>a) Remove leaf litter from cottage gutters</p> <p>b) Refix roofing sheets/gutters and ensure that water is adequately diverted away from the cottage.</p> <p>c) Repoint the sandstone retaining wall</p>	<p>Gutters</p> <p>Gutters</p> <p>Retaining wall</p>	<p>1</p> <p>2</p> <p>2</p>
<p>Internal Fabric</p> <p>None identified as access was not permitted</p>		
<p>Joinery</p> <p>a) Repair ends to timber boarding underneath roof sheets and install fascia board to gable end</p> <p>b) Install ends to weatherboard where required and install edge corner trims to the cottage where missing</p> <p>c) Reinstate missing window architrave to the exterior of the small bedroom window</p>	<p>Gable to north facade</p> <p>To exterior</p> <p>Western facade</p>	<p>1</p> <p>1</p>

<p>Metal</p> <p>a) Replace vent to chimney</p>	<p>To bedroom chimney</p>	<p>2</p>
