Illawarra Escarpment Mountain Bike Concept Plan Geotechnical Assessment Report (Revised Trail Network)

Niche Environment and Heritage Pty Ltd

24 March 2022

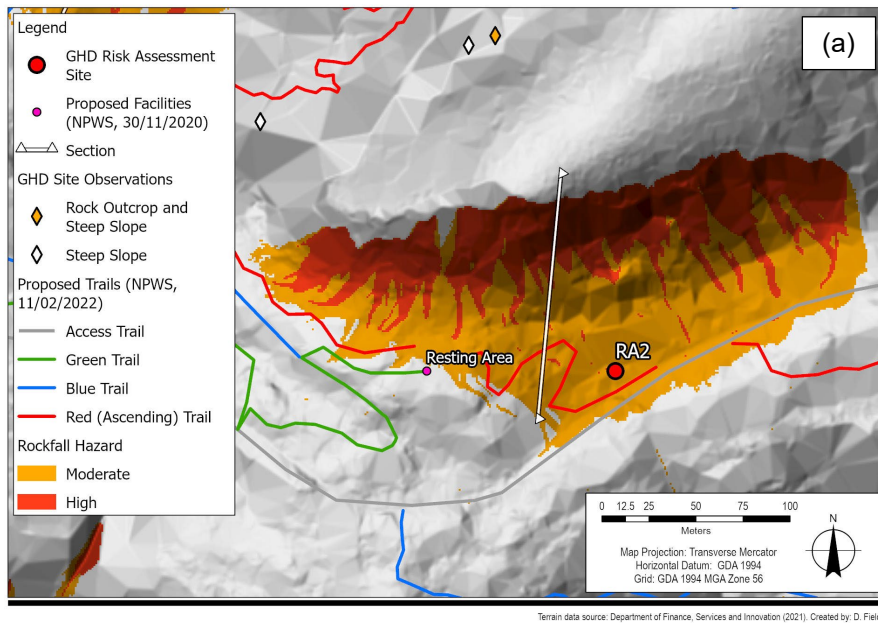
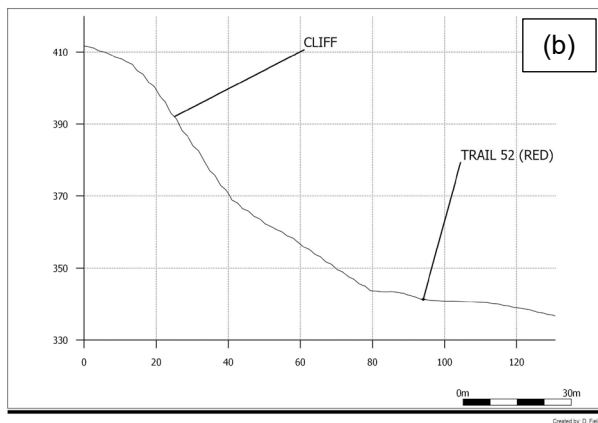
Figure 9: Geohazard risk assessment site RA2 large scale plan (a), cross section (b) and site photo (c)

As well as possible rockfall hazards originating from the cliff (a), evidence of landslide activity was also noted on the lower slopes including, broken vegetation, seepage and undulating / hummocky ground.

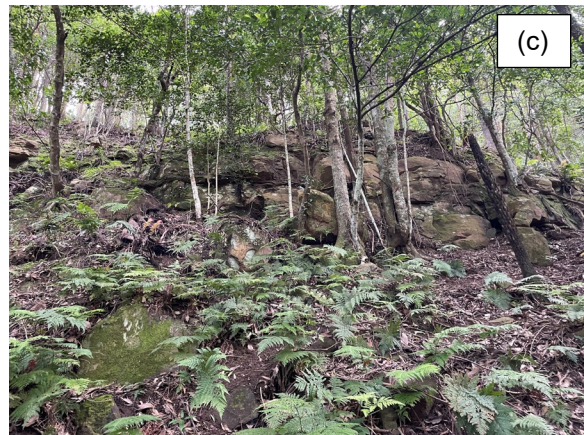
Figure 10: Geohazard risk assessment site RA3 large scale plan (a), cross section (b) and site photo (c)

As well as rockfall hazards originating from the cliff (a), evidence of landslide activity was also noted on the lower slopes including, broken vegetation canopy and leaning / distressed trees, small headscarps and translational slides in colluvial soils.

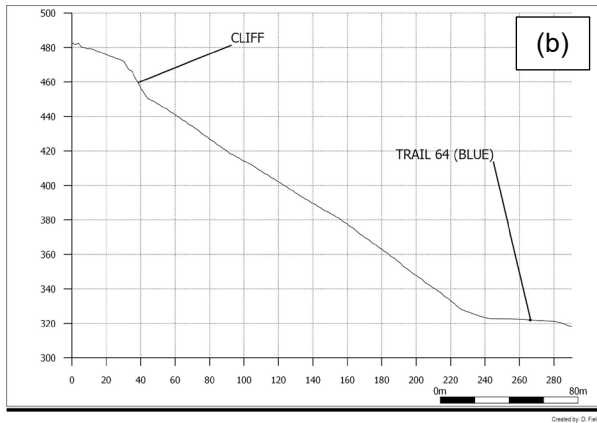
Figure 11: Geohazard risk assessment site RA4 large scale plan (a), cross section (b) and site photo (c)

As well as possible rockfall hazards originating from the cliff (a), evidence of landslide activity was also noted on the lower slopes including, broken vegetation and areas of open tree canopy.

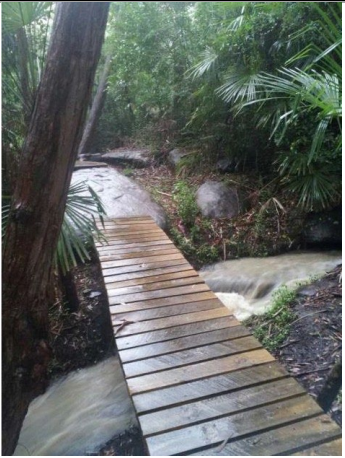
<p>Short bridge over creek, bolted to insitu rock either side</p>	<p>Trail type not disclosed</p>	<p>General comment: Assumed these structures are in place where there are large boulders or massive rocks which are not susceptible to movement. Likely to be in areas of historic rock falls in creeks and tributaries.</p> <p>Construction: Prior bolting to medium strength to fresh sandstone boulders/rocks, a visual assessment of the rocks to confirm they are well embedded into soil mass with no undercutting present.</p> <p>Maintenance: Regular inspection of the bridge condition and underlying rocks.</p>

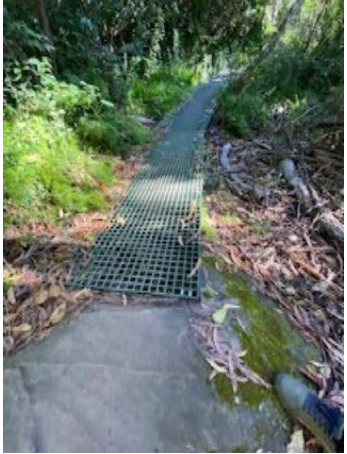
<p>Low raised boardwalk, wet area, timber post construction set in concrete with fibre reinforced panels (FRP) top, bolted to large rocks where present of tiber post supports</p>	<p>Trail type not indicated, assumed Green, Blue, Black</p>	<p>General comment: Assumed to be used in damp or wet ground conditions.</p> <p>Construction: Synergy description refers to use of timber posts set in concrete. Need to ensure suitable ground condition for foundation.</p> <p>Maintenance: Regular inspection of support posts.</p>
