# Illawarra Escarpment Mountain Bike Concept Plan Geotechnical Assessment Report (Revised Trail Network)

Niche Environment and Heritage Pty Ltd

24 March 2022

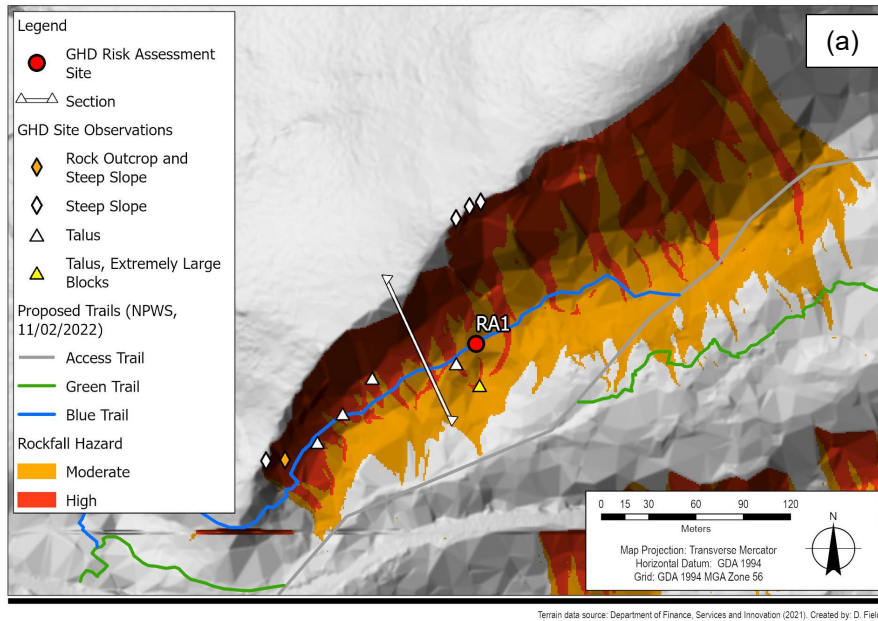
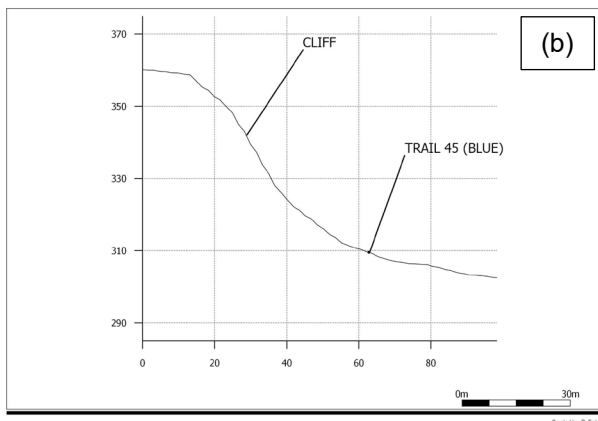
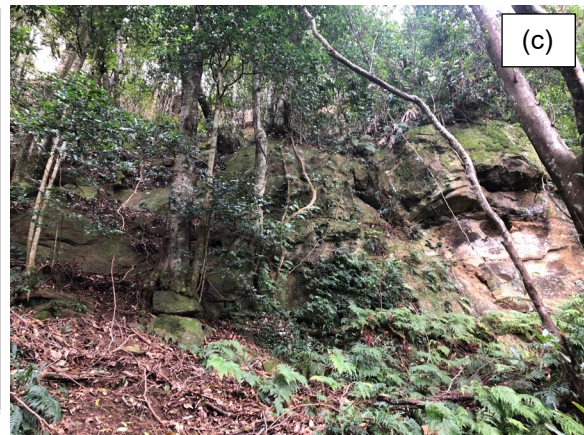
Figure 8: Geohazard risk assessment site RA1 large scale plan (a), cross section (b) and site photo (c)

As well as possible rockfall hazards originating from the cliff (a), evidence of landslide activity was also noted on the lower slopes including, broken vegetation and areas of open tree canopy.

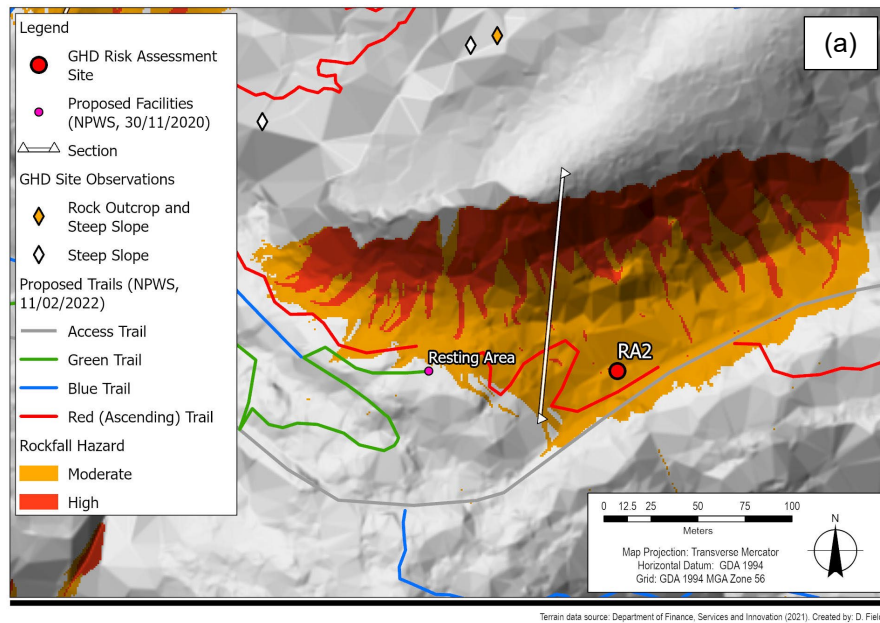
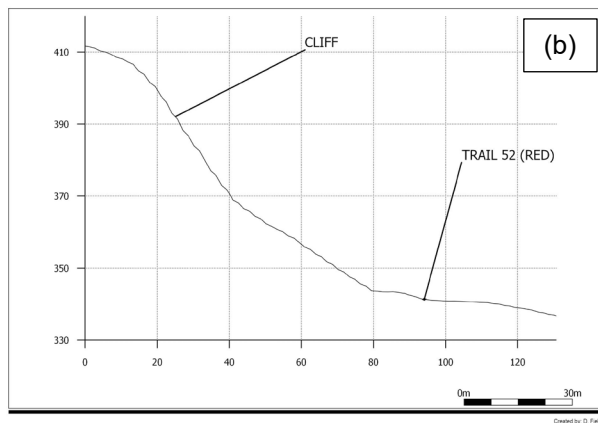
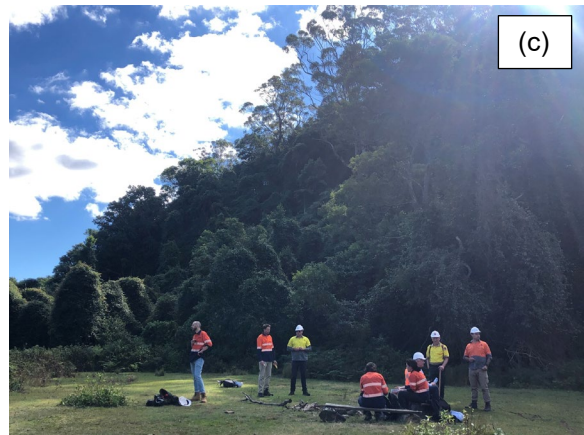
Figure 9: Geohazard risk assessment site RA2 large scale plan (a), cross section (b) and site photo (c)

As well as possible rockfall hazards originating from the cliff (a), evidence of landslide activity was also noted on the lower slopes including, broken vegetation, seepage and undulating / hummocky ground.

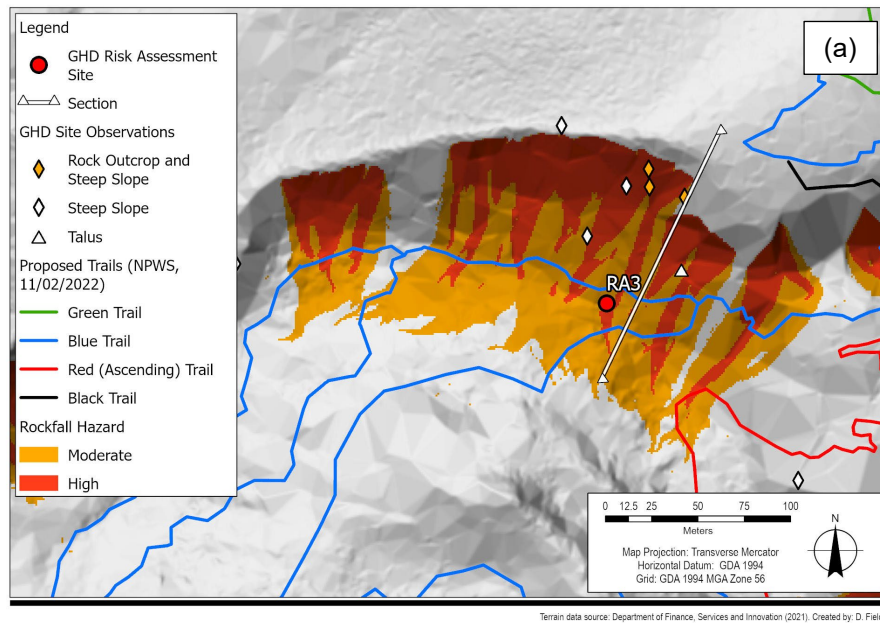
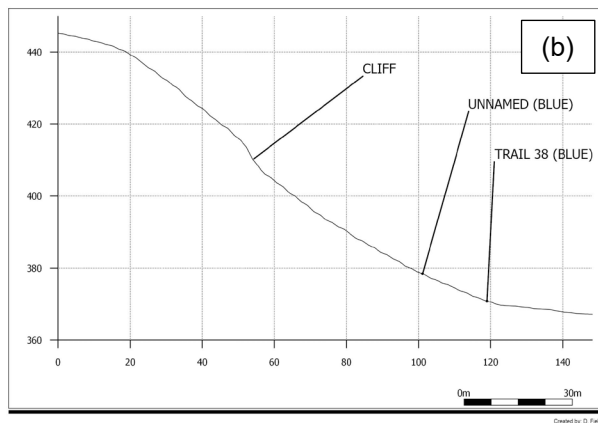
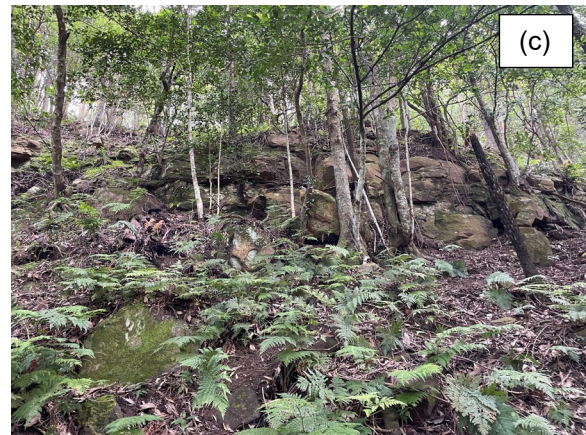
Figure 10: Geohazard risk assessment site RA3 large scale plan (a), cross section (b) and site photo (c)

As well as rockfall hazards originating from the cliff (a), evidence of landslide activity was also noted on the lower slopes including, broken vegetation canopy and leaning / distressed trees, small headscarps and translational slides in colluvial soils.

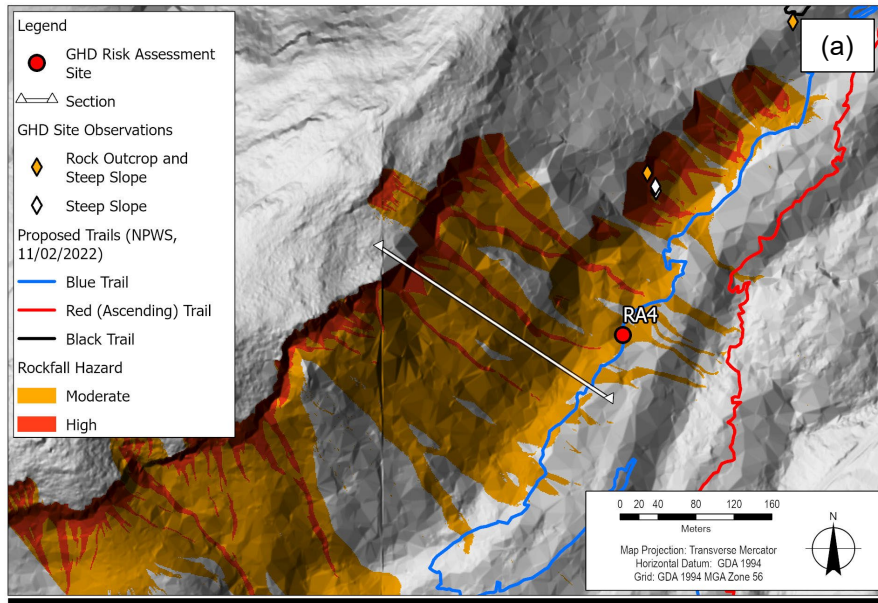
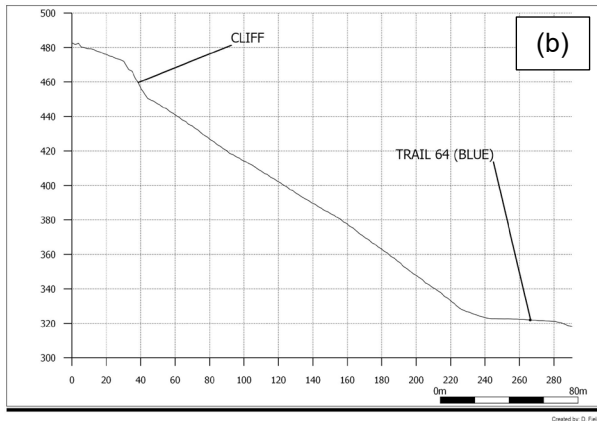
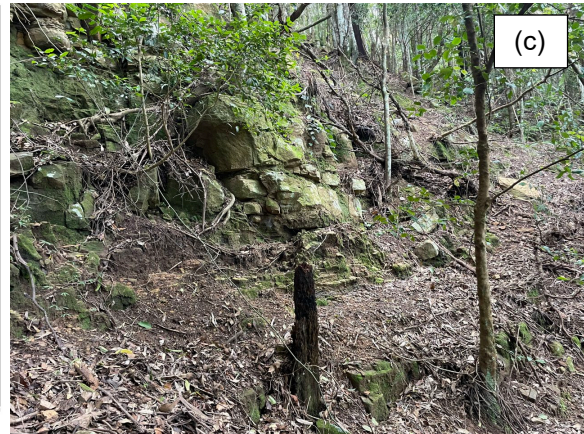
**Figure 11: Geohazard risk assessment site RA4 large scale plan (a), cross section (b) and site photo (c)**

As well as possible rockfall hazards originating from the cliff (a), evidence of landslide activity was also noted on the lower slopes including, broken vegetation and areas of open tree canopy.

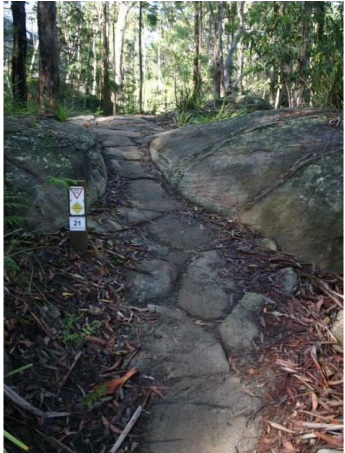
<p>Rock armouring between rocks. Built between climbing areas.</p>	<p><b>Green</b>, Blue, Black</p>	<p><b>General comment:</b> Assumed use is limited to sandstone units of the Narrabeen Group and not the claystone units such as the Stanwell Park &amp; Wombarra Claystone units.</p> <p><b>Construction:</b> No comment. Good solution for this type of terrain on gentle to moderate slopes.</p>

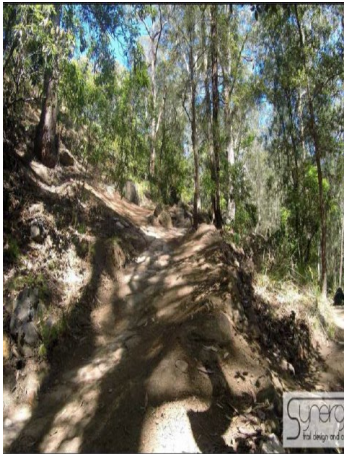
<p>Trail descent, machine built, rock armoured</p>	<p>Blue, Black</p>	<p><b>General comment:</b> Potential for descent trails to create drainage pathways for surface water runoff.</p> <p><b>Construction:</b> Sediment control measures required to retain sediment and to reduce the likelihood of scour &amp; erosion between rock armouring. Shallow cut-off channels at the top of the descent and regularly spaced along the trail to ensure that surface water runoff does not lead to erosion &amp; scour and subsequent compromising of rock armouring. Ensure suitable compaction of fill placed in trail formation.</p> <p><b>Maintenance:</b> Regular inspection to ensure sediment control measures are in place and to assess adequacy of drainage measures. Check for slumping of trail walls and erosion of trail base.</p>

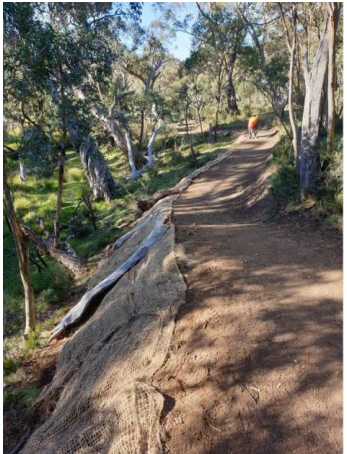
<p>Machine built trail (on a slope), soil placement, fabric placement on batter slopes</p>	<p>Green, Blue, Black</p>	<p><b>General comment:</b> Trail susceptible to upgradient surface water runoff leading to erosion and scour and downslope batter failure. Saturation of fill formation and possible slumping of batter.</p> <p><b>Construction:</b> Assume an appropriate level of compaction is applied to fill material to ensure the trail is not subject to settlement and/or erosion. Construct appropriate upgradient drainage is in place to ensure surface runoff is directed to designated drainage channels. Batter slope assumed to be constructed at no steeper than 1V:2H for soil slope. Rock armouring likely required in addition to erosion matting.</p> <p><b>Maintenance:</b> Regular inspection of upgradient drainage control measures.</p>

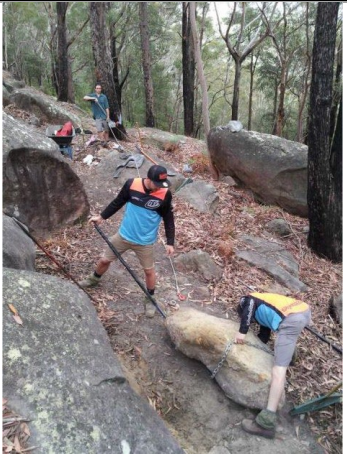
<p>Rock armouring through natural slots in rocks, hand construction only, using local sourced rocks within or near the trail</p>	<p>Blue, Black</p>	<p><b>General comment:</b> Source rocks to be limited from sandstone boulders of sandstone units of the Narrabeen Group such as the Coal Cliff Sandstone (lower escarpment) Scarborough (middle escarpment) and Bulgo Sandstone (upper escarpment).</p> <p><b>Construction:</b> Assumed some form of bedding material will be used underneath the sandstone boulders to assume they are secure. Unclear if a stabilised bedding sand may be used to secure the boulders. May require some upgradient surface water drainage control measures to ensure water doesn't flow through the 'natural slots' and undermines placed sandstone boulders.</p> <p><b>Maintenance:</b> regular inspection of the rock armouring to ensure surface runoff has not eroded sediments beneath sandstone boulders causing them to be understand.</p>

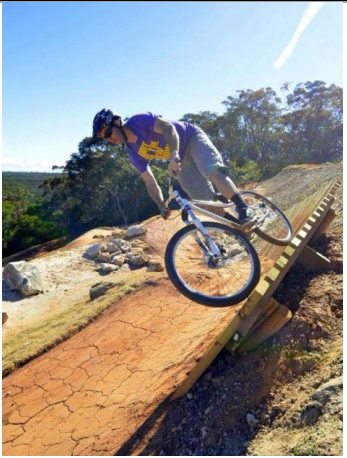
<p>Technical Trail Feature (TTF) - Wall ride (timber construction), machine built</p>	<p>Green, Blue, Black</p>	<p><b>General comment:</b> Timber wall appears to be resting directly on a slope made with fill material.</p> <p><b>Construction:</b> Appropriate compaction of fill to create the batter slope adjacent to the timber ramp. Ensure structure is well anchored to ground.</p> <p><b>Maintenance:</b> Potential for rock armouring under timber if settlement becomes an issue.</p>

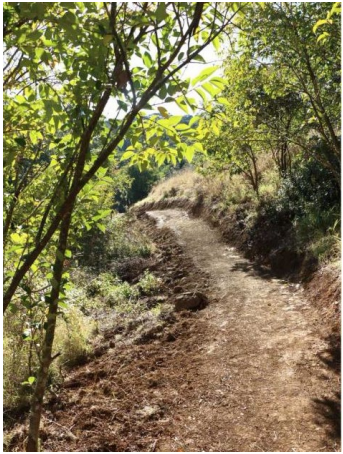
<p>Full bench on '20% side slope', machine cut</p>	<p>Blue, Black</p>	<p><b>General comment:</b> Trail susceptible to upgradient surface water runoff leading to erosion scour and slumping of cut and fill batters.</p> <p><b>Construction:</b> Assume an appropriate level of compaction is applied to fill material. Construct appropriate upgradient drainage to direct surface runoff to designated drainage channels. Batter slope assumed to be constructed at no steeper than 1V:2H. If gradient is greater than 1V:2H, construction may need to consider some support such as rock revetment.</p> <p><b>Maintenance:</b> Regular inspection of upgradient drainage control measures</p>

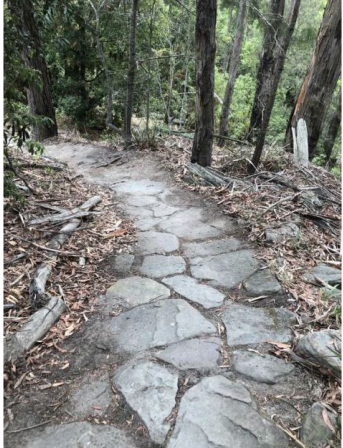
<p>Rock armoring using locally sourced sandstone</p>	<p>Trail type not disclosed</p>	<p><b>General comment:</b> Assumed use is limited to sandstone units of the Narrabeen Group (Coal Cliff, Scarborough &amp; Bulgo) and not the claystone units such as the Stanwell Park &amp; Wombarra Claystone units.</p> <p><b>Construction:</b> No comment</p>

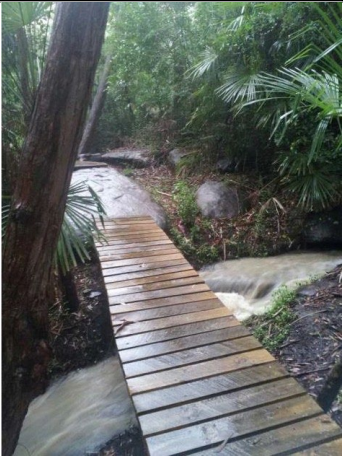
<p>Short bridge over creek, bolted to insitu rock either side</p>	<p>Trail type not disclosed</p>	<p><b>General comment:</b> Assumed these structures are in place where there are large boulders or massive rocks which are not susceptible to movement. Likely to be in areas of historic rock falls in creeks and tributaries.</p> <p><b>Construction:</b> Prior bolting to medium strength to fresh sandstone boulders/rocks, a visual assessment of the rocks to confirm they are well embedded into soil mass with no undercutting present.</p> <p><b>Maintenance:</b> Regular inspection of the bridge condition and underlying rocks.</p>

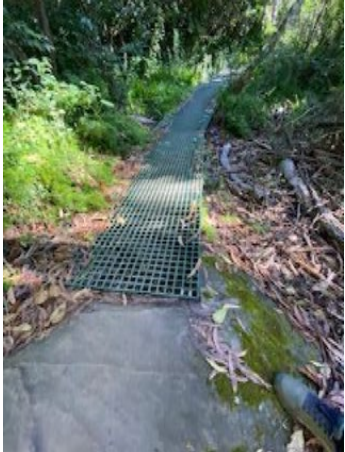
<p>Low raised boardwalk, wet area, timber post construction set in concrete with fibre reinforced panels (FRP) top, bolted to large rocks where present of tiber post supports</p>	<p>Trail type not indicated, assumed Green, Blue, Black</p>	<p><b>General comment:</b> Assumed to be used in damp or wet ground conditions.</p> <p><b>Construction:</b> Synergy description refers to use of timber posts set in concrete. Need to ensure suitable ground condition for foundation.</p> <p><b>Maintenance:</b> Regular inspection of support posts.</p>

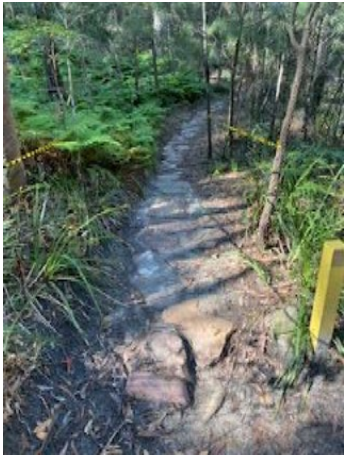
<p>Rock armoured trail, approximately 15m section, imported or locally sourced rock</p>	<p>Trail type not indicated</p>	<p><b>General comment:</b> Assumed use is limited to sandstone units of the Narrabeen Group and not the claystone units such as the Stanwell Park &amp; Wombarra Claystone.</p> <p><b>Construction:</b> No comment</p> <p><b>Maintenance:</b> Maintain drainage to prevent erosion and undercutting of rock slabs.</p>

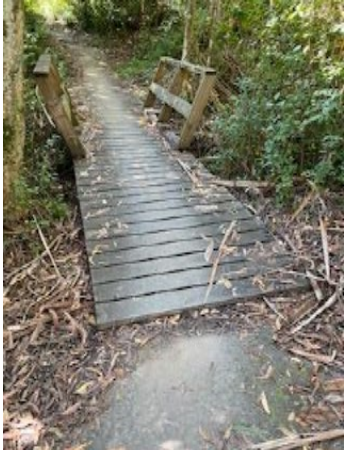
<p>Timber bridge with handrail over small creek, bolted to rock either side, treated pine timber can be replaced with FRP panels as shown above</p>	<p>Trail type not indicated, assumed <b>Green</b>, Blue, Black</p>	<p><b>General comment:</b> Check stability of creek banks at crossing.</p> <p><b>Construction:</b> Ensure suitable foundation for bridge support. Provision of creek bank protection by revetment rock or similar.</p> <p><b>Maintenance:</b> Regular inspection of the bridge condition and underlying rock armoring of creek where provided.</p>
