SOUTH HEAD SYDNEY HARBOUR NATIONAL PARK

Conservation Management Plan

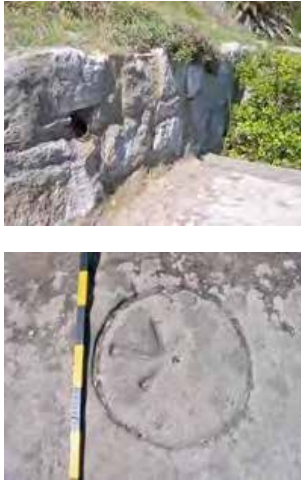
2.5	<p><i>Former bridge and walkway</i> Small concrete slabs on bedrock with adjacent timber planking remnants and concrete pier in between. This appears to be the remnants of a small bridge between two rock outcrops. It is one of a number forming part of the path and bridge system running around the cliff face.</p>		340 718.53E 6254 511.73N

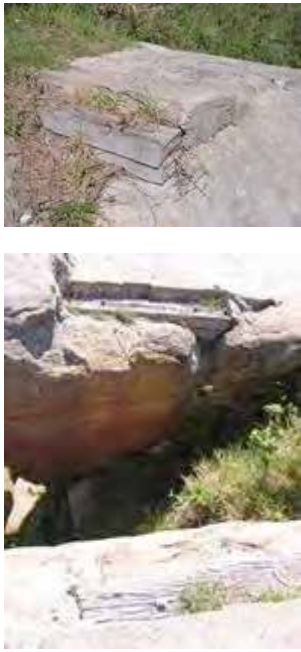
4.2 Historical Archaeology – Inventory Table

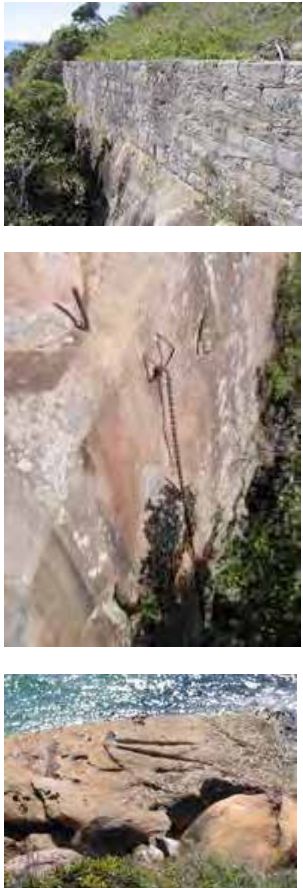
2.7	<p><i>L-Shaped (rifle?) walling</i> with cement mortar. Appears to be a rifle gallery or similar. Slots evident. The wall is up to 6ft tall in places and the ends abut the cliff face. A concrete path continues on either side of this element. On the northern side the path leads to element 2.8.</p>		340 699.53E 6254 574.33N

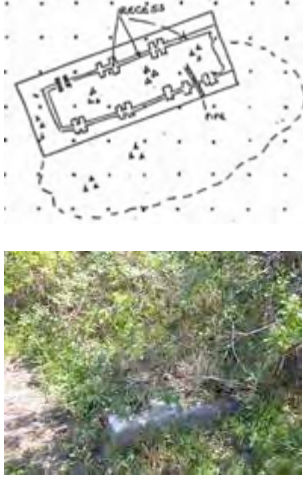
4.2 Historical Archaeology – Inventory Table

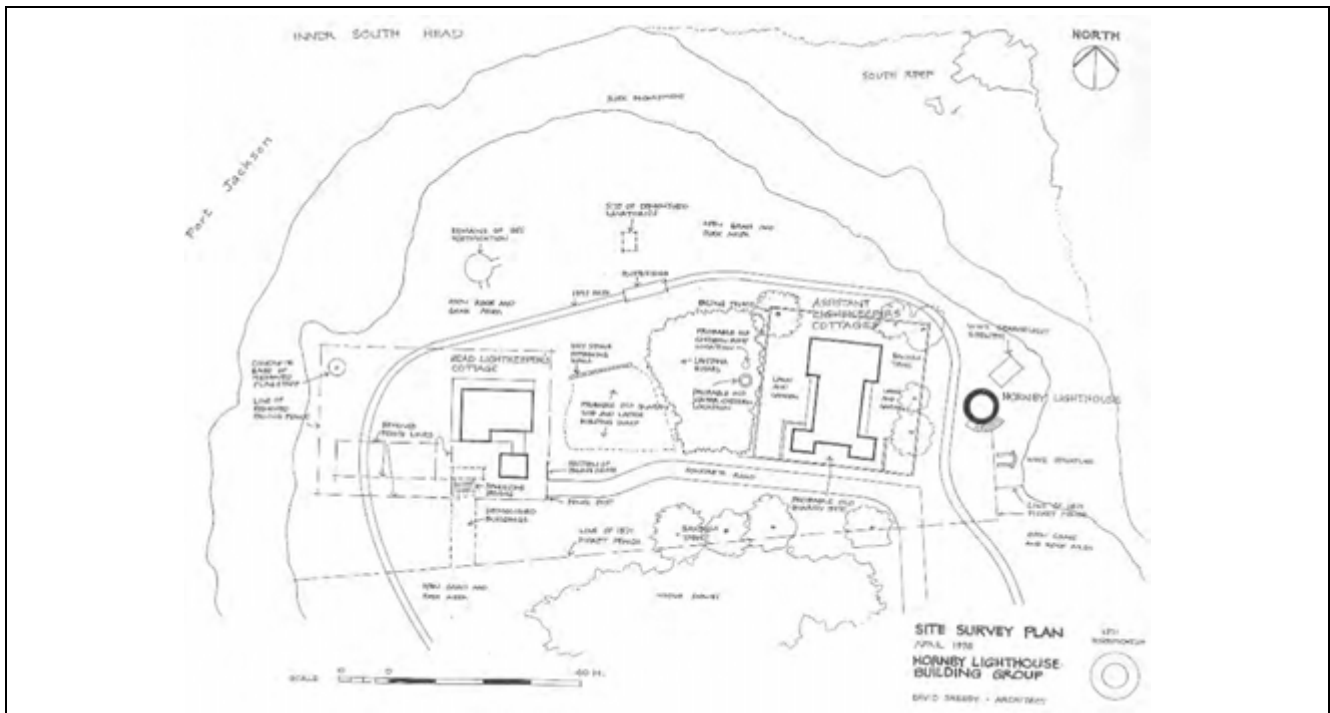
Site Plan by David Sheedy showing relationship to missing garden features and adjacent Lightstation structures.

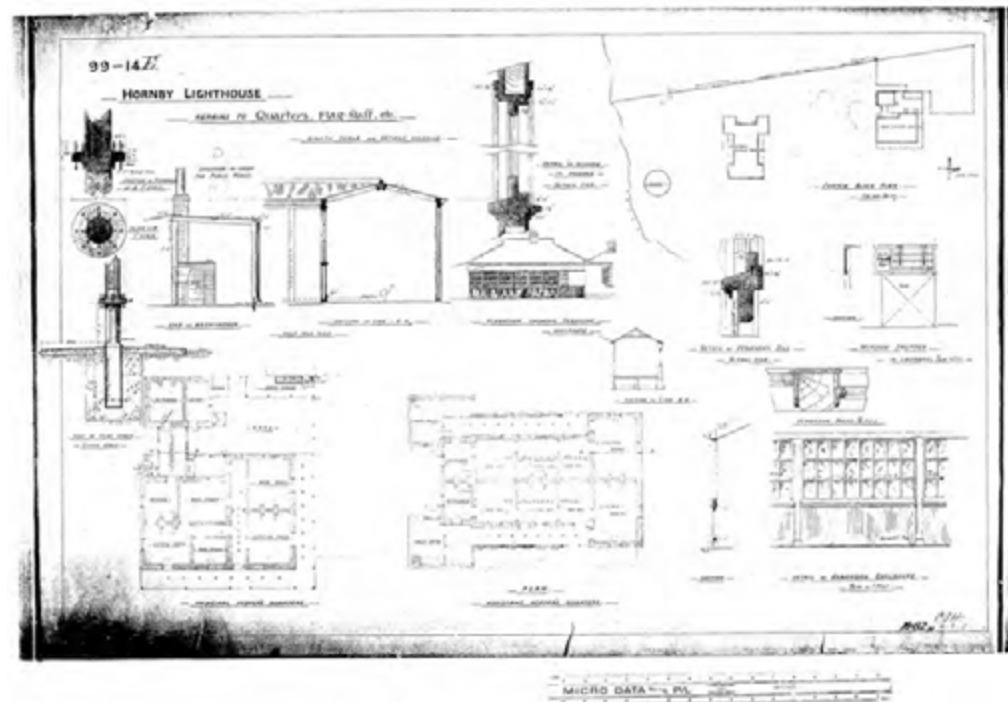
View of set of plans showing proposed additions and alterations to the Head Light Keepers Cottage (left side of the plan). The proposed additions were a washhouse and enclosed passage. Source: Plan cabinet at Greycliffe House.

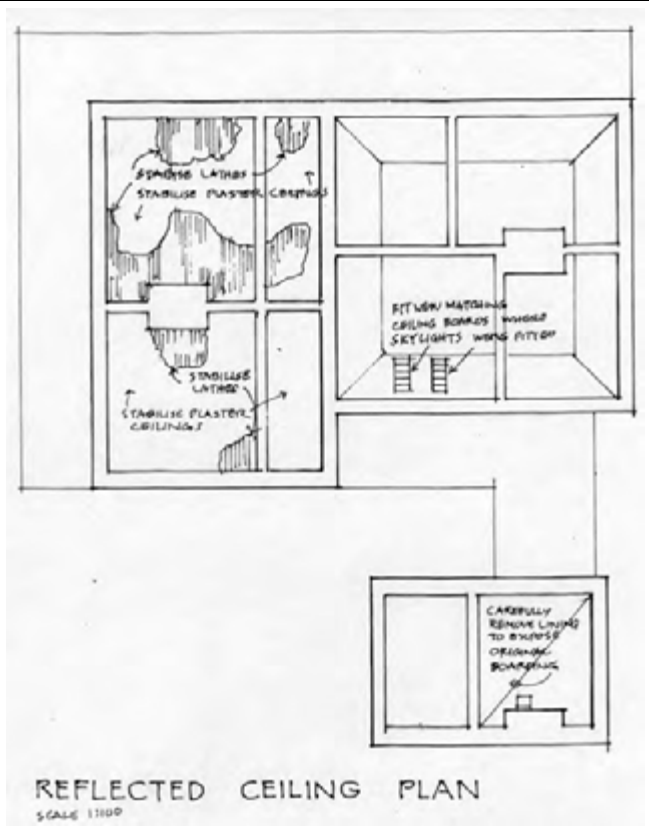
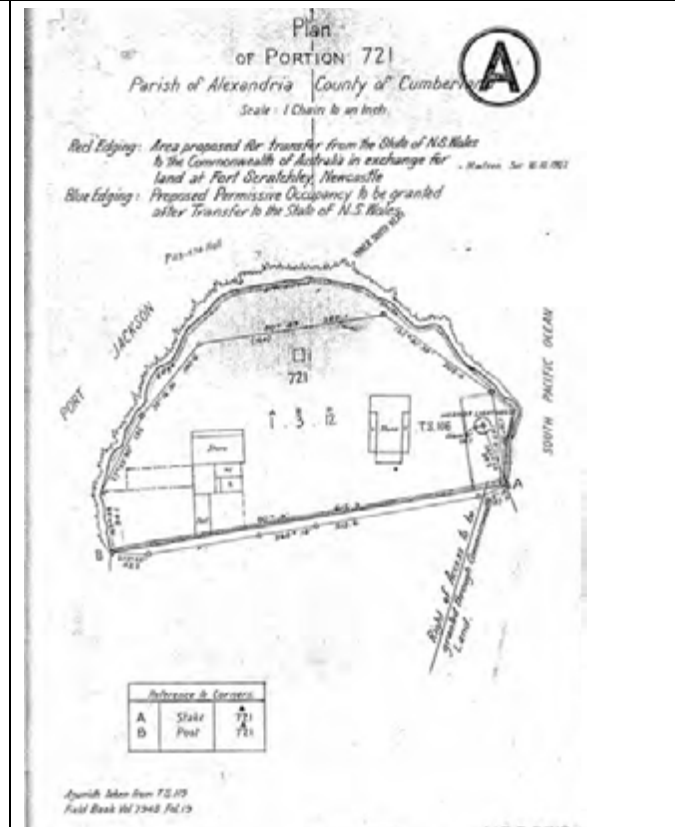
Sketch of reflected ceiling plan showing works to the ceilings. It is not known if this work was carried out. Source: NPWS files and plan cabinet Greycliffe House.

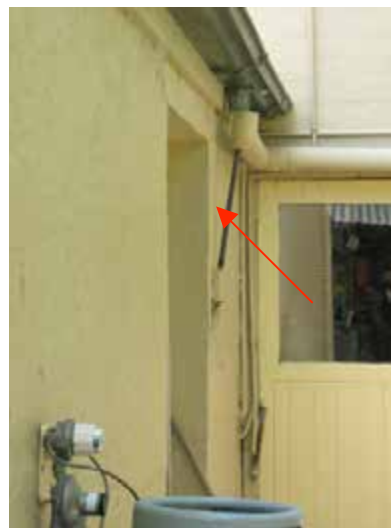
View of the rear plumbing to divert water from rear of building. Noted pipe is propped (arrowed).

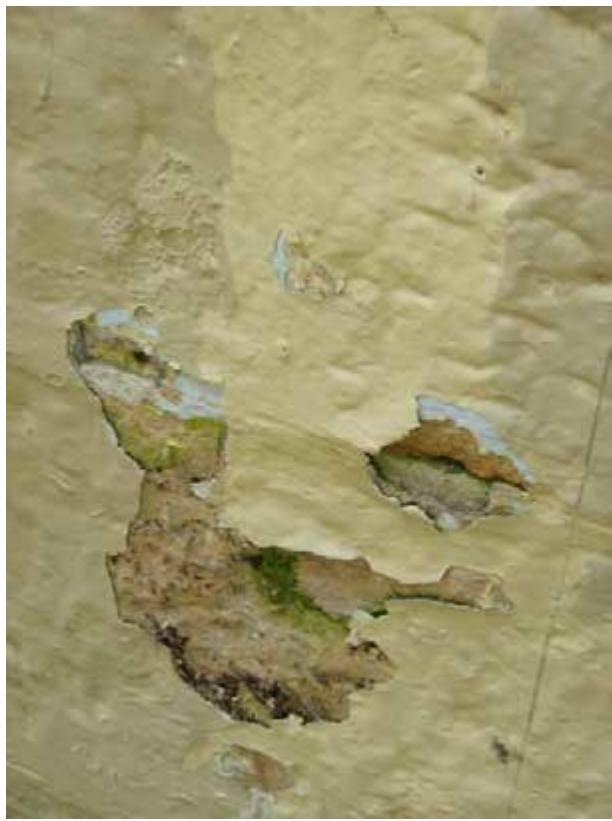
View of rear wall with damp and mould behind impervious paint.

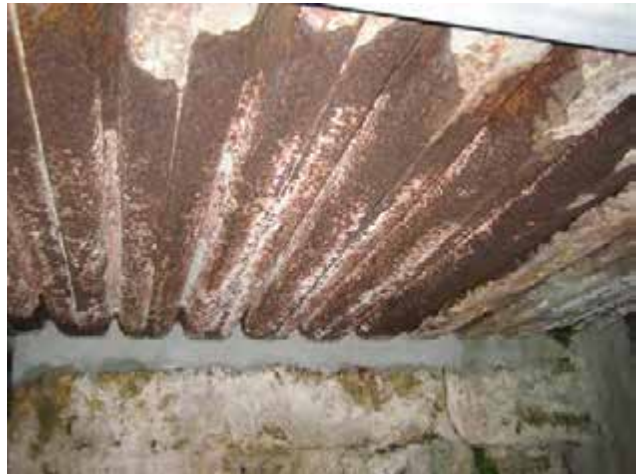
View of the rusted original Barlow rails supporting the concrete slab.

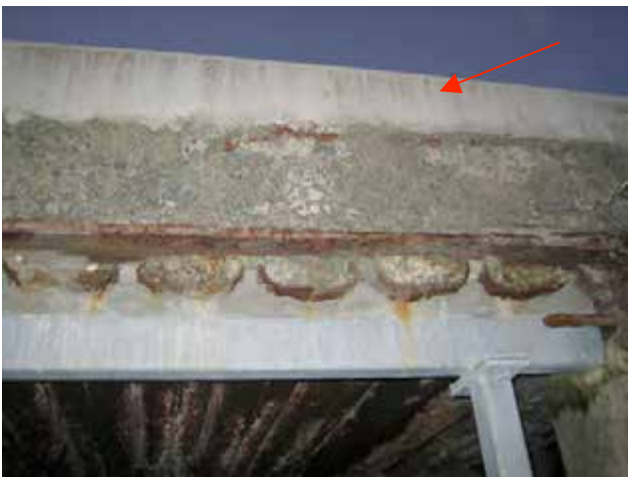
End view of Barlow rails supported by a new steel structure and new concrete slab over (arrowed).

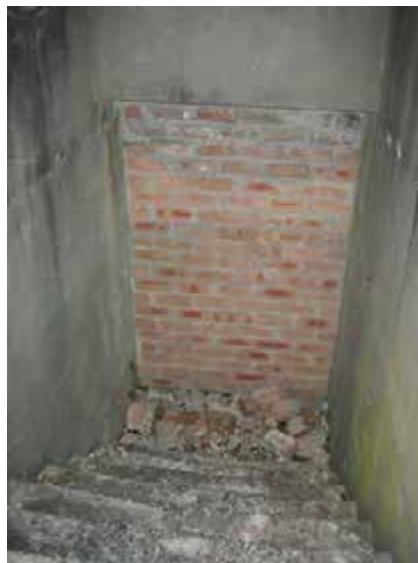
Exterior of door to Staff Room bricked up on exterior.

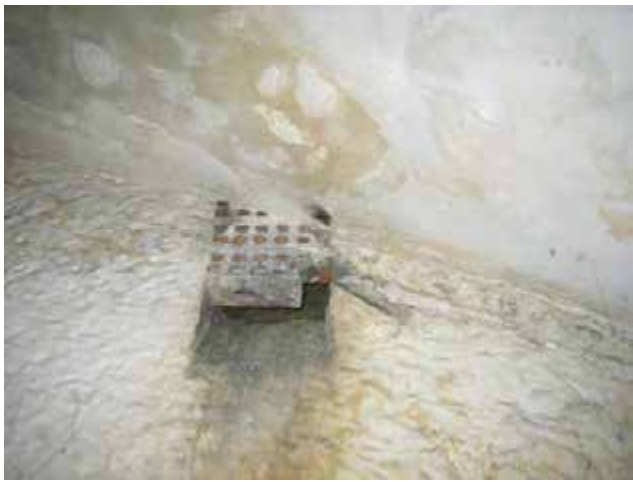
One of four vents to the exterior (at ceiling).

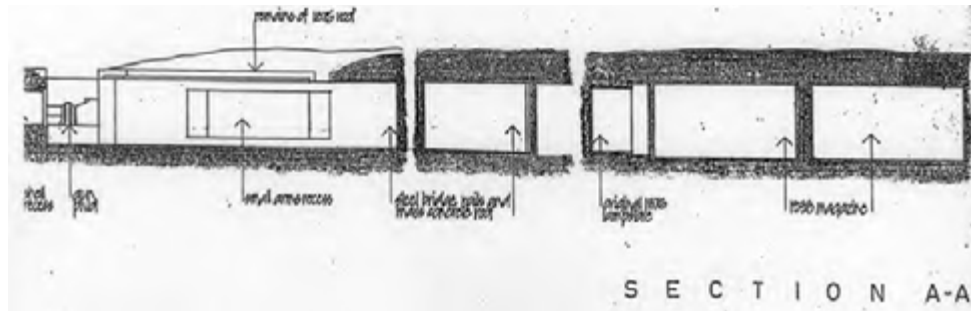
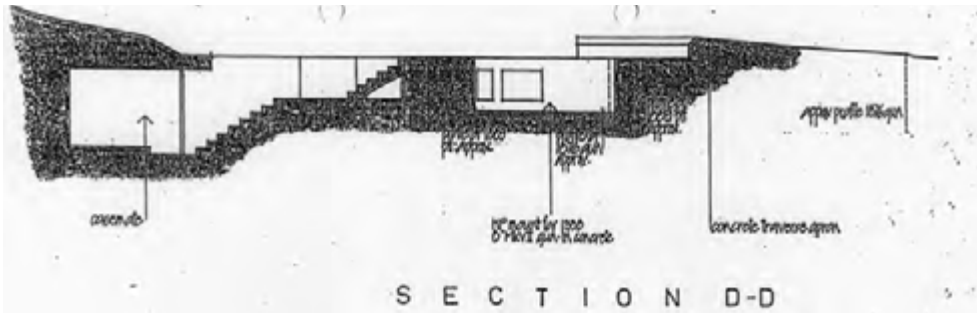
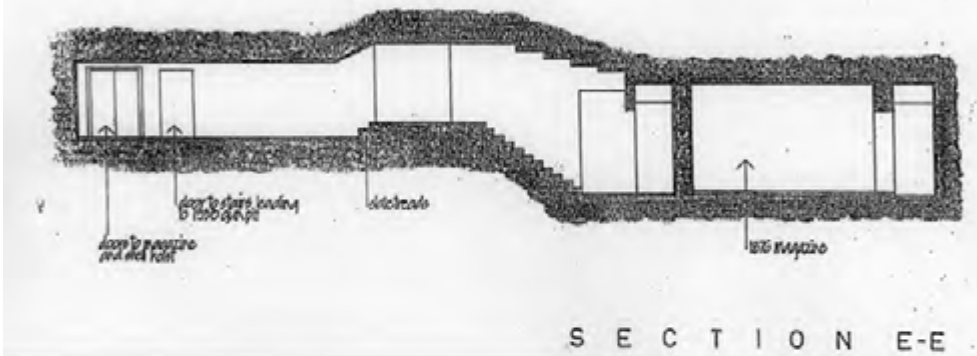
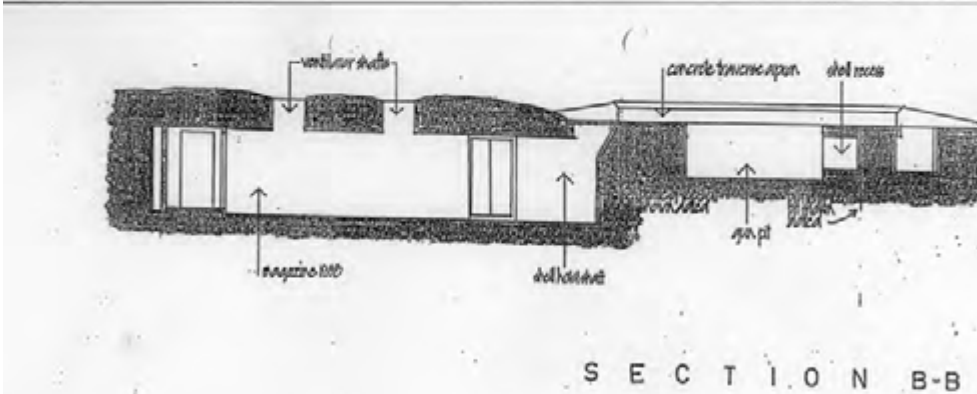
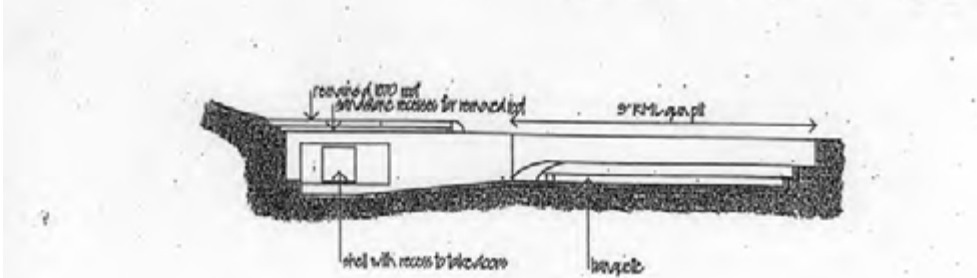
Drawings showing sections of the Hornby Battery. These sections were found but the drawing that would locate the section and show the battery in plan was not found. Source: Plan cabinet, Greycliffe House.

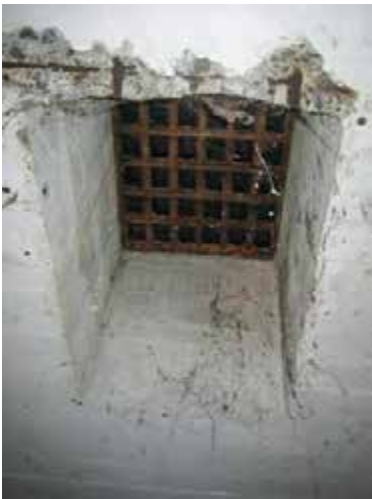
View of vent to exterior in the passage west of Shell Store. Iron grill over remains. Note concrete deterioration.

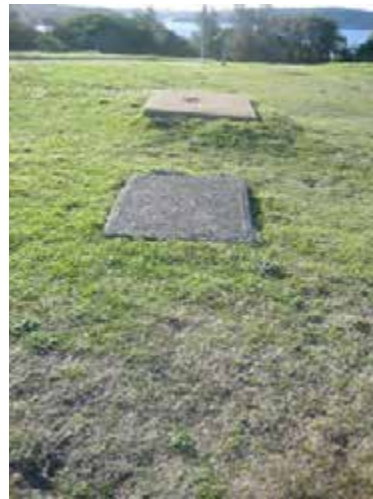
View of the two vent covers over the passage west of Shell Store, looking northwest from above.

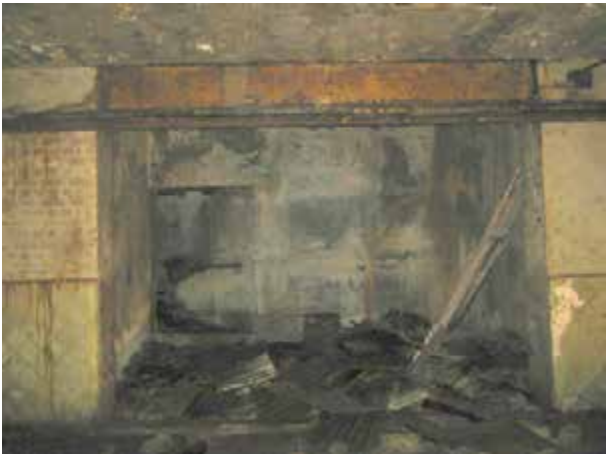
View of the opening to the lightwell with the passage, possibly connecting to the Staff Room, located the left side of the lightwell. Noted debris on the floor, mainly timber and cgi sheets.

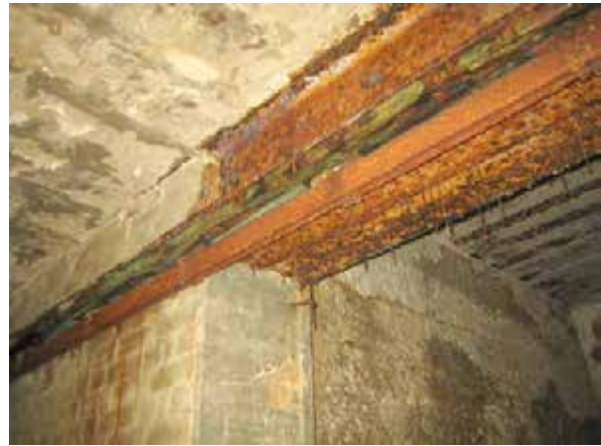
View of the steel beam over opening to the lightwell. The sliding door track crosses in front of the beam.

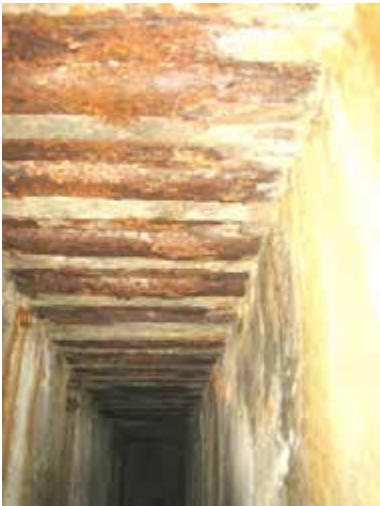
View of the ceiling of the passage showing rusted Barlow rails.

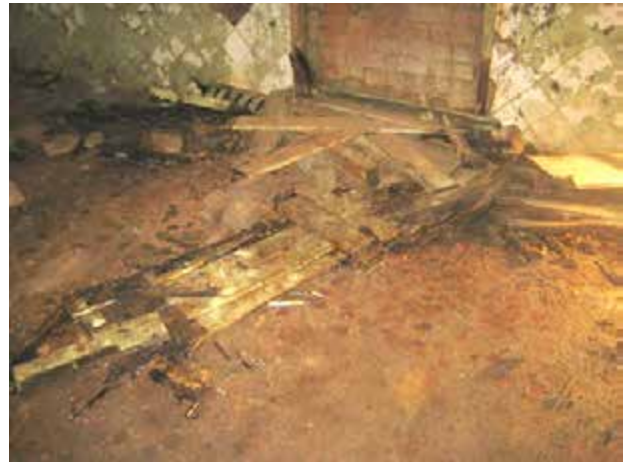
Remains of the door, now bricked up, in the south wall.

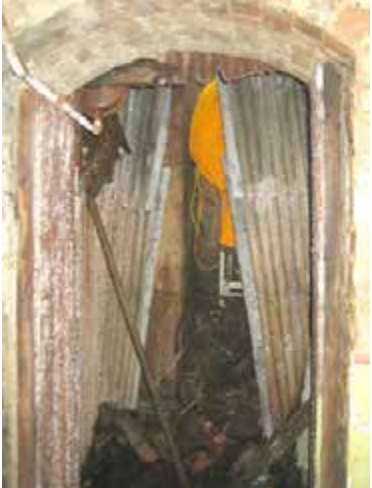
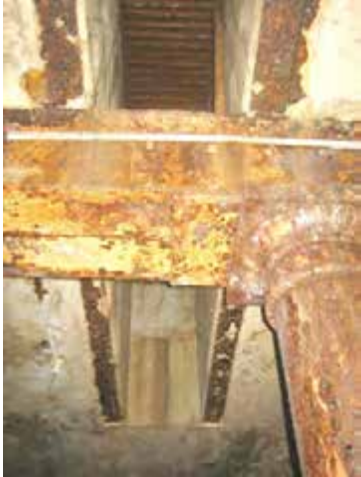
<p><i>Detail of coal chute showing cgi lining, which is loose, and debris on the ground.</i></p>	<p><i>View of the skylight located next to the southmost central column. Noted original metal grill.</i></p>

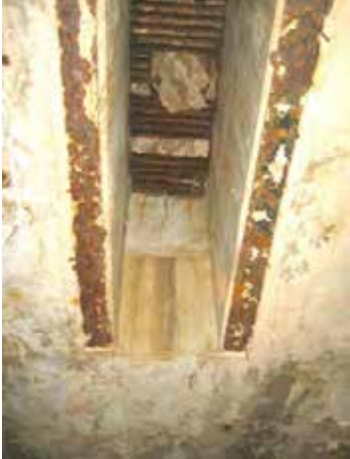
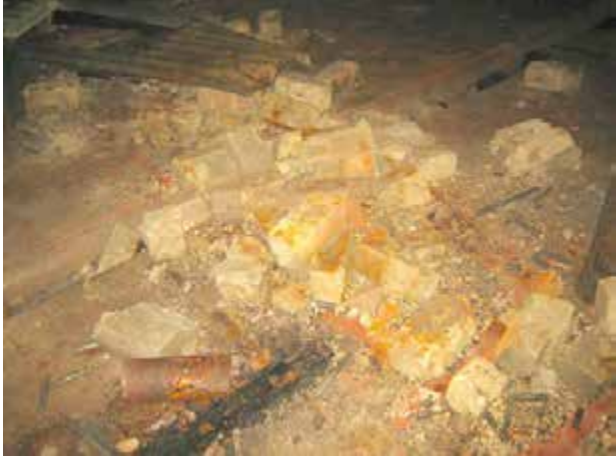
<p><i>View of the skylight located next to the south column. Noted grill is damaged with brick fill over falling through.</i></p>	<p><i>Detail of floor space under Engine Room skylight showing bricks that have fallen through the grill.</i></p>

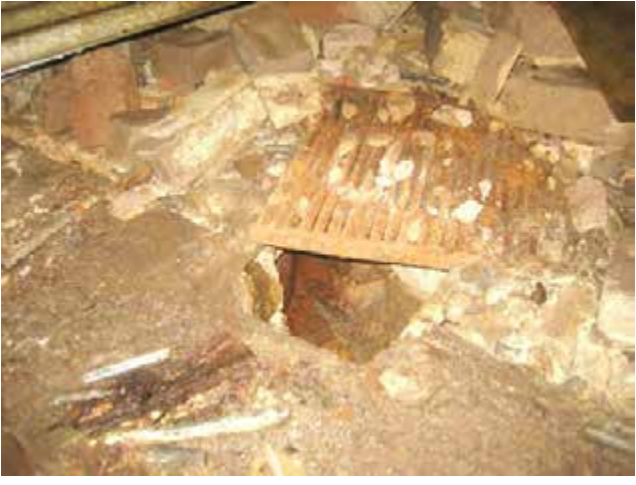
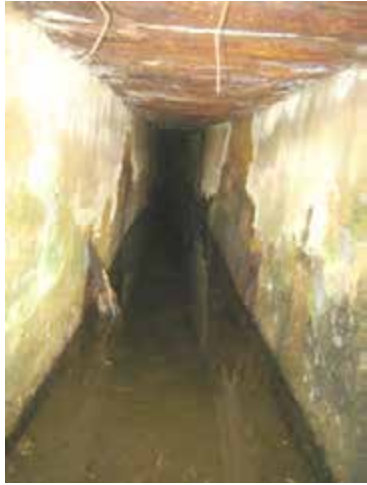
<p><i>View of the drain cover located in the lightwell floor.</i></p>	<p><i>View of drain interior, looking east from the exit on south side of inner South Head loop walking trail. Noted the rusted Barlow rails and roots inside.</i></p>

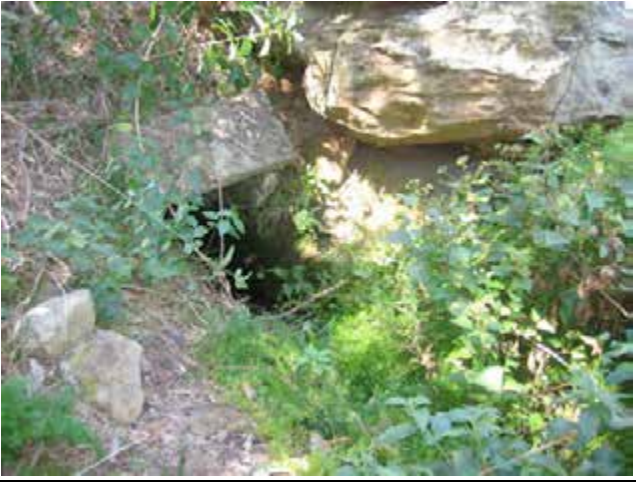
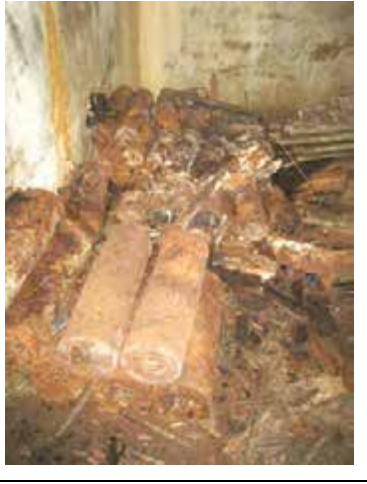
<p><i>View of Engine Room drain exit located on the south side of Inner South Head loop trail.</i></p>	<p><i>Carbon rods (for arc lights) stored in canisters in lightwell.</i></p>

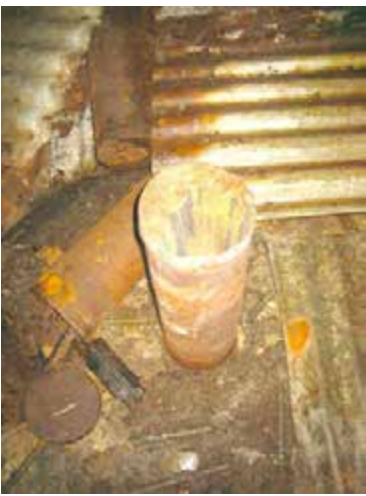
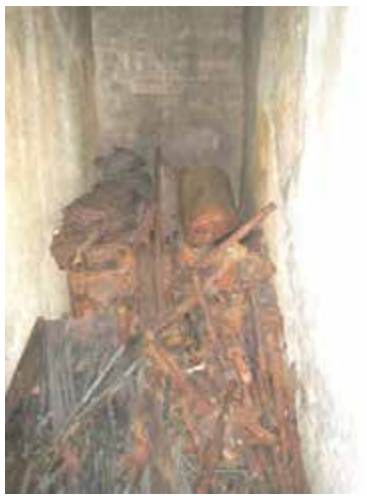
<p><i>Detail of an open canister showing the carbon rods in sawdust.</i></p>	<p><i>Items stored in the end of passage from the lightwell, including box with long carbon rods and steel items.</i></p>

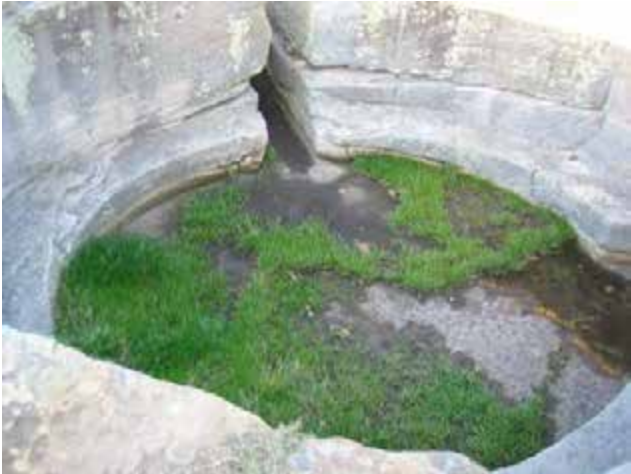
View of the Gun Emplacement pit. Noted that silt with grass is accumulated at base of pit.

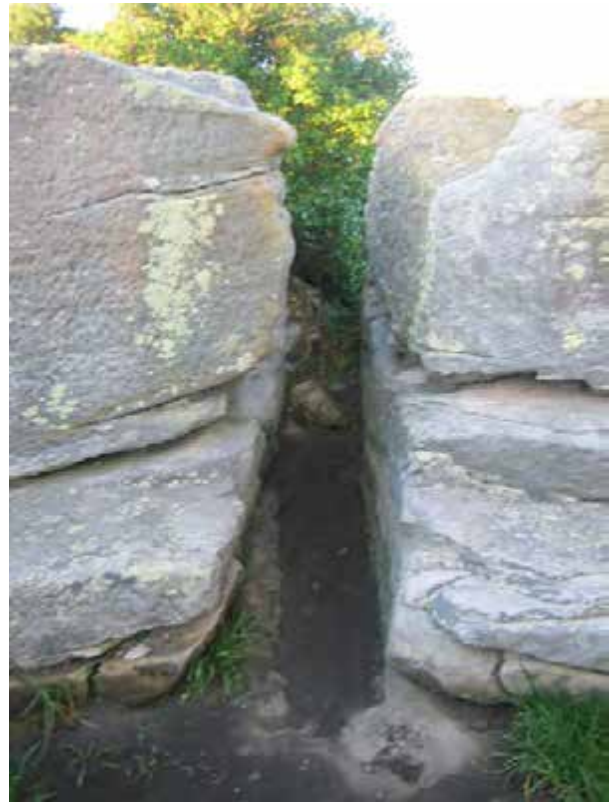
Drain from pit filled with silt and blocked by plant and roots.

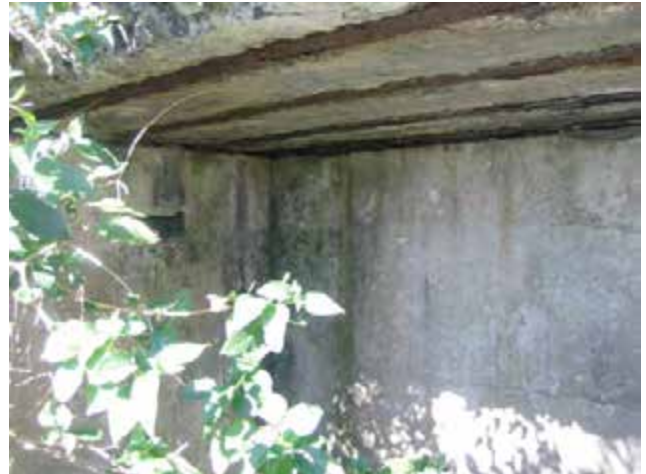
View of Item 2.8, between Camp Cove & Lady Bay Beach, remains of the 1890s searchlight observation station. The structure is partly collapsed. The roof slab is supported by rusted rail tracks. Further corrosion could lead to collapse.

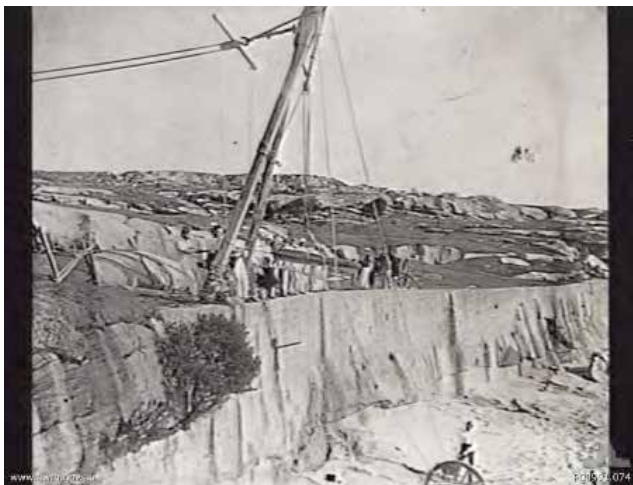
Using shear legs to lift a gun from the beach after rafting it to the beach, 1898. This image shows the low vegetation and the extensive stone walls. Source: AWM P00991.074.

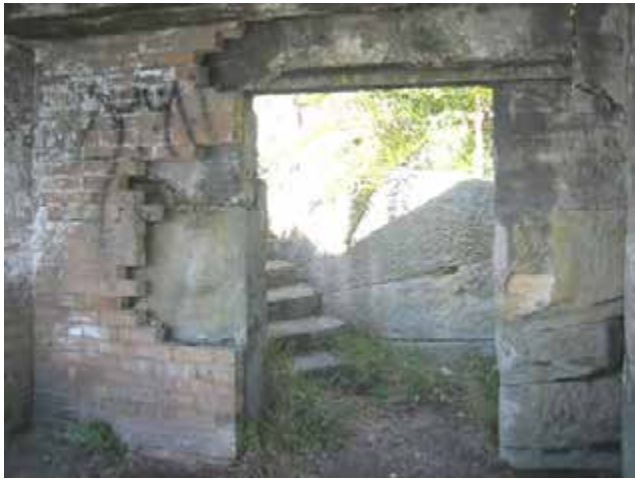
View of the entry from above. The lintel over doorway is rusted. Note the brick lining has been partly removed.

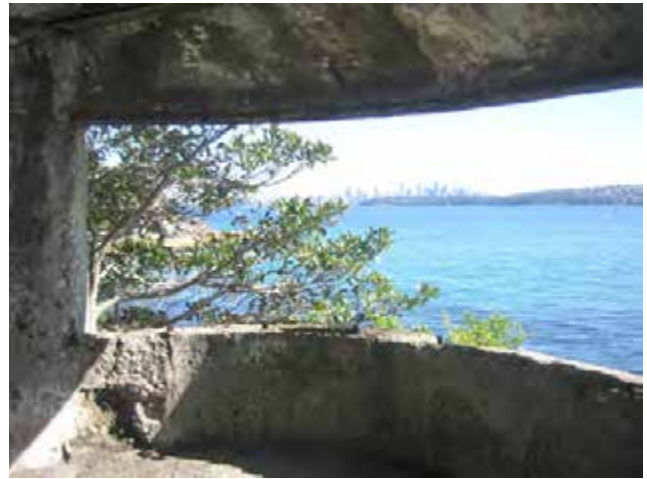
View of the opening to the harbour, looking west. The steel members supporting the concrete above opening are badly rusted. The fig tree, to the left, is growing in the structure.

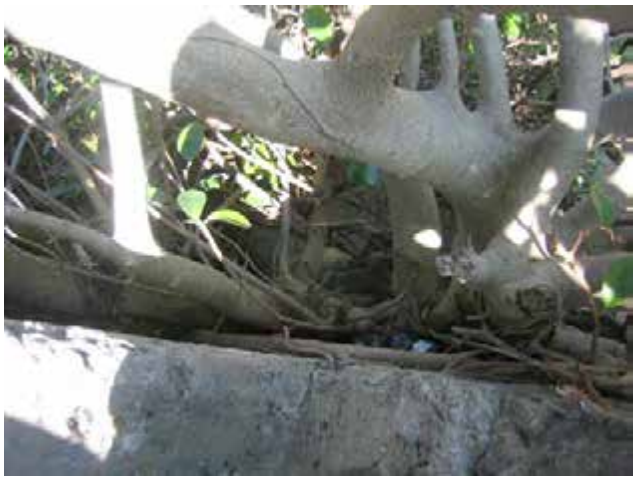
View looking down on the exterior at the fig tree has grown in the structure.

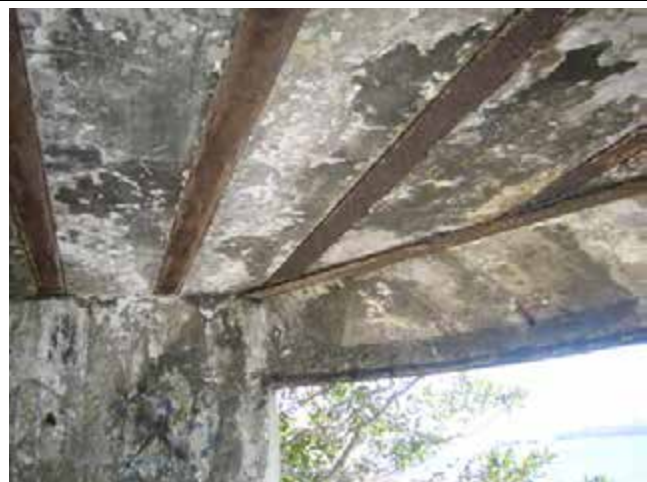
View of the concrete slab with the rusted ferrous metal rail track reinforcing.

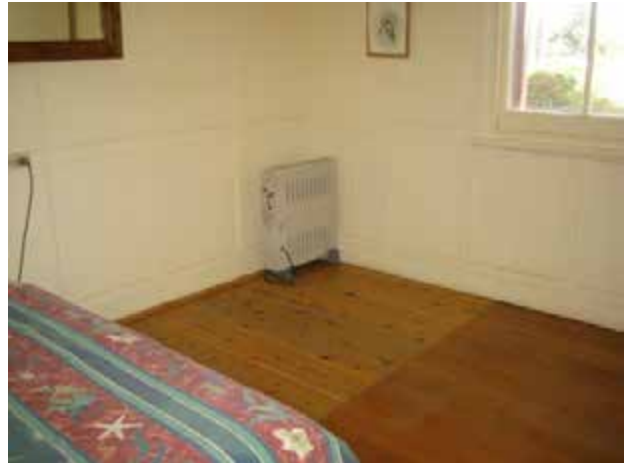
View of bedroom with partially replaced floor.

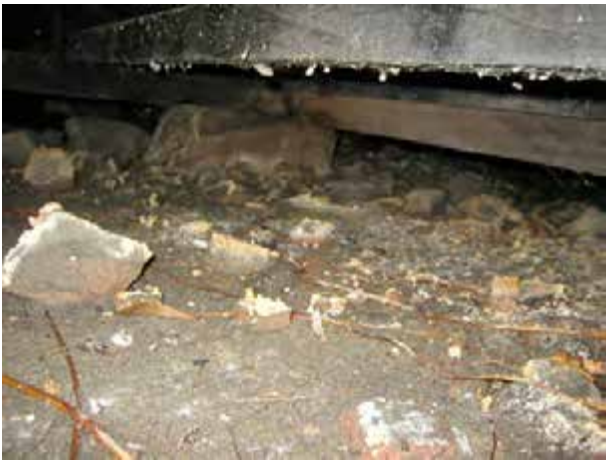
View of the underfloor space showing rocks used as footings. Note signs of damp and salts on rocks and minimal space under floor.

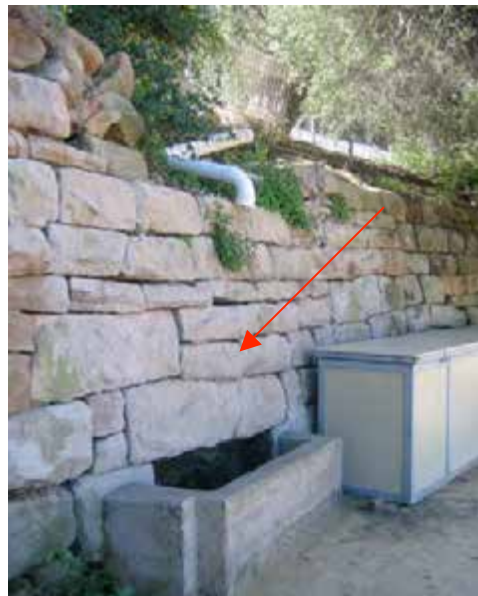
View of driveway retaining wall, at end of Camp Cove beach. Note stormwater pipe and that the stone lintel has a large crack.

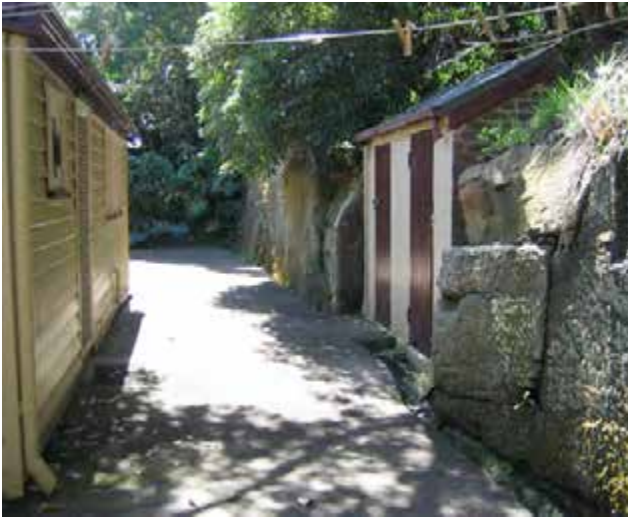
View of the rear space, with cemented paving, the down pipes discharging onto the paving on left side. The structure let into the cliff is the former WC's. There is a drain on the right.

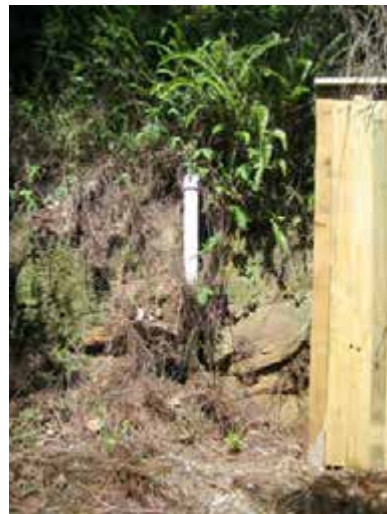
View of a drain pipe on cliff.

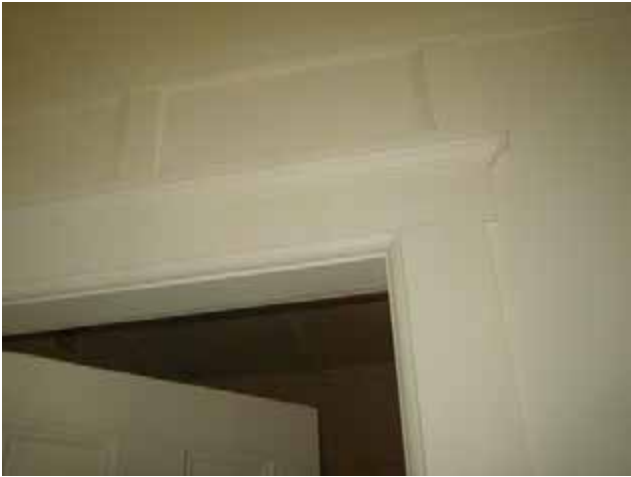
View of the entablature mouldings over a door.

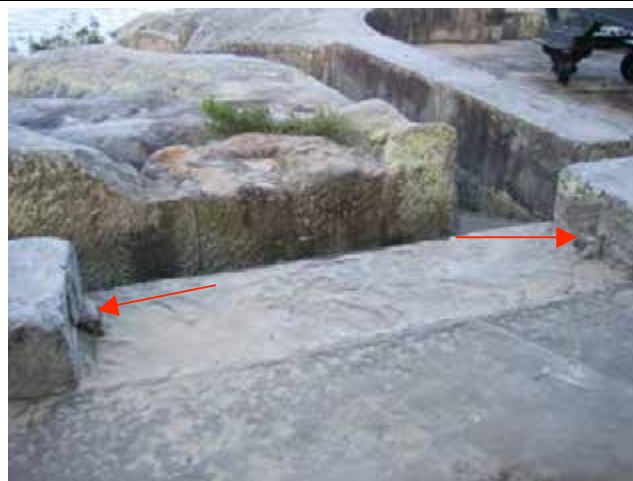
View of kerb to the access road with a missing stone block. Note the iron joggles projecting from the remaining stones. (arrowed)

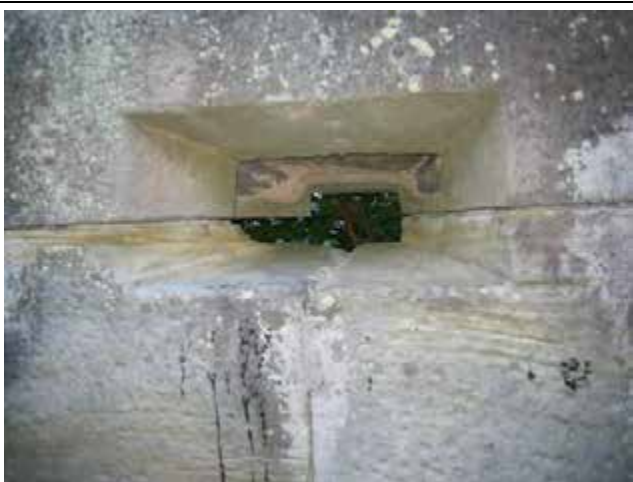
View of firing window [loop hole], showing detail of eroded stone.

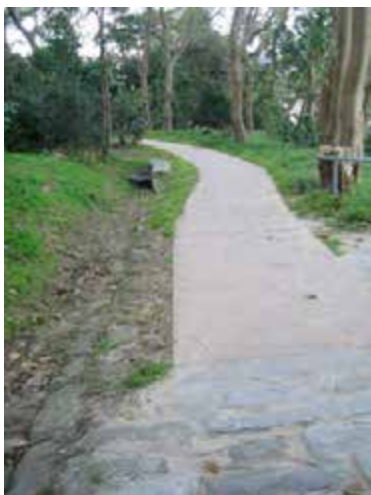
View of the cement path below Cobblestone Road looking south towards Camp Cove Beach. Noted drain on left side of the path.

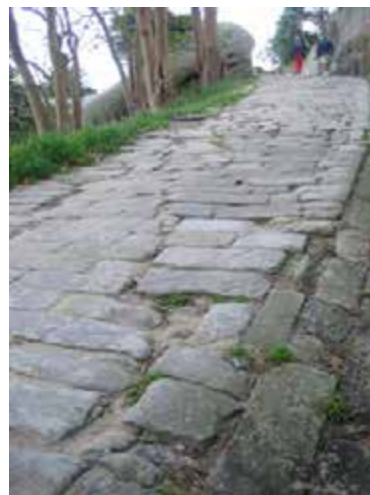
View of the Cobblestone Road, showing where sewer crosses the road on the diagonal.

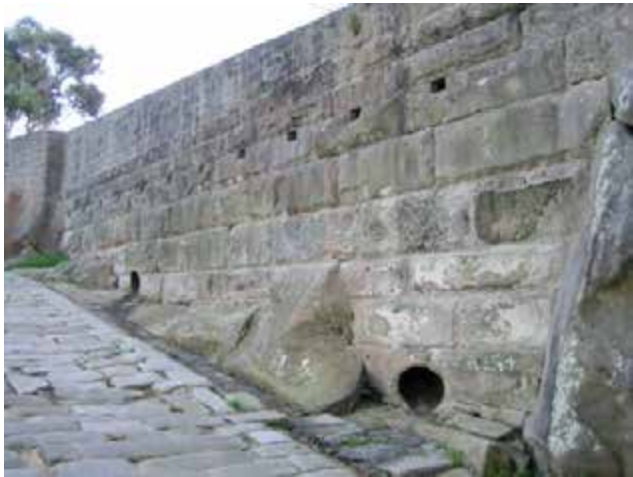
View of the rifle wall above Cobblestone Road. Noted two drains that should be inspected for blockages from above.

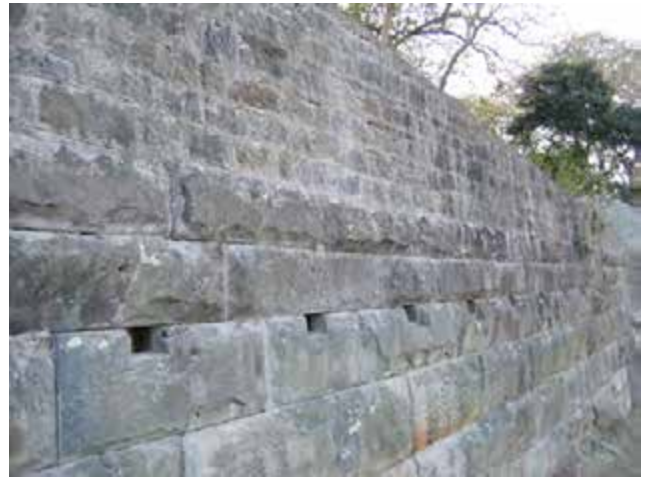
View of the rifle wall. Note the two stages of construction.

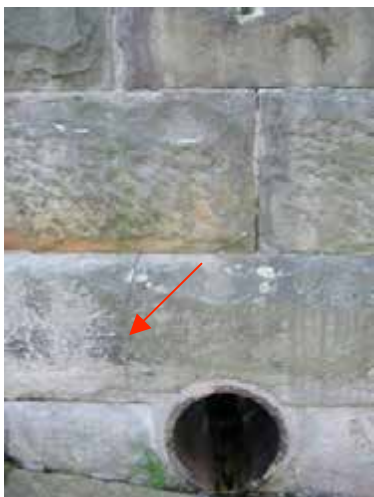
View of the rifle wall showing crack in the stone indicating some movement of the wall.

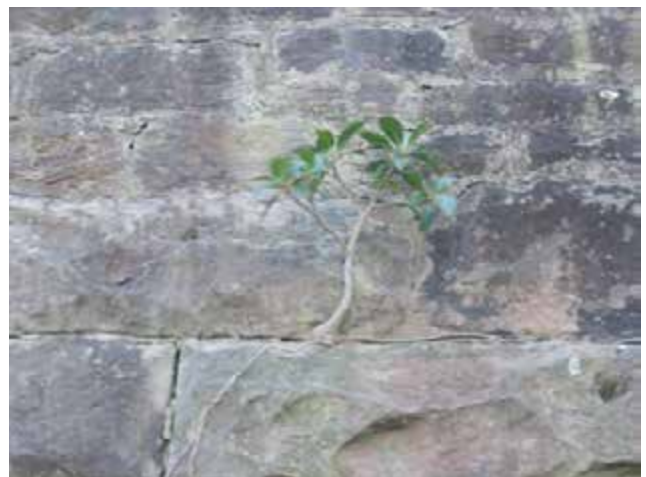
View of the rifle wall with a young fig tree growing in a mortar joint.

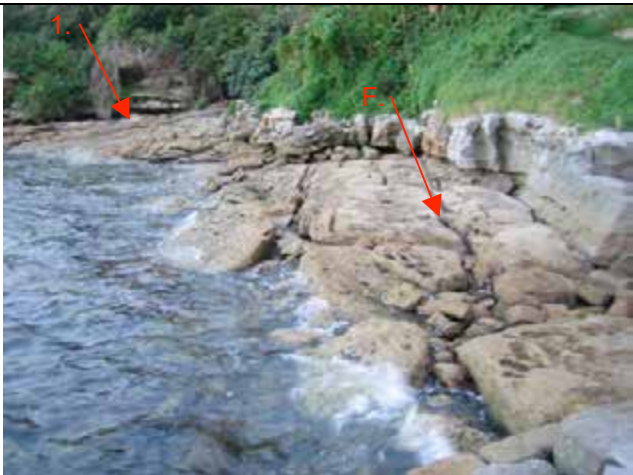
Current view of Camp Cove headland, showing the location of the remains of slipway (1.) The steps in the foreground where part of the wharf. The fissures (F.) are natural features not related to a former structure at that location.

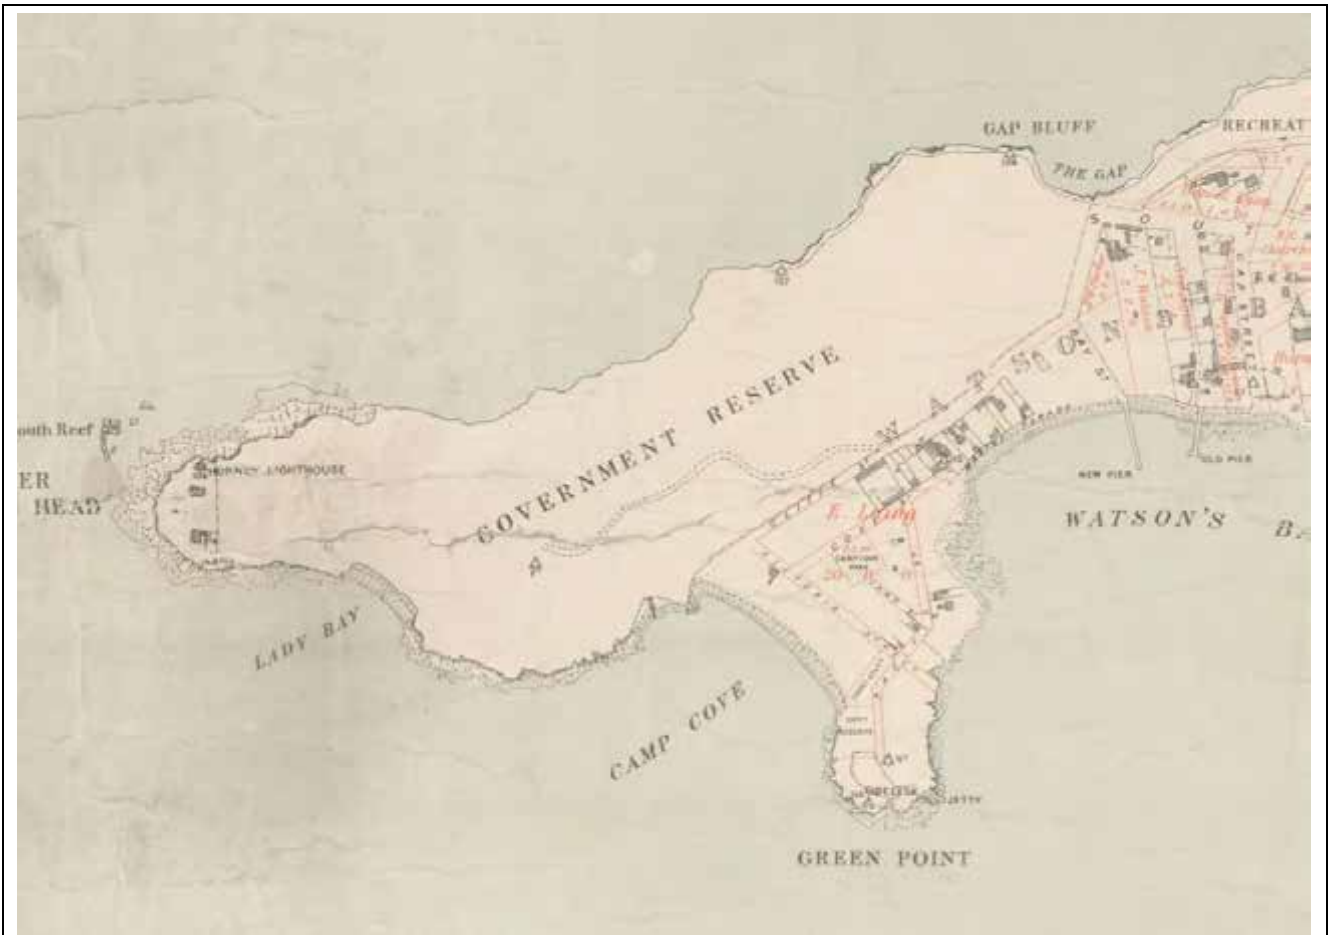
Extract from a survey of the Parish of Alexandria undertaken 1888-89 showing the path from Cliff Street. Structures are shown in Camp Cove but are not labelled. There is also a jetty at Green Point. NLA Maps F133 tile3

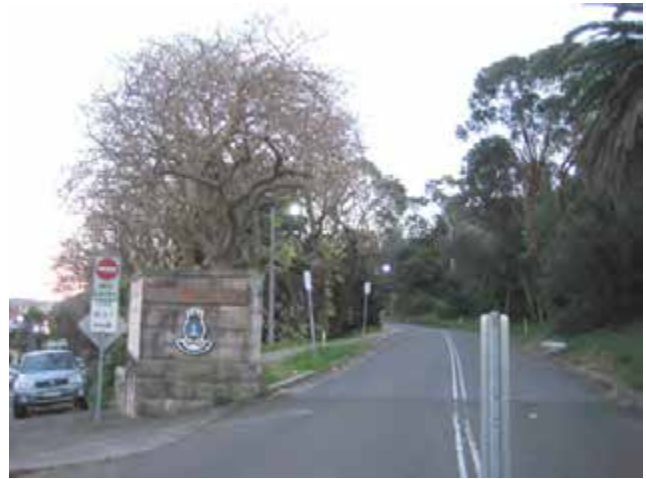
View of the entrance to the HMAS Watson. Noted Coral trees on left side of gate.

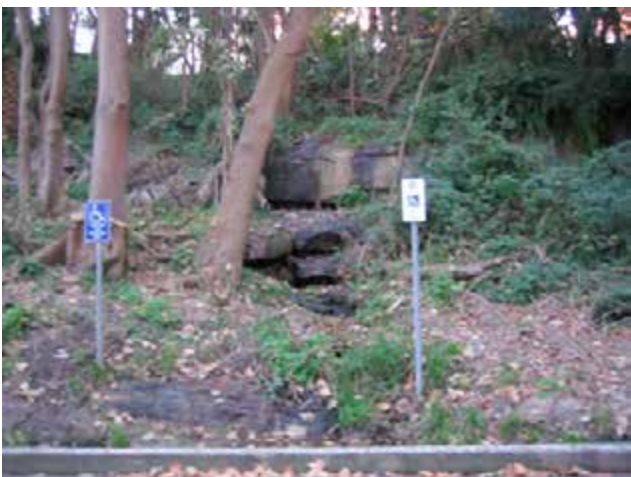
Water continually flows over this rock at the public parking area and may indicate a leaking pipe or similar above.

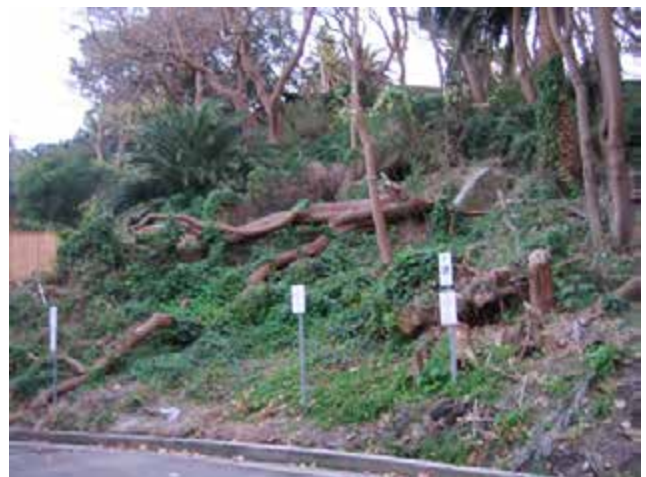
View of the senescent Coral tree that has fallen at the public parking area exposing a midden at its base.

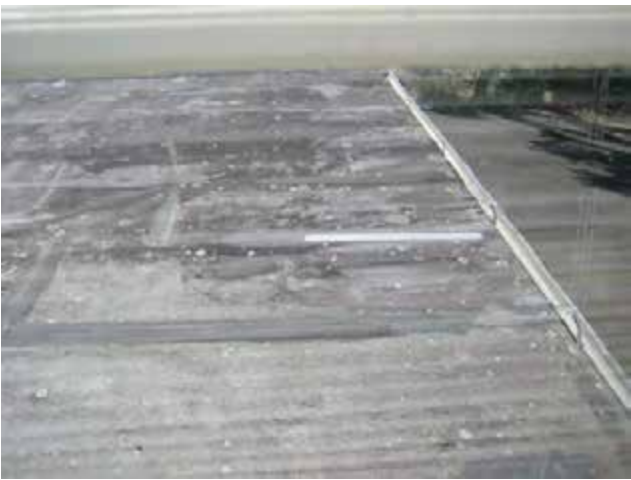
<p><i>View of flat roof where membrane needs replacement.</i></p>	<p><i>View of water damaged ceiling under flat roof.</i></p>

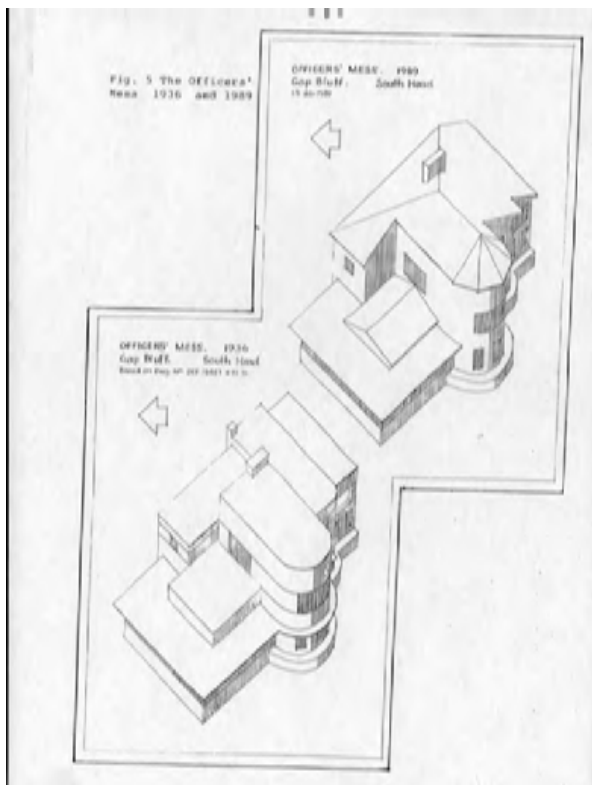
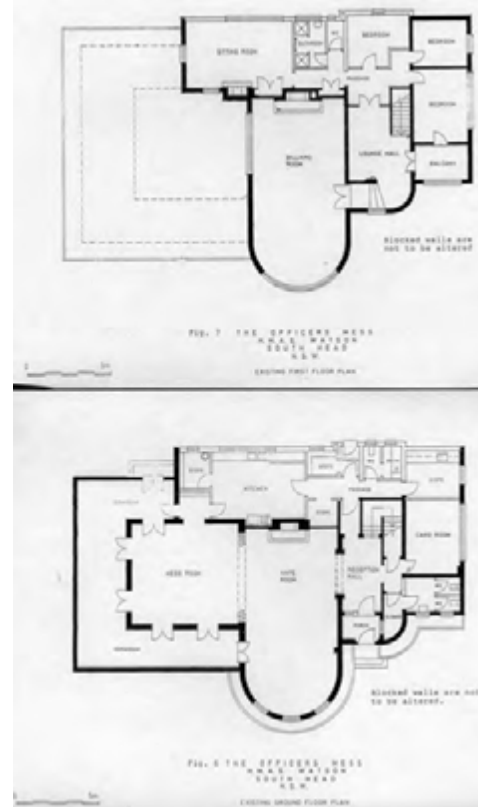
Drawing from CMP indicating how the building has been altered.

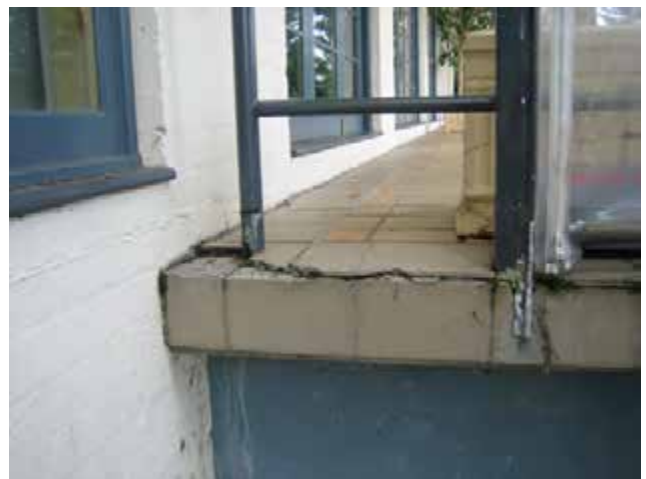
View of the modern verandah, front elevation (west), damaged rusting steel.

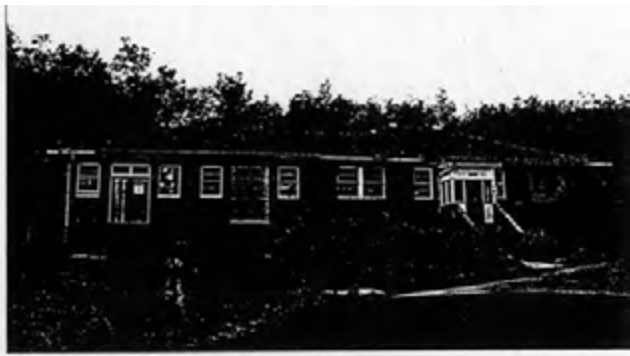
1941/52 1936
 Building N24 Artillery Store fig 3.502
 Gap Bluff
