SOUTH HEAD SYDNEY HARBOUR NATIONAL PARK

Conservation Management Plan

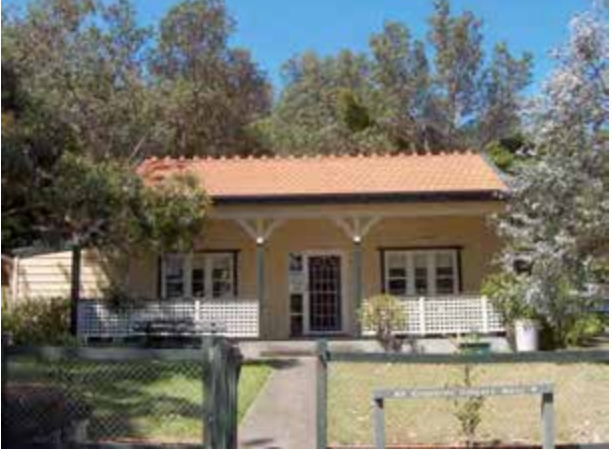
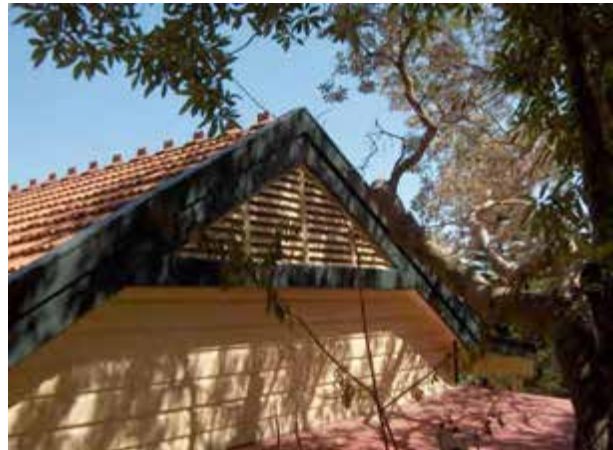
<p><i>View of front (west) elevation of the former Workshop. October 2006.</i></p>	<p><i>View of detail of the northern gable that is similar to the detail at Green Point Cottage. October 2006.</i></p>

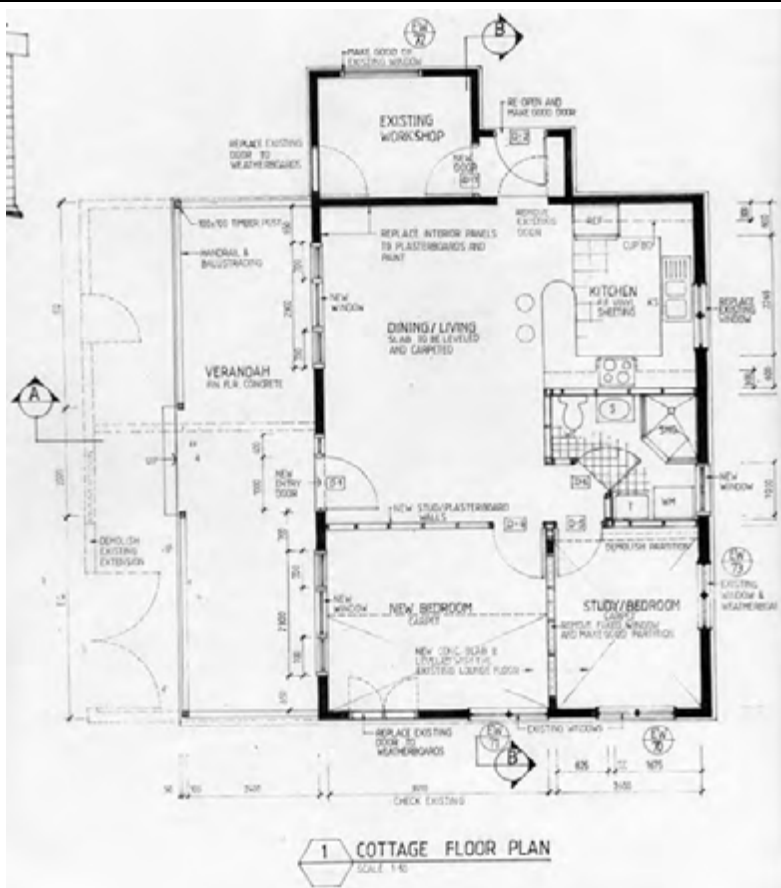
Plan showing alterations to adapt building as a residence. The plan indicates dotted the former extent of the lean-to addition demolished and replaced by the verandah

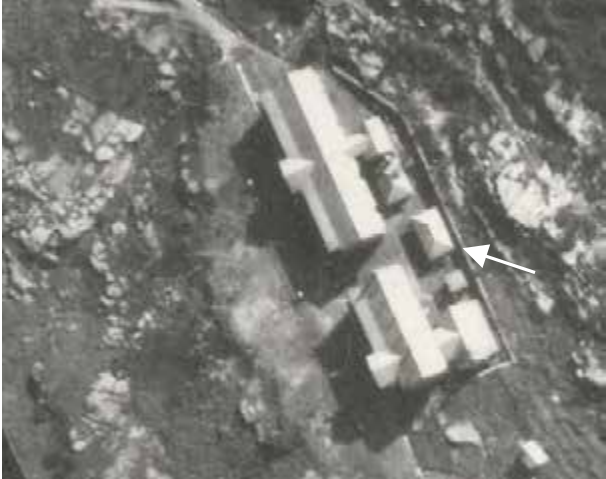
NAME: Site of the 1912 School of Artillery Barracks Including Latrine – Ref: 4A.4.		LOCATION: Lower Gap Bluff	
HHIMS ID: Not found	MAP:	ZONE:	GPS:
CURRENT USE: Open Space & Public Toilets		FORMER USE: Latrine for the School of Gunnery/Artillery	
Photograph

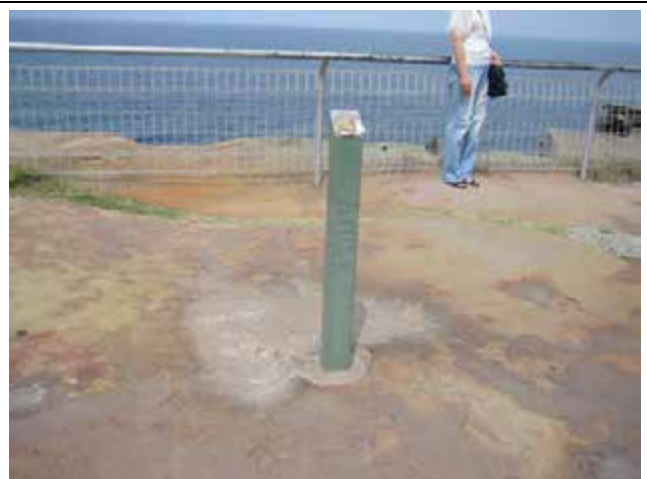
View of lookout area, looking east. Noted remains of vandalised interpretative sign.

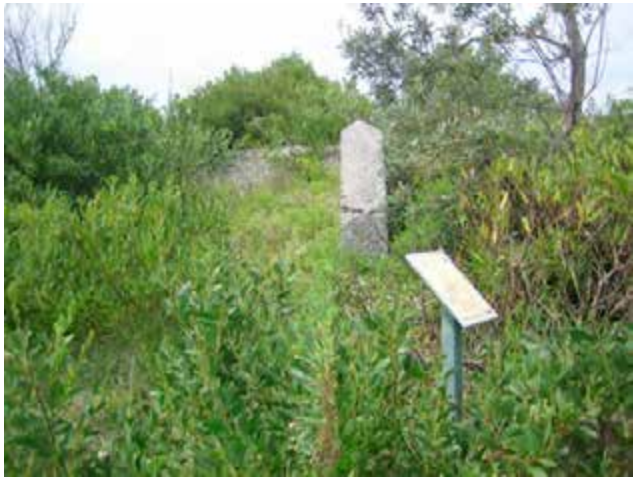
View of the remaining firing walls, at the east of the Gap Bluff area. Note interpretative sign and intrusive vegetation.

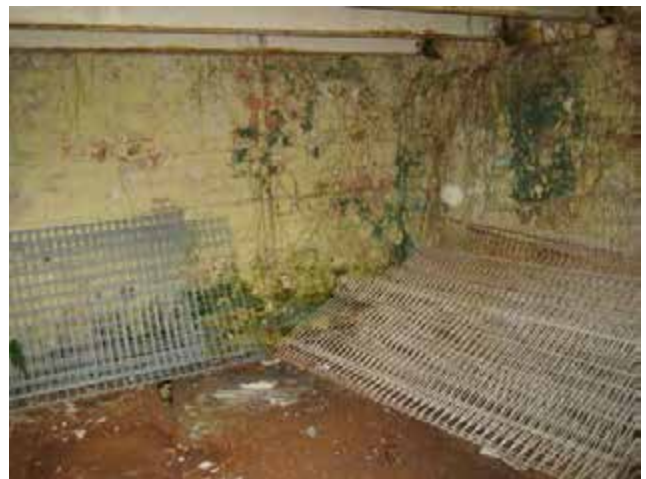
View of the building interior 4B.15, currently used for storage. In poor condition with deterioration of slab roof.

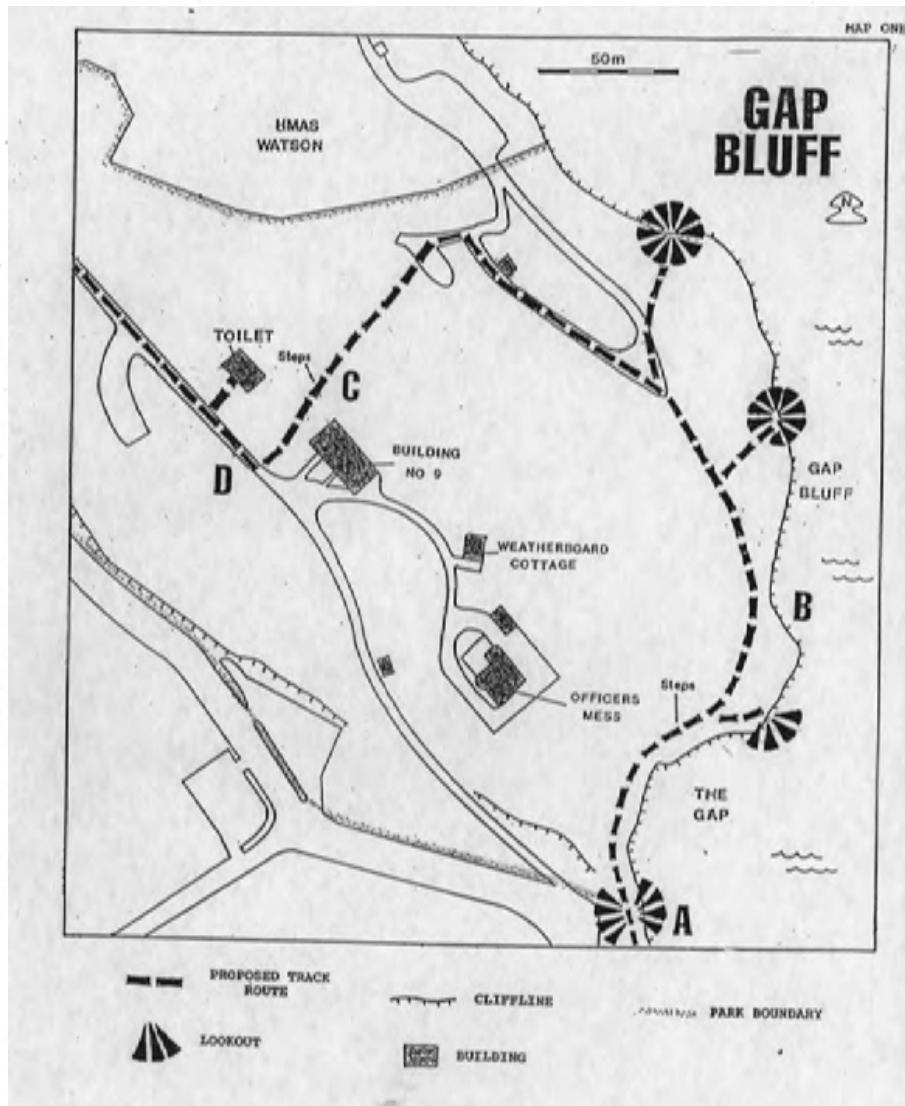
The Gap Bluff Track Proposal shows the route of the partly completed track. Source: Greycliffe library (SHR10)

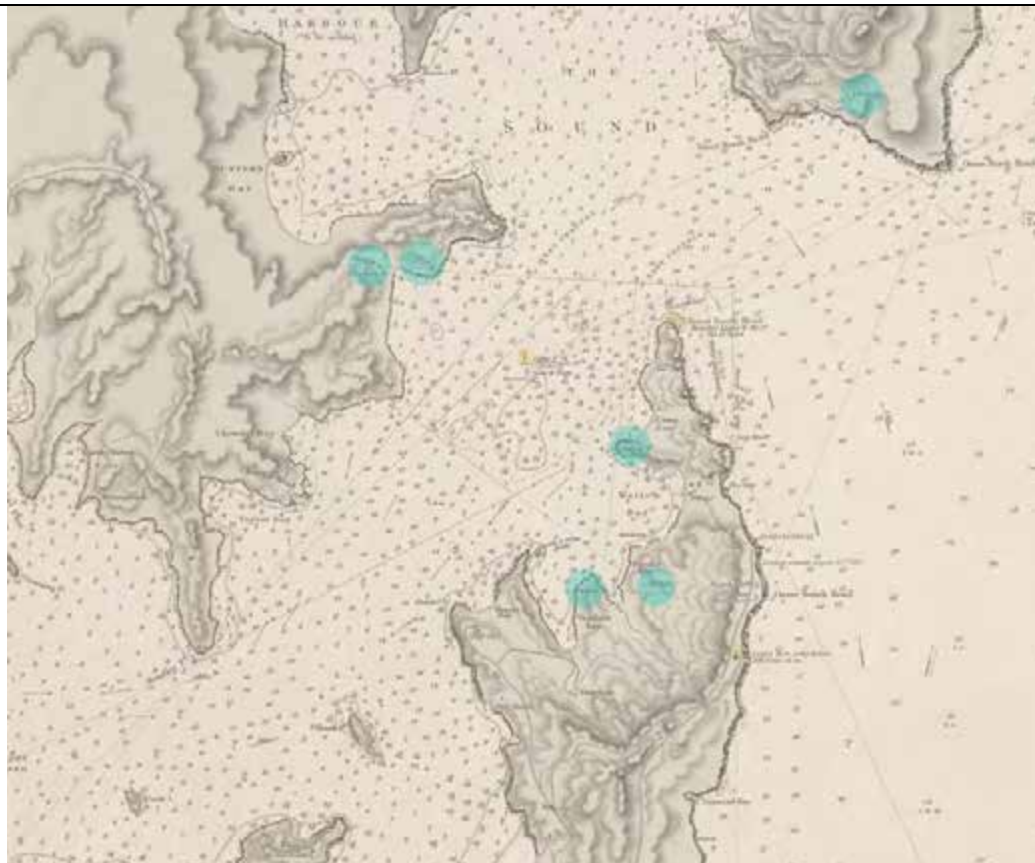
Extract from the Admiralty Chart of Port Jackson with the location of the navigational obelisks shaded. North Fort, North Head CMP figure 2.1.4

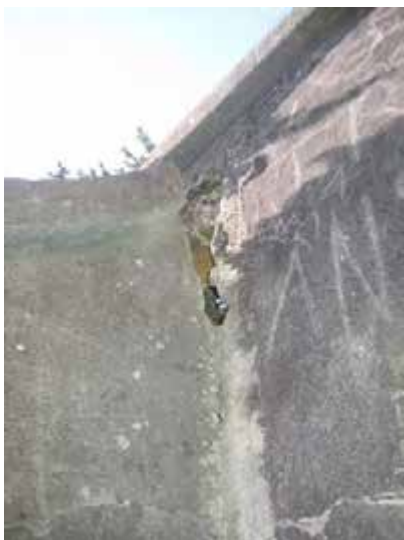
Detail of main entrance to underground structures. A large structural crack has opened up between the side and end walls. There has been movement in the structure.

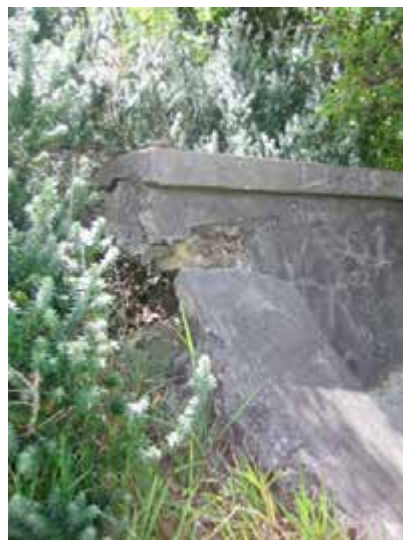
View of the same location shown in left picture. Vegetation and soil has built up above the walls.

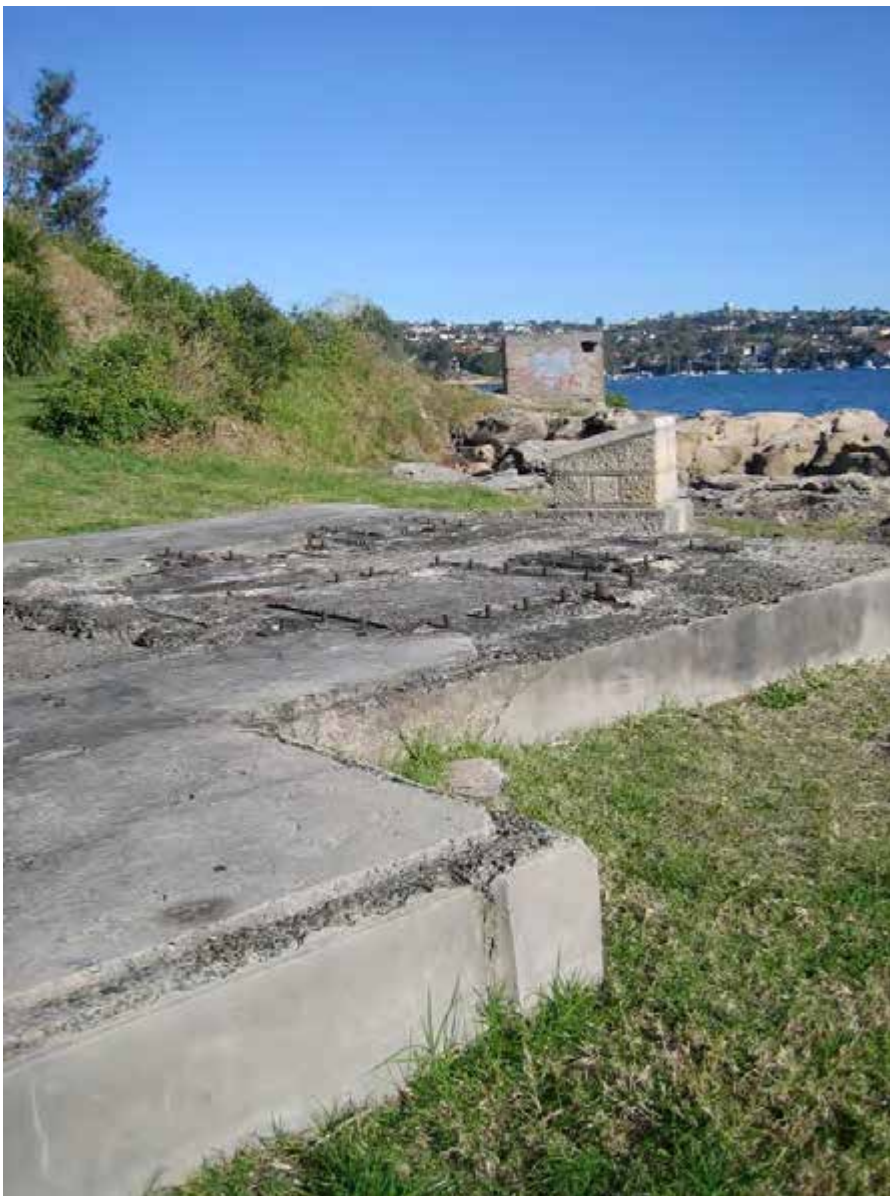
View of remains of the floor slab with evidence of former features such as the Searchlight and associated items. Immediately to the rear is the small stone memorial with interpretative plaque. In the background is small brick structure, item 5.6, a WWII observation post. The 1850's Navigation obelisk, item 5.3, is behind the photographer and to the right.
