Arboricultural Report

Unicorn Falls and Day Camping Area

Client:
National Parks and Wildlife Services

Report compiled by
Northern Tree Care
ABN 73 674 526 681

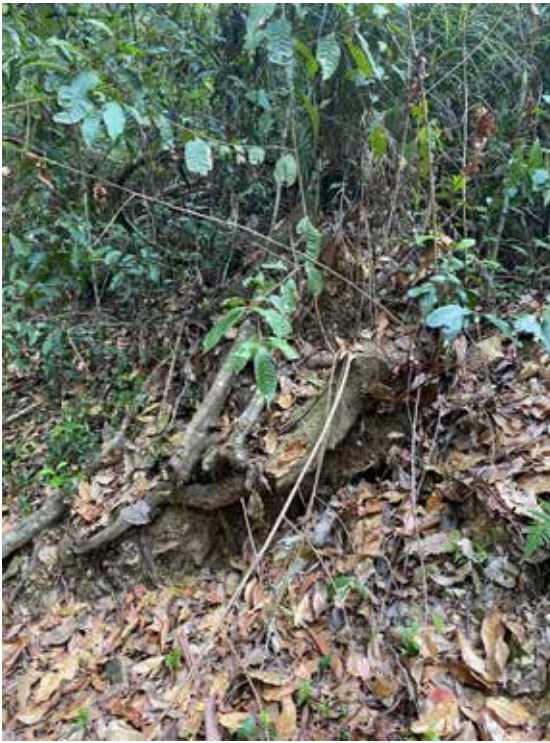
This is a young mature tree growing in or next to a pile of fill soil. The soil has eroded slightly leaving some roots exposed. The tree has adjusted to the erosion and is stable. The risk from the tree is acceptable. The planned construction of the new carpark will require some removal of this pile of fill. If the removal does not encroach to closer than 3 m of the tree, the tree is not expected to suffer any significant consequences. If the removal encroaches to 2 m or less from the centre of the base of the tree, the tree is likely to become unstable.

Photo 1
Day Use Area Tree # 2
Rose Walnut

It is recommended that tree # 1 be removed before construction commences. It is recommended that the car parking area be constructed so as to retain the fill at least to 3 m from the trunk of tree # 2. If the fill is required to be excavated to 2 m or closer to the tree, the tree should be removed. Tree # 4 should be cut down to a minimum of 2 m high.

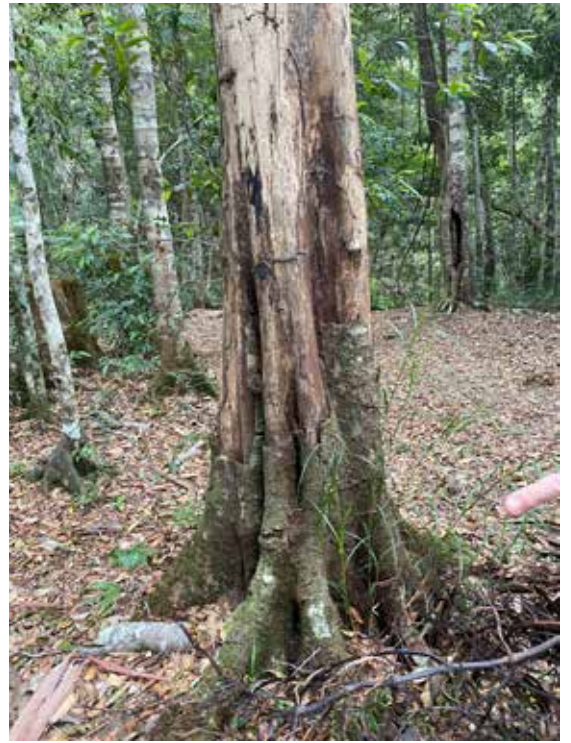
The risk from this tree is calculated to be on the high end of the tolerable range.

Photo 2
Day Use Area Tree # 4
Dead tree

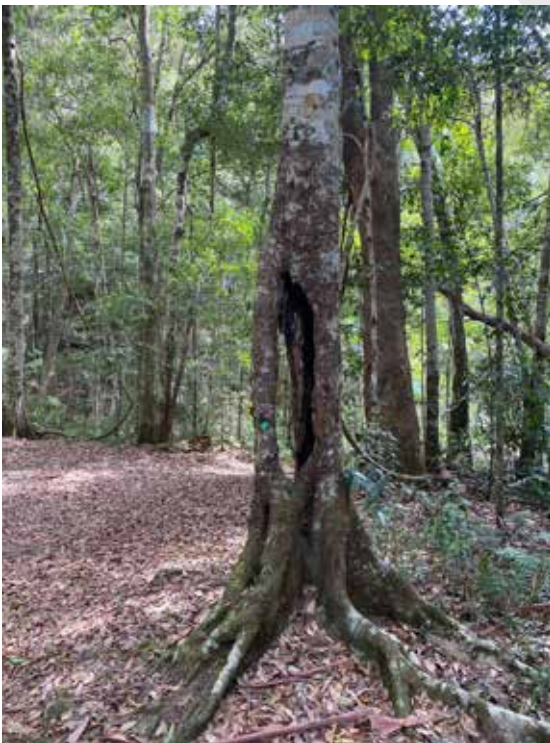
This is a mature aged tree. It has a large cavity at the base of the trunk. The tree has grown reaction wood to compensate for the loss of the wood strength. The risk from the tree is calculated to be acceptable.

Photo 3
Day Use Area Tree # 6
Tree has a hollow at the base

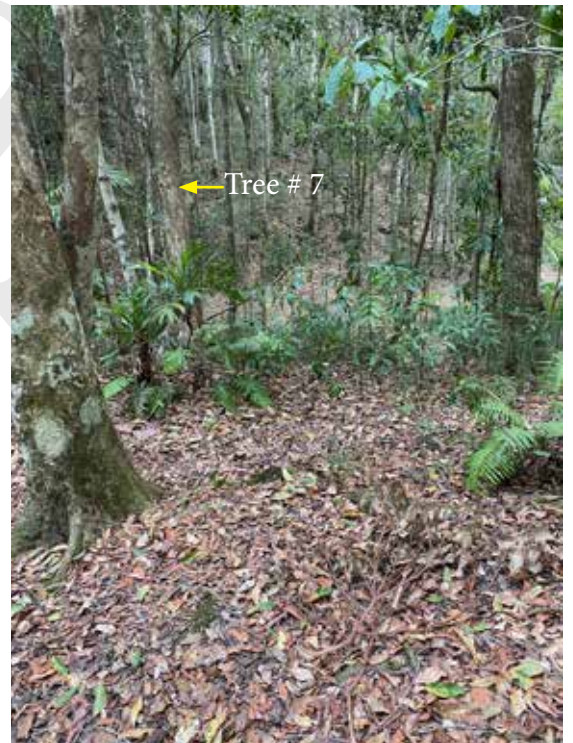
This tree is growing on the creek bank close to the proposed walkway down to the creek. The tree is leaning. The risk from the tree is calculated to be acceptable.

Photo 4
Day Use Area Tree # 7
A path is planned to run beside this tree

Tree # 7 is growing close to the planned track down to the creek. It is recommended that the construction of the track be carried out so that the minimum disturbance occurs the ground. This could be achieved by building steps and paths up instead of excavating. The large native vine at the top of the bank should be retained and protected by minimizing the soil disturbance close to the vine.

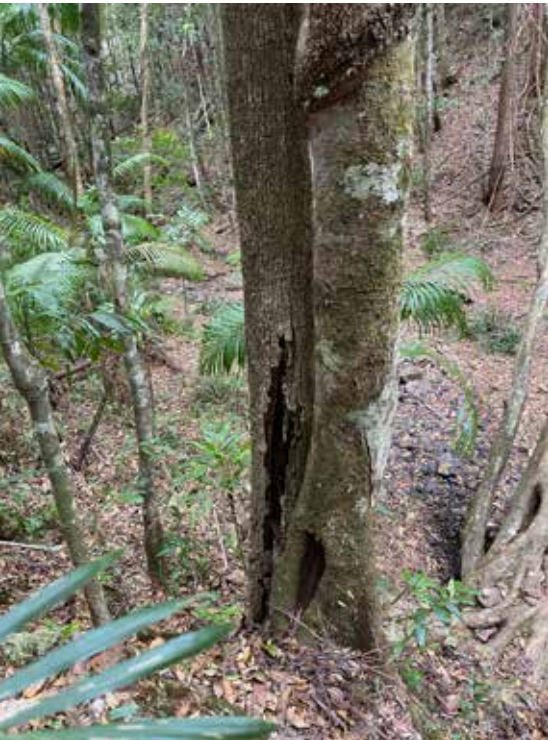
This is a mature aged tree on the edge of the creek. It has a hollow at the base of the trunk. The tree has grown compensatory reaction wood to compensate for the loss of wood strength. The occupancy rate for the fall zone of the tree is low. The risk from the tree is calculated to be acceptable.

Photo 5
Day Use Area Tree # 8
Hollow at the base

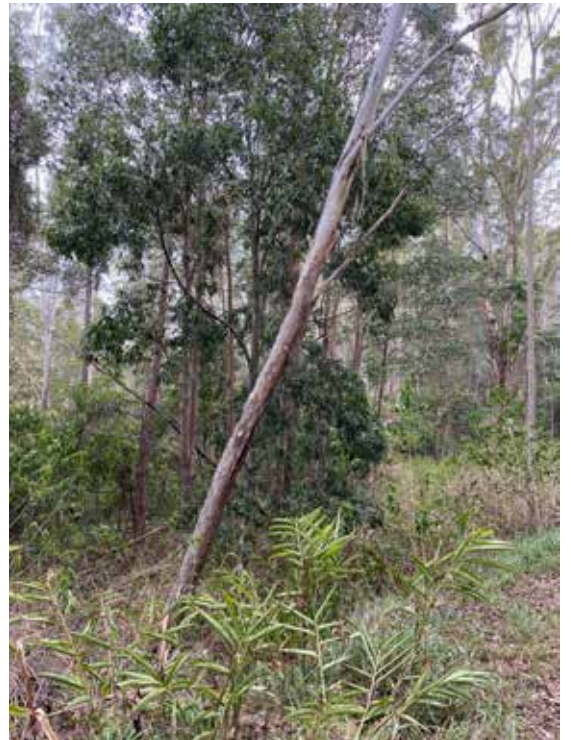
Approximately 200 m from the turnoff to the day use area, on the northern side of the road a Gum tree is growing with a lean over the road. The tree appears to be an epicormic shoot that has grown up after the original tree has fallen. The tree has an elevated likelihood of failure in high winds. If it failed it would fall onto the road.

Photo 6
Road into Day Use Area
Leaning Tree

The Gum tree leaning over the road running down to the day use area is recommended to be removed.

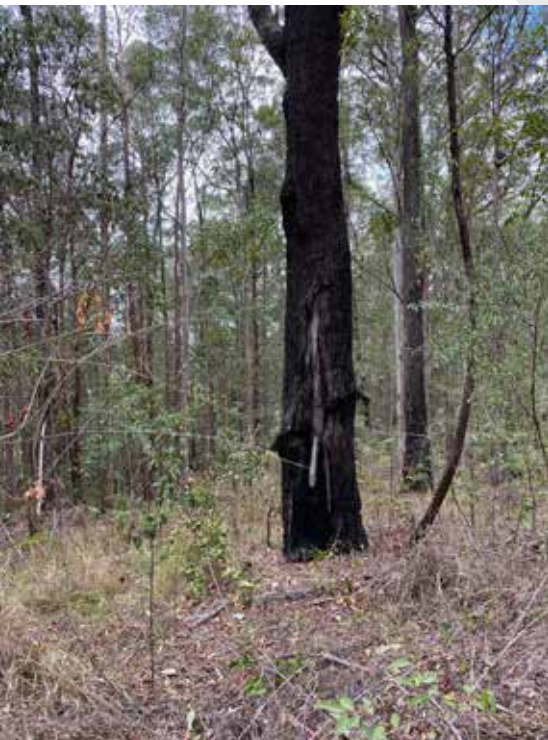
This is a mature aged tree near the entrance to the camping area. The risk from the tree is calculated to be acceptable.

Photo 7
Camping Area Tree # 1
Ironbark

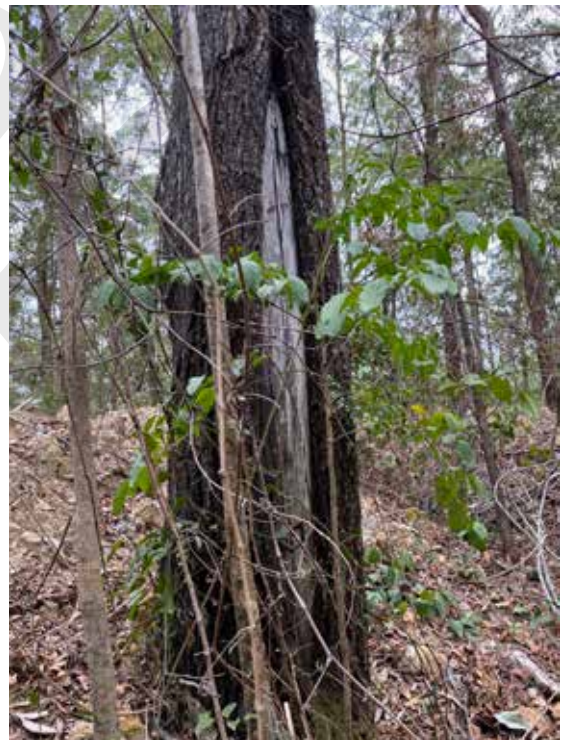
This tree is close to the edge of the planned car parking area. It may be possible to retain the tree. It has had injuries to the lower trunk and bark has been lost. The underlying wood is sound and there is signs of woundwood forming. The pile of spoil material is currently being stored at the base of this tree. The risk from this tree is calculated to be at the low end of the tolerable range.

Photo 8
Camping Area Tree # 3
Ironbark

It is recommended that the spoil material be removed from the base of trees # 3 and 4. If they are retained in the camping area they should be pruned to remove the dead branches in the crown that are larger than 50 mm in diameter. The pruning must be carried out by an Arborist qualified to a minimum of AQF 3 in Arboriculture and in accordance with the Australian Standard AS 4373-2007 *Pruning of amenity trees*.

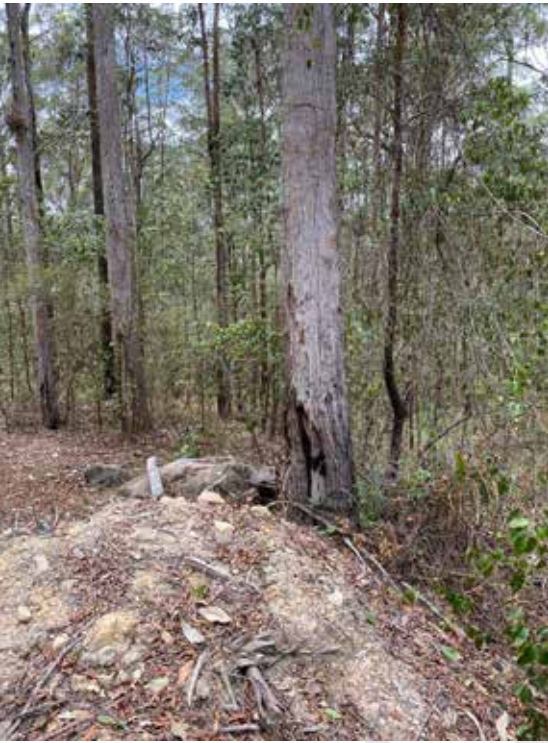
This tree is close to tree # 3 and is also affected by loss of bark on the lower trunk and the storage of spoil material at the base of the tree. The risk from the tree is calculated to be on the lower end of the tolerable range.

Photo 9
Camping Area Tree # 4
Tallowood

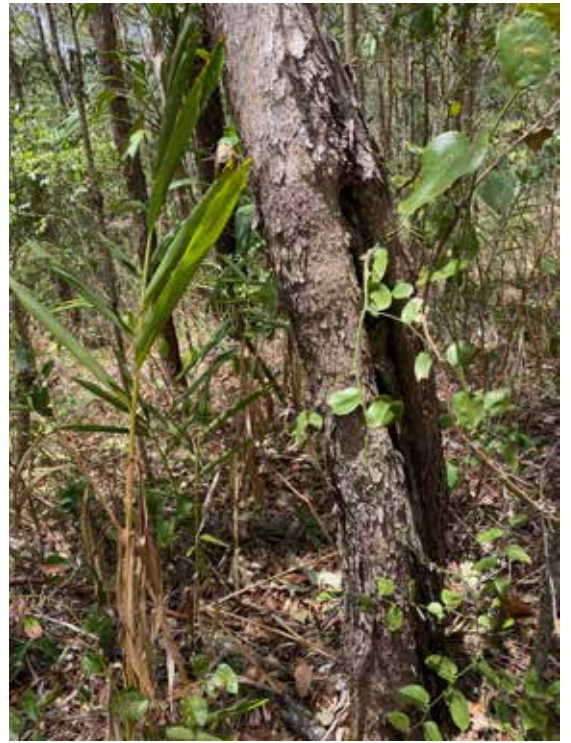
This tree is a mature aged and in good condition. The tree is leaning. The risk from the tree is calculated to be acceptable.

Photo 10
Camping Area Tree # 5
Tallowood

It is recommended that tree # 5 be removed before construction commences.

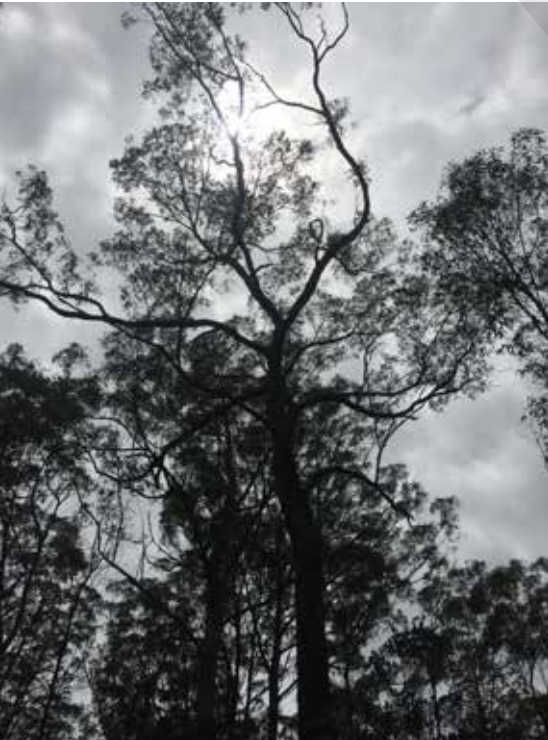
Photo 7
Camping Area Tree # 3
Dead branches in the crown.
