# **Statement of Heritage Impact**

Demondrille Signal Box

October 2023

Project Number: 210458

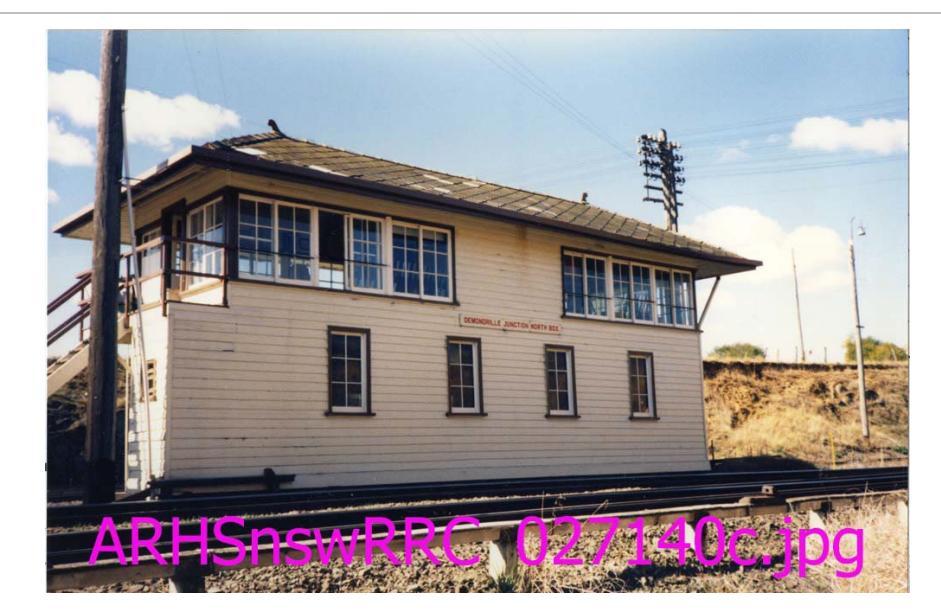
Figure 3-6 Demondrille signal box, c.1995. Note the deterioration of the paint on the weatherboard (Source: Australian Railway Historical Society)

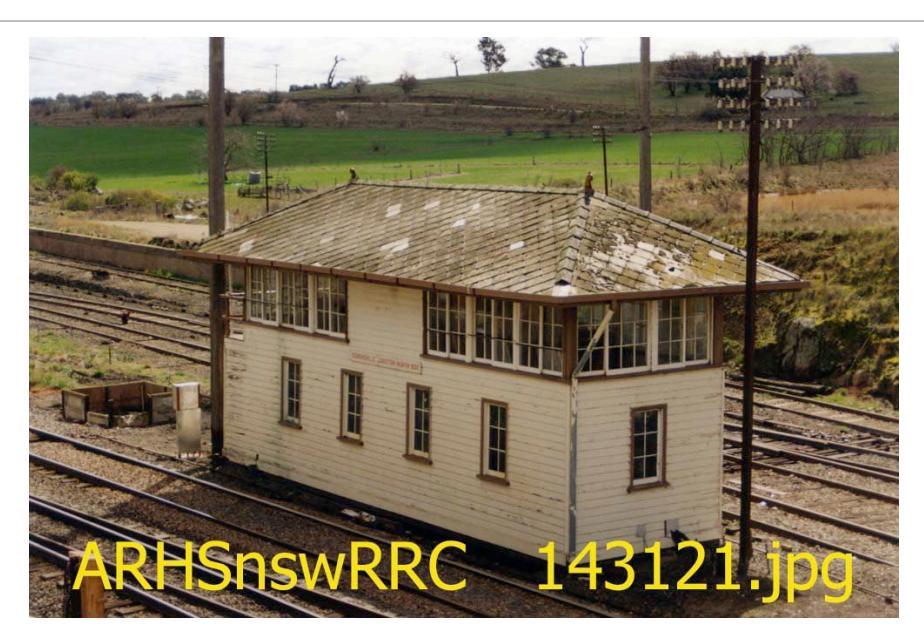
Figure 3-7 Demondrille signal box, c.1995. Note the deterioration of the paint on the weatherboard (Source: Australian Railway Historical Society)

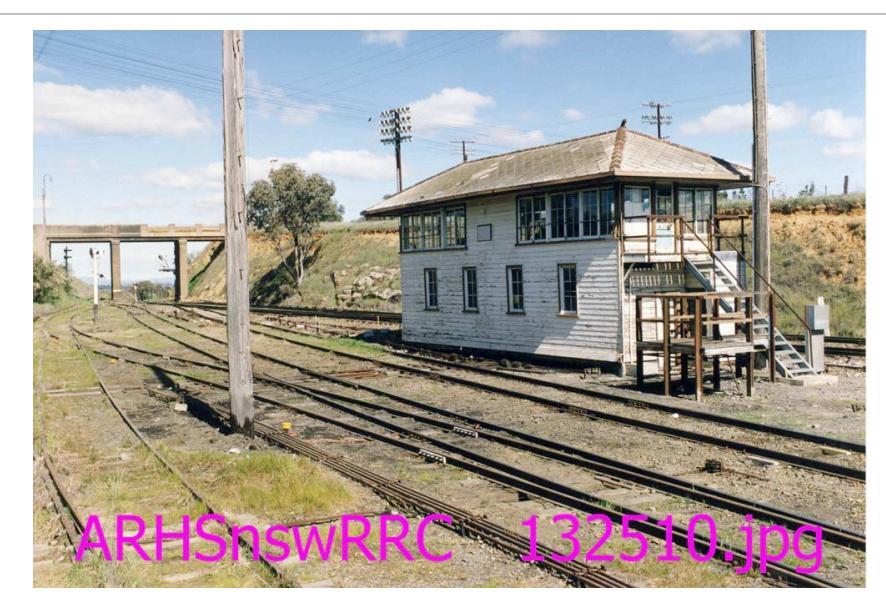
Figure 3-8 Demondrille signal box, c.2000. Note the significant deterioration of the paint on the weatherboard (Source: Australian Railway Historical Society)

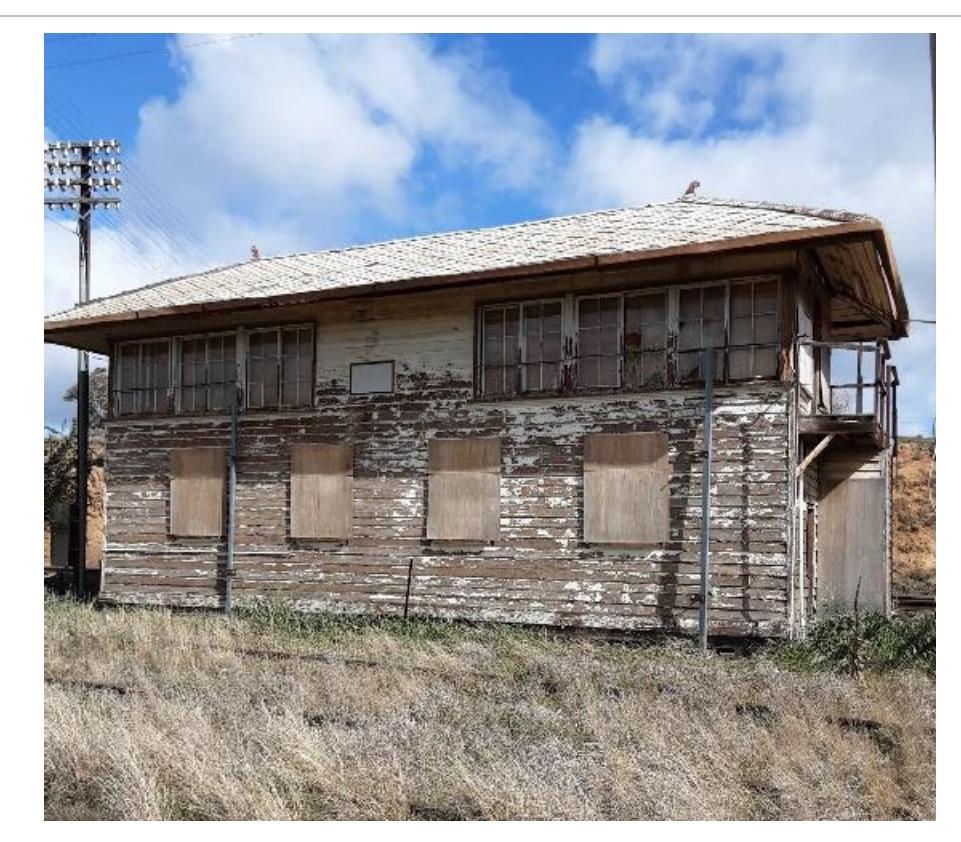
Between 2014 and 2019, access to the structure was restricted when the external stairs collapsed. In order to prevent further collapse of the structure, ARTC installed external bracing columns to hold the structure in place (Figure 3-10).

Figure 3-11 Demondrille signal box bracing installed by ARTC to prevent the collapse of the building (2019 Asbestos Register)

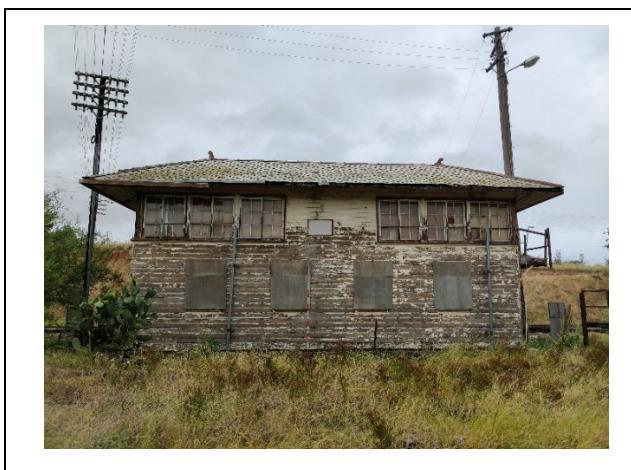
Plate 3-1 Severe weathering on the exterior of the signal box. Lower windows have been boarded up due to vandalism damage

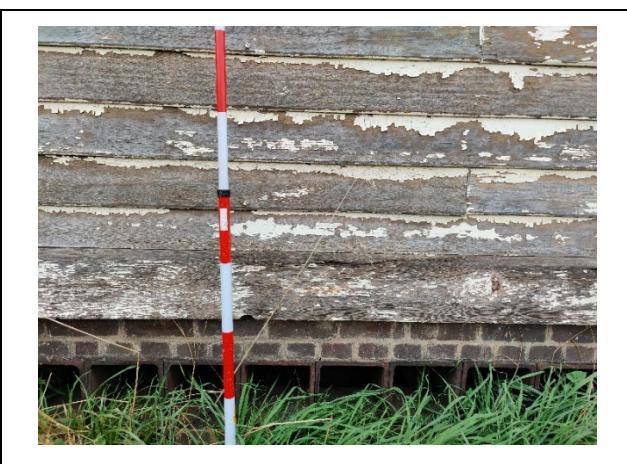
Plate 3-3 Significant weathering of the weatherboard, set atop brick and steel foundations

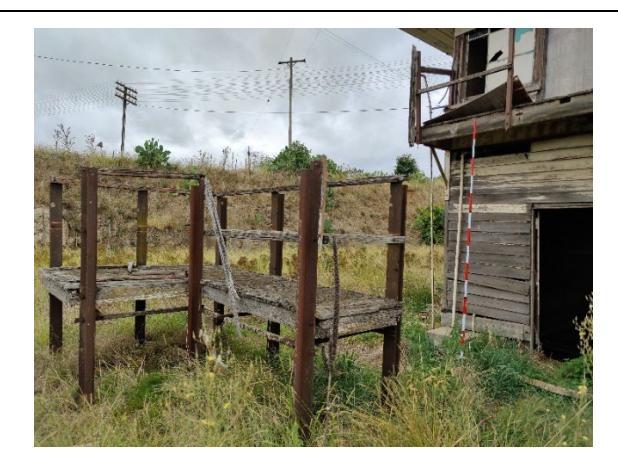
Plate 3-6 External stairs to reach the second storey originally located on the northern side of the structure have been mostly removed

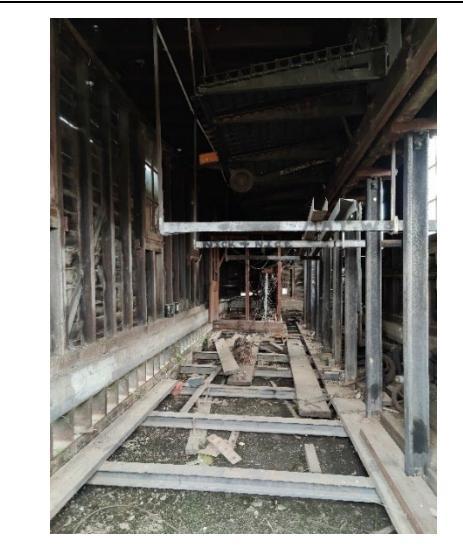
Plate 3-7 Current interiors of building with steel supports

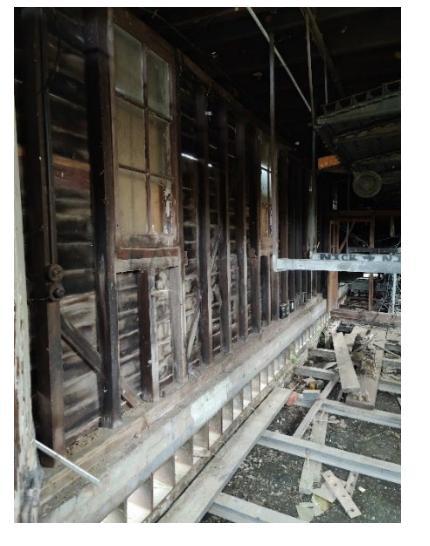
Plate 3-8 Lower level window frames are still present behind the boarding up. Windows contain cracked glass due to vandalism

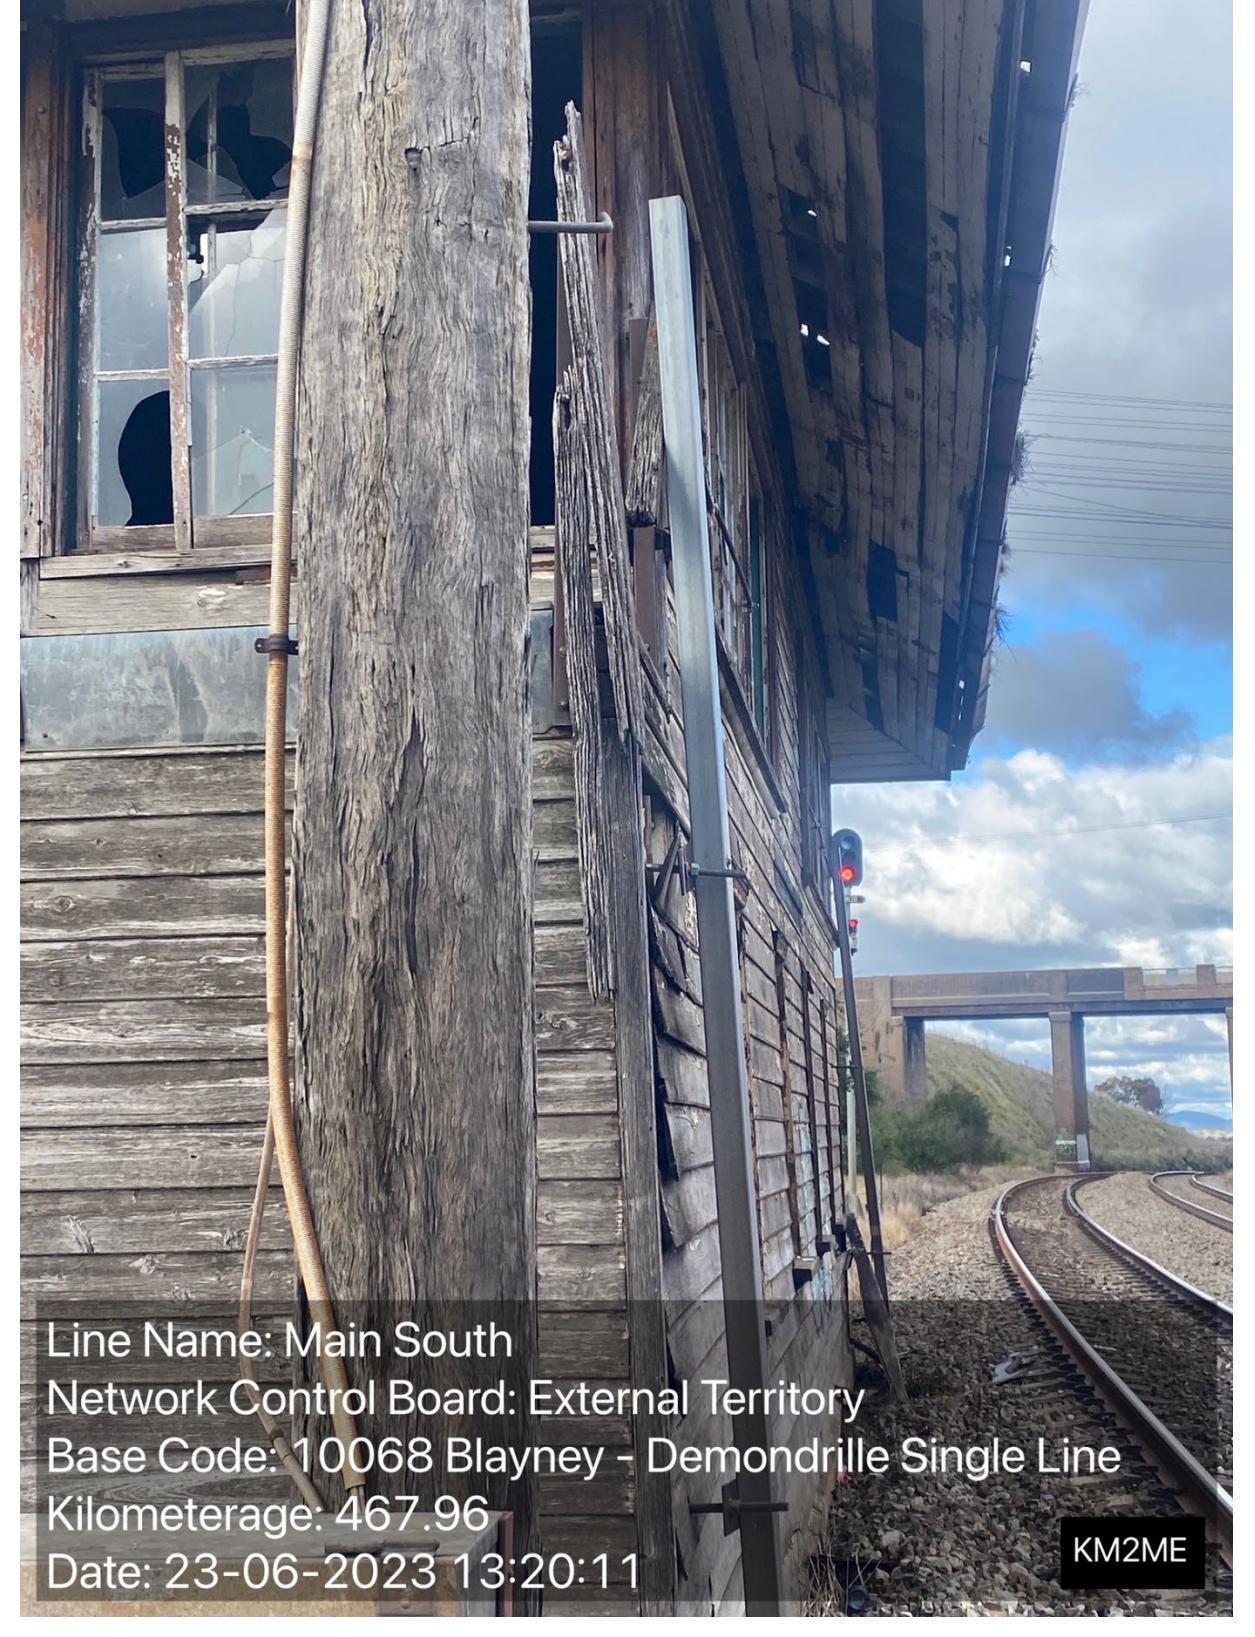
Plate 3-9 Current deteriorated condition of the external elements of the building.

Note the cladding that is pulling away from the walls and the deteriorated uprights. The external bracing columns are no longer effective at helping to maintain the building upright due to the restraints only being attached to deteriorated weatherboard cladding (ARTC 2023).

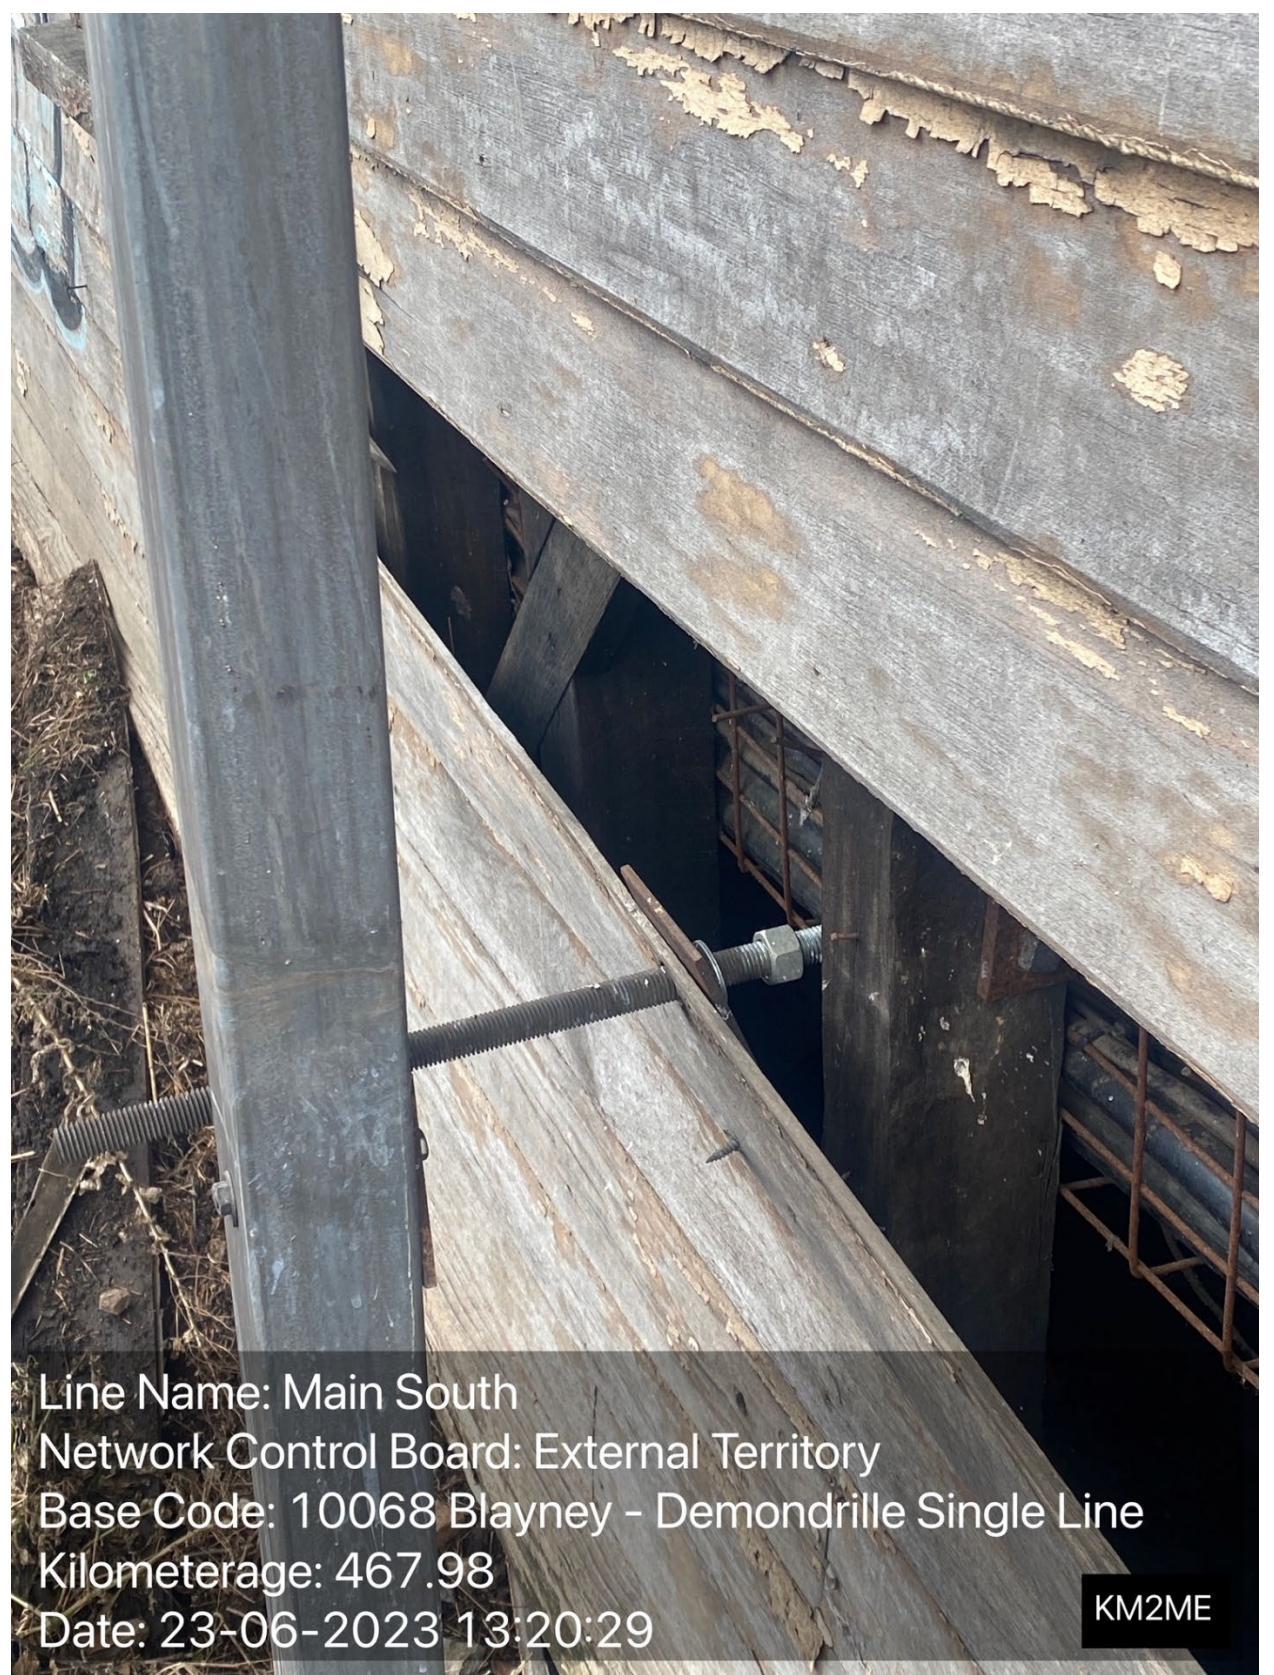
Plate 3-10 Current deteriorated condition of the external elements of the building

Note: The external bracing beams are no longer effective at helping to maintain the building upright due to the restraints being only being attached to deteriorated weatherboard cladding. (ARTC 2023).
Demondrille Signal Box

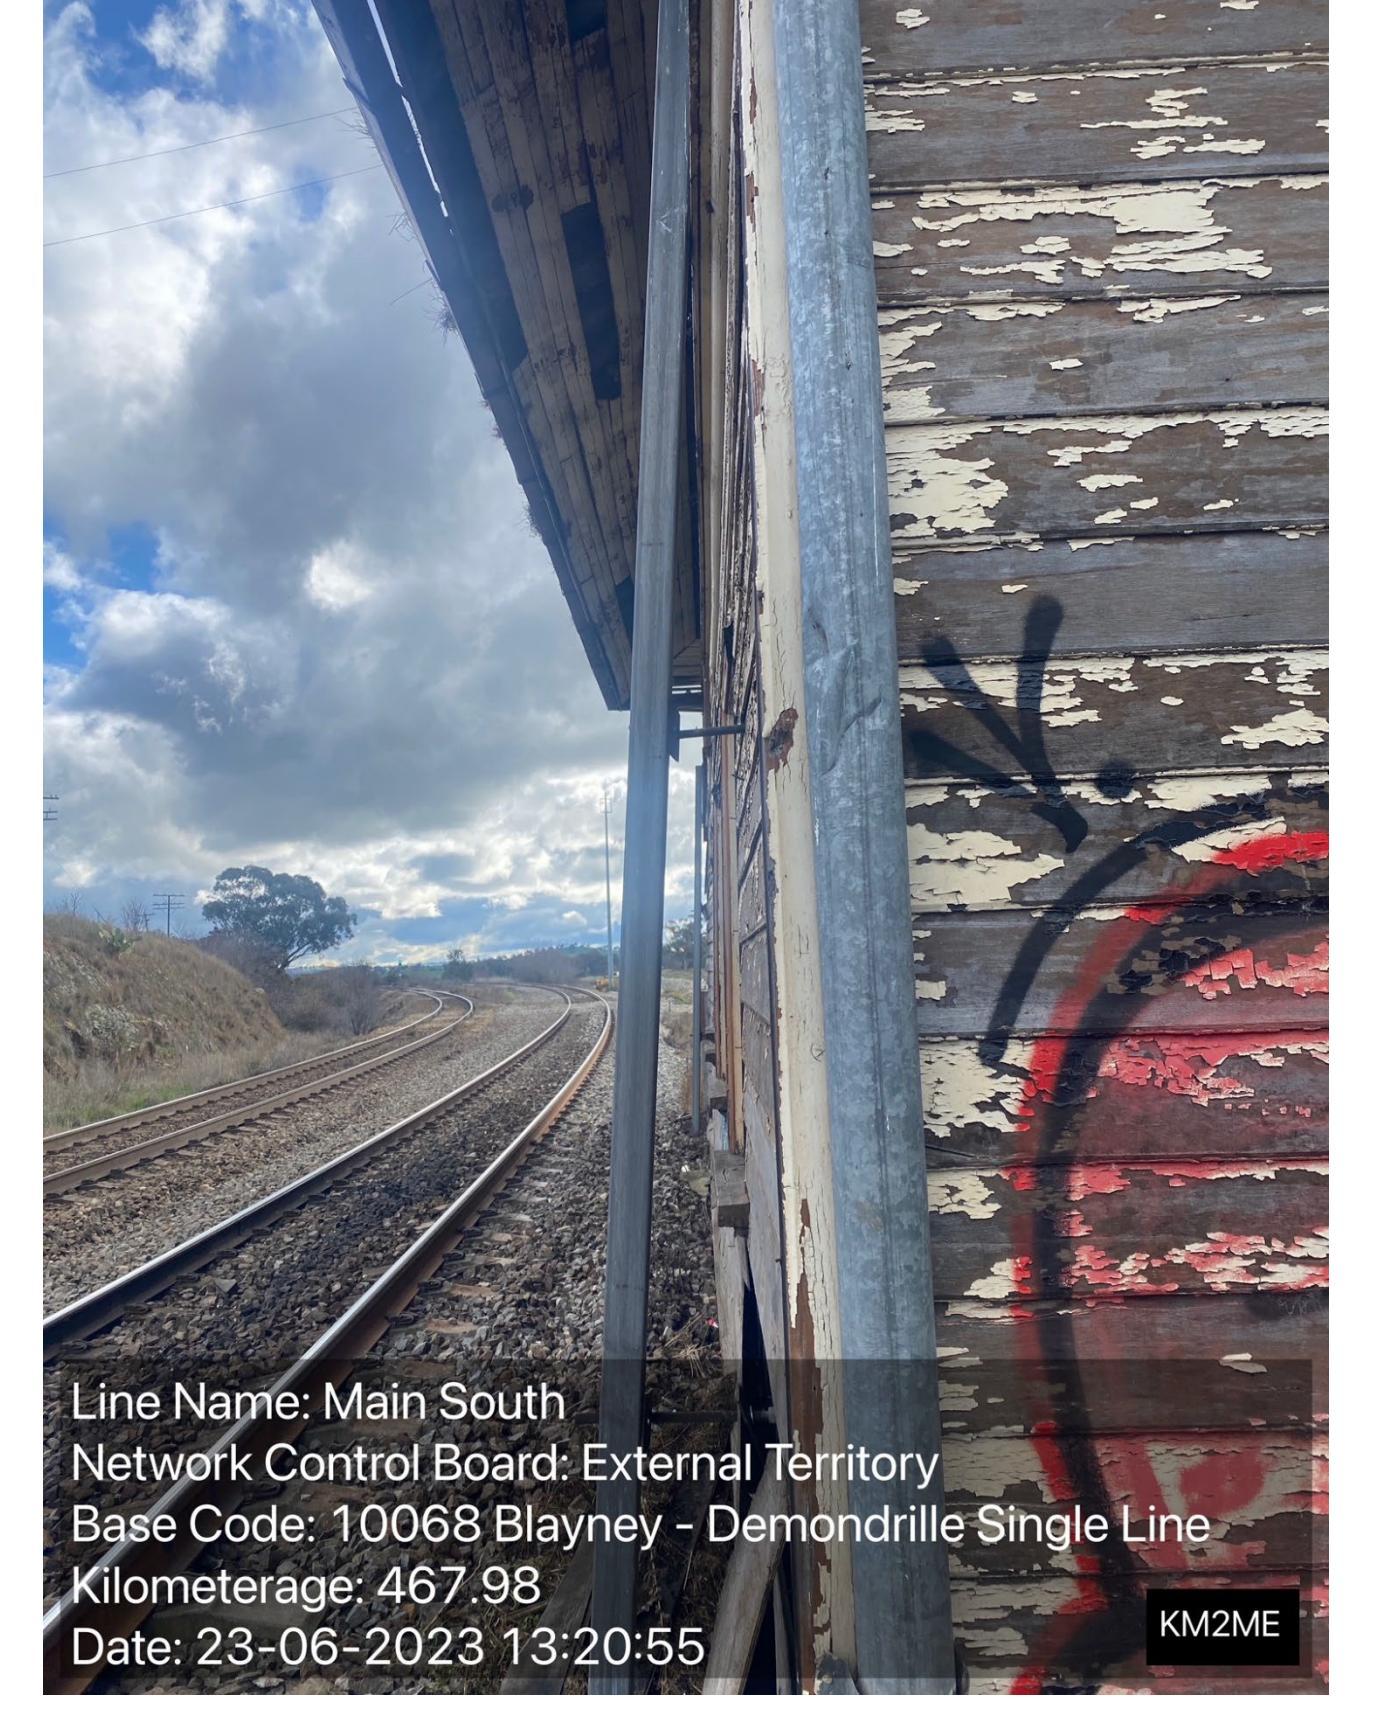
The building shows significant signs of vandalism, and the location of the building is in an area that is easily accessed by the public (but not necessarily visible) which would allow for ongoing damage to occur to the structure. If ARTC were to place a fence around the structure in order to avoid any further access or vandalism by the public, the fencing would have to be significant in order to reduce the ongoing safety issue and risk of collapse. It has further been identified that a fence would be impracticable as the signal box is within the danger zone of the railway track and any fence would be 3 sided, (not complete). The 2 road overbridges in close proximity to the signal box would prove to make corridor fencing near impossible to keep vandals out.

Plate 3-11 Vandalism that has occurred to the building due to it being publicly accessible (ARTC 2023)

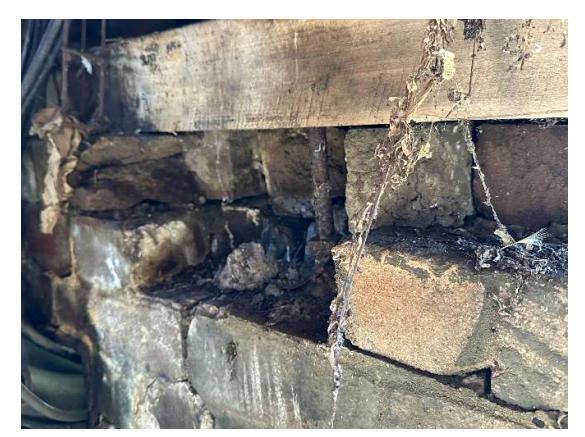
Photo 15.

- Masonry supports at tie down location has deteriorated refer photo 15.
- Cracking to sub-floor masonry wall refer photo 16.

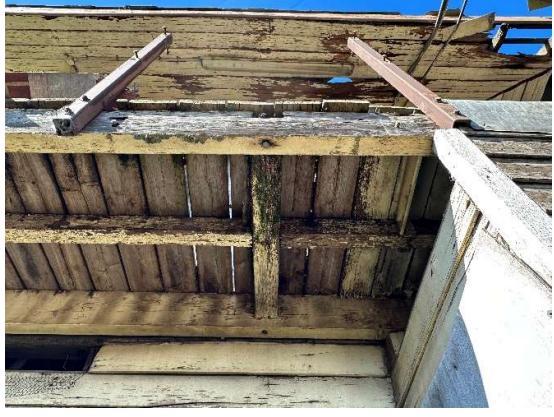
Photo 18.

- External landing timbers are extremely weather damaged with connections compromised. Stair access • has been removed – refer photo's 17 to 19.
- Steel posts have been installed as an attempt to stabilise the building, however, the tension rods have ٠ been fixed to the cladding only - refer photo's 20 to 22.
- Eaves lining board are weather damaged and are out of plane with separation from the underside of the • rafters - refer photo's 23 to 25.
- Ends of timber rafters appear weather damaged with guttering dislodged refer photo 26. ٠
- Gutters are full of debris and have rotated outwards refer photo 27.
- Timber weather boards are extremely weather damaged and are dislodged at some locations refer ٠ photo 28 & 29.
- There is an overall lack of maintenance and adequate site surface drainage to the surrounds of the • building - refer photo 30 & 31.
