**Volume 3: Appendices Bobbin Head + Apple Tree Bay Masterplan 2006**  
Ku-ring-gai Chase National Park

**Volume 3: Appendices**  
**Bobbin Head + Apple Tree Bay Masterplan 2006**  
**Ku-ring-gai Chase National Park**

February 2007

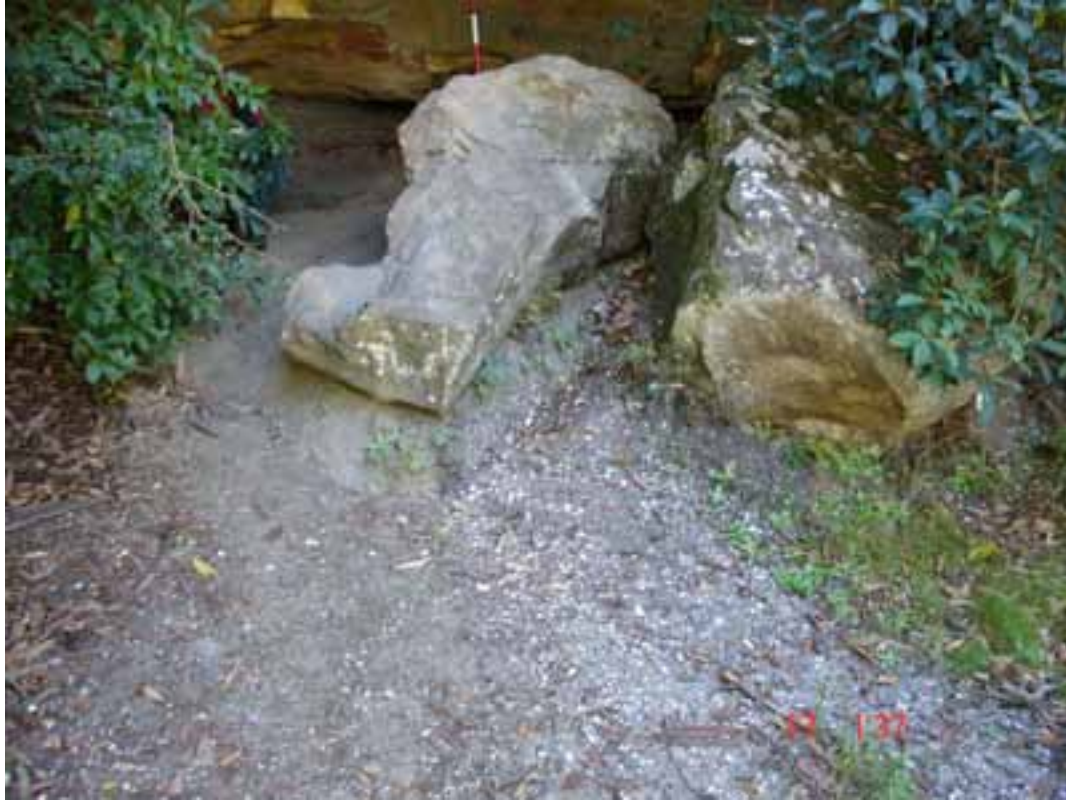
**Photo 1. Shell midden deposit at BH 1. Although deposit is dispersed investigation of site revealed intact stratified deposits.**

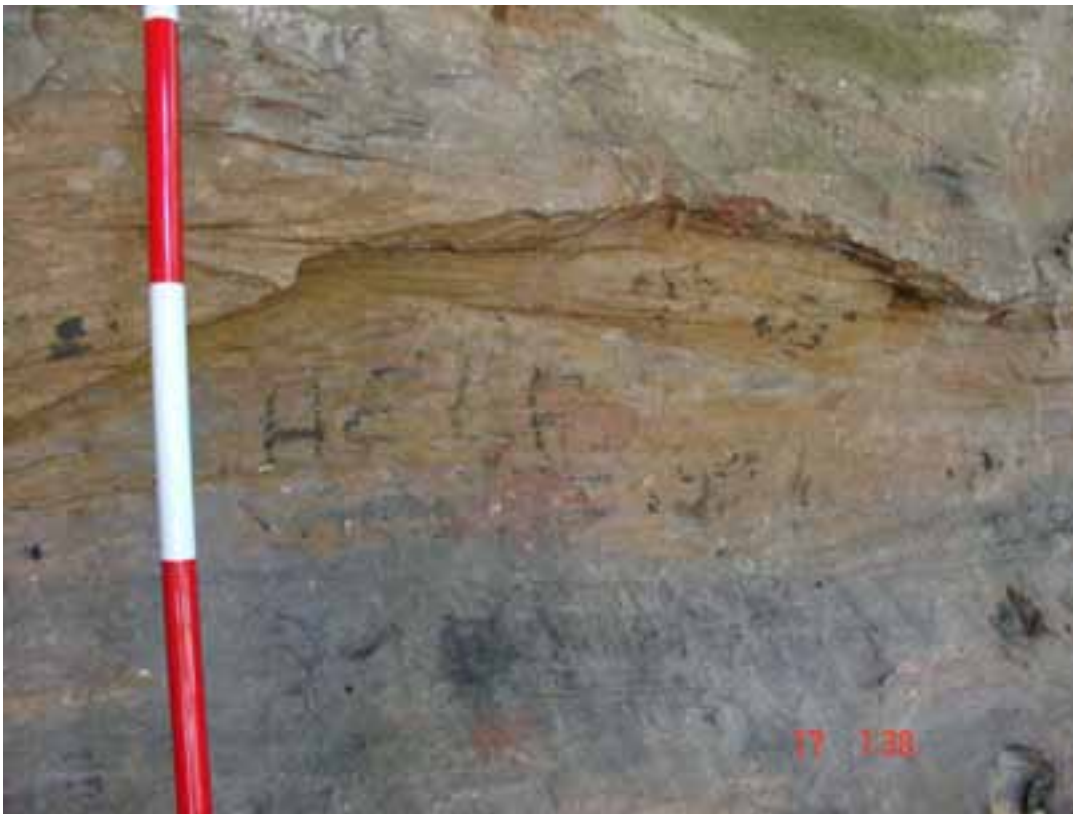
**Photo 2. Graffiti written in charcoal on rockshelter wall at BH 1.**

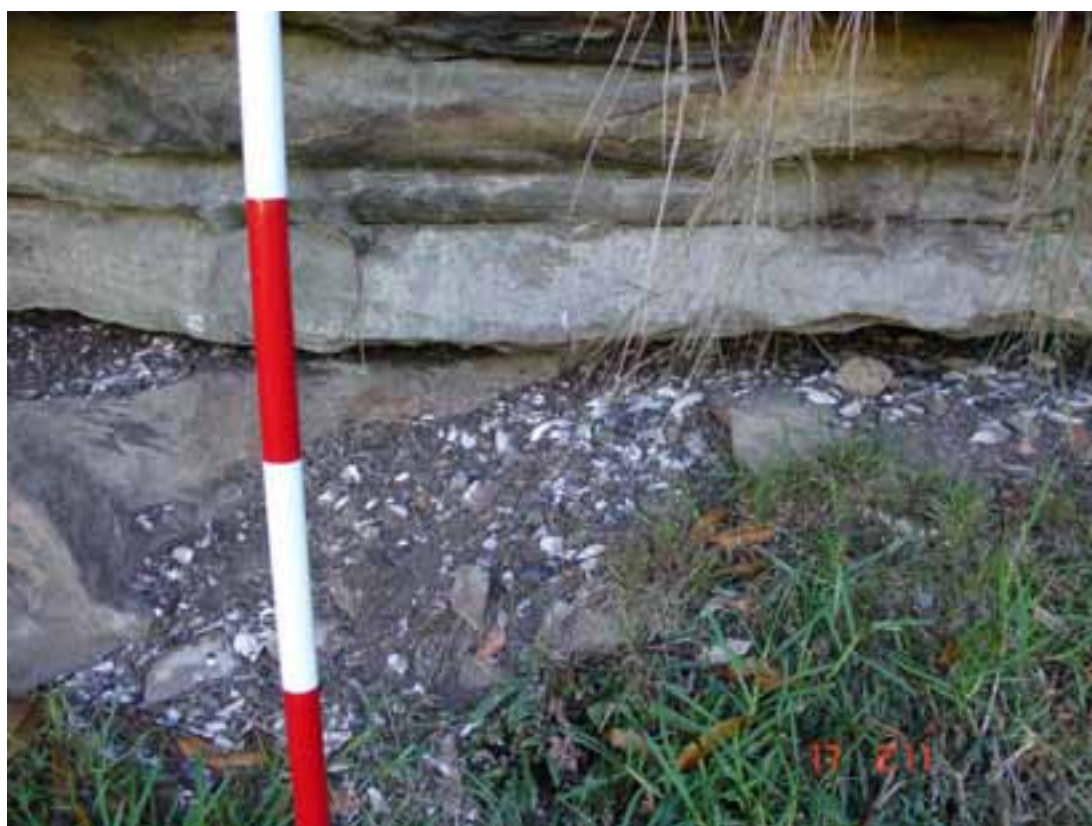
**Photo 4. Redeposited shell midden material (BH 2). Deposit includes cultural shell remains and fragments of ceramic and asbestos.**

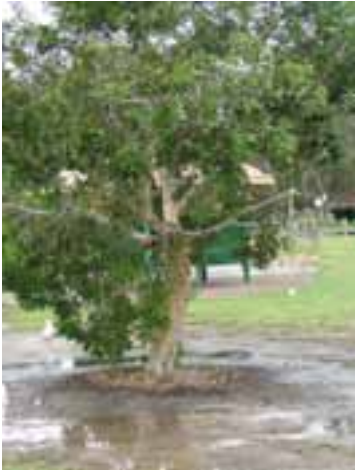
*Sea inundation at trees (January 2006)*

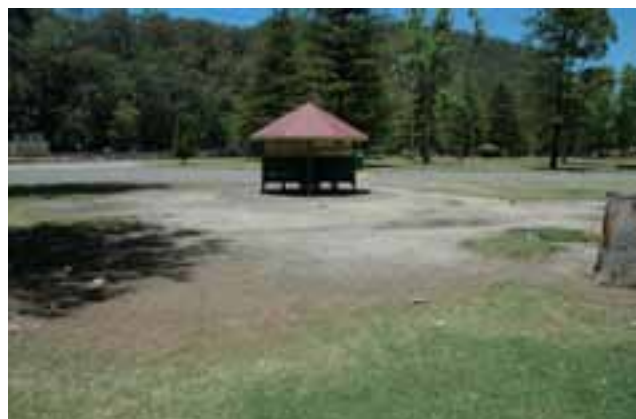
*Saline effects on soil conditions (January 2006)*

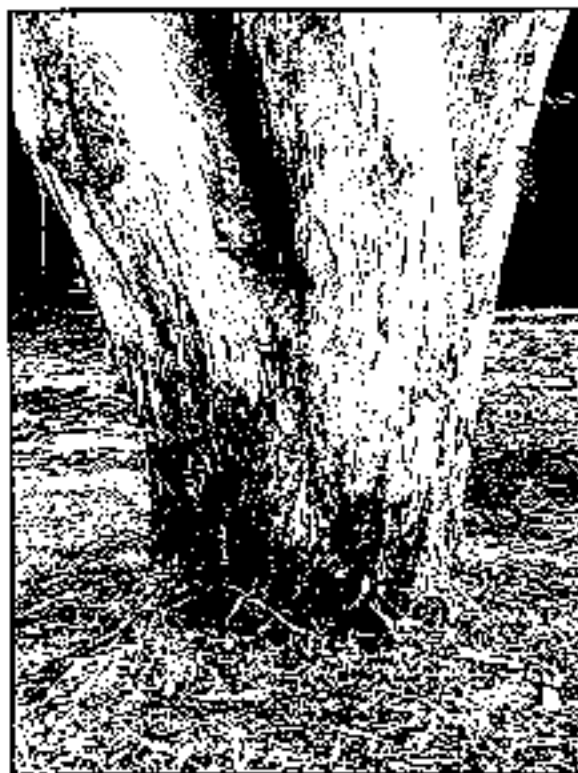
**Photo D:** Tree 328 Blackbutt Bark inclusion potential failure point.
