3 Physical Analysis

3.1 Environment and Landscape Analysis

The following map shows the extent of the precinct and is followed by a larger scale map of the Yanga Lake area where the sites are concentrated. The maps show the location of the items in the table. Detailed plans of the Homestead and Woolshed Groups are included in the following section on detailed descriptions of the principal buildings.

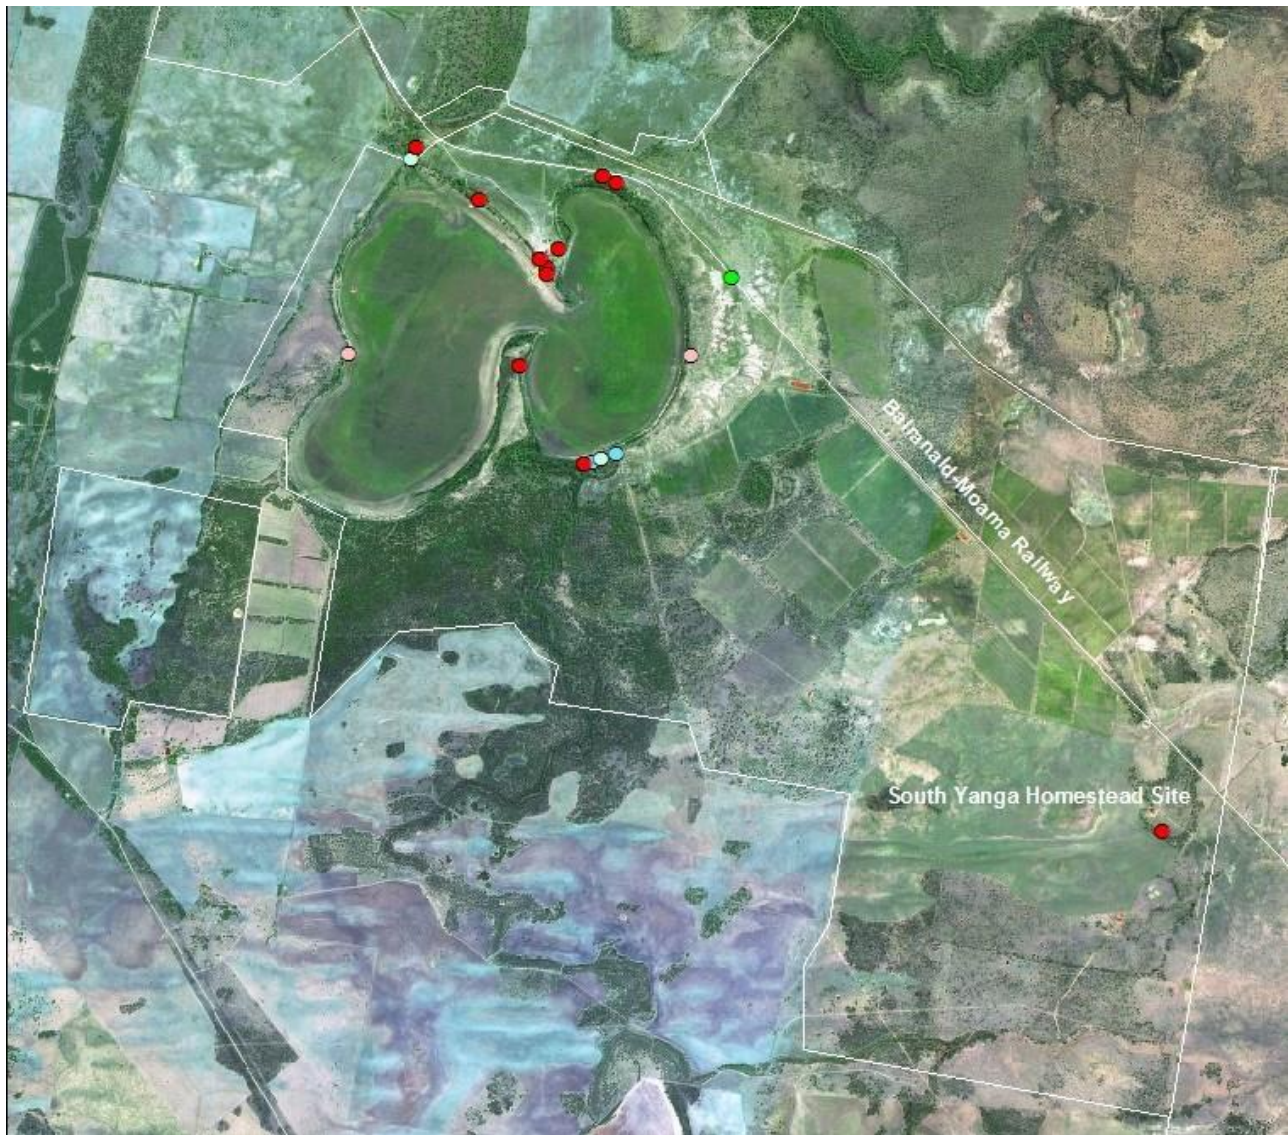
Figure 3.3.1 Yanga Homestead Precinct showing historic sites. Source: Hope / CMP authors.

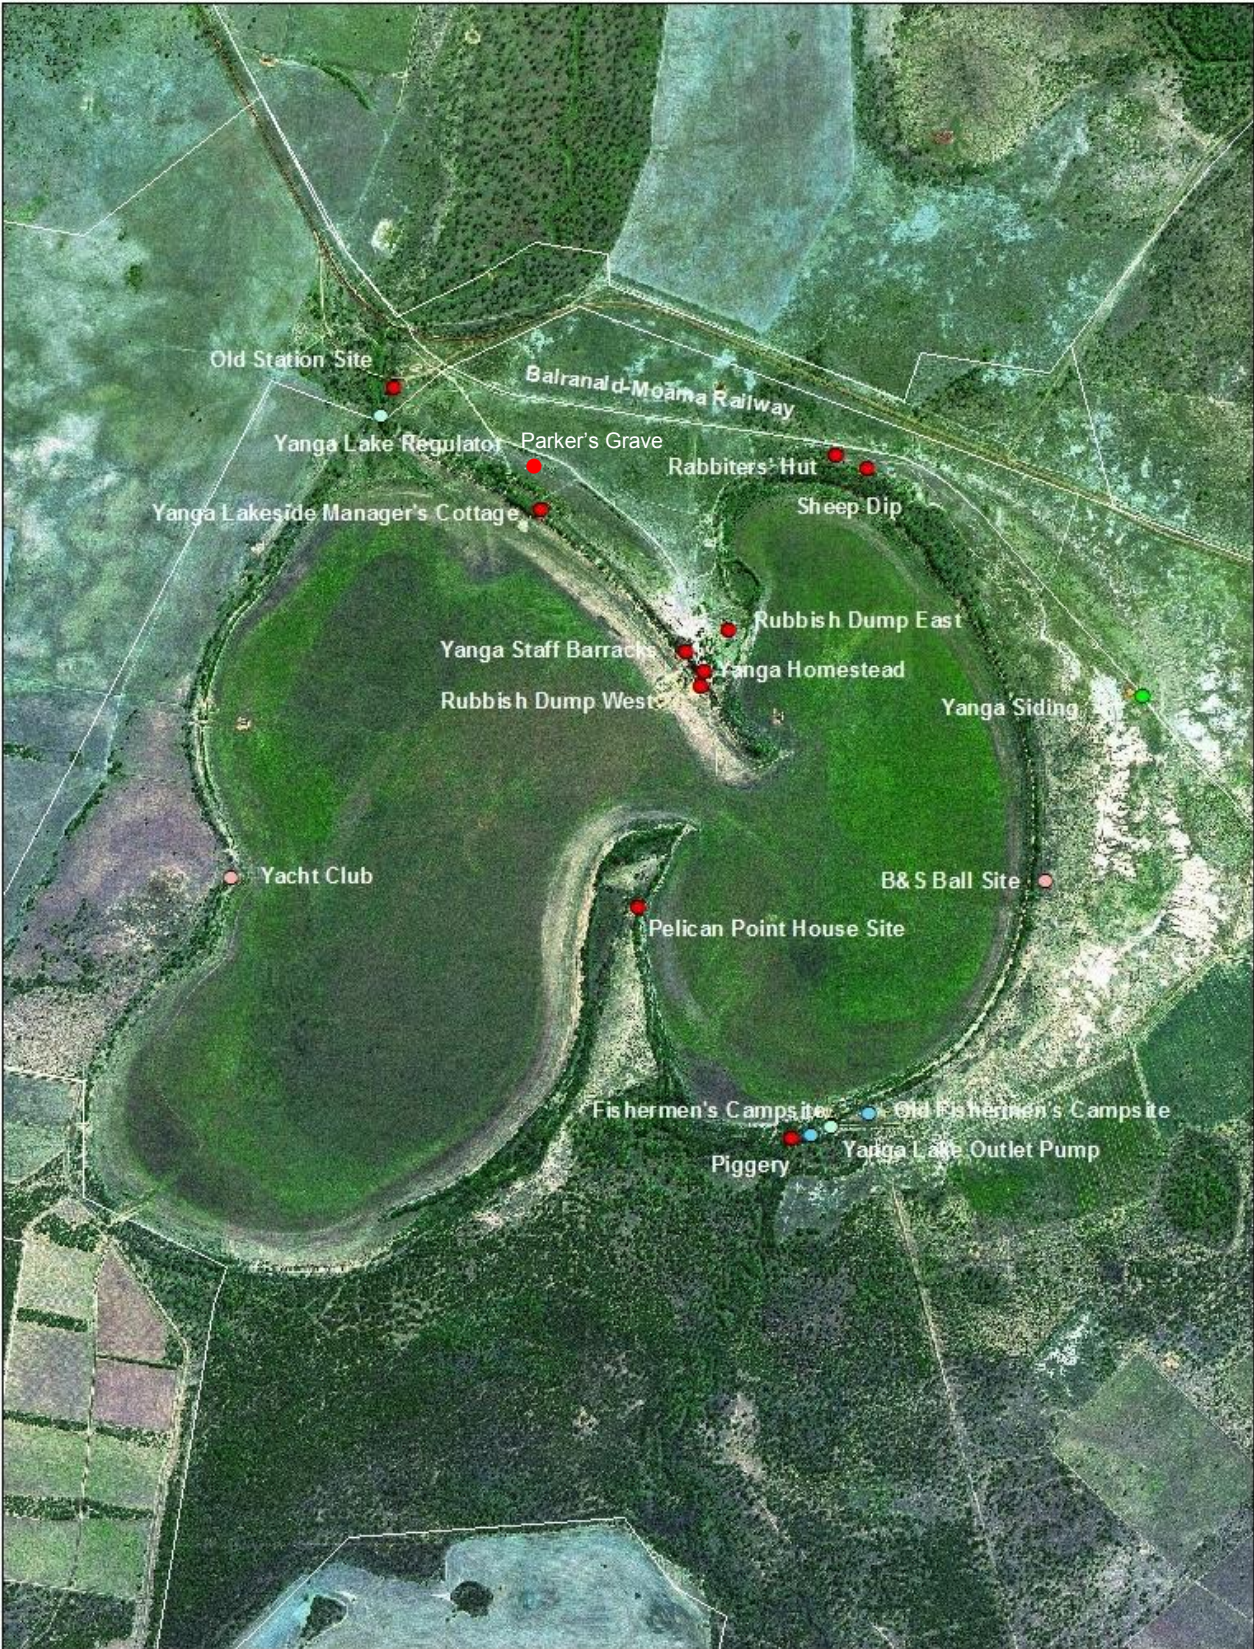
Figure 3.3.2 Enlargement of Yanga Homestead and Lake showing historic sites. Note that “Fishermen’s Campsite” is also referred to in this CMP as ‘Henry’s Camp’ and “Old Fishing Campsite” is also referred to as “Old Fishing Camp”. Source: Hope / CMP authors.

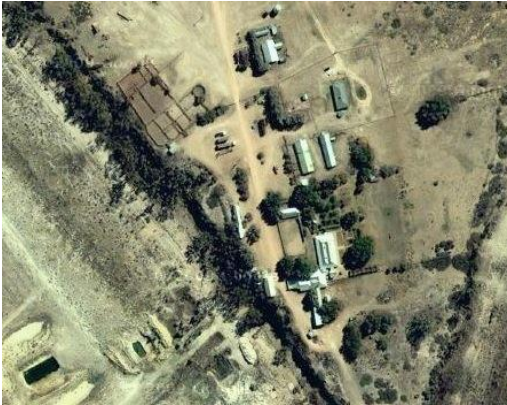
NAME	PHYSICAL ANALYSIS OF ITEM	IMAGE No.
<p>Yanga Homestead Group, homestead & residences</p> <p>This group of buildings is south of the Sturt Highway on a peninsular that projects into Yanga Lake accessed by a road from Yanga Creek and the site of the earlier Homestead. The original structure was an outstation and was a cottage looking south to the lake. It is believed it was added to or rebuilt into a larger structure to become the present kitchen wing. The main house wing was added facing east to the lake and forming an L shape with the main gardens to the east and a smaller garden in the L to the west of the main wing with a wind break of pepper trees along the west side.</p> <p>The main house is surrounded by a series of sheds, outbuildings and landscape features.</p> <p>(See detailed description later)</p>

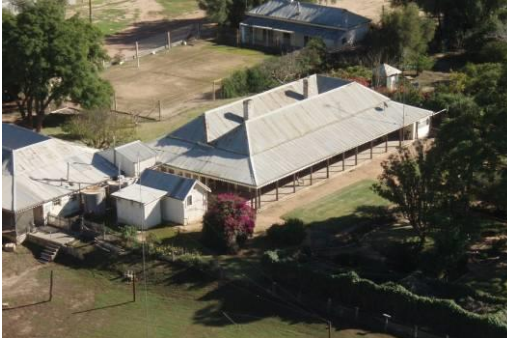
<p>Source: Google, 2010.</p>
<p>Main building</p>	<p>The Main House is a rectangular building oriented north south. It has an M shaped roof with a central valley running north south. The building has wide verandahs all around with enclosures on the north and south.</p> <p>(See detailed description later)</p>

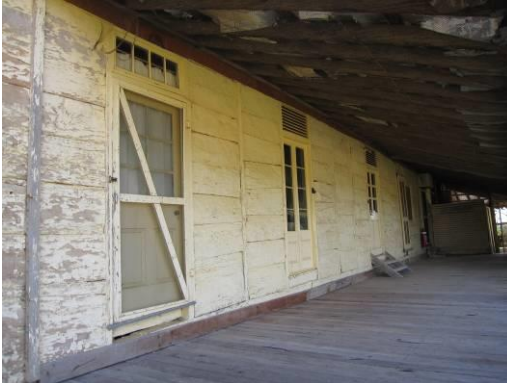
<p>Kitchen wing</p>	<p>The kitchen wing is a rectangular building oriented east west. It has an M shaped roof with a central valley running east west but discharging to the south at the centre of the wing where there is a break in the south-most ridge. The building has wide verandahs on the north and south sides and a later addition to the west.</p> <p>(See detailed description later)</p>

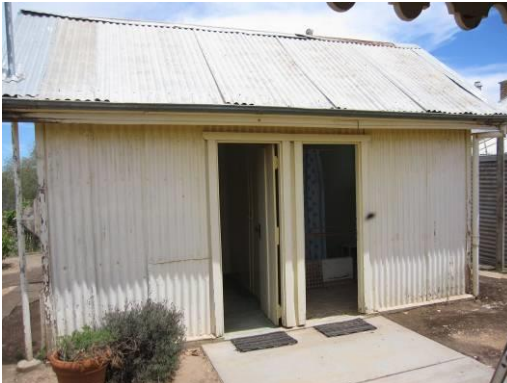
<p>Source: CMP authors, 2009.</p>
<p>Ablution block</p>	<p>Gable-roofed corrugated iron clad building with two central doorways and a leanto addition to the rear.</p>

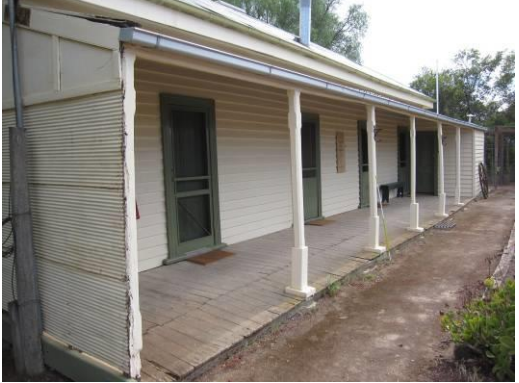
NAME	PHYSICAL ANALYSIS OF ITEM	IMAGE No.
Cook's cottage	<p>A separate residential building with a timber frame and gabled, hipped roof clad in corrugated iron. The walls of this building are clad in a combination of ripple iron, corrugated iron, fibro and weatherboard.</p> <p>It was built in stages including the widening of the verandah and addition of a toilet and shower at the end of the verandah. The stages of construction reflect the change in use of the building believed to be originally the Jackaroo Quarters, then altered to the Cooks Accommodation and now exhibition space. See the later detailed description.</p>

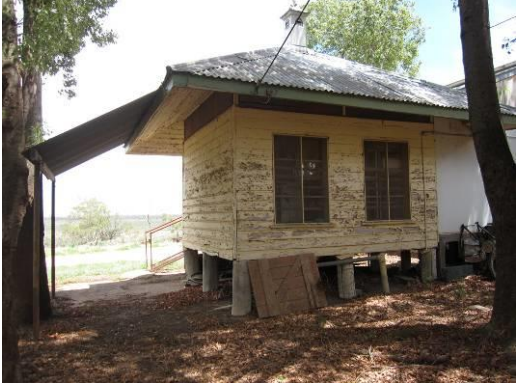
<p>Source: CMP authors, 2009.</p>
Meat house	Weatherboard clad meat house with a pyramidal roof and wide overhanging eaves shading the wall. The large gauzed windows, gauzed panels at the top of the walls and fleche or vent on the roof provide ventilation (c1920s?). A modern cool room has been added to the right (west).

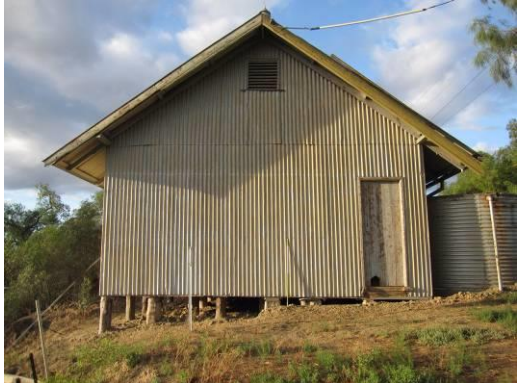
<p>Source: CMP authors, 2009.</p>
<p>Former stores building</p>	<p>The Store is located west of the Kitchen Wing and adjacent to the cliff line at the edge of the lake. There is a water tank on the ground adjoining the building on the southeast corner and the main Homestead elevated water tanks adjacent the building to the north. There is an Outhouse to the west of the Store. The store is a rectangular building with a gabled roof running north south. The walls are clad in corrugated iron, fixed with corrugations running vertically, over a timber stud frame with 90 x 50mm studs. (See detailed description later)</p>

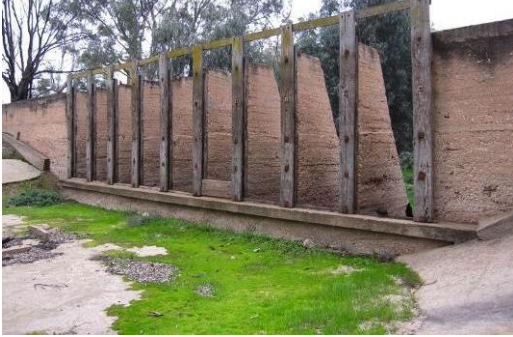
<p>Regulator. Source: CMP authors, 2009.</p>

<p>Source: CMP authors, 2009.</p>
<p>Yanga Lake regulator and bridge site</p>	<p>The Yanga Lake Regulator is a dam-like structure designed to allow water to enter Yanga Lake along Yanga Creek and retain water in the lake. It consists of a wide concrete footing and aprons extending across the creek from bank to bank. Concrete walls are constructed at each bank and buttressed on the creek side. The eight concrete buttresses are approximately 3 metres high. A framework of hardwood boards is bolted to the lake side of the buttresses and edge walls. These are fabricated to form vertical slots into which individual boards are fitted to form a weir. The original concrete elements of the regulator are concrete cast in situ using a quartz aggregate. The structure of the regulator has been reinforced with a different type of concrete.</p>

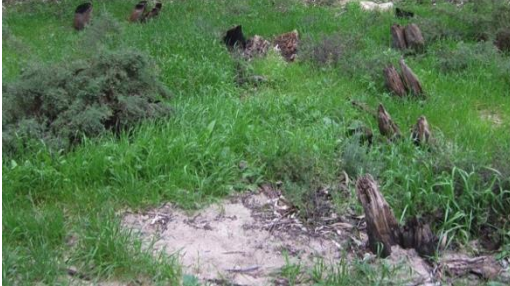
NAME	PHYSICAL ANALYSIS OF ITEM	IMAGE No.
	<p>Remnants of the original bridge at the location are located in the creek bed below the regulator (on the north side or creek side).</p>

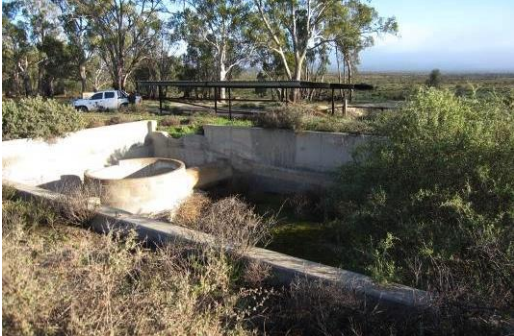
<p>Yacht Club toilets. Source: CMP authors, 2009.</p>
Pumping Station	Large complex concrete structure with pumps and tanks for lifting water from the tank to the concrete and earth irrigation channels to North and South Breeding paddocks. Machinery is also insitu.

<p>Infrastructure at lake edge. Source: CMP authors, 2009.</p>

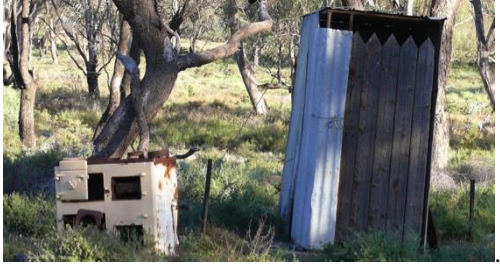
NAME	PHYSICAL ANALYSIS OF ITEM	IMAGE No.
Henry's Camp	Site of Henry Davies' fishing camp at the south end of Yanga Lake, with a number of caravans. There were nine caravans, many run down vehicles and several substantial buildings. There was a lawn going down to the lake and a large garden with fruit trees. The site was cleaned up before the sale to DECCW, a large pit was dug and everything bulldozed into it, except the toilet and a radio tower.

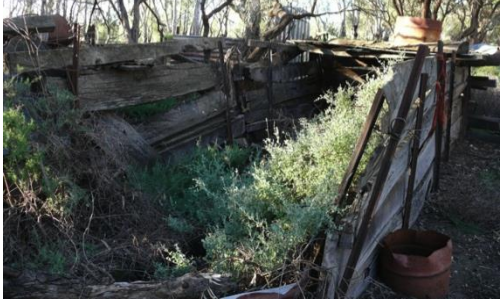
<p>Source: CMP authors, 2009.</p>
Piggery	A set of wooden stalls and runs on the southern shore of Lake Yanga. The site is probably 20 th C as indicated by the use of star pickets in the structure.

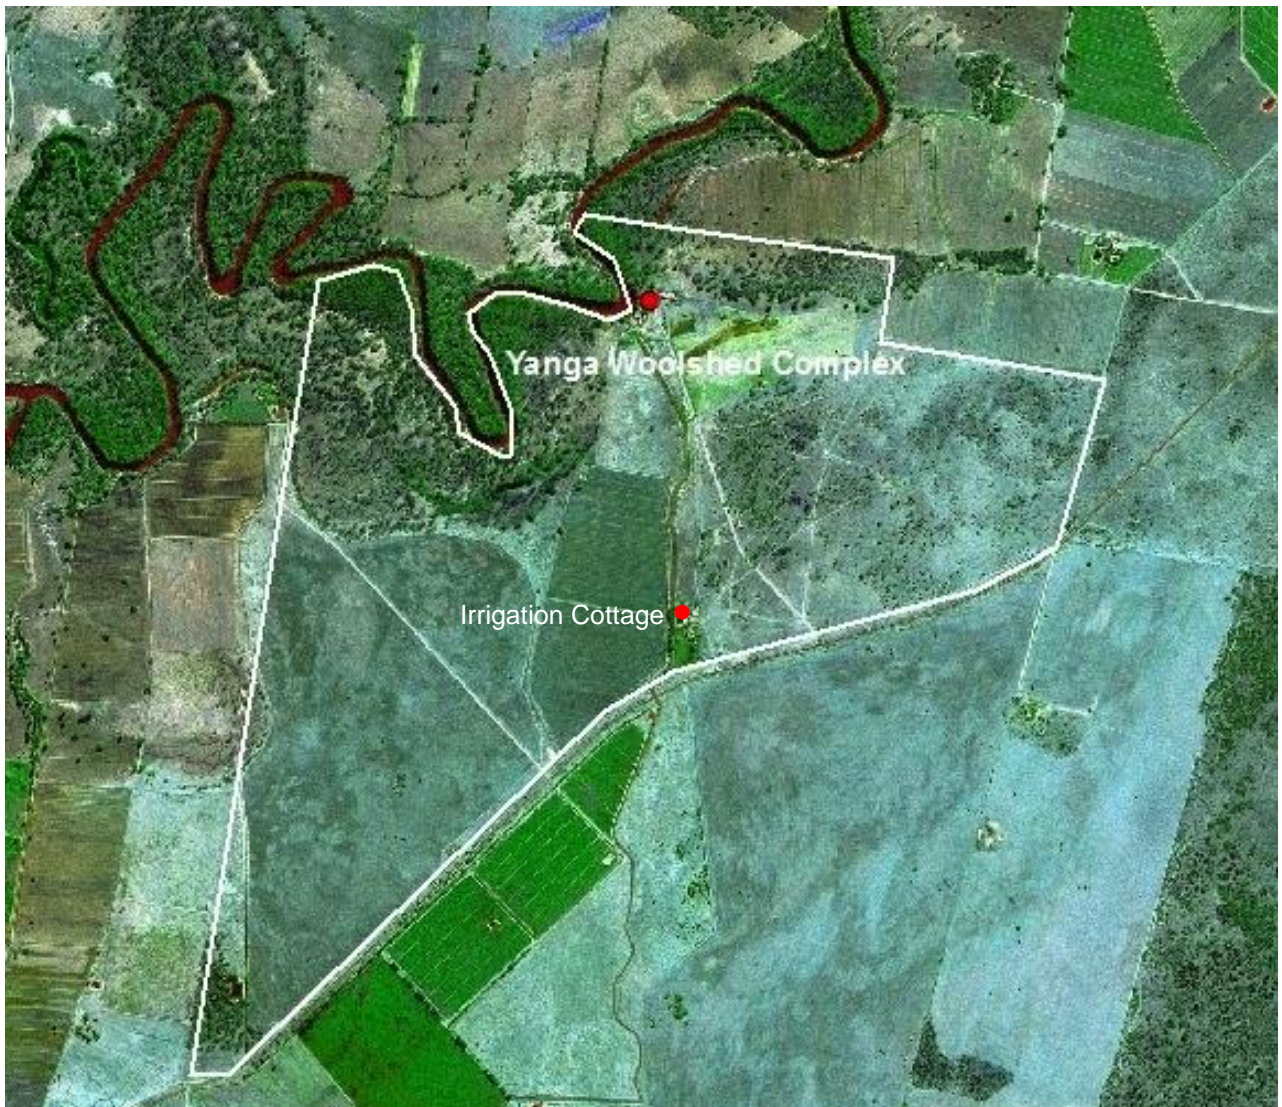
Figure 3.3.3 Woolshed Precinct showing historic sites Source: Hope / CMP authors.

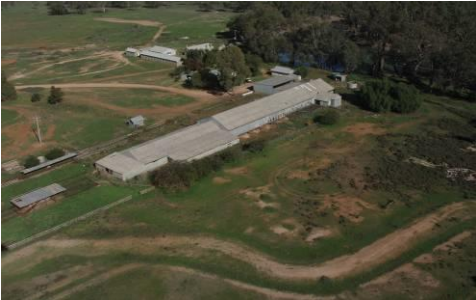
NAME	PHYSICAL ANALYSIS OF ITEM	IMAGE No.
Yanga woolshed	A timber-framed woolshed of linear design, rebuilt in 1896 replacing an earlier woolshed which burnt to the ground. Built in stages before 1911. In the foreground is the embankment to protect the site from floods and the site of the set of demolished quarters.

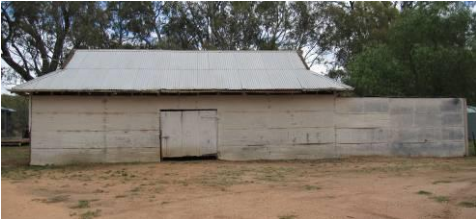
<p data-bbox="919 517 1396 577">Source: NSW NPWS, 2010, (photo taken by Narelle Jones, May 2007).</p>
Woolshed stables	Timber framed corrugated iron shed with ventilated gables and eaves. The same design as Breer Hut. Skillion roofed addition to the right is a stable. The corrugations on the wall run horizontally.

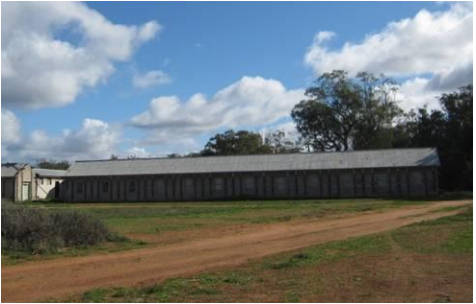
<p data-bbox="919 801 1396 835">Source: CMP authors, 2009.</p>
Yanga Shearers' Quarters	Long building comprising row of 12 individual rooms with doors on the west and windows on the east. Constructed of probably locally made concrete blocks prior to 1911. The roof is a gable form and clad in cgi. Designed by architects Tunbridge and Tunbridge for the E S & A Bank. Timber uprights added later in an attempt to stabilise the walls.

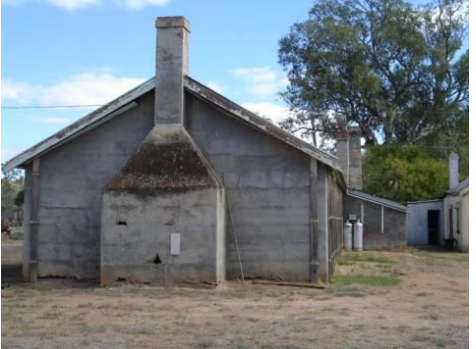
Cookhouse	Cookhouse constructed as above. The original plans for the buildings are on display in the Cooks House exhibition at the Homestead. The building has a mess room at the east end. At the northwest corner is the kitchen and ovens in an attached skillion. At the southwest corner is the cook's bedroom.

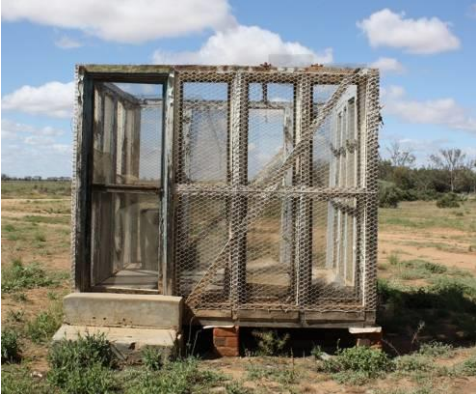
<p data-bbox="919 1536 1396 1574">Source: High Ground Consulting, 2006</p>
Meat house	Sawn timber frame structure with wire netting walls. No roof. The roof of the building is visible in the 1911 photo of the quarters and was a pyramid form with overhanging eaves.

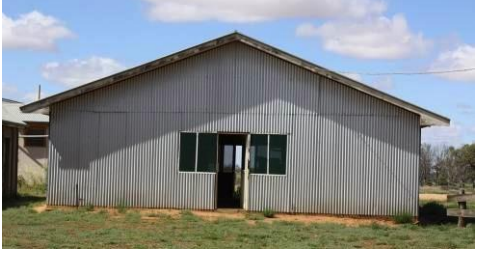
NAME	PHYSICAL ANALYSIS OF ITEM	IMAGE No.
Shearers' barracks	Modern shearers' quarters with central space and rooms on each side. Sawn timber framed, sheet lining and cgi cladding and roof.

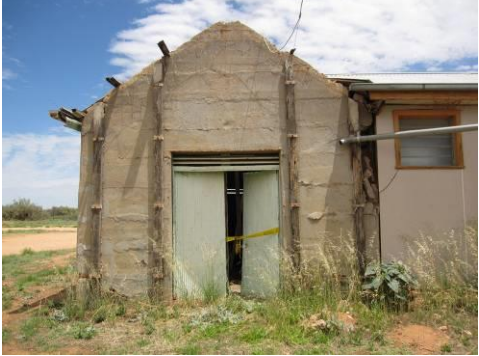
<p>Source: CMP authors, 2009.</p>
Old Wash House and New Shower Block	Washhouse constructed of concrete blocks similar to the shearers quarters. The adjacent later shower block to the right has provided a path for termites which have destroyed the roof structure.

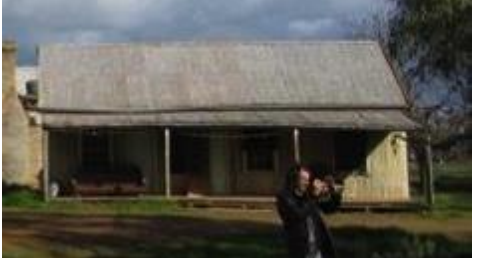
<p>Source: CMP authors, 2009.</p>
Contractor & experts quarters	Timber framed structure clad in mini orb and corrugated iron with a gabled roof running east west and verandah on the northern side. Has a central room with fireplace on the south side and four bedrooms opening off it. Possibly predates the 1911 quarters. A lean-to with two rooms adjoins the main building to the southwest.

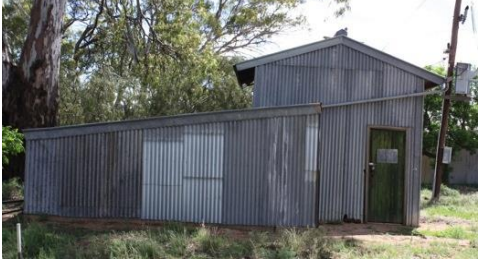
<p>Source: CMP authors, 2009.</p>
Yanga Irrigation pump house	Corrugated iron clad shed with working irrigation plant inside.

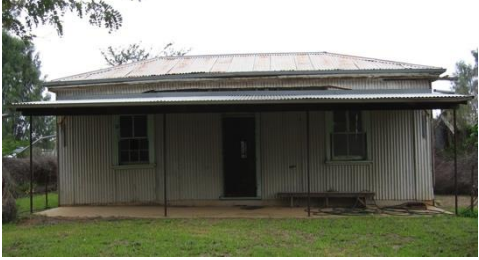
Woolshed cottage	<p>Woolshed Cottage is a timber-framed, corrugated iron clad residence with a M shaped hipped roof. The cottage was originally smaller, and is believed to date from the late 19th century. The earlier bullnosed verandah on the west (front) has been replaced with a modern low slope verandah. A bathroom and kitchen have been added to the rear of the cottage under skillion roof and the main roof may have been altered. It is possible that the kitchen and bathroom may have been wings off the rear of the original cottage.</p> <p>The interior of the front five rooms of the cottage is lined with Fibrolite walls and Caneite ceilings. The rear sections are lined with masonite or similar sheeting.</p> <p>The house is set within a fenced yard with domestic garden plantings. There is a water tank on the north side. A separate corrugated iron clad laundry has been constructed on the southern side of the cottage. This is typical of laundries built at Yanga Station residences (c.1960s?). A modern carport and garden shed are near the laundry.</p>

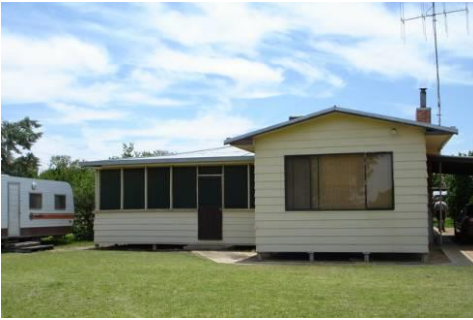
NAME	PHYSICAL ANALYSIS OF ITEM	IMAGE No.
<p>Irrigation cottage Not inspected in detail by authors. High Ground Consulting previous description included here.</p>	<p>Irrigation Cottage is a timber-framed, double-fronted residence constructed some time in the late 1940s or early 1950s. Originally clad with weatherboards and is set on concrete stumps with ant caps the cottage has been partially reclad in hardiplank</p> <p>The cottage was relocated in two halves to its present position in the mid 1950s. It was constructed as a three bedroom house with an eat-in kitchen and separate lounge room. The interior of most of the house is lined with horsehair plaster. The Bathroom is lined with Versalux sheets. A verandah, attached to the bedroom wing on the southern and western side of the house has been partially enclosed and now acts as a store room.</p> <p>The front of the house has been extended to create a formal dining area. (High Ground Consulting, 2006)</p>

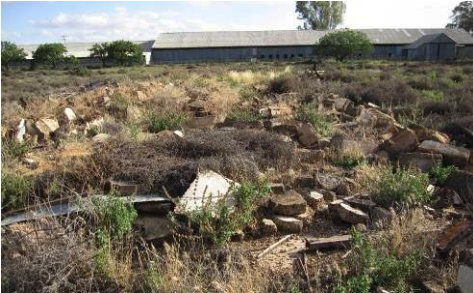
Others		
<p>Site of North Shedhand Quarters</p>	<p>Archaeological remains. The concrete floor slabs remain and rubble from the walls indicating the same construction as the shearer quarters. Remains include the quarters, ablution block and a cooks/mess building. Now overgrown with weeds.</p>

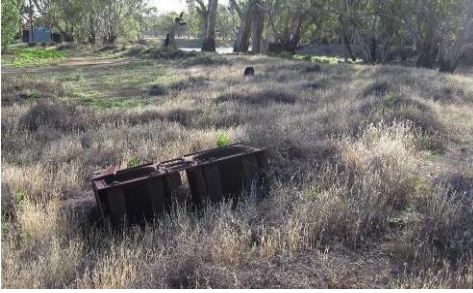
<p>Source: CMP authors, 2009.</p>
<p>Embankment</p>	<p>This extensive levee is an earth mound around the north of the woolshed precinct joining higher ground to the east. It functioned in the late 2010 floods to protect the woolshed. A stove in the photo is probably from the former north cook/mess building nearby.</p>

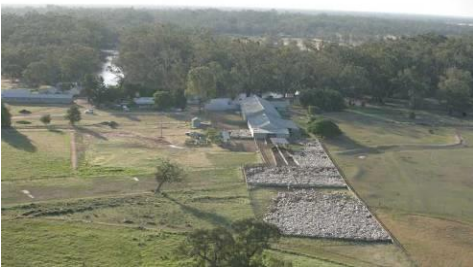
<p>Source: CMP authors, 2009.</p>
<p>Sheepyards</p>	<p>Steel and wire yards replacing the earlier timber yards. There are yards on the north and south of the shed for shorn sheep. Yards extend east of the Woolshed for sheep waiting to be shorn.</p>

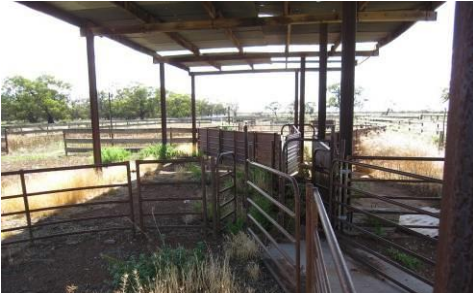
<p>Races and Shelters over</p>	<p>Lightweight shelters over the races. Steel frame with cgi roof. The yards join races under the shelters for sorting, checking and drenching sheep.</p>

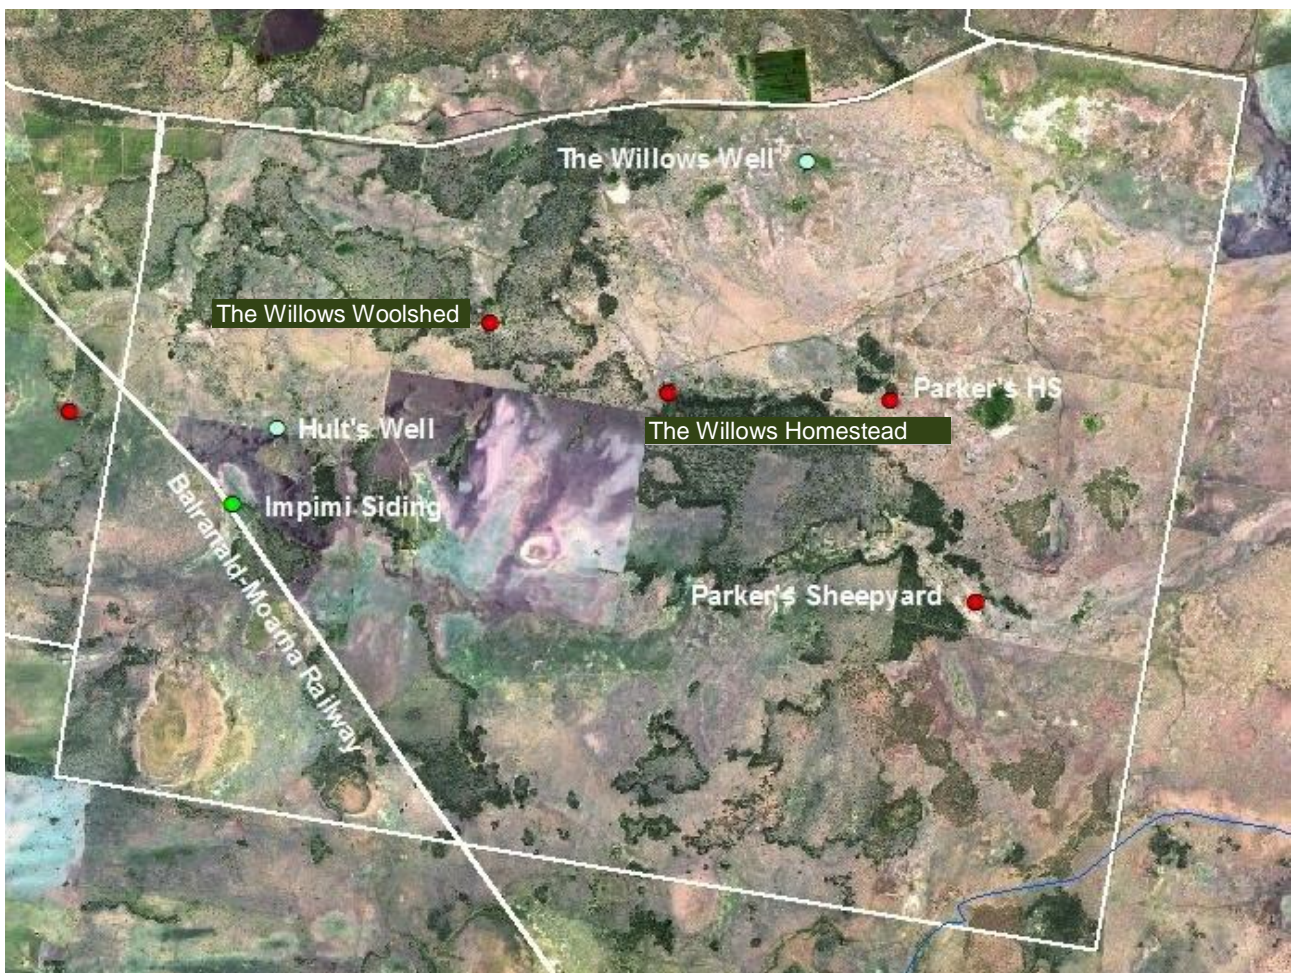
Figure 3.3.4 Woolshed Precinct showing historic sites Source: Hope / CMP authors.

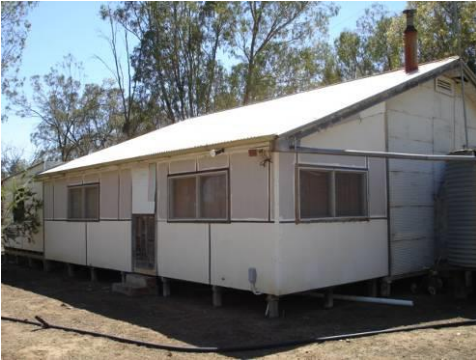
NAME	PHYSICAL ANALYSIS OF ITEM	IMAGE No.
<p>The Willows Homestead Not inspected in detail by authors. High Ground Consulting previous description included here.</p>	<p>The Willows Homestead is a 1920s Bungalow style residence with a low-pitched corrugated iron clad roof and external walls clad in ripple iron. The building is set on milled hardwood stumps.</p> <p>The homestead has been modified by the enclosure of the wide front verandah. This verandah appears to have originally covered approximately 1/3 of the floor space under the main roof. A skillion-roofed extension has been added along the northern side of the building and a timber-framed carport added to the north of this extension. A corrugated iron clad laundry and generator room, typical of laundries constructed at Yanga outstations and residences during the 1960s, is located near the eastern side of the building. This building contains a concrete base for a generator once used to provide electricity to the house.</p> <p>(High Ground Consulting, 2006)</p>

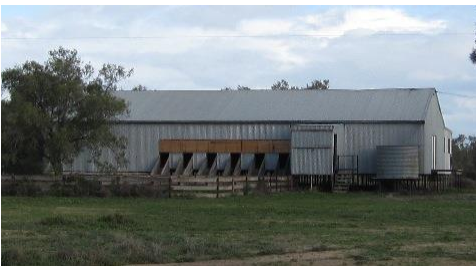
<p>The Willows Woolshed</p>	<p>The building has a gable roof clad in cgi. The building has steel piers and steel internal posts and a timber wall frame clad in corrugated galvanised iron vertically laid. The timber shutters at the shearing stands have been recently replaced. Yards constructed of steel pipe with large section horizontal timbers are at the east of the shed and counting pens on the north.</p> <p>There is a cgi tank adjacent to the building at the north west corner and the entry is a lean-to structure between the tank and counting out yards. A separate amenities building is west of the woolshed and a large concrete water tank is on a rise to the east.</p> <p>(High Ground Consulting, 2006 and TZG)</p>

<p>Willows Woolshed viewed from the north. Source: CMP authors, 2009.</p>
<p>Others</p>		
<p>Parkers Homestead Ruin</p>	<p>Site only known from NPWS HHIMS database.</p>	<p>No image available.</p>

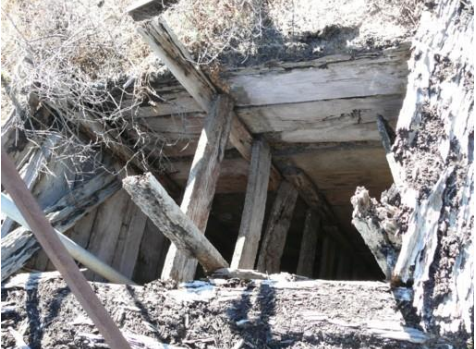
<p>Parkers Sheep Yards</p>	<p>Site only known from NPWS HHIMS database.</p>	<p>No image available.</p>
<p>Railway and Impimi siding and town site</p>	<p>Site not inspected. The railway route continues outside within the reserves.</p>	<p>No image available.</p>
<p>The Willows Well</p>	<p>A slabbed well with the timbers in good condition with a Southern Cross windmill still in place, vanes of mill on ground. The well is basically the standard government design: two compartments, each 2ft 6in square, divided by a brattice or ladder extending from top to bottom of the shaft. The timber is Murray pine. There are two associated iron tanks and a water trough, with a scatter of timber and metal objects around the site.</p>

<p>The slabbed well in the Willows paddock. There is also a windmill similar to that pictured below. Source: CMP authors, 2009.</p>

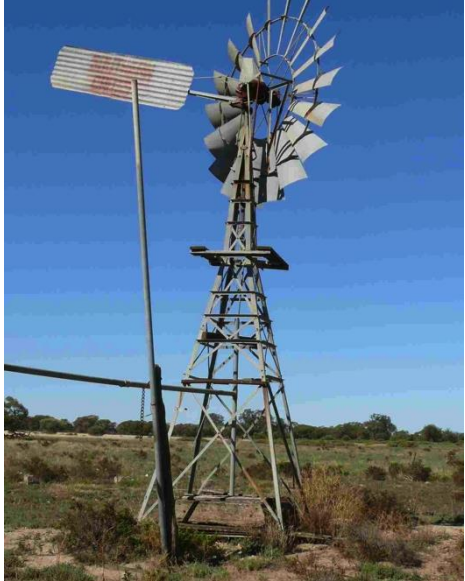
NAME	PHYSICAL ANALYSIS OF ITEM	IMAGE No.
<p>Hults Well</p>	<p>A slabbed well with the timbers in good condition with a Southern Cross windmill still in place, and water visible in well. The well is basically the standard government design: two compartments, each 2ft 6in square, divided by a brattice or ladder extending from top to bottom of the shaft. The timber is Murray pine. There are two associated tanks, one of concrete and one of sheets of iron stencilled "Metters Patent Steel Squatters' Tank". There are a water trough and a scatter of timber and metal objects around the site.</p>

<p>The Windmill in Hults paddock. In is near the slabbed well similar to that pictured above. Source: CMP authors, 2009.</p>

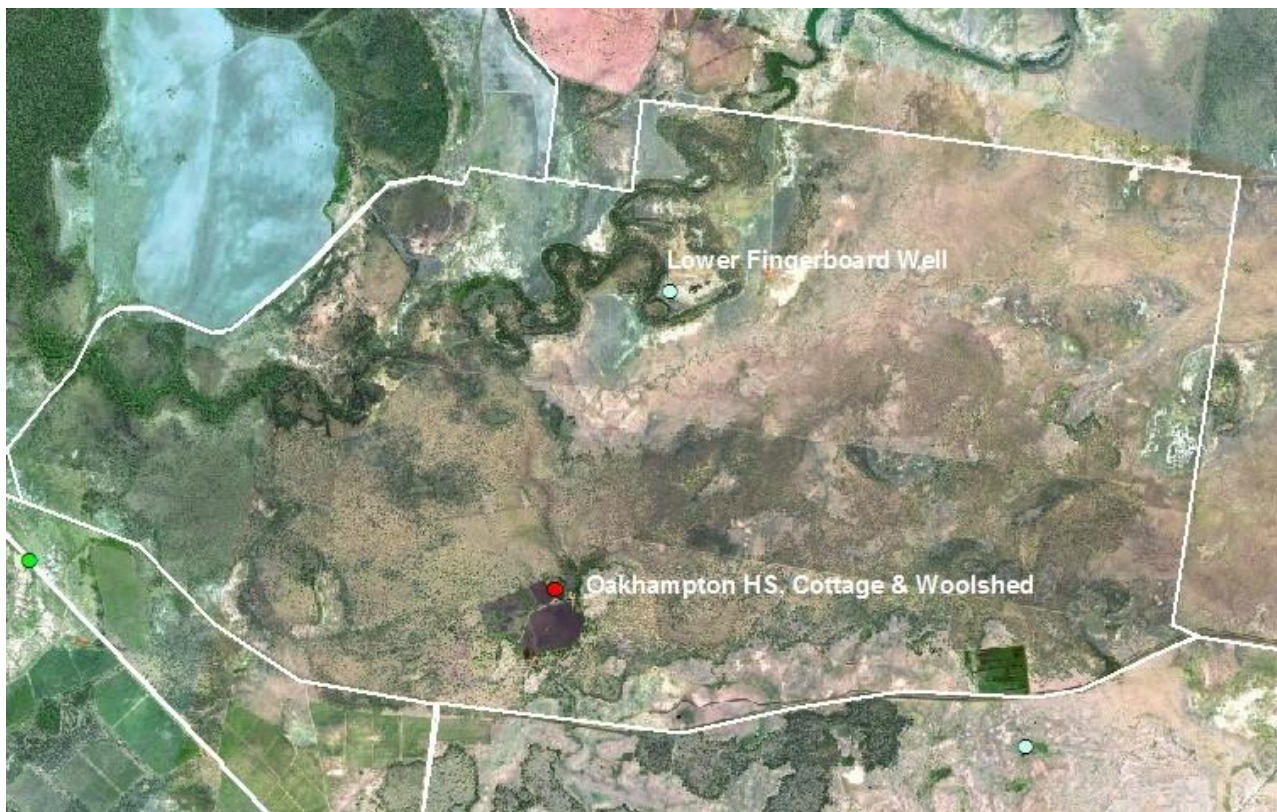
Figure 3.3.5 Oakhampton Precinct showing historic sites Source: Hope / CMP authors.

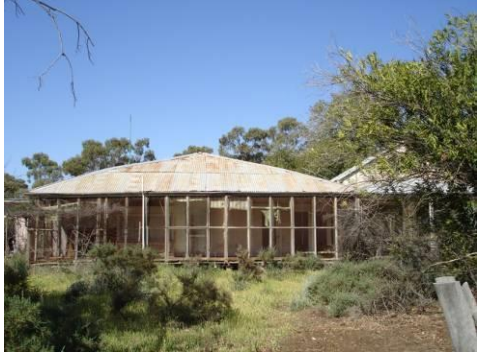
NAME	PHYSICAL ANALYSIS OF ITEM	IMAGE No.
<p>Oakhampton</p> <p>Oakhampton Homestead Not inspected in detail by authors. High Ground Consulting previous description included here.</p>	<p>Oakhampton Homestead is a mid 1920s house with a square footprint and pyramid-shaped, hipped, corrugated iron clad roof that covers an encircling verandah. This house was originally clad in the half-timbered style commonly found on timber-framed houses in the 1920s. This consists of weatherboards up to dado height and compressed asbestos fibre sheets above. The verandahs have been progressively enclosed. There is a large, gable-roofed living room with brick chimney constructed onto the southern side of the house possibly prior to World War II.</p> <p>Various outbuildings, including;</p> <ul style="list-style-type: none"> • A fibro clad laundry with skillion roof possibly constructed in the 1950s • A fibro clad toilet, • A small potting shed, • A greenhouse, • A garden shed converted from a silo manufactured some time after 1957, • A chook house. • A mature garden with paving. • A large corrugated iron clad vehicle and machinery shed located to the east of the homestead. • A large water tank on a high stand. • A corrugated iron clad woolshed located south of the homestead. • Remnant shearers' quarters for the woolshed. <p>(High Ground Consulting, 2006)</p>

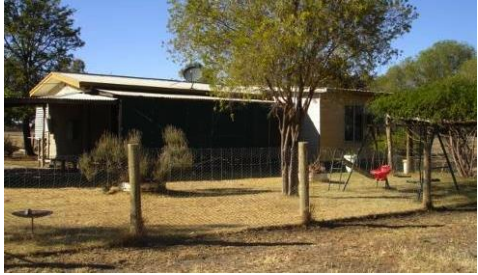
<p>Oakhampton Cottage Not inspected in detail by authors. High Ground Consulting previous description included here.</p>	<p>Oakhampton Cottage consists of the following:</p> <ul style="list-style-type: none"> • A hardiplank clad relocatable dwelling mounted on concrete stumps, • A two-roomed extension on the northern side of the original dwelling, • Steel and timber framed verandah and carport extensions, • Water tank, • Adjacent vehicle shed. <p>(High Ground Consulting, 2006)</p>

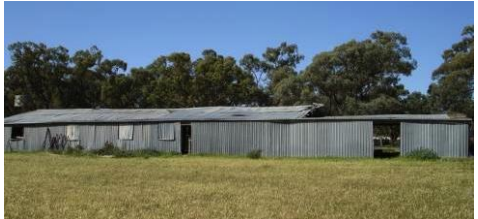
<p>Source: High Ground Consulting, 2006</p>
<p>Oakhampton Woolshed Not inspected in detail by authors. High Ground Consulting previous description included here.</p>	<p>A corrugated iron clad woolshed located south of the homestead. (High Ground Consulting, 2006)</p>

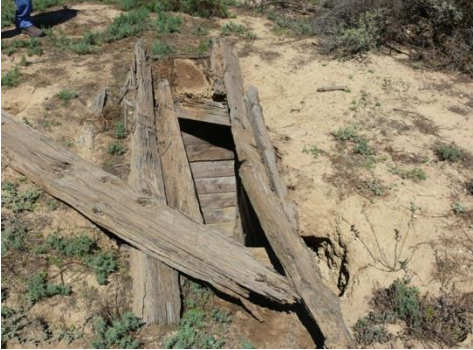
<p>Source: Google, 2010.</p>
<p>Abercrombie channels</p>	<p>The Abercrombie Channel runs along the north side of the Sturt Highway from the east and terminates at Oakhampton. It is a major irrigation system supplying water for agricultural and domestic use.</p>	<p>No image available.</p>
<p>Lower Fingerboard Well Note the well is located in Lower Fingerboard paddock close to the boundary of Top Fingerboard paddock.</p>	<p>A slabbed well with the timbers in good condition but windmill superstructure gone. The well is basically the standard government design: two compartments, each 2ft 6in square, divided by a brattice or ladder extending from top to bottom of the shaft. The timber is Murray pine. The timber stumps for a large water tank are preserved nearby but the tank has gone. There is a scatter of timber and metal objects around the site.</p>

<p>Slabbed well. Source: CMP authors, 2009.</p>

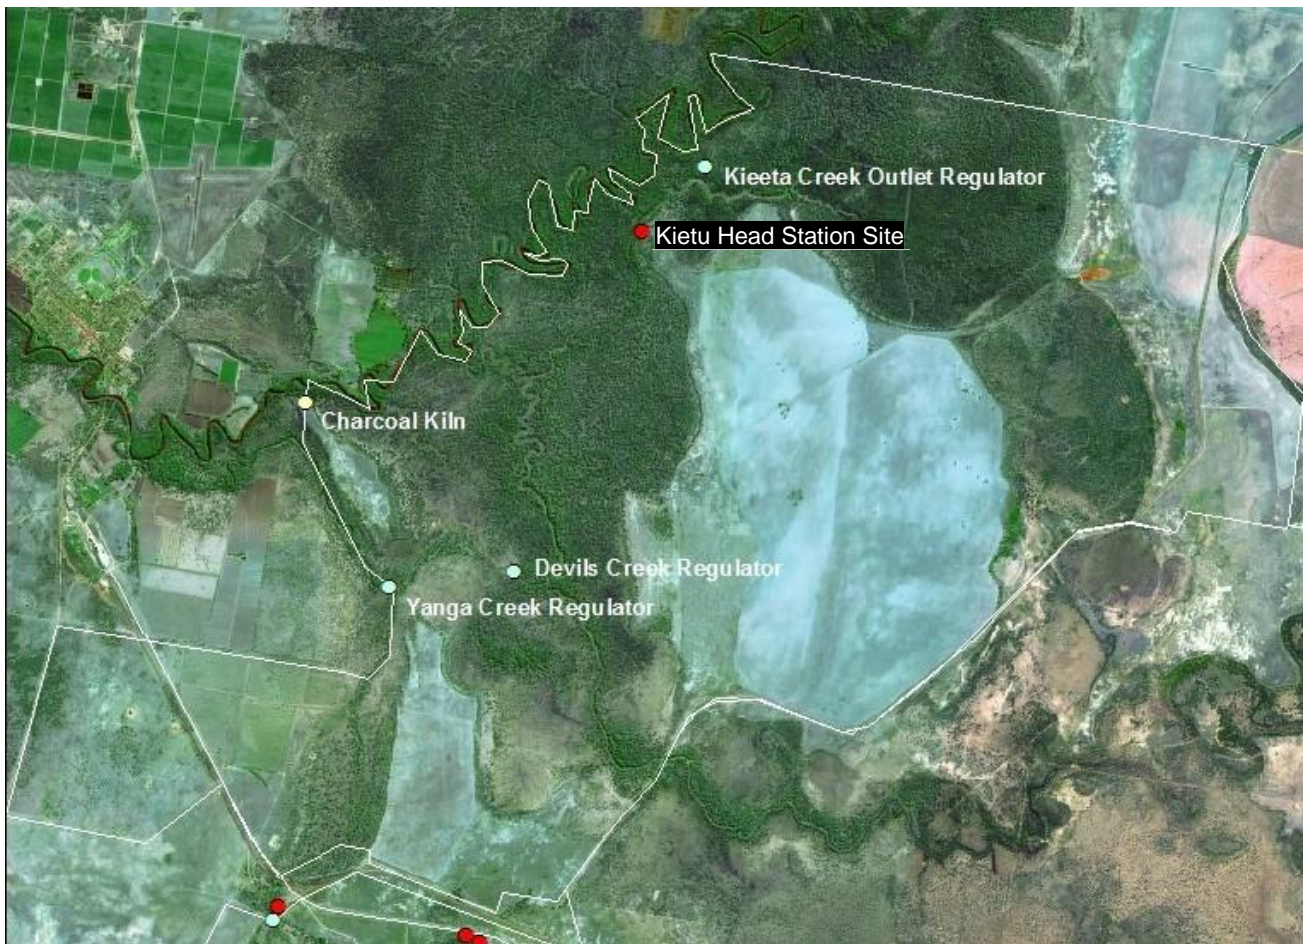
Figure 3.3.6 Uara Precinct showing historic sites. Note that the boundary is incorrect in this map. The precinct no longer extends so far to the right and extends further to the north (top). See maps in Section 1 for the new boundary. Source: Hope / CMP authors.

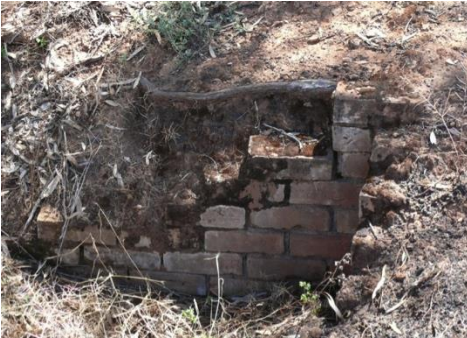
NAME	PHYSICAL ANALYSIS OF ITEM	IMAGE No.
<p>The Island Charcoal Kiln</p>	<p>This consisted of three square brick lined pits now marked by collapsed hollows each approx. 2x4m. In the easternmost one, the brick work of one corner can be seen. Around the hollows are a scatter of bricks, mesh (for sieving) and other metal pieces.</p>

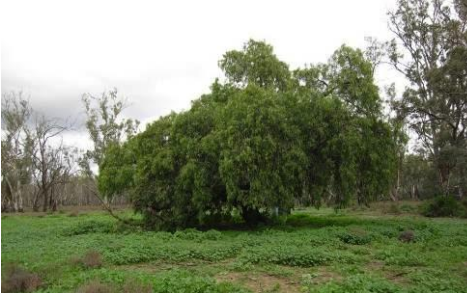
<p>Source: CMP authors, 2009</p>
<p>Kietu Head Station site</p>	<p>The site consists of a thin scatter of artefacts, including fragments of sandstock bricks, bottle glass, ceramic (including blue-and-white transfer-printed ware), and clay smoking-pipe stems (one marked '[Gla]sgow'). There are also iron fragments, both cast and forged. The artefact scatter is in two parts, an area of thinner scatter probably marking the house site and another area probably indicating a garbage deposit. The location is marked by a large peppercorn tree. There are farm fences and yard remnants in the vicinity, probably a later period.</p>

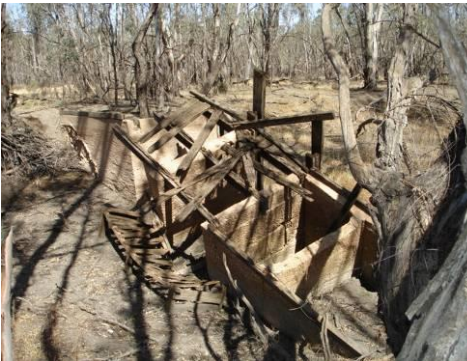
<p>Kieeta Creek Outlet regulator (ruin) (Kieeta Escape) Not inspected in detail by authors. High Ground Consulting previous description included here.</p>	<p>This is a dam-like structure designed to regulate water flow in Kieeta Creek. The regulator appears to be of similar vintage to the Yanga Lake and Old Swamp Regulators. It consists of the following:</p> <ul style="list-style-type: none"> • Two concrete caissons originally erected against each bank of the creek. The western caisson has collapsed. • One concrete pier set between the two caissons. • A hardwood structure fixed to the concrete section of the regulator. This includes remnants of a bridge and walkway, and framework to allow placement of boards into the regulator to regulate water flow. • Remnants of a log-framed coffer dam and evidence of bracing between the coffer dam and regulator. <p>(High Ground Consulting, 2006)</p>

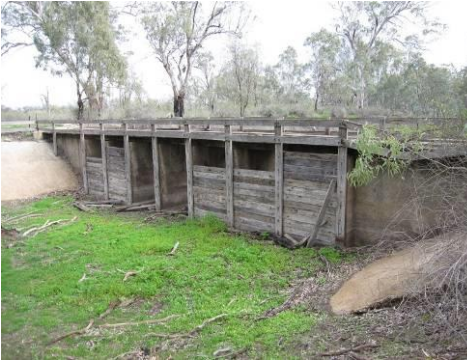
<p>Yanga Creek regulator</p>	<p>This is a dam-like structure designed to allow water to enter Yanga Lake along Yanga Creek and retain flood water in Yanga Creek. It consists of the following:</p> <ul style="list-style-type: none"> • A wide concrete footing and aprons extending across the creek from bank to bank. • Concrete caissons constructed at each bank. • Eight concrete piers approximately 3 metres high. • A framework of hardwood boards bolted to the eastern (Yanga Lake) side of the piers. These are fabricated to form vertical slots into which individual boards are fitted to form a weir. • A timber bridge deck and railings allowing vehicle movement over the regulator. The railings on the eastern side of the regulator are integral with the timber weir structure. <p>The original concrete elements of the regulator appear to have been made with reinforced concrete formed up in situ. (High Ground Consulting, 2006)</p>

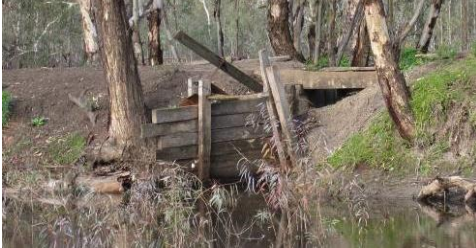
NAME	PHYSICAL ANALYSIS OF ITEM	IMAGE No.
Other irrigation regulators	<p>There are several other regulators in the Yanga Creek and Devil's Creek irrigation systems. Some are in modern concrete from the late 20th century and some in an earlier concrete material from the early 20th century. They have not all been surveyed or located.</p>

<p>Example of an unidentified regulator. Source: CMP authors, 2009</p>
Devil's Creek regulator	<p>This is a dam-like structure designed to regulate water flow in Devil's Creek. The regulator is set in large levee bank and carries the roadway that runs along the top of the levee. It consists of the following:</p> <ul style="list-style-type: none"> • A wide concrete footing extending the width of the levee bank. • Two concrete abutments with return walls at their upstream ends. • One concrete pier set halfway between the two abutments. • Milled hardwood wings on the upstream side of the bridge abutments. • A framework of hardwood boards bolted to the northern side of the abutments and pier. These form vertical slots into which individual boards are fitted to form a weir. • A timber bridge deck allowing vehicle movement over the regulator. A railing on the northern side of the regulator is integral with the timber weir structure. <p>The original concrete elements of the regulator appear to have been made with reinforced concrete formed up in situ. (High Ground Consulting, 2006)</p>
