3 Physical Analysis

3.1 Environment and Landscape Analysis

The following map shows the extent of the precinct and is followed by a larger scale map of the Yanga Lake area where the sites are concentrated. The maps show the location of the items in the table. Detailed plans of the Homestead and Woolshed Groups are included in the following section on detailed descriptions of the principal buildings.

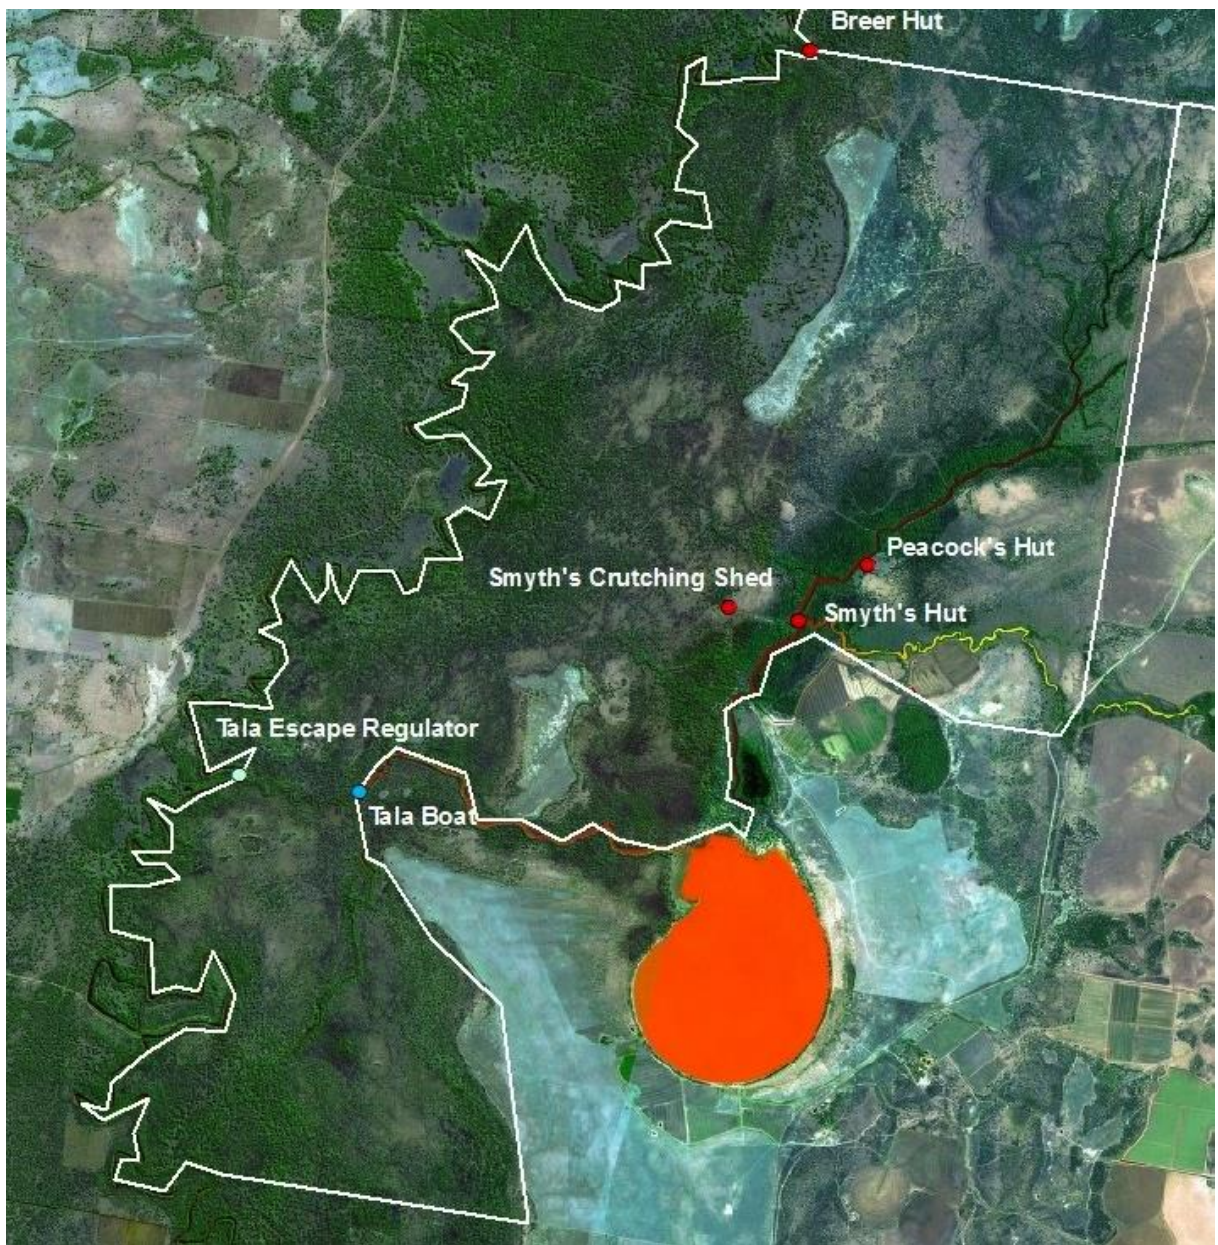
Figure 3.3.7 Tala Precinct showing historic sites Source: Hope / CMP authors.

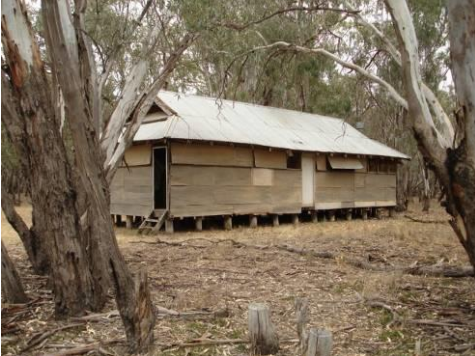
NAME	PHYSICAL ANALYSIS OF ITEM	IMAGE No.
<p>Breer Hut Complex</p>		
<p>Breer Hut Not inspected in detail by authors. High Ground Consulting previous description included here.</p>	<p>The accommodation building was relocated to its present location from South Tala. It is set on River Redgum stumps and consists of the following:</p> <ul style="list-style-type: none"> • Milled hardwood frame supporting a gabled roof clad in corrugated galvanised iron, • Ripple iron external wall cladding and ripple iron clad window shutters. • The building has a central room that appears to be a common or dining room. A kitchen with large fuel stove is located at the northern end of the building and two bedrooms are accessed from the southern end of the structure. The flue for the fuel stove is typical of the galvanised sheet flues installed in Yanga buildings during the 1950s. Two large wooden dining tables and beds are in the dining room. • The presence of Lysaught Galvanised Tinned corrugated iron suggests the structure was originally constructed between 1887 and the 1920s. • The 1956 flood level has been carved into one of the floor stumps, confirming a date of erection at River Breer prior to that event. <p>(High Ground Consulting, 2006)</p>

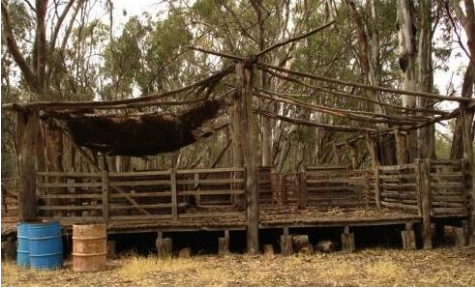
<p>Breer Hut crutching shed Not inspected in detail by authors. High Ground Consulting previous description included here.</p>	<p>The crutching shed is a timber-framed structure built as follows:</p> <ul style="list-style-type: none"> • Unmilled River Redgum posts and stumps, • Milled Redgum floor bearers, joists and boards, • Milled Redgum fencing and entry ramp, • Gabled roof frame of saplings supported by Redgum posts. Chicken wire attached the roof frame collects leaf litter from surrounding eucalypts, providing a shaded shelter for the shed. • Internal gates are tubular steel. <p>(High Ground Consulting, 2006)</p>

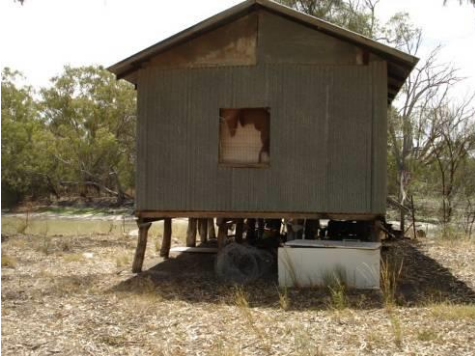
<p>Source: High Ground Consulting, 2006</p>
<p>Smyth's</p>		
<p>Smyth's Hut Not inspected in detail by authors. High Ground Consulting previous description included here.</p>	<p>Smyth's Hut is a simple, timber-framed fishing hut built with an open end and a deck fronting Talpee Creek. It has one room with a low gable roof and corrugated iron clad walls. The building is set on stumps with ant caps. The timber deck at the front of the hut has no ant caps. Termites entering through this deck have severely damaged the structure. The floor of the hut is particle board sheeting.</p> <p>The hut appears to have been constructed or enclosed in two stages. Wall cladding at the rear is corrugated galvanised iron and that at towards the front is Zinalume. A dining bench and barbecue area are located to the south of the hut.</p> <p>(High Ground Consulting, 2006)</p>

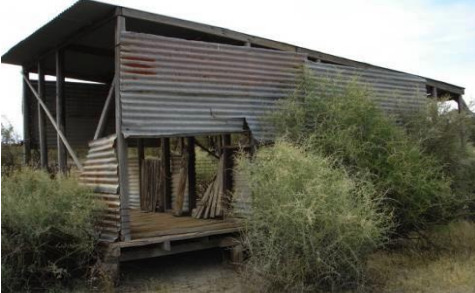
<p>Smyth's Crutching Shed Not inspected in detail by authors. High Ground Consulting previous description included here.</p>	<p>Smyth's Crutching Shed is a simple, skillion-roofed structure constructed with a milled timber frame and partially clad in corrugated galvanised iron. The structure is set on hardwood stumps. The shed is located at the western end of a set of yards in the corner of a large paddock.</p> <p>(High Ground Consulting, 2006)</p>

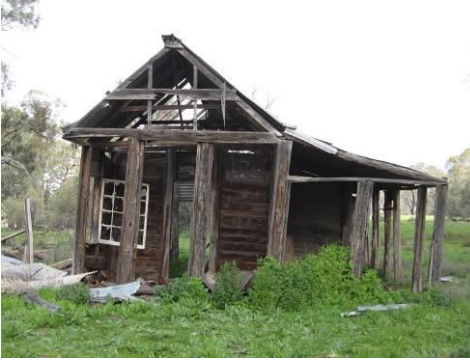
NAME	PHYSICAL ANALYSIS OF ITEM	IMAGE No.
Peacock's		
<p>Peacock's Hut</p>	<p>Peacock's Hut is a four-roomed drop slab dwelling possibly erected in the 1860s. All of the walls of the hut are constructed from adzed slabs set within pit-sawn battens fixed to adzed posts. The front two rooms are covered by a corrugated iron gable roof and the back two rooms are covered by a corrugated iron clad skillion roof. A new gabled roof of milled timber with corrugated cladding and weatherboard clad gable ends was fitted in the early 1920s. New windows were possibly fitted around the same time.</p> <p>The hut is in poor condition with many drop slabs missing from the external walls and substantial termite damage visible in the uprights on the northern end. Many slabs are laying on the ground.</p> <p>A separate skillion-roofed, corrugated iron clad laundry/outhouse appears to have been constructed in the mid 20th century.</p> <p>The floor and other components of a separate large structure relocated from South Yanga are located to the left but the structure has collapsed. It had a milled timber frame and elevated floor with T&G boards.</p> <p>(High Ground Consulting, 2006 & TZG)</p>

<p>Northern end of hut. Source: CMP authors, 2009</p>

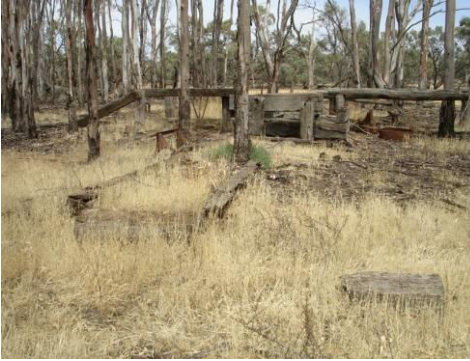
Others		
<p>Sawmill site on Smyth's (near Smyth's Crutching Shed)</p> <p>Not inspected in detail by authors. High Ground Consulting previous description included here.</p>	<p>An abandoned sawmill is located on a rise approximately 300 metres north of the crutching shed. Remnant features of the sawmill include the remains of a breaking down saw and log table, and a log dump. Various metal artefacts, once part of milling machinery, are scattered around the site.</p> <p>(High Ground Consulting, 2006)</p>

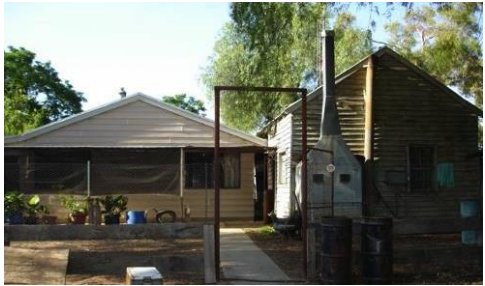
NAME	PHYSICAL ANALYSIS OF ITEM	IMAGE No.
<p>Waugorah Homestead & kitchen</p>	<p>Waugorah Homestead was constructed in 1987 replacing an earlier structure and is a three-bedroom house clad in Hardiplank. Attached is a weatherboard and corrugated iron clad kitchen and bathroom constructed in 1934. This is a simple rectangular building with a gabled roof. It has two rooms, a kitchen and a bathroom. A small corrugated iron clad boiler room has been constructed on the western wall of this building. The buildings are within a fenced home paddock. There is a cluster of outbuildings around the homestead. Waugorah Creek is located immediately to the north of the dwelling. There are remains of a jetty and bridge. (High Ground Consulting, 2006 & TZG)</p>

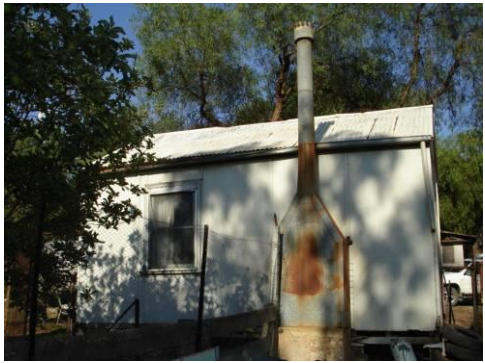
<p>Source: High Ground Consulting, 2006</p>
<p>Waugorah School House</p>	<p>A school building constructed in 1934. This rectangular one room building is clad in Fibrolite (asbestos) sheets and has a roof of corrugated galvanised iron. It was a sheet metal clad external fireplace with an ornate chimney cowl shaped to resemble a crown. (High Ground Consulting, 2006)</p>

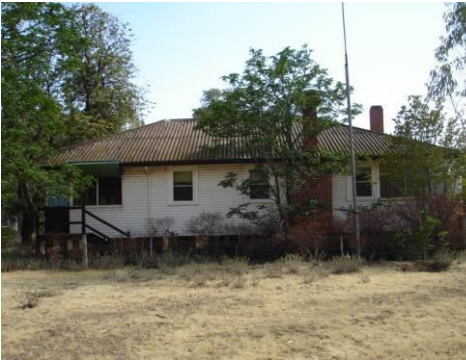
NAME	PHYSICAL ANALYSIS OF ITEM	IMAGE No.
<p>Redbank Cottage Not inspected in detail by authors. High Ground Consulting previous description included here.</p>	<p>Redbank Cottage is a simple post-war rectangular dwelling constructed of a timber frame mounted on brick piers. The cottage is clad in moulded weatherboards and has a hipped roof clad in Super 6 corrugated fibro. Brick chimneys service a living room fireplace and kitchen stove. All rooms have double-hung timber-framed windows except the dining room, which has screened louvre windows. Concrete paths access wooden steps leading to the three cottage entrances. The cottage has three bedrooms, internal bathroom and separate toilet. An enclosed verandah at the western end is accessed from the two front bedrooms. The living room is on the southern side of the house and the kitchen and dining room are at the eastern end. All rooms appear to be lined with masonite sheets. A corrugated iron water tank sits on brick piers adjacent to the kitchen. An elevated brick septic tank extends diagonally from the northern side of the cottage. A corrugated iron clad garage is east of the cottage. Two large water tanks provide a head of pressure for the building and redundant boundary riders' huts are located in the paddock to the east of the cottage yard. (High Ground Consulting, 2006)</p>

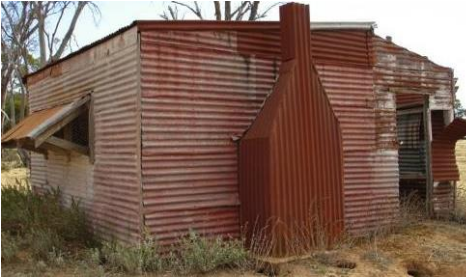
<p>Redbank Hut Not inspected in detail by authors. High Ground Consulting previous description included here.</p>	<p>Redbank Hut is a simple timber-framed, corrugated iron clad dwelling with a low gabled roof and corrugated iron clad chimney located on its southern wall. The hut has an earth floor. What is said to be a 19th century grave site is located east of Redbank Hut. This site is possibly unrelated to Redbank Hut. (High Ground Consulting, 2006)</p>

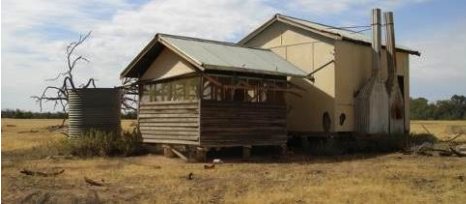
<p>Source: High Ground Consulting, 2006</p>
<p>Redbank Cook House and Meat House Not inspected by authors.</p>	<p>Two small adjacent buildings with gable roofs clad in corrugated iron. The meat house walls are clad in timber. The cookhouse walls are clad in fibro and features two sheet metal chimneys along one elevation. Both are elevated on piers. (High Ground Consulting, 2006)</p>

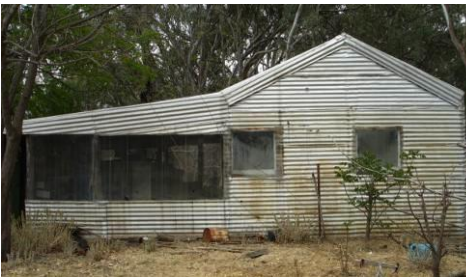
<p>Source: High Ground Consulting, 2006</p>
<p>Pocock's Hut Not inspected in detail by authors. High Ground Consulting previous description included here.</p>	<p>Fred Pocock's Hut is a simple timber-framed, corrugated iron clad dwelling consisting of a gable-roofed section including a combined bed and living room and a skillion-roofed kitchen section. A skillion-roofed verandah faces west. This building was constructed from second-hand materials after the erection of Redbank Weir. It has an earth floor. The hut retained its furniture in 2006 but much is since understood to have been removed. (High Ground Consulting, 2006)</p>

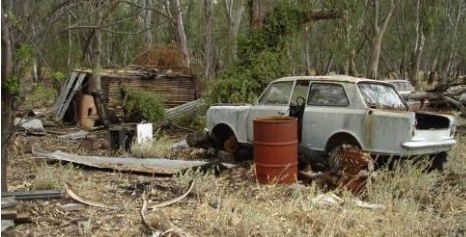
<p>Pocock's artefact scatter Not inspected in detail by authors. High Ground Consulting previous description included here.</p>	<p>Former vegetable gardens, orchard and a vineyard are located to the north of the hut. The site is littered with rubbish, including numerous abandoned cars and a complete prefabricated miner's hut removed from an old gold mine near Cobar. (High Ground Consulting, 2006)</p>

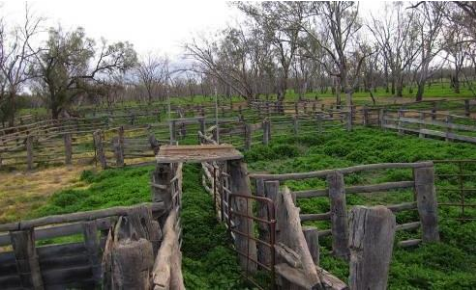
NAME	PHYSICAL ANALYSIS OF ITEM	IMAGE No.
Tarwillie yards	Extensive yards with round timber posts and rails and an earth loading ramp.

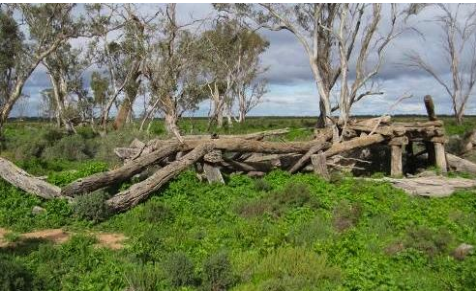
<p>Source: CMP authors, 2009</p>
Bridges over Redbank Swamp	Site not inspected.	No image available.
Hill Paddock Bridge (ruin)	The Hill Paddock bridge is a basic beam bridge showing evidence of bush carpentry skills. The piles and girders of the bridge are made from unmilled logs. The bridge trestles are of very simple construction and are unbraced. The tops of the bridge piles were cut to form a tenon that locked into mortices towards each end of the trestle beams. Decking beams were spiked to the tops of the trestles, which appear to have been shaped to create a shallow cradle for each decking beam. (High Ground Consulting, 2006)

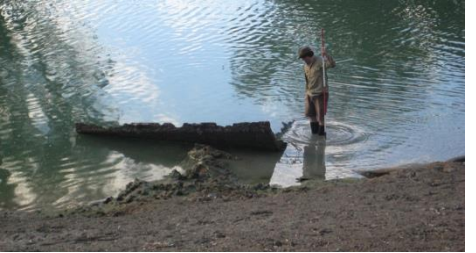
<p>Source: CMP authors, 2009</p>
Barge wreck Woolpress Bend	The wreck of a barge sunken in the Murrumbidgee is sitting on clay and is exposed only at very low water levels. The steel barge or punt is ca 3.5m wide, and at least 5m long, with a squared bow. Visible are a steel keelson, steel floors and a stringer but no frames. At the probable bow, there are remains of hinges suggesting an adjustable ramp was attached.

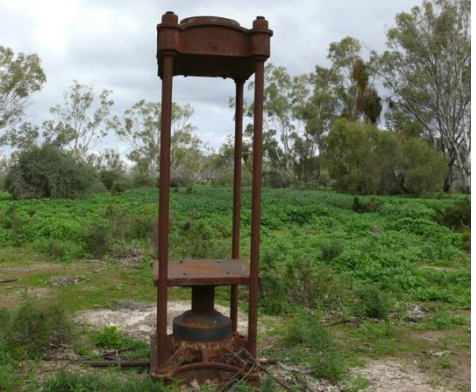
Woolshed site on Woolpress bend and embankment.	The area is marked by a dense growth of nettles limiting visibility. There is a thin scatter of ceramic and glass across the site, handmade nail, and half a blade shears (there is also a half shears blade embedded high in a nearby tree trunk). An hydraulic woolpress stands at the site, maker's mark: 'Robison Bros & Co Melbourne'. The archaeological remains of the Woolshed are indicated by the bright green weed growth at right. The embankment formerly surrounding the whole area is evident at the river but at other locations is obscured by regrowth.

<p>Site of Woolshed. Source: CMP authors, 2009</p>
House site near woolshed site	Archaeological material is scattered on a small circular rise in the flood plain, to the south of the Woolpress Bend Woolshed site. The material is fragmented ceramic, glass and clay pipes, makers 'McDougall Glasgow' and 'Murray Glasgow'. Two areas of highly fragmented bone may be the remains of Aboriginal burials. On a track running towards the woolshed is a sawn wooden plank gutter crossing.

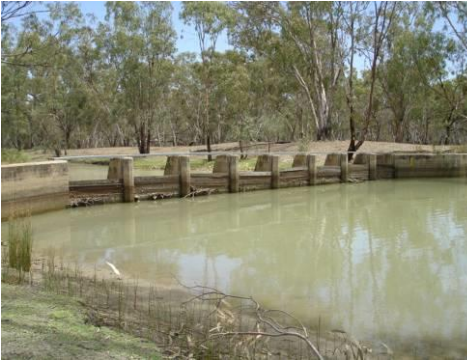
NAME	PHYSICAL ANALYSIS OF ITEM	IMAGE No.
<p>1AS regulator (R2) (Yanga) Not inspected in detail by authors. High Ground Consulting previous description included here.</p>	<p>1AS Regulator is a dam-like structure designed to allow water to enter wetlands north of Redbank Cottage and retain flood water. The regulator also carries a steel-decked footbridge It consists of the following:</p> <ul style="list-style-type: none"> • A wide concrete footing and aprons extending across the creek from bank to bank. • Concrete wings constructed at each bank. • Seven buttressed and slotted concrete piers approximately 1.8metres high. • A narrow steel walkway across the top of the piers. • Timber planks inserted into the slots in each pier to create a weir. <p>The concrete elements of the regulator appear to have been made with reinforced concrete formed up in situ. (High Ground Consulting, 2006)</p>

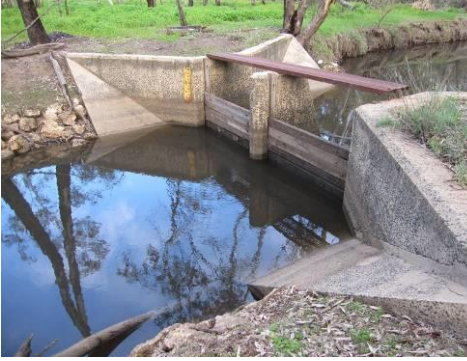
<p>1ES regulator (R1) Not inspected in detail by authors. High Ground Consulting previous description included here.</p>	<p>1ES Regulator is a dam-like structure designed to allow water to enter wetlands of Shaws Paddock and retain flood water. The regulator also carries a steel-decked footbridge It consists of the following:</p> <ul style="list-style-type: none"> • A wide concrete footing and aprons extending across the creek from bank to bank. • Concrete wings constructed at each bank. • One buttressed and slotted concrete pier approximately 1.8metres high. • A narrow steel walkway across the top of the piers. • Timber planks inserted into the slots in each pier to create a weir. <p>The concrete elements of the regulator appear to have been made with reinforced concrete formed up in situ. (High Ground Consulting, 2006)</p>

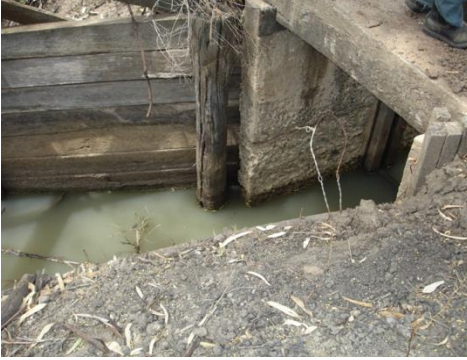
<p>Source: High Ground Consulting, 2006</p>
<p>Old Swamp regulator (Shaws regulator) Not inspected in detail by authors. High Ground Consulting previous description included here.</p>	<p>The Old Swamp Regulator is a dam-like structure designed to allow water to enter wetlands of Shaws Paddock and retain flood water. It consists of:</p> <ul style="list-style-type: none"> • Earthen banks narrowing the creek passage. • Concrete uprights on each side of the narrow creek opening. Each pier is fitted with a pair of cleats creating slots for planks inserted into the regulator. • Wings of milled hardwood planks along bank. • Two hardwood slabs separating and stabilising the concrete uprights. • Timber planks inserted into the slots in each pier to create a weir. <p>(High Ground Consulting, 2006)</p>
