Proposed construction of a walking track between Jigamy Farm and Fisheries Flat, via Eden, NSW: Aboriginal cultural heritage due diligence assessment – Addendum August 2024

August 2024

Report to Wolfpeak and Eden Local Aboriginal Land Council

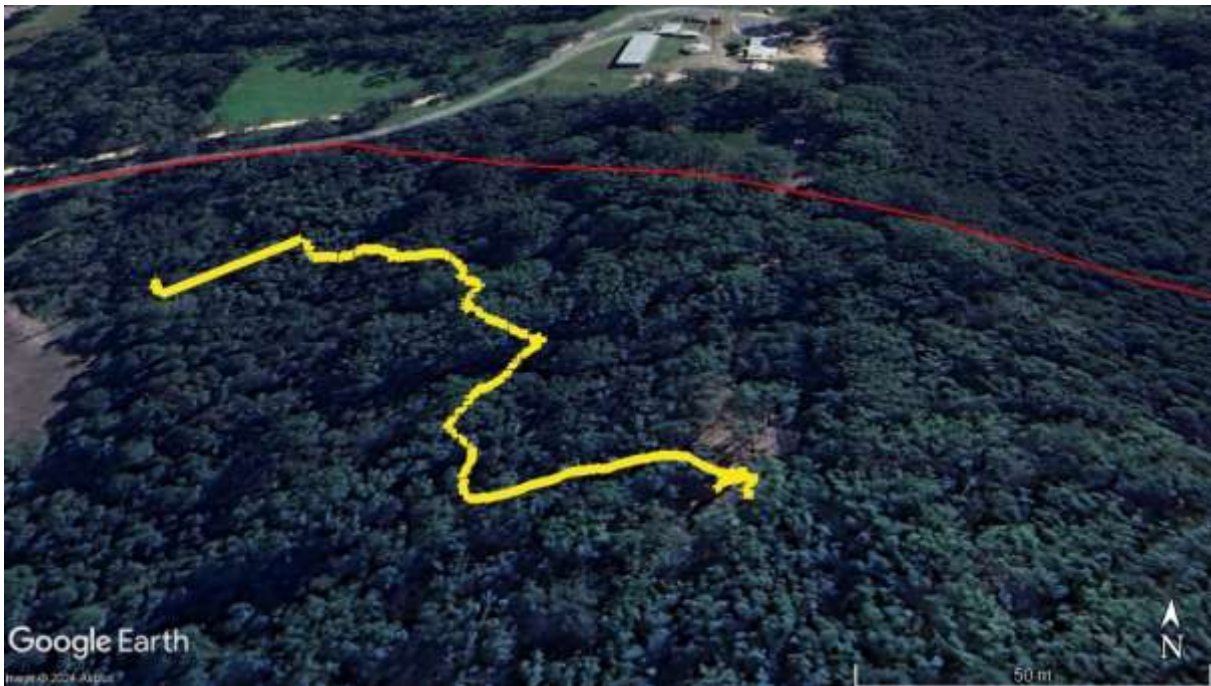
Figure 1: Proposed realignment 2024

The youth camp component of the walking track comprises approximately 320 metres of track realignment between Jigamy Creek and the boundary between Eden LALC land and the national park as shown in Figure 1. Specifications for track construction will be in accordance with that described in the initial due diligence report and REF.

The field investigation involved the field crew walking a 300 metre long and 21 metre wide transect following a proposed realignment of the walking track as shown in Figure 1 above, and carefully inspecting the ground for stone artefacts and other evidence of pre-contact Aboriginal occupation and use. The 21 metre wide inspection corridor allowed for any deviations of the track to avoid artefacts and ensure they are not impacted during walking track construction.

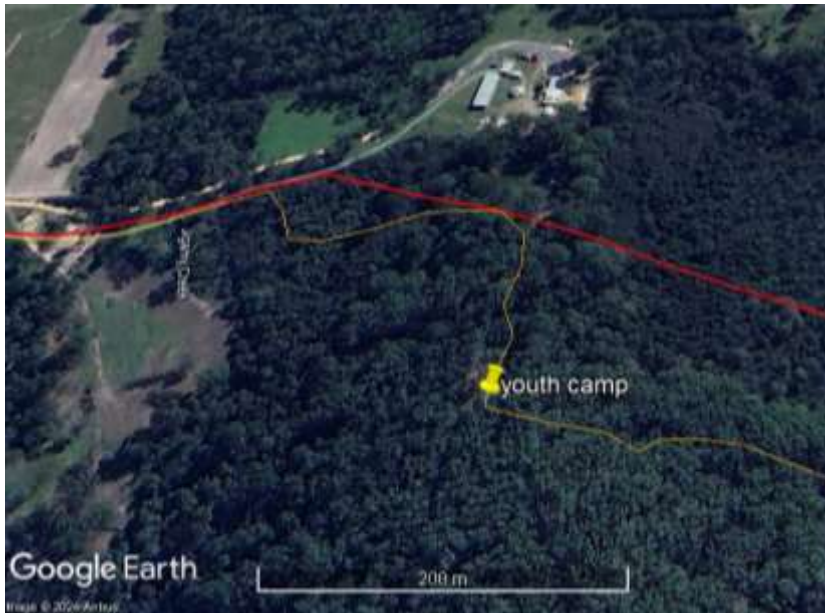
Figure 2: Map showing location of site on walking track route

The initial survey for the Bundian Way was conducted in 2021 and its location in the vicinity of the youth camp is shown in Figure 2 (Feary, 2022). One site was found on/close to the proposed route in the area, comprising a single silcrete flake (labelled 'youth camp' in Figure 2). Because of the potential for other artefacts to be present, the report recommended monitoring during vegetation clearing for the track (mainly leaf litter) with a buffer, to avoid any artefacts (Feary, 2022). Figures 3 and 4 show the location of the isolated flake, and the silcrete flake respectively.

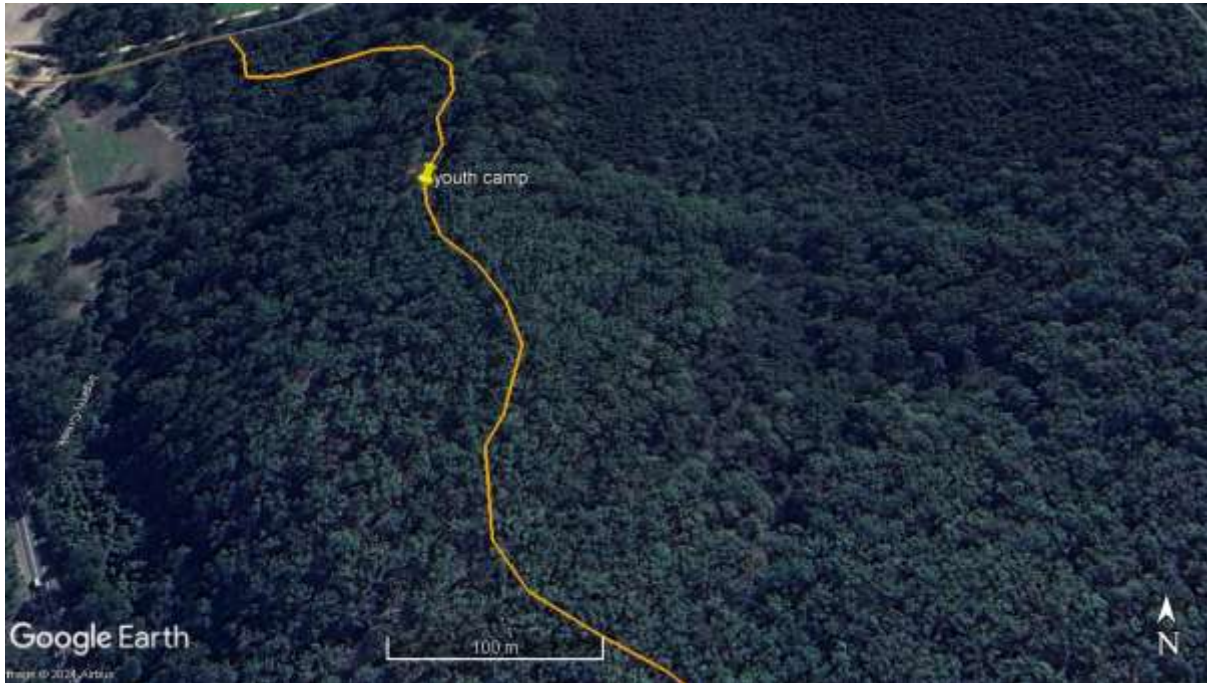
Figure 5: February 2022 realignment of northern section of walking track showing location of site 'youth camp'

An amended alignment for the walking track between Jigamy Farm and The Pinnacles was surveyed in early 2022 by archaeologist Gerard Niemoeller. The amendment affected a small section of the walking track located within Eden LALC land (Figure 5). The route was unchanged in the vicinity of the recorded site, which was not re-located during the survey. No sites were found and the alignment was assessed as traversing landforms of low archaeological potential (Feary, 2022b).

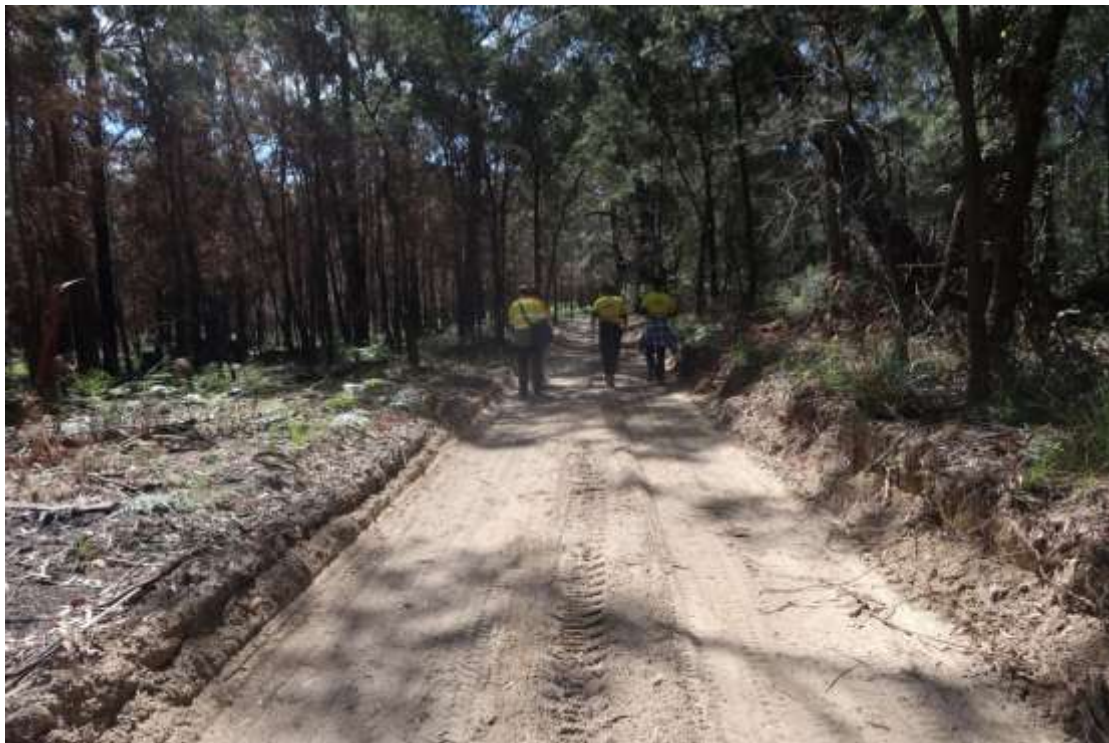
Figure 10: North Head road

For the section south of the Terrace Beach track, the initial 2021 cultural heritage survey followed the existing unsealed road, and no artefacts were recorded (Feary, 2022a) (Figure 10). Despite the disturbed nature of unsealed roads, surveys on logging roads in timber production forests across southeastern NSW have been found to frequently contain artefacts because they are often the only places that provide any archaeological visibility (Byrne, 1983; 1984a and b; Feary, 1988).

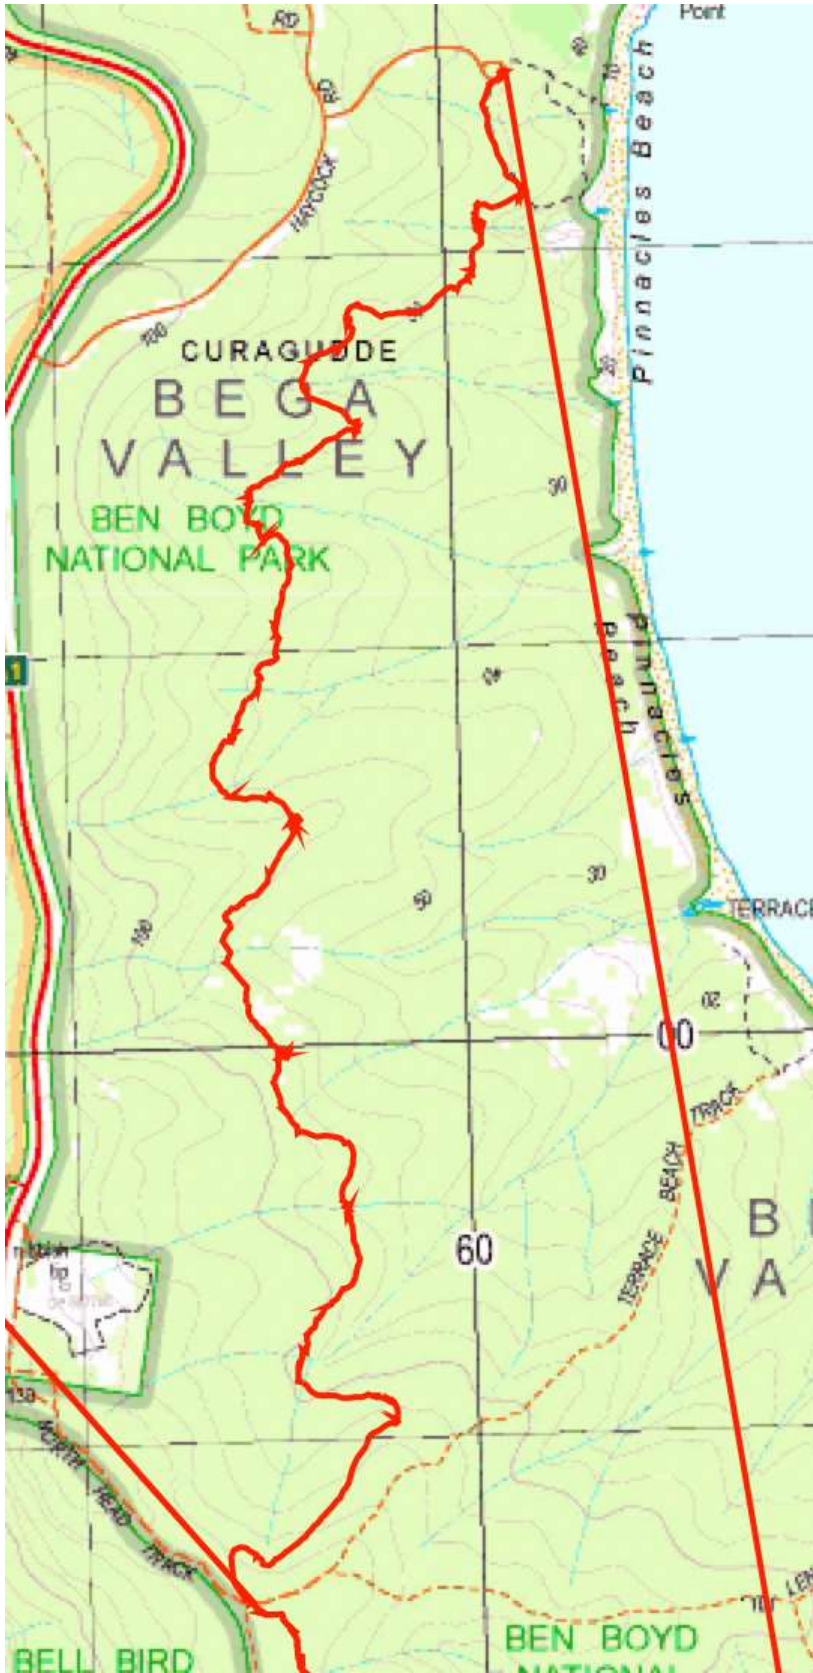
Figure 11: Northern realignment, Beowa NP between Pinnacles and Terrace Beach Track (red line)

The entire proposed realignments (approximately 10 kms) were inspected on foot with a transect ‘search width’ of approximately 6 metres. Figures 11 and 12 show the survey transect for the northern and southern sections respectively. The ground was carefully searched for stone artefacts where bare earth was exposed and all mature trees were inspected for cultural scarring. Archaeological visibility was documented and locations with archaeological potential were recorded. Note was made of factors causing ground disturbance and their likely impacts on artefact detection.

The northern survey transect contoured mid- to upper-slope topography on the eastern side of the ridge line, approximately one kilometre to the west of the local coastline. Localised topographies encountered included simple slopes (upper ridge side), spur tops, crests and sides. Nine uppermost reaches of first and second order drainage lines were also encountered. Zones of higher disturbance from past land use (chiefly forestry) were noted in some places. The northernmost several hundred metres of the transect passed through an area previously planted to pine trees.

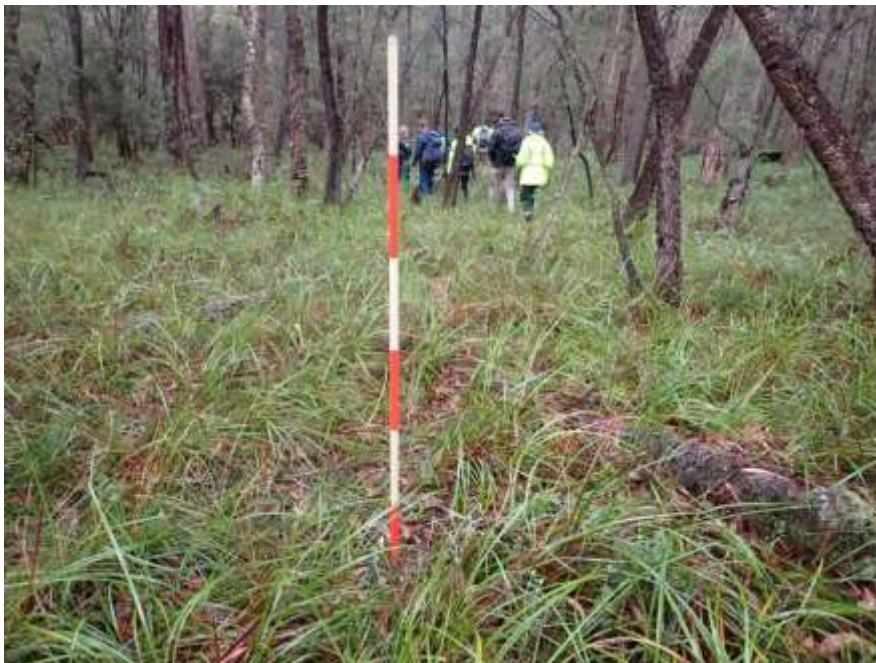
Figure 13: Example of ground visibility, southern section - flat terrain

Archaeological visibility was generally very low due to leaf litter and understorey shrubs and grasses, and restricted to occasional bare patches, animal digging and four wheel drive tracks that were crossed at points. These vehicle tracks provided comparatively very good surface visibility (albeit for a very limited extent) at points in the landscape where a slightly elevated archaeological potential might be expected (i.e. following natural Aboriginal pathways such as spur tops between the forest and the coastline), e.g. Cockle-eye Ricky track in the southern section (see Figures 13 to 17).

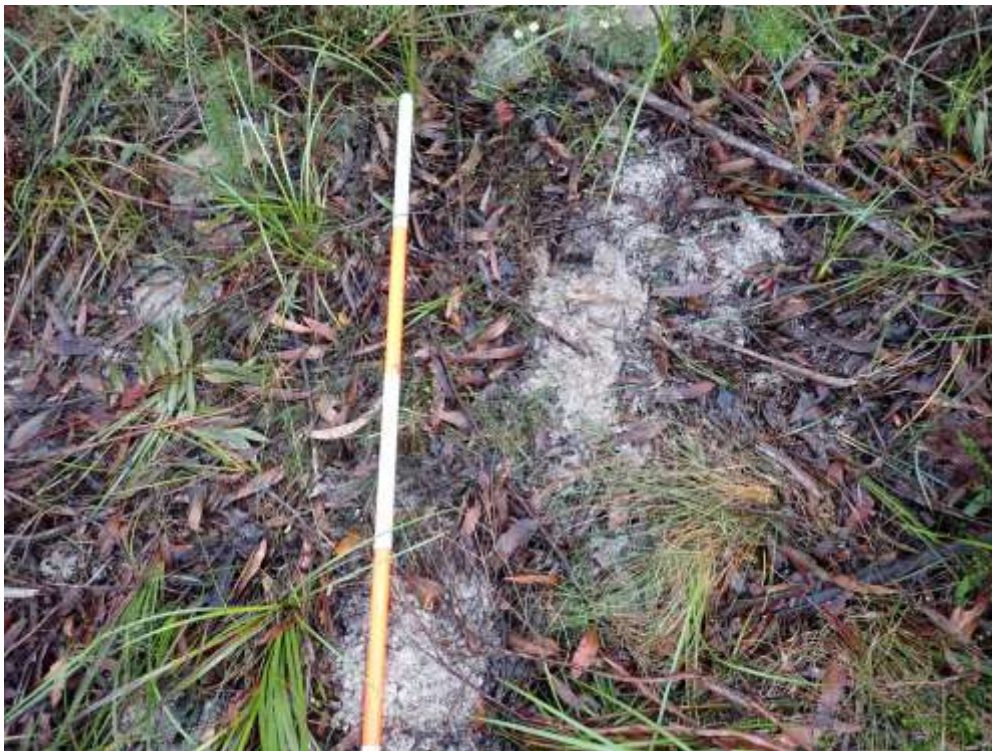
Figure 18: Example of bioturbation

Previous disturbance to the landscape was generally quite low and restricted to parts of the northern transect. The heaviest levels of change evident within the local soils can be expected to occur in the form of natural mixing through bioturbation by vertebrates such as bandicoots and invertebrate action. Bioturbation is highly apparent across the entire landscape but most marked on lower lying low gradient surfaces such as creek flats and flat ridge tops. This has resulted in a 'micro-hummocky' terrain surface that is evidence of substantial mixing of upper soil levels at least (Figure 18).

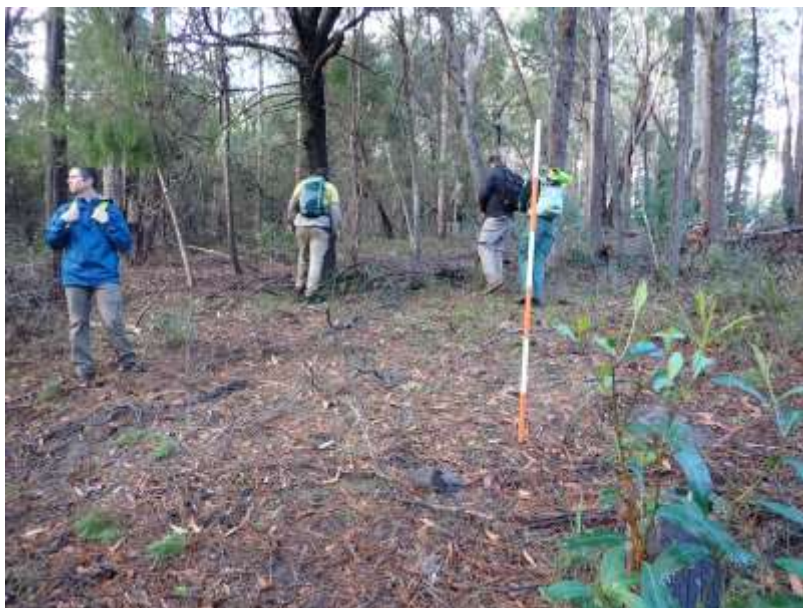
Figure 21: South bank of drainage line, looking south. This position is a concise low gradient spur crest.

Comprises a well incised first order drainage line with a concise low gradient spur top constituting its south bank. This position represents a zone archaeological potential within the local landscape. Of note is the presence of planted pine trees (now largely cleared) on the south side of the creek, indicating some level of disturbance.

Monitoring by members of Eden LALC during initial vegetation clearing should occur at the four locations of archaeological potential as described in Section 9.4 above. Monitoring should occur for at least 5 metres along the route on each side of grid reference. If artefacts are found, careful searches should be conducted to identify all artefacts in the near vicinity. The track should be adjusted to avoid the artefacts, with a suitable buffer. The adjusted route should be inspected to ensure no artefacts are present. If it is impossible to avoid the site, works will need to stop at this location and advice sought on the need for an Aboriginal Heritage Impact Permit (AHIP).

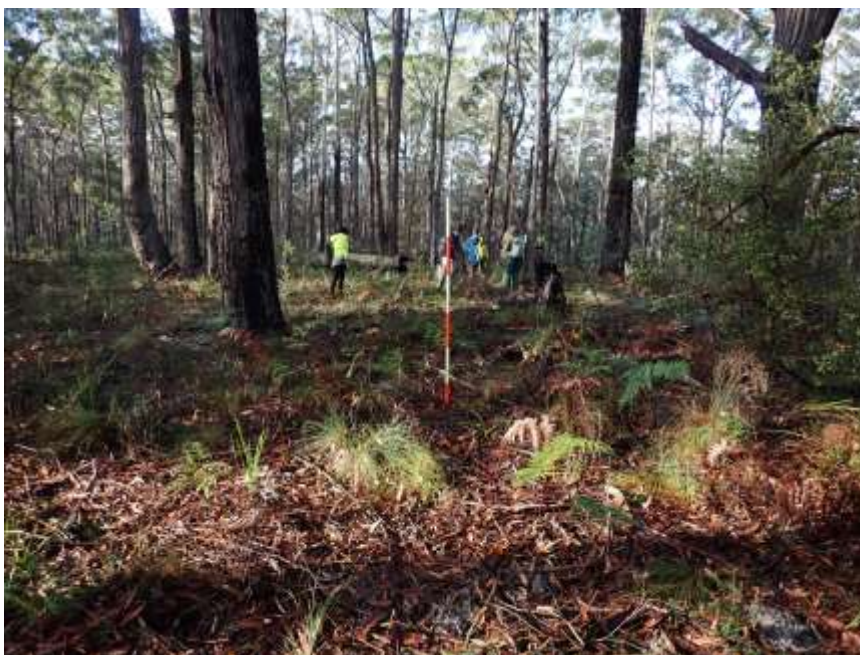
Figure 23: Spur top, Beowa 2

Comprises a concise low gradient spur top with archaeological potential. Abundant bioturbation is apparent.

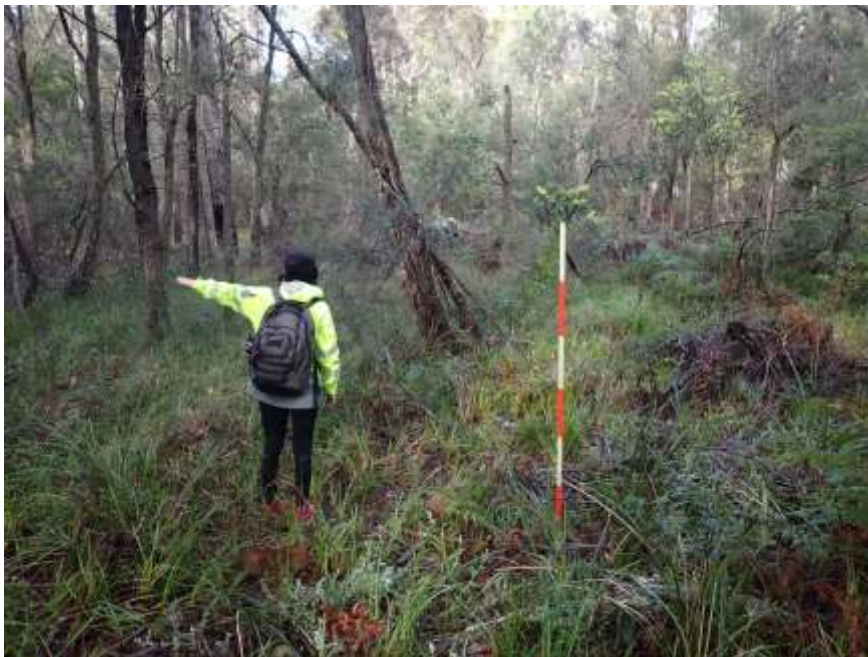
Figure 25: Flat terrain, Beowa 3

Flat area which is locally uncommon and may have archaeological potential. A substantial degree of bioturbation is evident resulting in a 'micro-hummocky' terrain surface that is evidence of substantial mixing of upper soil levels at least.

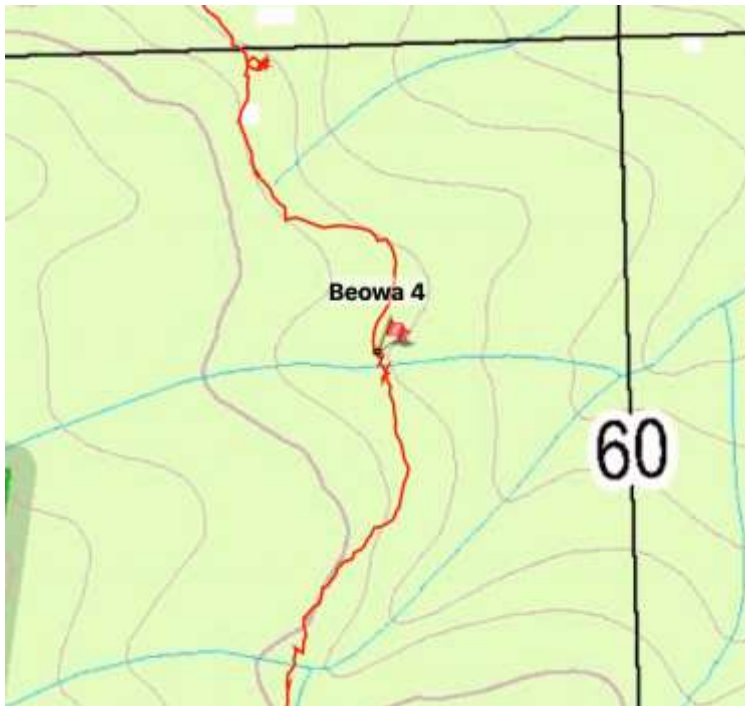
Figure 26 Eden 1:25K topographic map showing location of Beowa 4

Grid reference GDA94 Z 55 759676E 5899605N

Drainage line with level flanking terrain. This setting i.e. flats on both sides of the creek, has archaeological potential.

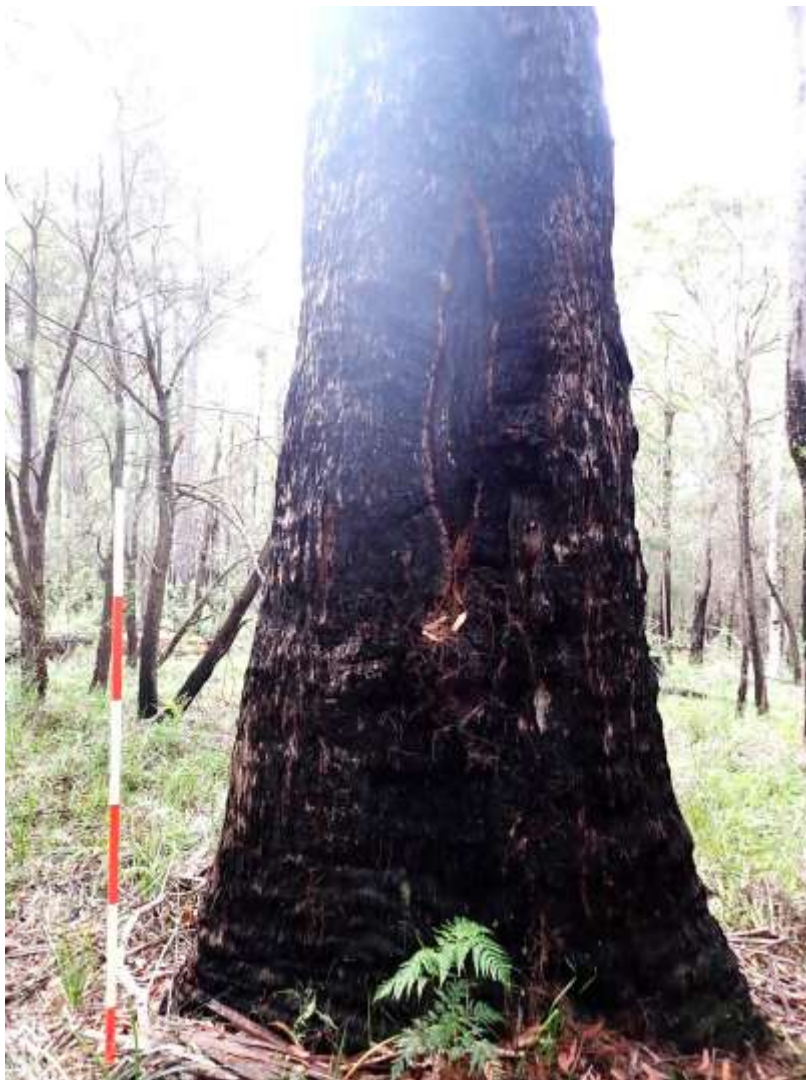
BST1

A potential cultural scar on the lower west-facing trunk of an old blackbutt tree. Scar dimensions are: 140cm long x 20cm wide x 25cm deep. Base of scar is 110cm above ground level. The tree is old and approximately 30m tall. Approximate trunk girth at breast height (DBH) is 3.6 metres.

The tree occurs to the immediate east/downslope of the proposed walking track corridor. Some areas of historical disturbance from forestry occur along the transect to the south of the scarred tree location.
