Bantry Bay Conservation Management Plan (draft)

Garigal National Park, NSW

Prepared for the National Parks and Wildlife Service by:
Graham Brooks & Associates
Taylor Brammer Landscape Architects
Mary Dallas Consulting Archaeologists

NSW National Parks and Wildlife Service May 2002

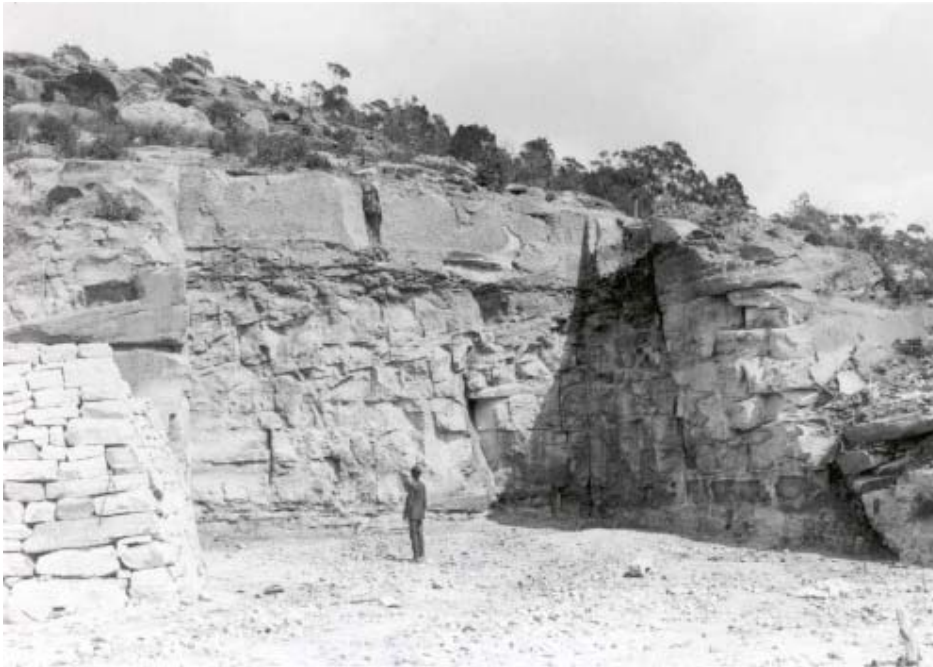
Figure 2.4.7 Large cutting at site of new magazine, Bantry Bay, c.1913. GPO1-31380, reproduced with permission of State Library of NSW.

Figures 2.4.7 and 2.4.8 show the extent of the reclamation and the excavation of the embrasures for the magazines. The excavation involved an enormous amount of rock removal which was then used to create a new sea wall and reclamation of flat concourse areas in front of the magazines. The excavation, reclamation and sea wall, the light rail and drainage, the reservoir and two timber wharves were completed in 1913.³² A surveyor's plan drawn in 1931 indicates the original line of the hill and the extent of reclamation of flat concourse and excavation for the magazines was extensive.

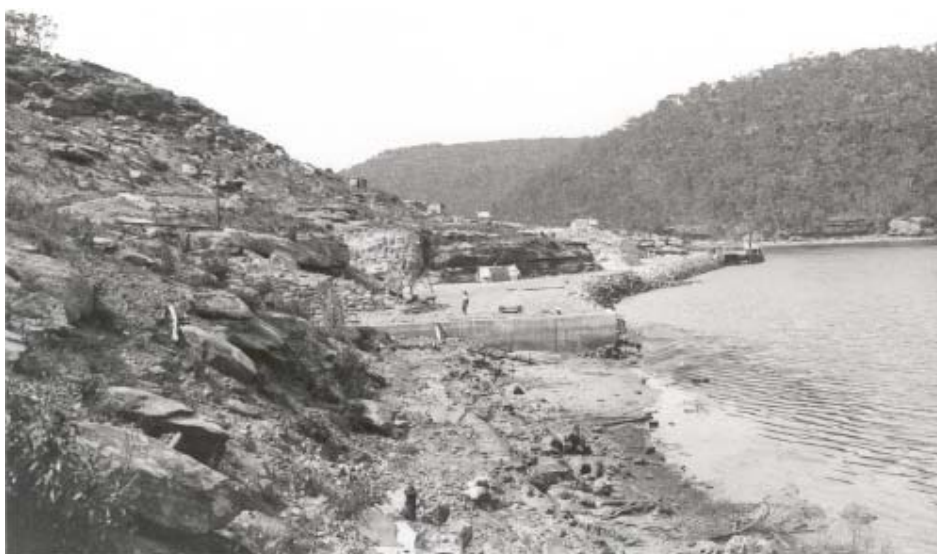
Figure 2.4.8 Site of new magazine station, Bantry Bay, c.1913. GPO1-31373, reproduced with permission, State Library of NSW.

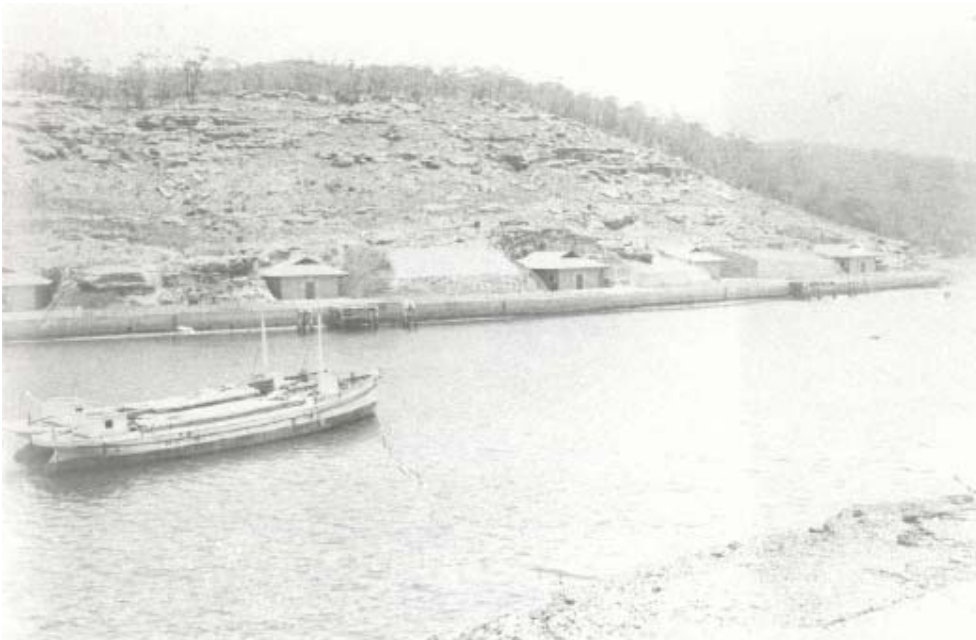
Figure 2.4.9 General view of magazine station, receiving house, jetties, January, 1916, GPO1-31859. Reproduced with permission, State Library of NSW.

A light rail system ran from each jetty to the porch of each magazine. Another line ran along the seawall, past each jetty, with a turntable system at the intersection. A branch line ran in a curve from each magazine to connect to the sea wall line. The light rail system was the only means of transporting the crates from the lighters to the magazines.

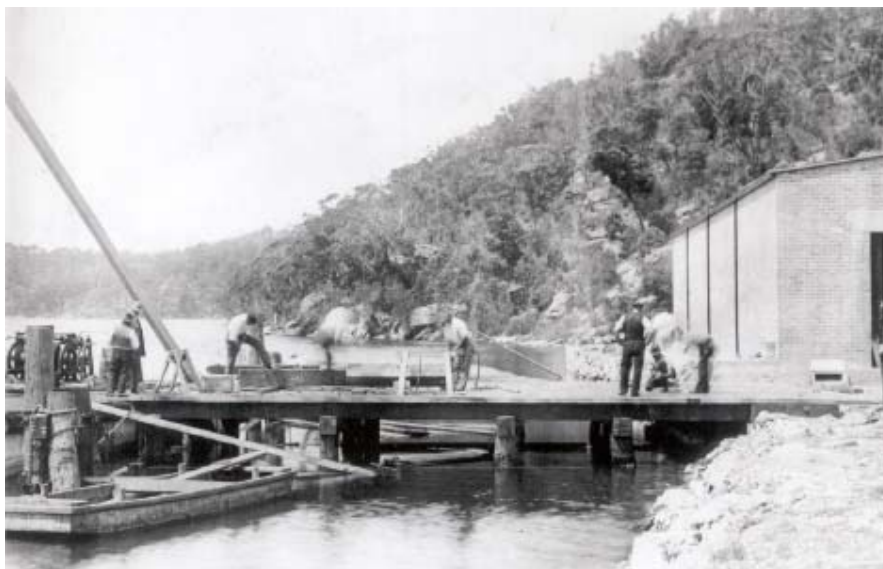
Figure 2.4.10 Construction of jetty for powder magazine in Bantry Bay, January, 1917, GPO1-24431, reproduced with permission, State Library of NSW.

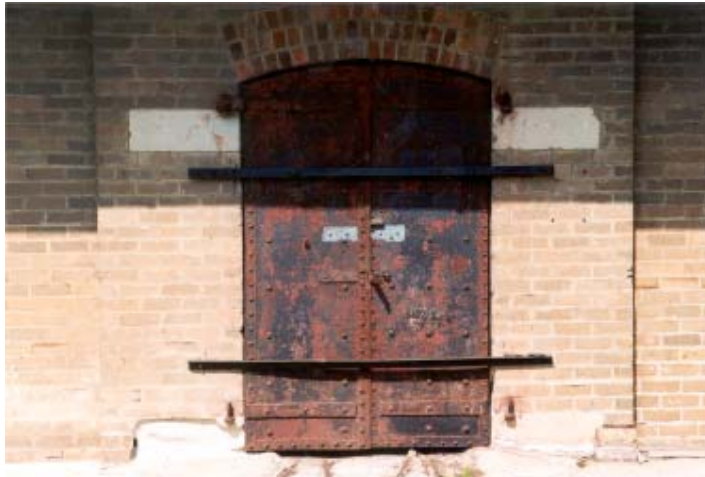
Figure 3.6.7 Detail of iron double doors, 2001

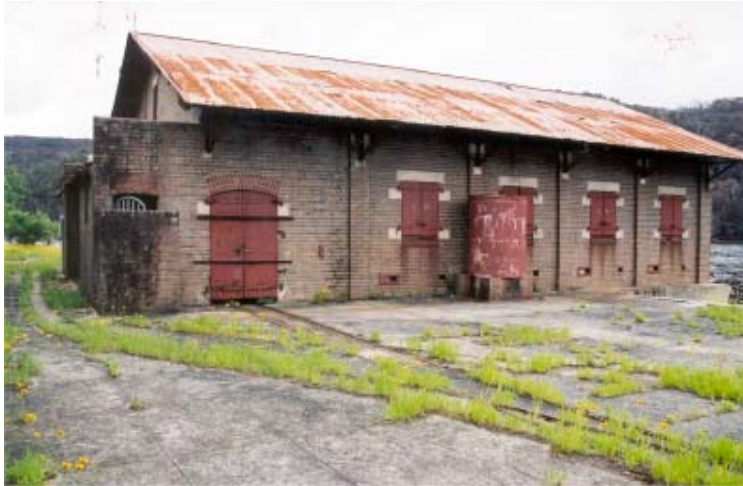
Figure 3.6.10 Detail of southern elevation of receiving shed, 2001

The main portion of the building has four windows along either side, with internal timber shutters and external iron shutters, and two sets of double doors facing onto the water, which allowed for the unloading of the lighters. The window openings have stone lintels and anchor blocks for the steel shutters, and the door openings have semi-arched heads of polychromatic brickwork, and similar stone anchor blocks for the external steel double doors. Similar door openings provide access into the trolley bay on either side of the building. Two small toilet blocks are located at the rear of the building on either side, and are not housed under the main portion of the building, but rather are located under flat roofs behind parapet walls.

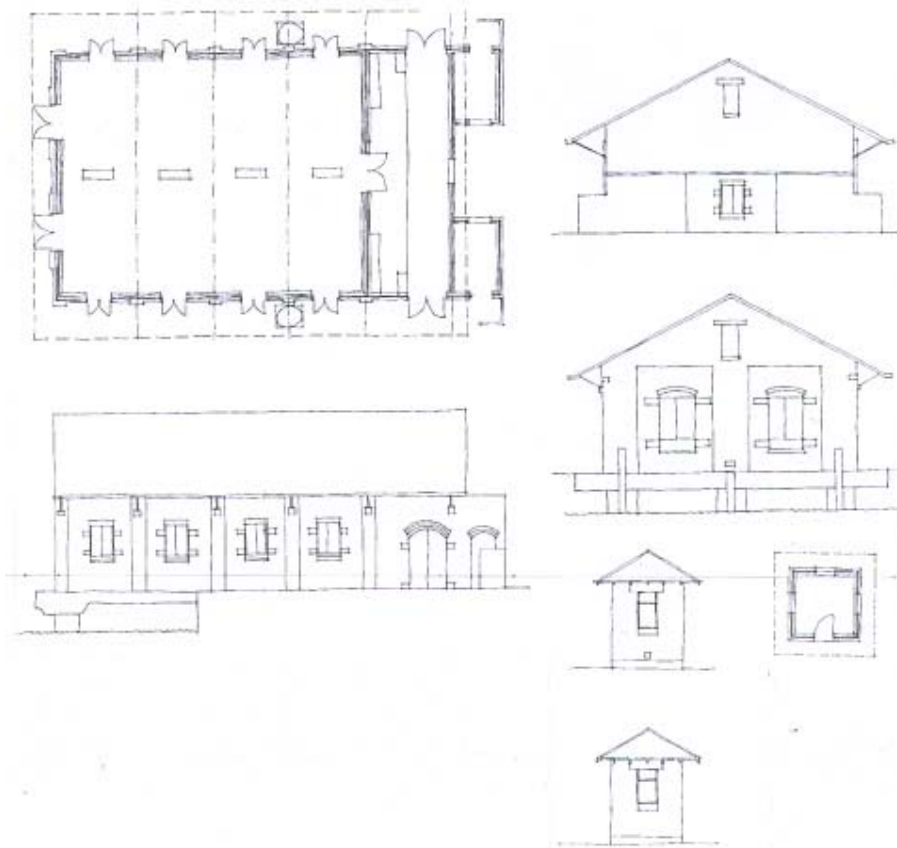
Figure 3.6.11 Receiving shed No 1 and telegraph exchange (Scale 1:200)

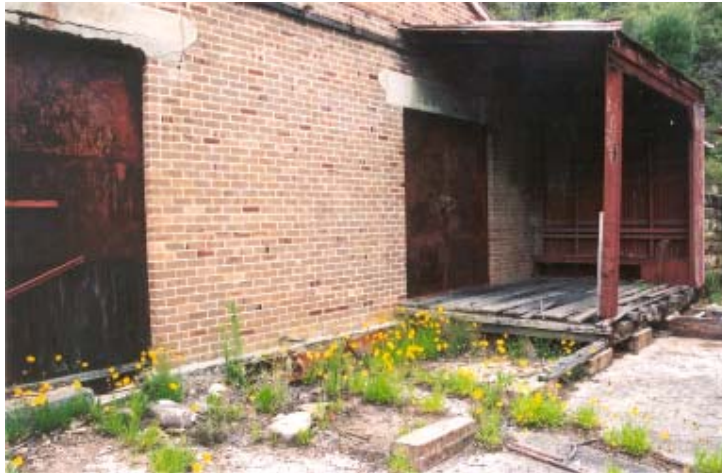
Figure 3.6.13 Partially demolished verandah to magazine No.9, 2001

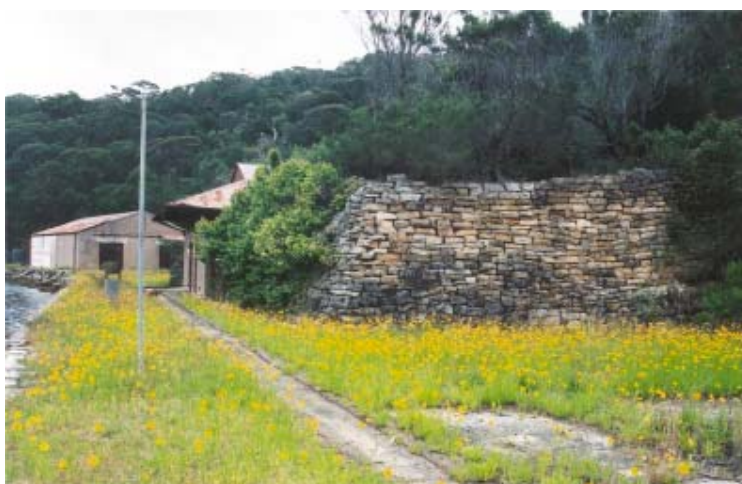
Figure 3.6.20 Stone retaining wall on concourse, with light rail track in front, 2001

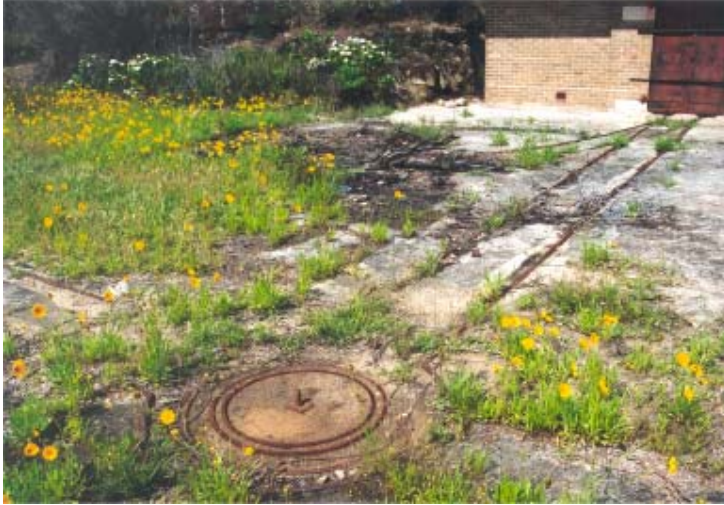
Figure 3.6.21 Concrete concourse with light rail tracks and turntable, 2001

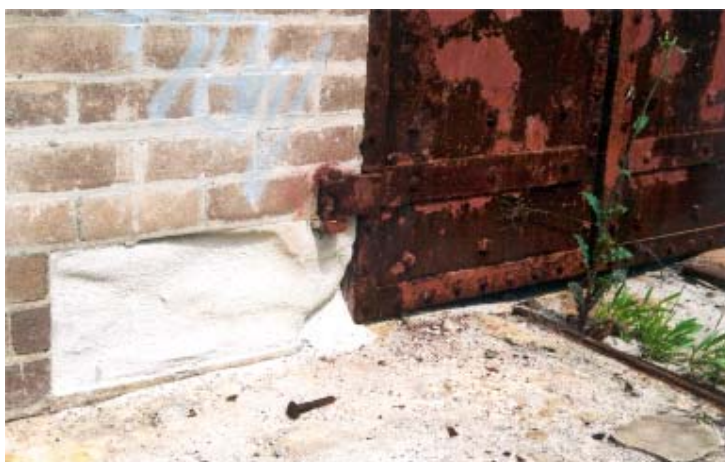
Figure 3.6.27 Erosion of sandstone anchor block of magazine, 2001

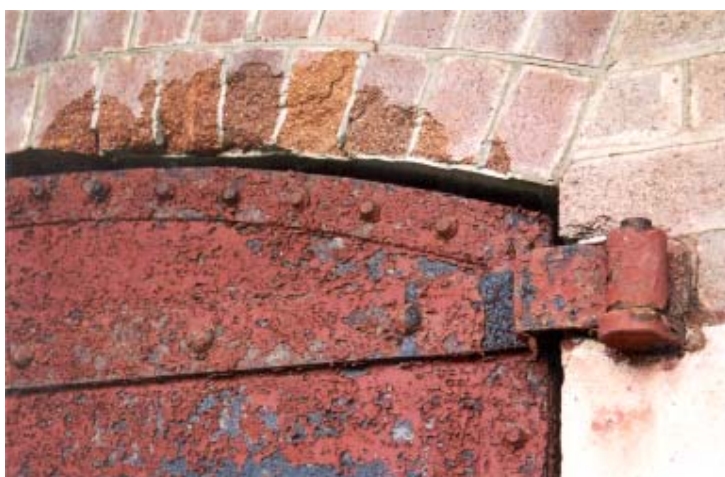
Figure 3.6.28 Corrosion to external iron doors of magazine, 2001

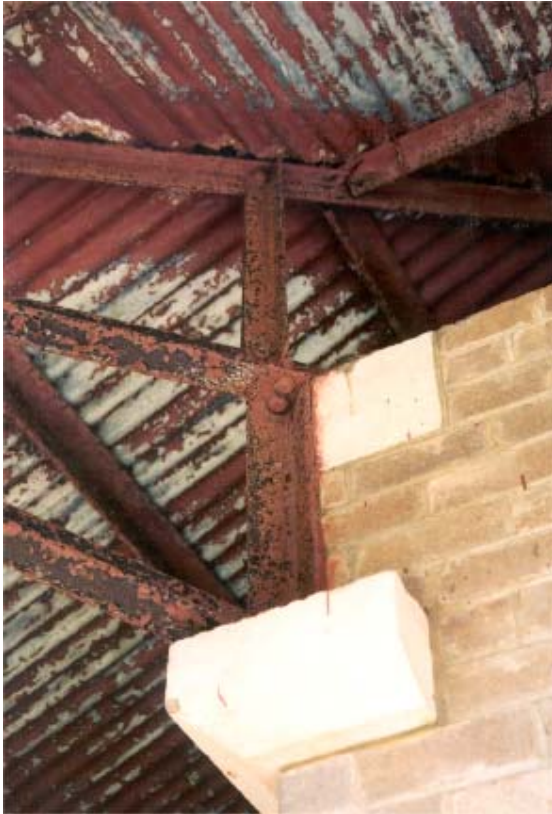
Figure 3.6.29 Corrosion and flaking paint of magazine roof, 2001

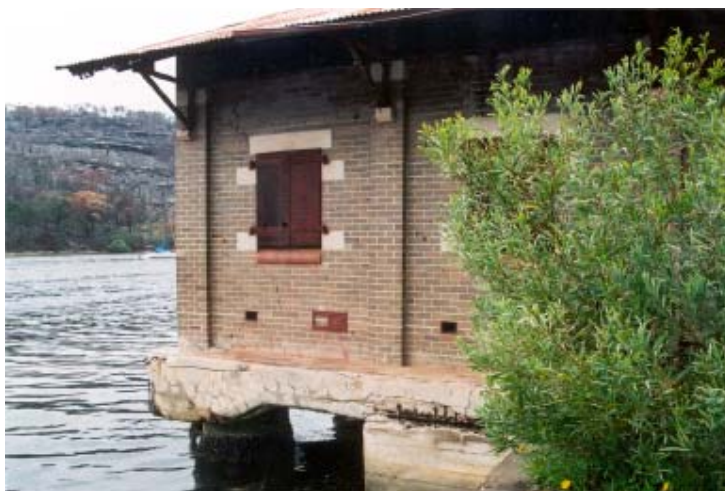
Figure 3.6.30 Suspended floor of receiving shed over water, note concrete corrosion, 2001

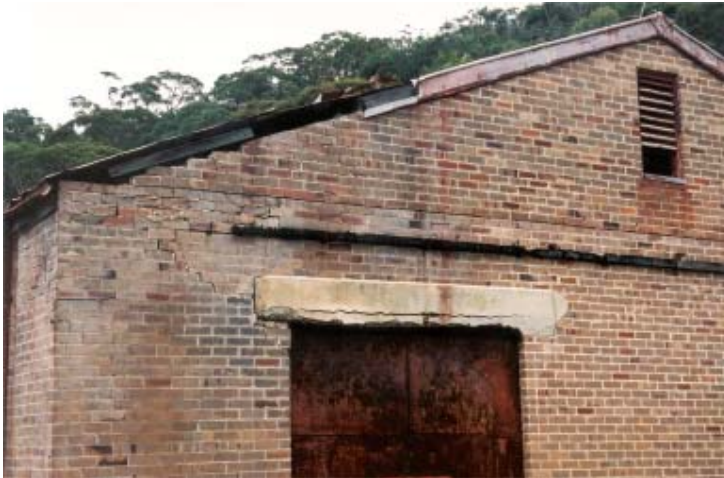
Figure 3.6.32 Cracking to magazine No.9, indicating subsidence, 2001

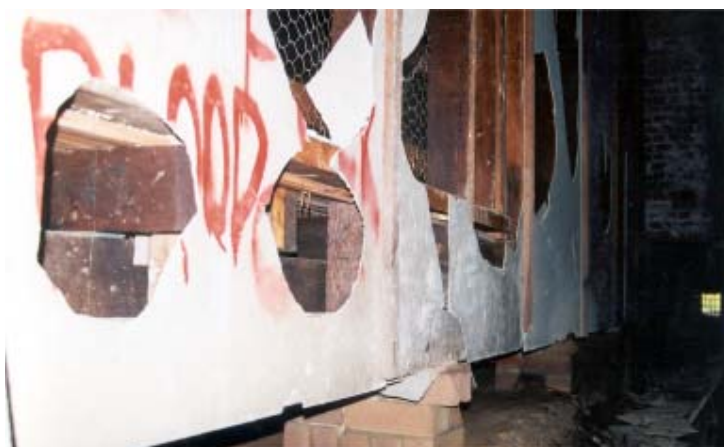
Figure 3.6.33 Damage caused by vandals to interior of magazine No.16, 2001

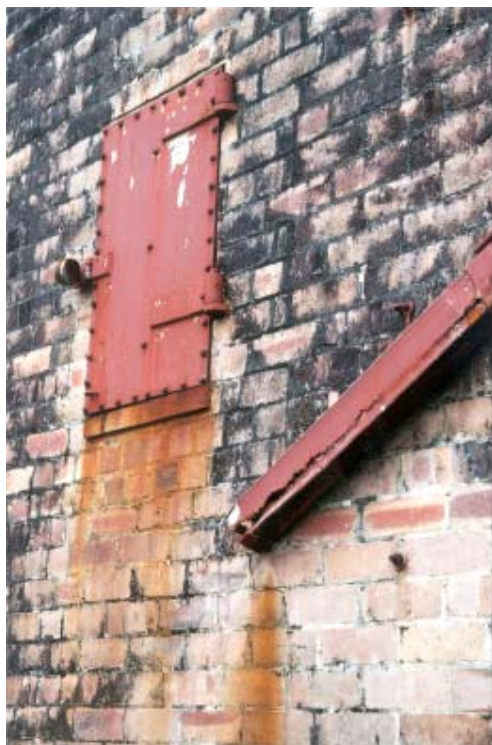
Figure 3.6.34 Water staining from shutters and downpipes to magazine No.16, 2001

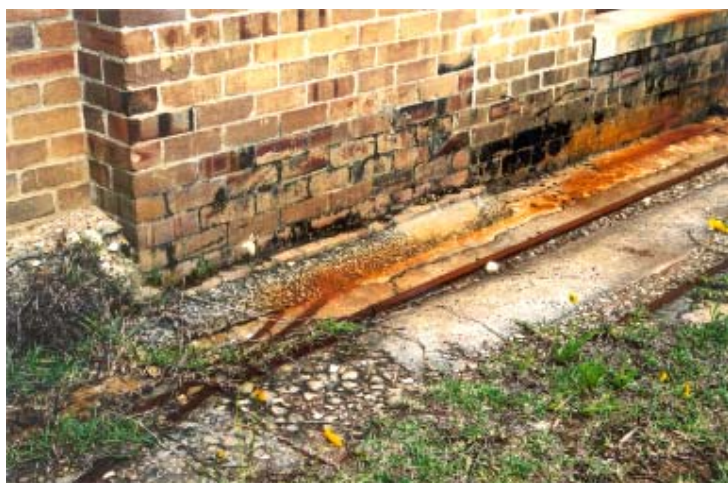
Figure 3.6.35 Rising damp to front wall of magazine No.14, 2001
