BARRENJOEY HEADLAND

CONSERVATION MANAGEMENT PLAN

Prepared for the Office of Environment and Heritage

This Conservation Management Plan was prepared by the Government Architect's Office,
NSW Public Works for the Office of Environment and Heritage.
GAO Report No. 11038

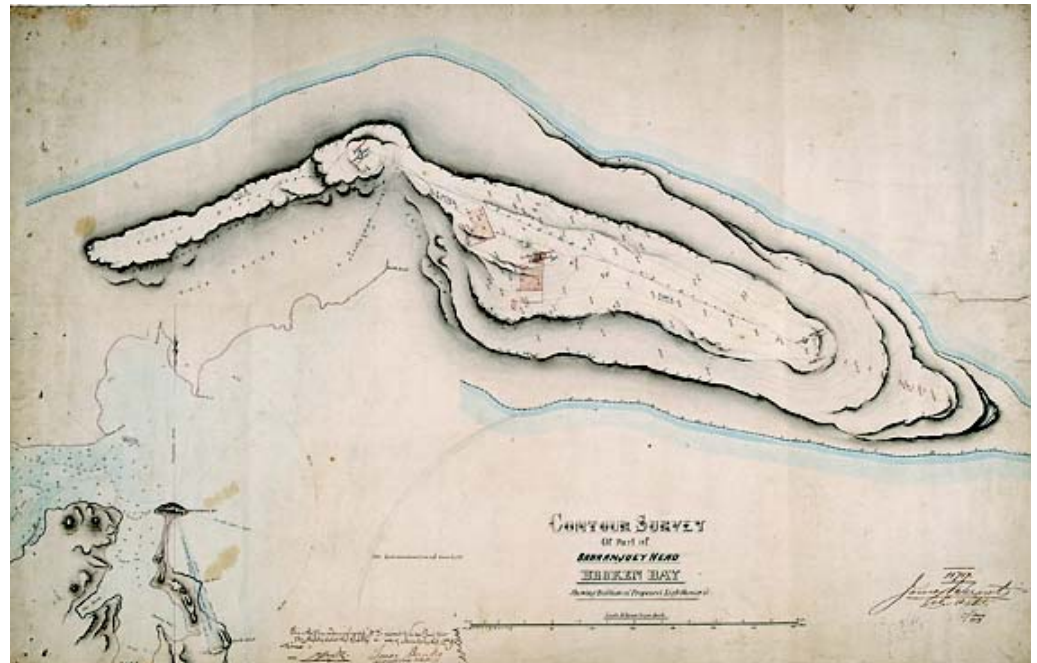
Figure 2.3

1877 Contour Survey of the Barrenjoey (sic) Headland. This plan shows the two Stewart Tower lights at each end of the headland as well as the proposed site for the erection of the new lighthouse (Source: National Archives Australia Map 4957003)

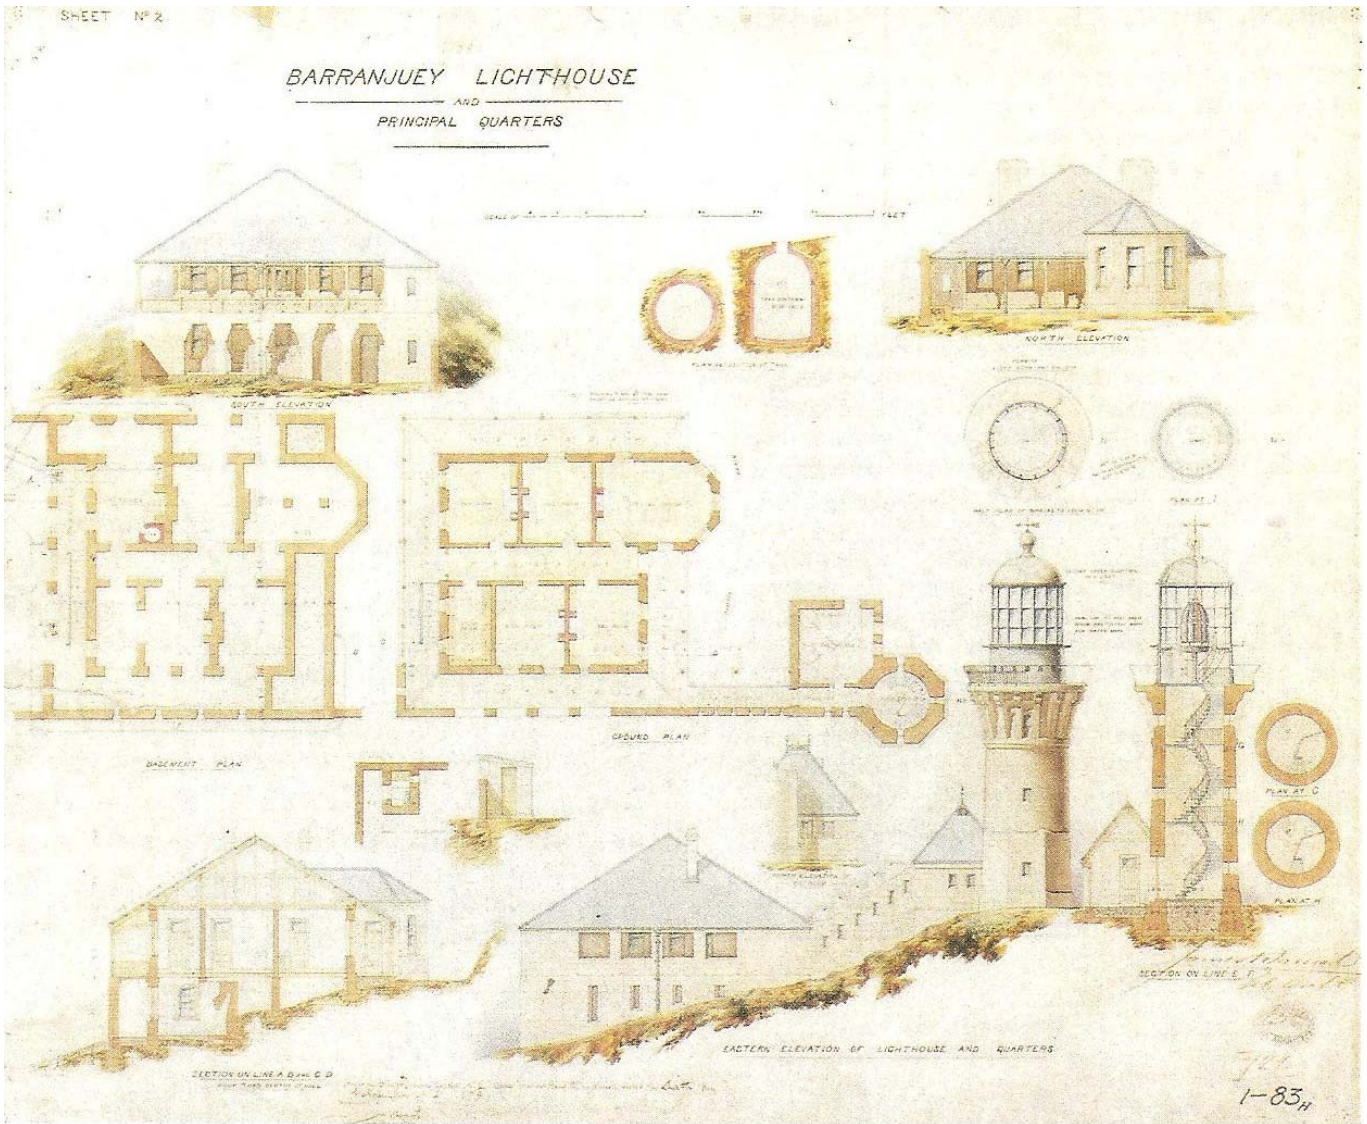
Figure 2.4

James Barnet's plan for the Barrenjuey Lighthouse and attached head Lighthouse Keeper's Cottage. This plan shows clearly the use of the site topography for the placement of the quarters (Source: reproduced in AMSA CN-1-83H)

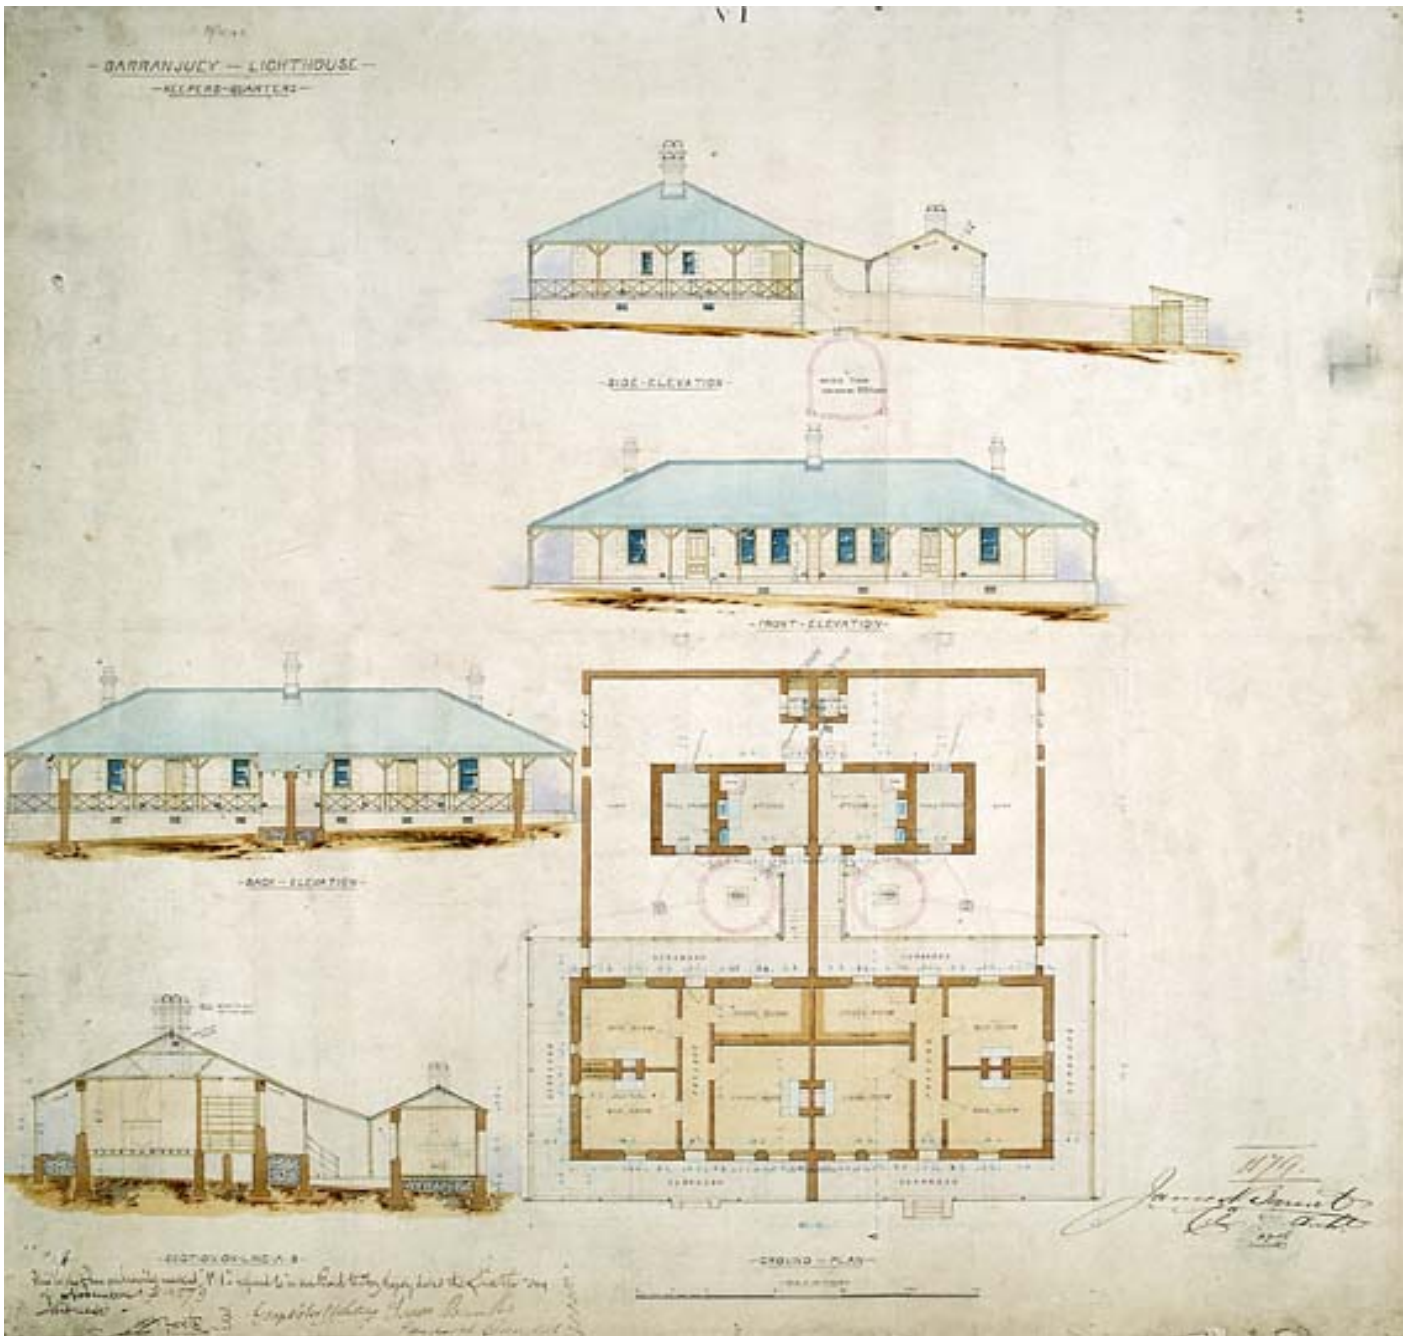
Figure 2.5

1879 Barnet Plan of the Assistant Keepers' Duplexes for Barrenjoey Lighthouse showing the underground water tanks inside the enclosed yards (Source: reproduced in AMSA CN-1-83H)

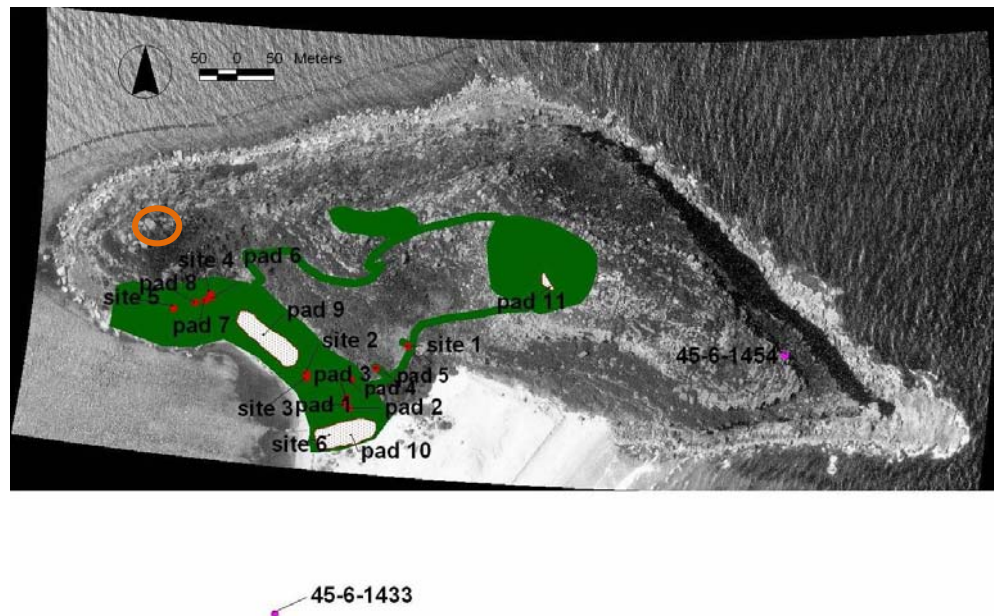
Figure 3.1
Sites identified by McIntyre-Tamwoy in 2004. The site numbers relate to the data in Table 3.1 below)

In the 2004 Archaeological Management Plan, McIntyre-Tamwoy re-identified 3 sites that had already been listed on the NSW Aboriginal Heritage Information System (AHIMS), found six new sites and eleven potential archaeological deposits (PADs). She noted the high likelihood of more sites that have not yet been recorded across the headland.

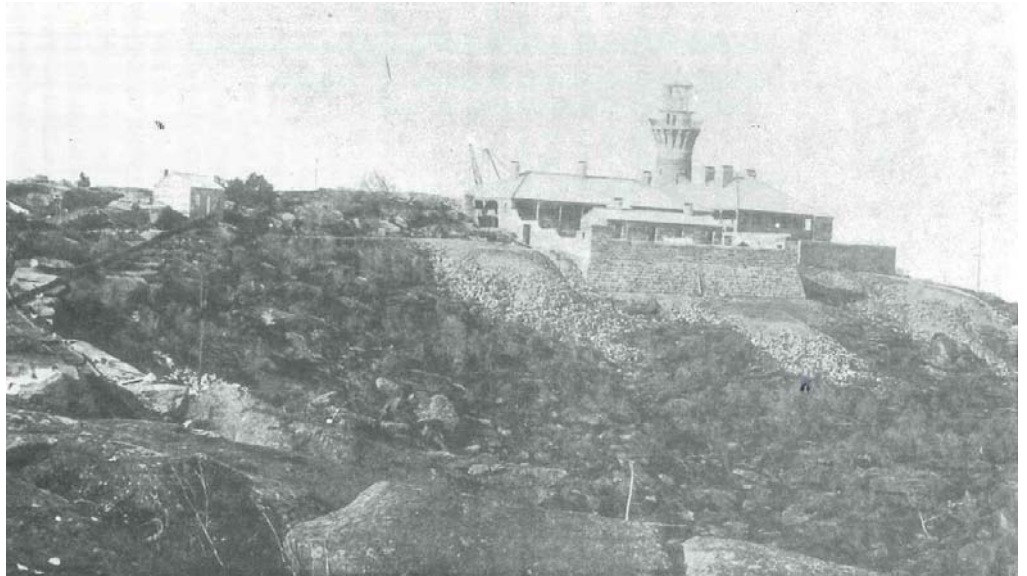
The Lighthouse Complex in June 1881 during the last month of construction. The screes of stone noted by Gojak can be seen in front of the Assistant Lighthouse Keeper's Cottage duplex (Reproduced from Sparks 1992:26).

The Assistant Lighthouse Keepers' duplex sits in a quarried cut, which was also presumably a source of stone for construction. Gojak also noted areas of scree that he interpreted as quarry waste below the Assistant Lighthouse Keepers' Cottages. These can be clearly seen in Figure 3.8.

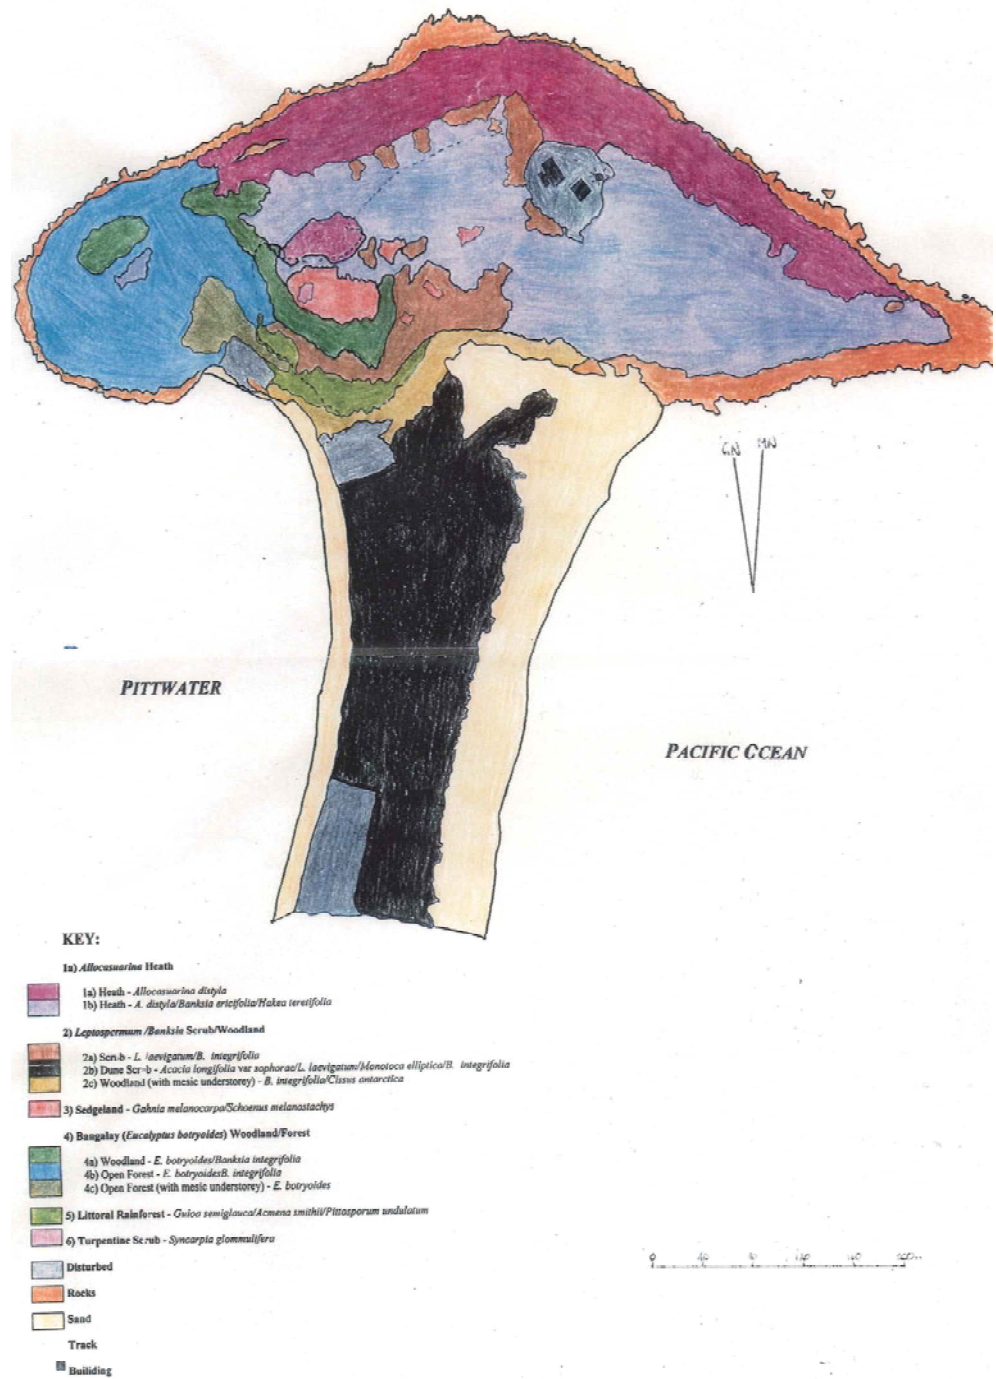
Figure 4.1
Barrenjoey Headland Vegetation
Map (Source: NPWS, OEH).

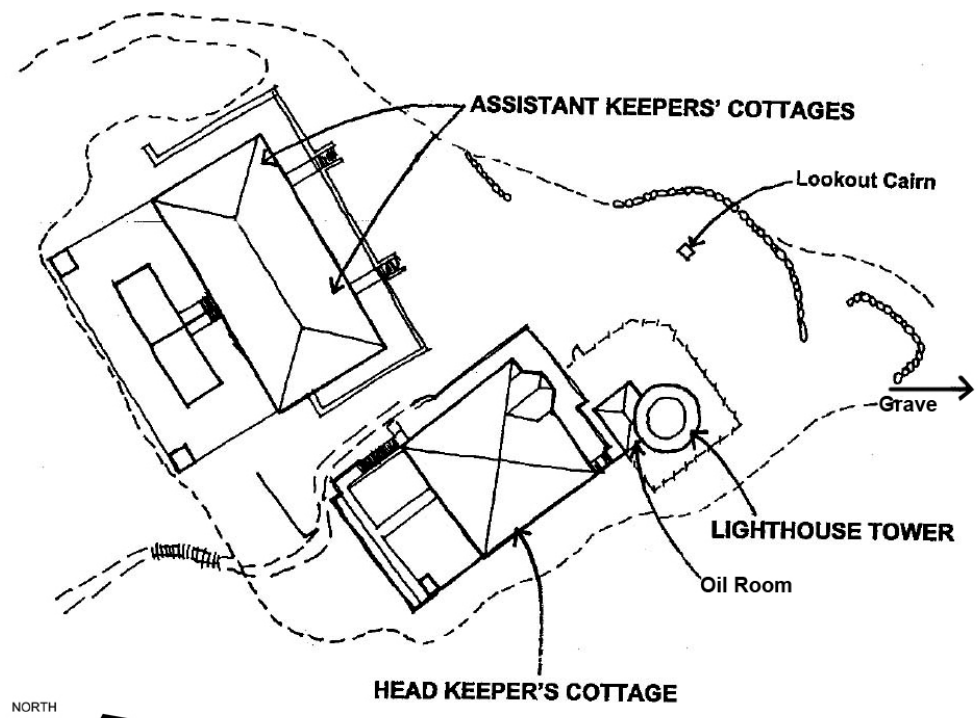
Figure 4.4
Built Elements in Lighthouse
Precinct (Source: Graham Brooks
& Associates Pty Ltd)

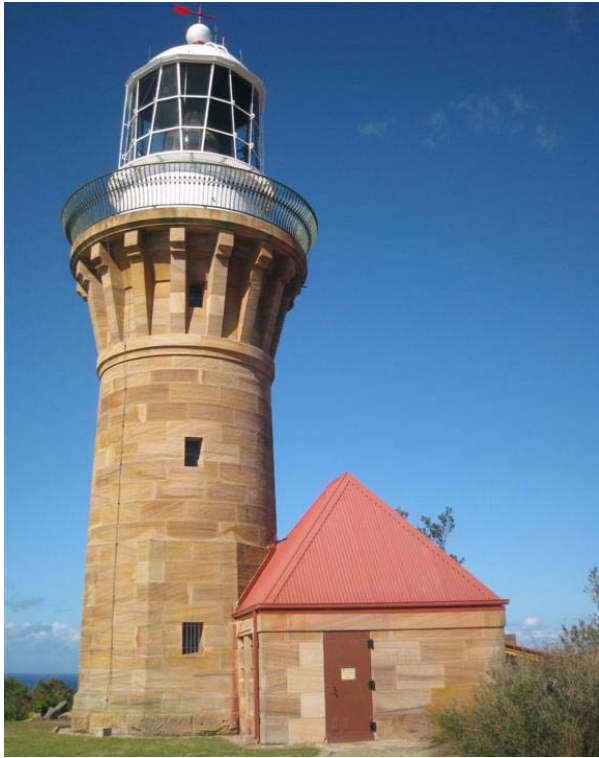
Figure 4.5
Lighthouse and attached oil room (Source: GAO, 2011)

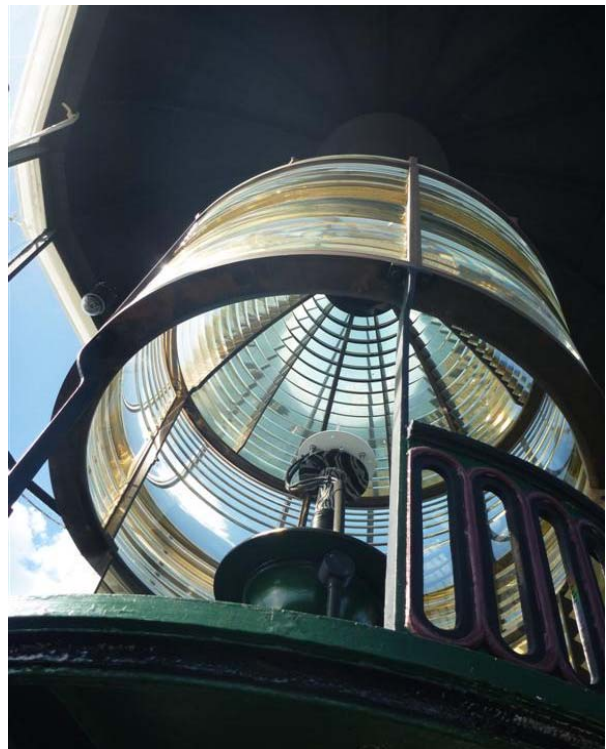
Figure 4.8
Original Chance Bros. Lantern (Source: GAO, 2011)

The lantern level of the tower comprises a lantern control room with painted iron walls and glazing above. The lantern manufactured by Chance Brothers and Co is the original 12ft diameter cast iron and copper lantern with diagonal pattern glazing system, comprising a segmental cast iron murette, cast iron framed copper clad dome, precast internal and external catwalks and copper ball vents.

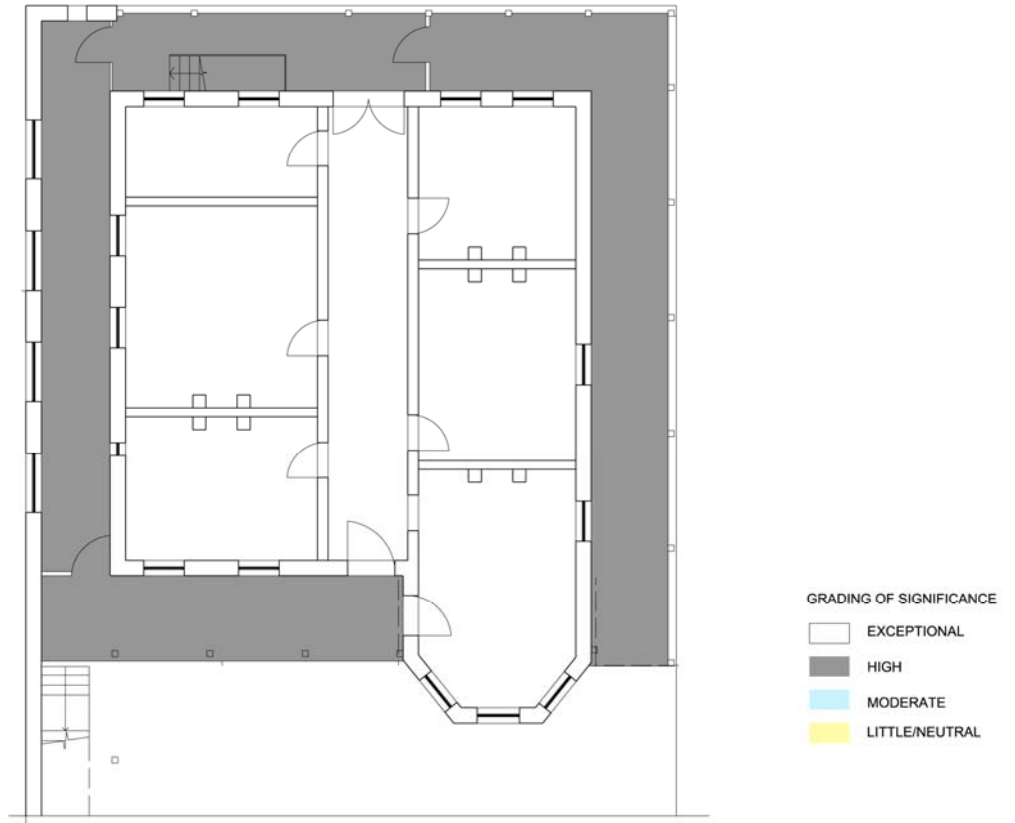
Figure 6.2
Grading of significance of spaces within the Head Lighthouse Keeper's Cottage

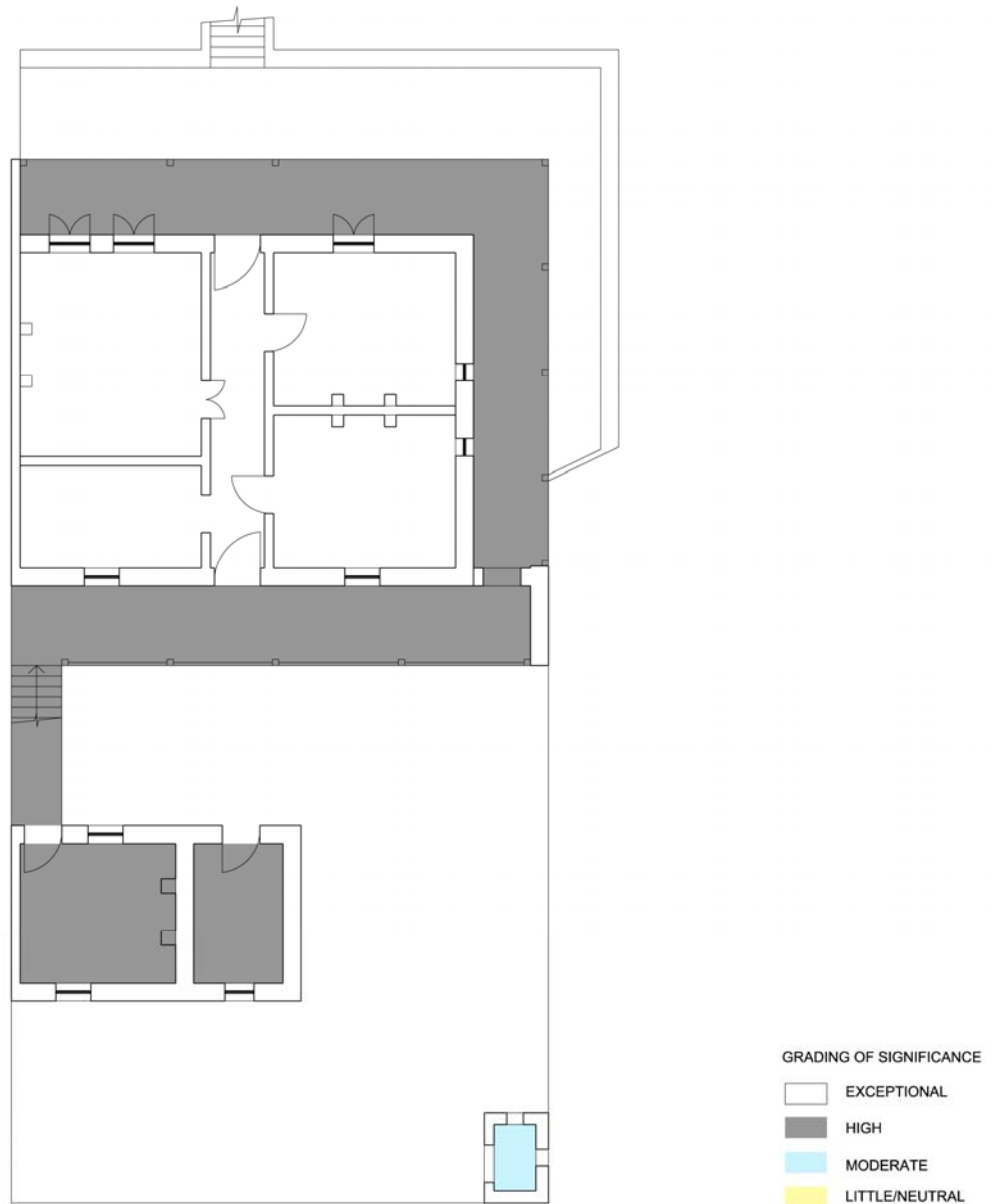
Figure 6.4
Grading of significance of spaces within the Assistant Keepers' Duplex (south)

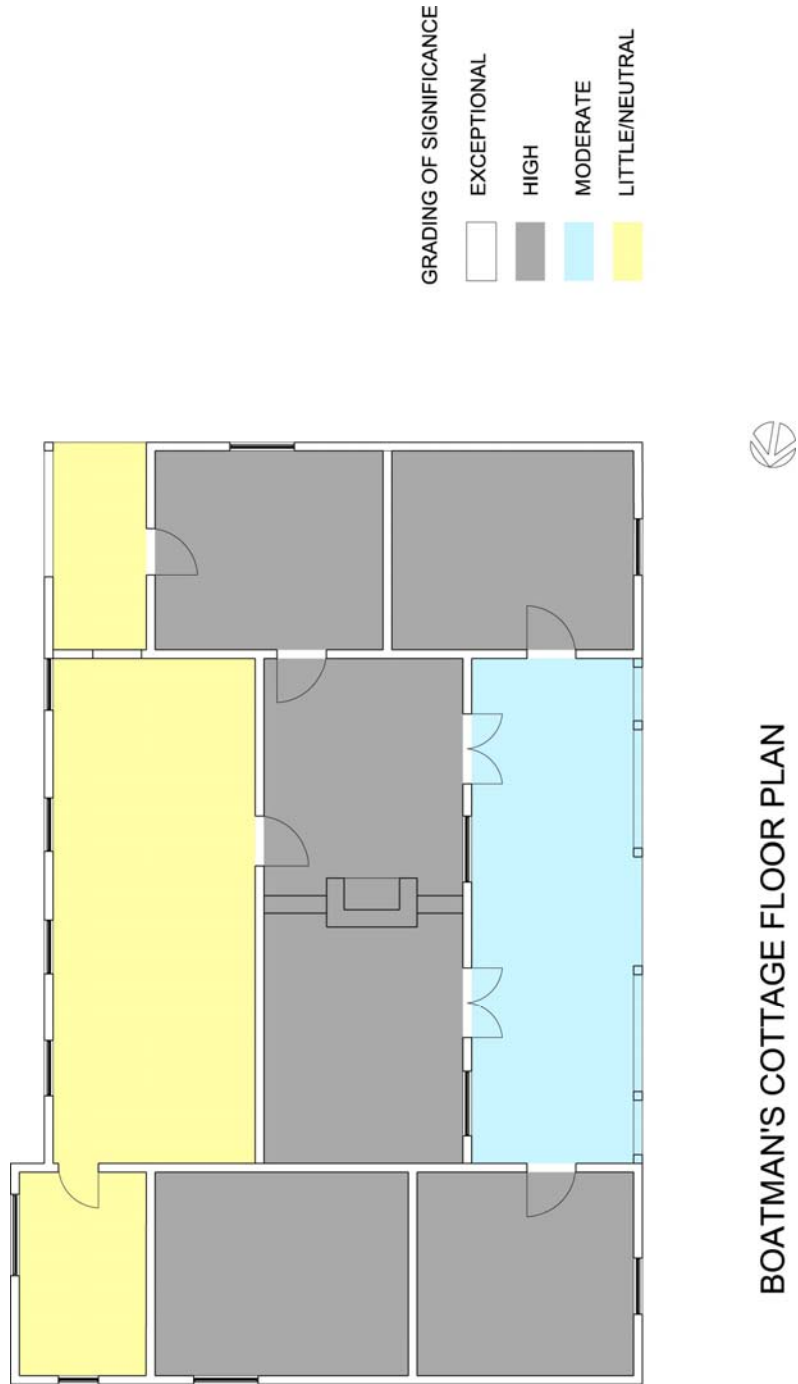
Figure 6.5
Grading of significance of spaces within the Boatman's Cottage
