## **PART 2: CONSERVATION MANAGEMENT PLAN**

## Contents - Part 2: Conservation Management Plan

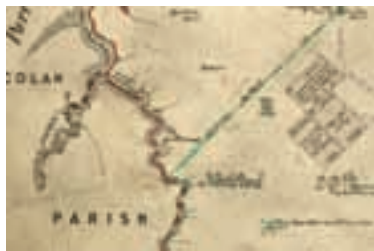
Figure 2.2. Parish of Broken Bay 1895 showing Duffy's land grants and location of Duffy's wharf. Bobbin Head and Cackle (Gibberagong) Creek is shown left of frame (Source: Dept. of Lands/ ID No. 14012501)

Prior to works involving excavation, the CMP should be consulted to determine whether archaeological features are likely to be impacted (see Figures 2.2 to 2.6 and Section 2 Grading of Significant Elements - Bobbin Head, Potential Archaeology). Should there be the possibility of an impact an archaeologist should be employed to monitor and record.

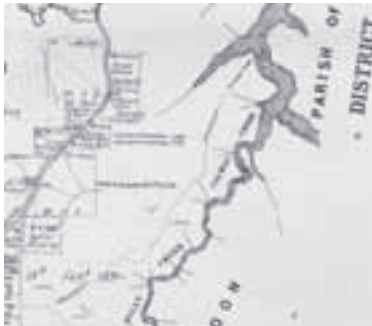
Figure 2.3. Parish of Broken Bay 1891 showing early track leading to Bobbin Head (Source: Mitchell Library/ Z1891)

Initially, access to Bobbin Head was by water or on foot through the bush. By the late 1880s, hand made tracks had been constructed through the area, allowing access from railway stations to the main recreation spots (refer to Figure 2.3). A description of a days travel and recreation at Cowan Creek beginning from Berowra railway station appeared in the newsprint in the late 1800s:

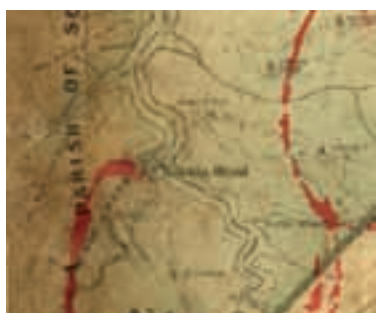
Figure 2.4. Parish of Broken Bay 1927 showing original alignment of access routes to Bobbin Head and causeway over Cockle (Gibberagong) Creek. (Source: Department of Lands/ Map ID. 14012301)

The joining of the two roads allowed for far greater access and services began to be established to accommodate the growing numbers of visitors (refer to Figure 2.4). Services had already begun to be introduced to the area including a horse paddock and stalls to the flats above Bobbin Head and a bicycle shed along Bobbin Head Road in 1900. In 1901 Eccleston Du Faur requested Shaw (on the eastern side) to build stables and ladies toilets to cater for the increasing number of visitors who came by horse and buggy and bicycle.<sup>72</sup> By 1905, Sainty's Boatshed (previously Shaw's) was selling refreshments, fruit and soft drinks, as well as hiring out boats and renting stable space.<sup>73</sup>

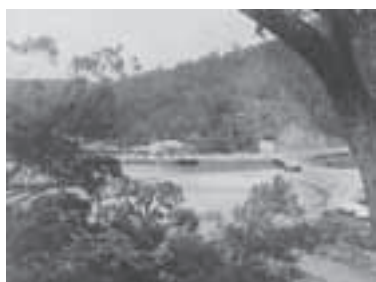
*P10. Cockle Creek showing seawall to north of causeway with Wharf Area and Orchard Park South already reclaimed, while Orchard Park awaits reclamation works (Source: Hornsby Council/ No. 00192)*

Reclamation of Bobbin Head began in 1911 when a recommendation was made that a wall near the boatsheds at Bobbin Head be extended for the purpose of erecting a motor shed (on the current Wharf Area). A rubble wall was also to be constructed from the bridge along the eastern side and the space to be reclaimed was proposed for the building of a large shelter shed.<sup>75</sup> By 1912-4 motor sheds were under construction on the east side with future plans for more garages and shelter sheds to be erected on the west side following the completion of reclamation works.<sup>76</sup> 1917-18 saw the completion of a seawall along the west side of Cockle Creek on either side of the causeway (Orchard Park and Orchard Park South). Some years elapsed before the Trustees were able to secure a dredge to enable completion of the reclamation work (refer to P10).

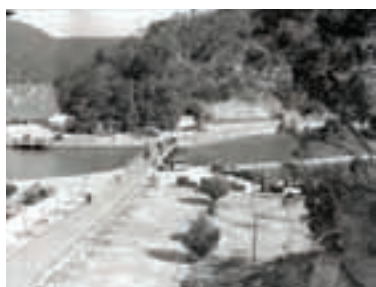
P11. Bobbin Head showing garages, toilet block and boatshed located on the Wharf Area and retaining wall along Orchard Park South (Source: NPWS Archives)

Farrar Avenue and Colah Road. The new stone septic toilet block was completed in 1932 from sandstone cut on site the previous year<sup>91</sup> (see P11). Although less formal than Orchard Park, landscaping works in the Wharf Area was viewed by the Trust at the time as 'greatly enhancing the natural beauty of the landscape...A large quantity of trees, shrubs, flowering plants and creepers as well as palms have been planted... this work has greatly improved the appearance of this natural beauty spot'.<sup>92</sup>

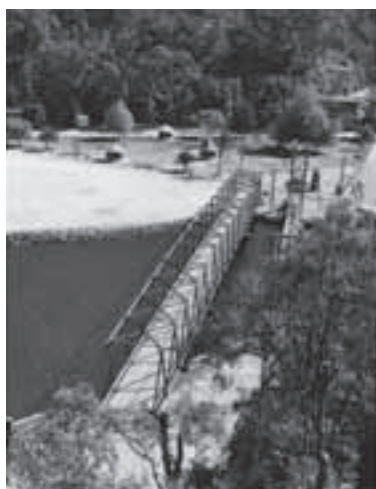
P16. The one lane Bailey bridge and adjacent footbridge across Cockle Creek. (Source: NPWS Archives)

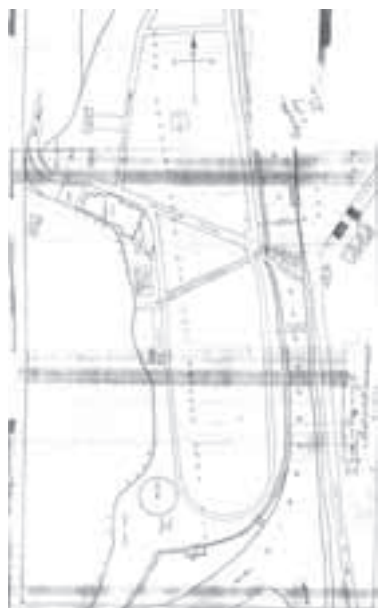
Figure 2.5. Plan of Bobbin Head in 1953. Plan prepared in conjunction with lease of Bobbin Inn (Source: NPWS Archives)

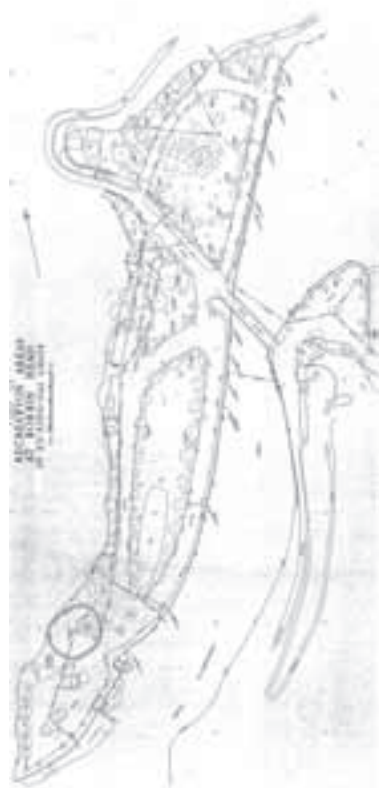
Figure 2.6. Plan of the Recreation Areas at Bobbin Head in Ku-ring-gai Chase 1967 (Source: NPWS Archives)

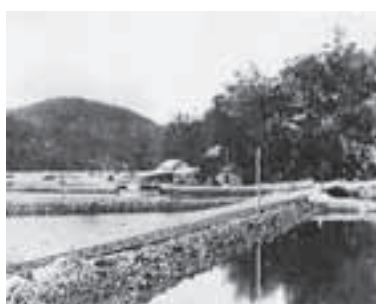
P20. Revetment walls constructed either side of Causeway on western side of Cockle Creek (source: NPWS Archives)

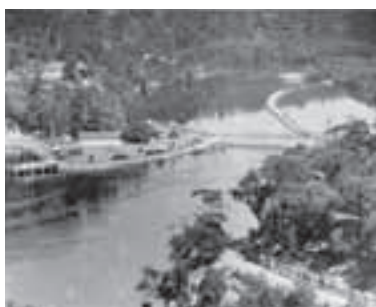
P24. Revetment wall to Gibberagong Park complete (source: NPWS Archives)

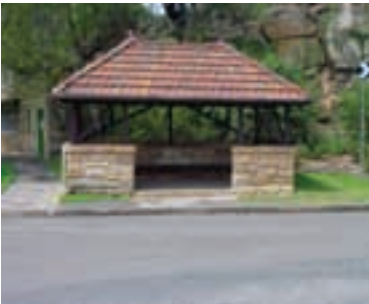
P45. Bus Waiting Shed, 2006  
(source: CM\*)

**Condition:** good

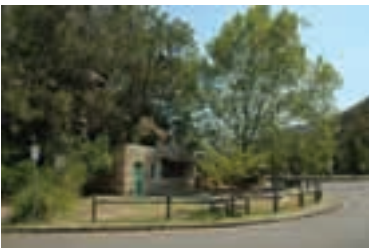
P46. Stone Kiosk, 2006 (Source: CM\*)

***Condition:*** fair

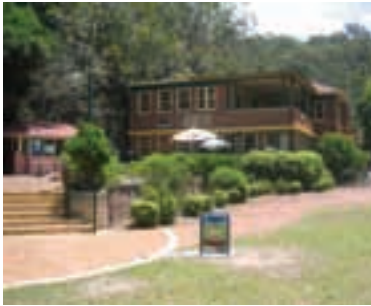
P47. Bobbin Inn, East Elevation, 2006  
(source: CM\*)

Equal access issues to upper levels including toilet. Cracks are not considered structurally significant (Refer to Volume 3, Appendix 1.7 Marine and Structural Engineering Report).

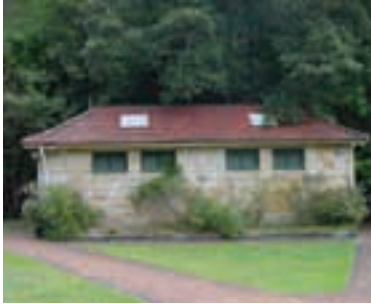
P48. Toilet Block, East Elevation, 2006 (source: CM\*)

- Cracking up to 10mm in width at southeast and southwest corner and finer crack at northeast corner.
- Cracking appears to be associated with differential foundation settlement.
- Cracking not considered to be structurally significant, but should be regularly monitored.
- Concrete mortar used in pointing of sandstone has resulted in deterioration of sandstone. Eaves, in close proximity to structural cracking, are bowing. Toilet seat missing.
- Amenities Buildings are not Disability Discrimination Act compliant.

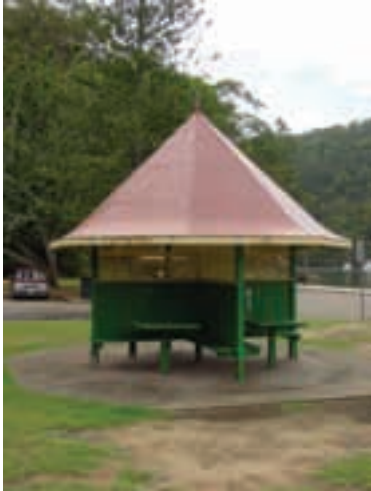
P51. Picnic shelter, Orchard Park, 2006 (source CM\*)

One low-roofed shelter has panelling repaired with smaller sized planks.

**Condition:** Evidence of rotting at the base of some timbers posts where they contact with the ground.

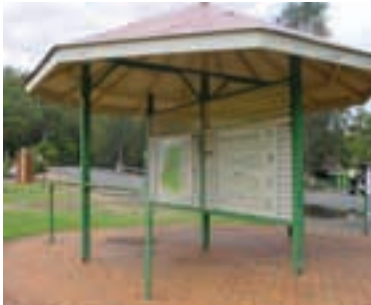
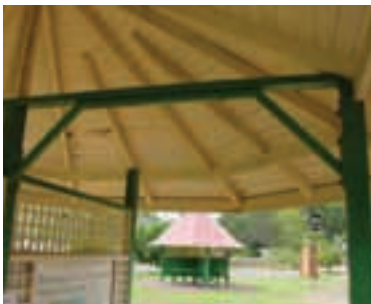
P53. Information Structure, 2006 (source: CM\*)

Octagonal shaped timber structure mounted on an octagonal brick paved area. Steel bracing supports timber roof beams. Timber panel and lattice treatment of central partition imitates the picnic shelter construction. Interpretation panels located on both sides of the partition wall within the structure. P53 and P54.

**Condition:** Good condition.

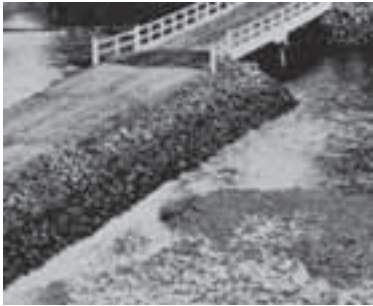
P55. Causeway and Bridge 1910s  
(source: NPW Archives)

The principal crossing to Cockle Creek. Historic photograph shows the causeway and early timber bridge. Several bridges were destroyed with flooding.

A two-lane pre-stressed road bridge with metal railings of DMR construction supporting roadway between east and west sides of Cockle Creek. Plaque marked: 'DMR 1956'.

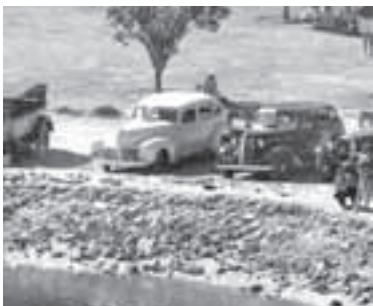
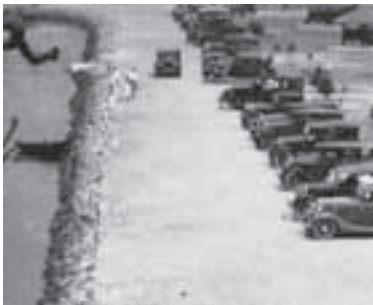
P56. Orchard Park Stone Revetment, 1930s (source: NPW Archives)

Construction of the stone revetment seawall commenced in 1911 as part of the first reclamation phase. The sandstone seawall near the Bobbin Head Bridge shows evidence of the earlier seawall construction. Photographic documentation indicates there are several layers of seawall construction. The seawalls were repeatedly repaired due to flood damage. The seawalls were initially revetment construction. The seawalls were increased in height in the 1930s as part of the unemployment relief works. It appears no foundations were constructed, rather the seawalls were built upon the reverents. In the early 1950s a new wall was added on the seaward side in front of the existing wall. The construction technique for this wall was a vertical mass wall constructed in solid blocks. It appears likely the earlier walls remain behind the existing wall.

In recent years further problems have been experienced with the seawalls. Sections of walls are in poor state of repair, due to excessive movement from settlement, slumping, rotation and collapse. Repairs have been undertaken in recent years, however, problems continue. Stormwater outlets are evident in the seawall construction.

The seawalls were initially constructed utilising locally quarried sandstone (former quarry site is in approximately to the Bobbin Inn area). Later repairs required sourcing sandstone from other quarries.

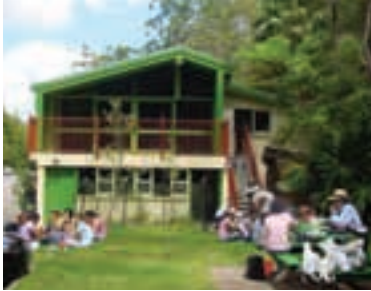
P60. Gibberagong Environmental Education Centre, North Elevation, 2006 (source: CM\*)

**Description:** Constructed in 1961 of besser blocks and pebble-crete panels (based on a design by RC Smith and Associates). Two-storey building has ten (10) garages and laboratory located at ground level. Residential accommodation and staff rooms are located on the first floor, together with kitchen, dining and living rooms. Additions were undertaken to the northern section in 2003. External steel stair connects to first floor at northern end and timber stair located at southern end.

**Condition:** Good condition

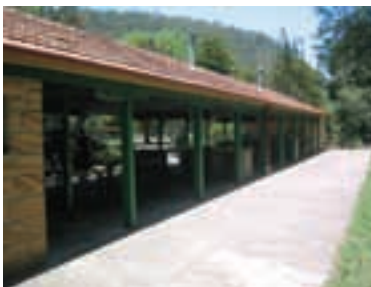
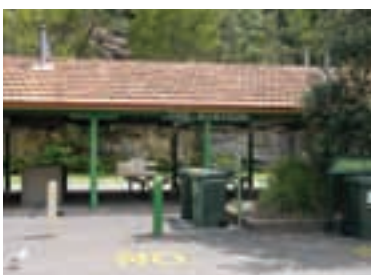
P63. The Station Picnic Area, 2006 (source: CM\*)

Three timber frame windows are located on the East Elevation. Glazing has been removed and replaced with perforated steel grille. Skylights are installed in the terracotta-hipped roof over the toilet area. Two vents are located over each of the two barbeque areas.

Two stations of double gas barbeques are located within the picnic area. Disabled amenities to be checked for Disability Discrimination Act and BCA compliance

**Condition:** Good

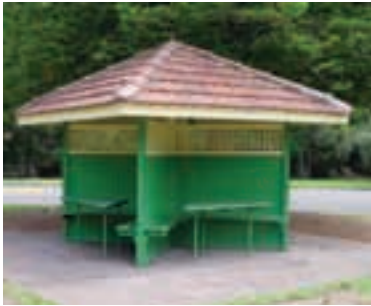
P65. 1950s Picnic Shelters, 2006  
(source: CM\*)

Former octagonal shaped concrete base is evident and has been extended to square shape design.

**Condition:** fair

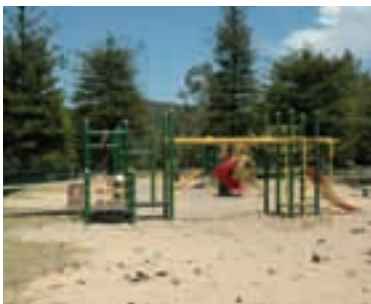
P68. Sandpit and Playground, 2006  
(source: CM\*)

Proprietary children's play equipment constructed from steel frame and PVC was installed in the 1990s.

**Condition:** Sections of the crazy paving have deteriorated in small sections. Playground equipment is in fair condition.

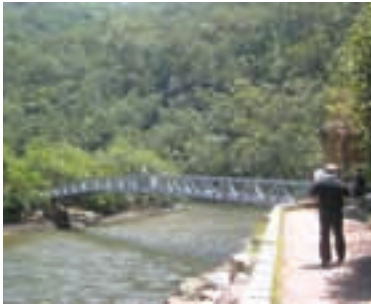
P69. Footbridge, 2006 (source: CM\*)

Built in galvanised mild steel and timber. The bridge is constructed as steel trusses with asymmetrical cable stays and is tied to concrete and sandstone foundations with steel fixings. Timber decking is bolt-fixed to the steel framing.

**Condition:** good

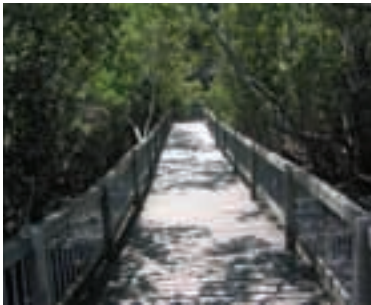
P70. Board Walk, 2006 (source CM\*)

**Condition:** prone to tidal inundation, subsidence.

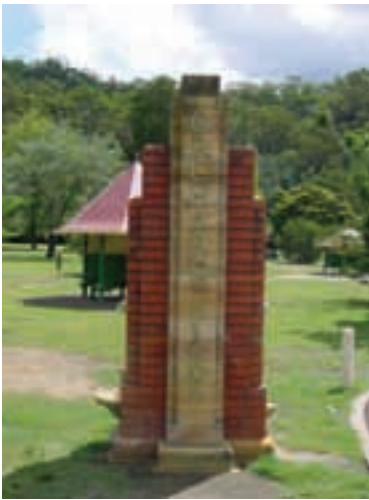
P71. Bobbin Head Marker, Orchard Park, 2006 (source: CM\*)

**Condition:** Taps are non-operational, basins broken on southern and northern markers; evidence of eroding sandstone at base of monument possibly due to saline condition of the soils. The word 'PARK' is missing from the Monument on the south side of the bridge.

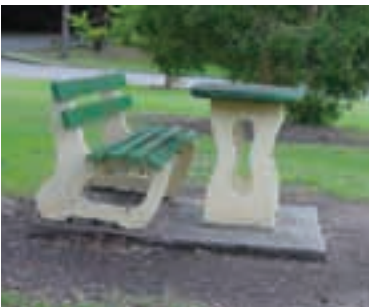
P72. Bench and Picnic Table, 2006 (source: CM\*)

**Description:** Possibly dating to 1960s. Designed as single bench facing water with table. Frame of bench designed in formed concrete with timber slats (four on seat and two on back). Table has concrete base and tabletop. All bench and picnic table sets are mounted on a concrete base in alignment with the grassed area. Painted green and cream.

**Condition:** Poor condition.

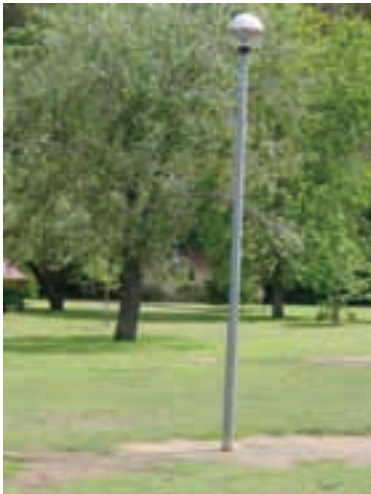
P75. Lamp Post, 2006 (source: CM\*)

**Condition:** Fair

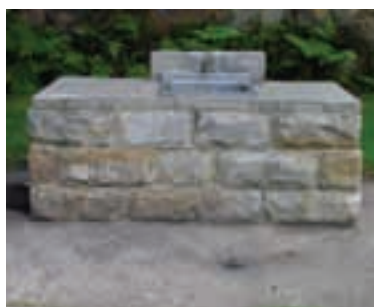
P77. Washing Facility, 2006  
(source: CM\*)

The sink is constructed as a rectangular sandstone plinth with a stainless steel sink installed. Ceramic tiles are fixed to the top surface.

**Condition:** Fair

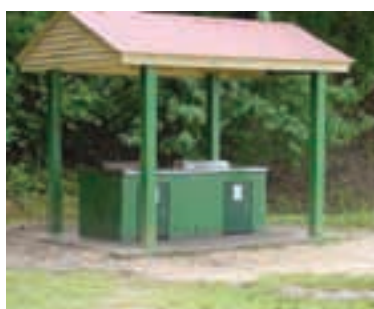
P78. Barbeque Shelter, 2006  
(source: CM\*)

**Condition:** Maintenance issues reported

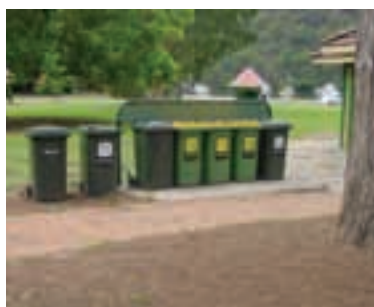
P79. Garbage Bin Station, 2006  
(source: CM\*)

**Condition:** good

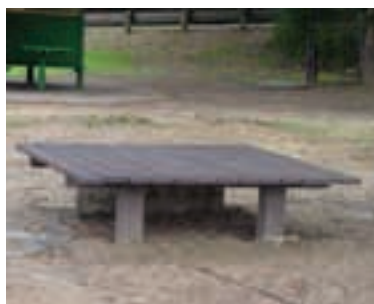
P80. Picnic Platforms, 2006  
(source CM\*)

**Condition:** good, maintenance and cleaning issues reported.

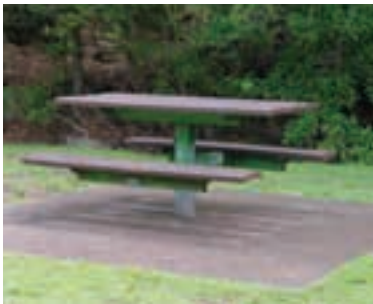
P82. Picnic Table and Seat, 2006  
(source: CM\*)

**Condition:** poor, maintenance issues reported.

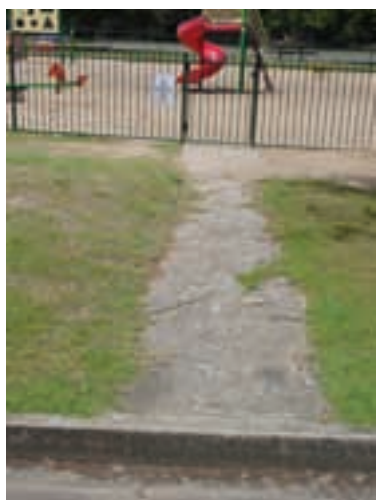
P84. Crazy-paving Stone, 2006  
(source: CM\*)

Built 1950s the sand pit in Gibberagong Park is formed with sandstone crazy paving edging. Two paths lead from the sandpit edge to the roadway. The edging to the sandpit is damaged in small sections.

**Condition:** Fair to Poor (1950s) Good (1950s)
