PART 3: LANDSCAPE MANAGEMENT PLAN

This Landscape Management Plan provides a comprehensive assessment of the existing park conditions, identifies key opportunities and outlines principles and actions directing the future development and management of the landscape. The Conservation Management Plan and the Landscape Management Plan together inform the Masterplan for Bobbin Head.

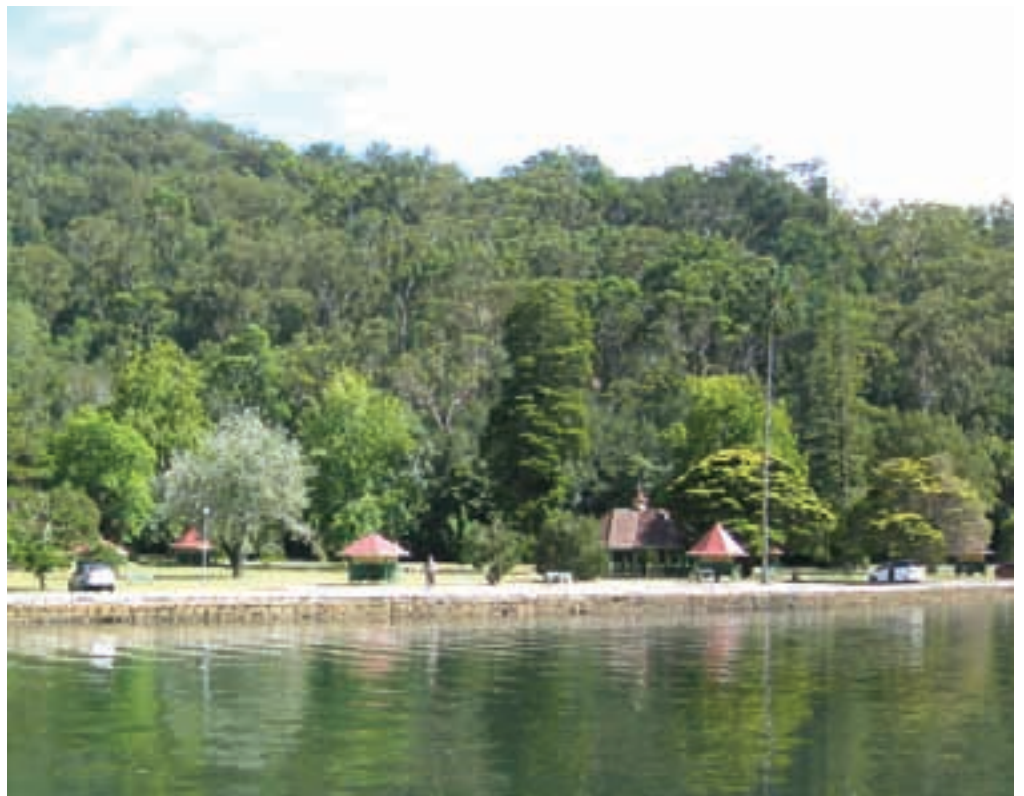
P9. View of Orchard Park from The Wharf Area (source: CMt)

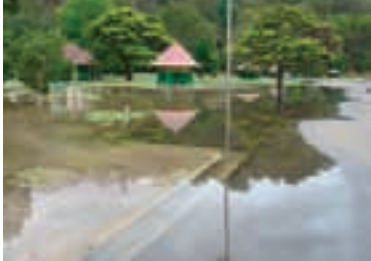
P10. Orchard Park with King-tide inundation (January 2006). (source: CM*)

Subsoil hydrology is likely to consist of ground water flowing from the base of the sandstone hills through the sandy subsurface layers and at some point within 10 to 15m of the seawall, meeting the saline tidal water. Due to the compacted, impermeable surface layers of soil in the park, the surface water and subsoil water systems are likely to be essentially separate. As a result surface soils are likely to alternate between dry, saline and waterlogged, creating hostile conditions for tree roots.

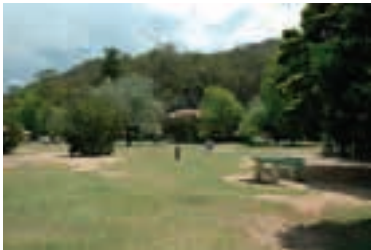
P11. Saline effects on soil conditions (January 2006). (source: CM*)

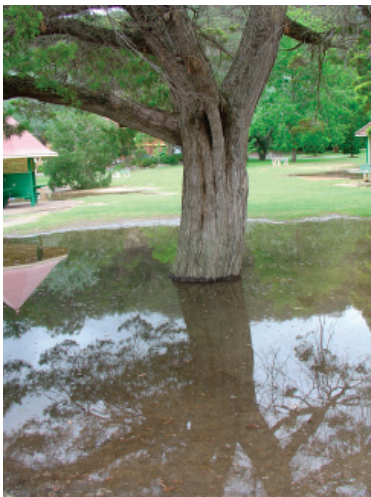
P12. Sea water around trees (June 2006). (source: CM*)

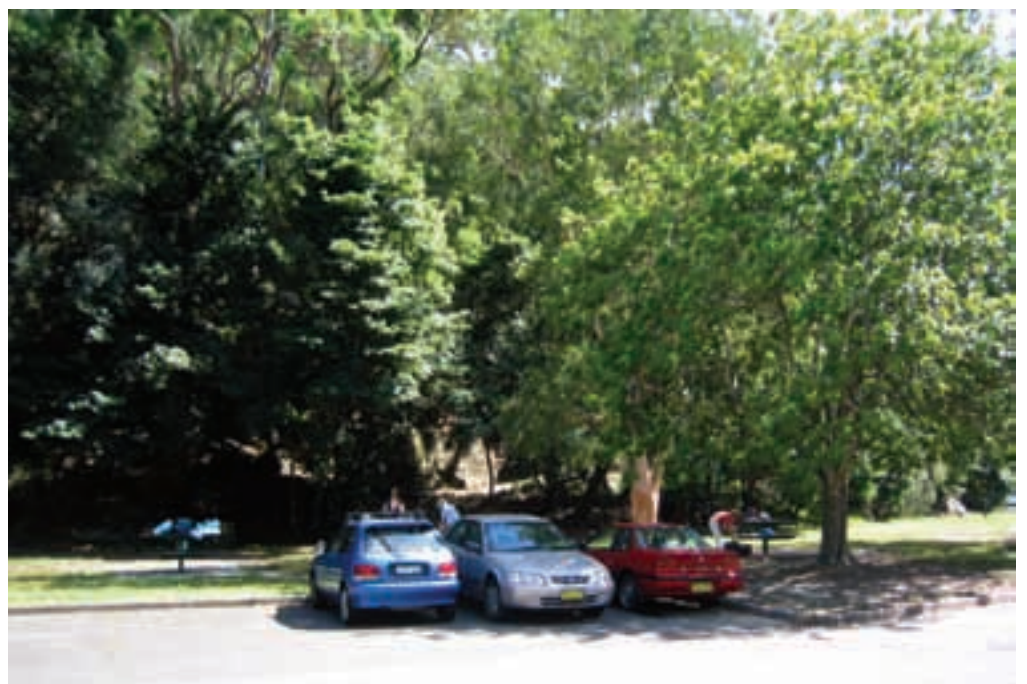
P13. On warmer days the favourable microclimate at the rear of the site encourages the use of this area in preference to foreshore areas. Gibberagong Park, (source: CM^t)

The middle of park, behind the water's edge, has a greater degree of protection and shade with less hard surfacing. At the rear of the park the adjacent steep slopes and vegetation provide a relatively protected environment with dense shade. On warmer days, this area is the preferred location for picnicking and most other recreational activities.

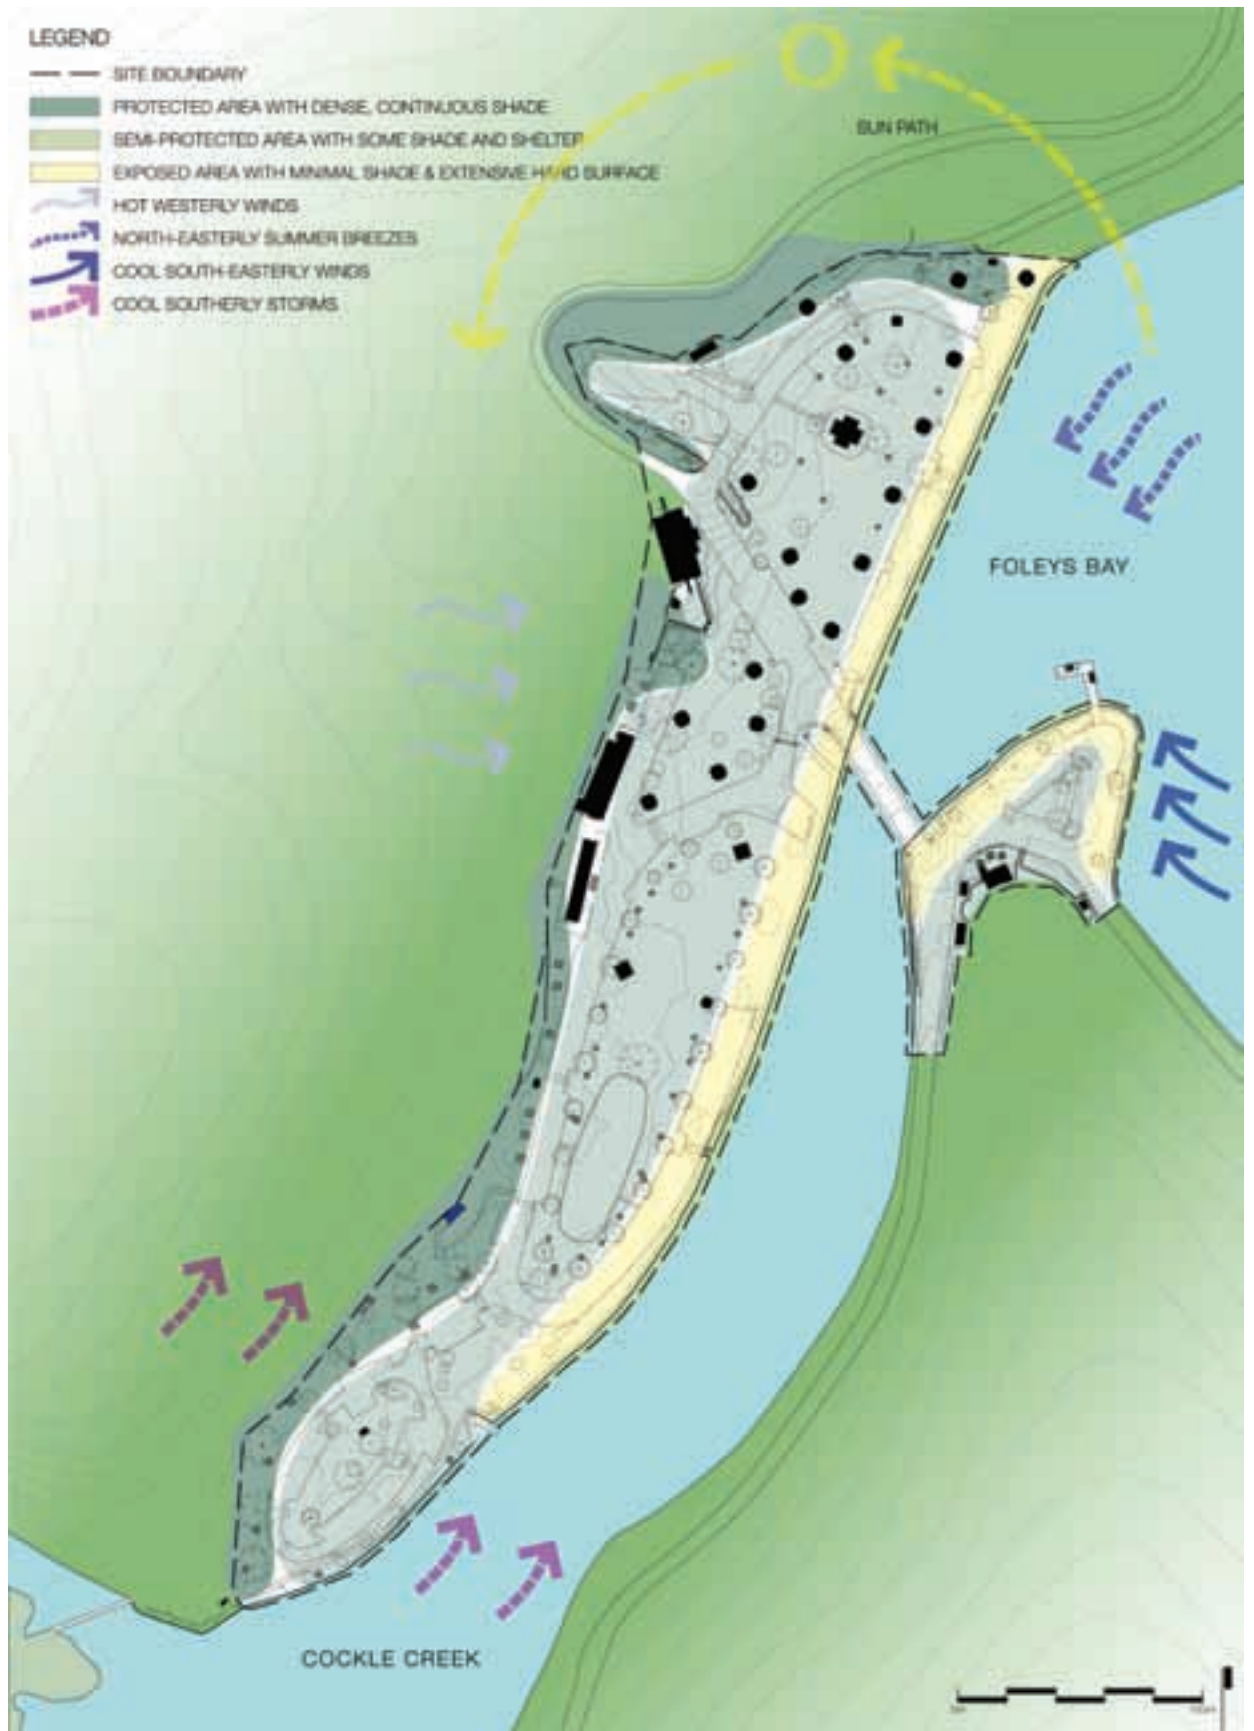
Figure 4.2. Existing Microclimate

The location of the parklands, within the valley, causes them to be relatively protected from strong winds.

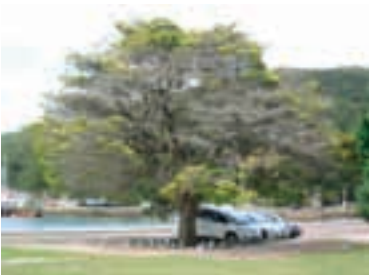
P14. Orchard Park. Soil compaction, nutrient deficiencies and saline soils are affecting the condition and vigour of site vegetation. (source: CM*)

Soil compaction, nutrient deficiencies and soil salinity are affecting the condition and vigour of trees and turf (Refer to Appendix 1.5: Improving Soil Conditions for Trees and Turf. A lack of attention to trees in their early stages of establishment is also evident. This has resulted in a backlog of pruning tasks such as weak branching, multiple leaders, overly dense canopies and trunk and branch fungal decay. In terms of tree hazards, the bushland trees at the periphery of the parklands adjacent to the picnic areas contain most of the trees of concern.

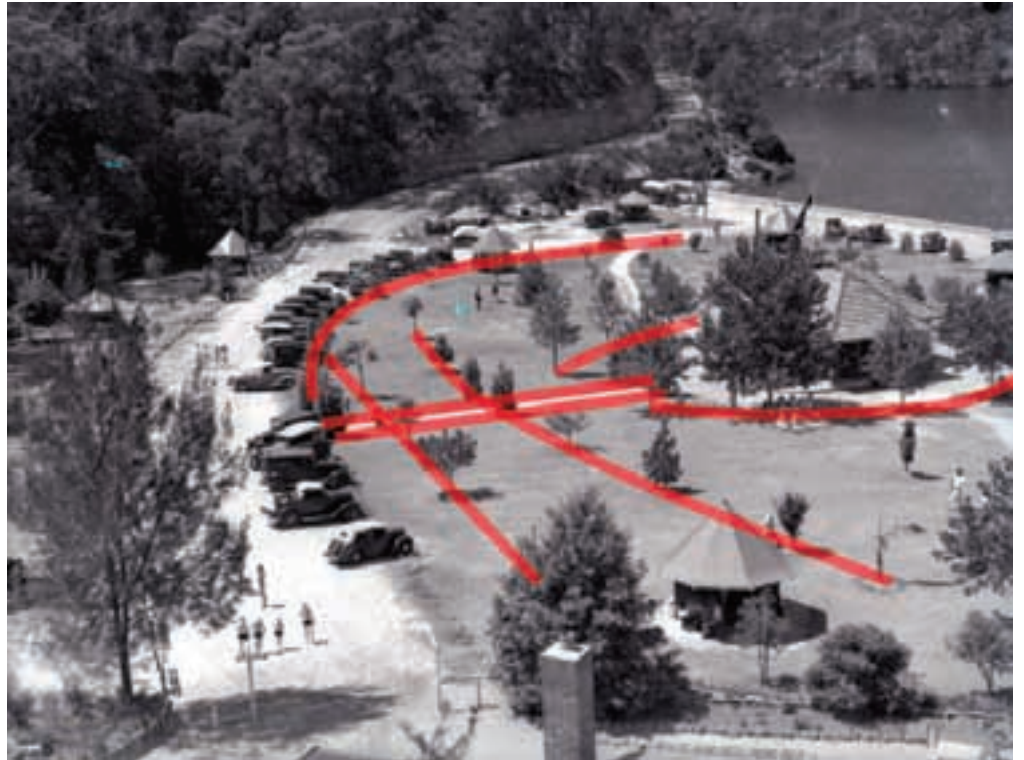
P15. View 1: looking Northeast toward Orchard Park North from above Bobbin Inn, undated - c.1930s (NPWS Archives)

Orchard Park was initially developed in the 1930s following reclamation. The character of the 1930s design could be described as semi-formal, with diverse plantings and a range of structures set out in an ordered arrangement. Early photographs show a range of tree and shrub species planted into rows and along axes, reflecting the layout of pathways, roads and structures in the park and around its periphery (Refer to Figure 4.4 and corresponding plates P.15, P.16 and P.17). The layout was semi-formal, however the structure and symmetry of the design was weakened by the mixed arrangement of exotic tree species along many of the rows.

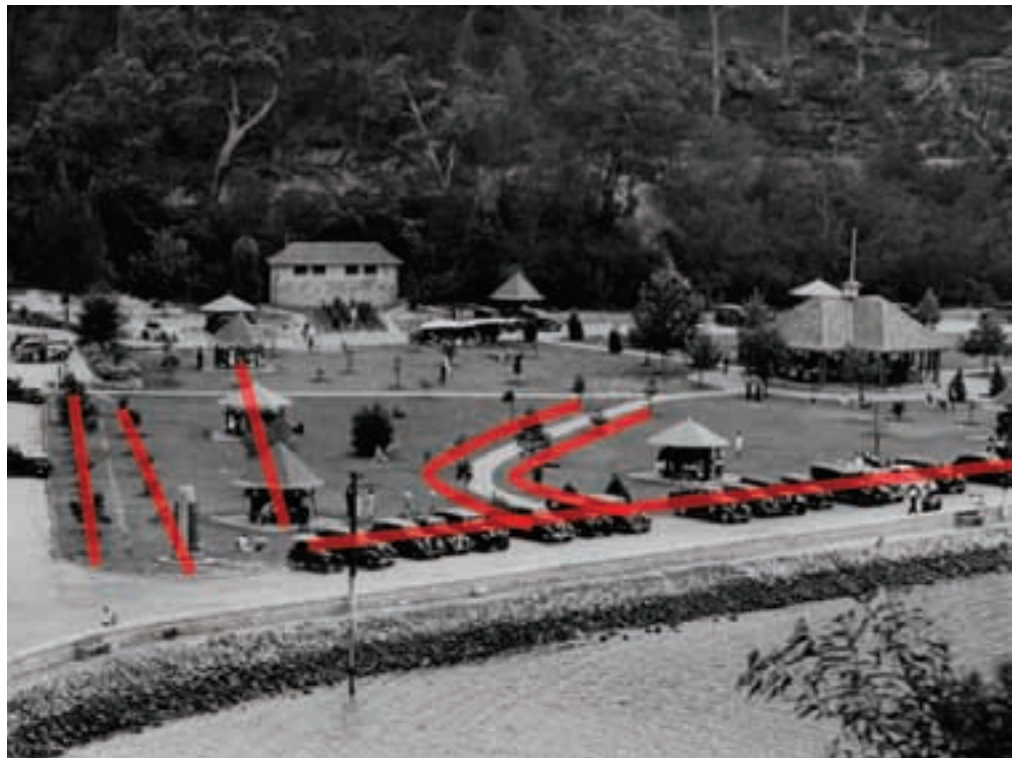
P16. View 2: looking Northwest toward Orchard Park North, undated - c1930s (NPWS Archives)

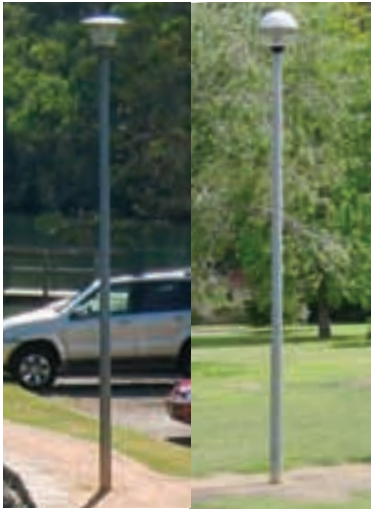
P34. Lamp post types. (source: CM⁺)

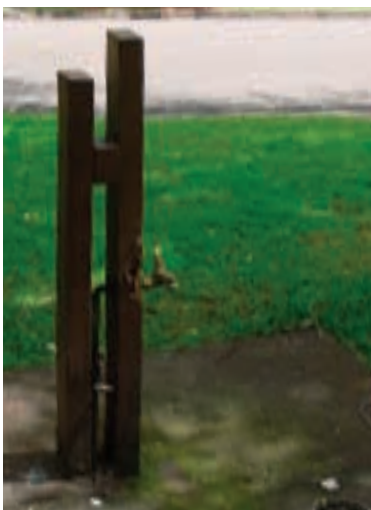
P37 Underground water services. (source: CM⁺)

All services at Bobbin Head are located underground and include electricity, gas, sewage, stormwater drainage, tele-communications and water.

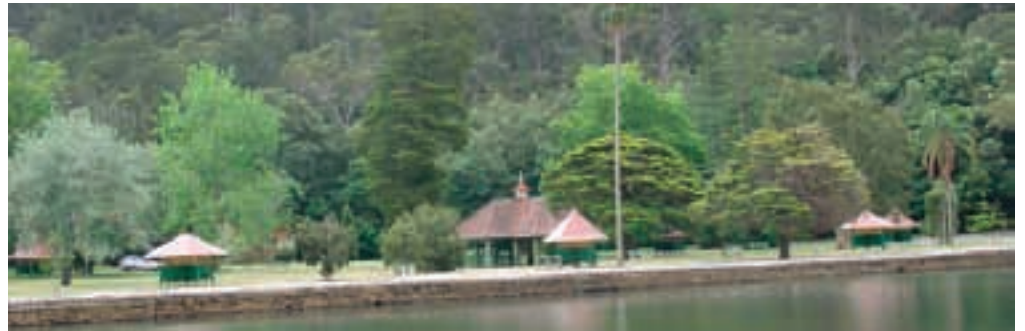
P38. Orchard Park retains qualities of its 1930s design (source: CM*)

Character zones within Bobbin Head are illustrated in Figure 4.11. There is a transition from semi-formal parkland character in Orchard Park to the informal parkland character dominated by native trees in the southernmost part of the park. The majority of the water's edge in Bobbin Head is dominated by car parking and suffers from a lack of shade. The 1930s character in Orchard Park is compromised by more recent native plantings and layouts which do not reflect the 1930s design intention. Gibberagong Park suffers from a lack of spatial definition due to the road and landscape layout.

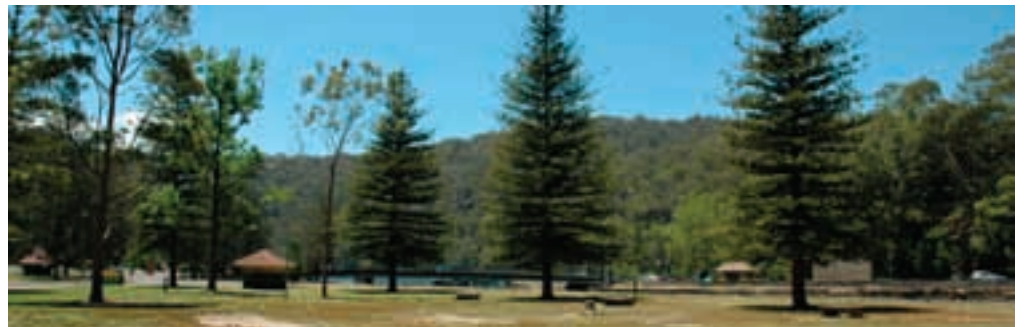
P39. The Araucarias in Gibberagong Park are strong character elements (source: CM*)

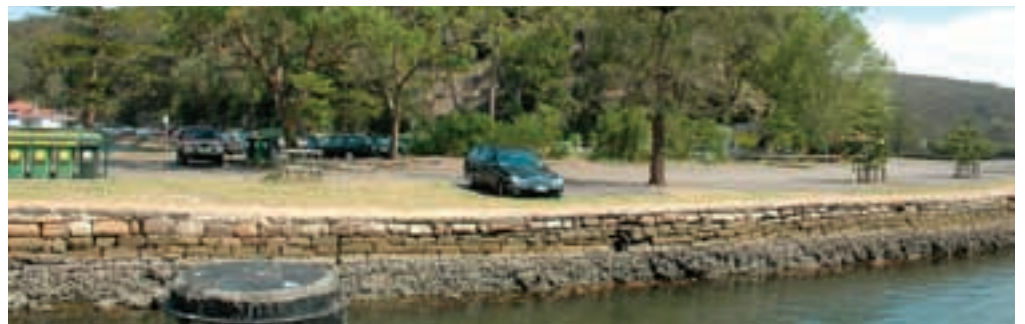
P40. The Wharf Area is currently dominated by expanses of bitumen (source: CM*)

- Waterfront areas are dominated by expanses of car parking.
- Grass wear occurs through much of the parklands giving it an unkempt appearance.
- The existing children's playground is visually incongruent within the tranquil and elegant nature of the parklands
- The setting of Bobbin Inn is compromised by the clutter of infrastructure and traffic control devices and narrow entry area in front of it.

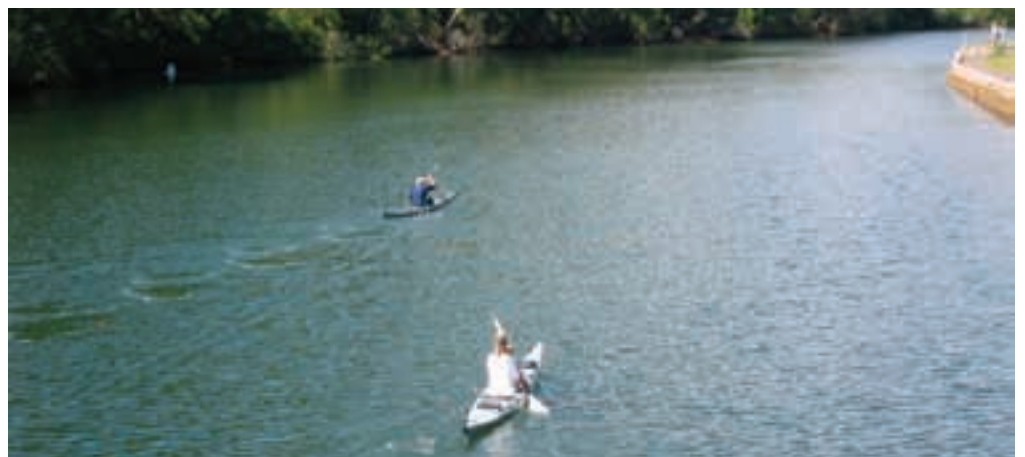
P41. Canoeing is a popular activity at Bobbin Head, although launching facilities are in need of upgrading (source: CM)*

- Amenities buildings are not Disability Discrimination Act compliant and, while well maintained, are insufficient and require upgrading.
- There are no wash down facilities, information signage or short-stay loading zone adjacent to the Bobbin Head canoe ramp and the ramp is a hazard to users.

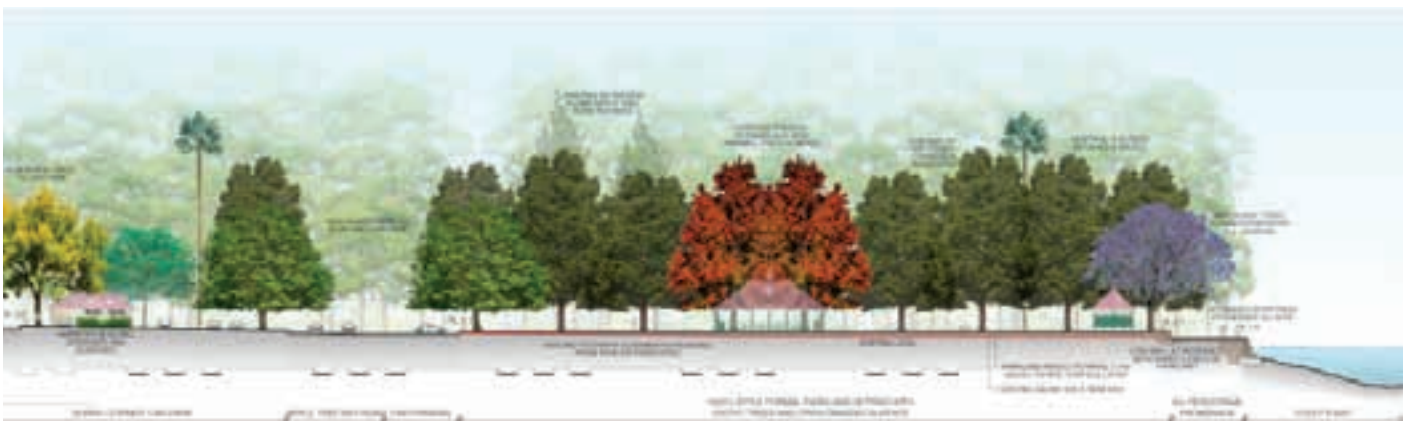
It is proposed that Orchard Park and Orchard Park South be raised above King Tide levels, involving reconstruction of the seawall, raising Ku-ring-gai Chase Road, the removal of saline soils, installation of drainage and infilling with suitable fill including a layer of topsoil and installation of an irrigation and drainage system. Failure to raise the park levels would result in a continued decline in site vegetation and grass, further reducing the amenity of the park in spite of improvements to facilities. Successful implementation of the design requires inundation resolution, which is causing an ongoing decline in the aesthetic and environmental characteristics of the park. Further information on the condition of Orchard Park, seawall re-construction and the reason for the raising of the park is contained in Volume 3, Appendix 2 Bobbin Head Seawall Advice Report and soils reconstruction is provided in Volume 3, Appendix 1.6 Improving Soils Conditions for Trees and Turf Report.

Figure 7.2. Orchard Park Section (not to scale)

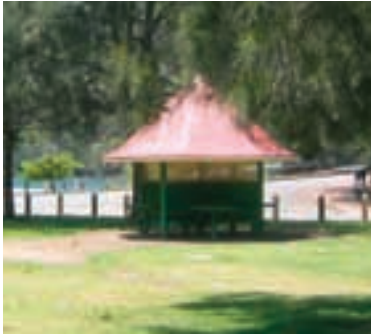
P43. Heritage Shelters (source: CM*)

Currently there are a variety of picnic shelters and barbeque shelters. So as to reduce the visual confusion it is proposed that during the upgrade to Bobbin Head two families or types of shelters will eventuate in Bobbin Head. The original 1930s conical roof shelters will be seen in Orchard Park, Orchard Park and the Wharf Area. A new shelter and barbeque shelter type will be seen in Gibberagong Park and Gibberagong South.

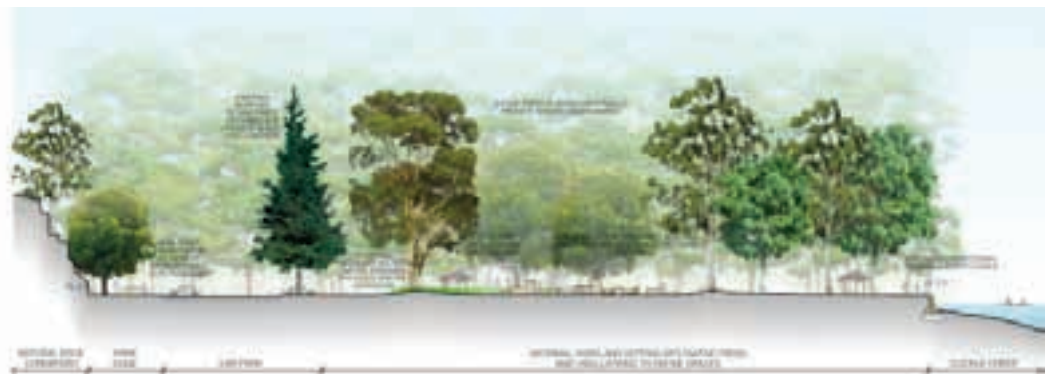
Figure 7.3. Gibberagong Park Section (not to scale)
