**Gap Bluff Centre, South Head  
Sydney Harbour National Park**

**Heritage Impact Statement**

**EXHIBITION DRAFT**

**June 2015**

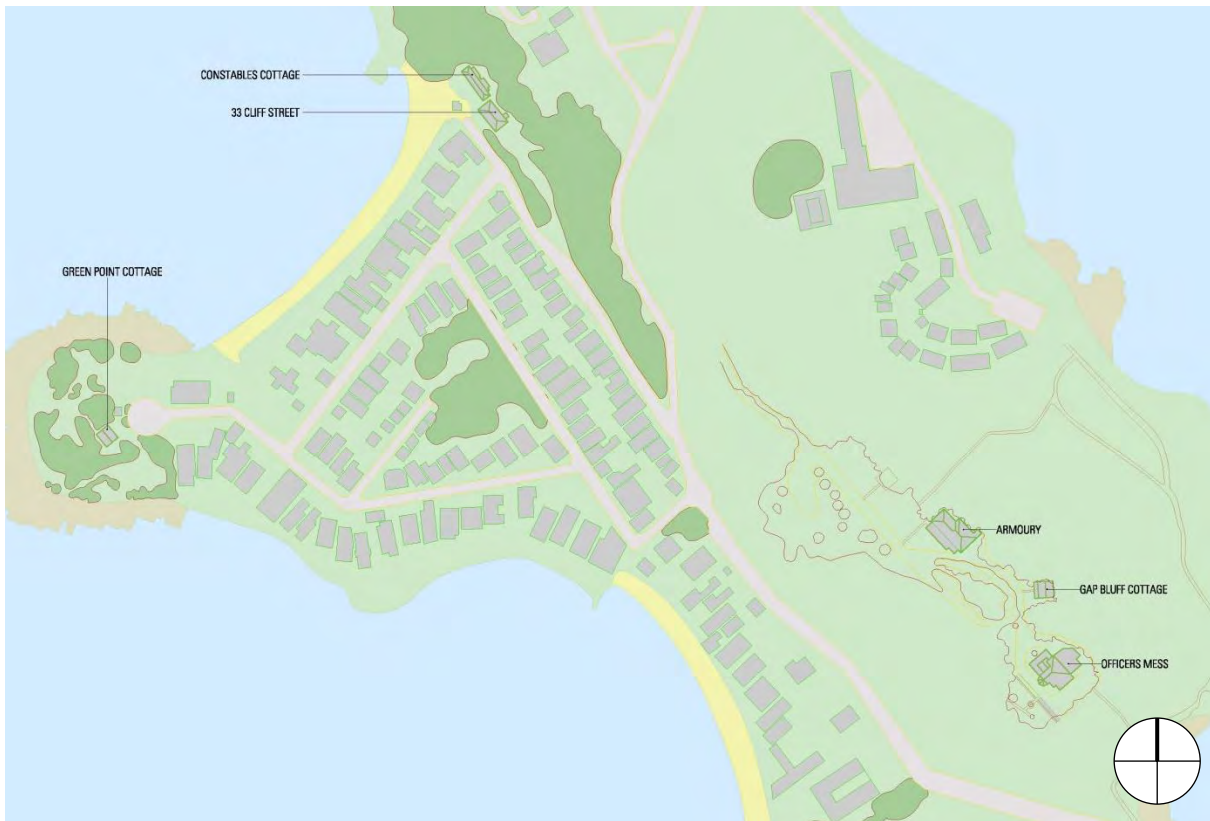
Figure 1.2 Site plan. (Source: JPW 2015)

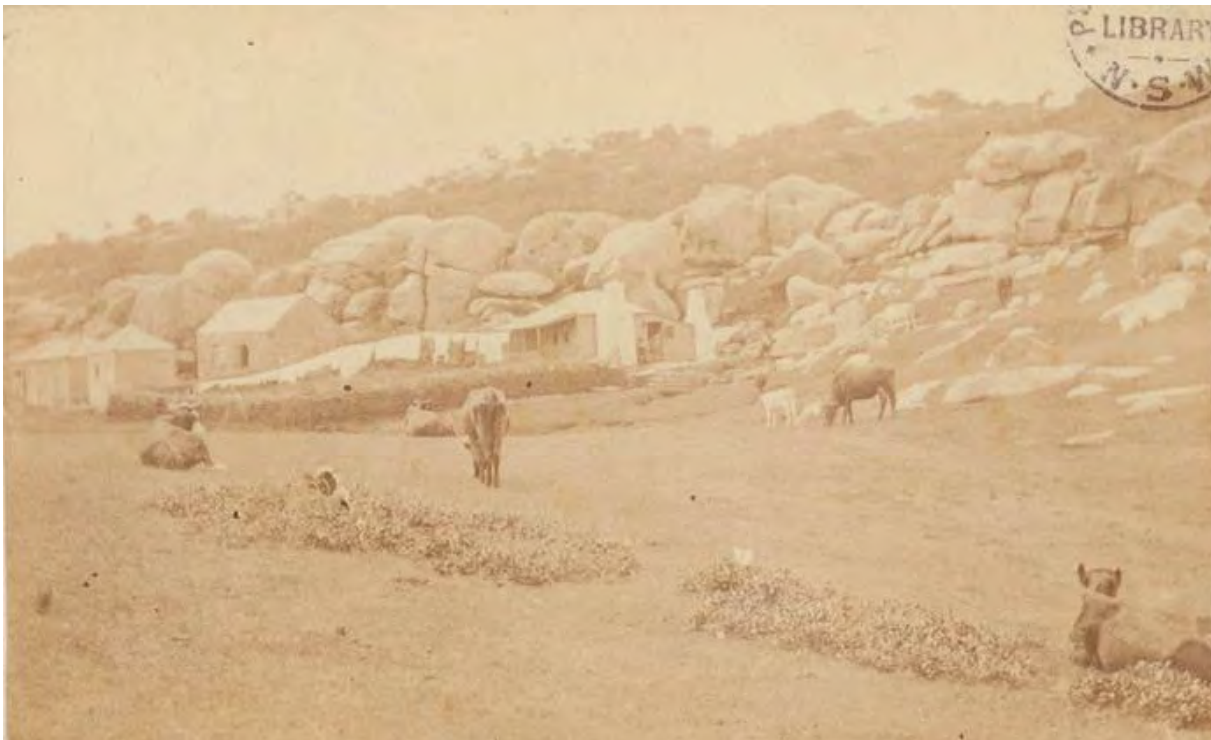
**Figure 2.4** 1869–1874 photograph of the Water Police Station and the associated timber accommodation buildings at Camp Cove. (Source: SLNSW SPF 808 a089808r)

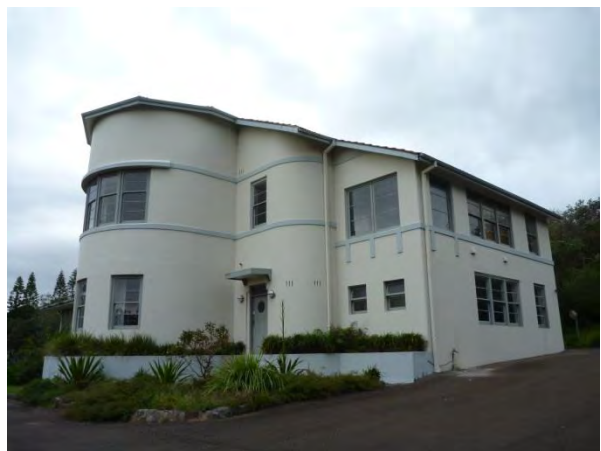
**Figure 3.9** The primary (southern) elevation and eastern elevation of the Officers' Mess. The 1950s hipped roof has compromised its aesthetic significance. (Source: GML 2015)

The current roof to the original building is hipped, with narrow eaves, and is laid with Marseilles tiles (Figures 3.6, 3.8 and 3.9). It was a 1950s replacement of the original flat roof and is unsuited to the

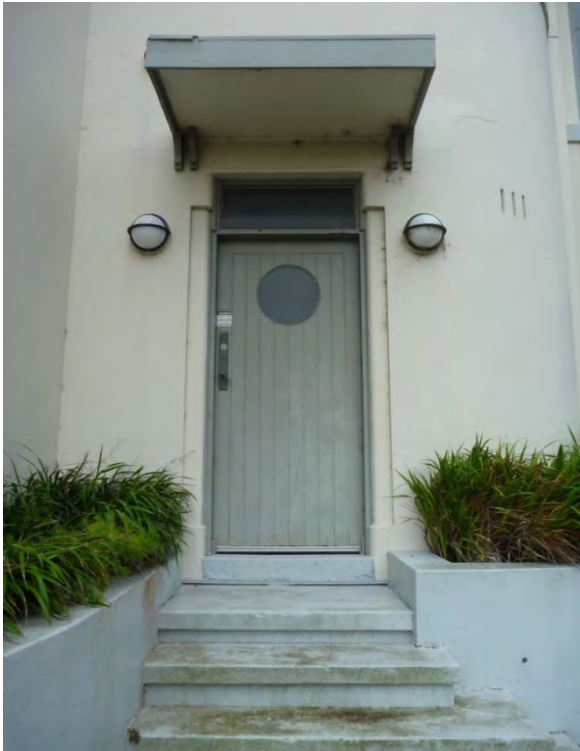
**Figure 3.12** The original entrance, western elevation, with raised garden beds and concrete steps. The awning was constructed c1950s, replacing an earlier awning. (Source: GML 2015)

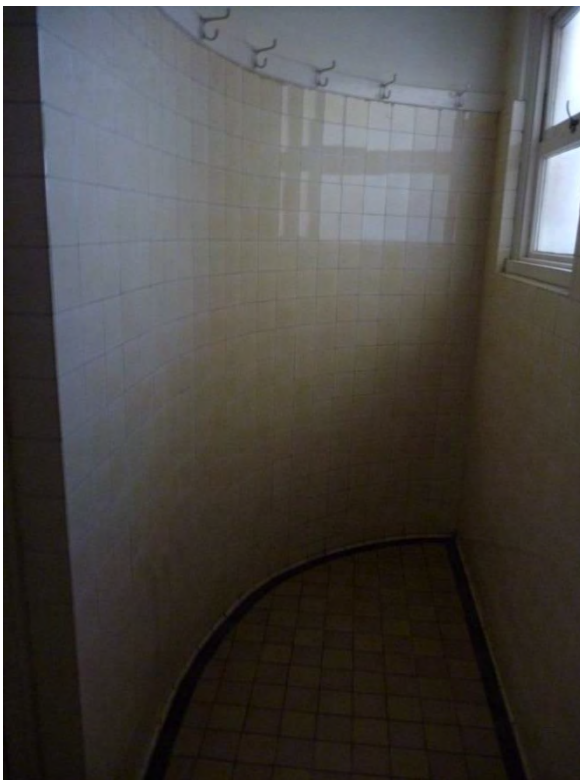
**Figure 3.14** Original tiles and coat hooks within the ground-floor bathroom. (Source: GML 2015)

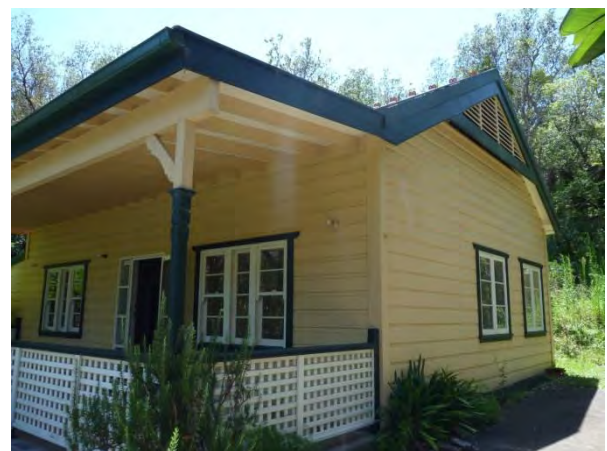
Figure 3.29 View of the Gap Bluff Cottage. Most windows are modern, simplified reproductions. (Source: GML 2015)

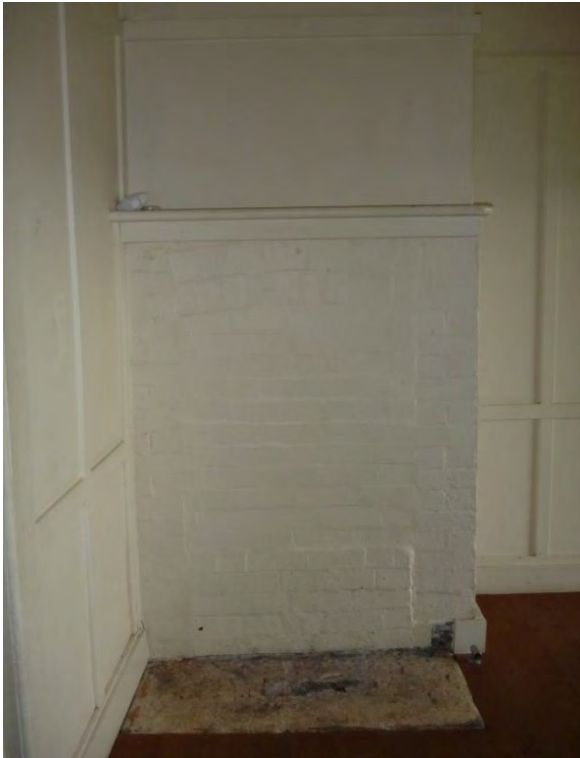
**Figure 3.42** The original fireplace, mantelpiece and hearth in the western half of the cottage. (Source: GML 2015)

(Figure 3.42). The fireplace in the lounge room retains its sandstone hearth and opening, but has otherwise been modified. The timber floorboards have been replaced in sections throughout the residence.

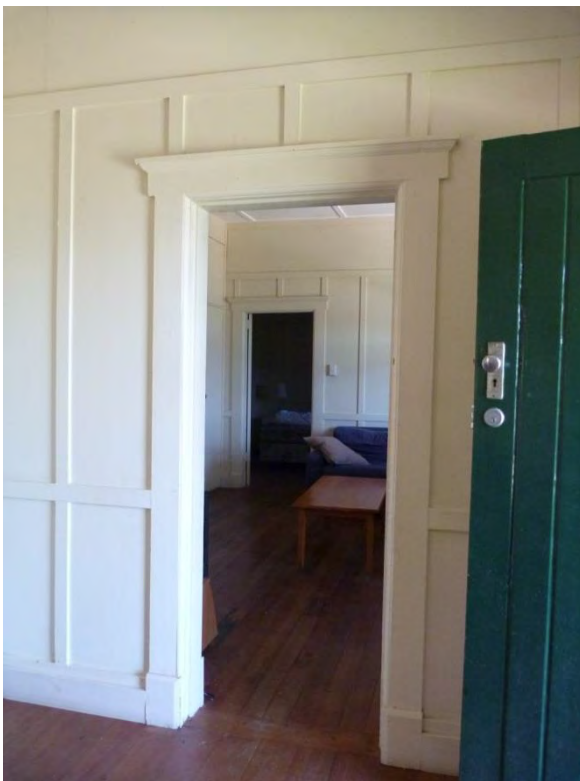
**Figure 3.44** View from the dining room to the living room, showing the entablature architraves around a post-1952 doorway and an original doorway in the background. (Source: GML 2015)

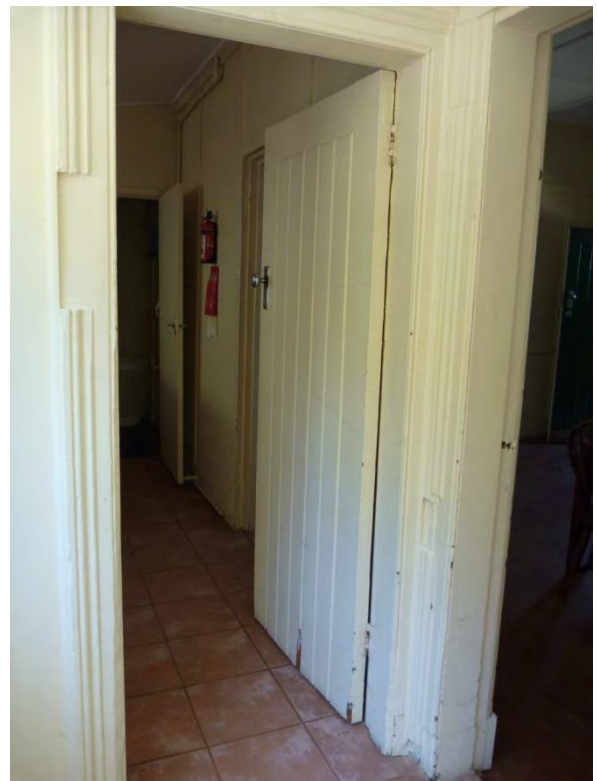
**Figure 3.45** View from the rear enclosed verandah showing the remnant early/original architrave around the doorway to the rear wing. (Source: GML 2015)

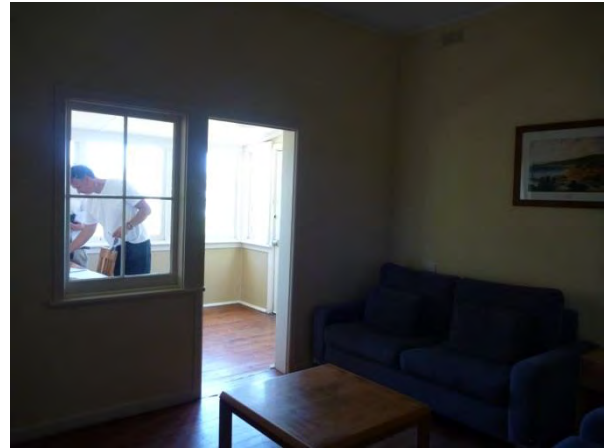
**Figure 3.53** The original interiors of the cottage have been replaced. (Source: GML 2015)

Overall, the external form and appearance of the cottage appears reasonably intact, with the exception of the enclosed verandah. Internally, there is little to no original fabric remaining, with all joinery having been replaced, and modern suspended ceilings, kitchen and bathroom installed (Figure 3.53).

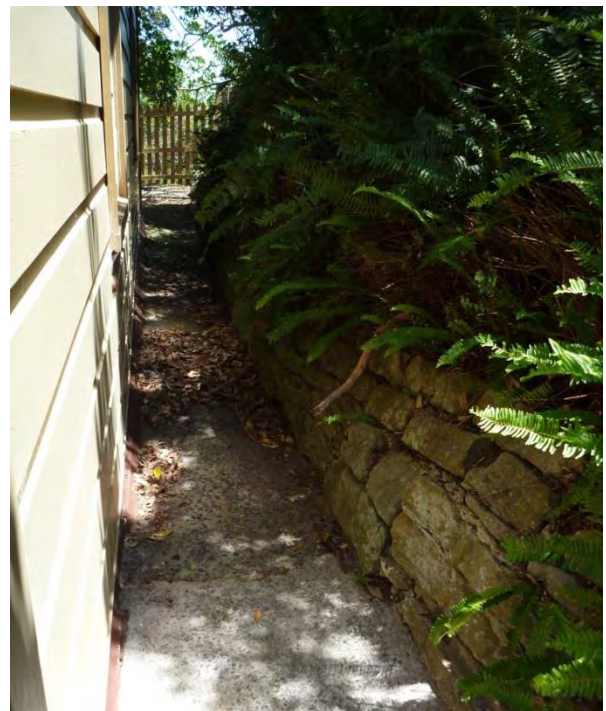
**Figure 3.55** Sandstone block wall along the rear of the cottage. (Source: GML 2015)

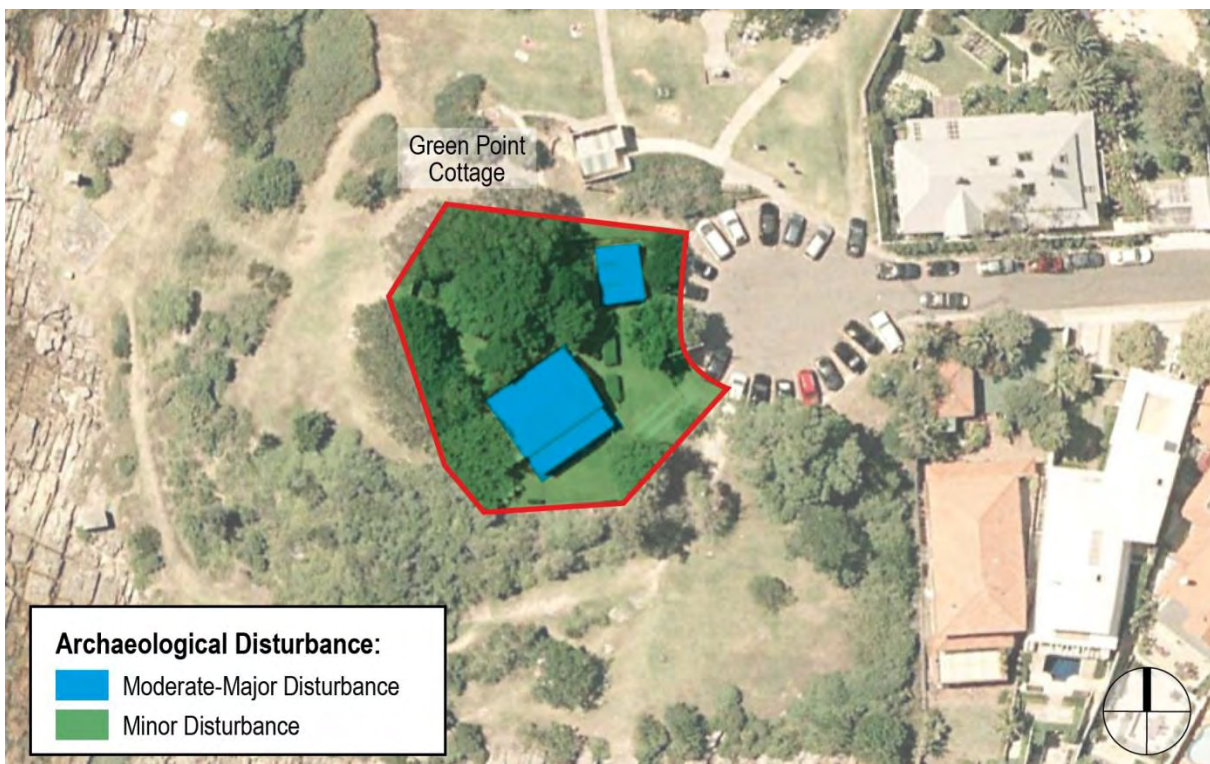
Figure 4.3 Zones of potential disturbance to historical archaeological resources within the study area at Green Point, South Head, Sydney Harbour National Park. (Source: Google Earth Pro with GML additions 2015)

The construction of Green Point Cottage in 1903 may have disturbed earlier archaeological features or deposits associated with the battery erected at Green Point in 1872. Construction of a garage to the north of the cottage in the 1960s would have caused moderate–major disturbance to any archaeological evidence associated with earlier uses of Green Point. Renovations of the interior of the cottage may have caused moderate–major disturbance to any significant underfloor deposits associated with earlier periods of occupation at Green Point Cottage. A depiction of estimated disturbance to potential archaeological deposits at Green Point is presented in Figure 4.3.

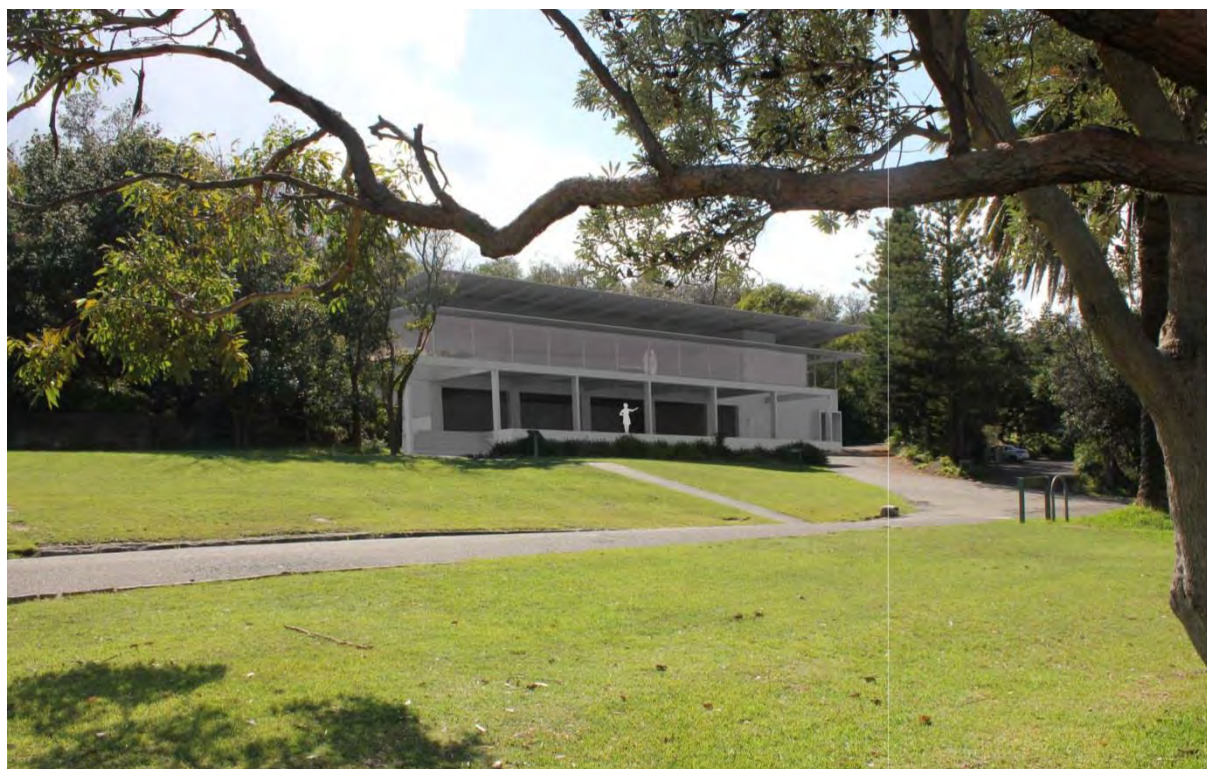
Figure 6.4 Photomontage of the proposed Armory additions and alterations. (Source: JPW 2015)

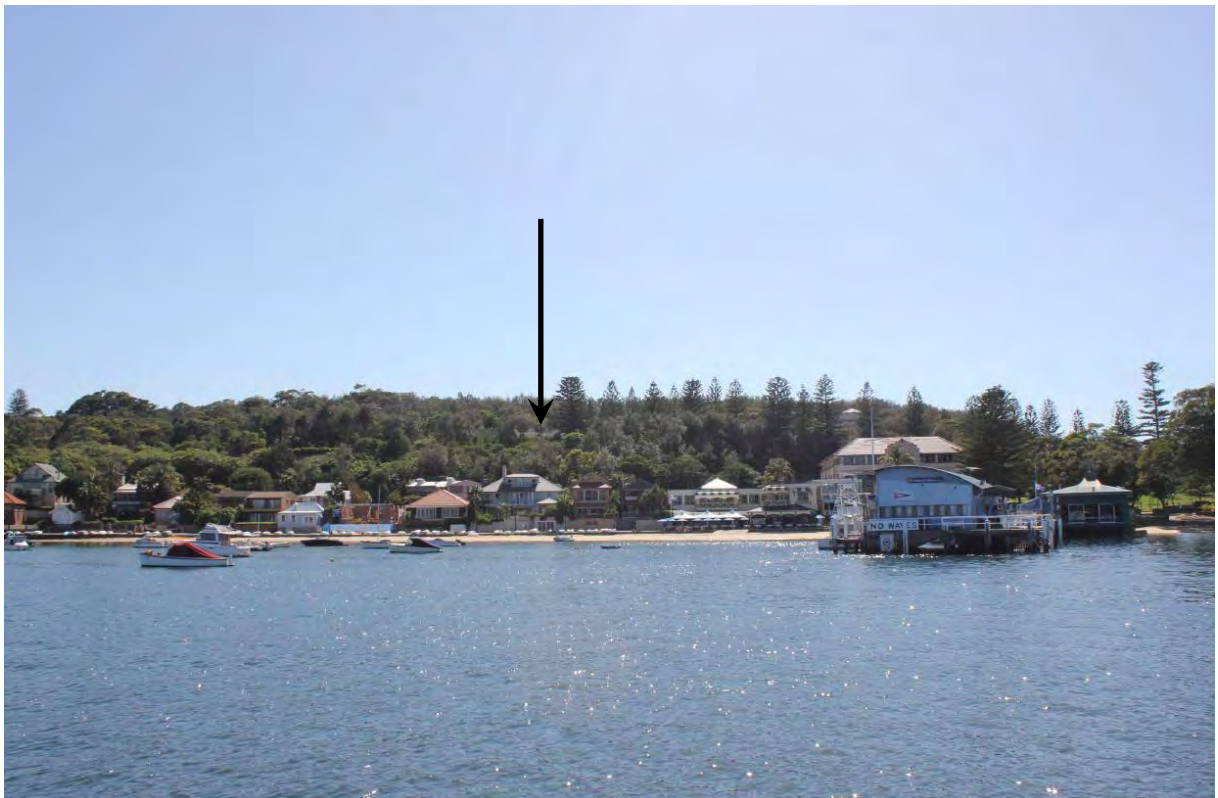
**Figure 7.5** Photomontage of the Armoury extension in the view toward Gap Bluff from Sydney Harbour. The Armoury is indicated with an arrow. (Source: JPW 2015 with GML overlay)
