HARTLEY HISTORIC SITE CONSERVATION MANAGEMENT PLAN

PREPARED FOR THE NPWS
BY OTTO CSERHALMI & PARTNERS P/L ARCHITECTS

DECEMBER 2002 FINAL REPORT

Prepared by Otto Cserhalmi and Partners P/L
on behalf of NSW National Parks and Wildlife Service

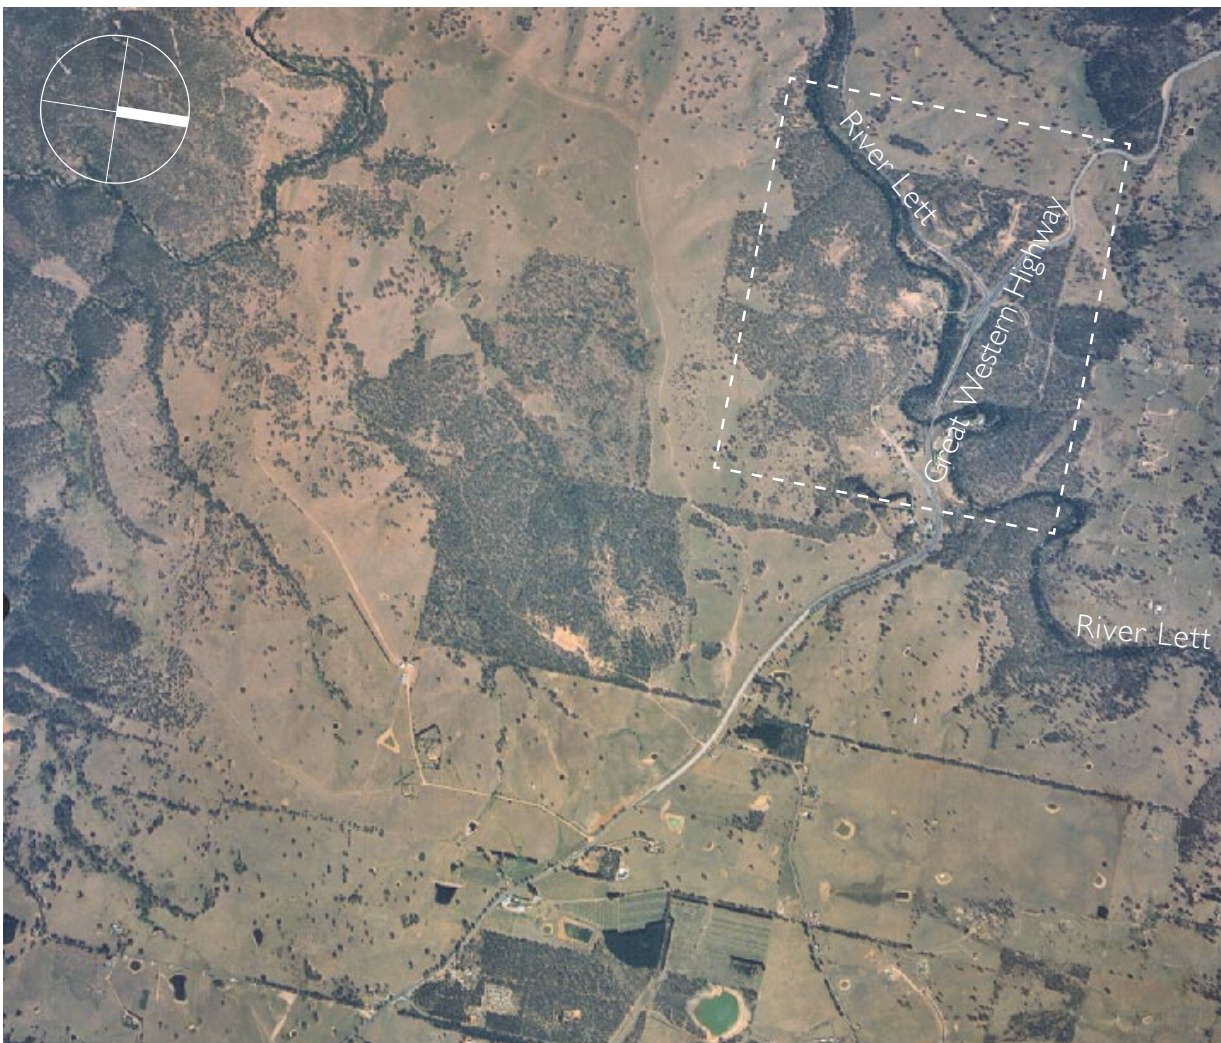
Aerial View of Hartley and environs, with the 1836 Hartley Village Reserve dotted. Source: Surveyor General's Department Date: 1994
Approximate scale 1:25000

The aerial photograph below clearly shows that the square village reserve is still evident in the landscape. The square is a cadastral boundary which has subsequently been used to form the boundary of the Register of the National Estate Listing. This square reserve is often mentioned during the report. It should be noted that the study area only comprises those portions of land owned by NPWS and which lie within this square.

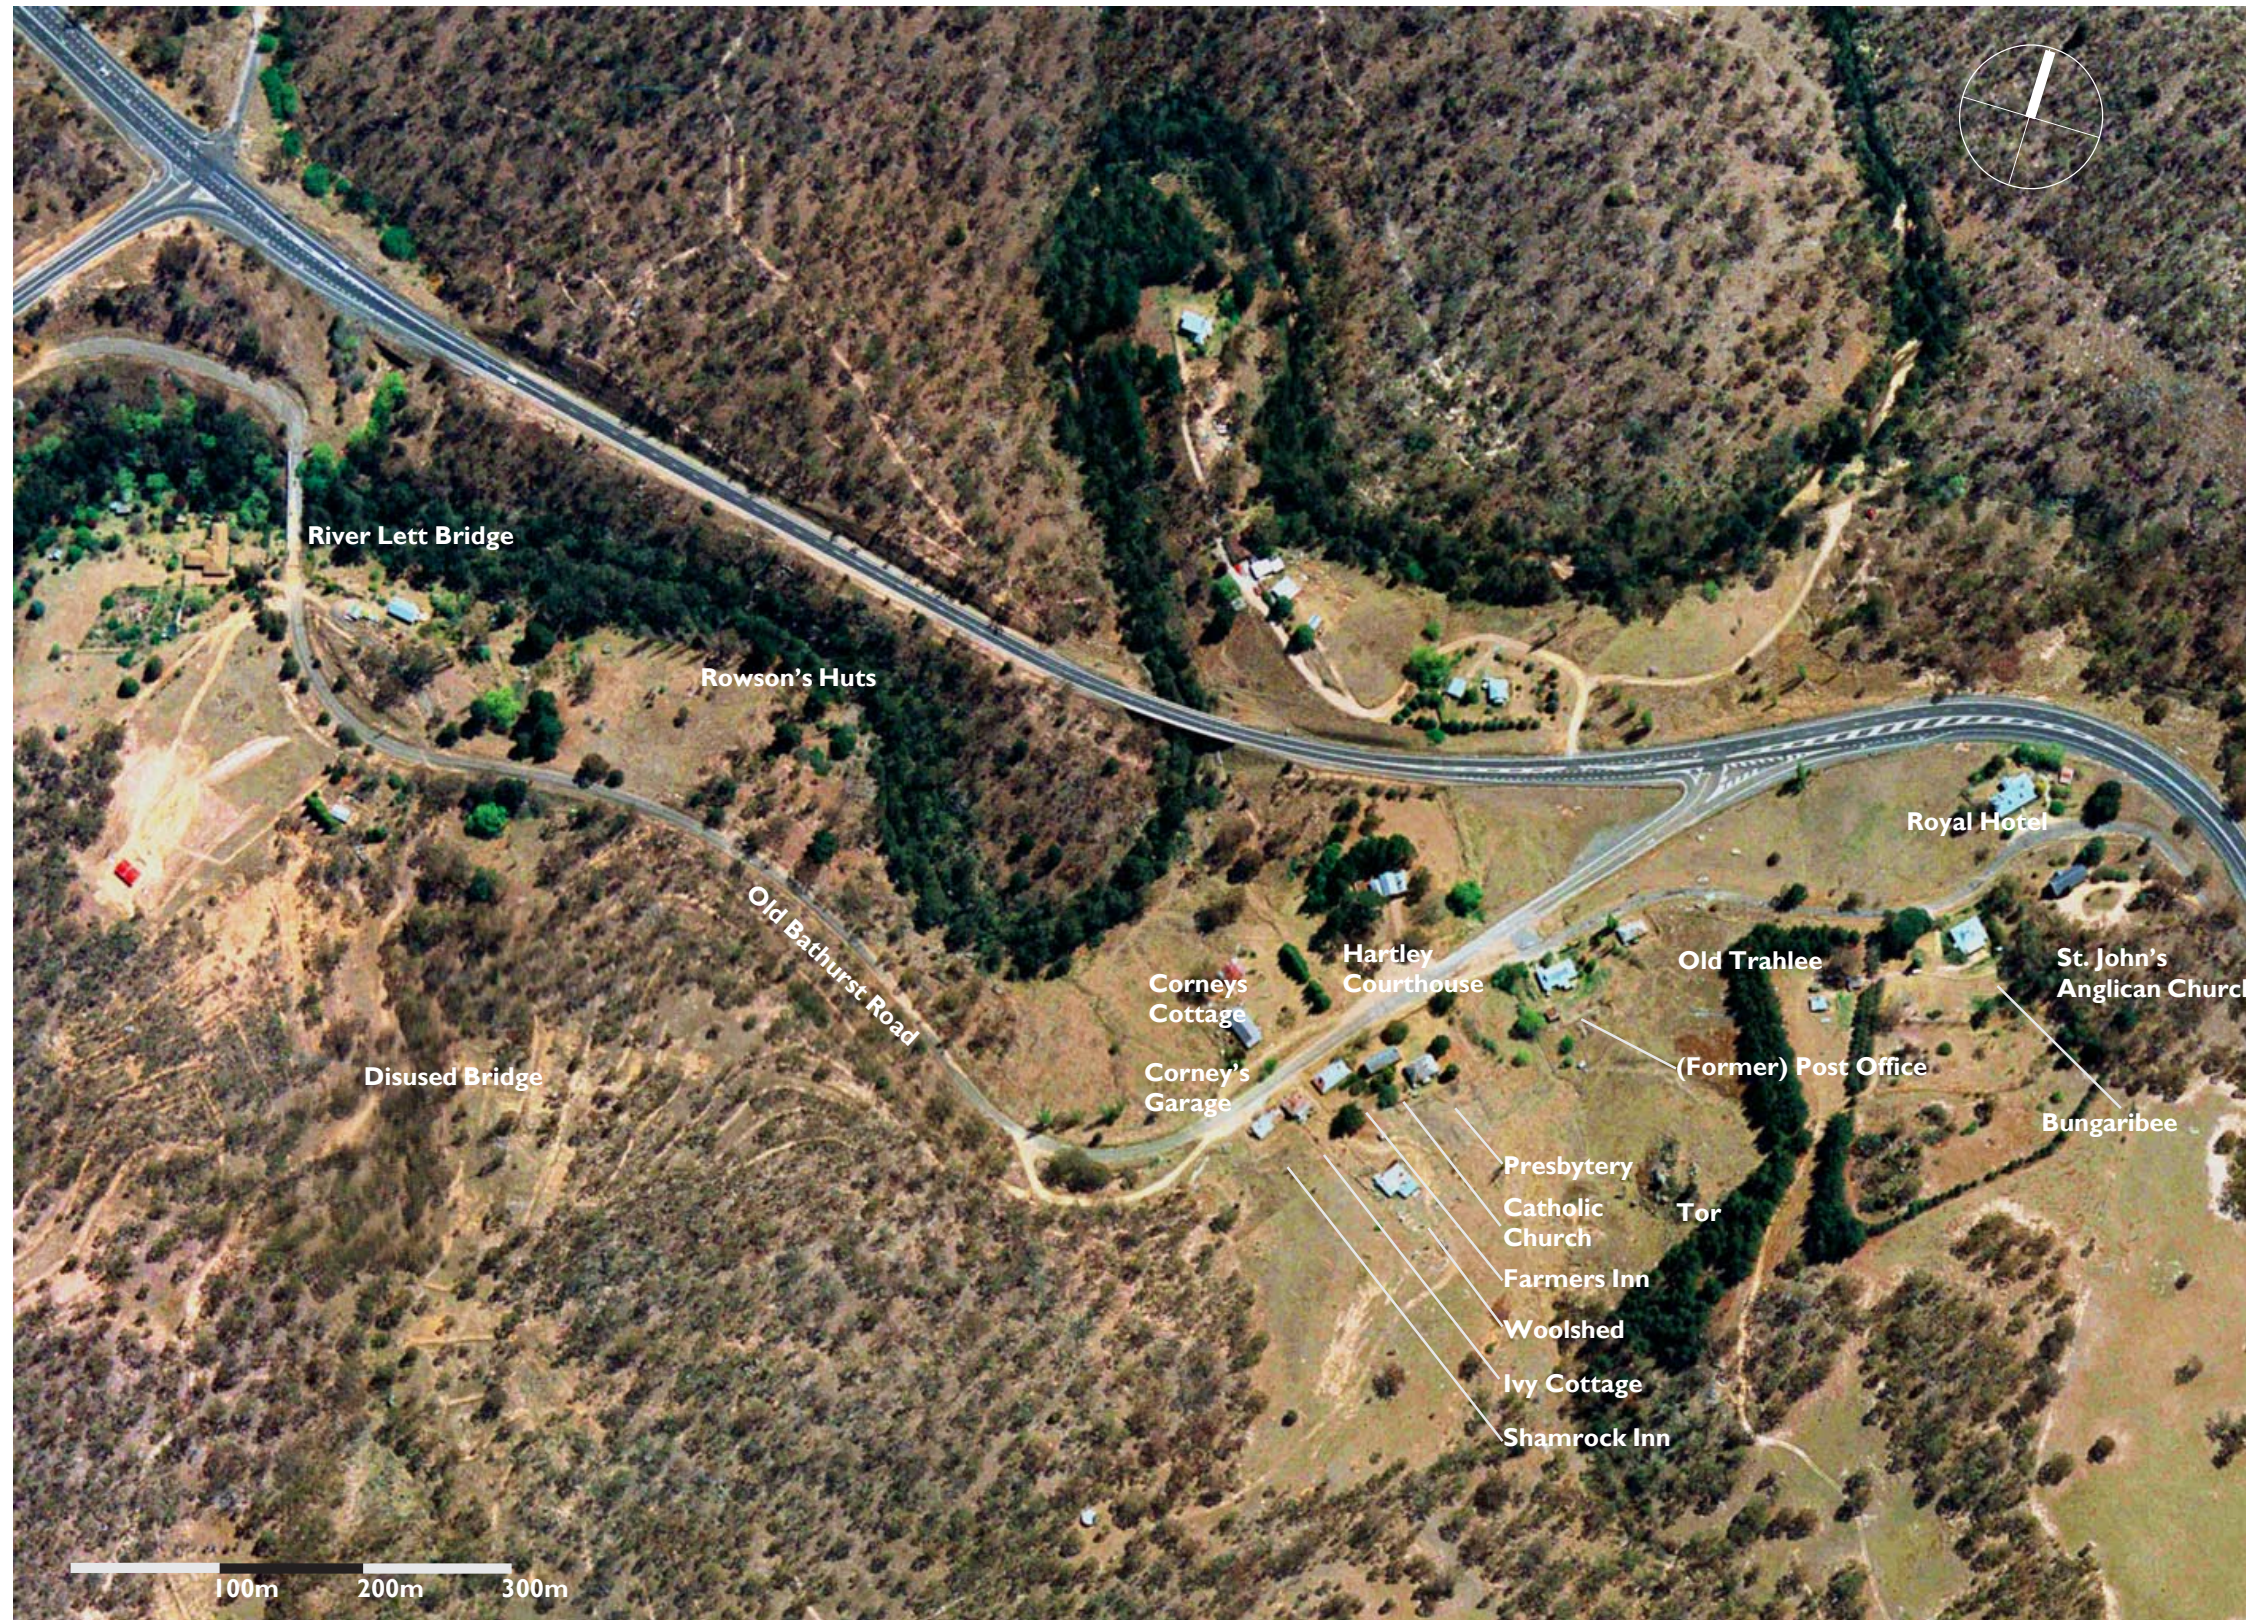
This extract from the 1994 aerial view of the site locates the built items within the Hartley Village Precinct of the study area. Detailed layouts of the buildings, where appropriate, accompany the text. The two cottages on the banks of the River Lett are not discernable on the aerial photo and have not been shown on this map. They are located on the previous aerial/survey.

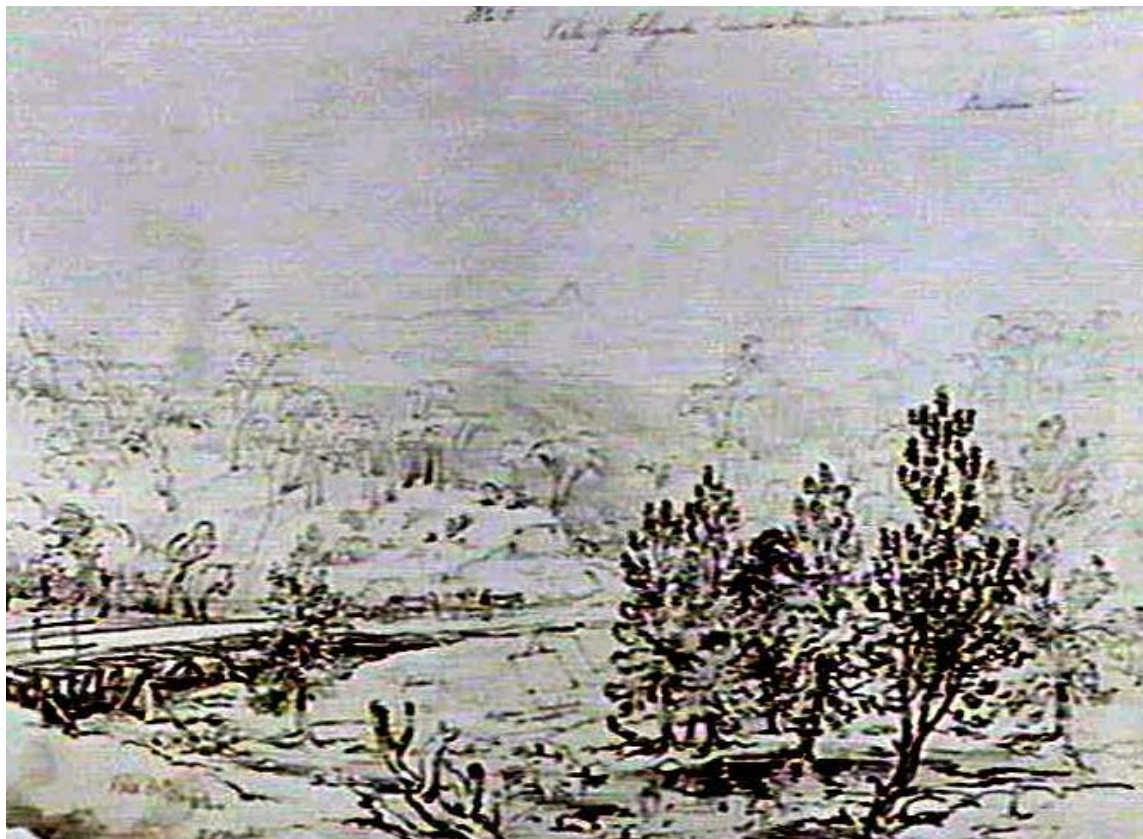
The crossing of the River Lett by the Great Western Road occurred at Hartley. The small settlement that developed there was known as Rivulet. The location of the crossing is shown on the *Sketch showing the different lines of road descending from the Blue Mountains towards Bathurst 27th July 1830*. In this sketch, the road had not been formed; the note on the sketch indicates that it had merely been marked. It also shows two further routes down into the valley, used prior to the construction of the Victoria Pass; these routes are now interpreted as walking tracks and can be accessed from York Lookout.

George F Angas' sketches of the River Lett Bridge
c. 1852
Source: ML

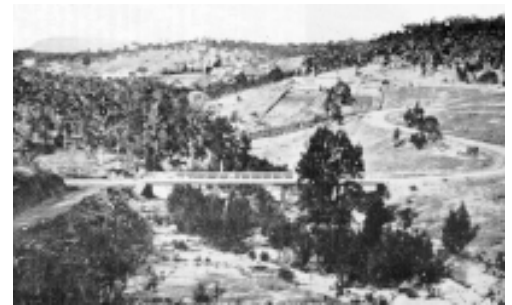
1879 View of the Bridge over the River Lett
Source: Lawrence Frost Album, ML

A photograph of a bridge reputed to have been designed by Mitchell survives in the Small Picture File at the Mitchell Library. It is too small to be the bridge over the River Lett, but gives an idea of the scale and character of the initial crossings. The current bridge dates from 1878.¹⁶

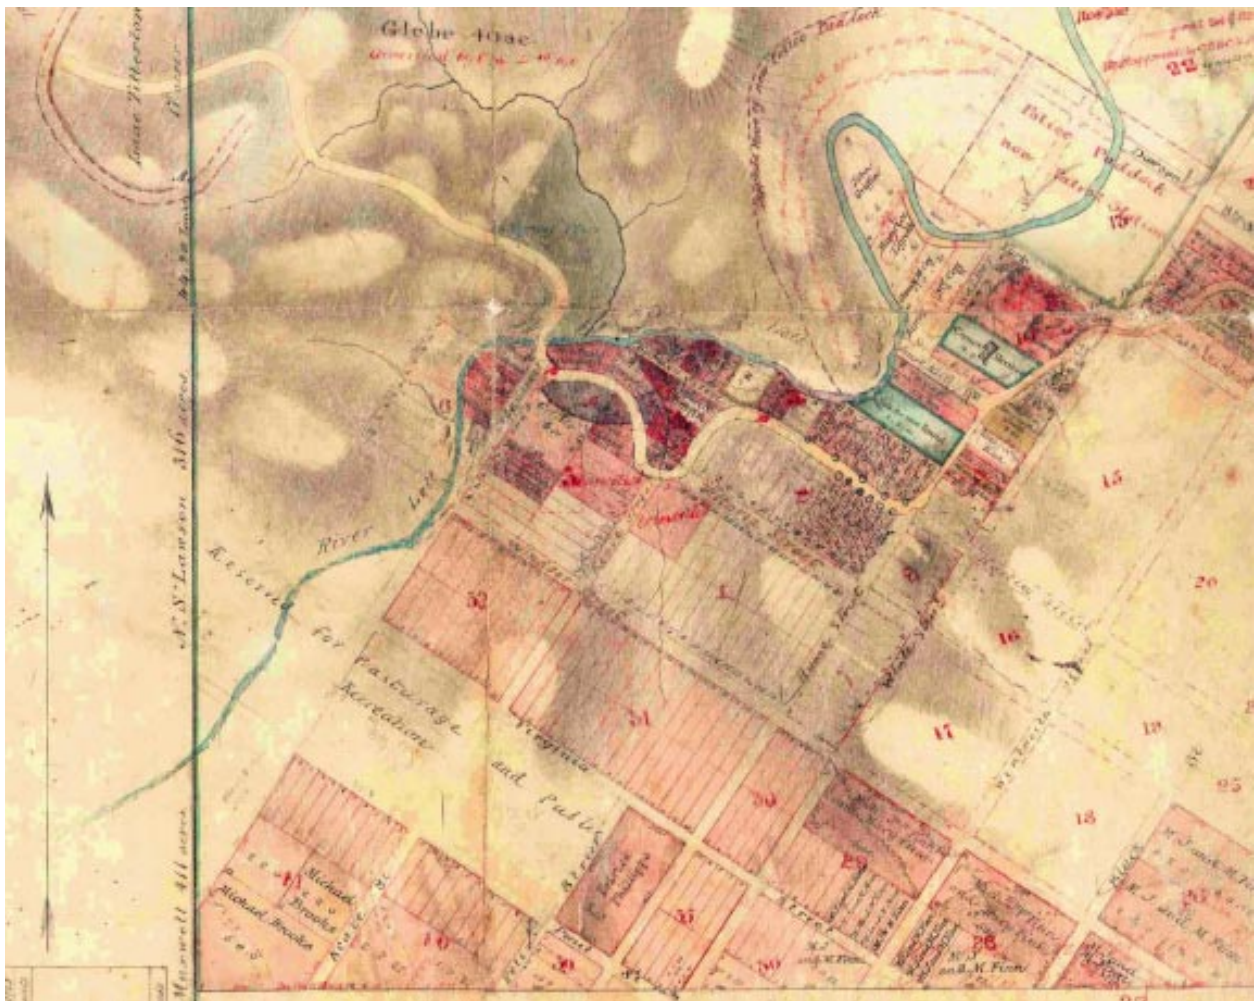
Plan for a town at the River Lett, 1836
Source: AONSW (State Records) AO Map 3102

A detailed survey of a town on the banks of the River Lett was prepared in July 1836 however the courthouse had already been designed by the Colonial Architect Mortimer Lewis, tenders called and accepted.³⁴ There was much debate concerning the choice of a site for the courthouse, and the site was not finally resolved until September 1836. The contract had already been awarded in April and the contractor had been quarrying stone in the vicinity of Hartley. The lack of a site for the building caused the contractor some anxiety. The Plan of Hartley laid before the Executive Council in December 1837 shows a small temporary courthouse adjacent to the site of the Courthouse.

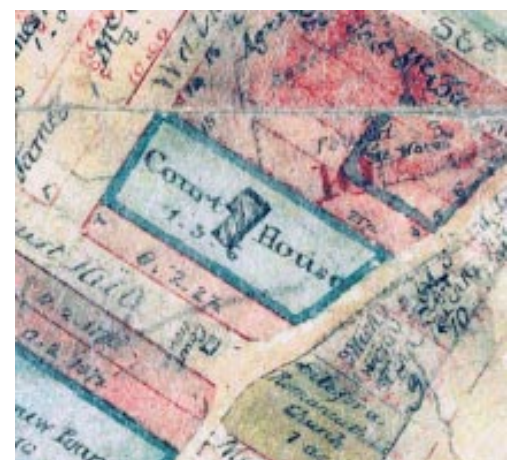
Extract from *Plan for a Town at the River Lett*, 1836 (approved Dec. 1837) showing the site of the Courthouse and the temporary courthouse (arrowed)
Source: State Records (AONSW) AO Map 3102

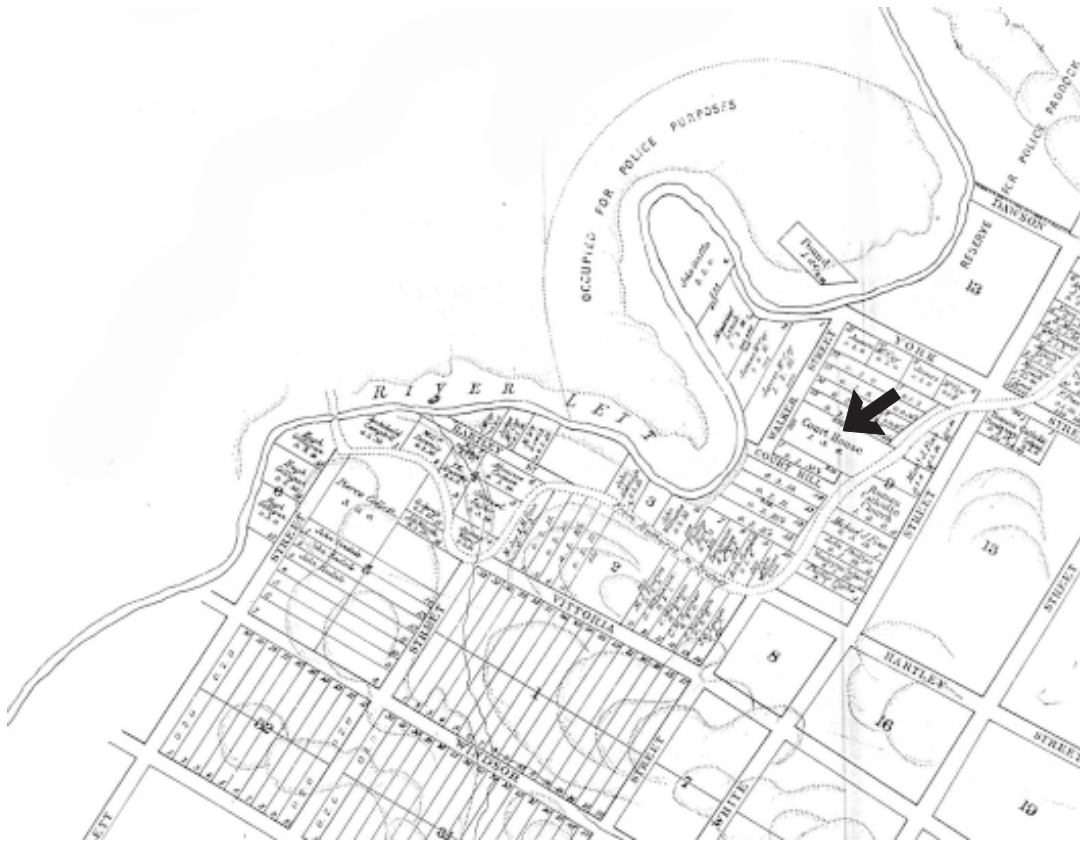
Plan of the Town of Hartley, County of Cook, N.S.W. 1870
 Source: State Records, AO Map 10610 Note: The site of the courthouse is shown arrowed

The remainder of the town was not laid out after the completion of the courthouse. The layout of the sections and portions that eventuated gave maximum frontage onto the irregular curves of Mitchell's road as it wound down the hill to the bridge. The streets shown on the 1836 plan of Hartley remained largely unformed, although they still appear on the most recent topographical map of Hartley. The planned marketplace and church ground did not eventuate.

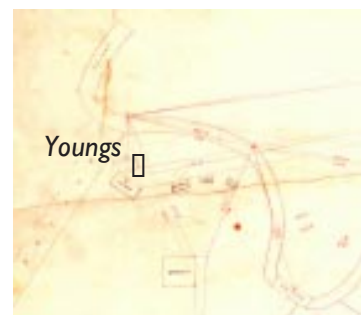
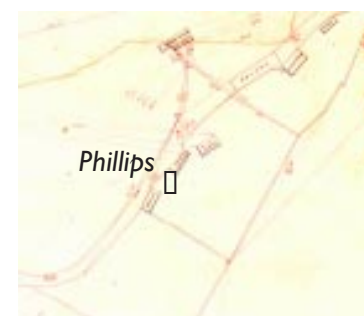
Extract from the 1858 Survey showing Young's and Phillip's Inns
Source: State Records, AO Map 3104

By 1845 a number of the town allotments had been sold in the yearly auctions and the village developed along the Great Western Road to Bathurst. A paper delivered to the Royal Australian Historical Society records a series of inns in the early 1840s: Philip's Hotel, Wood's Hotel and Young's Hotel.³⁸ These are the names of the proprietors not the names of the Public Houses. The licensing records only indicate one inn during this period.

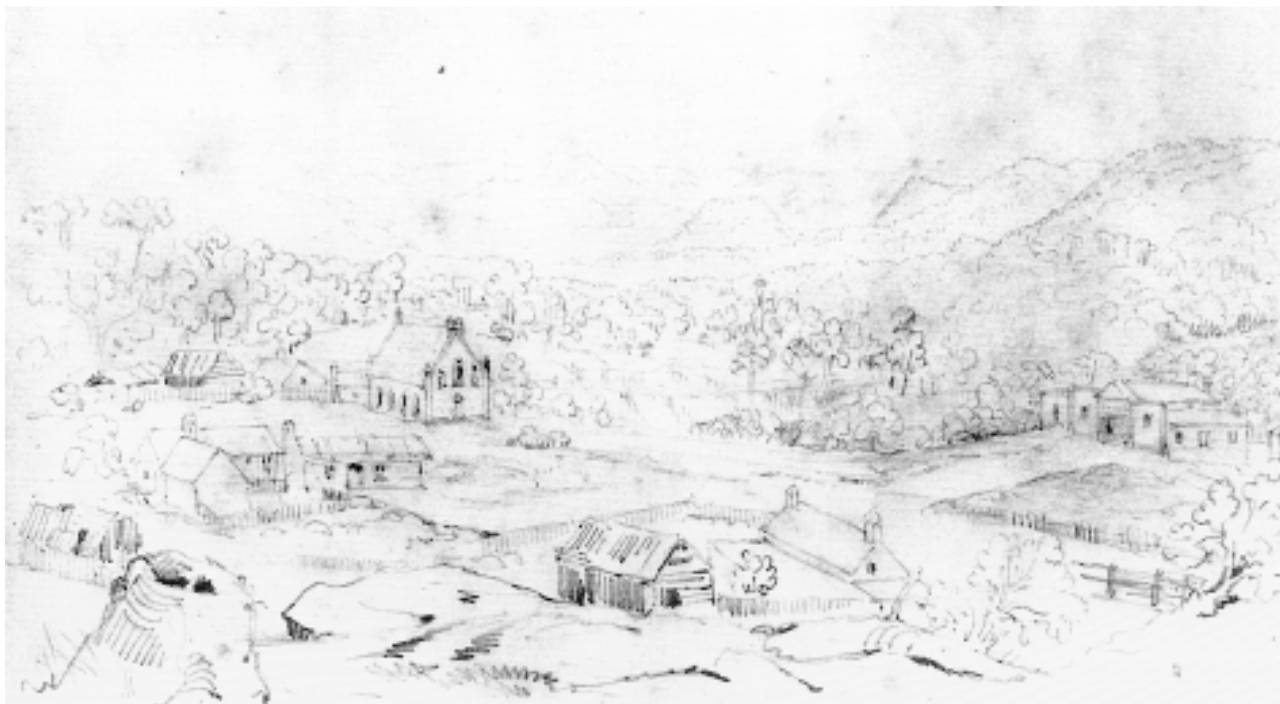
Hartley 1852, as sketched by Rebecca Martens, a very similar view to that of George French Angas
 Note that each building complex contains 2 or 3 structures, including substantial outbuildings
 Source: ML SPF

Photographs of the township taken in the mid 1870s and the earlier sketches by George French Angas and Rebecca Martens in 1852 show the numerous slab buildings. The township extended over a larger area than the current village. Little evidence of these buildings, or of the full extent of the township survived. The sketches and photographs show that by the early 1850s much of the land around the village had been cleared, this probably occurred in conjunction with the development of the residential precinct.

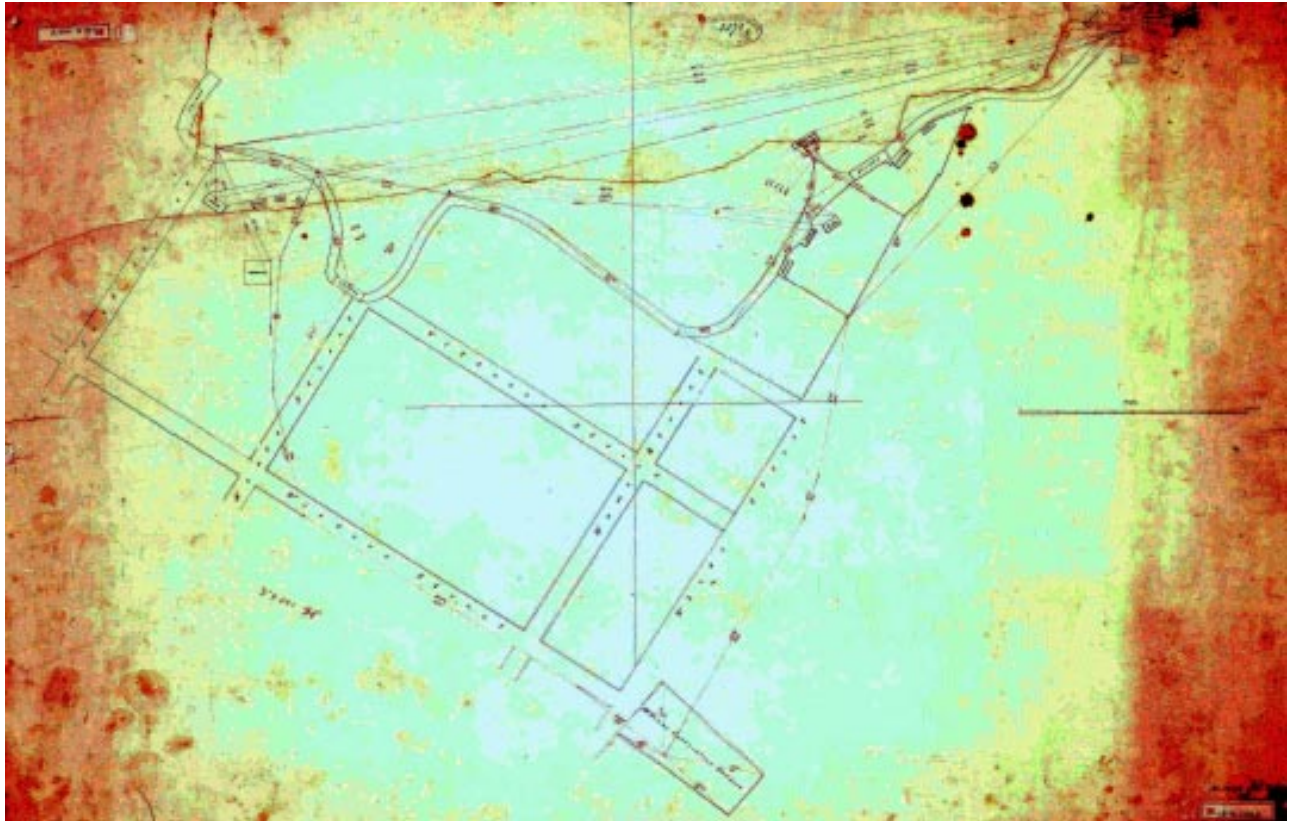
1858 Survey showing the alignment of the Great Western Road at Hartley
Source: AO Map 3104 (State Records) Untitled

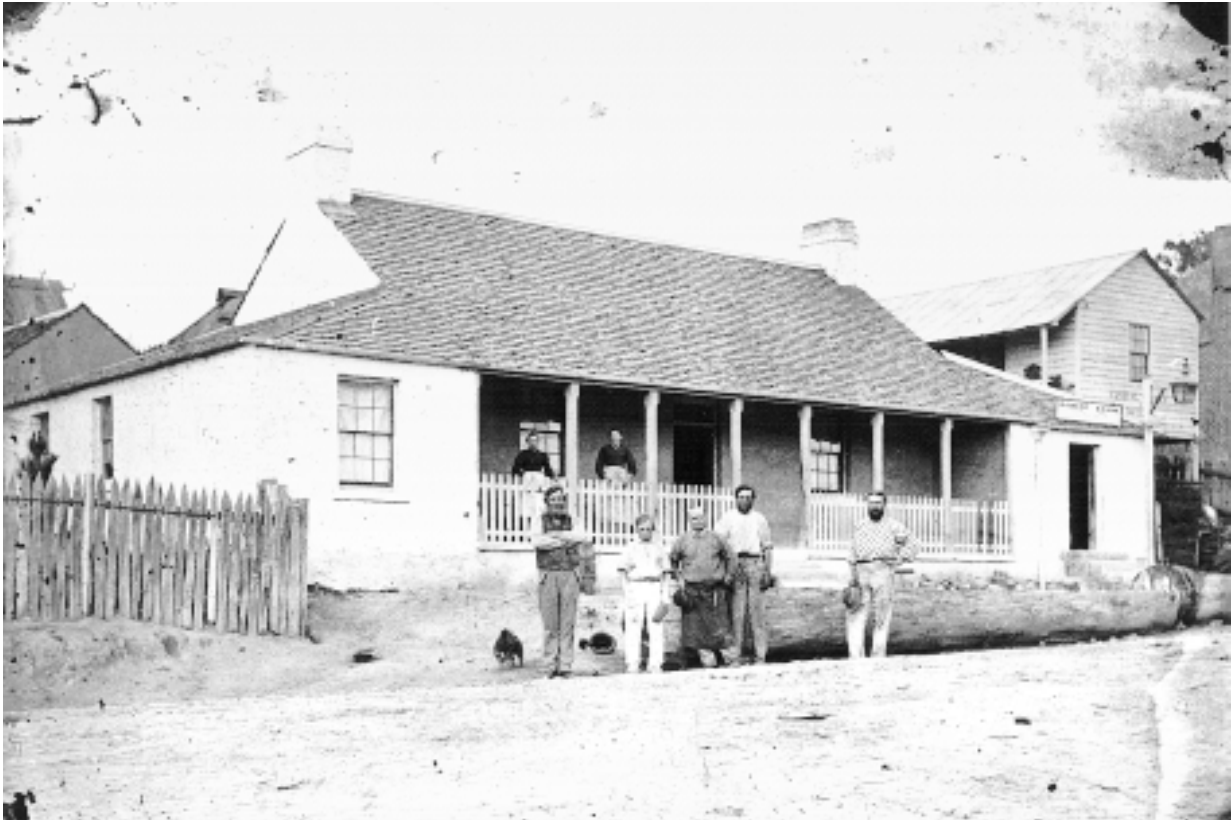
Robert Evans, Farmers Inn, Hartley

The two images on the following page show the character of the buildings in the 1870s and their relationship to the street. The Farmers Inn has a lamp, a requirement of a public house. Handpainted signage denotes the Post Office.

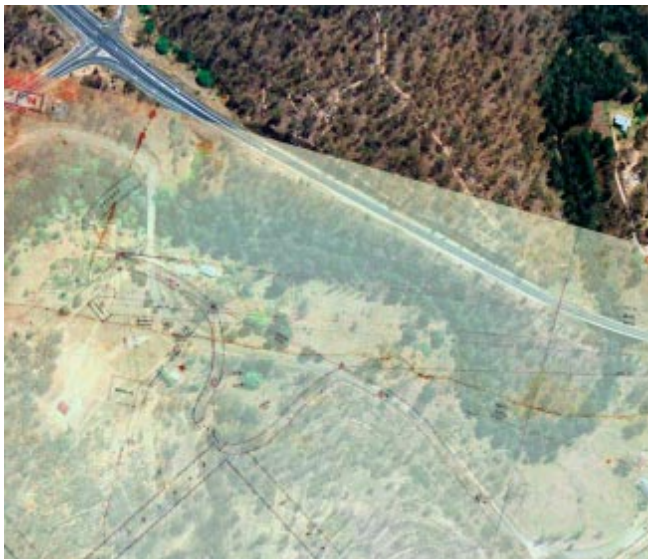
The extract from the overlay of the 1858 survey on the 1994 aerial below shows the original alignment Mitchells line of road, the c. 1839 inn and the bridge at Rivulet.

Extract from the overlay of the 1858 survey on the current Aerial photo showing Rivulet

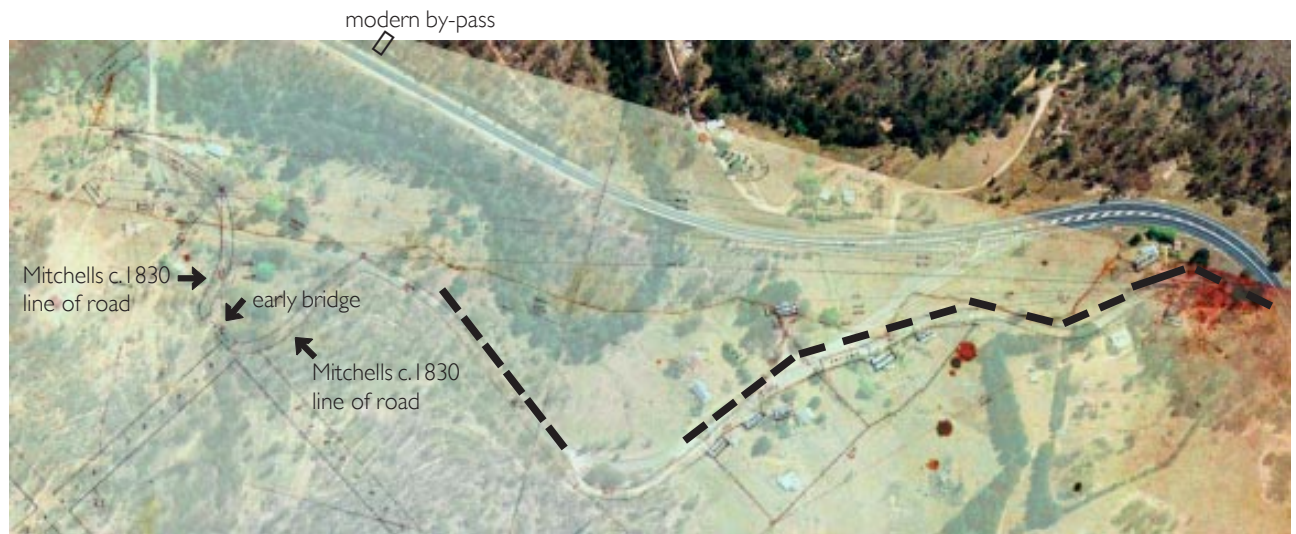
KEY
 ───────────
 Sections of Mitchell's line of road largely retaining their original alignment

Extract from the overlay of the 1858 survey on the current Aerial photo showing the alignment of Mitchell's line of Road.
 Source: Surveyor General's Department below, State Records AO Map 3104 over

Whilst cuttings were made, stone embankments and culverts such as those found on the Old Great North Road, north of Wiseman's Ferry do not appear here. A more recent culvert survives adjacent to the post office; replacing an earlier bridge. Below Hartley, the alignment has been modified, a hairpin bend removed, marooning the earlier bridge.

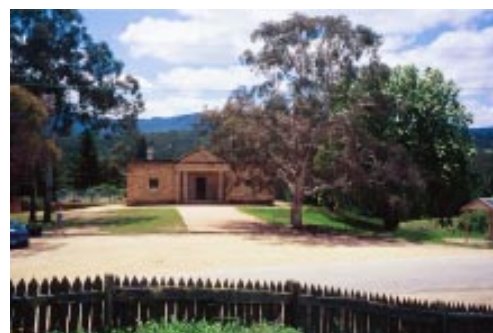
Current view of Hartley Courthouse and its forecourt
OCP Jan 2001

The Courthouse is a Colonial Greek Revival building designed by the Colonial Architect Mortimer Lewis. It was constructed of sandstone quarried locally (near Bowenfels it is thought). The exterior of the Courthouse is substantially intact. Whilst there have been modifications such as the installation of a concrete lintel, the overall form and detail of the building has been respected. Internally, evidence of the layout of the courtroom, magistrates offices and the cells survive. In particular, the cell block retains its stone floor and timber linings, including mid nineteenth century graffiti by the prisoners. The inscriptions have been recorded and the record is held by the NPWS at Hartley. Photographic evidence shows that the courtroom was empty in 1918. The current fit-out was installed by the NPWS in the 1970s. Elements appear to have been salvaged from other New South Wales courts. The layout of the original courtroom has not been determined.

The Courthouse retains its relationship to its setting, perched on a stone bluff above the river. The extensive forecourt to the building has undergone many changes in configuration, however it still functions as a public forecourt.

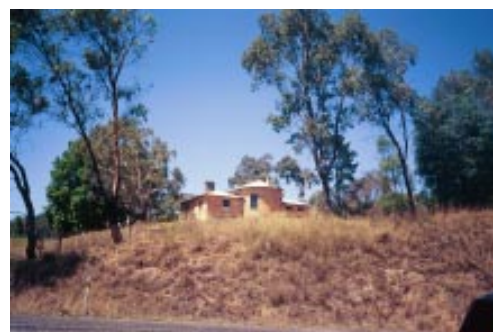
Current view of the rear of Hartley Courthouse
OCP Jan 2001

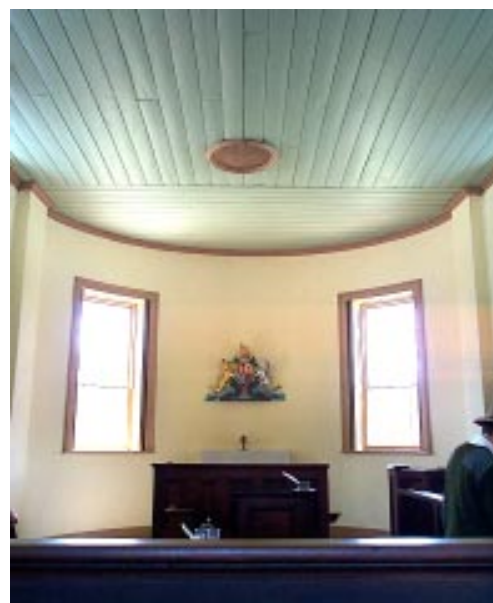
Current view of the interior of the Courthouse
OCP Jan 2001

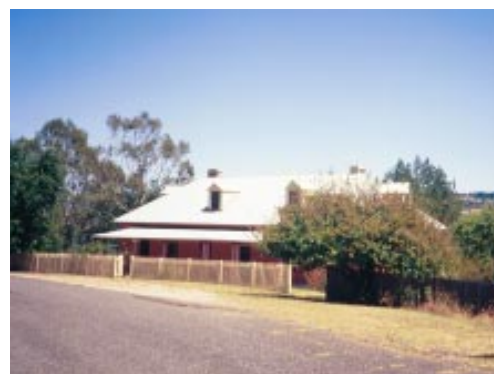
Current View of the Royal Hotel,
Source: OCP Jan 2001

The Royal Hotel has recently undergone a program of conservation works, which reinstated the original configuration of the verandah and external openings, in so doing removing twentieth century modifications deemed to not be significant. The hotel retains its front garden, 1950s fenceline and relationship to the Great Western Road. None of the extensive complex of nineteenth century outbuildings survive, however a garage, dating from its uses as a motor hotel still stands. The foundations of a rear addition or outbuilding also survives, as the evidence of an earlier fence line (marked by a stone plinth in the front garden).

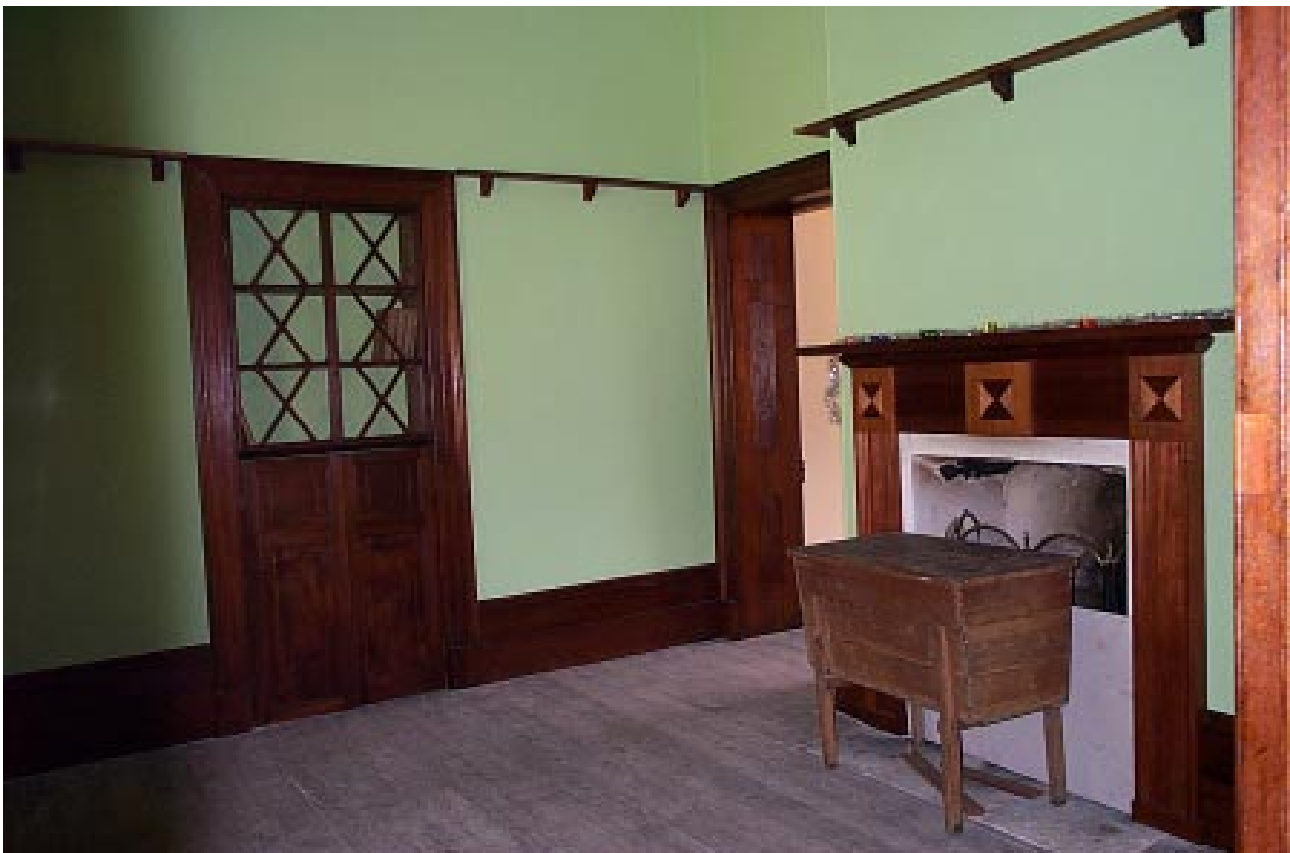
Current View of the conserved interior of the Royal Hotel
 Source: OCP Dec 2000

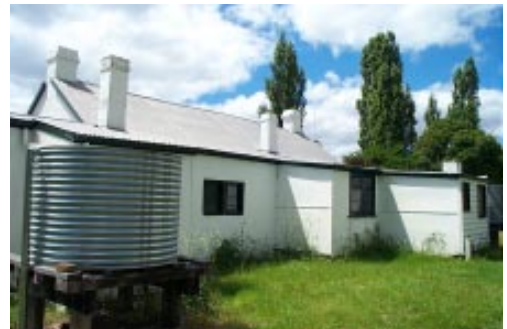
Current view of the additions to the rear of the former Post Office
OCP Dec 2001

During the Depression the re-use of items, on both a small and a large scale, was an economic necessity. This re-use included building materials, and in certain cases whole buildings. Hartley contains a number of buildings that provide evidence of the local economy during the Depression: the group of buildings the Corney family occupied, and Rowson's Huts. Previous conservation works have removed evidence of the activities of the Corney family who adapted the derelict colonial buildings in the central precinct of Hartley for their own family's use. Documentary evidence, including photographs, does however, indicate this phase of development of the place. This depression mentality survived with the children of those who had experienced the economic hardships of that era. It is now rapidly vanishing. There are today few examples in NSW where evidence of the depression mentality in relation to surviving/making do in conditions of hardship has been conserved and interpreted.

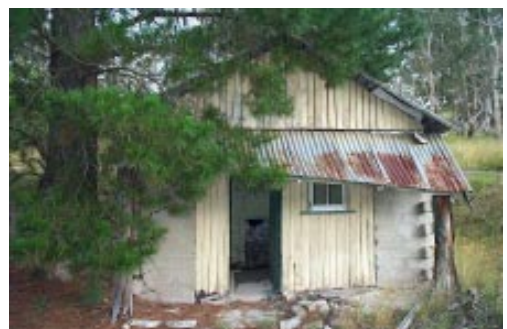
External view of the Cinder Block Hut [above] and internal view of the Log Hut, Rowson's Huts [below]
OCP Jan 2001

Rowson's Hut, built by a local auto electrician or electrical engineer c. 1940s also indicate the 'make do' approach of the Depression and subsequent World War. The two buildings, although in a derelict condition retain evidence of their layout and method of construction.

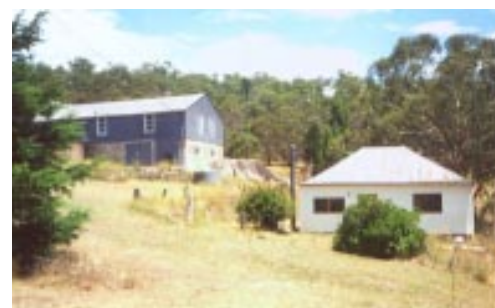
The relocated building (called Corney's Cottage) has recently undergone a program of conservation and maintenance works, including the reinstatement of external weatherboards. The earlier weatherboards had been removed and re-used inside to line internal walls of the garage. The cottage retains evidence of its standard schoolmasters residence layout, with the central corridor flanked by two rooms. It has not been determined if the original rear kitchen block was also relocated to Hartley. The cottage also retains evidence of later phases of its use, including the infilling of the front verandah. Evidence of its phases of use have largely been removed and it is almost impossible to read the building's previous phases of use in the current fabric.

Current View of Corney's Cottage
OCP Jan 2001

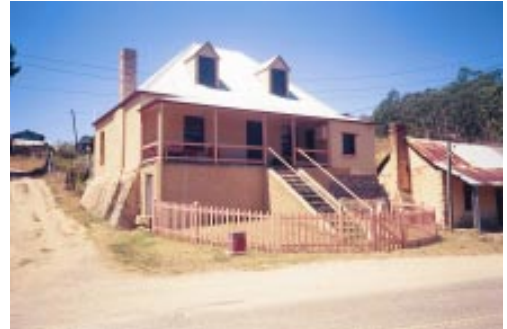
The NPWS have been undertaking maintenance works to the site since the mid 1970s. Buildings were modified to form staff accommodation, however the extent of works undertaken has not been major. The original roof form of Ivy Cottage has been reinstated in corrugated iron rather than with the original roofing material: timber shingles. The previous 1930s roof blew off during a storm in 1995.

Current View of Ivy Cottage
Source: OCP Jan 2001

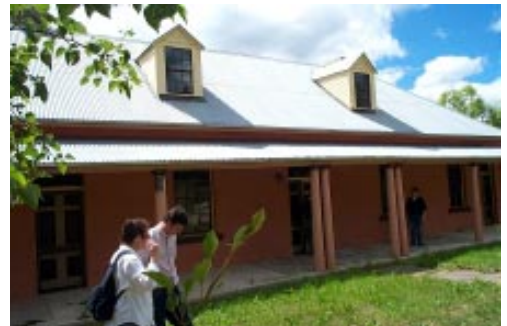
The NPWS have recreated a number of elements within the village based on photographic evidence. These elements include the log horse troughs, the signage to the former Farmers Inn, the front fence to Ivy Cottage, the small pane colonial Georgian windows to the Royal Hotel (including the dormers) and the signage to Comey's garage. In addition, a number of deteriorated elements have been substantially repaired and replaced. An extensive program of Conservation Works was undertaken between 1996 and 1999 on ten buildings, with concentration on the Royal Hotel, the former Post Office and Old Trahlee.

Current View of Royal Hotel
Source: OCP Jan 2001

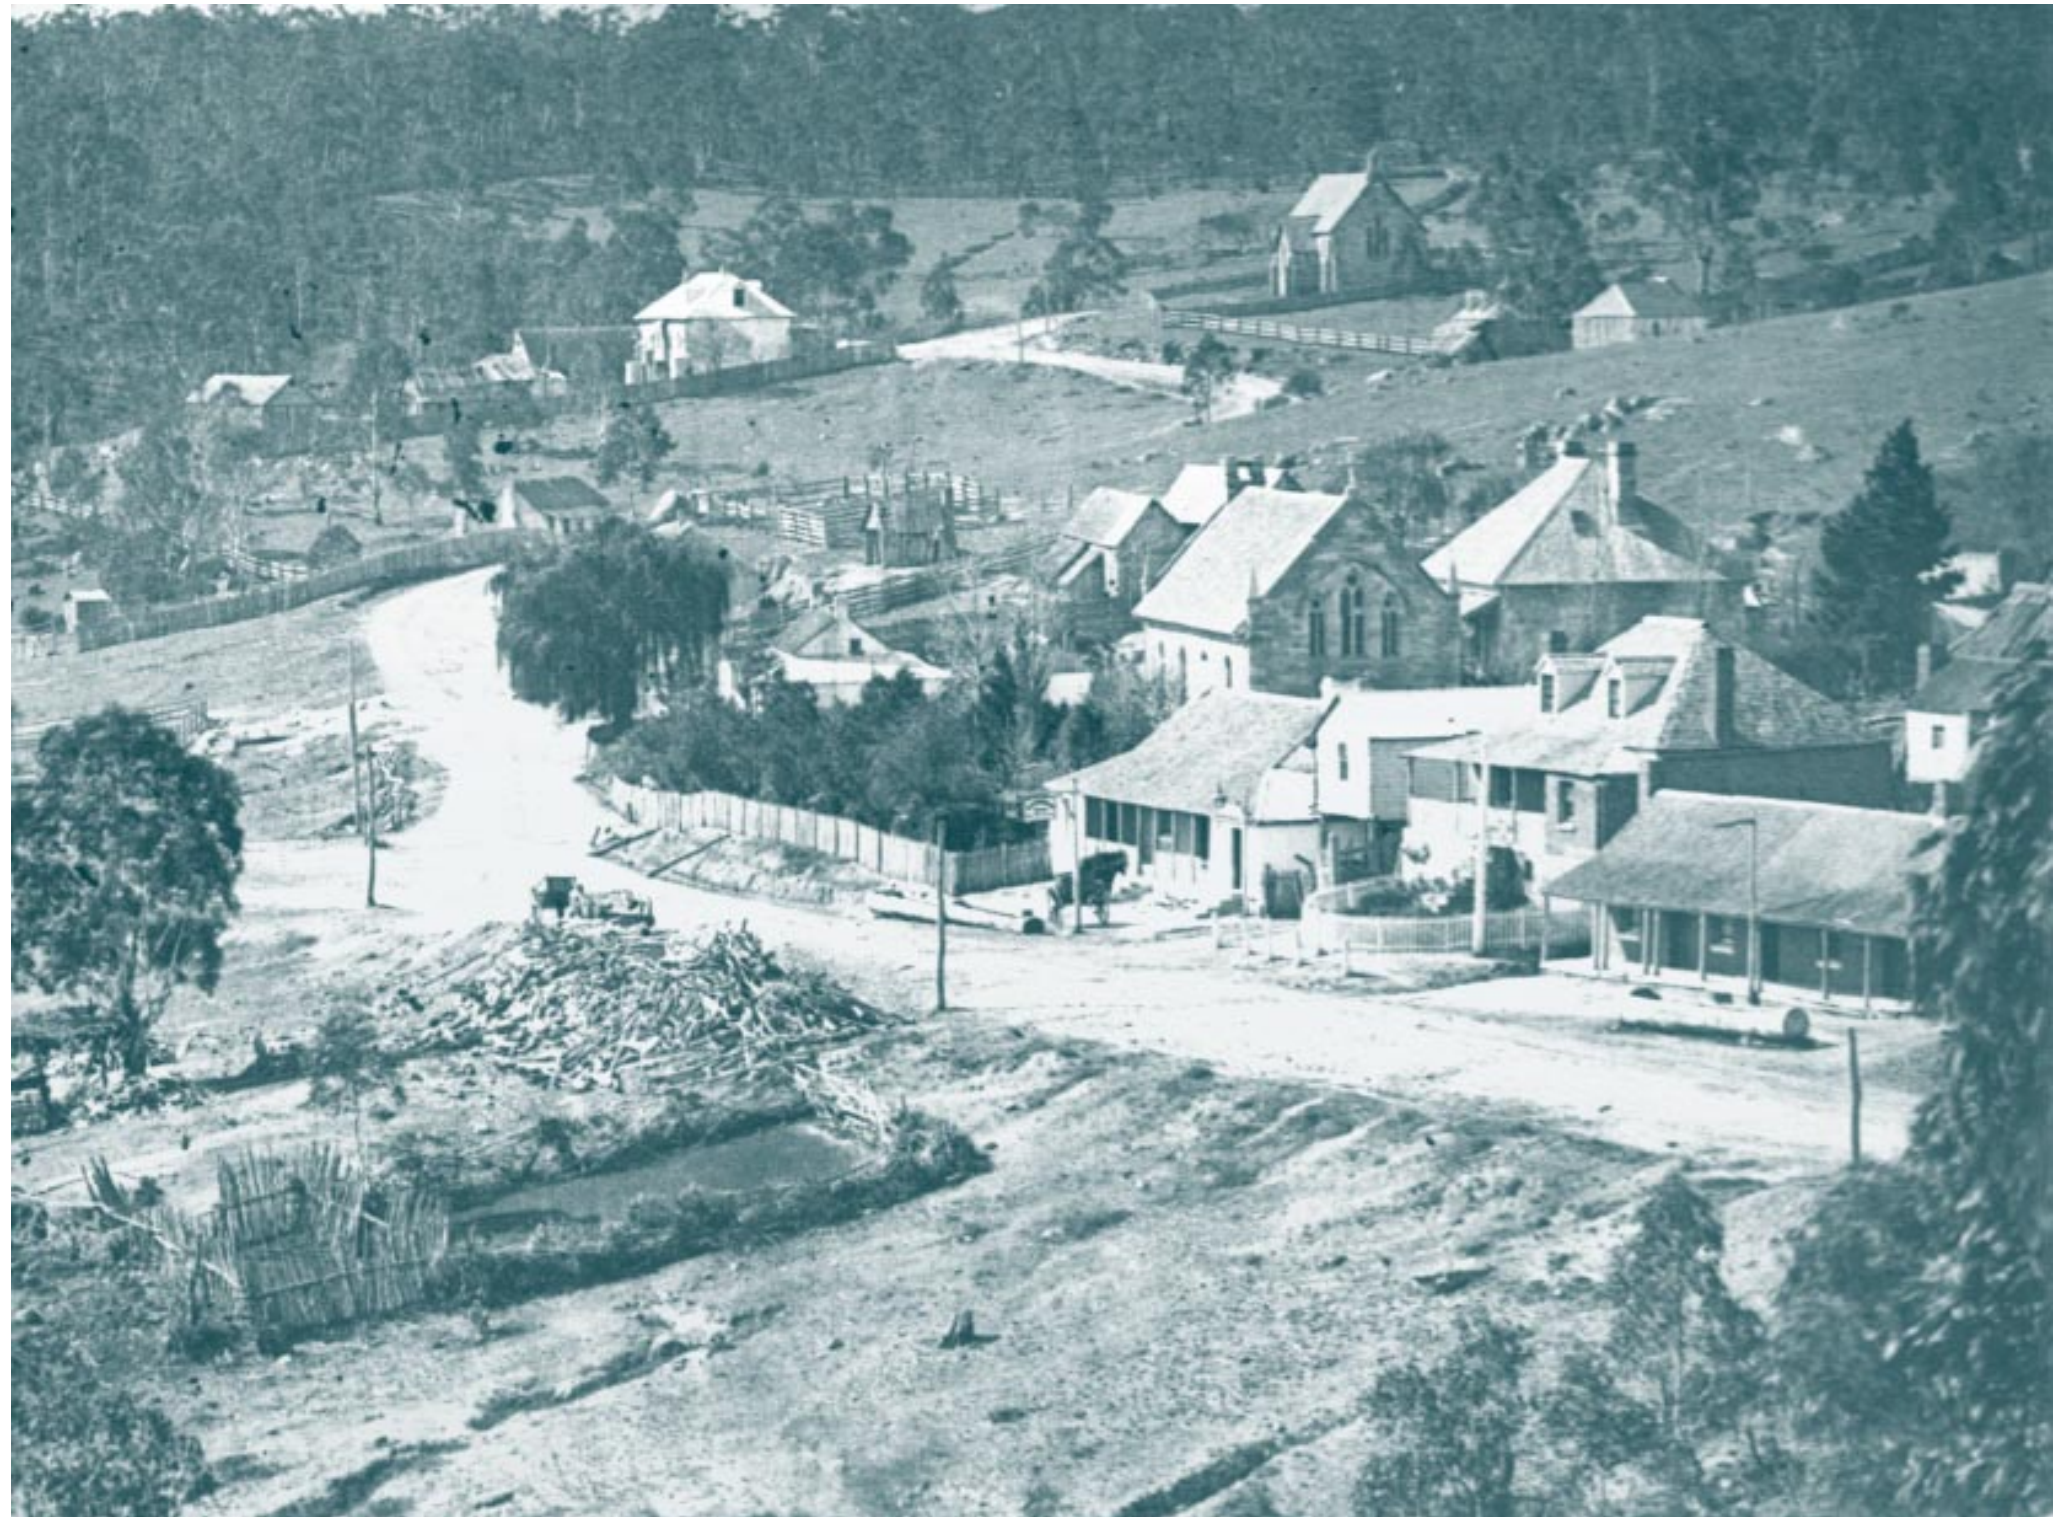
By contrast, there is a wealth of such detail in Holtermann's Hartley village photographic panorama taken during the 1870s. In Holtermann's panorama, native bush covers the hillsides surrounding the village in the distance. The town's most substantial buildings such as the two churches, the Royal Hotel, Ivy Cottage and the various inns can be seen, flanking the Great Western Road which winds down to the township from the northeast, through countryside largely cleared of native vegetation and divided into grazing paddocks with timber post and rail fencing. A stockyard stands in the middle ground on the hill behind 'Old Trahlee' (Old Trahlee is hidden from view by a large willow in front of the post office building). Residential buildings/farmhouses are mostly constructed away from the main road.

Panorama of Hartley, Holtermann
Source: ML Home and Away, Still 39895

Bark roofed slab huts stand out in paddocks along with isolated remnant eucalypts and rocky outcrops. There is a sense of openness in the village, as the native trees have been cleared from the paddocks and from the roadsides, and there are no roadside/avenue plantings. Apart from a willow in front of the Post Office, the trees in St. Bernard's churchyard comprise the only vegetation in the village centre. In the grounds of St. Bernard's there is a planting which appears to include several scattered deciduous trees and a row of five or so pine trees inside the Western Road boundary fence.

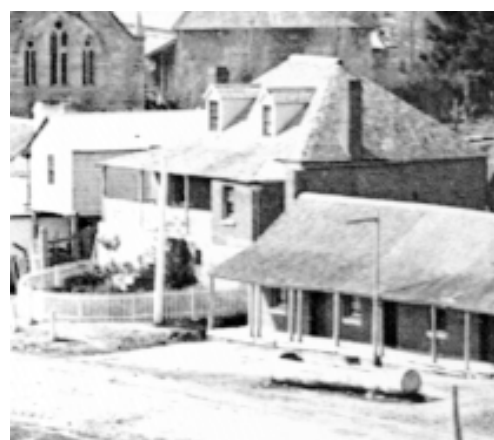
Detail of Ivy Cottage from the Panorama of Hartley, Holtermann c. 1875
Source: ML Home & Away Still 39895

In the 1870s Holterman photographs, five timber bollards form an edge between the footpath and the road in front Ivy Cottage. A small garden area with unidentified plants growing in it surrounds the foot of a steep set of steps up to the house. This garden is enclosed by an unusual waist high semi-circular timber picket fence. The bollards and fence do not exist in subsequent photographs; it is not there in photos of Ivy Cottage taken after the destructive 1895 fire. When the cottage was rebuilt in the 1930s, the replacement fence was neither timber picket, nor semi-circular, but ran in a straight line parallel to the edge of the highway.
