HARTLEY HISTORIC SITE CONSERVATION MANAGEMENT PLAN

PREPARED FOR THE NPWS
BY OTTO CSERHALMI & PARTNERS P/L ARCHITECTS

DECEMBER 2002 FINAL REPORT

Prepared by Otto Cserhalmi and Partners P/L
on behalf of NSW National Parks and Wildlife Service

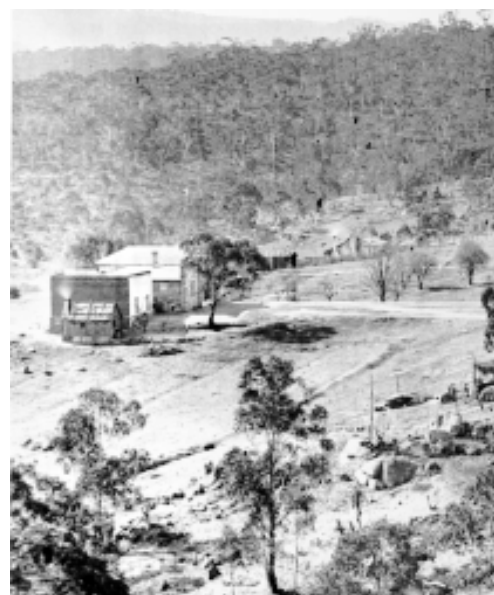
A lone Eucalypt casts its shadow in front of the lock up cells, which have been built against the south wall of the Courthouse. What appear to be a few willows or deciduous fruit trees can be seen growing in a large, sparse, fenced-in paddock in the dip/drainage area to the east side of the Courthouse.

Detail of Courthouse from the Panorama of Hartley, Holtermann. c. 1875
Source: ML Home & Away Still 39895

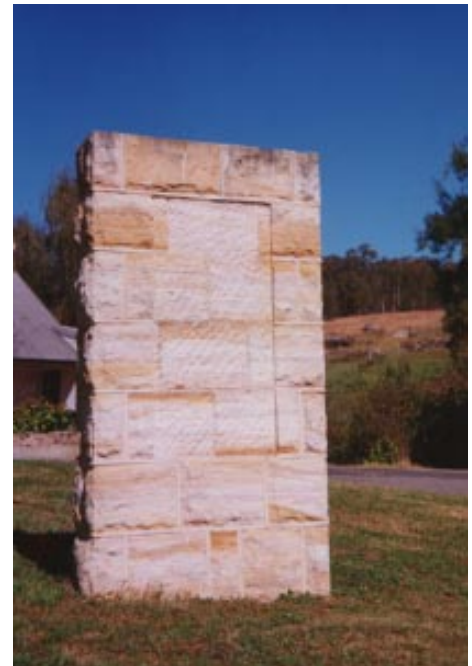
Stone plinth
Source: Gina Plate, November 2000

The Royal Hotel has recently undergone a program of conservation works, which reinstated the original configuration of the verandah and external openings, in so doing removing twentieth century modifications deemed to not be significant. The hotel retains its front garden, 1950s fenceline and relationship to the Great Western Road. None of the extensive complex of nineteenth century outbuildings survive, however a garage, dating from its uses as a motor hotel still stands. The foundations of a rear addition or outbuilding also survives, as the evidence of an earlier fence line (marked by a stone plinth in the front garden).

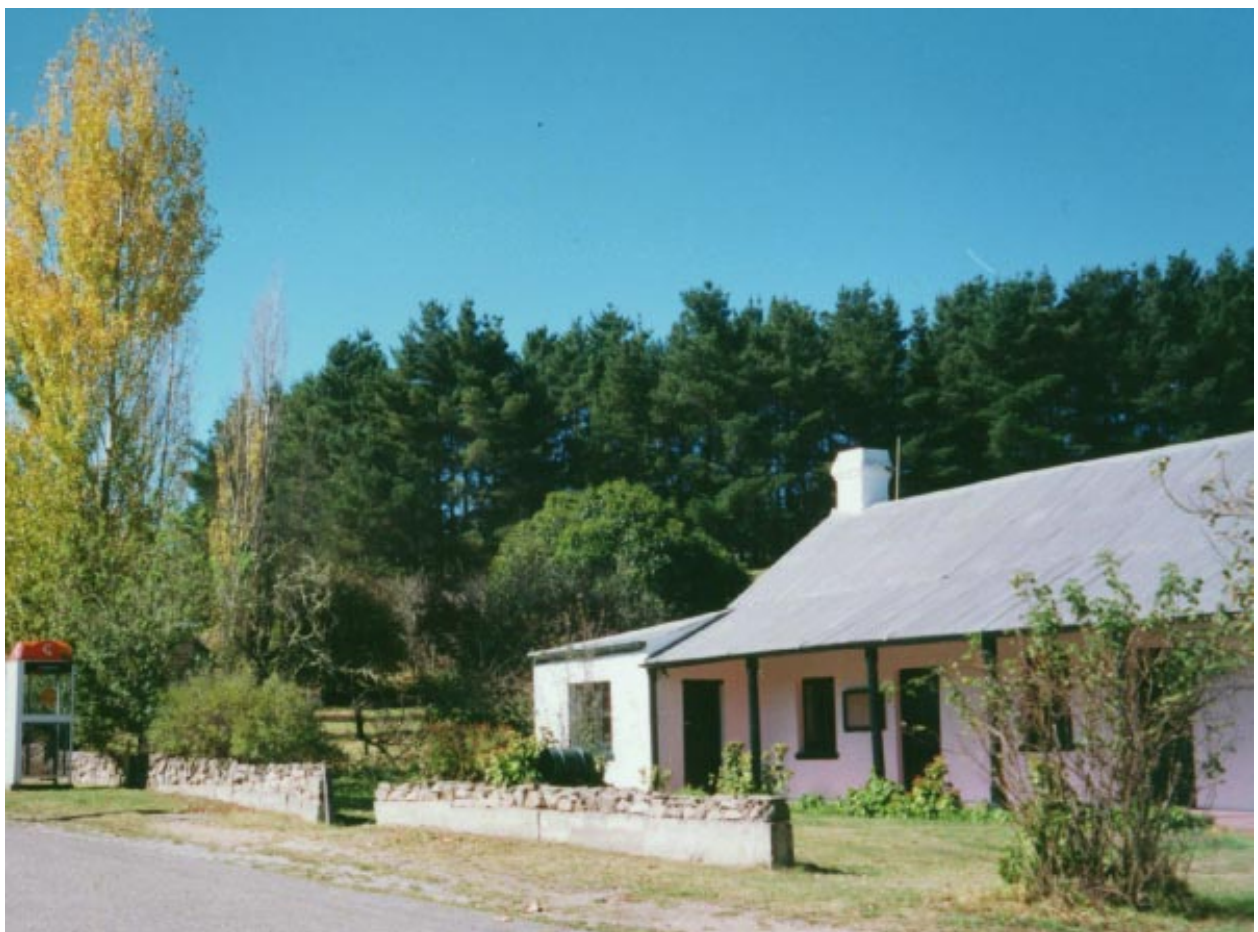
The gardens of The Royal Hotel and The Post Office and the Post Office orchard, which were never extensive, have dwindled so that only a few hardy trees and shrubs have survived.

Post Office with remnants of front garden
Source: Gina Plate November 2000

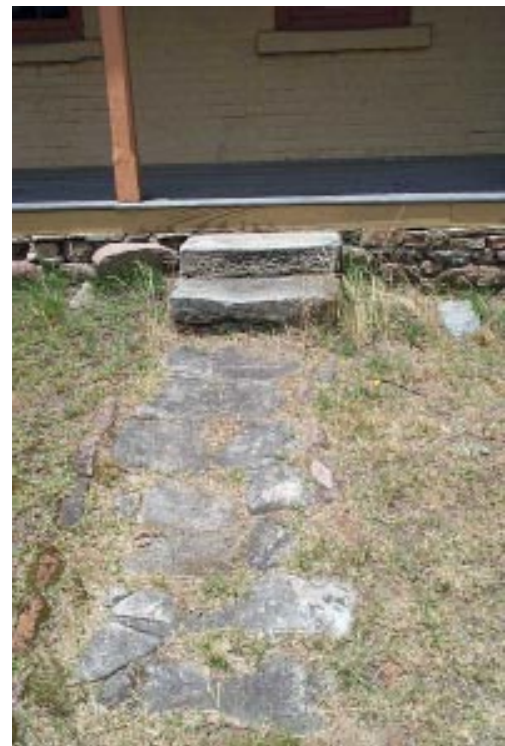
Photographs of Old Trahlee over time indicate that it probably never had much of a garden. The 1987 Public Works report includes a list of only 5 species of which only the Poplar survives now. The original, now sagging brick-edged sandstone flagged front path, and sandstone slab front steps remain. Moss growing in the driveway area at the northeast end of the house and in the front grassed areas, indicates that these areas suffer from poor drainage.

Old Trahlee original sandstone front path and steps
Source: OCP 2001

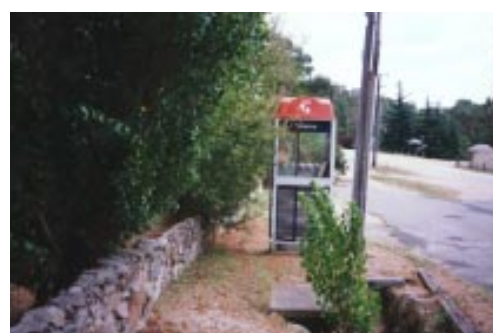
Telephone box in front of the former Post Office
Source: OCP 2001

There is also a gate in the southeast boundary fence, almost hidden by overhanging vegetation, which leads into the drainage/orchard area between the Post Office and the Presbytery. A contemporary Telstra Public Phone Box has been located in the nature strip outside the property boundary. No doubt its location was chosen as it is in close proximity to the erstwhile Post Office. The telephone box, of contemporary design and with a bright orange roof is incongruous and does not enhance the streetscape.

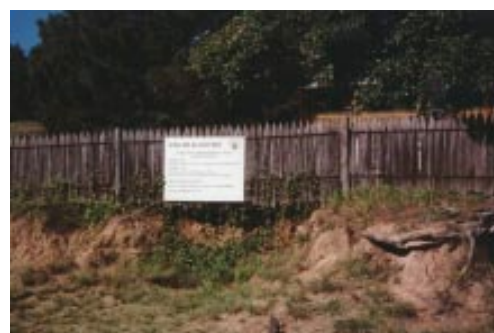
Possible location of photographers cutting in bank outside the grounds of St. Bernards
Source: OCP Jan 2001

There is a cutting in the roadside embankment outside the grounds of the church, but no sign to interpret whether or not this is the cutting made for the use of Hartley's commercial photographers as claimed in several previous reports.

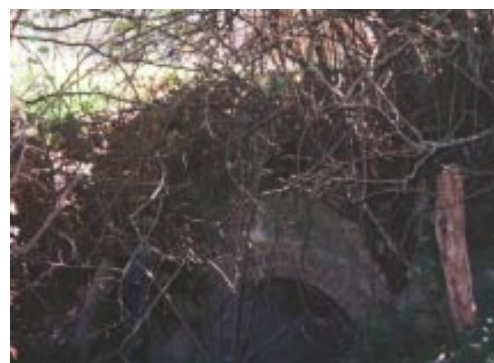
Stone culvert between Post Office and St. Bernard's Church is overgrown with vegetation
Source: OCP April 2001

The Stone Culvert on the east side of the under-road drainage pipe that drains the gully between the Post Office and the grounds of the Catholic Church, is overgrown and obscured by self sown fruit trees and hawthorns.

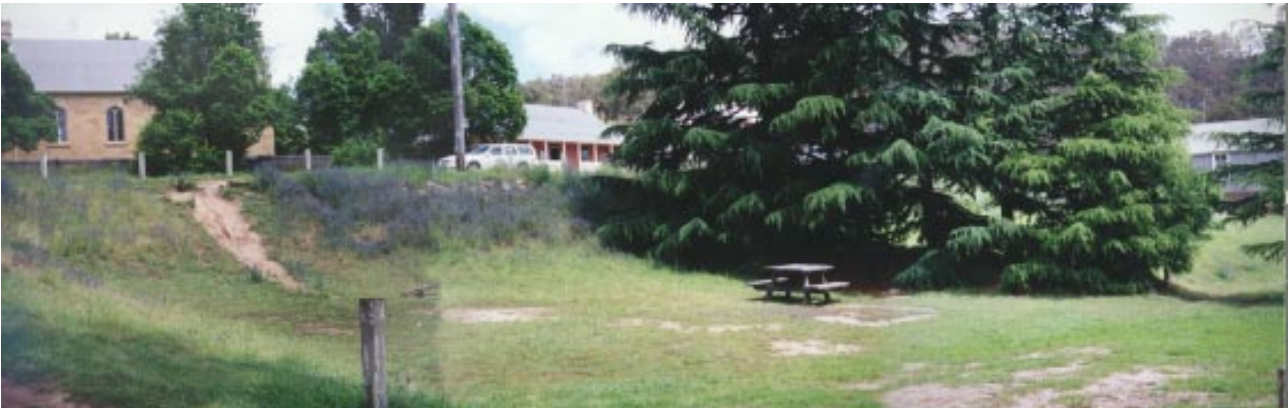
Picnic Area showing soil erosion
Source: OCP 2001

Pedestrians use the road to access the picnic area. However, school children climbing on the embankment below the road and above the picnic area has led to the slope being eroded. This eroded area is steep, slippery and there is a need to address health and safety issues. The picnic area receives considerable traffic noise from the Great Western Highway, and there is no tap for hand washing and drinking water. The water supply for the toilet block is pumped from the River Lett and is not potable.

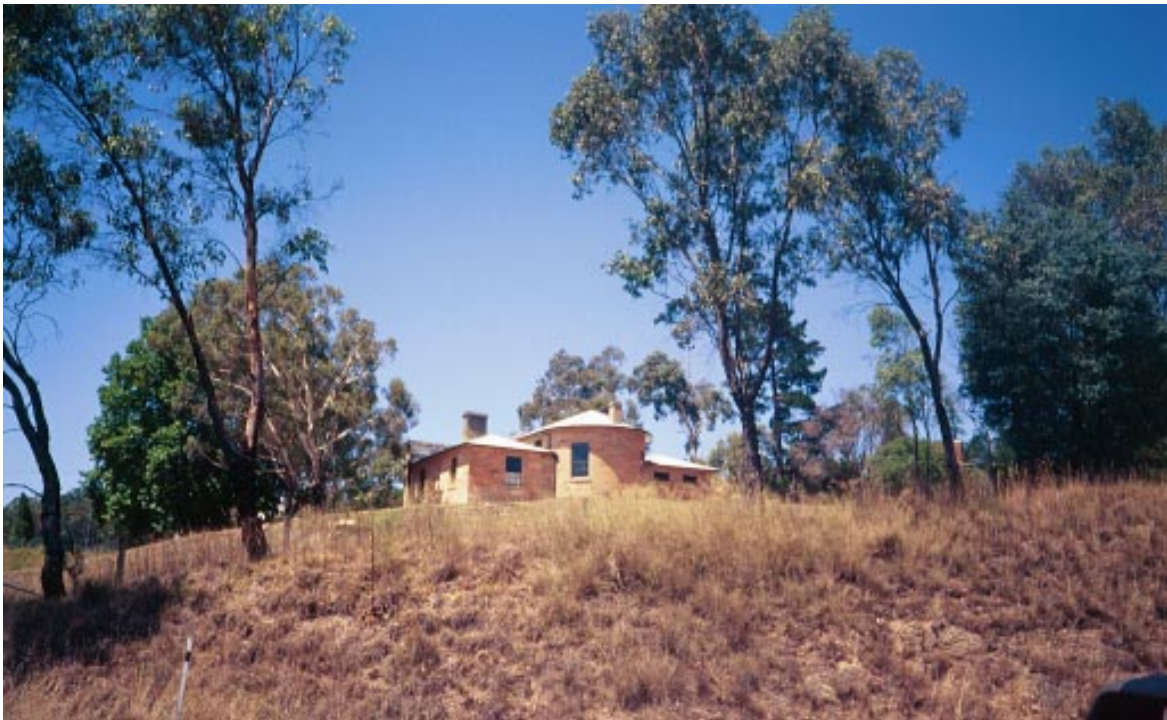
Current view of the rear of the Court House
Source: OCP Jan 2001

The extent of potential impact on any subsurface remains is unclear, however the retaining wall on the north side of the ladies toilet block appears to have been constructed using early sandstone masonry blocks. The source of these blocks is unknown, but could perhaps be the foundations of the stables building, if the source was nearby. Although the construction of the Great Western Highway has substantially removed adjacent Lots in Section 10, the Court House itself appears to have escaped significant incursions.

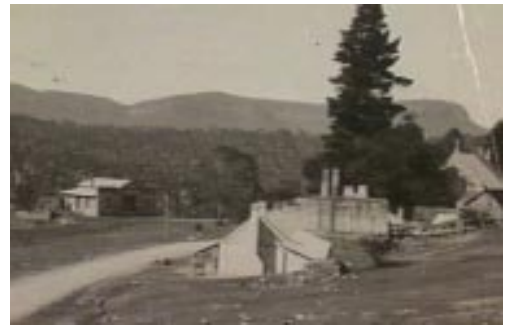
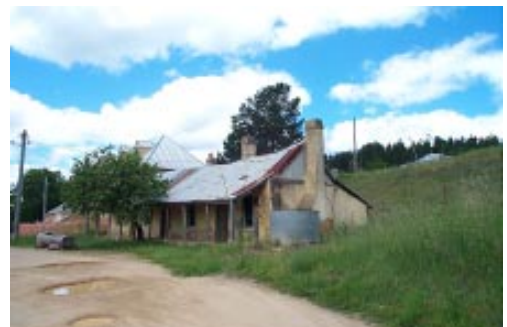
View of the slope adjacent to the Former Shamrock Inn during the 1920s (top) and today
Source: SLVic Still 08162, OCP Dec 2000

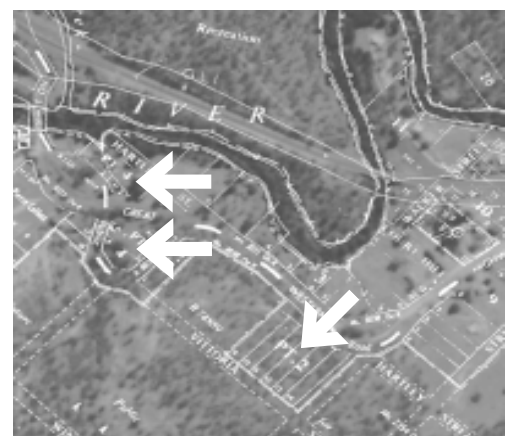
Overlay of Sections on the Aerial Photo, showing the location of Sections 2 and 4 (arrowed)
Source: OCP/Surveyor Generals Department

Both the present village configuration, and the Holterman panorama indicate that there was little westward expansion beyond the Shamrock Inn other than the known structures by the River Lett of Collitt's Inn, Morris Inn, a forge etc. on land currently in private ownership. However a photograph taken in 1879, looking back to the village from the River Lett indicates that this was not the case.⁵ The indications of housing in Section 2, beyond the Shamrock Inn invests this area with archaeological potential which should be further investigated. The photograph mentioned above of the 'Bark and Log House' thought to have been located on Lot 6 of Section 4, indicates a greater density of housing than indicated by the modern plan of the village. Although the incursions made in this part of the village by the road cutting will have had a significant impact on the associated archaeology, it is possible that some occupation evidence is retained in this area.

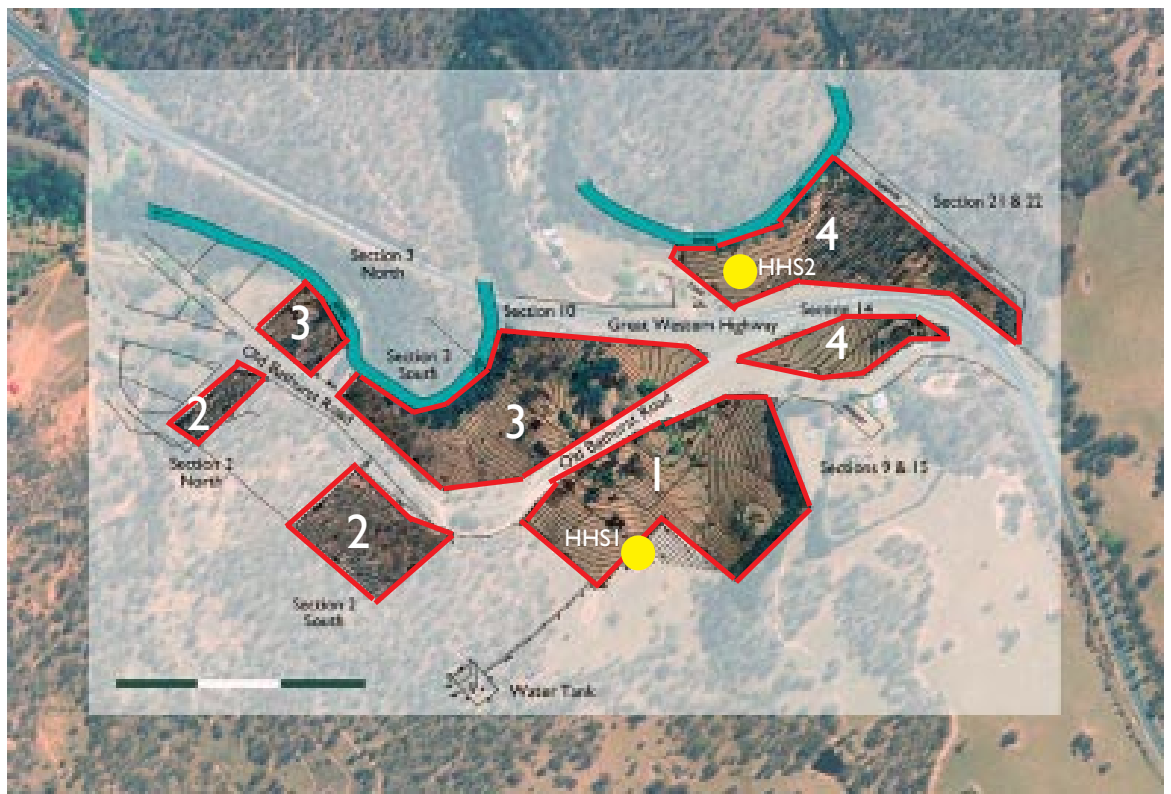
Plan showing the location of the Aboriginal Survey units with the locations of the Aboriginal Heritage Sites
Source: Dawala Lia/ NPWS survey overlaid on Aerial photo

Erosion scalds, and roadside banks and the bases of large trees were inspected for stone artefacts and other evidence of Aboriginal campsites. Well-established trees were checked for carvings and scars that result from bark removal (bark was used for making shields, coolamons or canoes). Exposed rock surfaces were inspected for engravings and axe-grinding grooves, and stone arrangements were sought wherever surface visibility permitted.

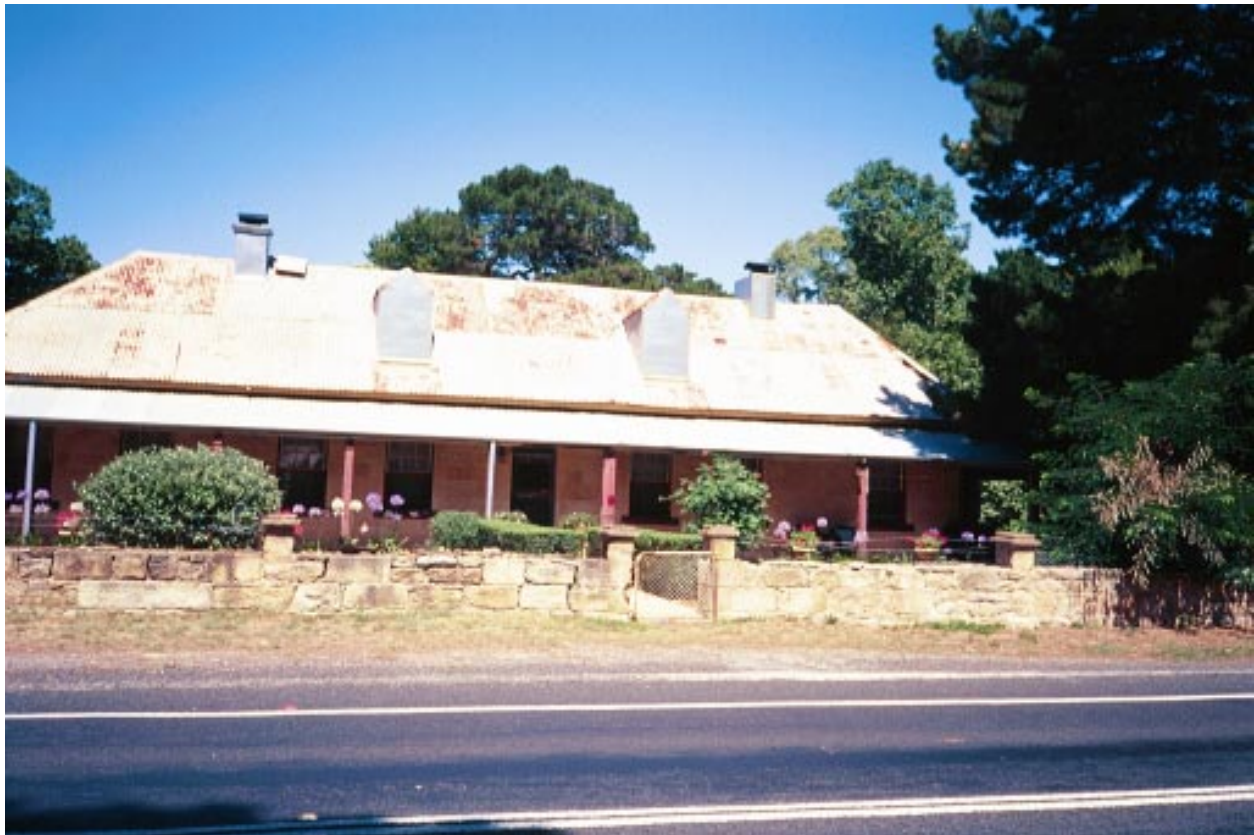
This former inn retains a large two storey stables building at the rear. Portions of the building, such as the dormer windows were sealed off until funds can be obtained to undertaken conservation works.

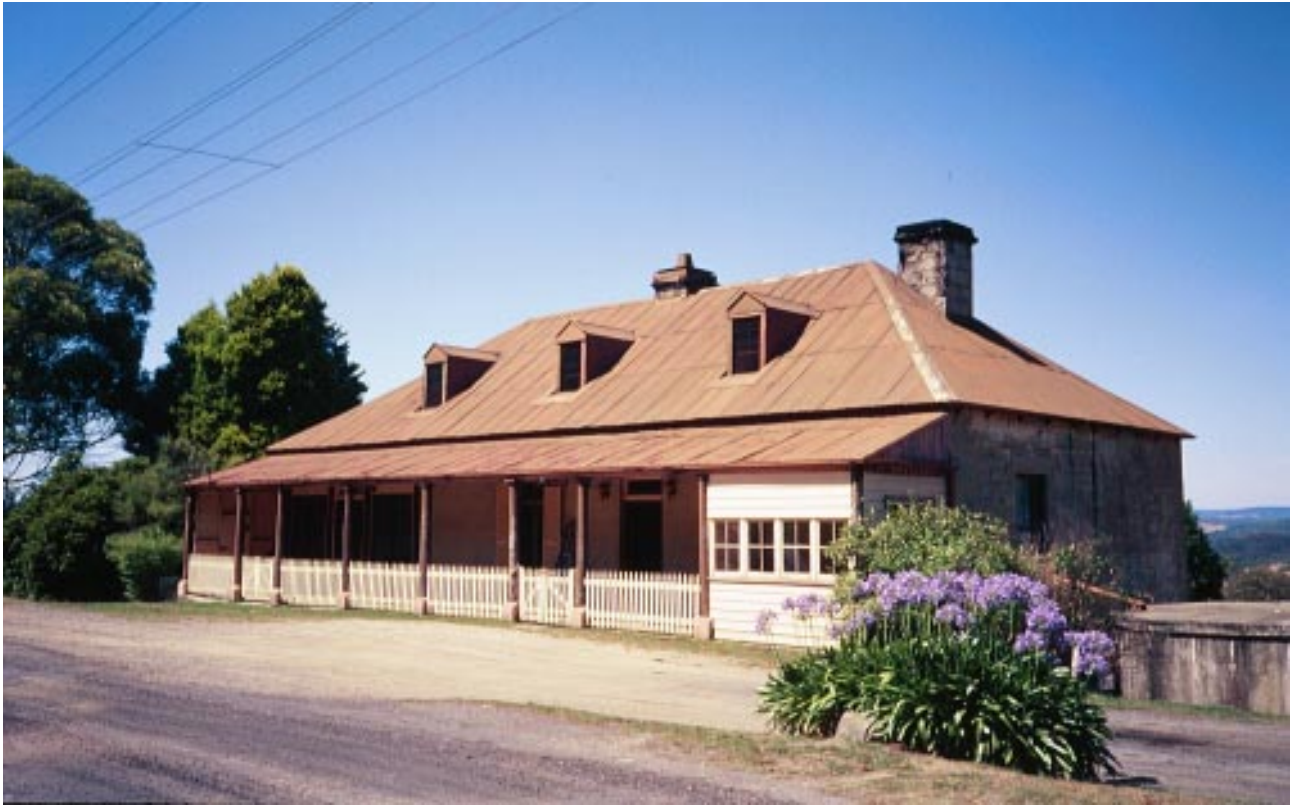
although the original shingles are still fixed under the iron. Three dormer windows are a prominent feature of the front elevation. Running the full width of the building is an eight bay verandah with fluted timber posts possessing capitals. The verandah floor is sandstone flagged.

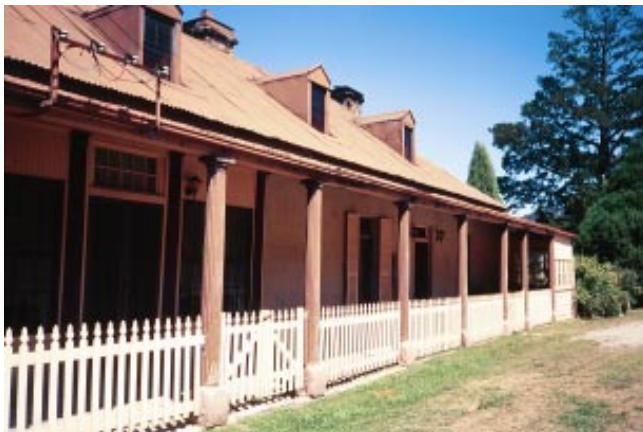
Current views of Ben Avon, Bowenfels
Source: OCP Jan 2001

Ben Avon is very similar in form and detail to the Royal Hotel at Hartley. It is not known to what extent the interior survives however there does appear to have been some fire damage in the past.

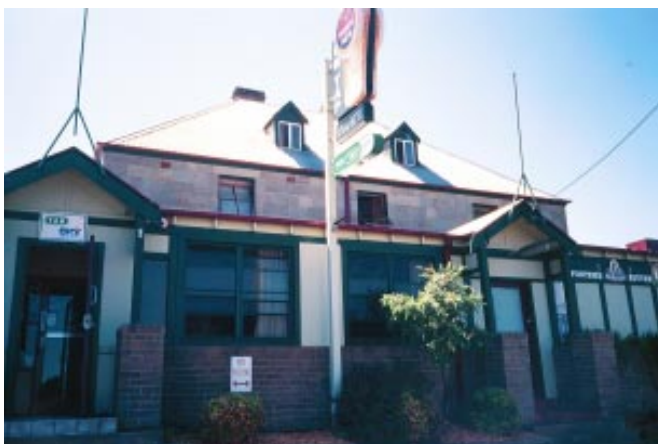
A current view of the Royal Hotel, Bowenfels
Source: OCP Jan 2001

The Royal Hotel at Bowenfels is a substantial two storey Colonial Georgian building constructed by Alexander Binning using sandstone quarried locally. It is one of the largest hotels in the group and is the only hotel or roadside inn still operating as a public house. This hotel was described by Colonel Mundy as being the best on the line. (Refer to the Historical Outline).

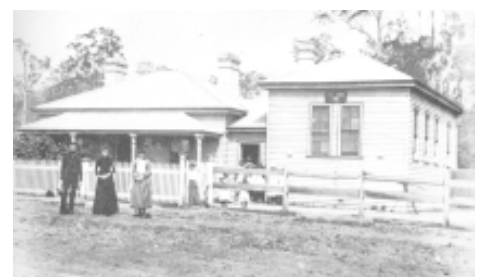
Wauchope Public School and Residence. The residence is very similar to the Mansfield's plan shown above.
Source: Sydney & the Bush

of tongue and groove and unlined. The schoolmasters residence is lined internally and any prefabrication is no longer evident.

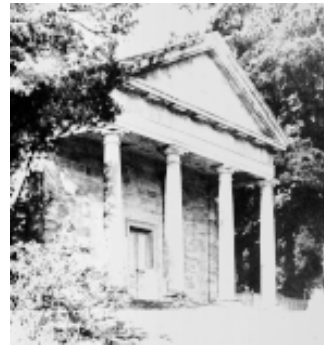
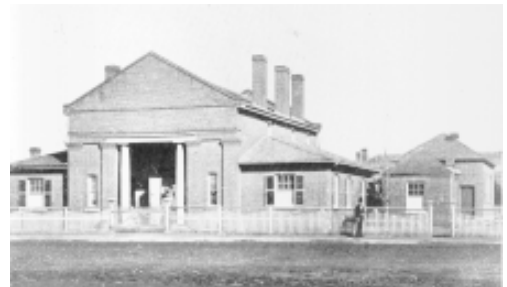
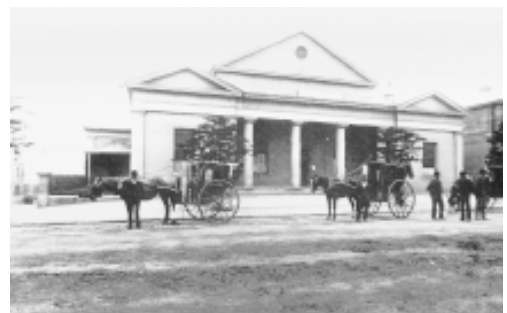
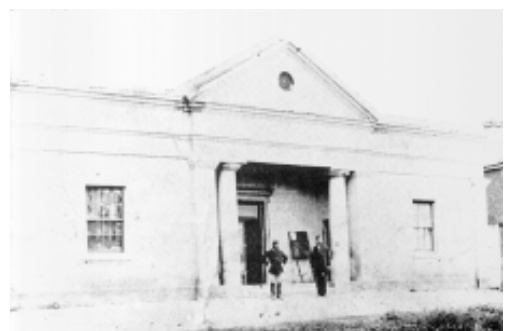
Mortimer Lewis' courthouses: Berrima, (top) and the three demolished courthouses: Bathurst, Newcastle, Yass

Hartley Courthouse features a temple front, with doric columns and pilasters. It is one of the earliest uses of a temple front motif outside of metropolitan Sydney, the other early example being Dalwood House at Branxton. Each of Lewis' courthouses including Berrima and Darlinghurst exhibit the same arrangement of a central courtroom, with the temple front and plain flanking wings. This symmetrical form, with the central court continued to be used by successive colonial architects until the 1890s when it was abandoned by Walter Liberty Vernon.

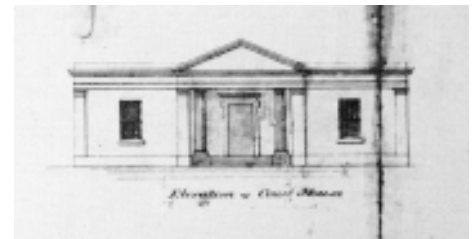
Plan and Elevation of Braidwood Courthouse. note the faint curve of the apse in the courtroom, and the layout of the furniture
 Source: Historic Courthouses of NSW

The plan of additions to Braidwood Courthouse prepared by James Barnet indicate that the building was initially very similar in plan and elevation to Hartley Courthouse, including the large apse to the courtroom. The building was demolished c. 1900 and a larger courthouse built.

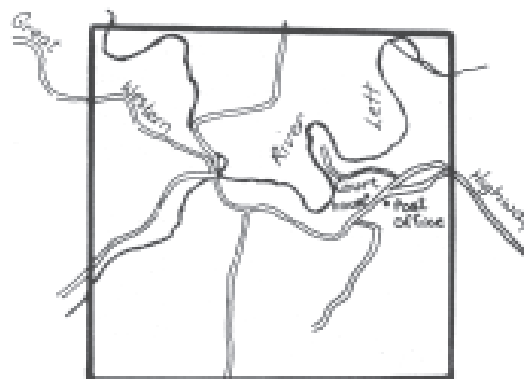
Sketch Map from the published Register of the National Estate showing the area covered by the listing

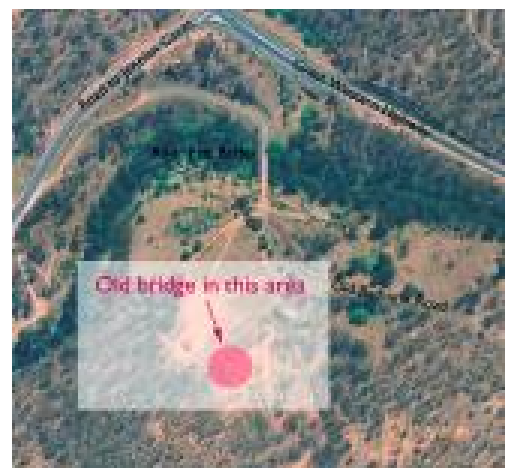
AREAS OF IDENTIFIED ARCHAEOLOGICAL POTENTIAL

The areas shown on the following plan have been identified as having archaeological potential. Whilst small scale investigations have occurred in conjunction with building works the individual portions still retain archaeological potential. The potential of the various portions has not been ranked, as investigations would contribute to a greater understanding of the place as a whole. The current philosophy regarding the conservation of

Note: the Bridge to the former alignment of the Great Western Road is not on the NPWS Estate
