Introduction To Rock Art Conservation

**A Guide to the
Preservation of
Aboriginal Rock Art**

Culture and Heritage Division

Published by:
Department of Environment and Climate Change (NSW)

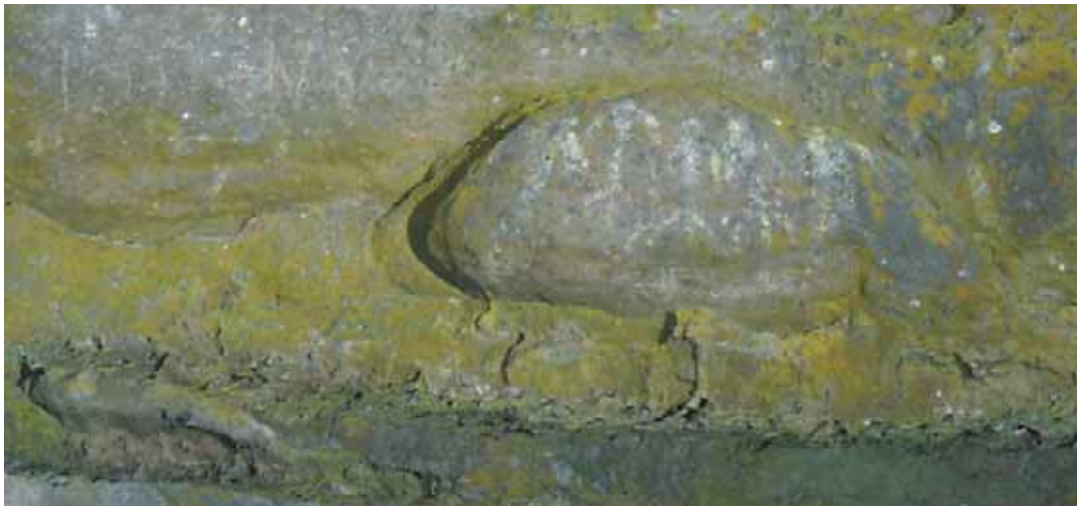
Plate 1: Dry lichen growth over paintings at Quiera in Morton National Park. Old photographs indicate that growth has significantly increased since the 1950s. Investigating the cause of such an increase informs the continuing conservation approach for this and other similar sites.

A long-standing example of dry lichen growing over rock art occurs at the Quiera site in Morton National Park (see Plates 1 and 2). A black and white photograph from around 1950 shows about half of the painted area of the shelter covered in dry lichen. By the 1980s, 40%–50% of the pigment had flaked off or been obscured. Clearly the dry lichen has been a feature at this shelter for a considerable time and, indeed, some of the paintings in white pigment are on lichen-covered rock. Changed conditions after fire opened up the understorey vegetation in the 1980s to allow more light and possibly moisture to the site which led to a dramatic resurgence of dry lichen growth. Clearing and grazing have also significantly altered the nearby vegetation and this may be a continuing factor in lichen growth.

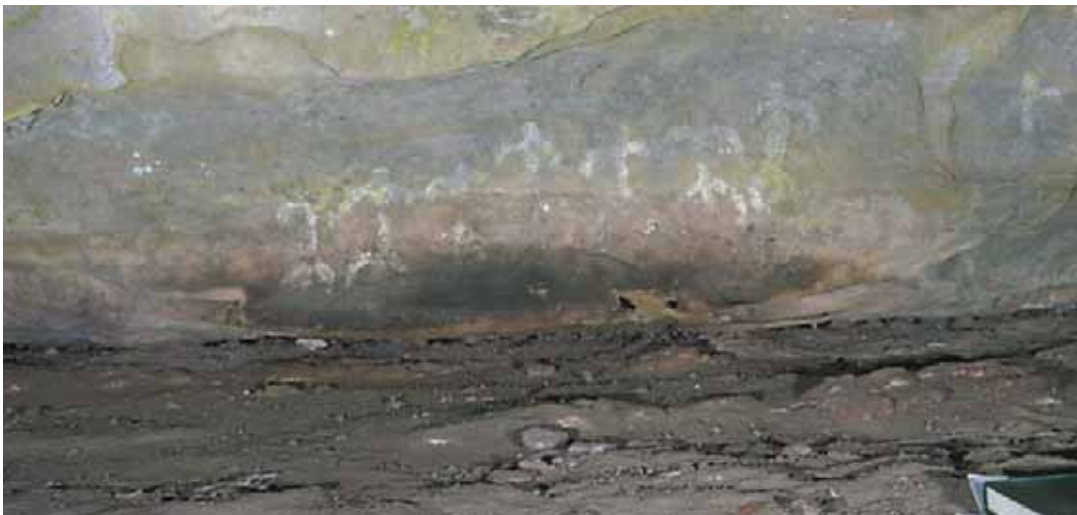
Plate 2: The same site after treatment for dry lichen. Note that it is difficult to completely remove dry lichen.

The dry lichen was loosened from the rock using bronze brushes followed by 100 mm bristle brushes. Because of the poor condition of the pigment and the weak pigment-to-rock bond, only very light brushing could be tolerated. In some areas of the shelter it was only possible to remove lichen adjacent to figures, leaving the loosely bonded pigment with some lichen still attached. The last step was to wash both ends of the shelter where no art was present to obtain more complete lichen removal in these areas.

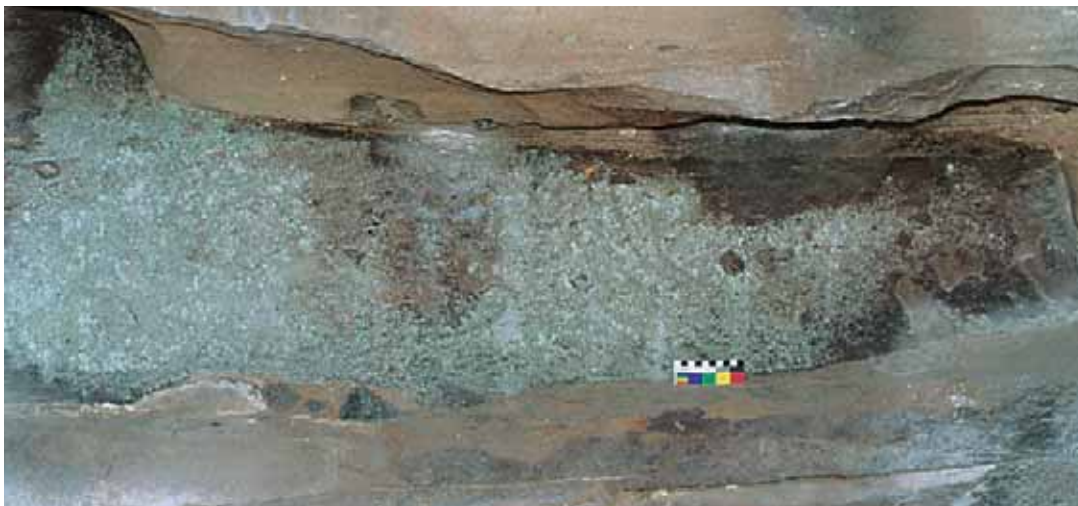
Plate 3: Dry lichen growth in a shelter at Gnatalia Creek. The dry lichen was near to, but not directly over, the rock art.

Dust lichen was removed at Gnatalia Creek, west of Nowra, in 2002. This is a damp site where a natural silica layer plays a valuable role in preserving the rock art. The lichen bloomed after fires, which burnt through the area. The dry lichen was starting to encroach onto the art and was easily removed by dry brushing before it was able to take hold (see Plates 3 and 4).

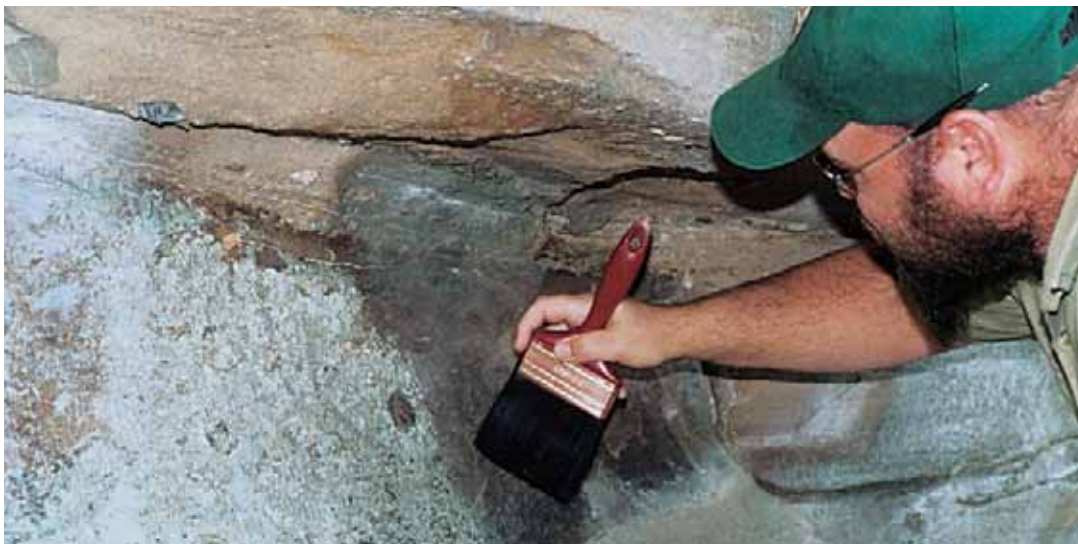
Plate 4: Dry lichen at Gnatalia Creek being removed by dry brushing. This work was carried out in 2002 and followed recent fires.

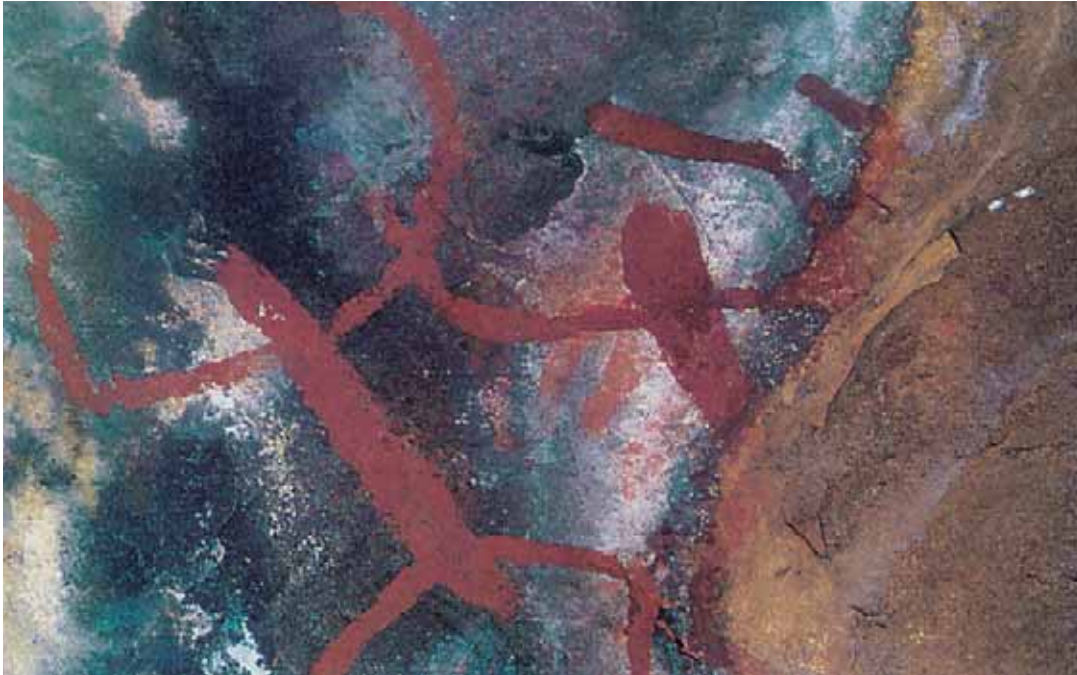
Plate 7: This painting site at Mt Grenfell, near Cobar, shows motifs which have been sharply cut by surface flowing water, and indicates the need for driplines. Note that the clean rock area to the right of the photo marks the area of surface water flow.

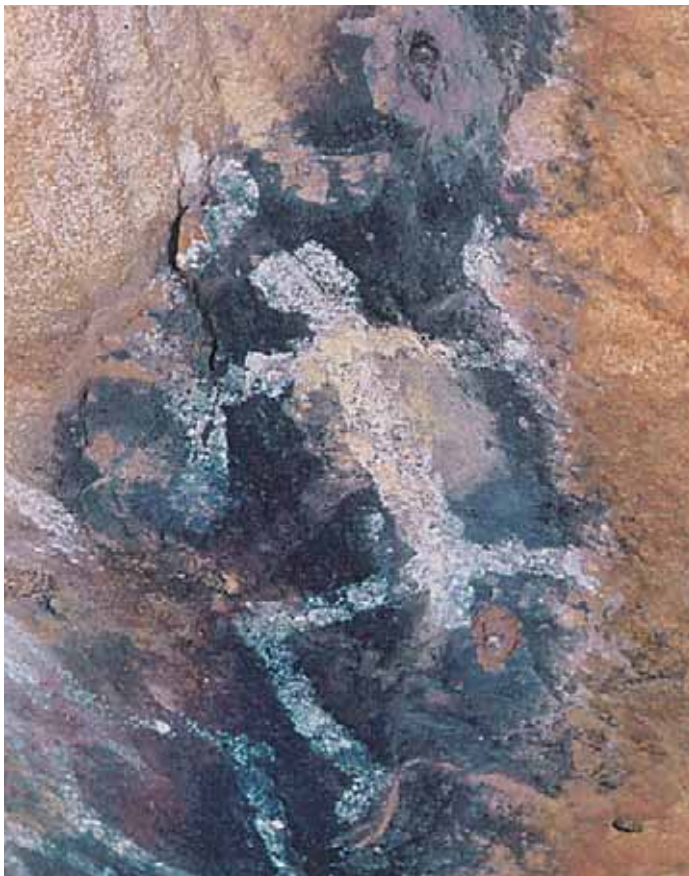
Plate 8: This example, also at Mt Grenfell, exhibits classical evidence of surface water erosion where a dripline is most appropriate. The clean rock zone at both sides of the photo is the area of water flow. The permanently dry area containing art is located in the black zone (centre), and is bordered by a white salt zone which is often the hydrated form of the black material (calcium oxalate).

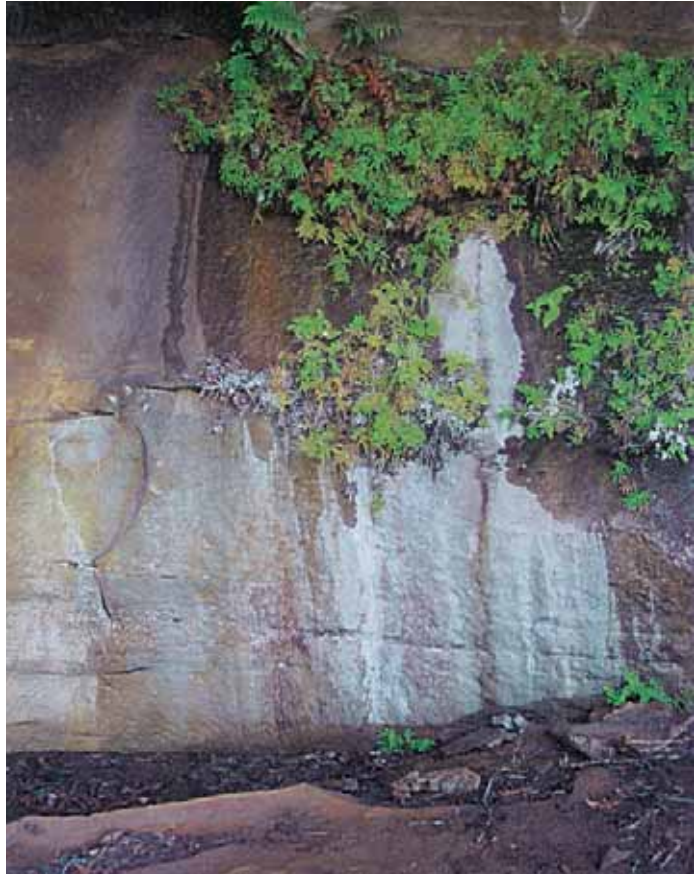
Plate 9: This shelter shows silica mineralisation being deposited on the rock surface by seeping water. At the left of the photo, the covering is only light and is helping to preserve the rock art. To the right of the photo where the water flow is longer lasting, the silica layer is thicker and pigments are much harder to see.

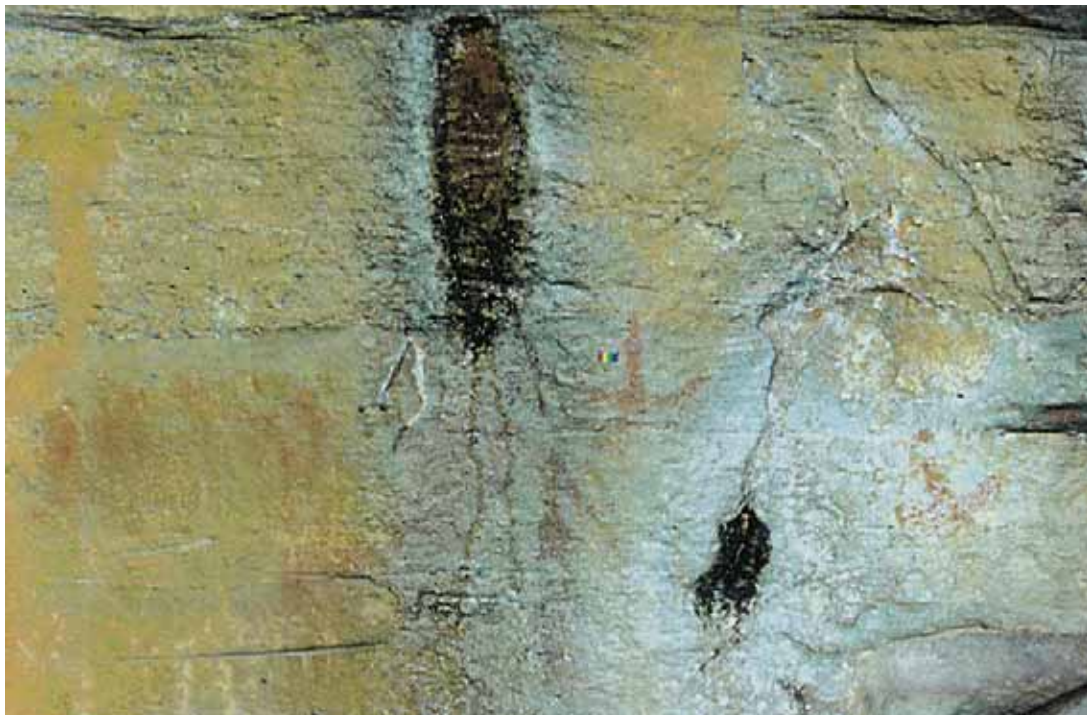
Plate 10: Another example in the same shelter, however this time the water is seeping from a point source where some iron salts mix with the silica resulting in a brown stain near the source.

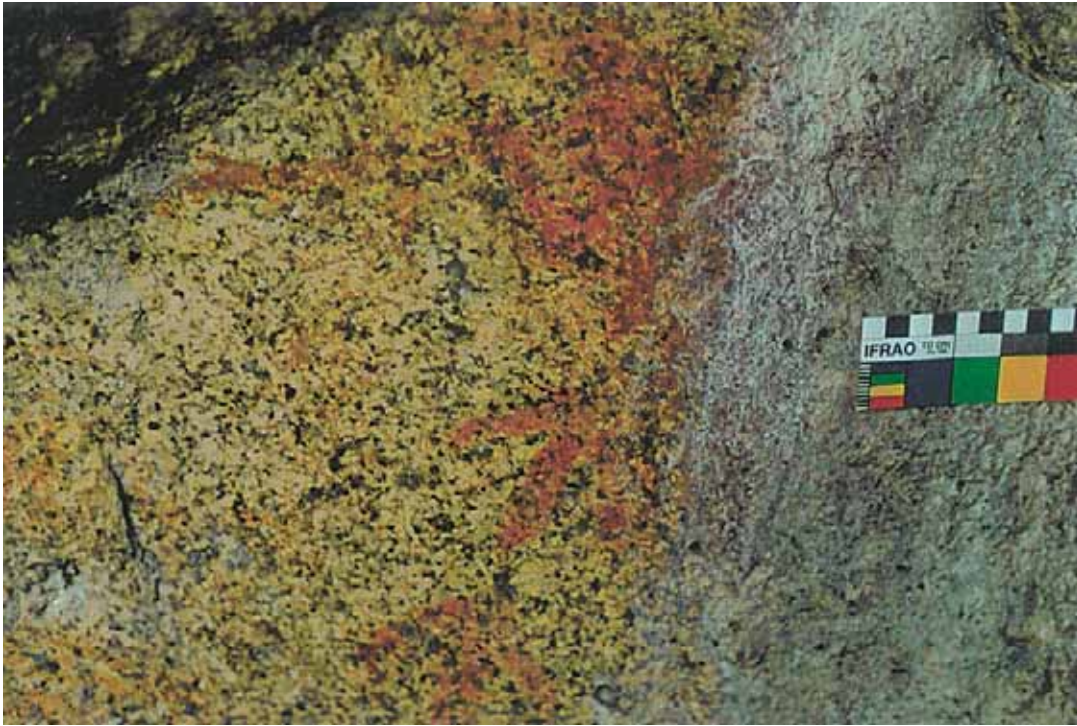
Plate 11: A second example of seepage from a point source bringing a mixture of minerals covering the art. This example is in a granite shelter at Back Creek near Inverell.

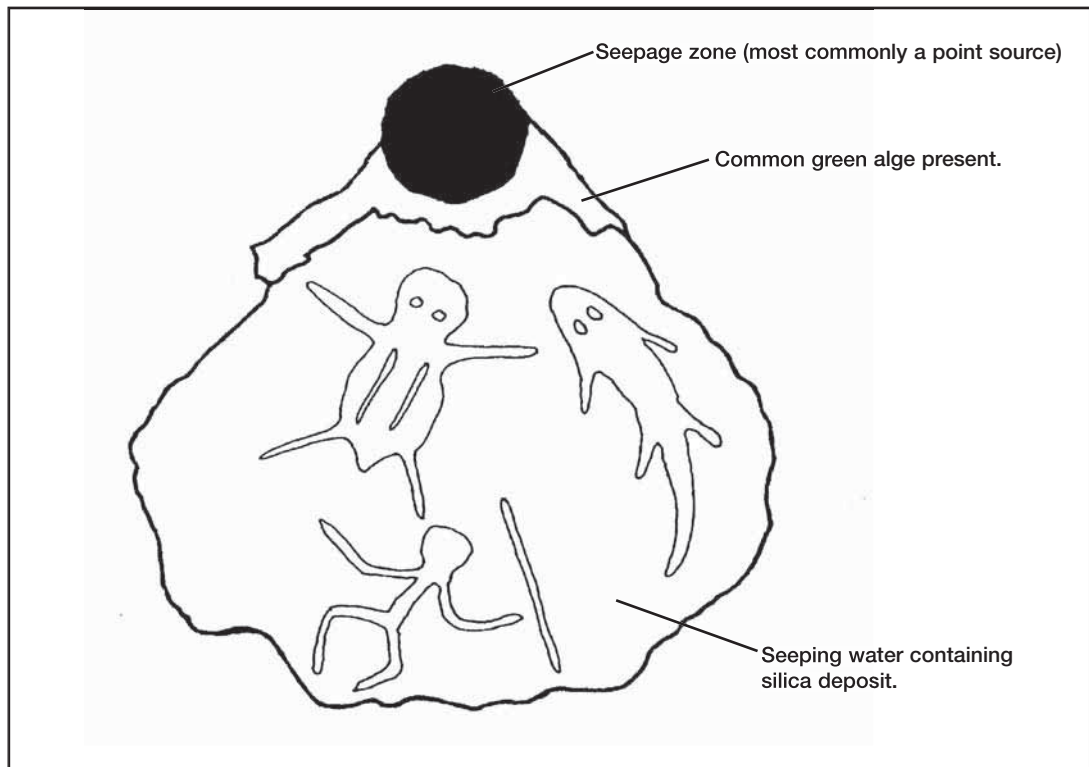
Figure 2: Detail of seepage zone.

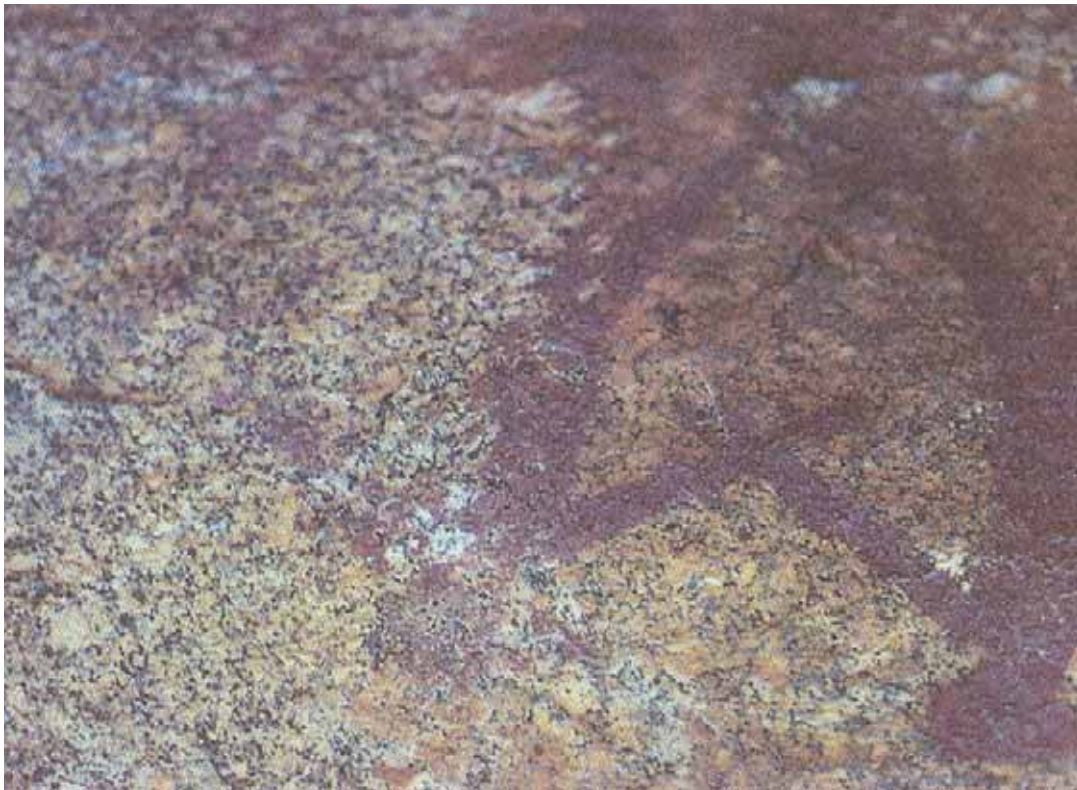
Plate 12: It is considered that the damage to this site is predominantly caused by frost. Freshly pitted rock occurs adjacent to undamaged motifs. There is no sharp vertical line cutting figures as displayed by surface water flow.

Whereas frost weathering is an area of major concern in cold countries like Canada (Wainwright 1985:25), there is no documentation of it at Australian sites. Observation at sites in the colder climates of the Snowy Mountains and New England areas in NSW would confirm whether frost damage plays a role in site deterioration. Water and green algae have been found behind rock flakes in granite boulder shelters in these locations and frost damage may result. The type of damage caused by frost is shown in Plate 12.

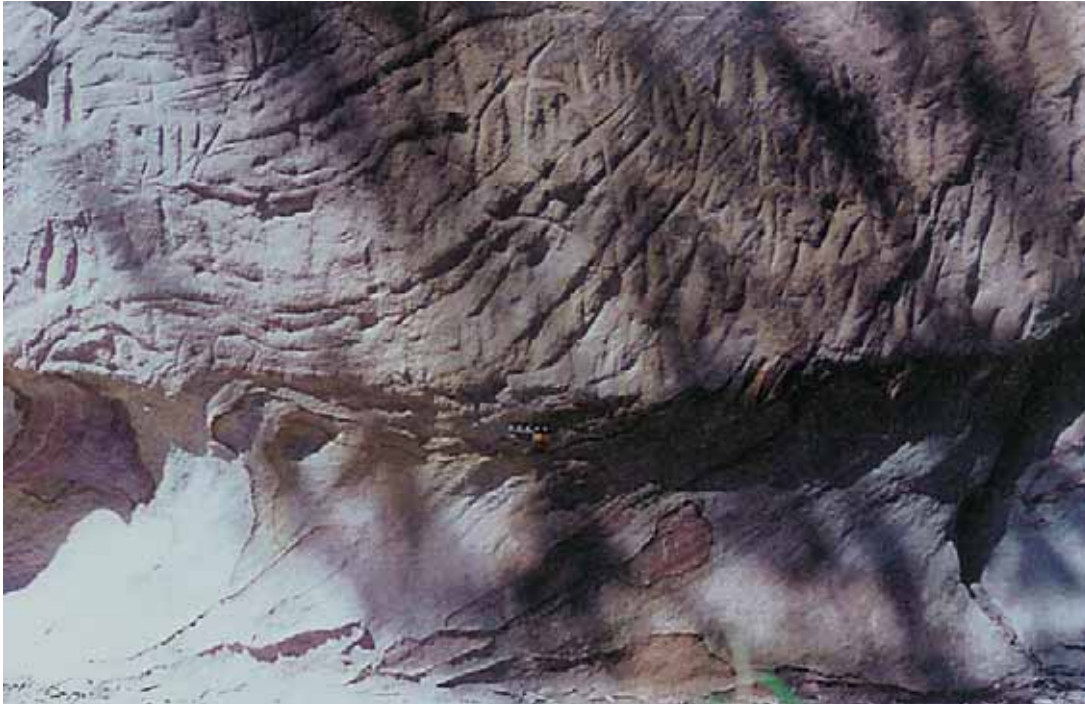
Plate 14: Salt weathering undercutting engravings at Pilliga Nature Reserve north of Coonabarrabran.

The rate of erosion of sandstone due to salt is high and of the order of 0.1 mm per year (Lambert 1980:32) making salt erosion a major factor in the weathering of sandstone shelters (see Plate 14). It is also interesting to note that salt decay is also prevalent in inland shelters.

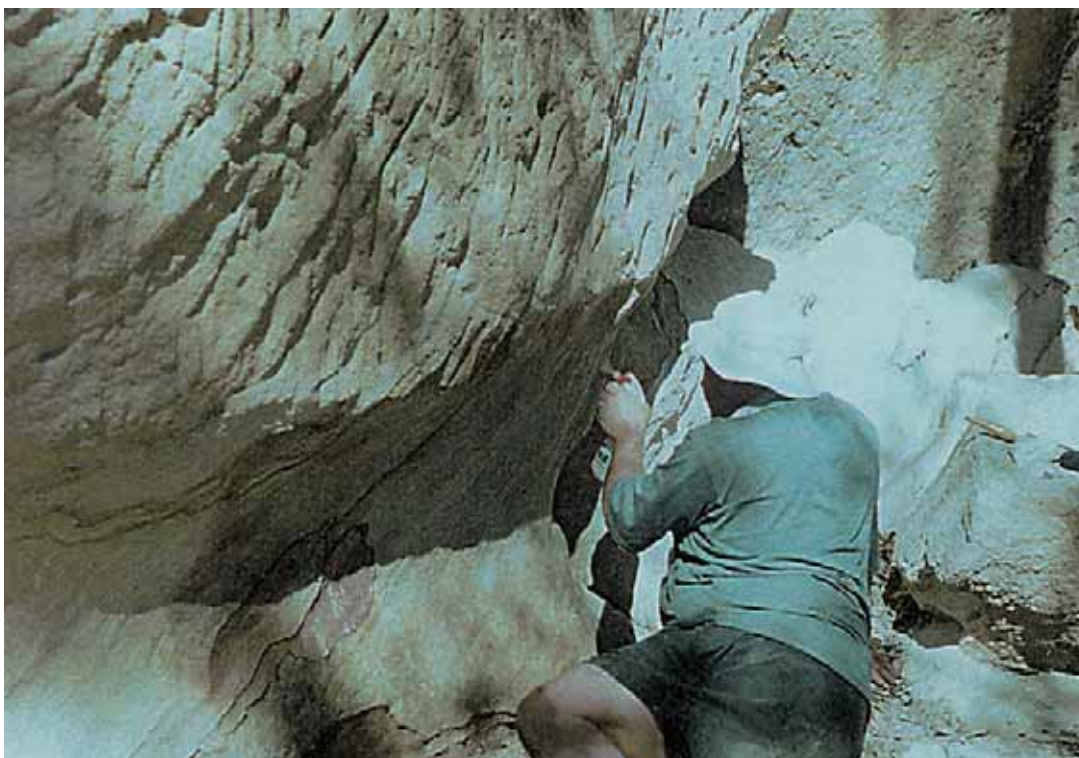
Plate 15: Spraying water on a salt-affected area at the above site as a trial to see if weathering is reduced. Note that the sandstone here becomes friable when wet so a very light spray is required to avoid further erosion

At sites in the Pilliga Nature Reserve north of Coonabarrabran the weathered sandstone runs much deeper than in other areas of the state (see Plate 15). Applying water to sites in this area is not recommended as wetting the affected stone results in it becoming extremely soft. More work is required in this locality in order to better understand the localised salt problem (see also Section 3.3.3).

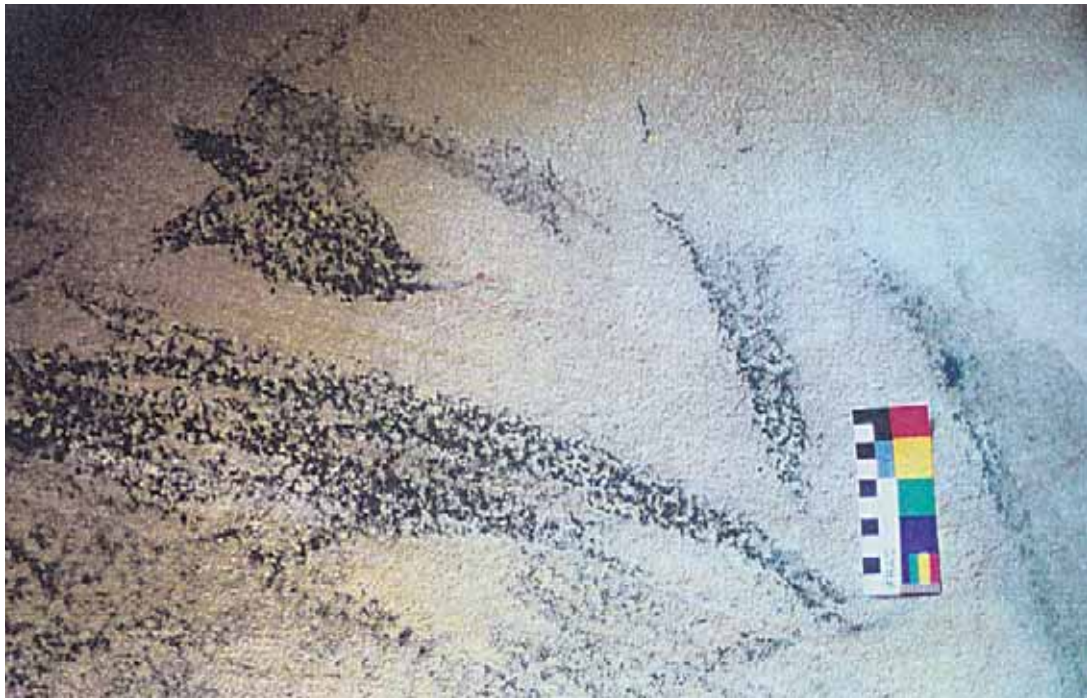
Plate 16: Monitoring photo of suspected salt weathering of charcoal drawings at Popran National Park. This monitoring photo will be retaken to ascertain whether a washing treatment is justified. If further damage is evident in the repeated photo then treatment using water spray and long fibre paper will be undertaken. Monitoring can continue to determine if the treatment has been successful in stopping the erosion.

Washing of dry pigments used in drawings can result in some pigment loss. Accordingly it may be preferable to monitor the site prior to treatment. Salt weathering can be rapid so monitoring may only need to be carried out over one or two years in order to be certain that treatment is warranted. Plate 16 is a monitoring photo of suspected salt weathering causing damage to charcoal drawings at a site in Popran National Park north of Sydney which will be retaken to

ascertain whether a washing treatment is justified. If further damage is evident then the site will be treated using the above techniques. Monitoring photos can then be retaken a year after treatment to confirm whether the treatment has worked.

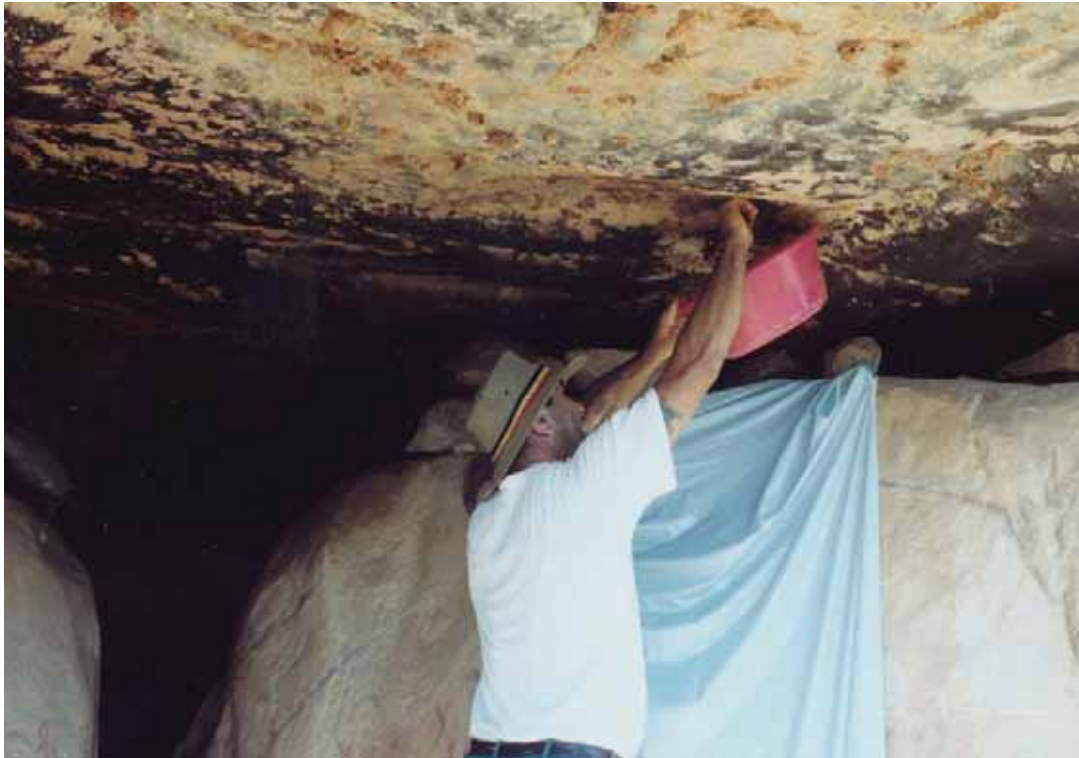
Plate 17: Swallow nest and associated droppings being removed at Wuttagoona, near Cobar NSW. Note that drop sheets used to reduce dust coming into contact with art.

Where the site cannot be washed without damaging the art the result will be less effective. Dry brushing can be tested on a small trial area, but may not be viable if smudging results. Plate 17 shows this procedure being carried out.

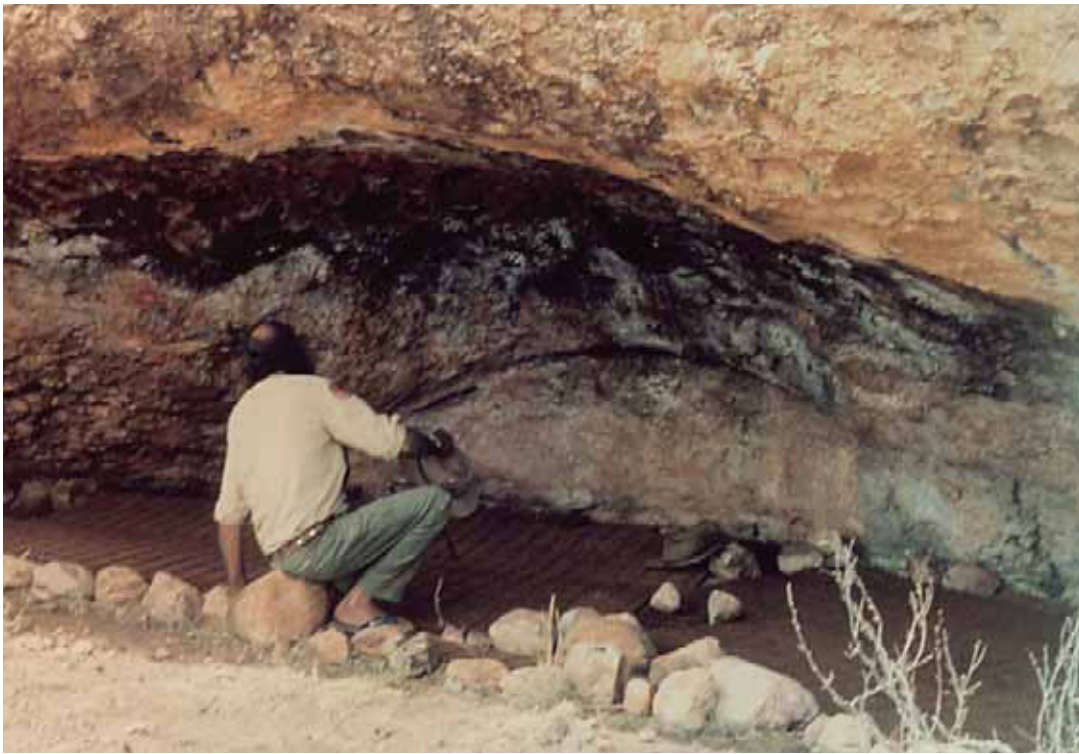
Plate 18. Inspection of the site and floor grid at Moonavale near Broken Hill. A small amount of goat dung was still evident after the grid had been installed and this was attributed to the grid not being raised off the ground.

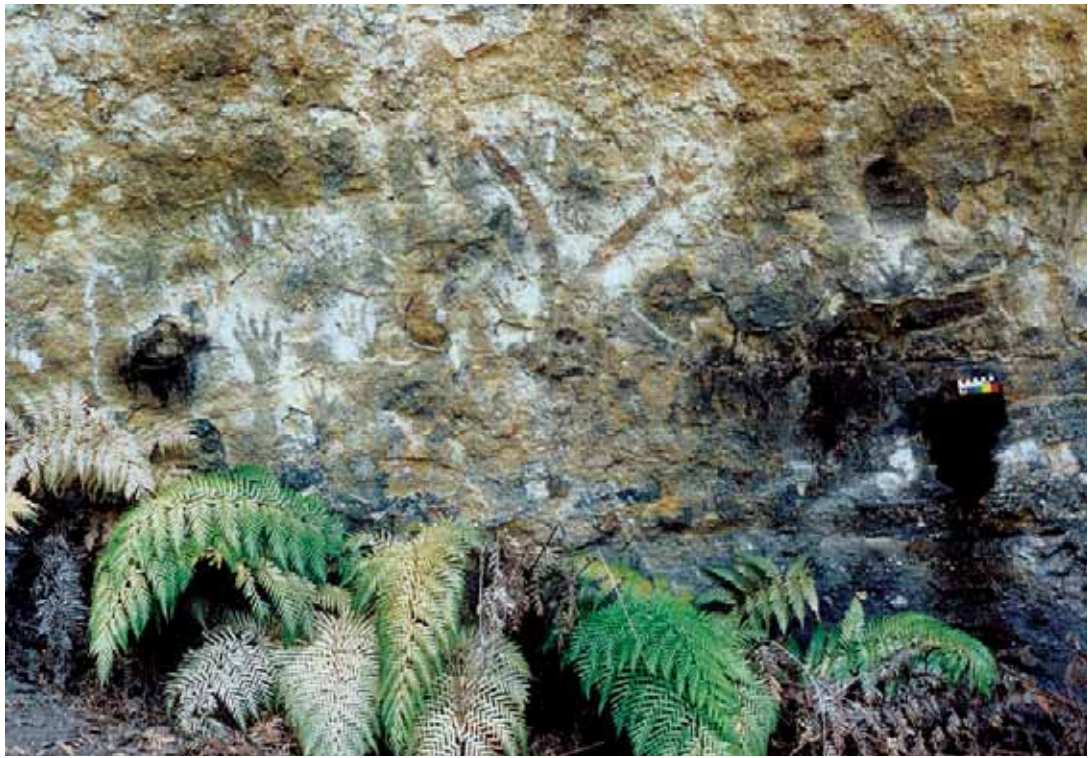
Plate 20. An example of vegetation growing too close to a site at Blackfellows Hands near Lithgow. Unchecked, direct rubbing of the rock surface will eventually damage the art at this site.

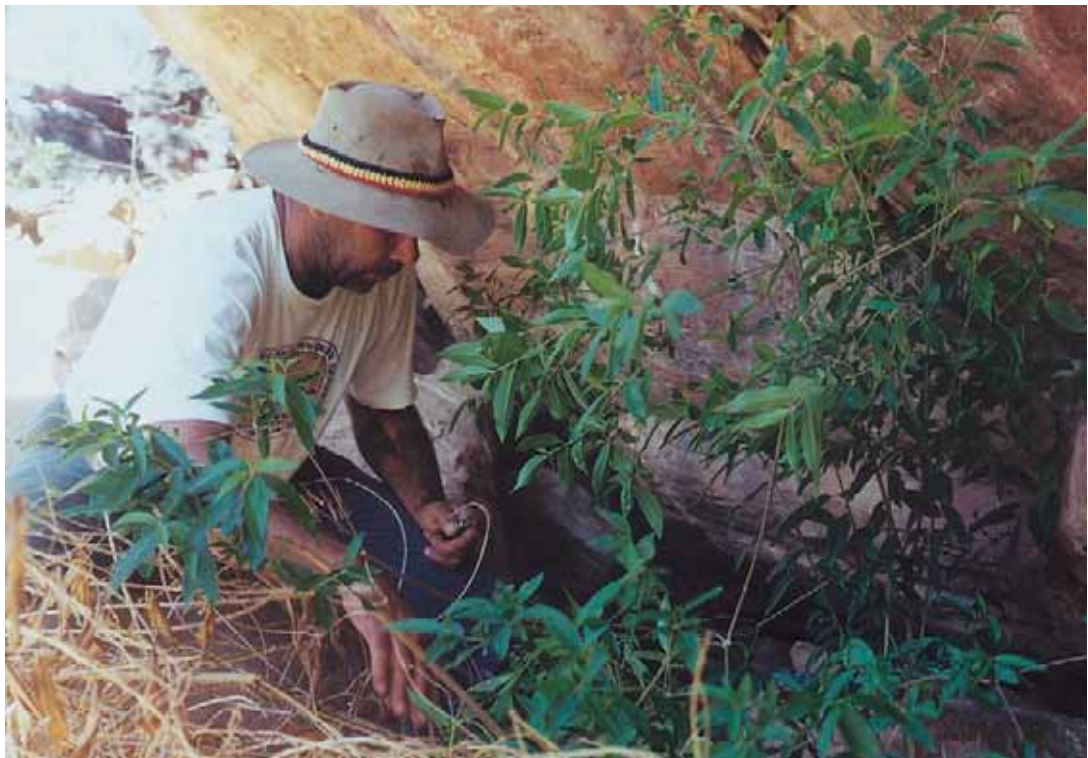
Plate 21. Removal of vegetation inside a goat exclusion fence at Wuttagoona near Cobar.

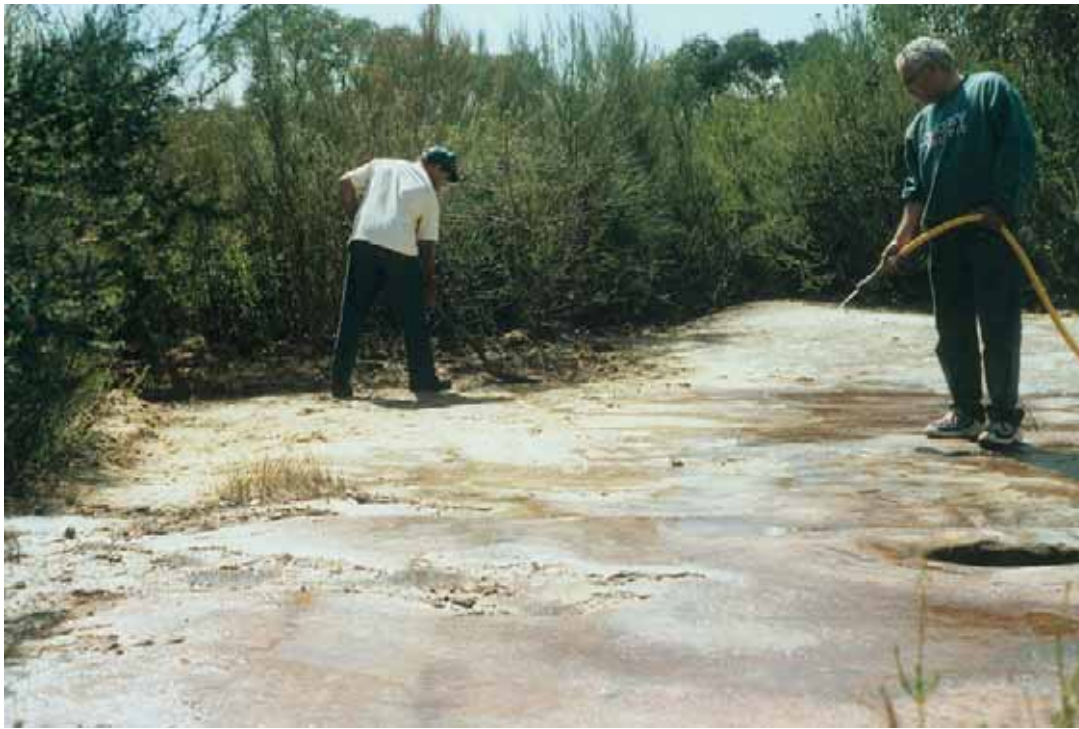
Plate 22. Removing soil and vegetation covering engravings by shovelling the upper soil layers and using low water pressure from a fire fighting striker unit. This site is located near West Head in Ku-ring-gai Chase National Park.

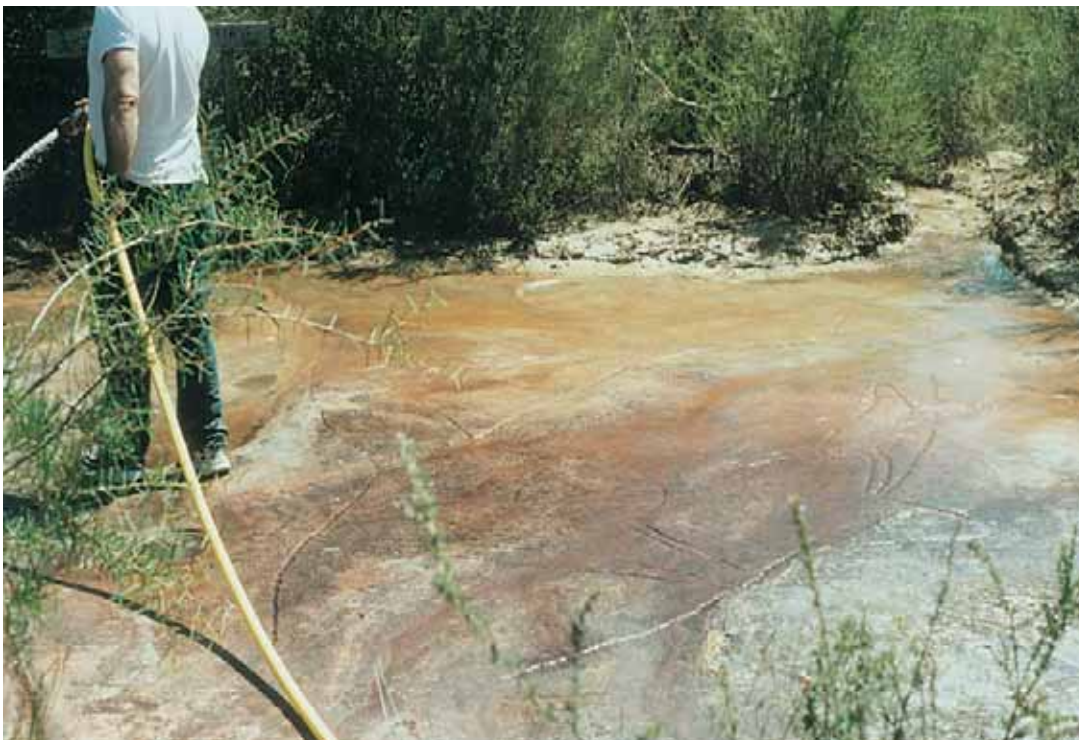
Plate 23. The final stages of the wash down. The drainage channel created at the right-hand side of the photo allows water and soil to run off and reducing future soil build-up.

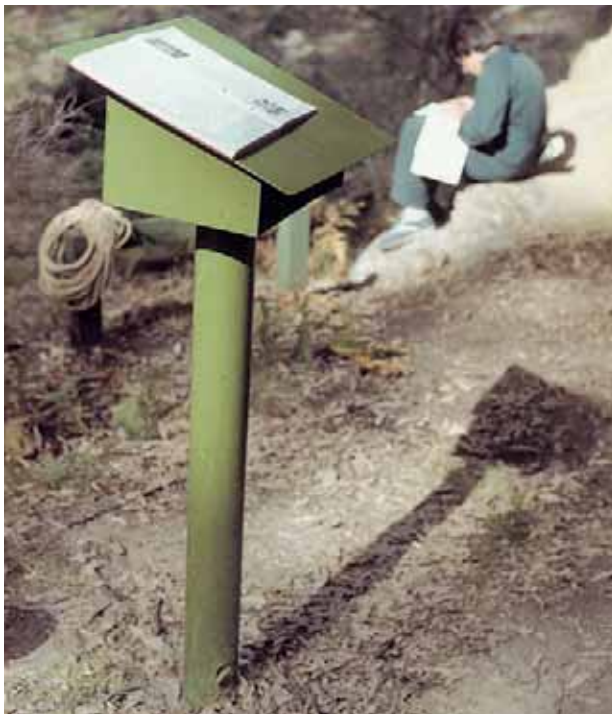
Plate 24. Metal stand housing a visitor's book and information specific to the site.

The book needs to be protected from the elements; a metal stand is often used (Plate 24).

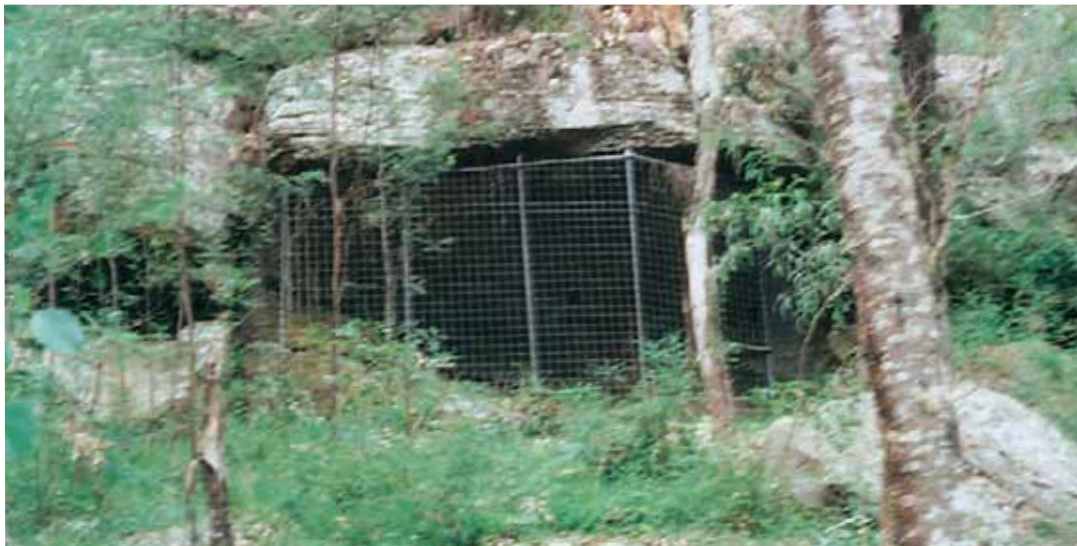
Plate 25. Main shelter at Appletree in Wollemi National Park – general view of the shelter and mesh screen which remains.

The Appletree site is located in a remote area of Wollemi National Park (see Plate 25). Visitation is low (up to 100 visitors per annum) and the area has been identified as suitable for ecotourism and cultural heritage tours.

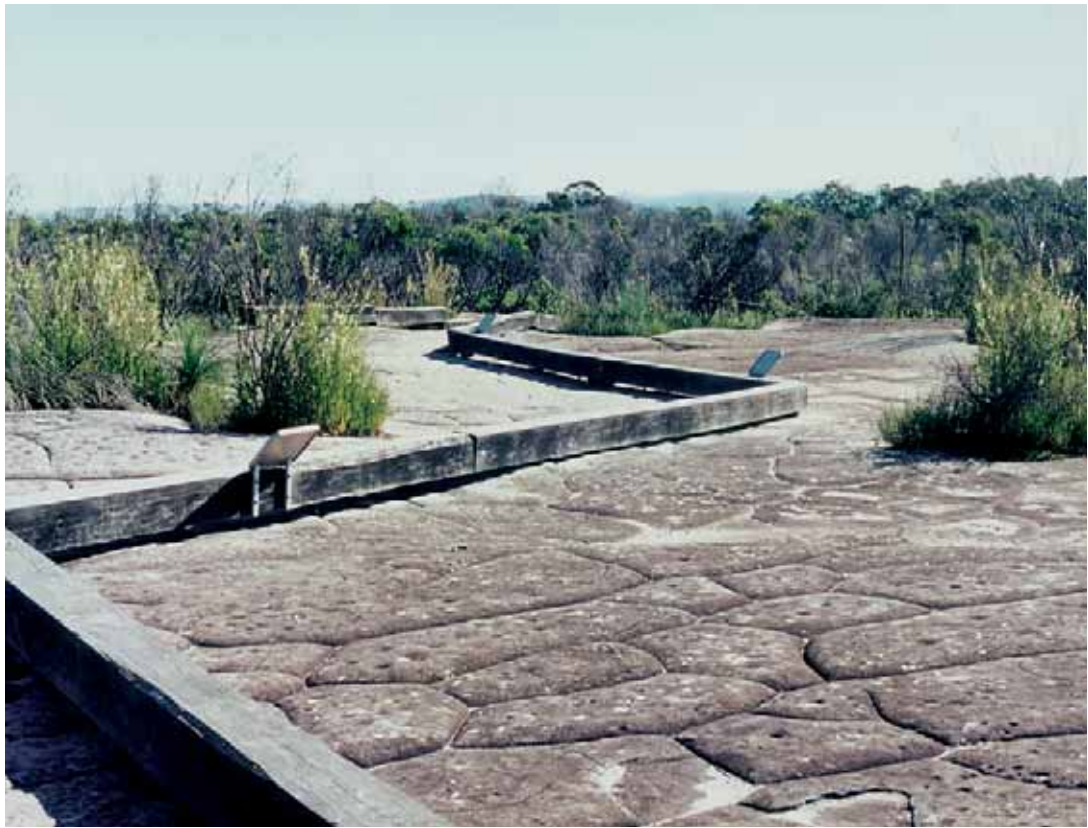
Plate 26. An example of a low barrier used to guide visitors over a site. This example is located at West Head in Ku-ring-gai Chase National Park and uses heavy 300 mm x 300 mm hardwood. Interpretive signs are mounted on the structure, and the rock is lighter in colour where visitors walk.

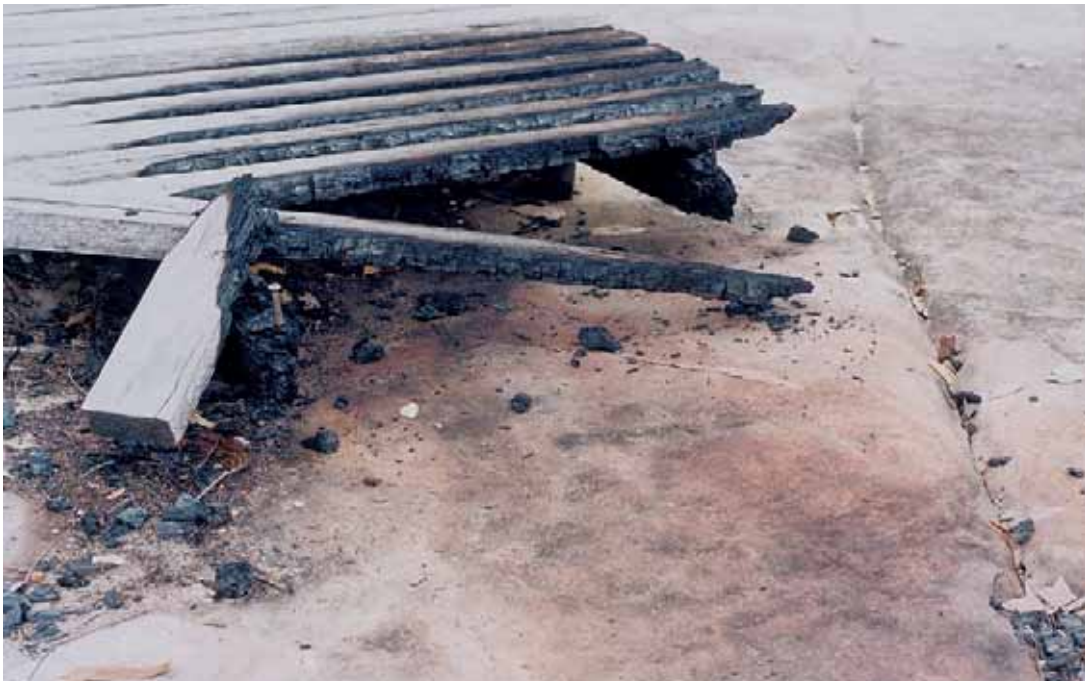
Plate 27. The old fire damaged boardwalk at Bulgandry. The heat generated by the fire caused damage to the sandstone.

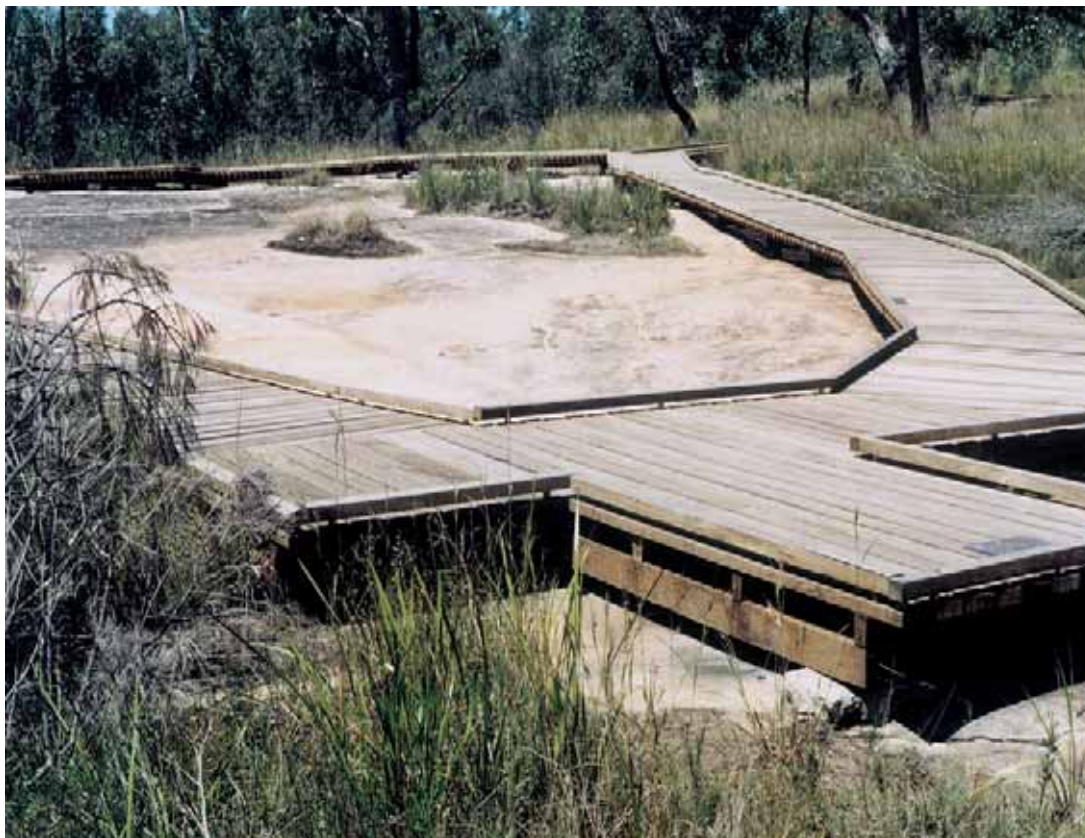
Plate 28. The new boardwalk at Bulgandry. It is designed to sit on the rock rather than being fixed by drilling into the rock.

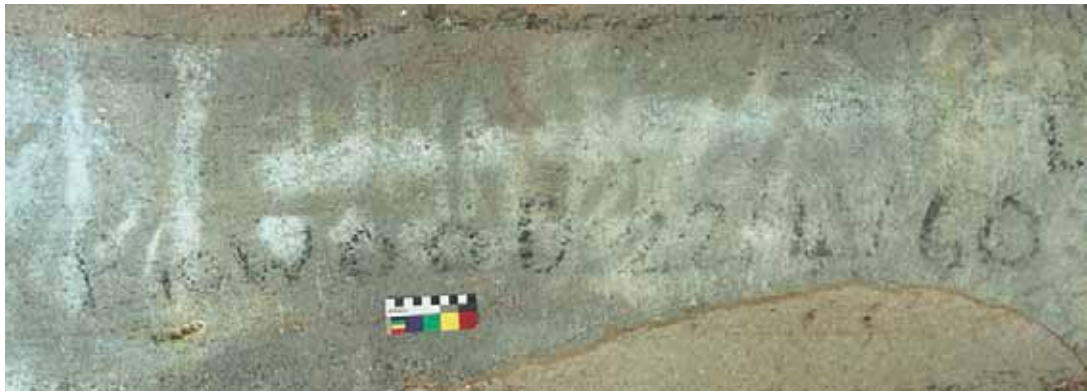
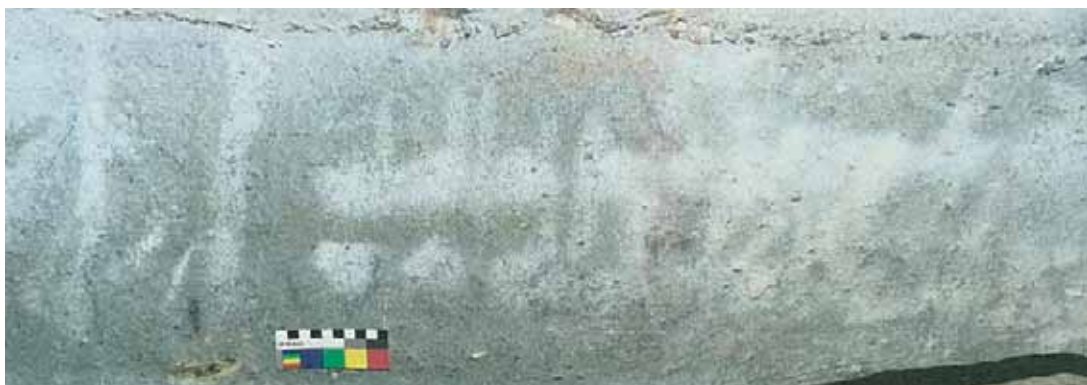
Plates 29 and 30: show the results of removing graffiti by dry brushing at Appletree in Wollemi National Park. Note that remnants of the charcoal graffiti remain but the visual impact of the graffiti is greatly reduced.
