Introduction To Rock Art Conservation

**A Guide to the
Preservation of
Aboriginal Rock Art**

Culture and Heritage Division

Published by:
Department of Environment and Climate Change (NSW)

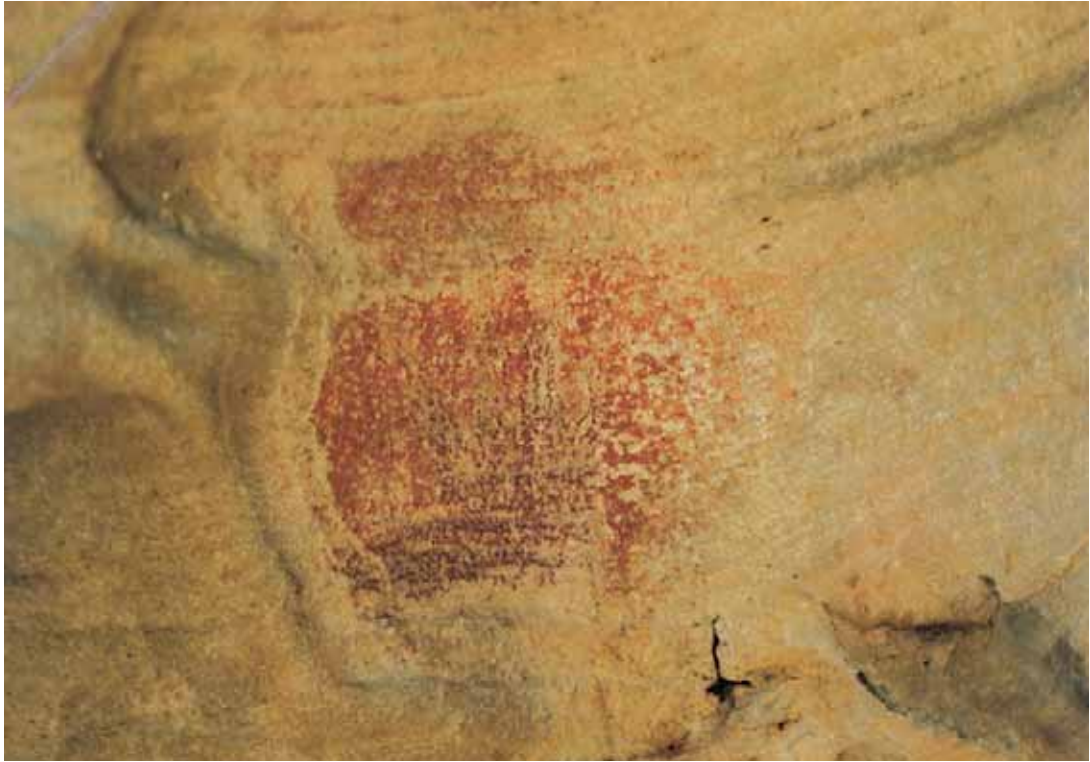
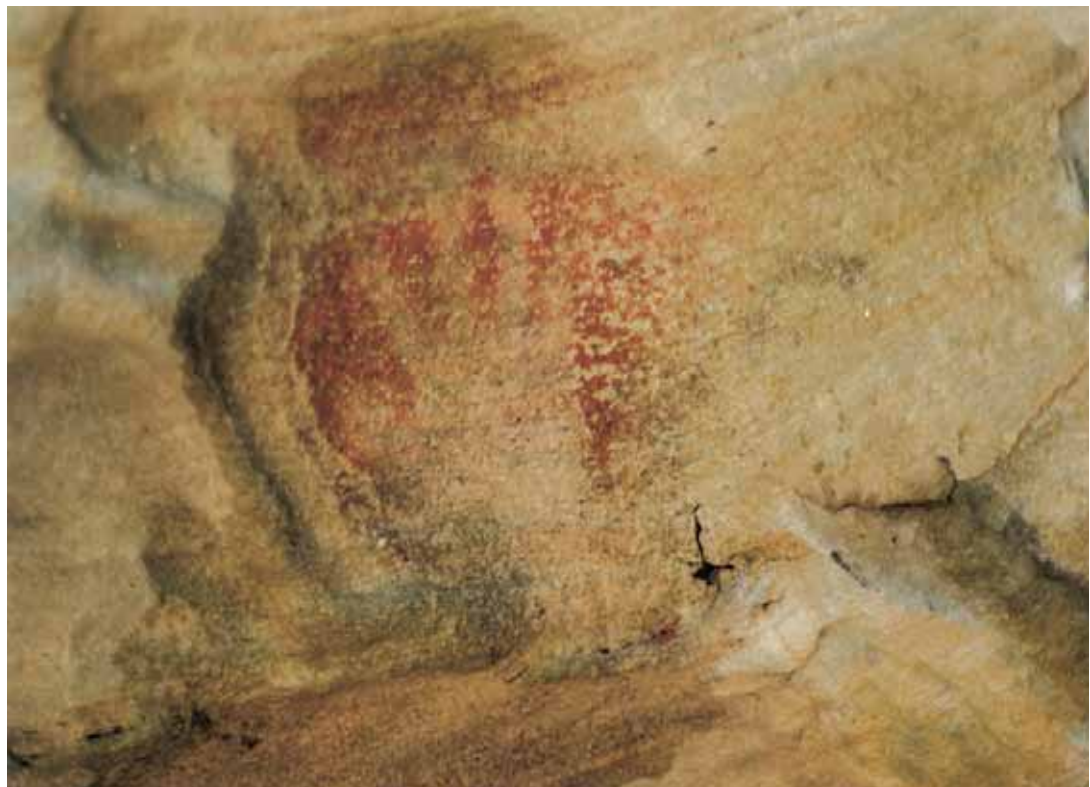
Plates 31 and 32: show before and after treatment of a graffitied stencil in Red Hands Shelter, West Head. The stencil had been rubbed over with a red material so the definition of the stencil outline was difficult to make out. This infill material was removed using the washing technique described.

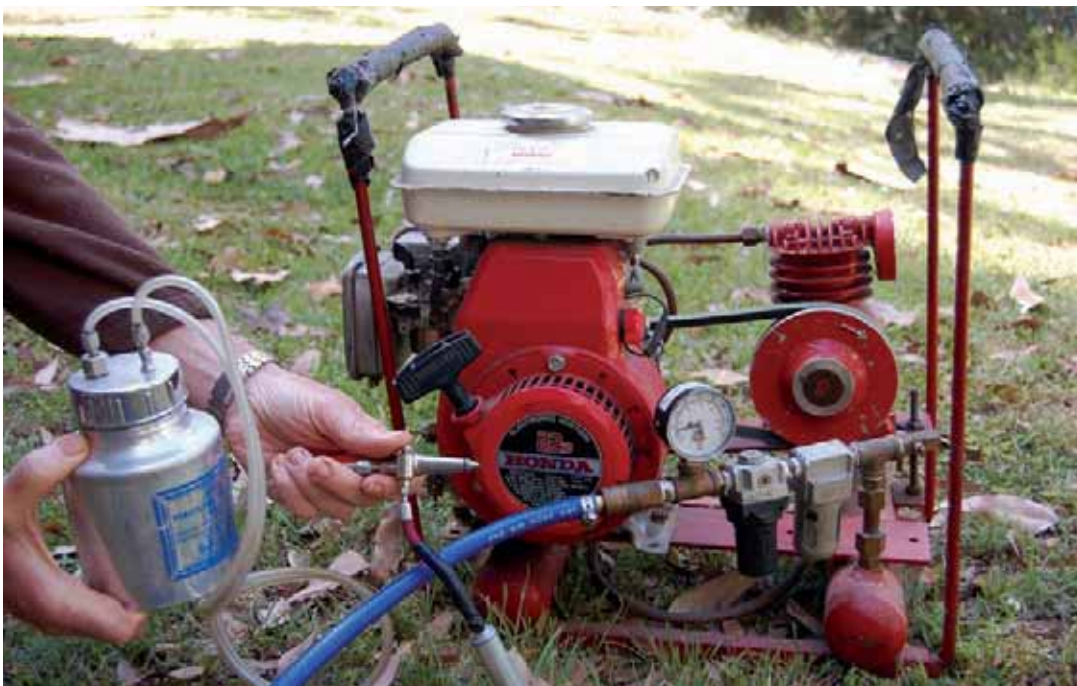
Plate 33: Air abrasive equipment which uses a light-weight compressor to drive a small air brush which delivers a fine stream of abrasive beads to remove graffiti.

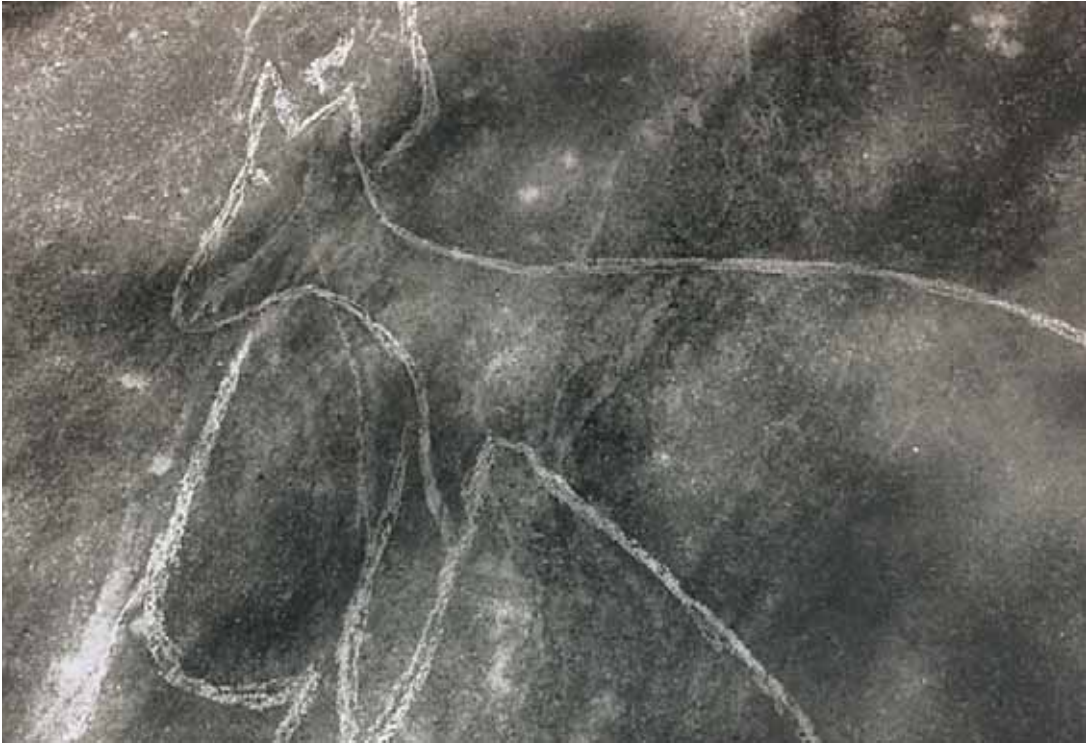
Plate 35: Vandalised engraving. Note that the scratched outline has missed the original groove and mistakenly followed an overlying canoe motif.

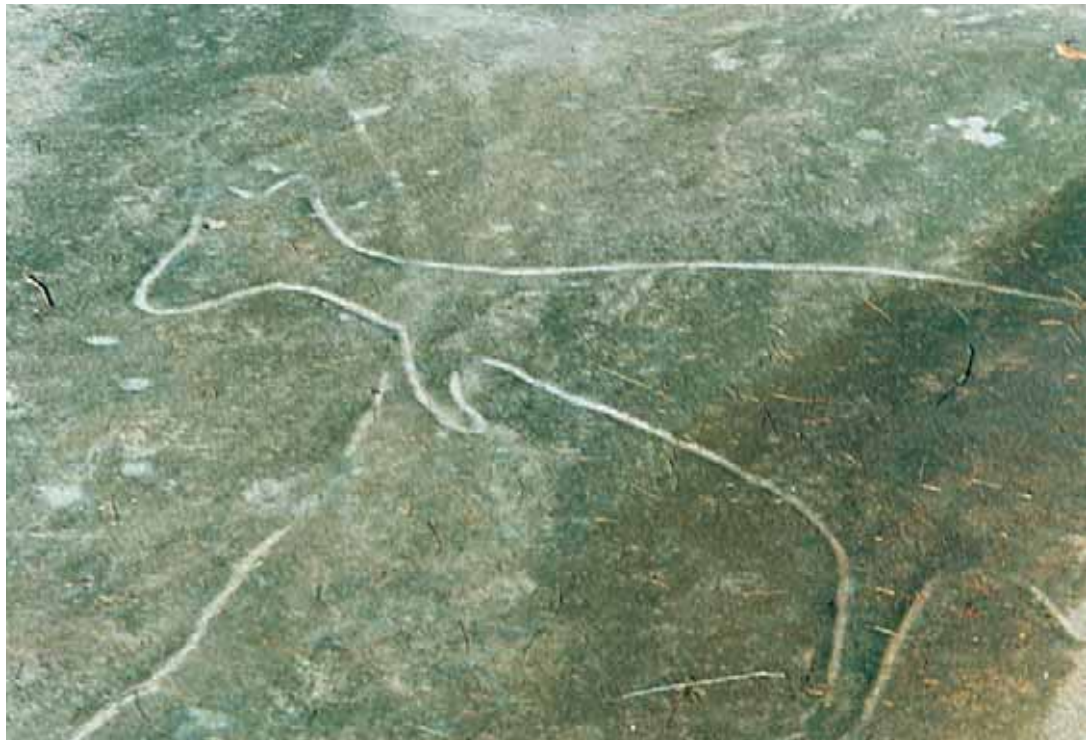
Plate 36: The same engraving one year later after highlighting. Note that the original groove outline, which was recorded well before the site was opened to the public, has been restored.

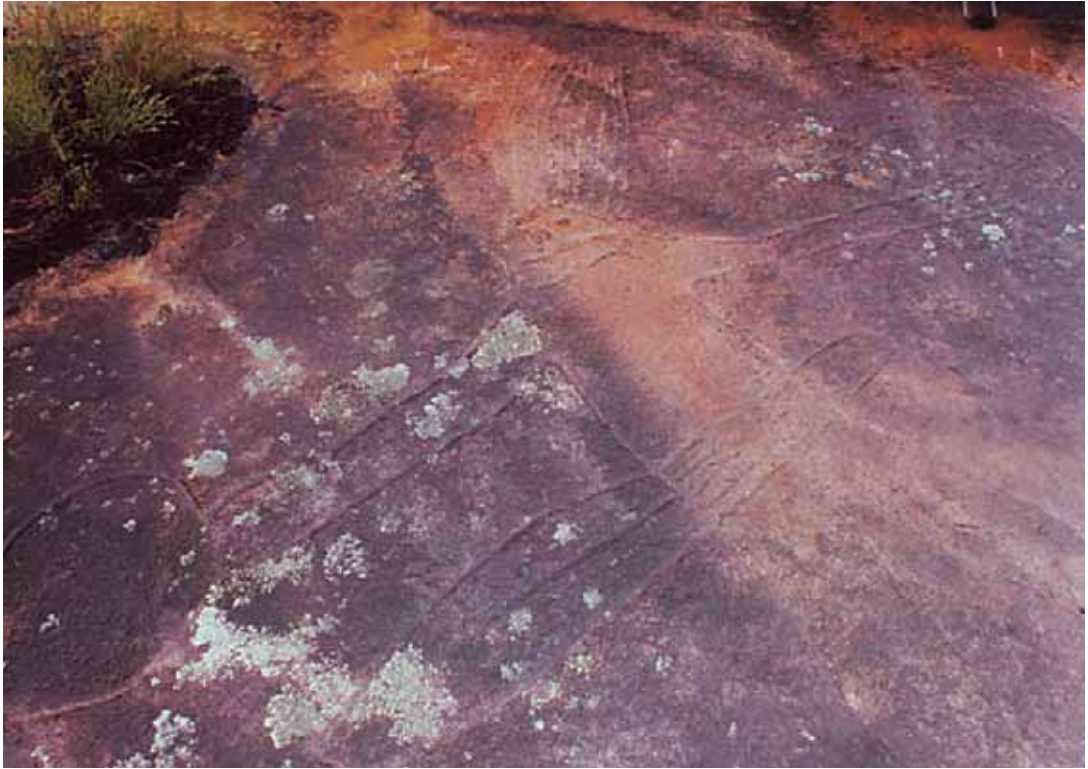
Plate 37: Engraving before groove cleaning. (photo David Kelly, NPWS)

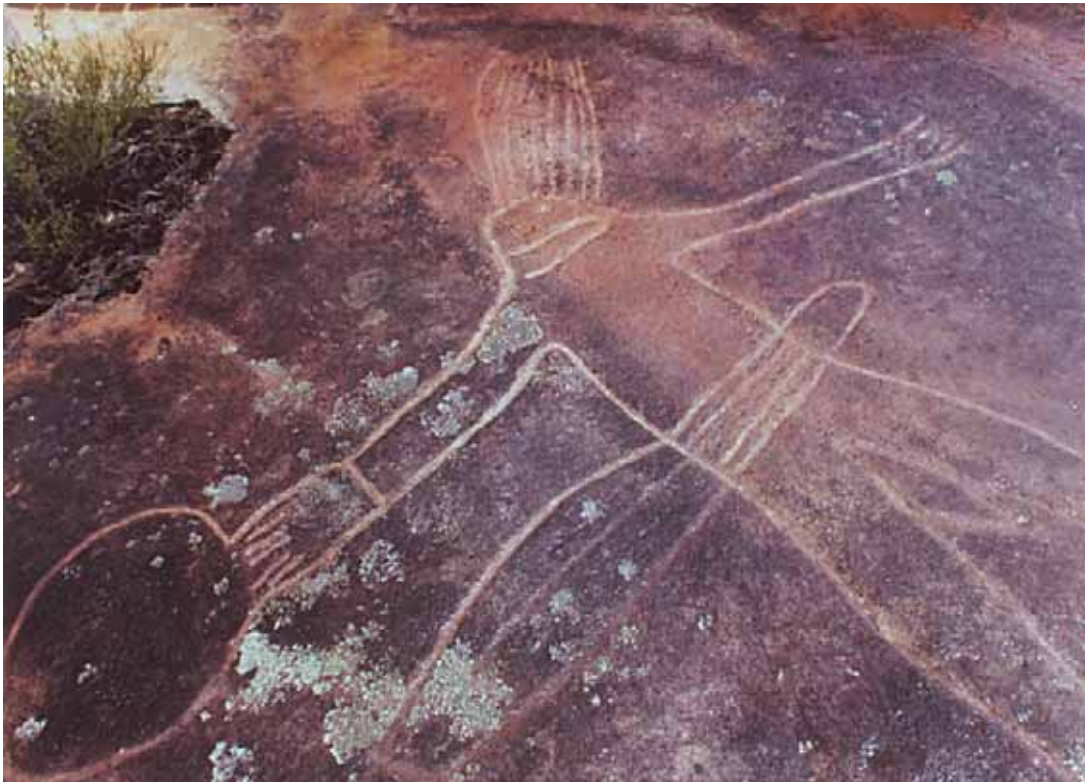
Plate 38: Engraving after groove cleaning. (photo David Kelly, NPWS)

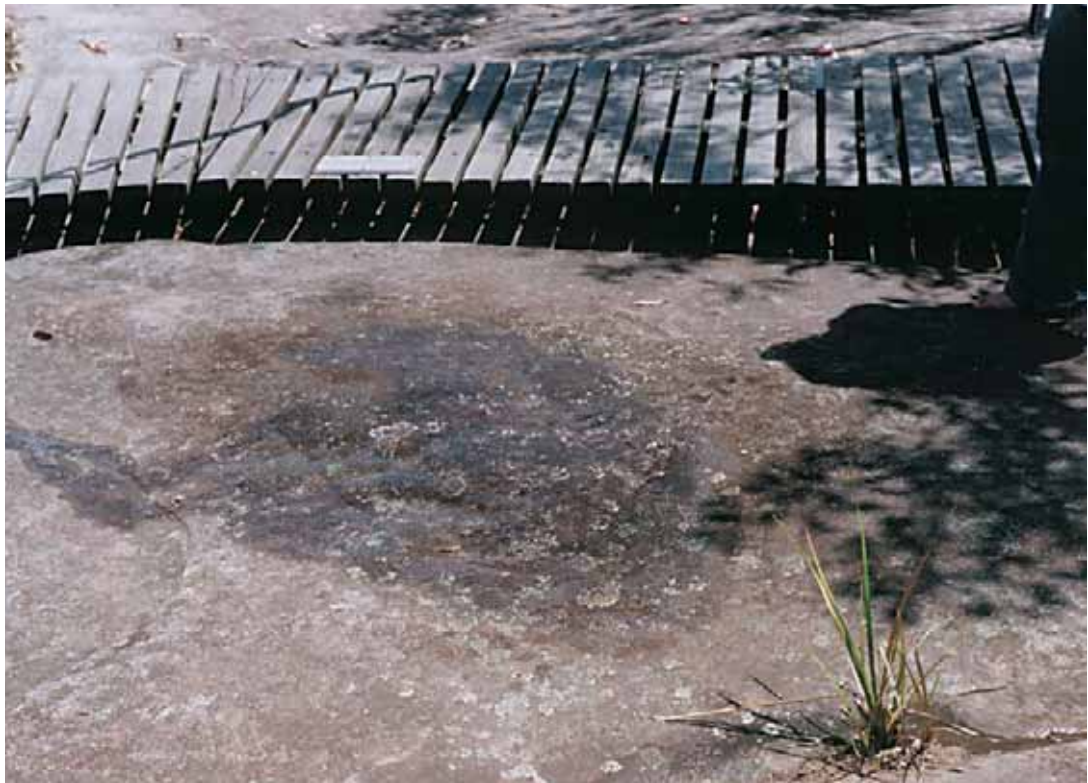
Plate 41: Before groove cleaning, the area is wet down.

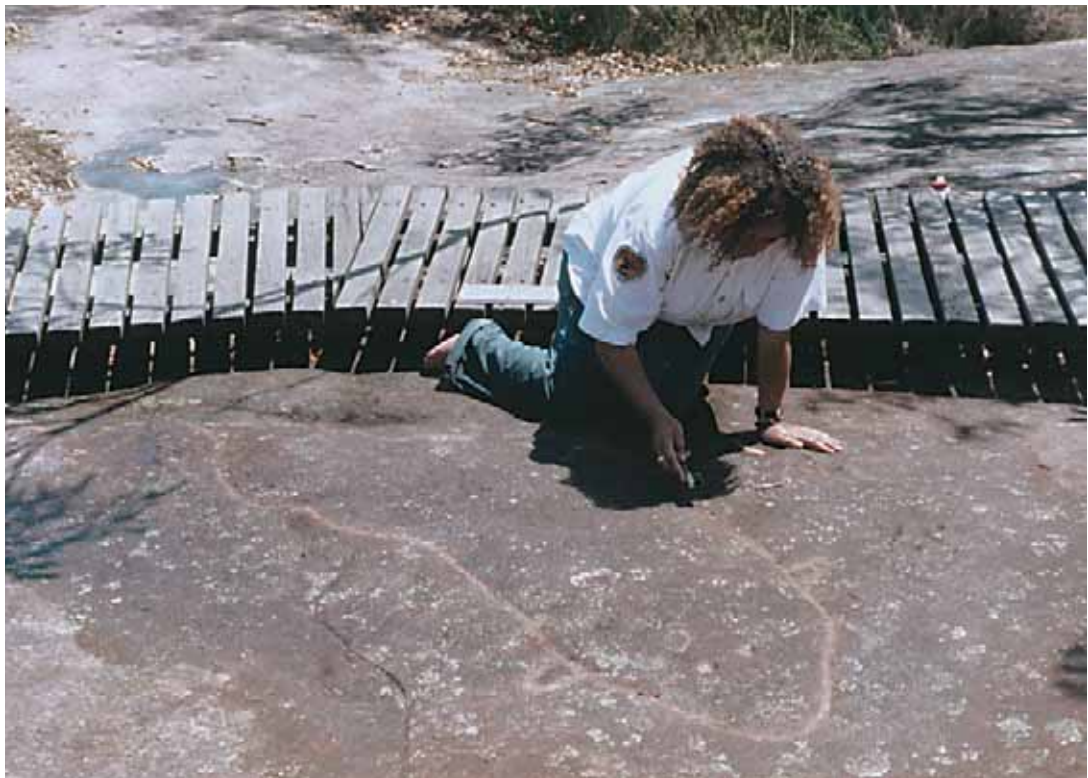
Plate 42: Highlighting the engraved area.

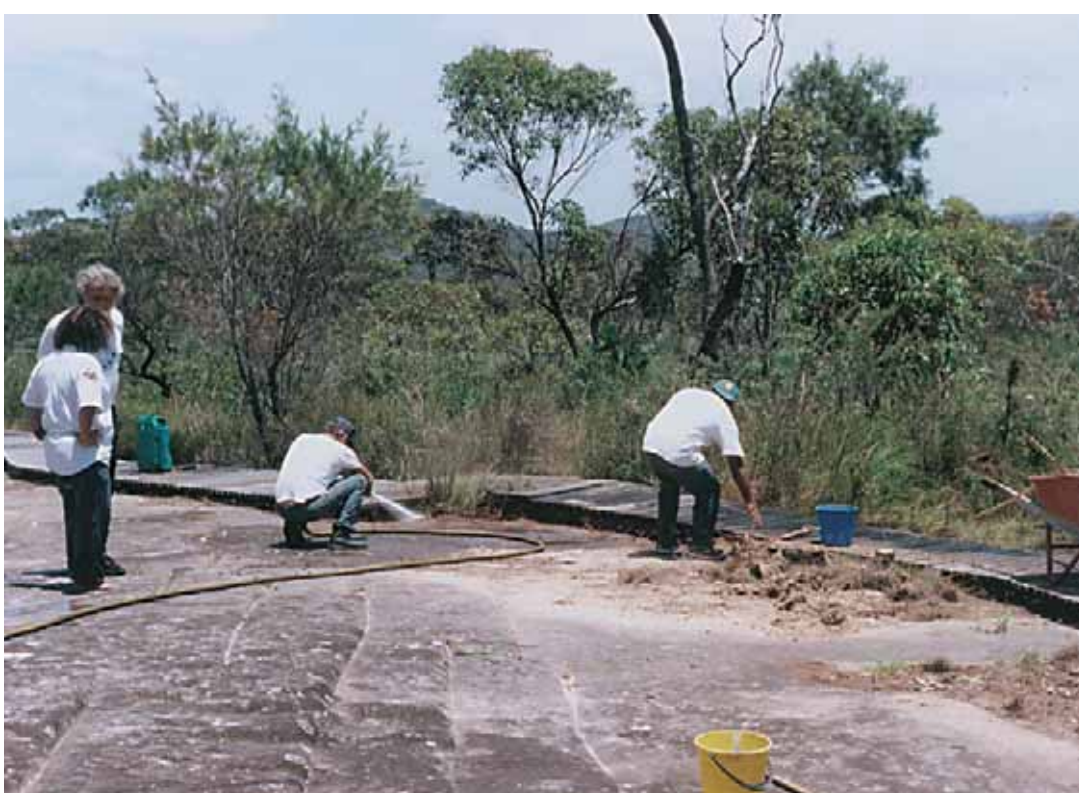
Plate 43: Removing soil and low tree (Casuarina) which was encroaching on the engravings.

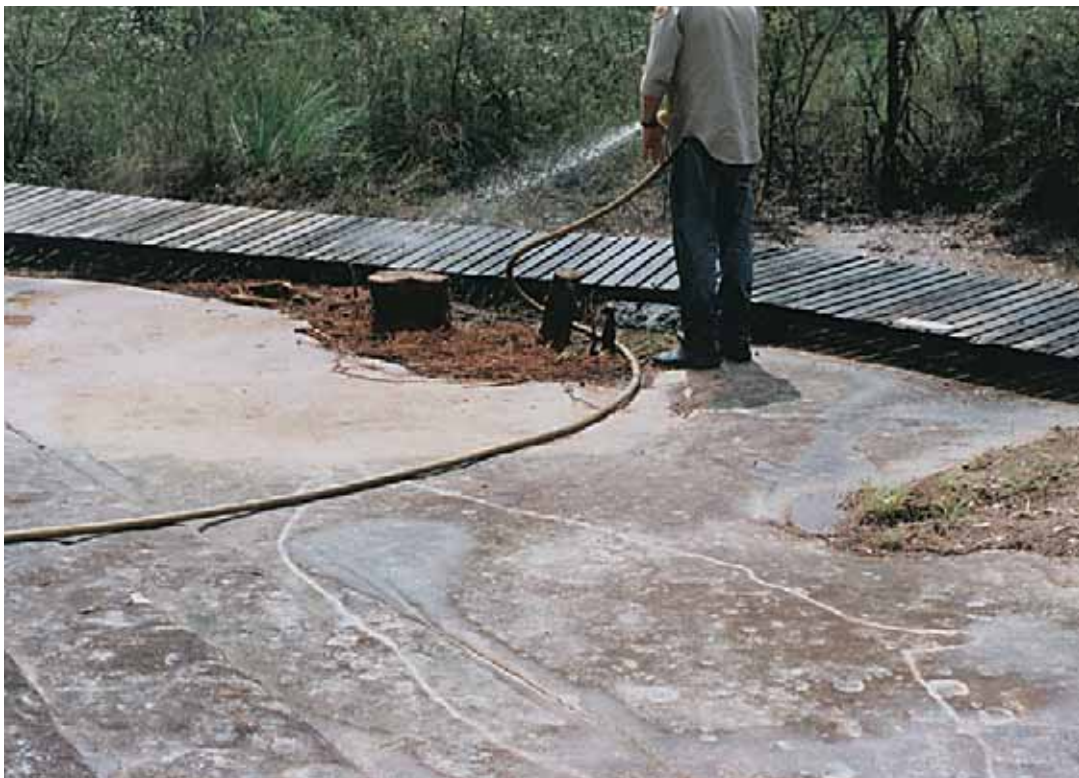
Plate 44: Washing away soil and tree roots.

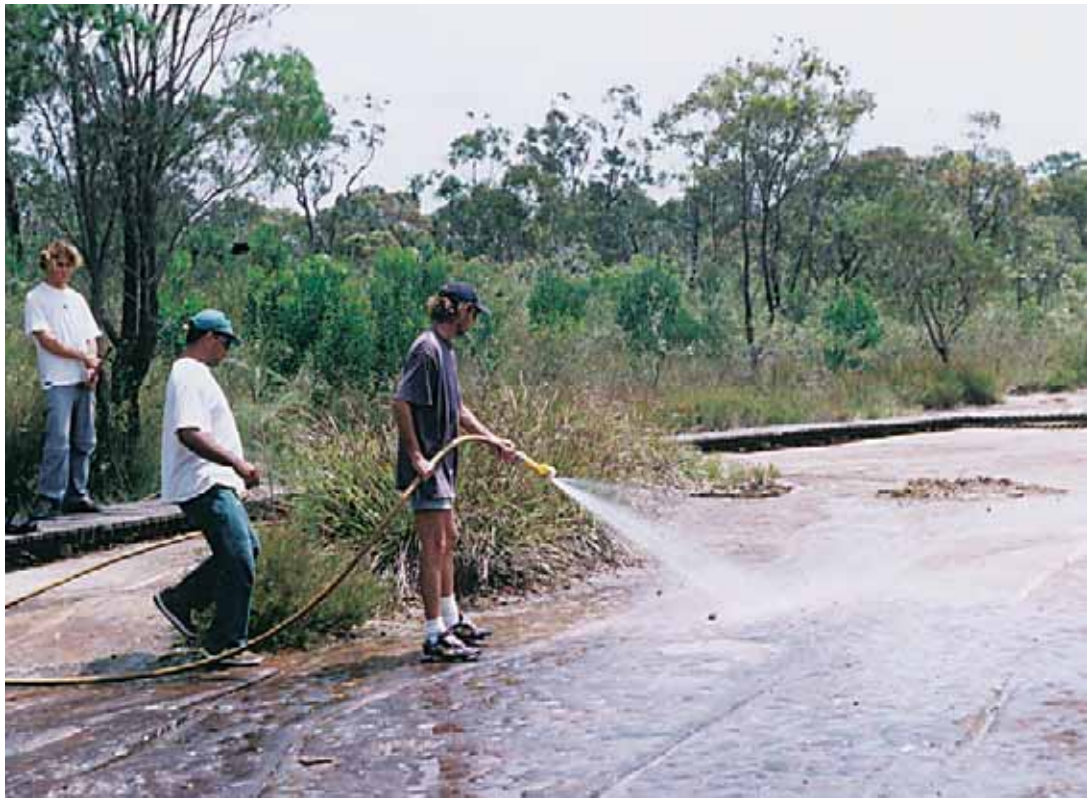
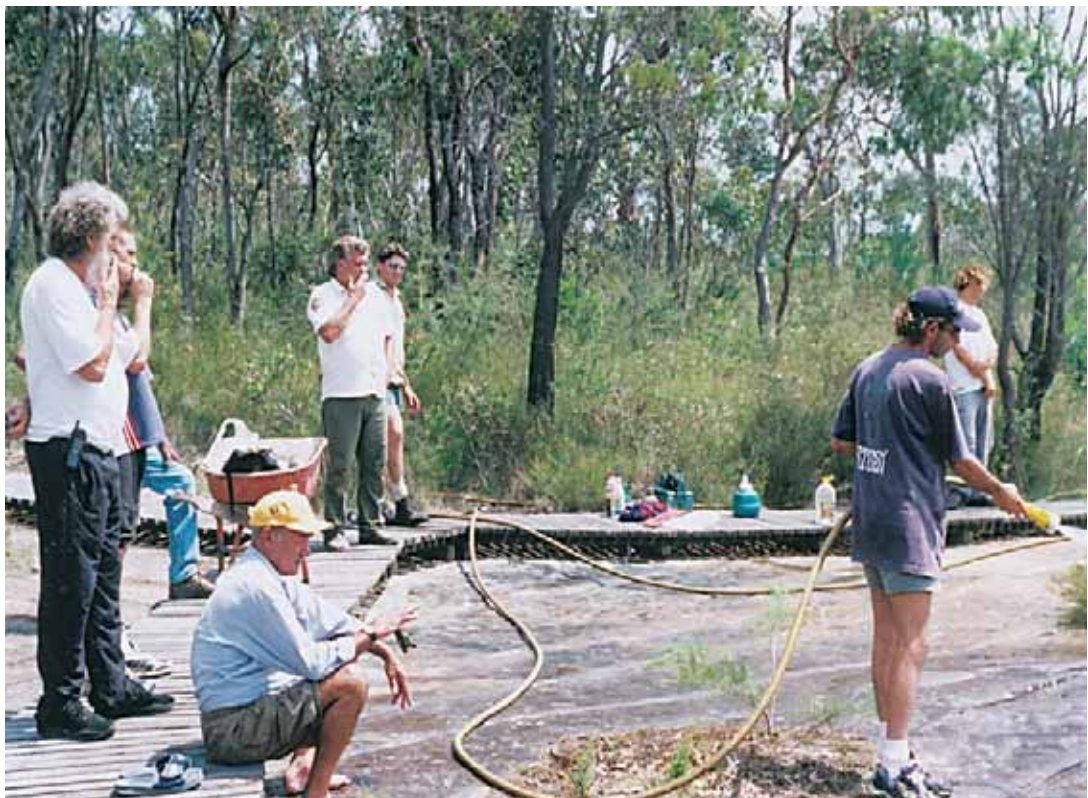
Plates 45 and 46: Final wash down after the work above had been completed.

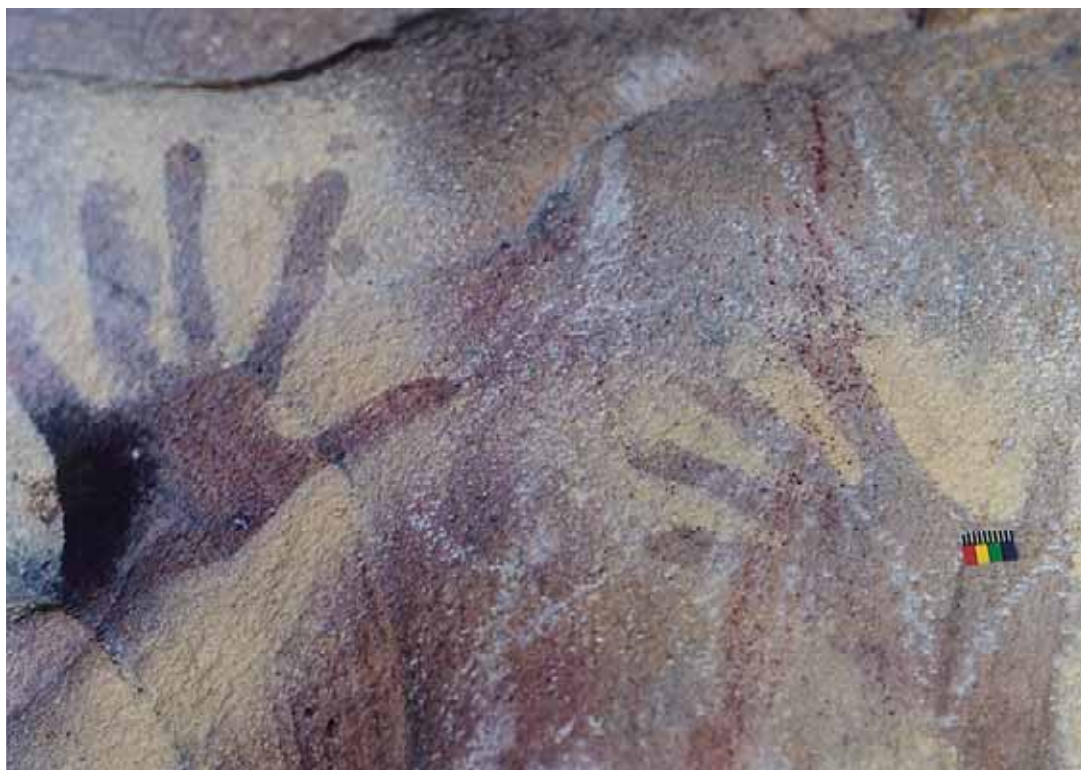
Plate 47: Photo for locating an area for monitoring. The colour scale is a reference point.

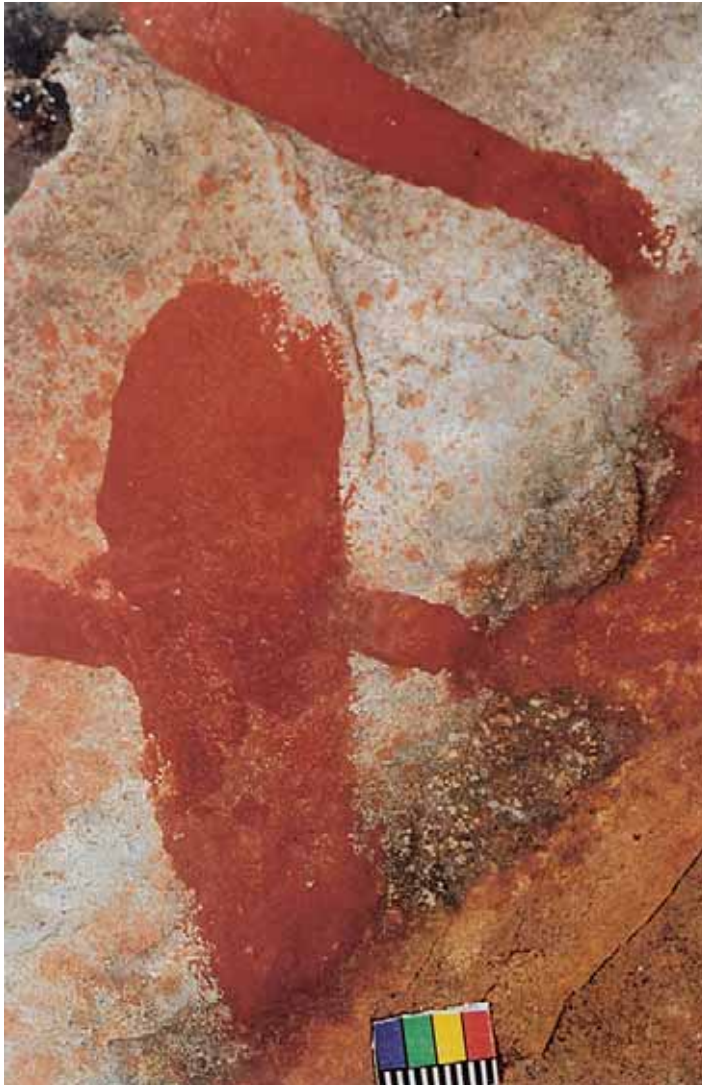
Plate 50: A painted ochre figure used for colour monitoring. Note that there are no cracks visible in this pigment type and the assumed mechanism of pigment loss will be loss by water wash as has happened at the lower half of the figure, or in other cases by granular loss by salt action. An artificial dripline has been installed in this shelter to reduce further loss by water wash.

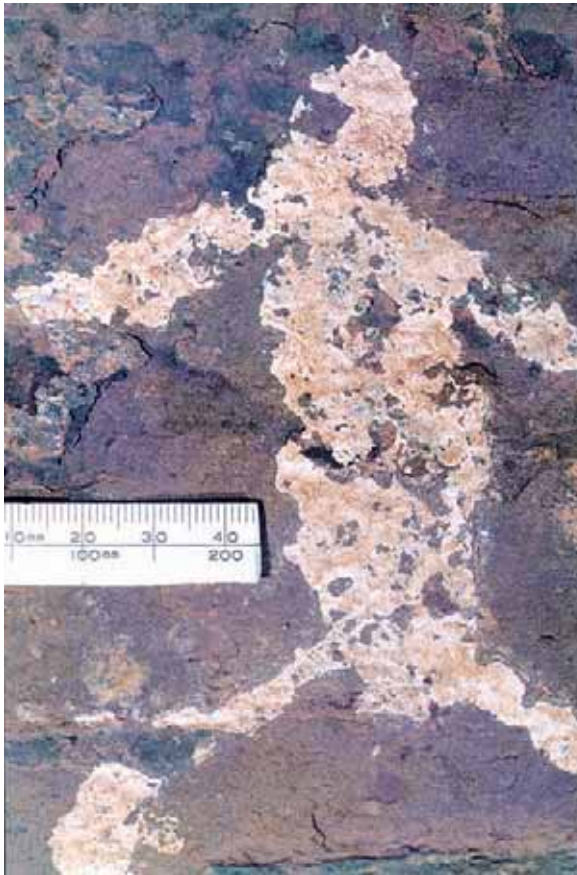
Plate 51: Gunderbooka – site 2 shows part of a human figure painted in white. Clay pigment photographed in 1990.

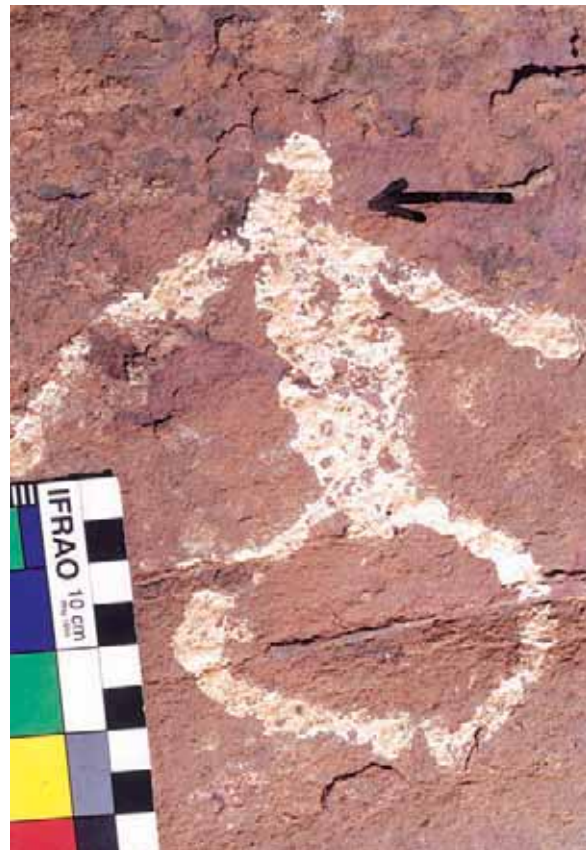
Plate 52: Gunderbooka – site 2. Follow up monitoring from 1990 report. Note loss of approximately 0.2 square centimetres of white pigment since 1990.
