FOREWORD

E. S. CLAYTON, H.D.A., Commissioner.

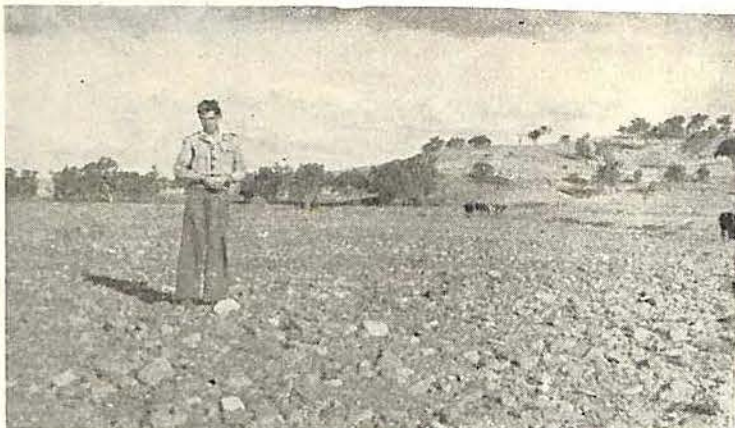
6. This photo was taken on the flats upstream of Jerry's Plains. This land previously carried an excellent stand of irrigated lucerne. The rocks and stones were deposited up to a depth of about 1 ft. 6 in. in what was the strongest part of the stream running across the flats. The stones were pushed into conical heaps so that they occupied as little ground as possible. Farm machinery has recently been able to work on this area.

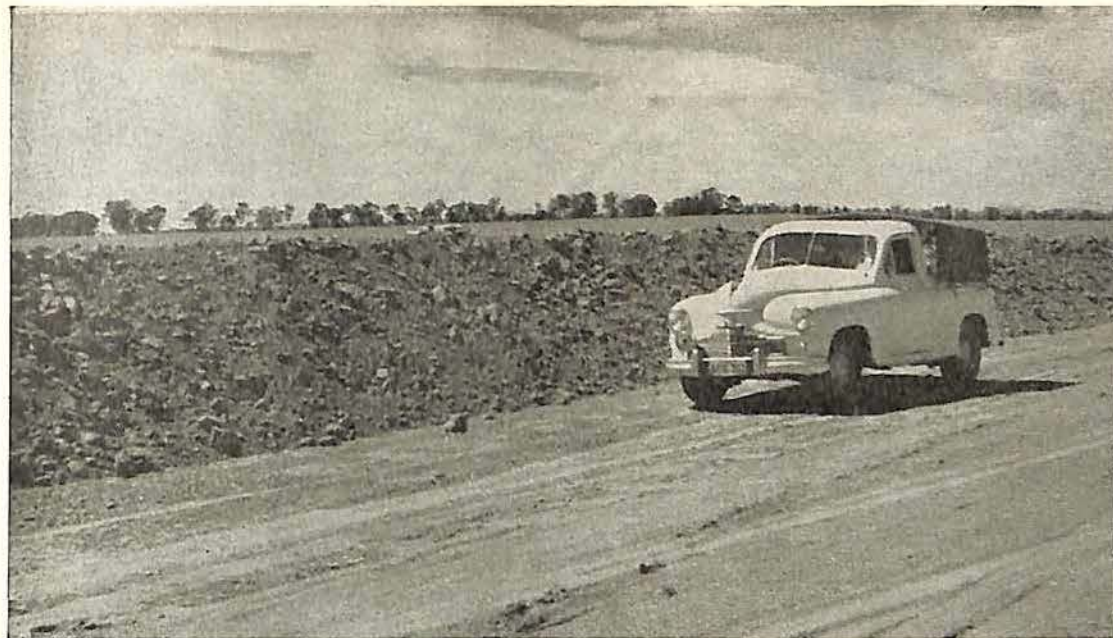
Fig. 3.—A massive absorption-diversion bank constructed by the Soil Conservation Service in the West Wyalong district.

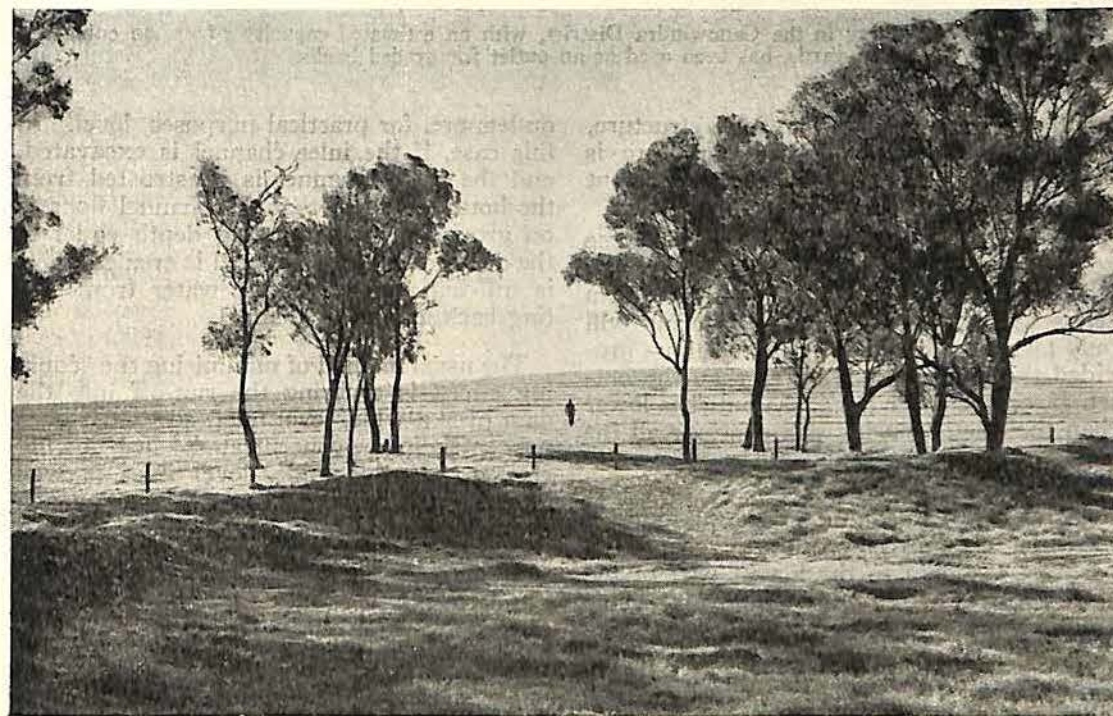
Fig. 4.—A well grassed natural watercourse on the Cowra Soil Conservation Research Station. Such a watercourse is an ideal outlet for water from banks.

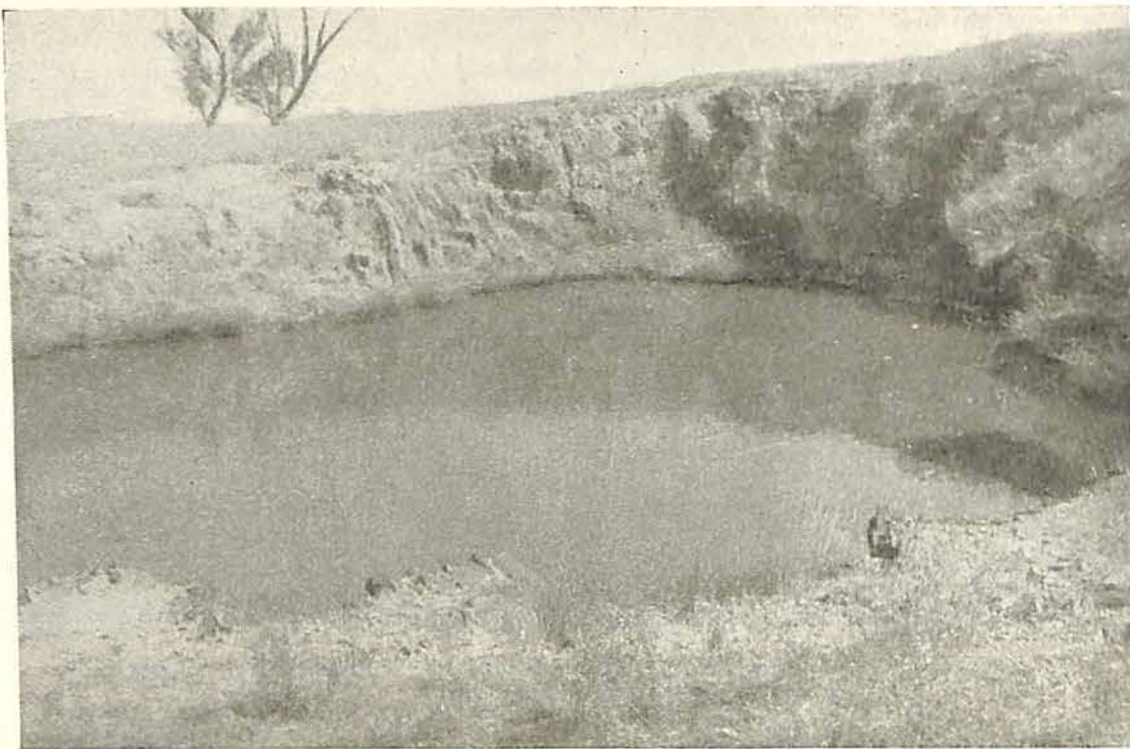
Fig. 5.—This quarry in the Canowindra District, with an estimated capacity of 15,000 cubic yards, has been used as an outlet for graded banks.

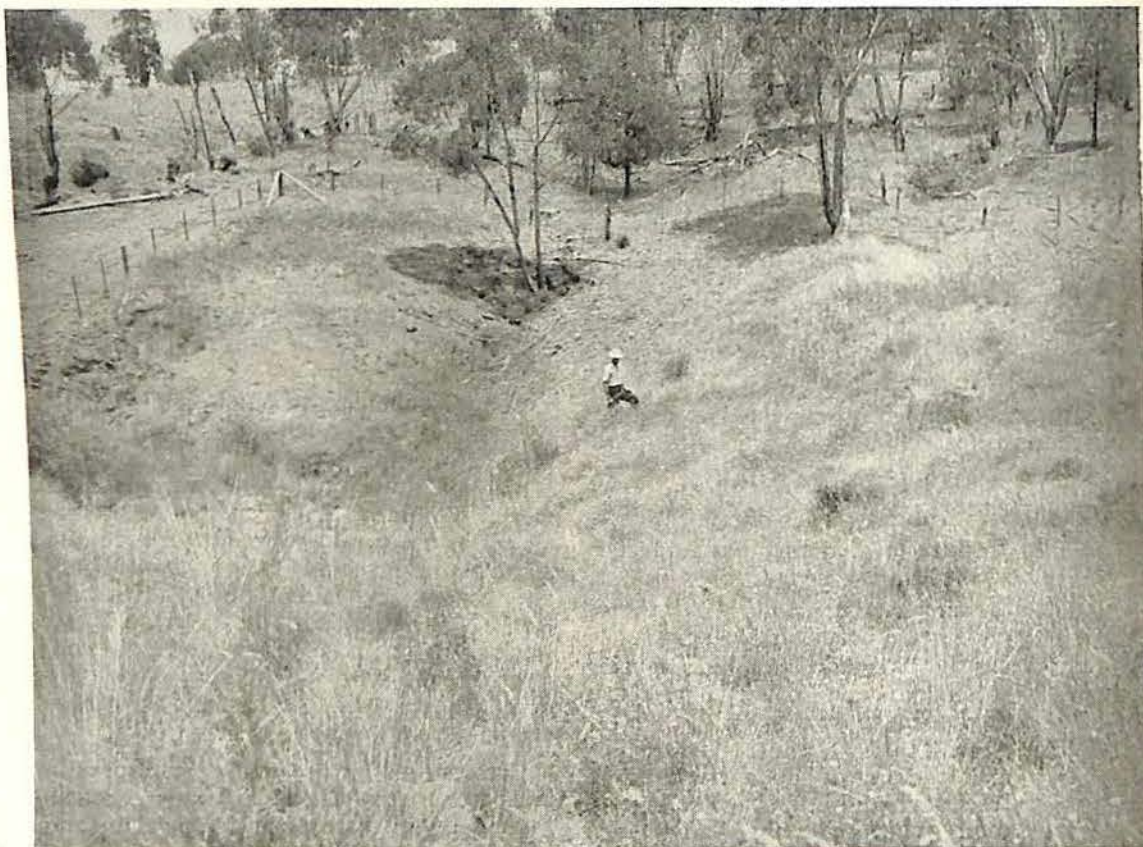
Fig. 2.—Back batter of dam wall completely stabilized with ungrazed Kikuyu grass. Note rilling on unplanted areas.

Dams should be sprig-planted around the top of the bank. This will succeed often when plantings fail on the sloped batters. However, if planted correctly, Kikuyu sprigged on the back batters and front batters above the water line will prevent rilling which invariably occurs on the bare earth.

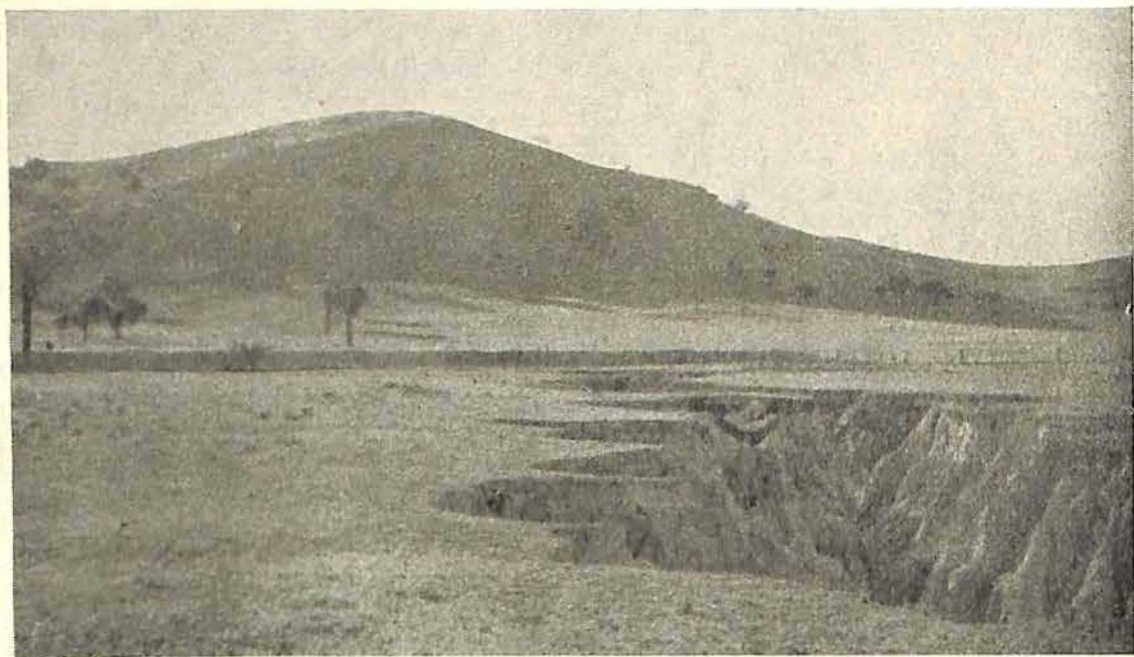
Fig. 2.—View from point B in Fig. 1, showing western arm of gully with a diversion bank at its head.

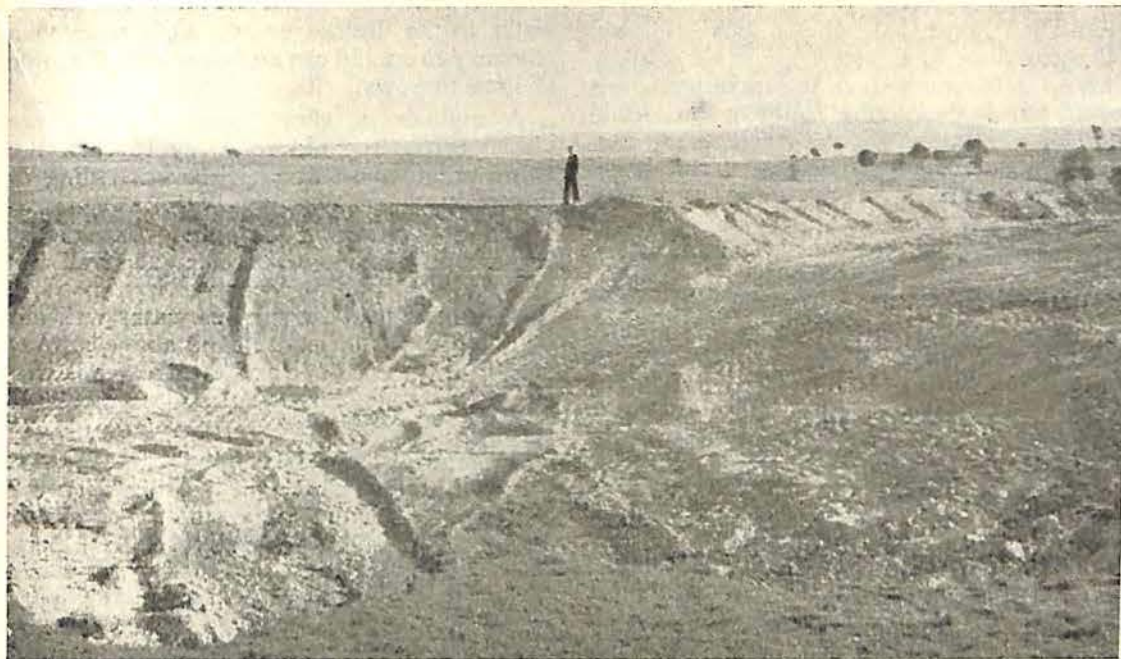
Fig. 3.—The gully check dam at A in Fig. 1, showing massive bank and overflow bank at right.

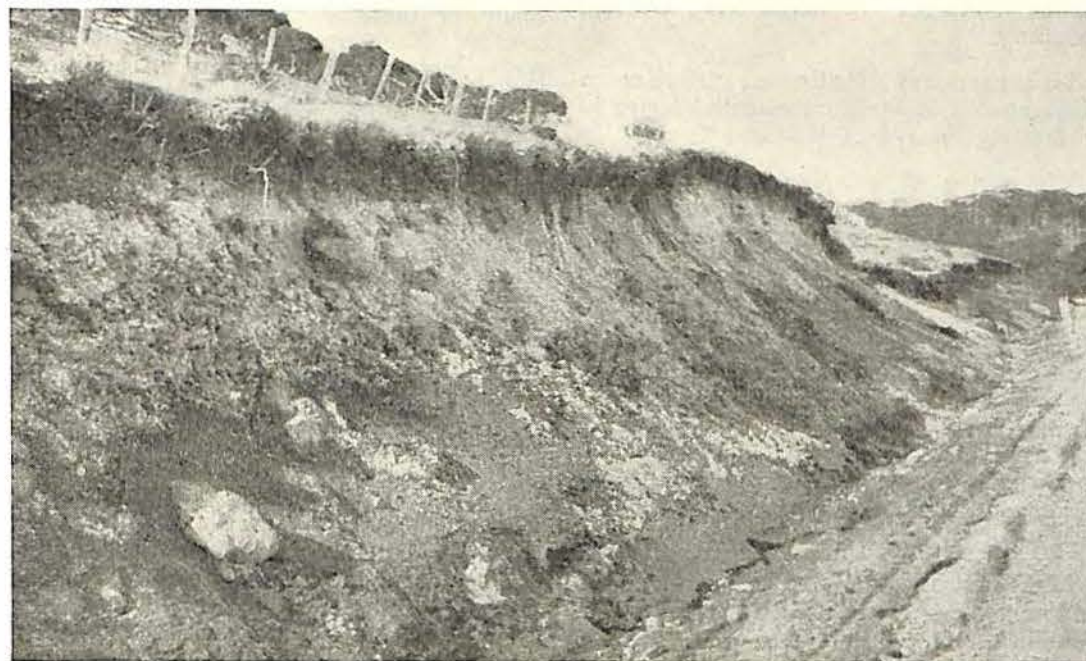
Fig. 2.—Needle ice on a road batter near Kiandra showing typical recession of the slope face.

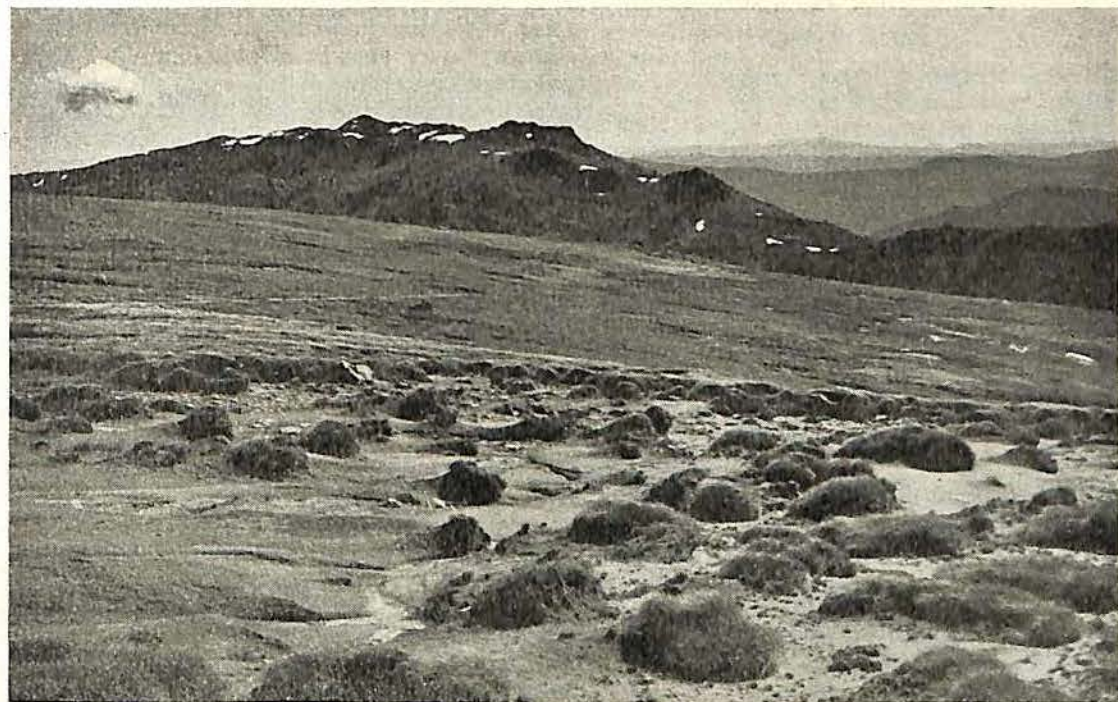
Fig. 4.—Erosion damage in the Mt. Twynam-Carruthers Peak area as a result of high winds, frost and water action.

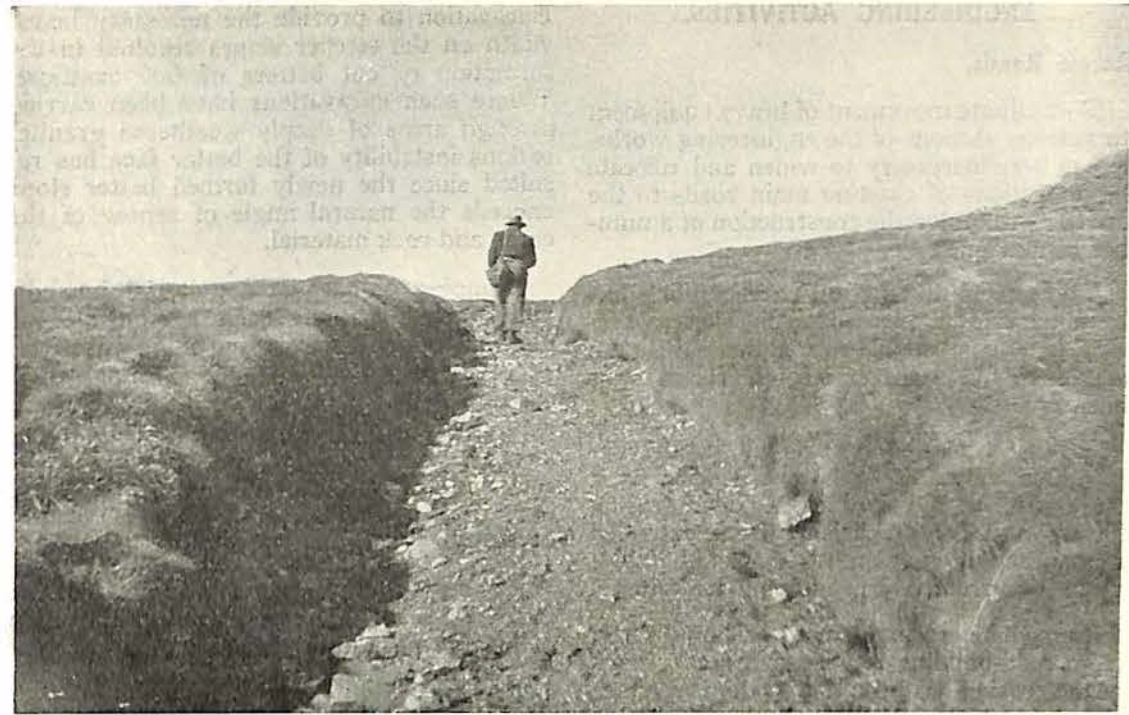
Fig. 5.—Erosion is widespread on many of the tracks in the area, like this section of the Blue Lake track. (Photo S.M.H.E.A.)

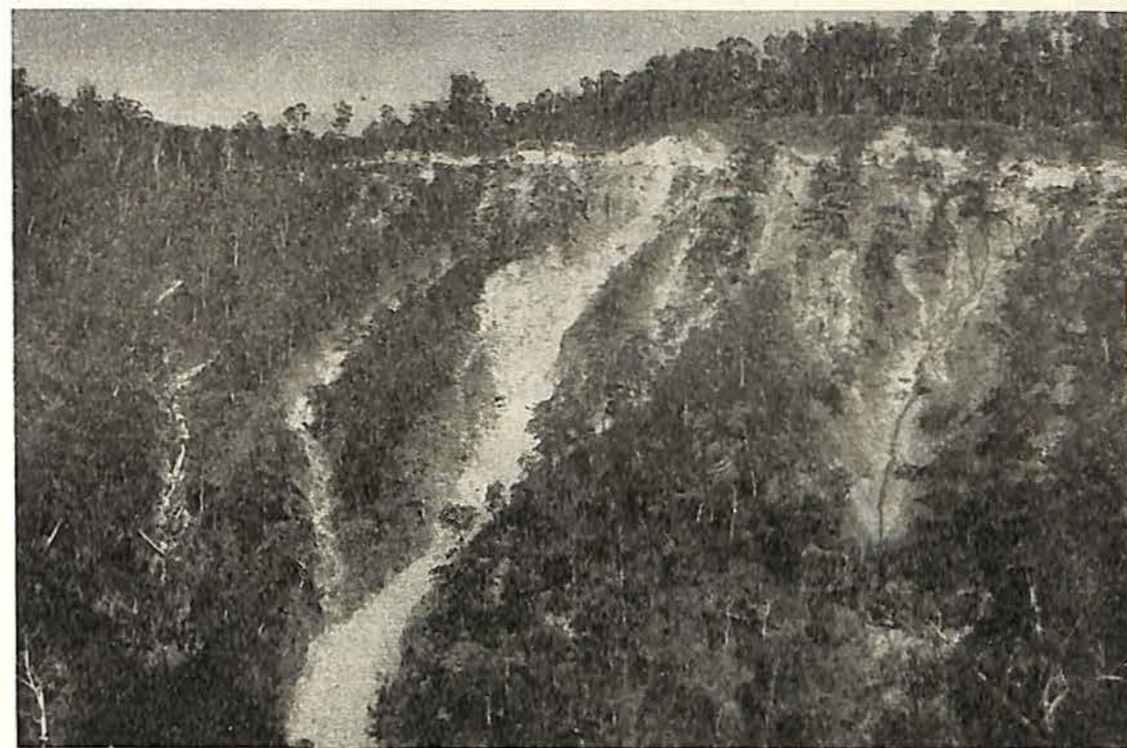
Fig. 7.—Dumping spoil followed by debris slides has destroyed the stability of this slope below Happy Valley road.

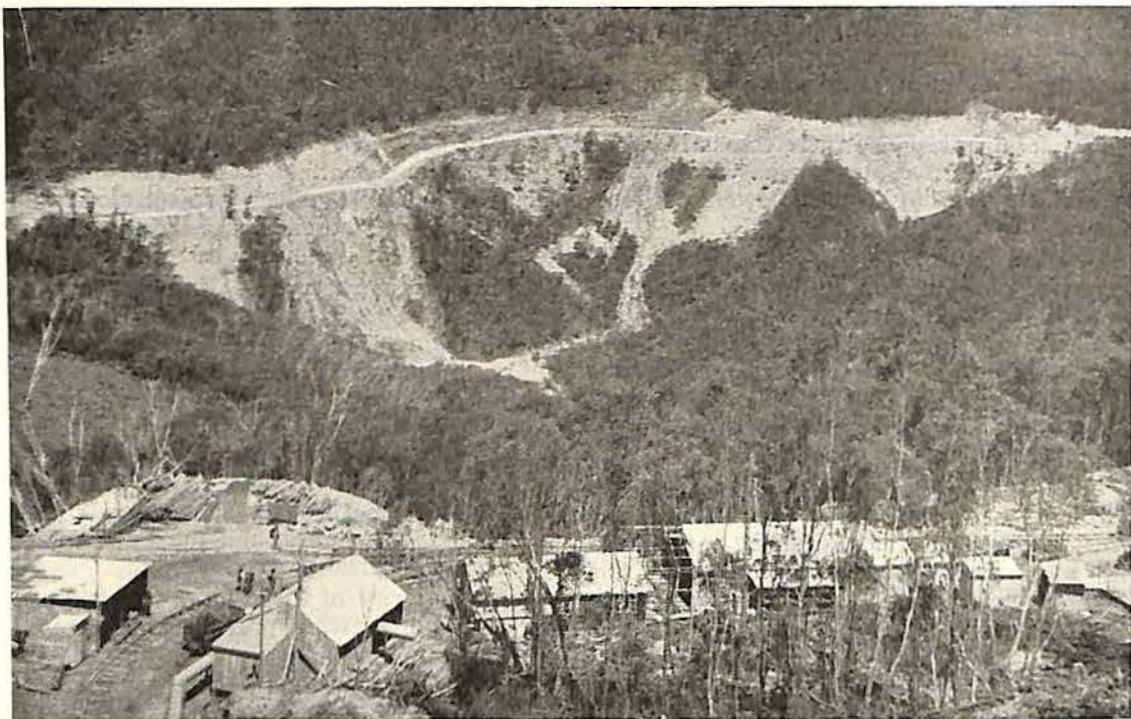
Fig. 8.—Serious erosion hazard created during construction of the Snowy Valley road near Munyang.
(Photo S.M.H.E.A.)

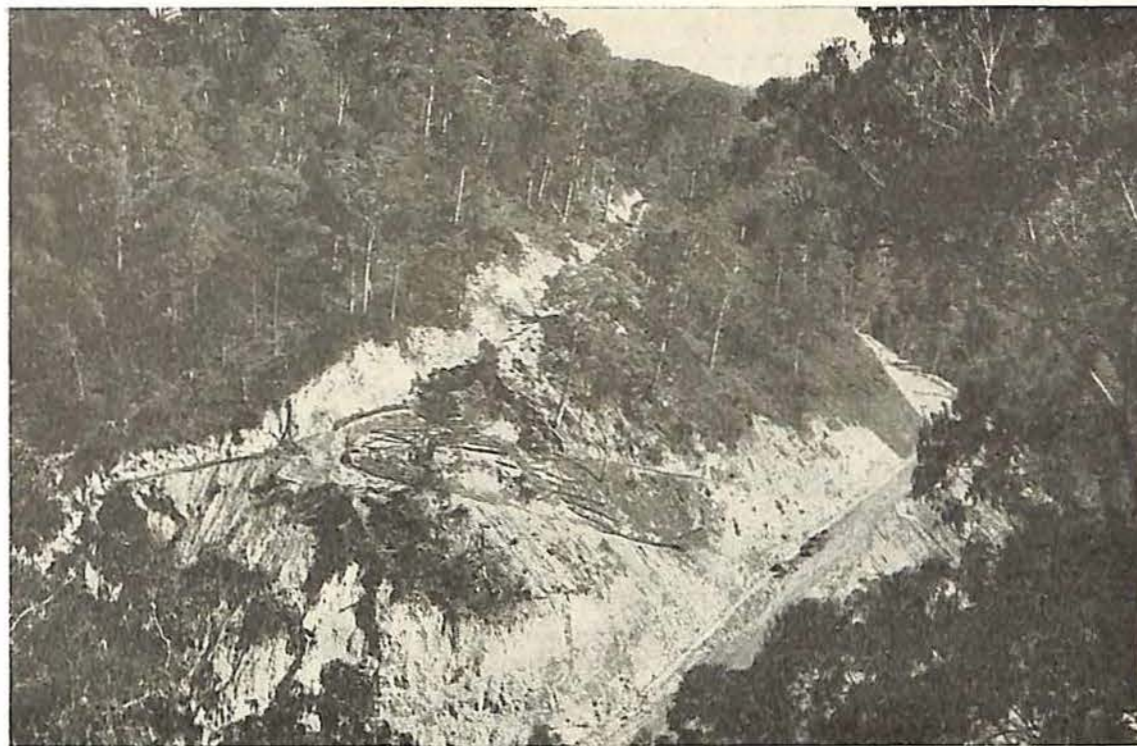
Fig. 9.—The lower leg of Happy Valley Road with the former access track above. The slopes have been seriously damaged by dumping spoil and opening the lower batter face.

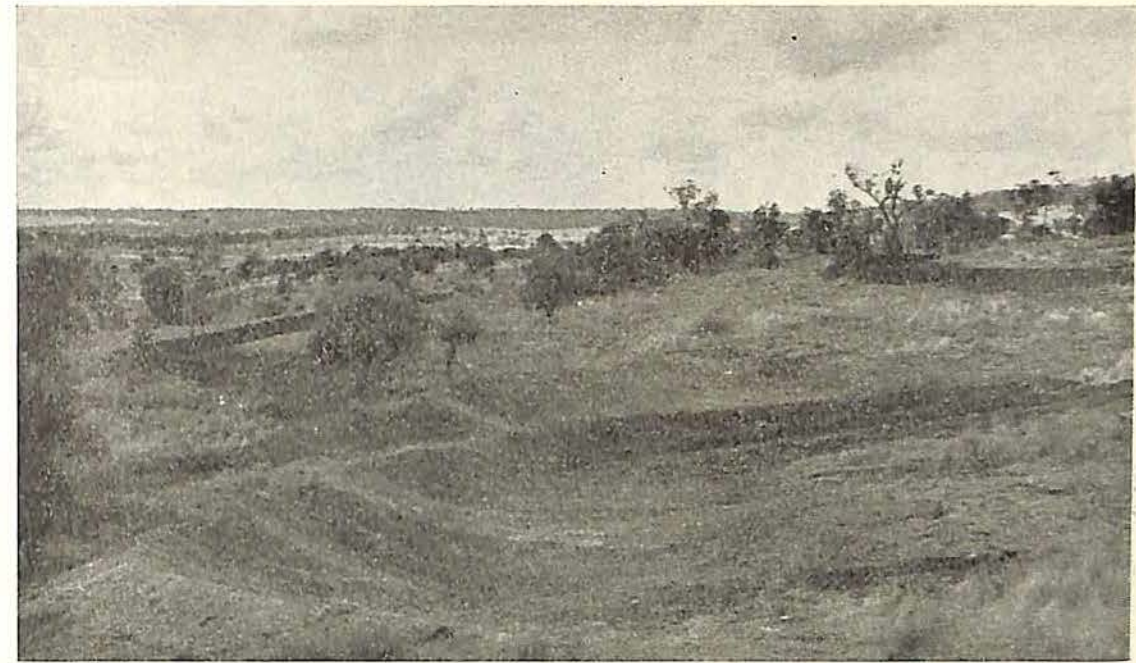
Fig. 4.—Absorption banks on steep hillsides retain water and protect the fertile lower slopes.

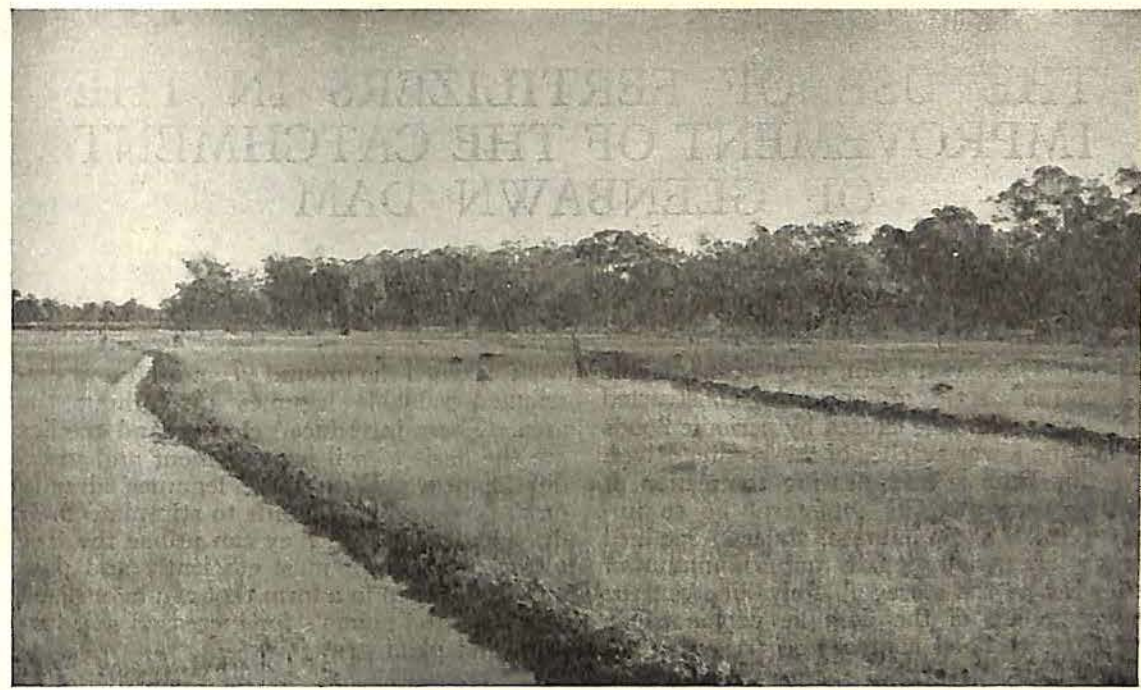
Fig. 6.—Pasture furrows, constructed with farming equipment, retain run-off.

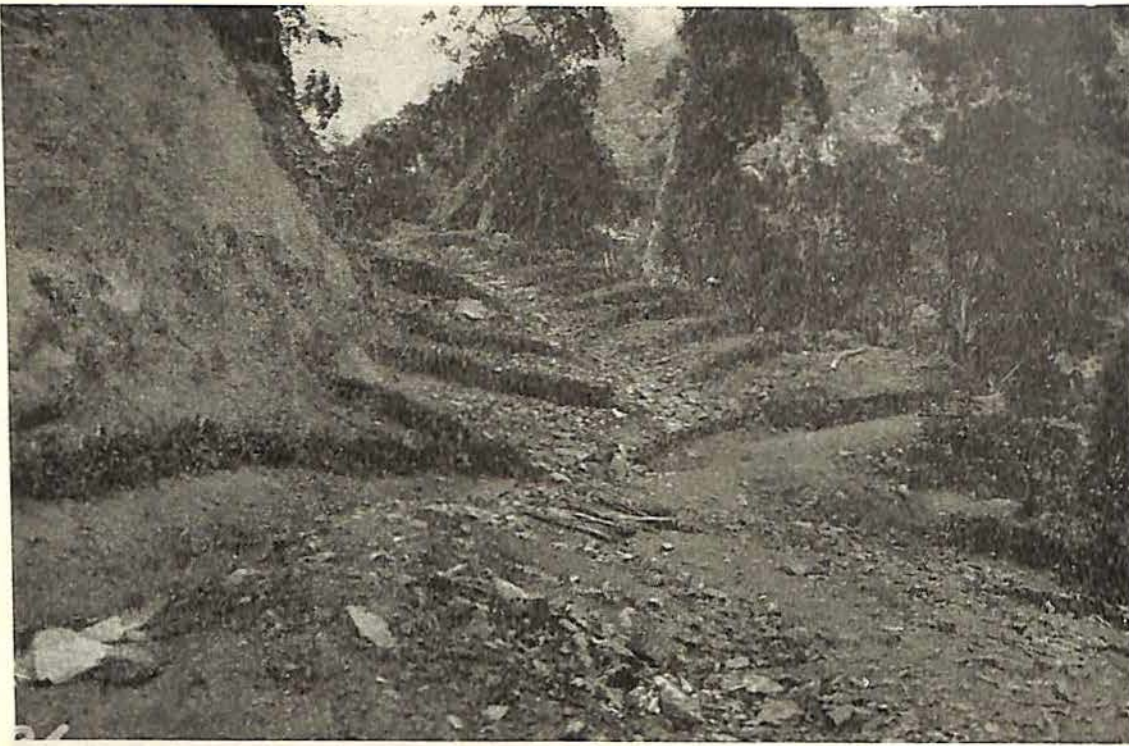
Fig. 14.—Wattled fences and a stone-pitched waterway in the early stage of revegetating a disused track. (Photo. S.M.H.E. A.)

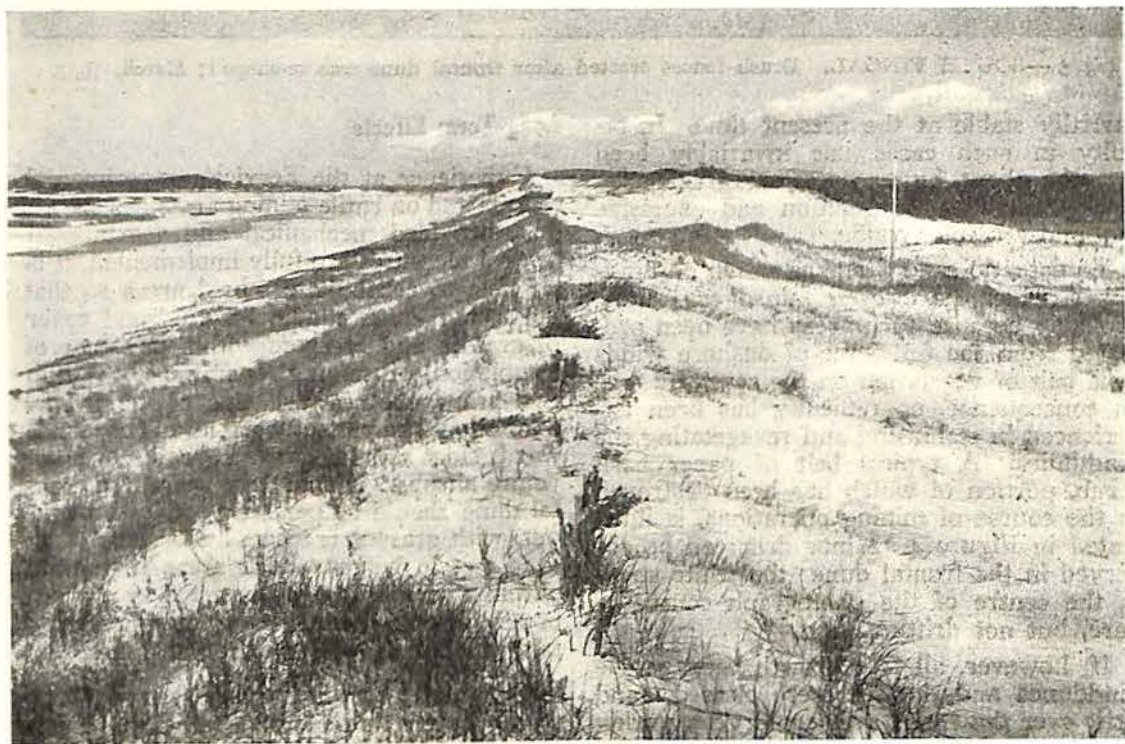
Fig. 6.—SOUTH FINGAL. Same area as Fig. 5, after frontal dune was planted to marram grass; September, 1955.

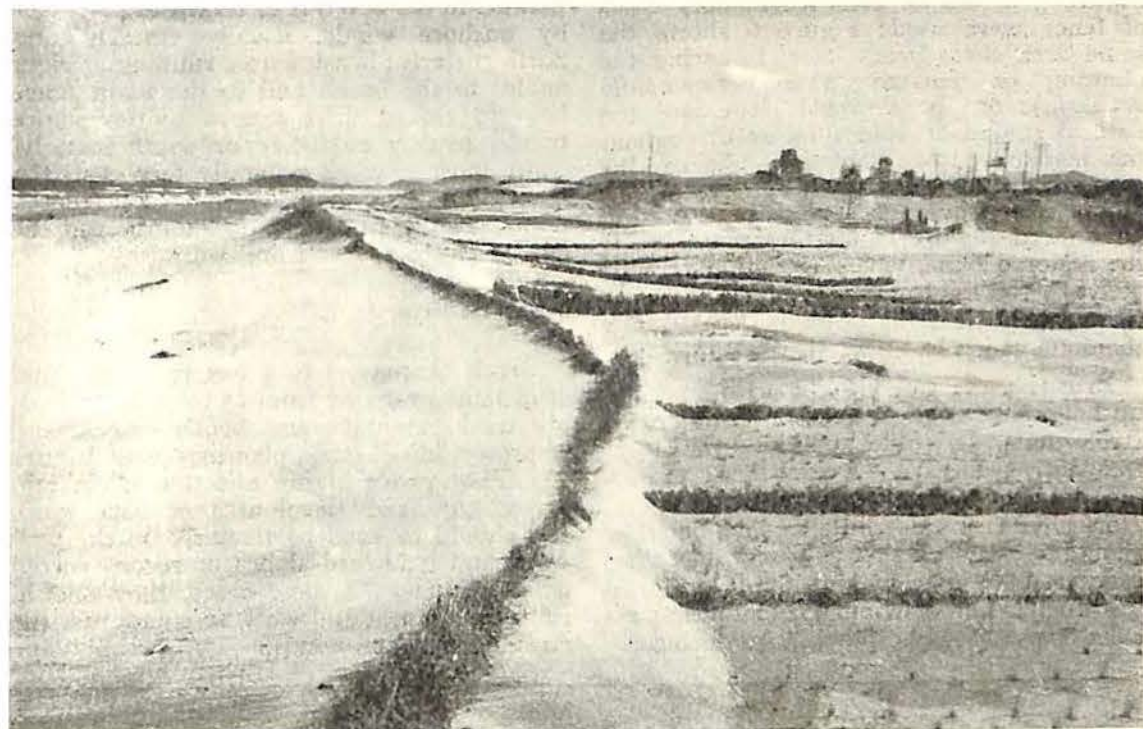
Fig. 7.—CUDGEN. Brush fence and barriers protecting young marram grass plantation; seaward slope not yet treated.

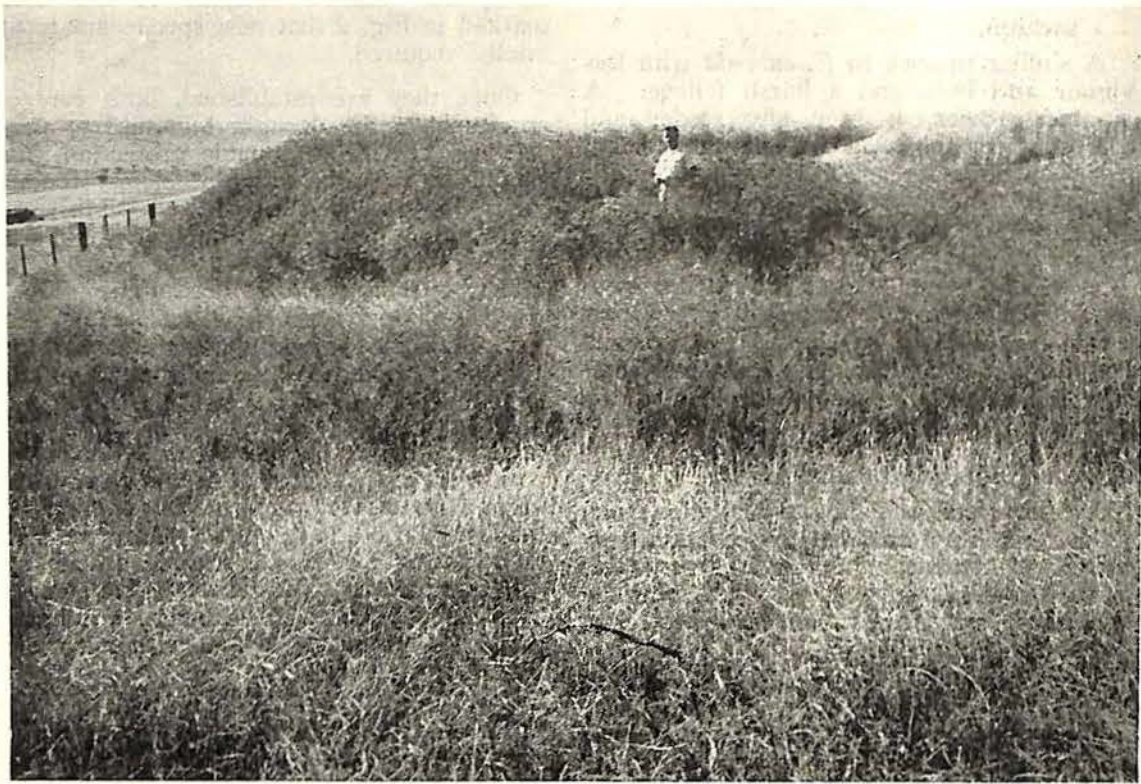
Fig. 7.—Vigorous growth of Rhodes grass stabilising a diversion bank at Scone.
