*THE  
JOURNAL OF THE  
SOIL CONSERVATION  
SERVICE  
OF N.S.W.*

*VOLUME 7*

*1951*

THE  
JOURNAL OF THE  
SOIL CONSERVATION  
SERVICE  
OF  
NEW SOUTH WALES

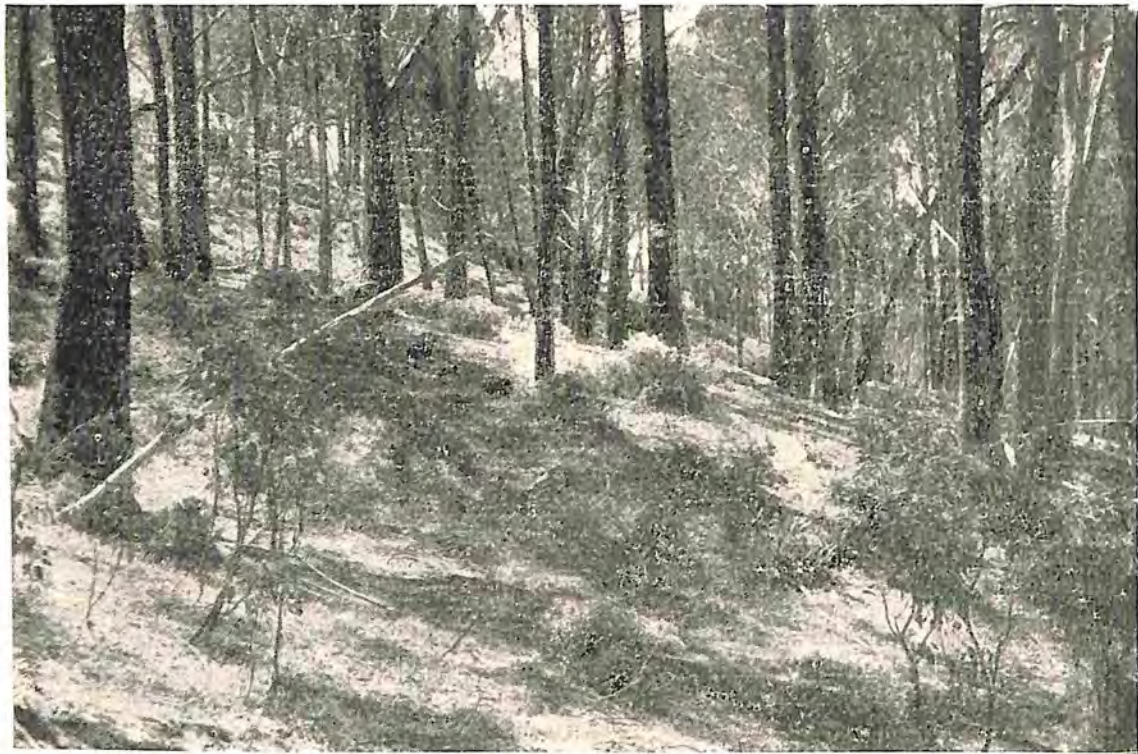
Fig. 2.—*E. gigantea* association (alpine ash), showing also the scattered undergrowth and good grass that occurs at the higher altitudes.

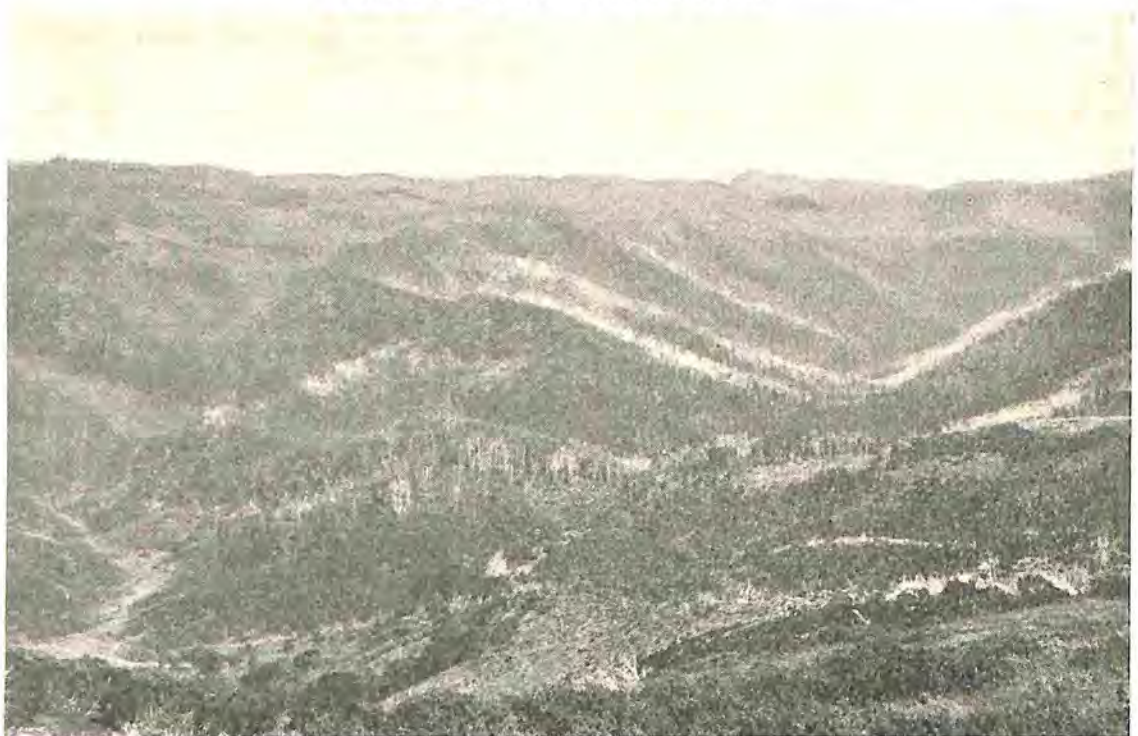
Fig. 3 — *E. gigantea* association (alpine ash), suffering severe fire damage in the Swampy Plain River gorge.

(ii) *Severe*: about 80 to 90 per cent. of the old crop trees killed, the remainder badly damaged. About half the alpine ash area is in this condition, a mass of white shafts.

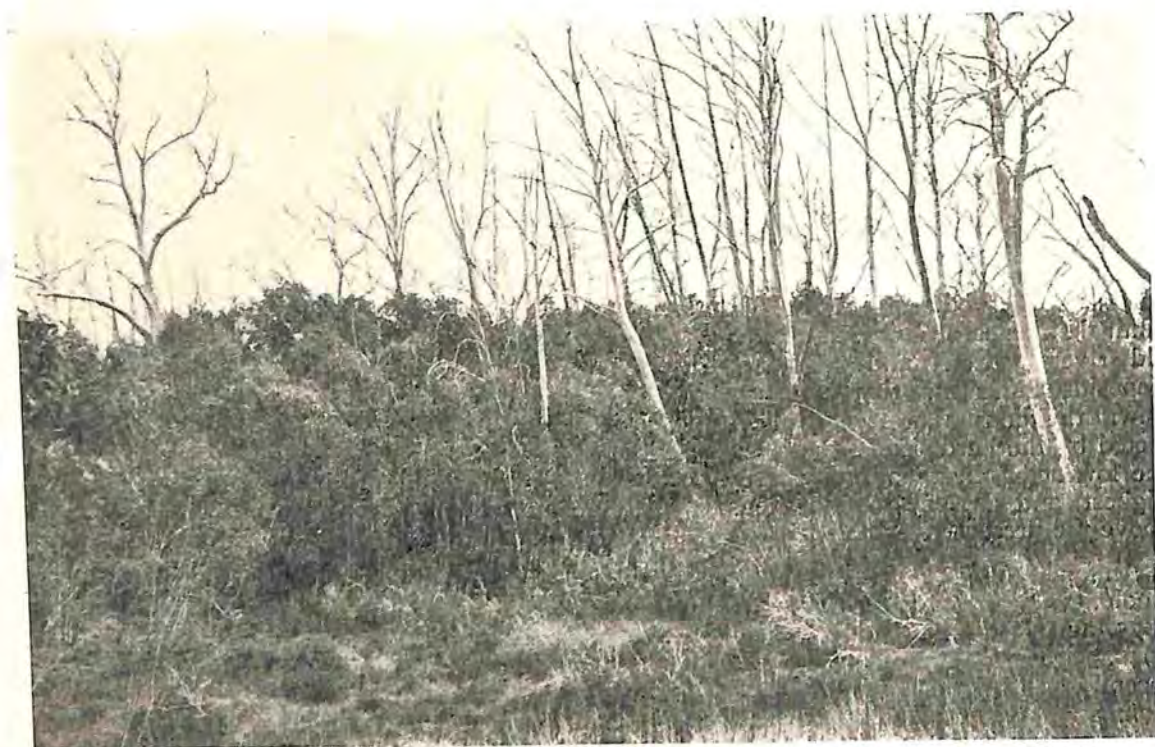
Fig. 4.—*E. gigantea* association (alpine ash). A close view of the severe fire damage. All old crop trees killed, dense sapling regrowth.

Usually a dense regrowth of tree saplings, wattle, and hopbush, rapidly comes up and restocks the burned areas. Therefore, the ground surface is actually vulnerable for only a short period following fires.

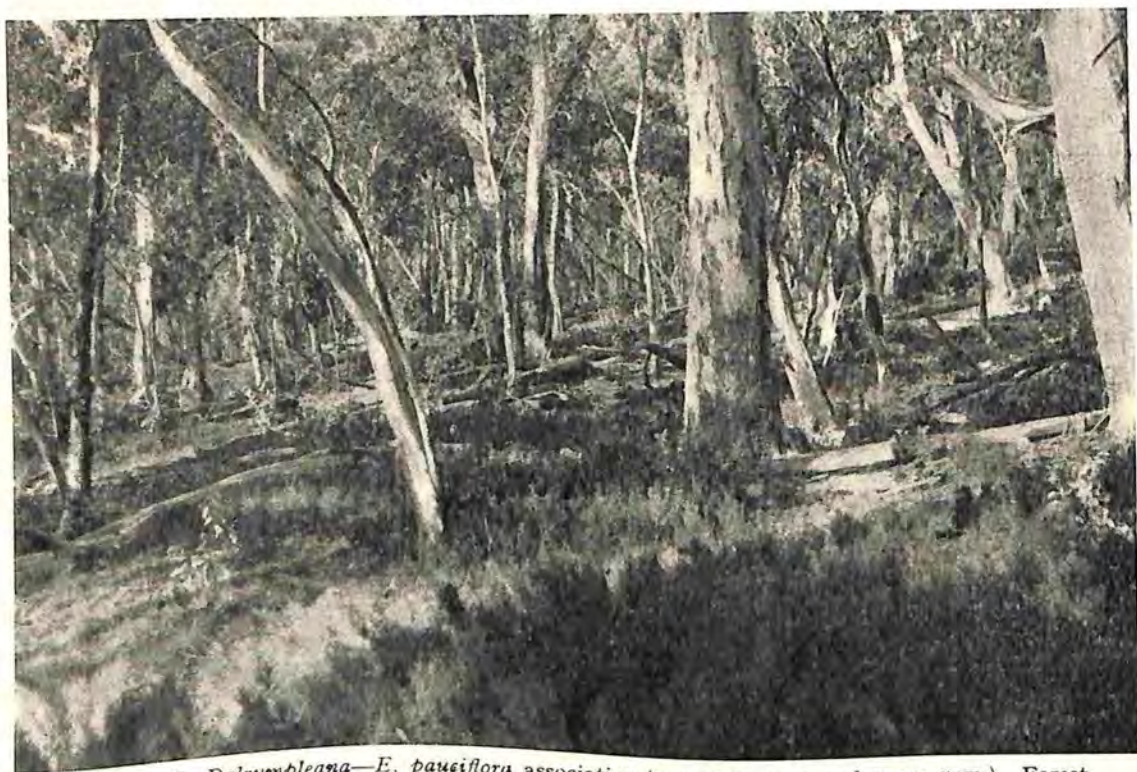
Fig. 5.—*E. Dalrympleana*—*E. pauciflora* association (mountain gum and snow gum.) Forest moderately fire damaged and semi-cleared.

*Fire Damage.*—The mountain gum is far less fire sensitive than alpine ash or snow gum, and the association is generally in fair condition. Small areas show severe damage, where most of the mature trees have been killed. Dense seedling regrowth has restocked these.

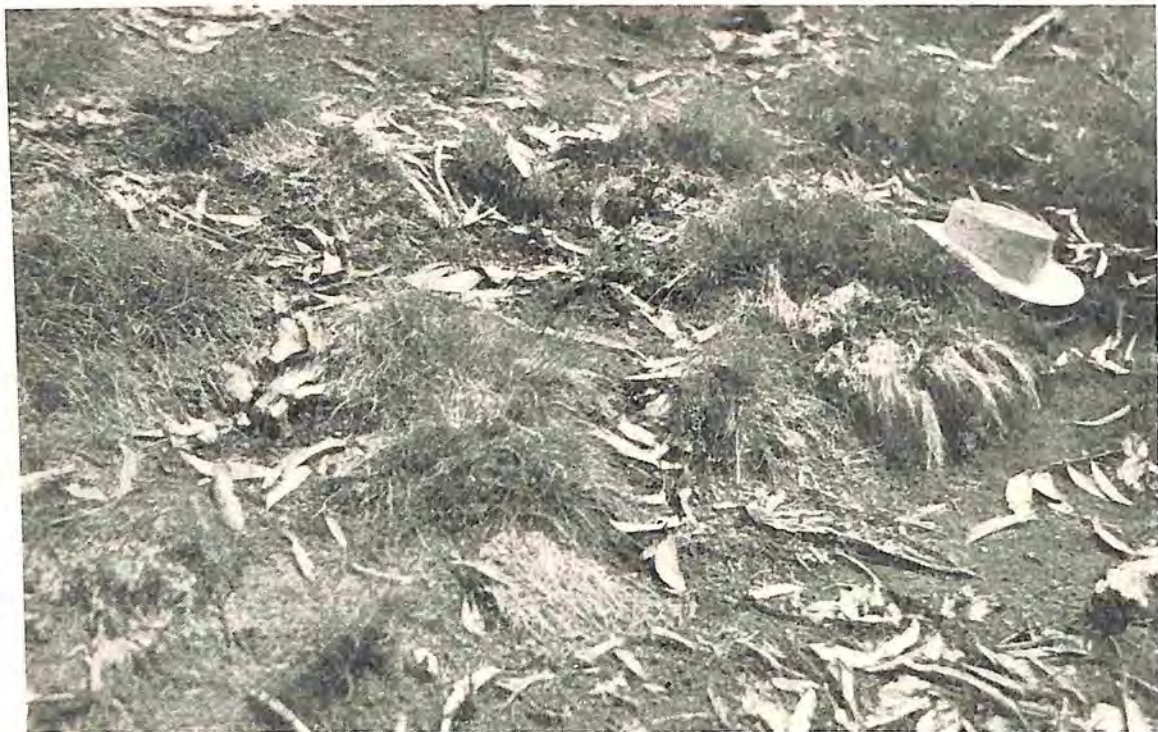
Fig. 6.—*E. Dalrympleana*—*E. pauciflora* association (mountain gum and snow gum). Moderate sheet erosion of the forest floor due to repeated burning of the snow grass.

On forested and semi-cleared woodland areas, any soil erosion is the direct result of fires. Destruction of undergrowth, grass cover, litter, and soil organic content, renders the soil vulnerable to water erosion.

*Erosion.*—Light fires which destroy the litter and burn back the snow grass tussocks to short stubble, have resulted in light sheeting, moderate on steeper slopes, in the moderate fire damaged areas. The grass soon recovers, and sheeting is controlled, but repeated burning every couple of years is keeping some areas in a continually unstable condition.

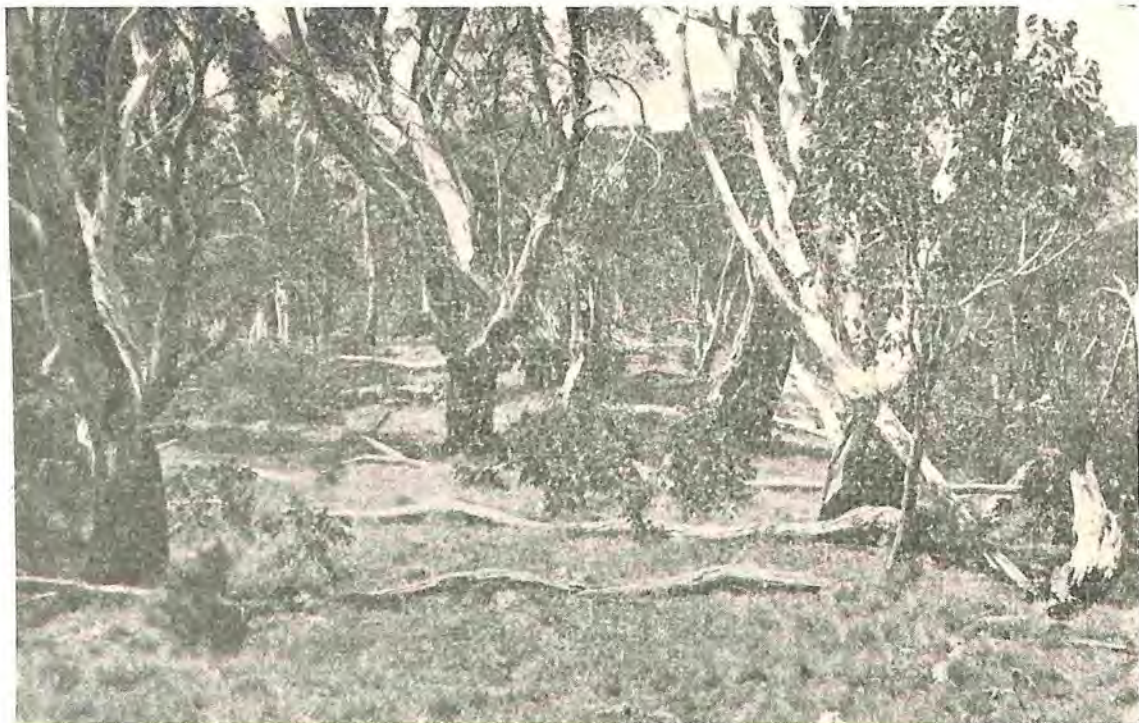
Fig. 7.—*E. pauciflora* association (snow gum). Forest moderately fire damaged and reduced to savannah woodland. There is scattered regeneration.

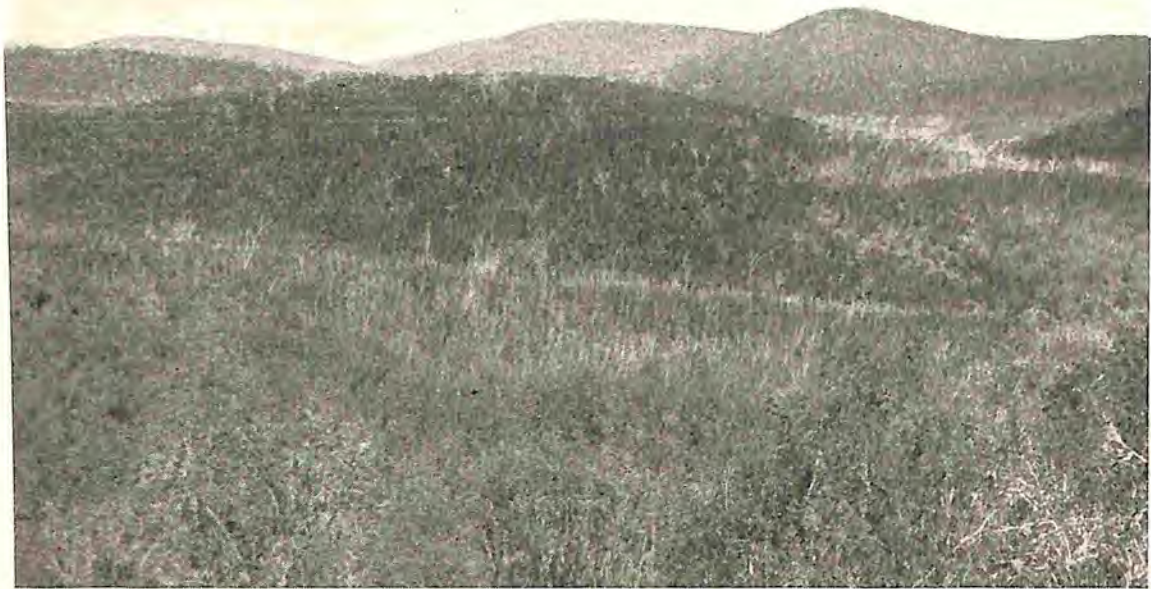
Fig. 8.—*E. pauciflora* association (snow gum). Forest severely fire damaged. All old crop trees killed, dense coppice regrowth.

Occasionally there are patches where old trees have been killed completely, but with no subsequent coppice growth, and the area has regenerated densely by seed.

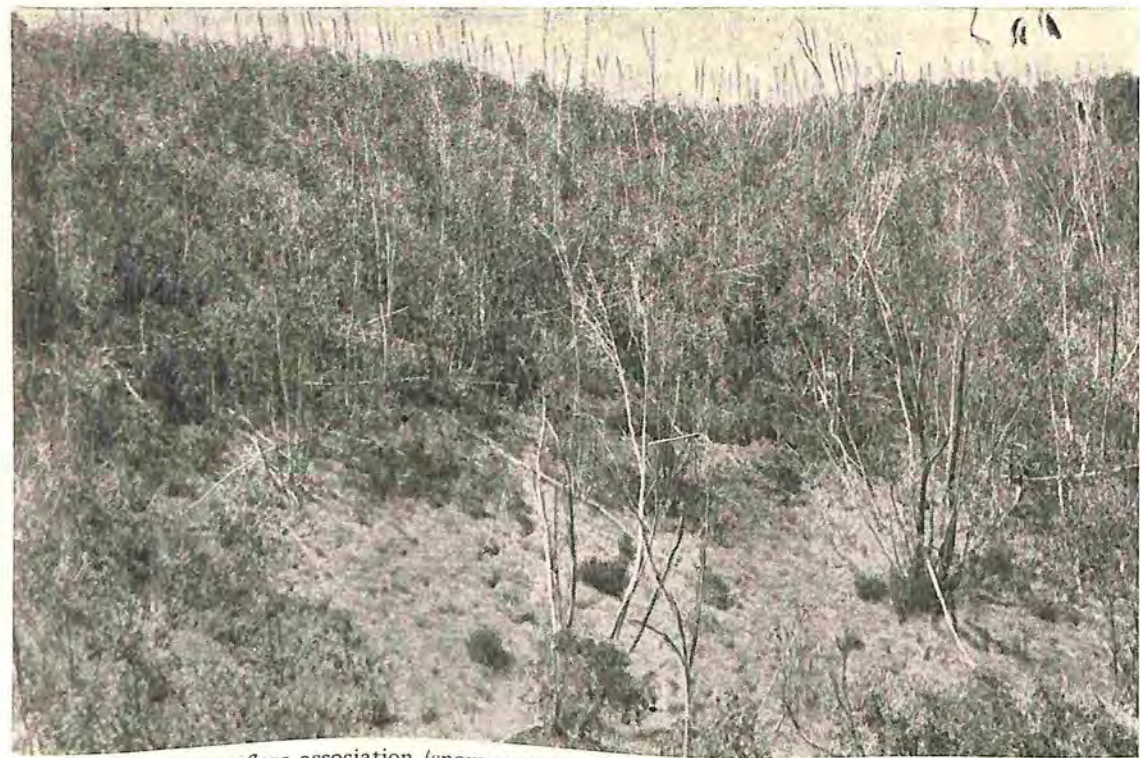
Fig. 9—*E. pauciflora* association (snow gum). Forest severely fire damaged. Shows the dense coppice regrowth. A previous coppice stand has been fire killed. The original crop of old trees has disappeared completely.

Further severe fire in these areas of dense coppice can be expected to leave large areas bare of tree cover.

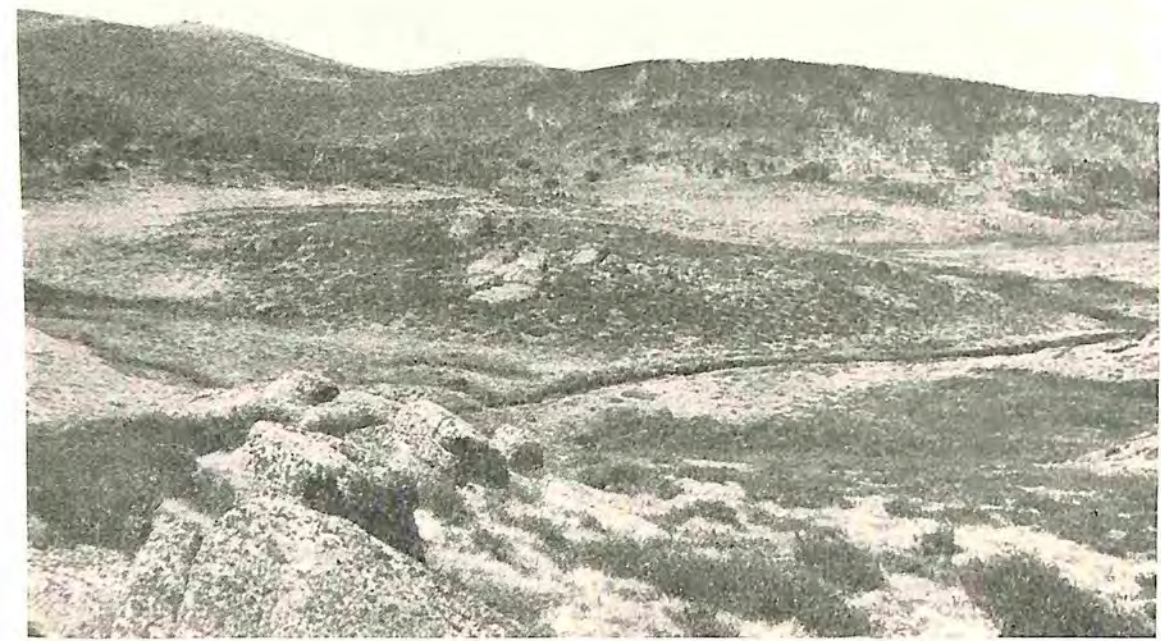
Fig. 10.—High Moor (*Bossiaea foliosa* association) on lower slopes at 4,500 feet. Snow gum forest on upper slopes.

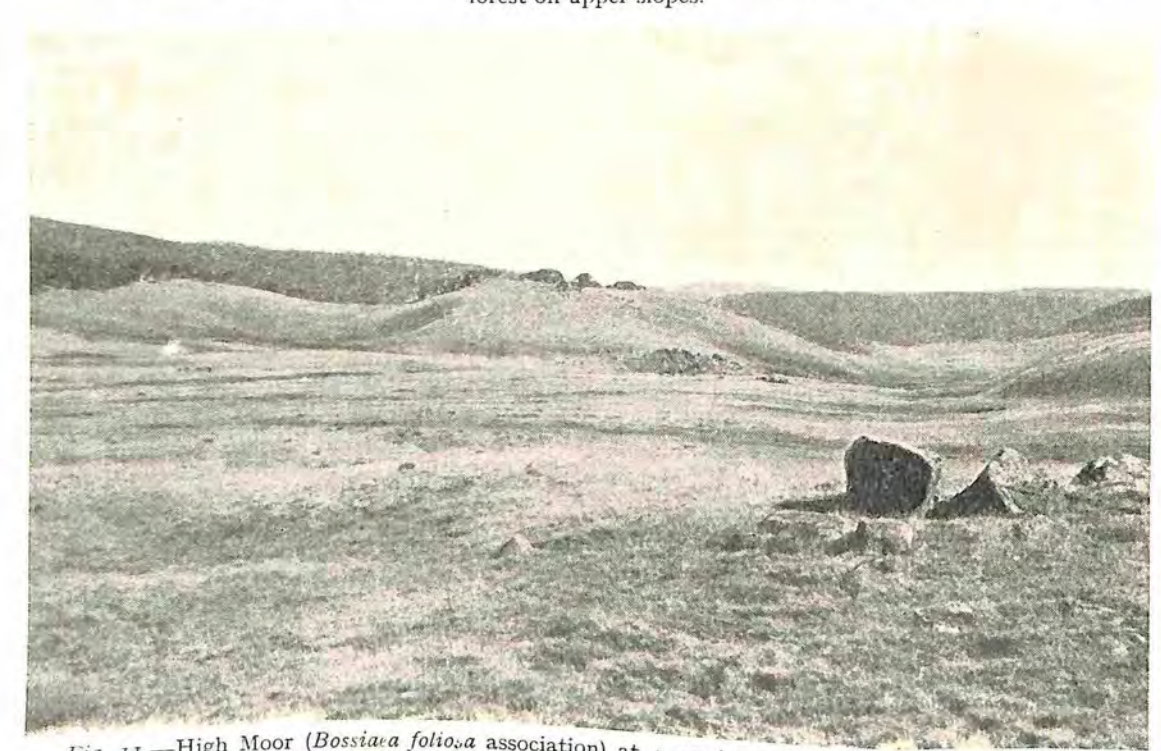
Fig. 11.—High Moor (*Bossiaea foliosa* association) at 4,500 feet. Snow gum and alpine ash on upper slopes. Shrubs completely replaced by snow grass.

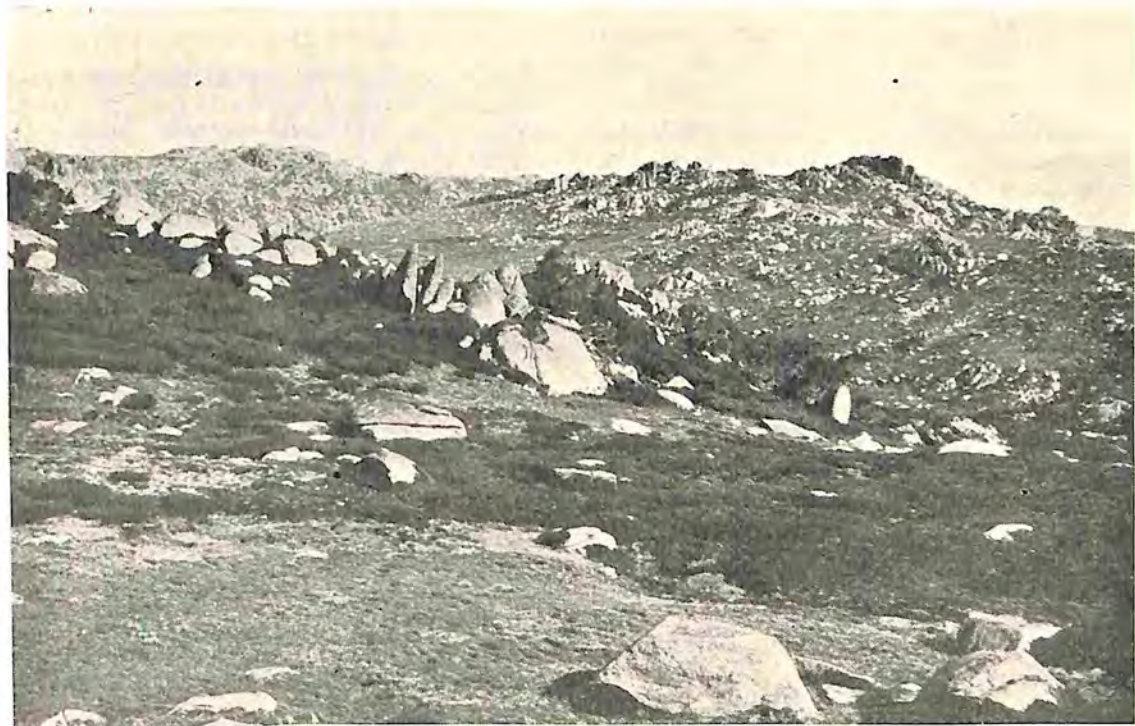
Fig. 12.—Alpine grassland at 6,500 feet, with a patch of woody shrubs on the warmer aspect.

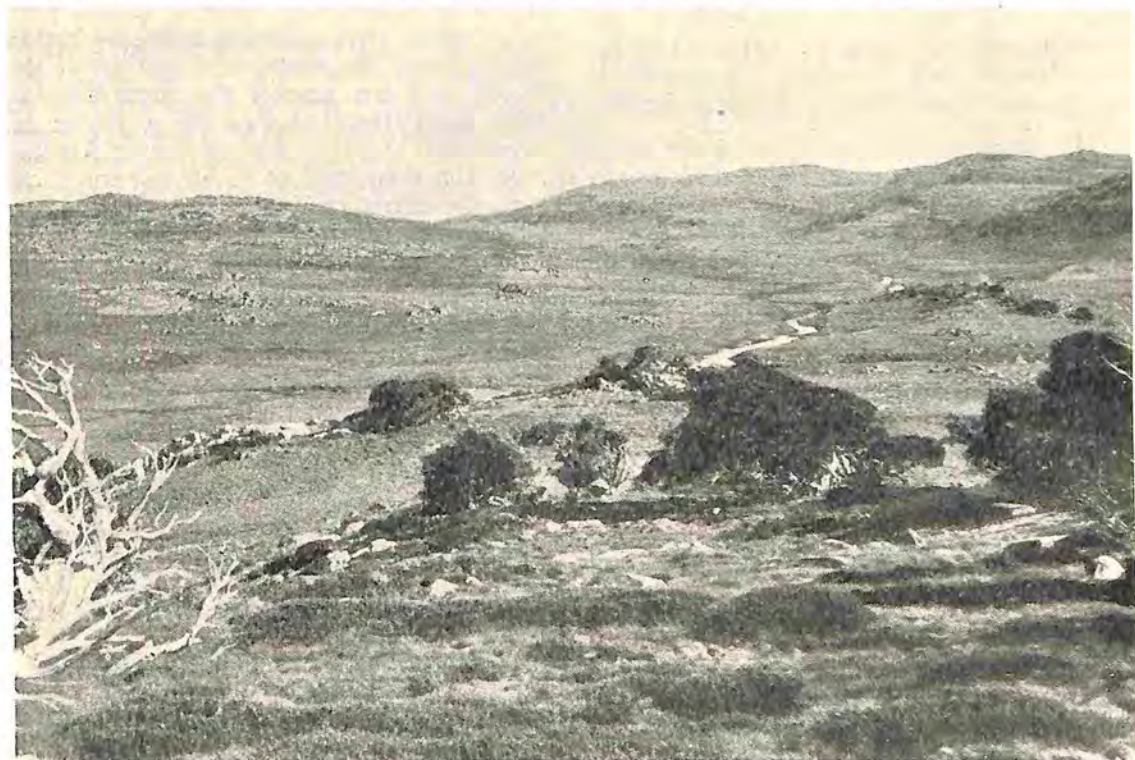
Fig. 13.—High Moor (*Prostanthera cuneata* association). Shrubs replaced by snow grass. A few shrubs in foreground at about 5,500 feet.

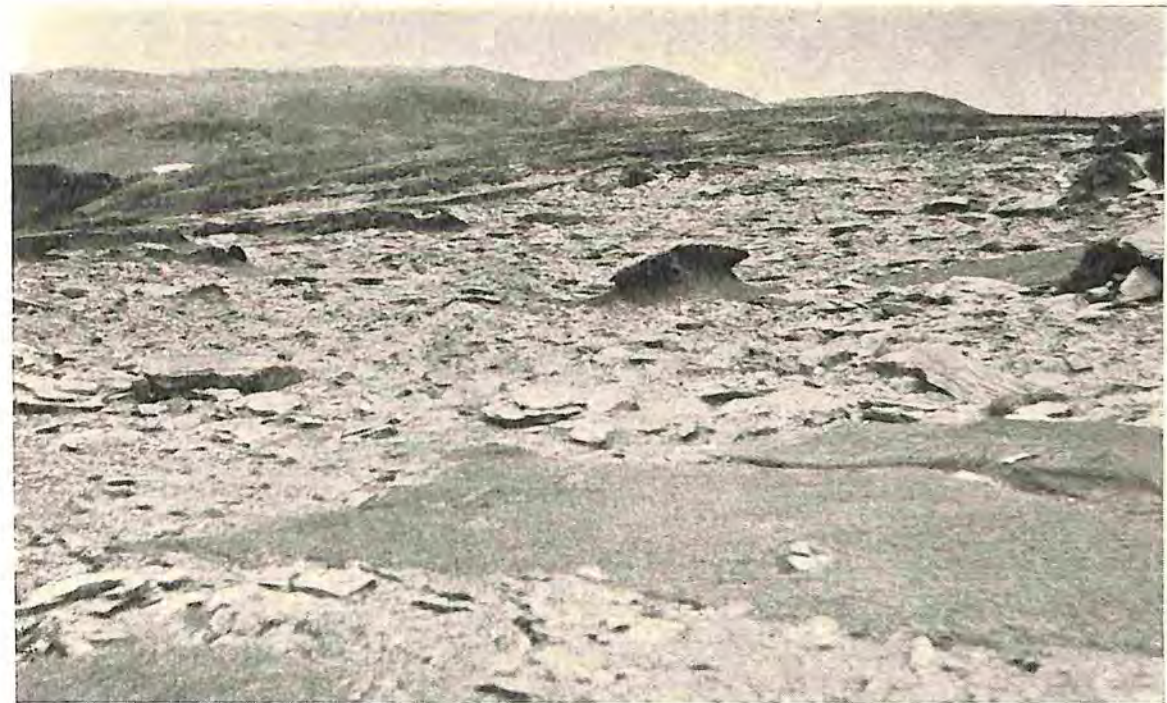
Fig. 14.—Alpine grassland. Wind erosion on the Divide at 7,000 feet. Soil removed to the "C" horizon.

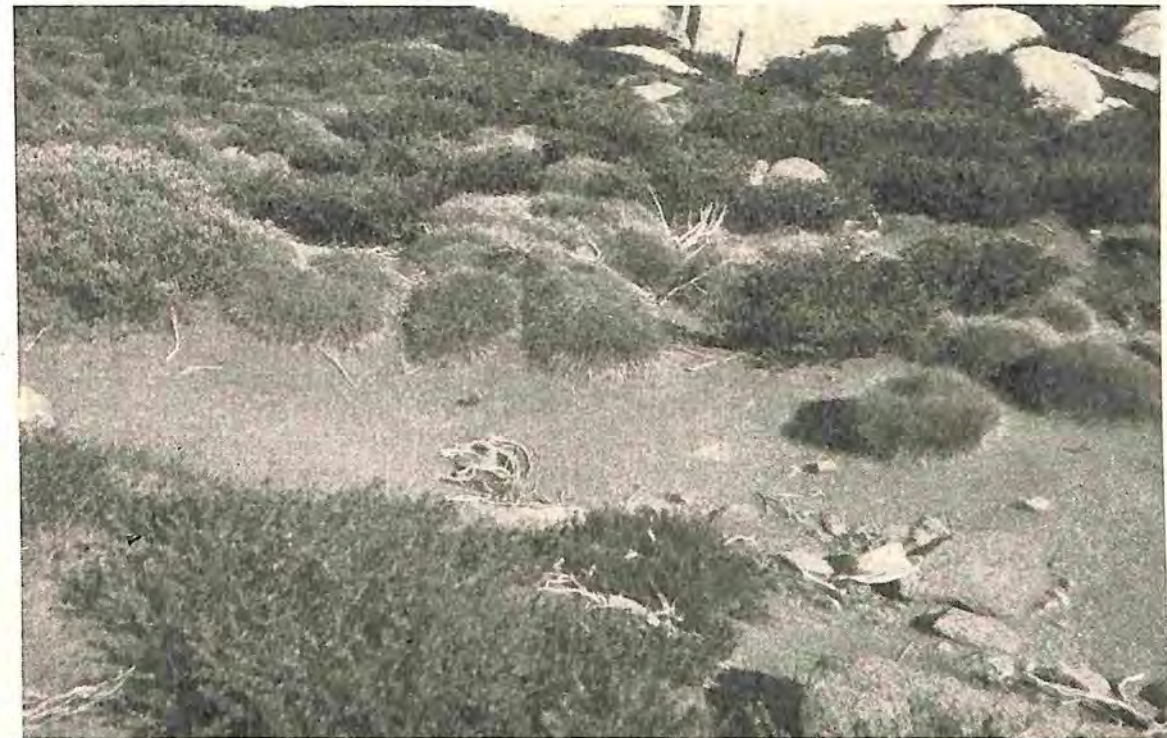
Fig. 15.—Alpine grassland. A "scour." Note size of hat lower right.

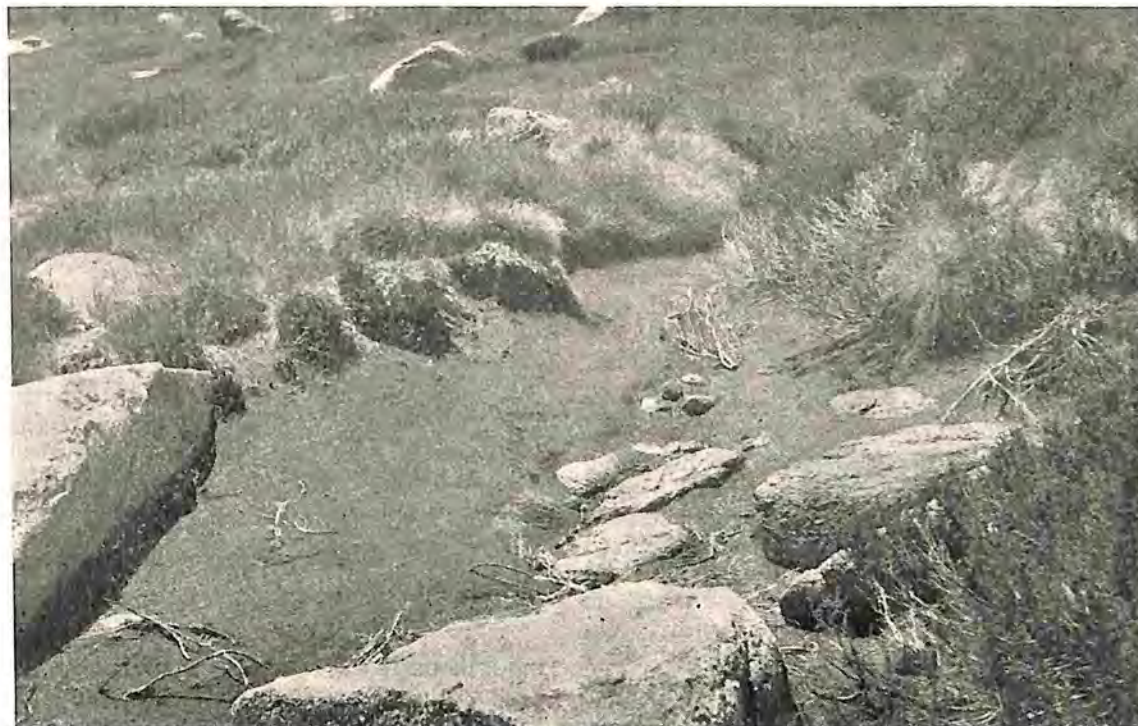
Fig. 16.—Alpine grassland. A "scour" in the deep humus soil.

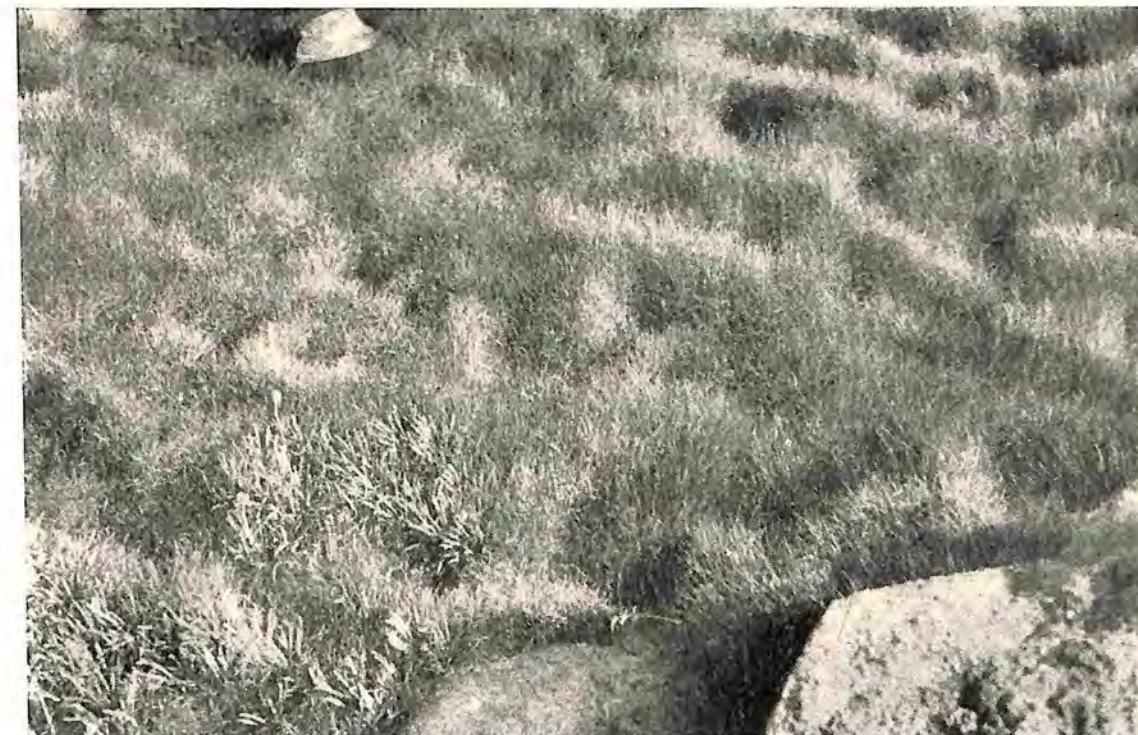
Fig. 17.—Snow grass (*Poa caespitosa*). No sheet erosion.

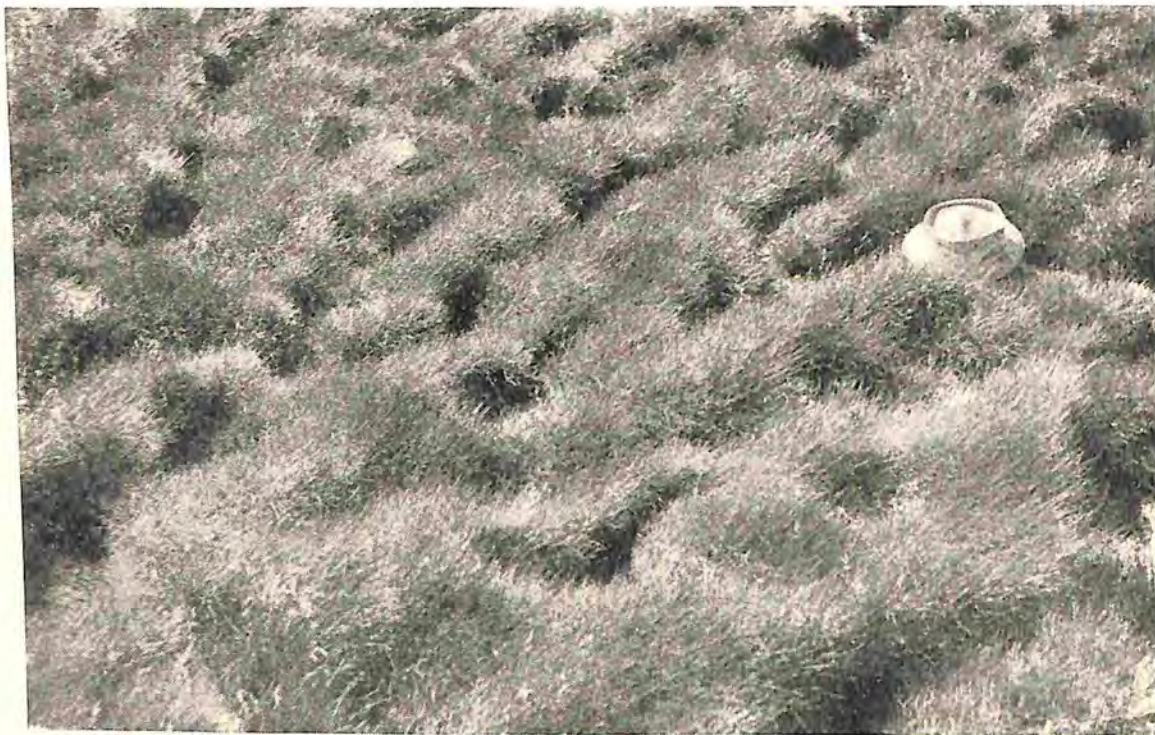
Fig. 18.—Snow grass (*Poa caespitosa*) country, showing light sheet erosion.

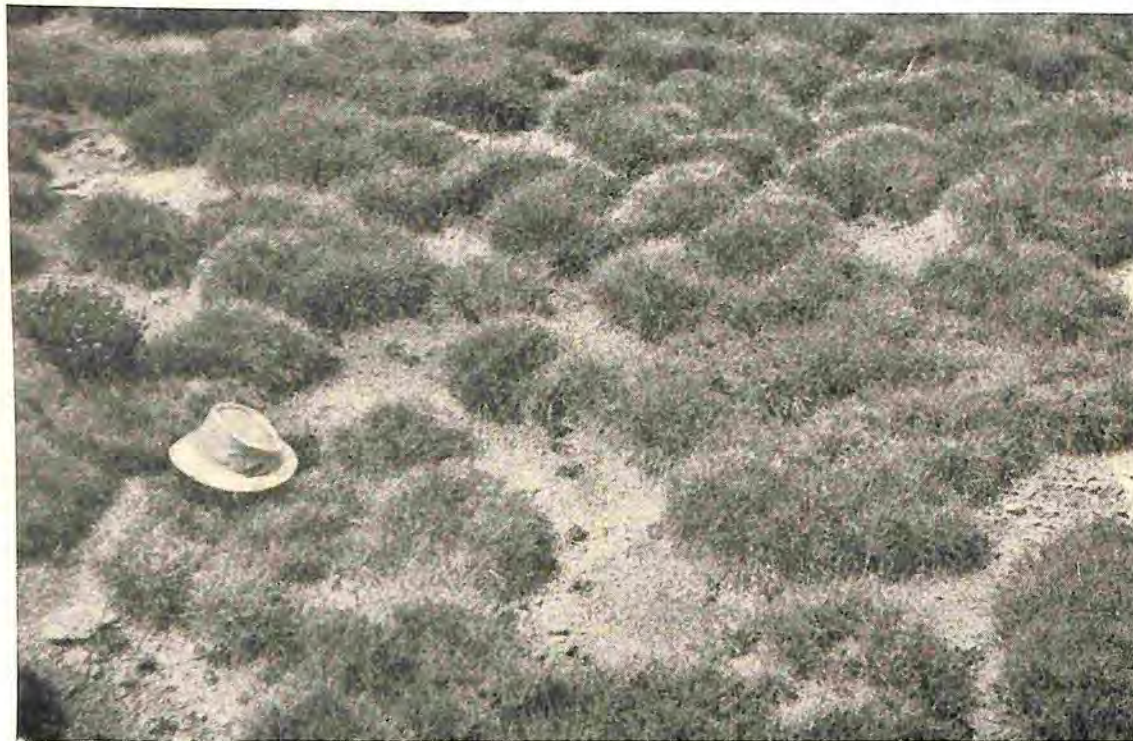
Fig. 19.—Snow grass (*Poa caespitosa*), showing moderate sheet erosion.

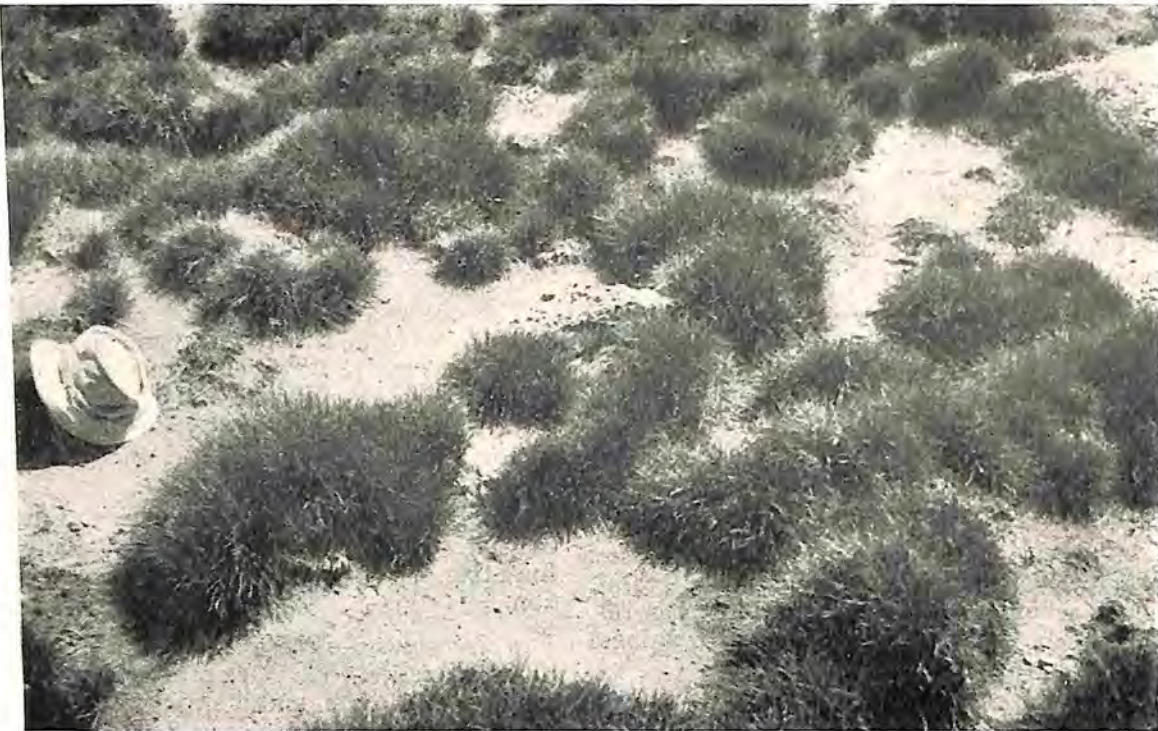
Fig. 20.—Snow grass (*Poa caespitosa*) country, showing moderate/severe sheet erosion. The elevation is about 6,000 feet.

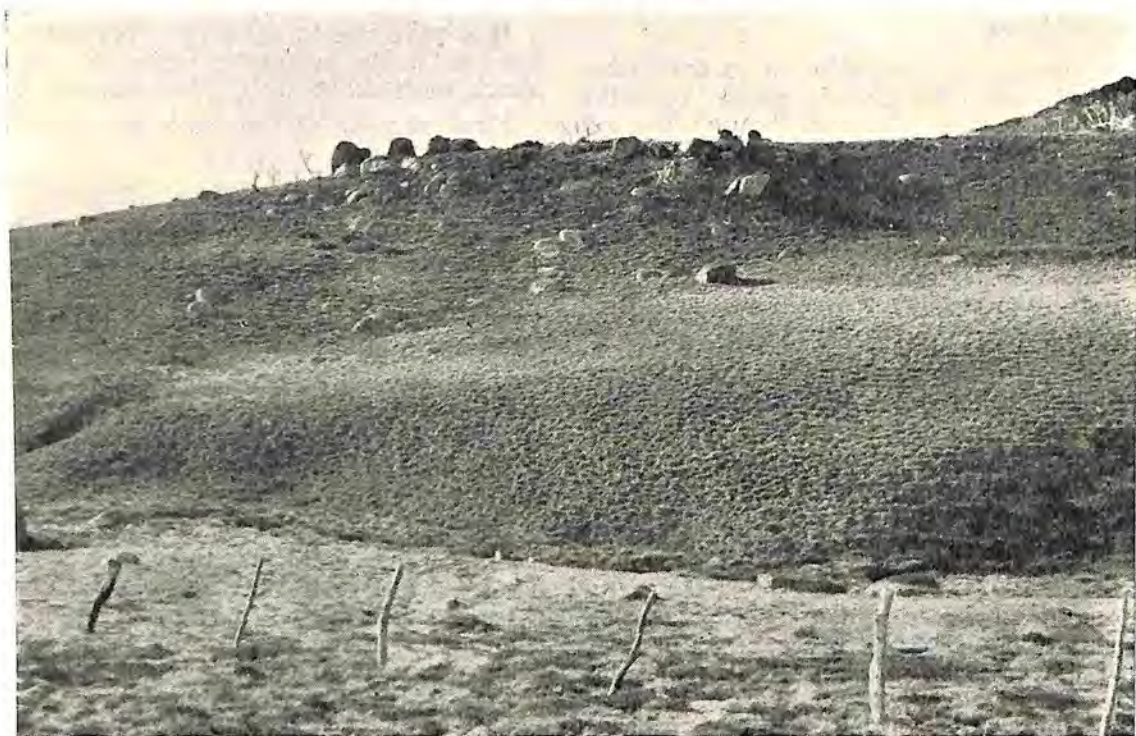
Fig. 21.—Snow grass (*Poa caespitosa*). View of moderately sheeting hillside at about 5,500 feet.

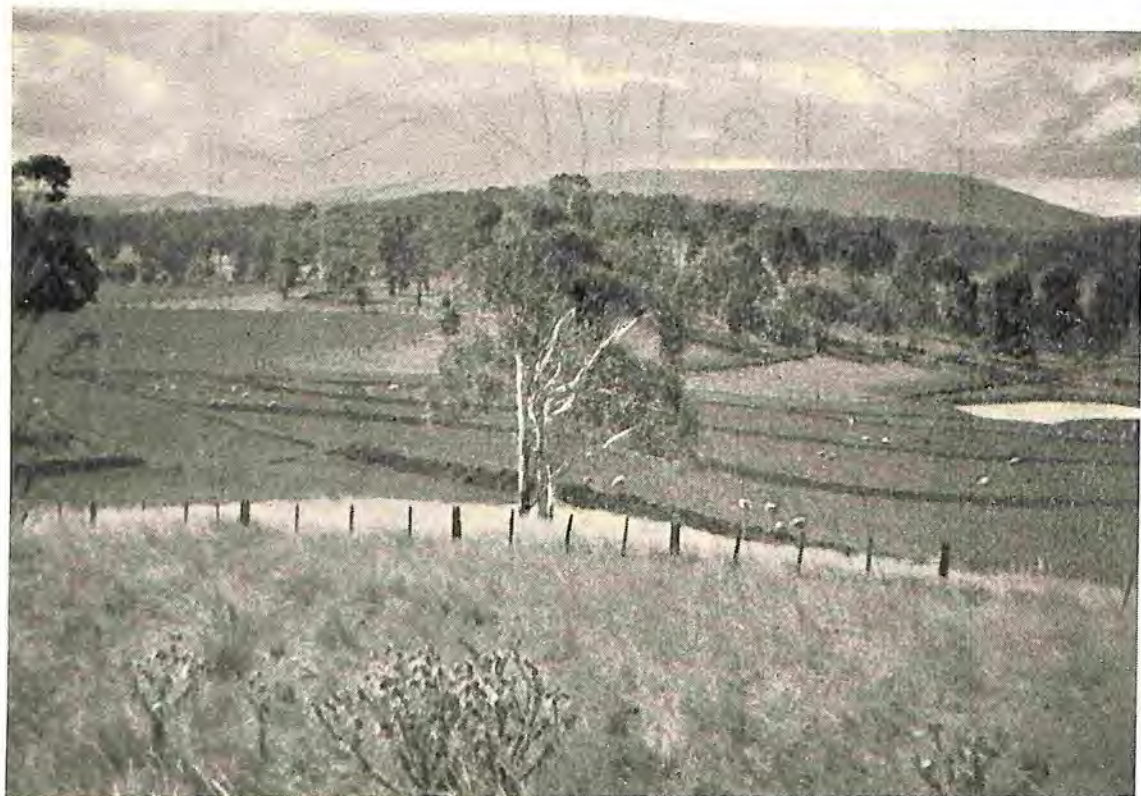
Fig. 2.—A well-grassed natural waterway at "Laurel Dale."

The waterways are a good demonstration of what can be done with depressions and stabilised watercourses in the New England district.

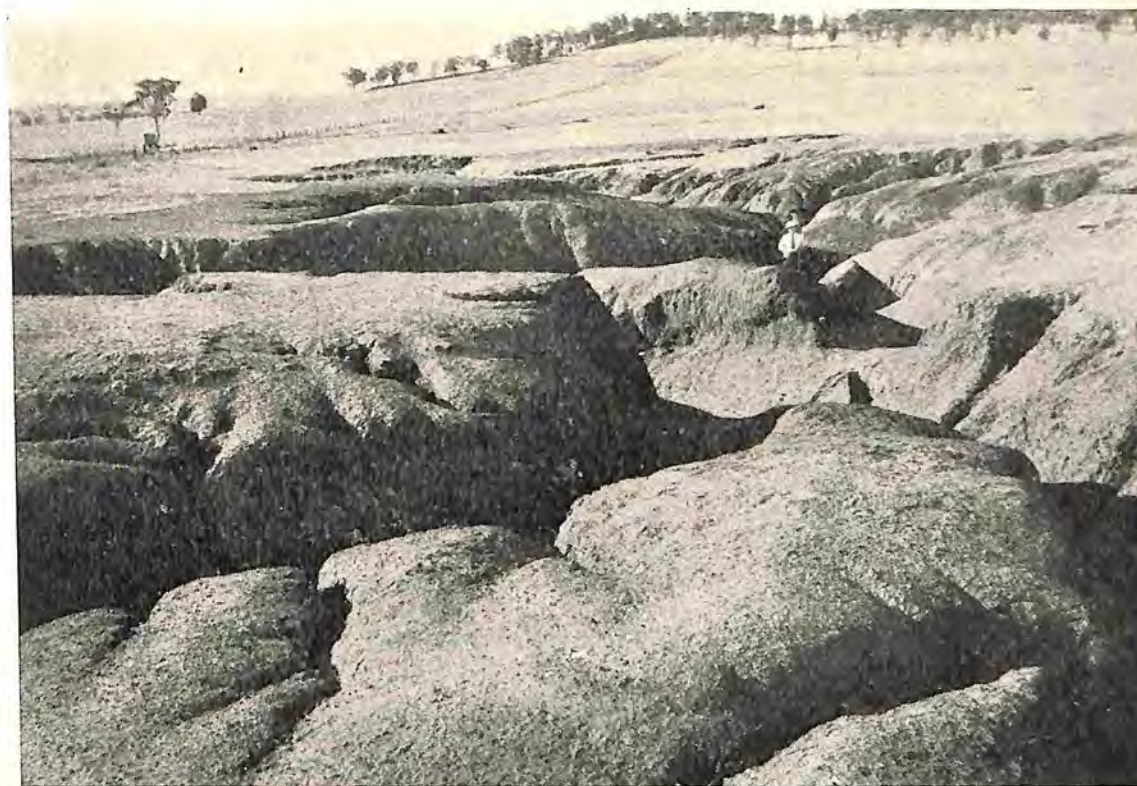
Fig. 1.—Sheet and gully erosion in the front paddock of Wellington Research Station in 1945, prior to Soil Conservation measures.

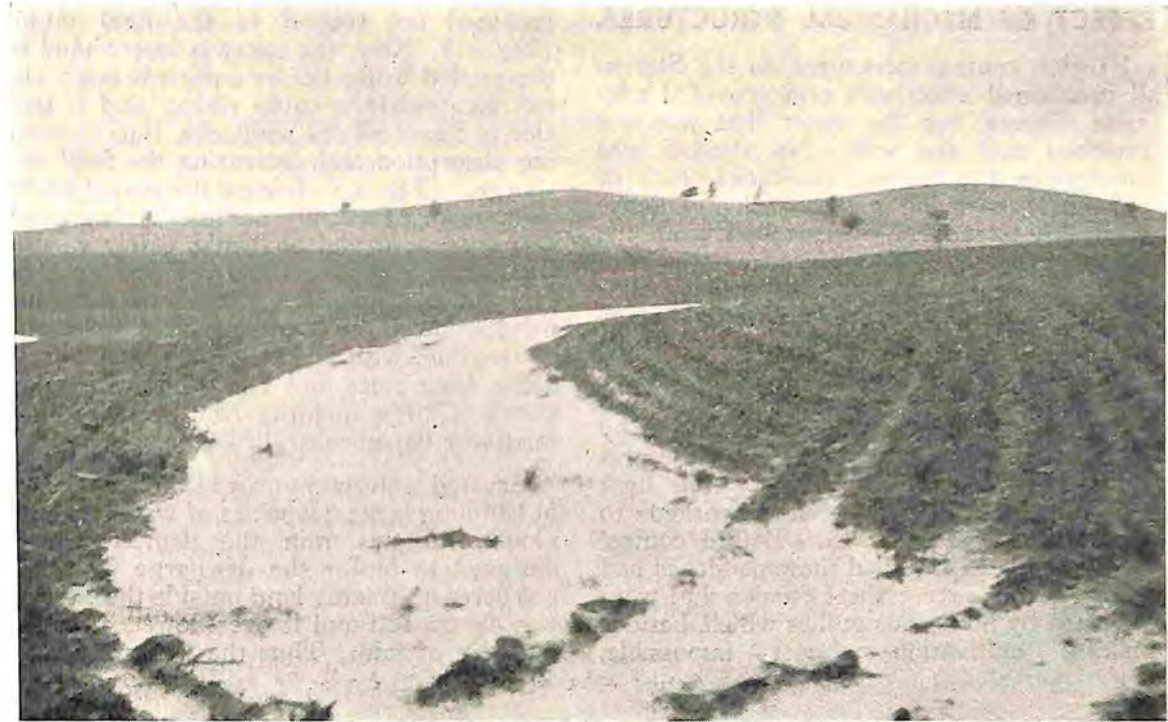
Fig. 2.—Run-off from arable land being discharged slowly and safely by graded banks.

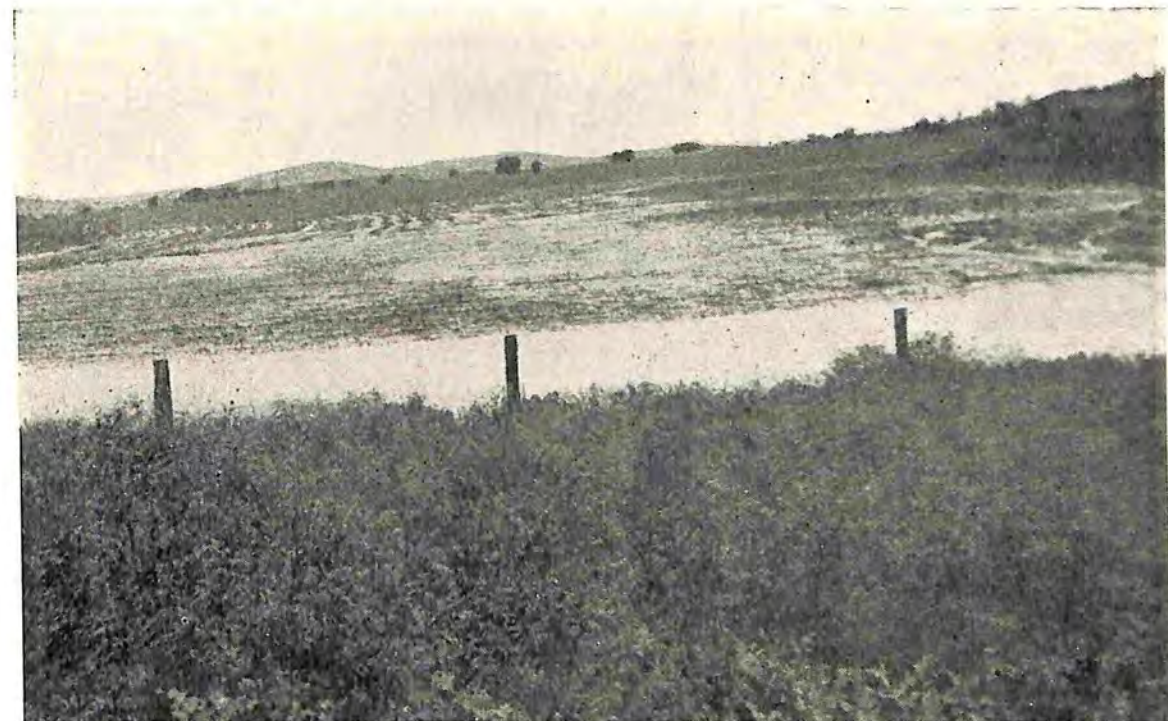
Fig. 3.—Water flowing from an uncontrolled fallow, Bodangora Road, Wellington, following 100 points of rain.

On the Research Station all cultural operations are carried out on the contour (Fig. 6), and this considerably reduces the run-off as each furrow acts as a miniature absorption bank. Figure 7 shows this effect, whilst in the background of Figure 3 furrows can be seen running down the slope, thus draining the water off the land. (A full discussion on contour cultivation was published in this Journal in April, 1949.)

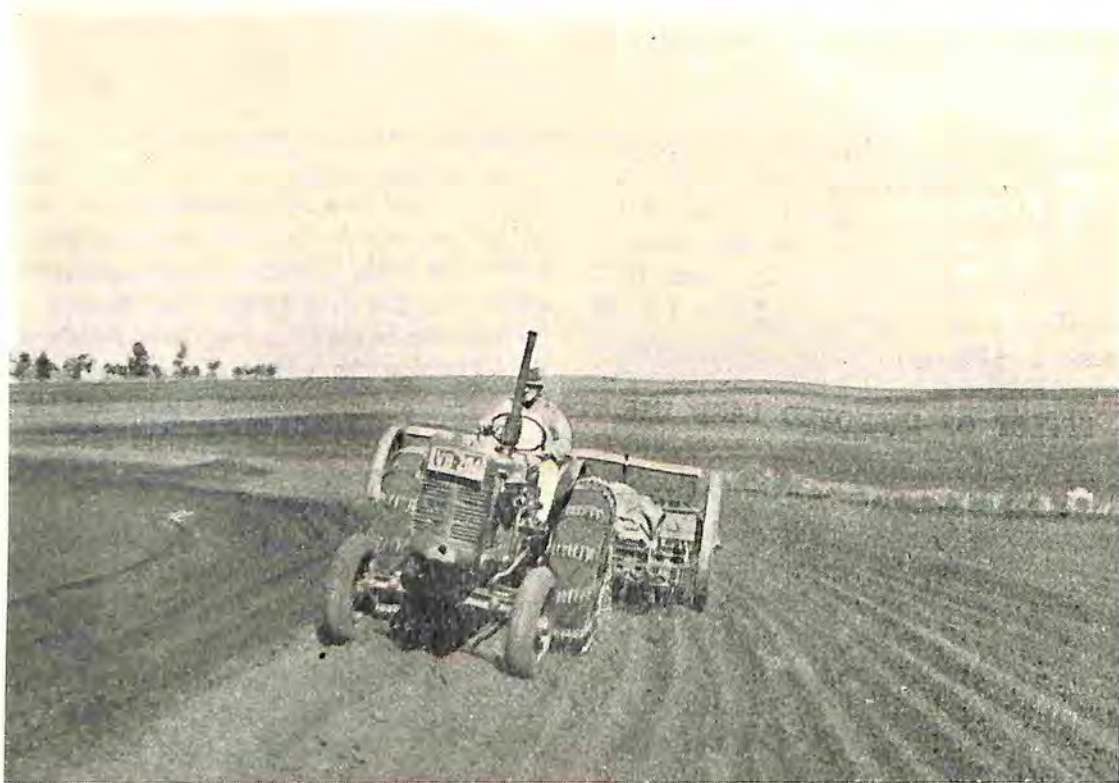
Fig. 6.—Sowing wheat on a graded bank.

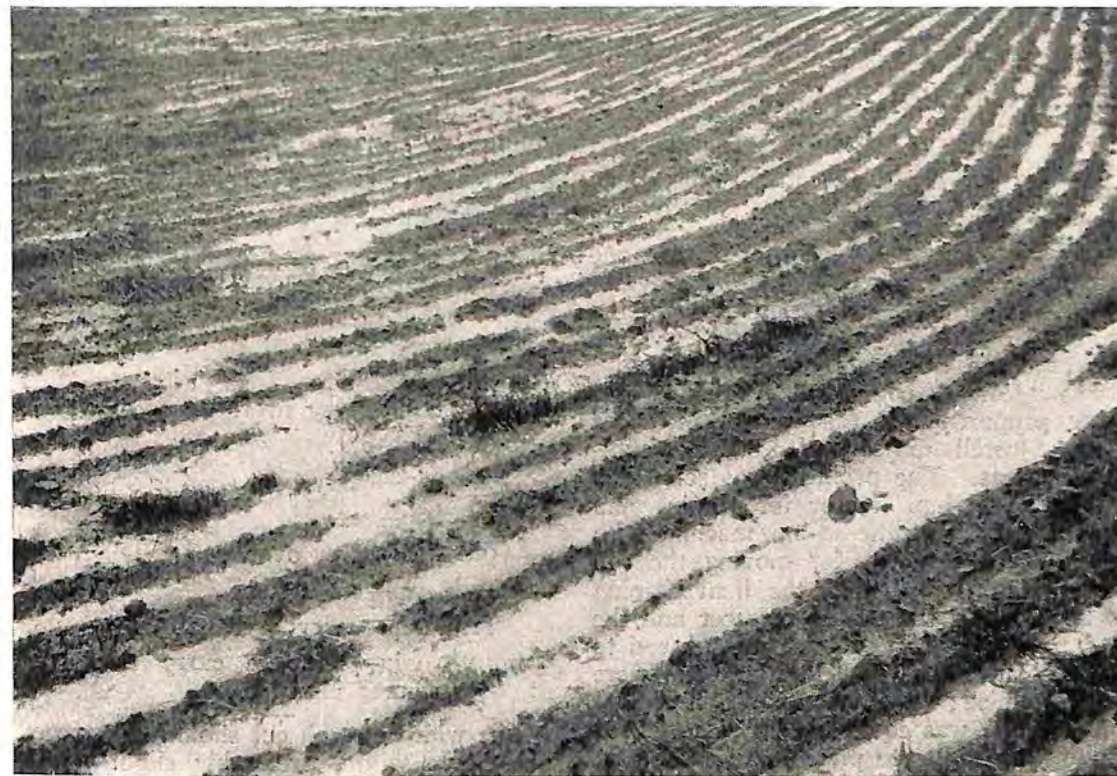
Fig. 7.—Contour cultivation on Wellington Research Station. Every furrow acts as a miniature absorption bank and prevents run-off.
