*THE  
JOURNAL OF THE  
SOIL CONSERVATION  
SERVICE  
OF N.S.W.*

*VOLUME 7*

*1951*

THE  
JOURNAL OF THE  
SOIL CONSERVATION  
SERVICE  
OF  
NEW SOUTH WALES

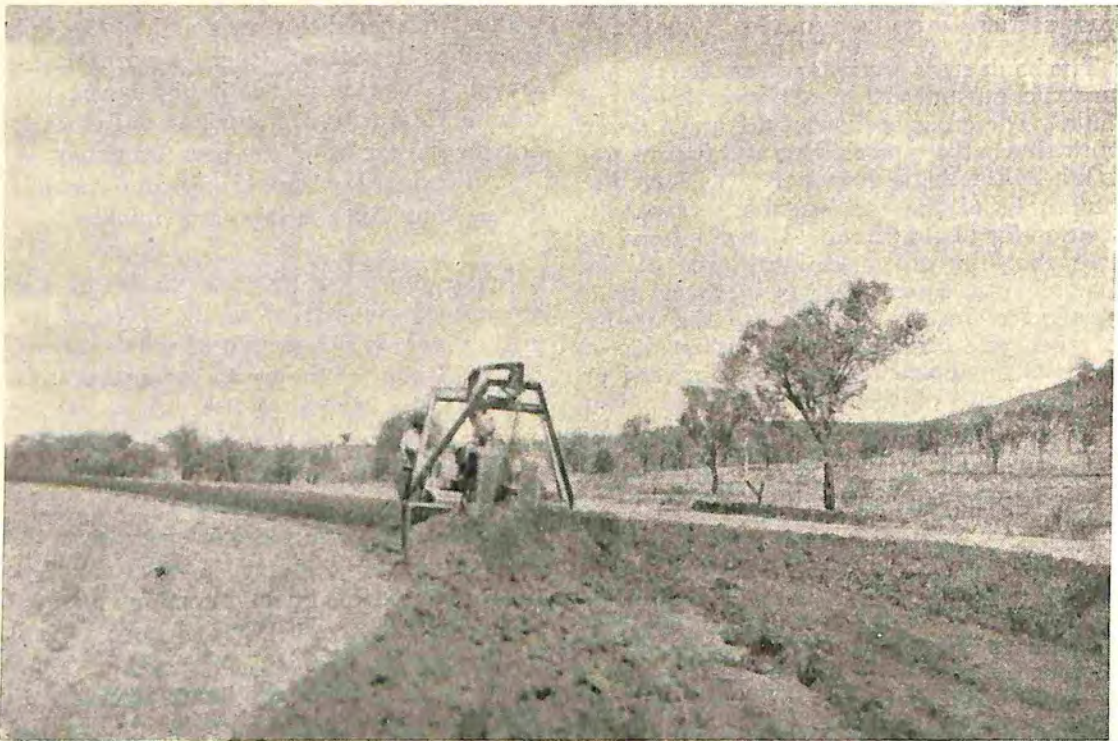
*Fig. 4.*—The final cut by the angledozer, forming the batter.

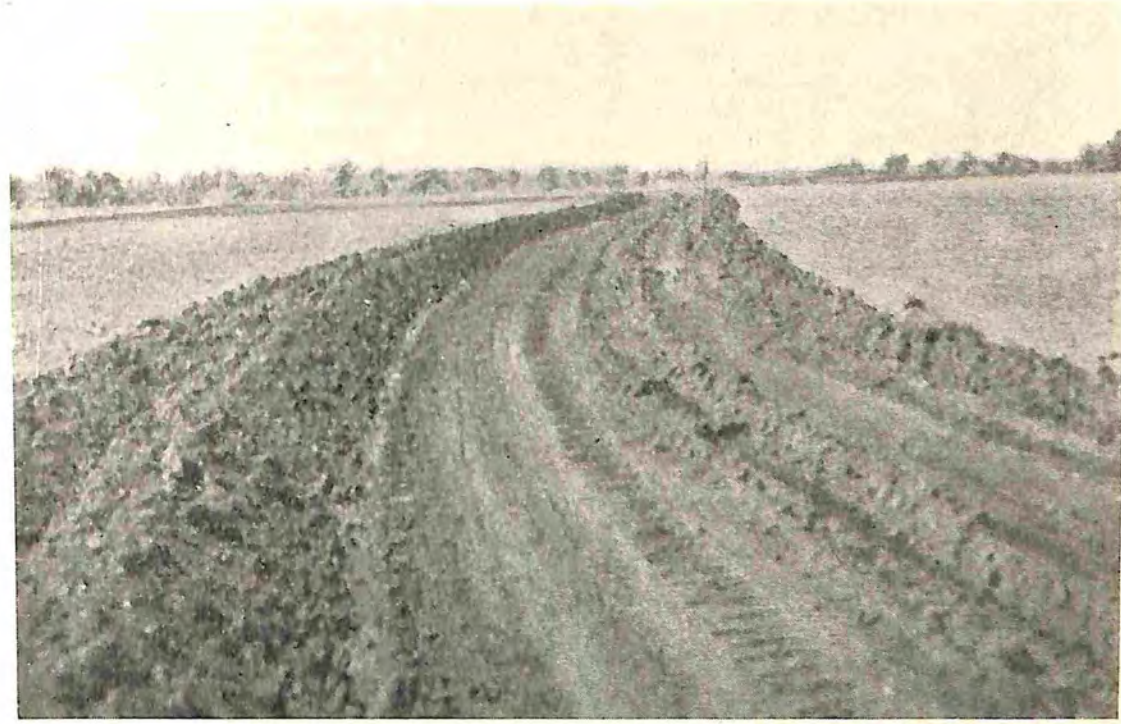
*Fig. 5.*—The bank and channel at completion of work by the angledozer.

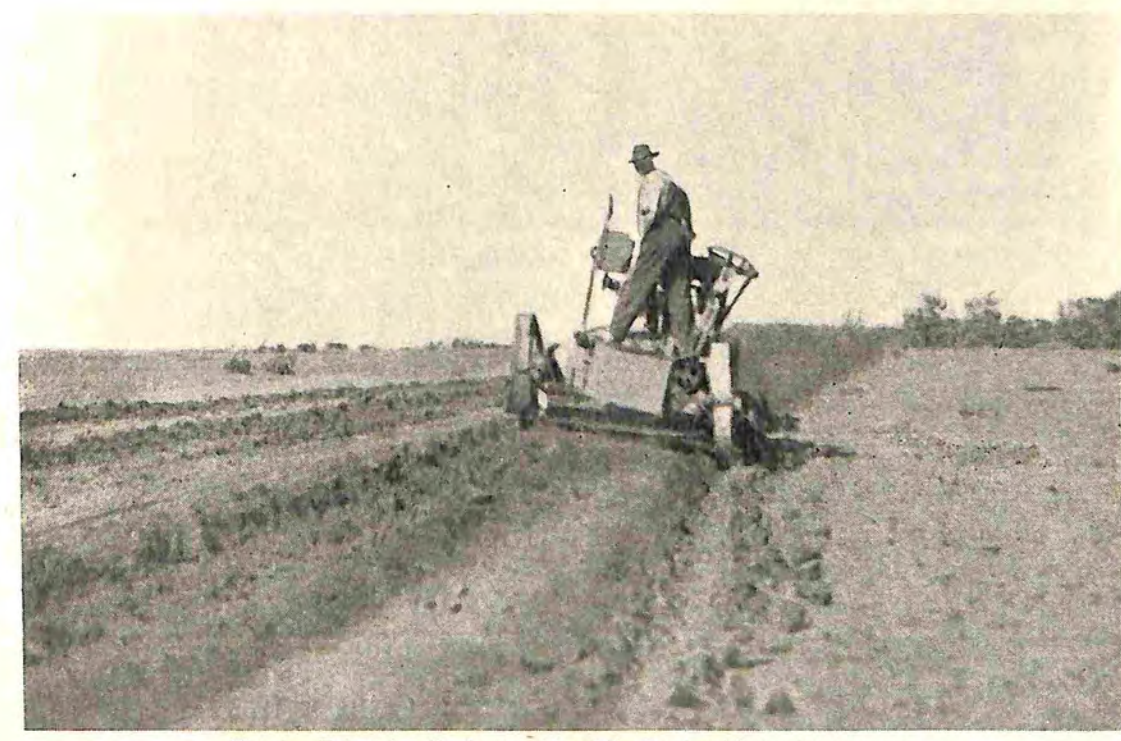
*Fig. 6.*—Trimming the lower side of the bank with grader-terraccer.

the side. In addition the capacity of the bank will be small in proportion to the amount of soil moved unless the grader terracer is utilised to give the final shape to the bank. The great value of this implement lies in its ability to move the soil to the desired position quickly, accurately and economically.

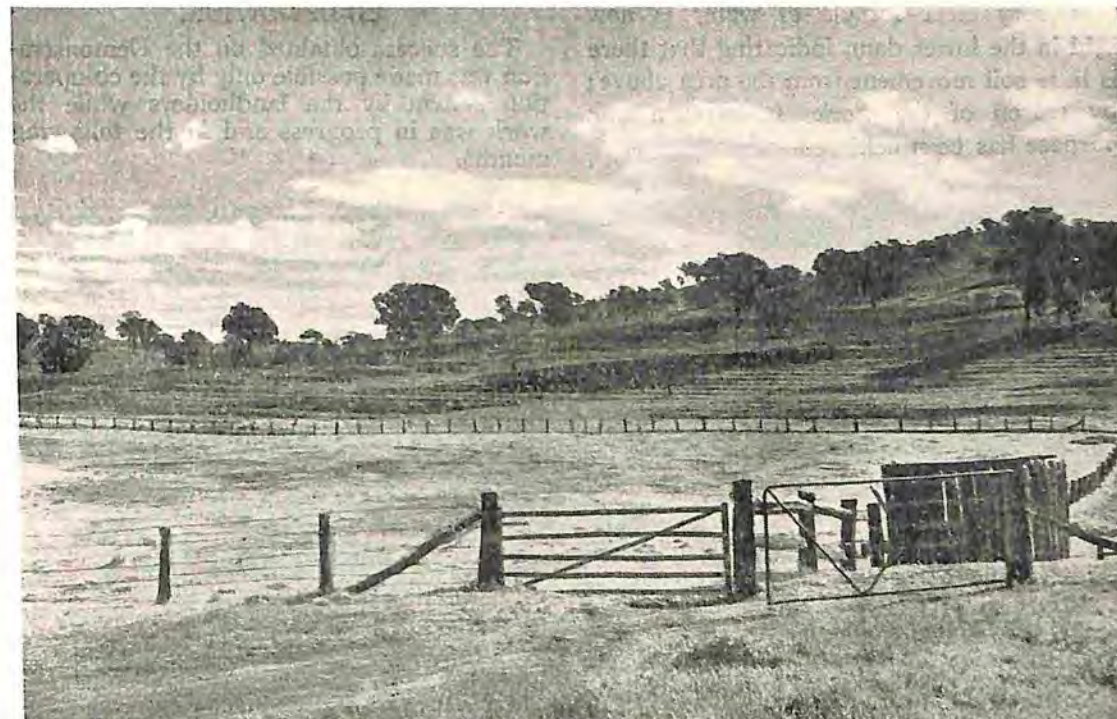
Fig. 3.—A hillside contour furrowed to prevent sheet erosion.

It has been noticed that very little water has flowed from the pasture furrowed area and constant soaks have developed which have increased the growth of natural grasses and the introduced grasses sown on the furrows and scalded areas which have been ripped.

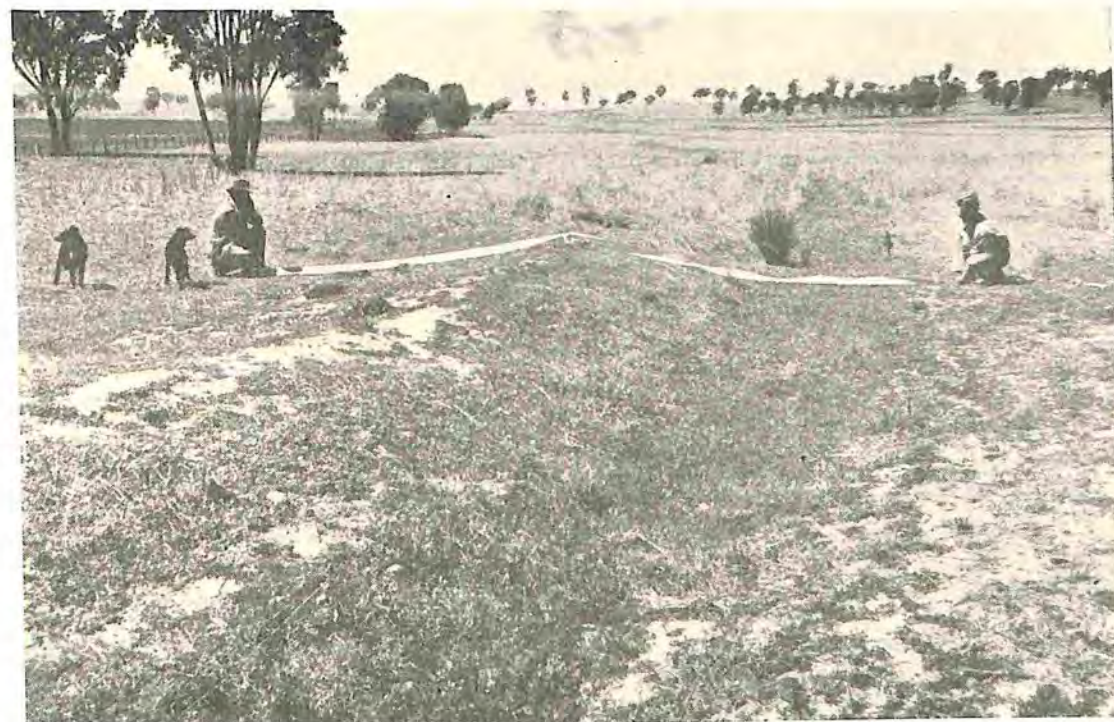
Fig. 4.—A well-vegetated diversion bank leads water to a safe outlet.

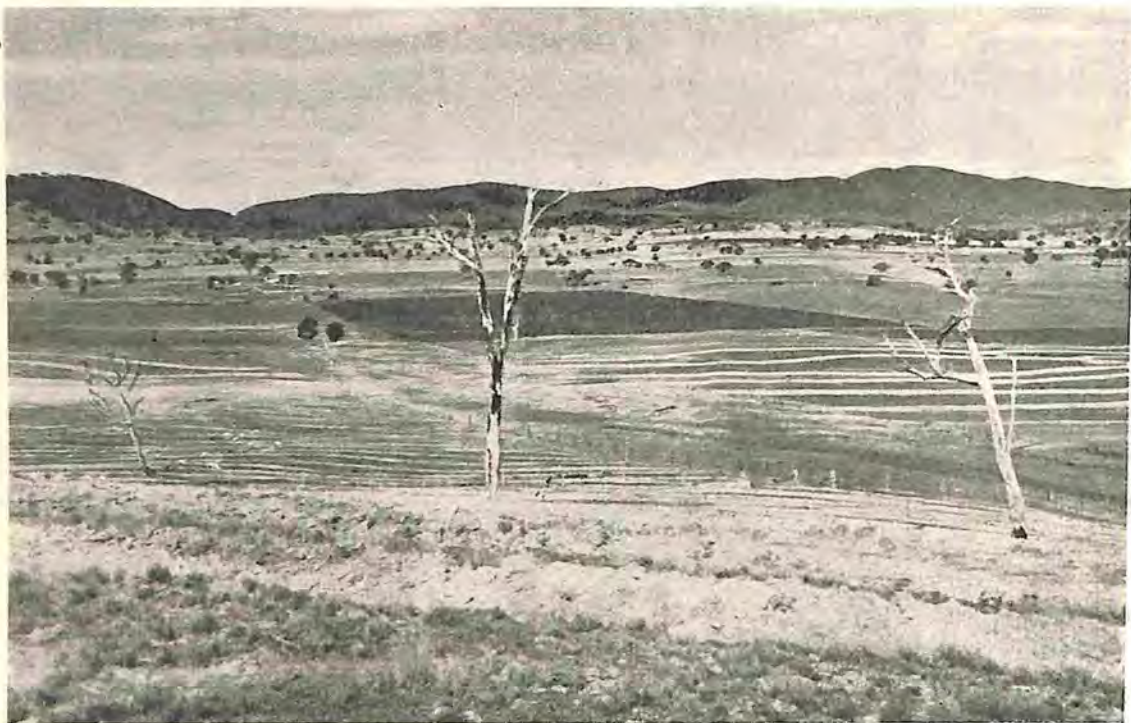
Fig. 5.—Pasture furrows and absorption banks on grazing land and graded banks on sloping arable land.

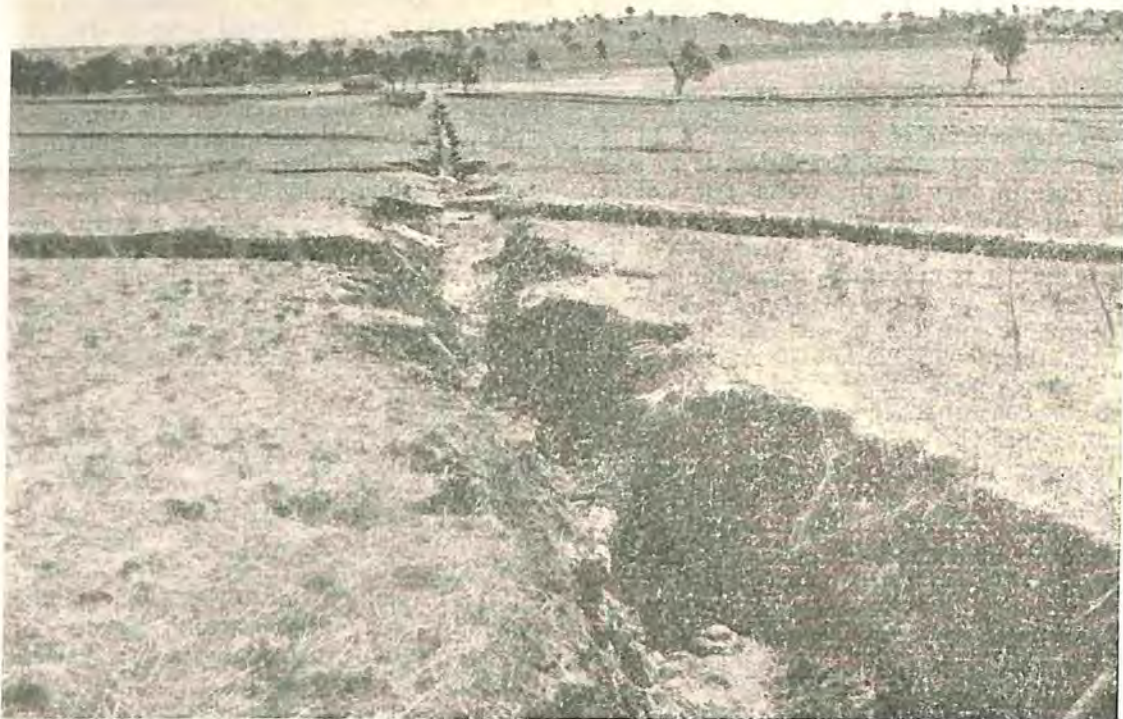
Fig. 1.—Failure to provide a waterway for the disposal of water from the banks caused this major gully and the extension back along the bank channel.

In most cases it will be found necessary to construct the waterway several months before the banks, so that the grass will be established sufficiently to enable water to be turned into the waterway immediately the banks are built. If, however, it becomes necessary to make the waterway at the same time as the banks a temporary outlet down the side of the waterway will have to be provided, with the bank finishing a few yards short of the waterway. This may result in the formation of a gully which can be filled when the banks are joined to the waterway.

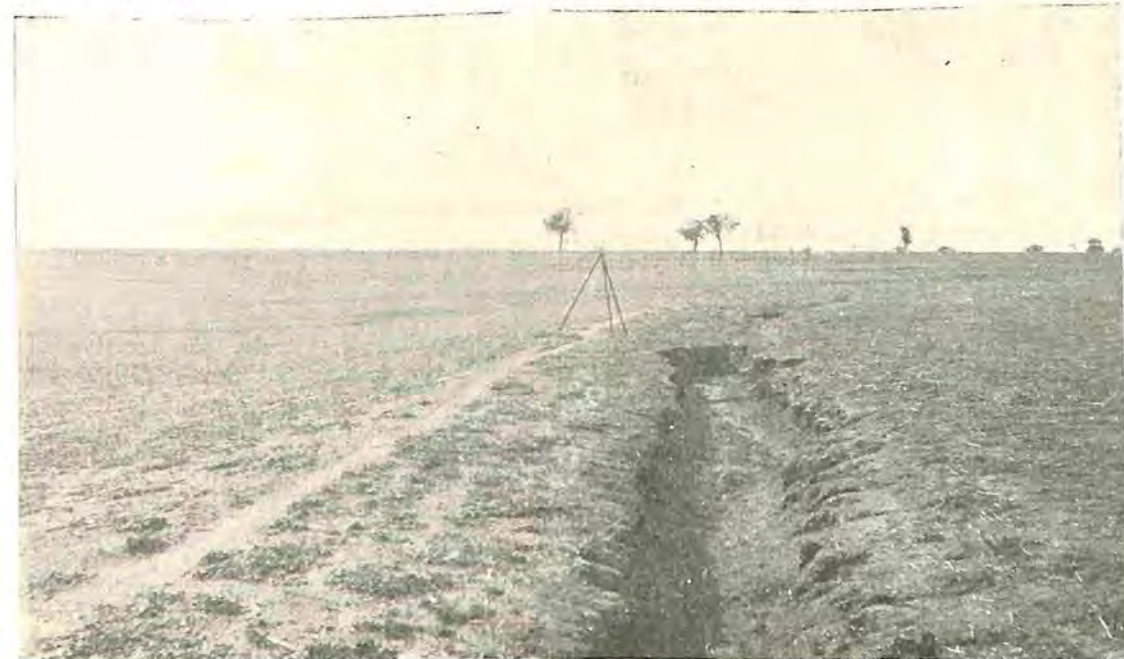
Fig. 2.—This gully formed in the bank channel because of excessive grade.

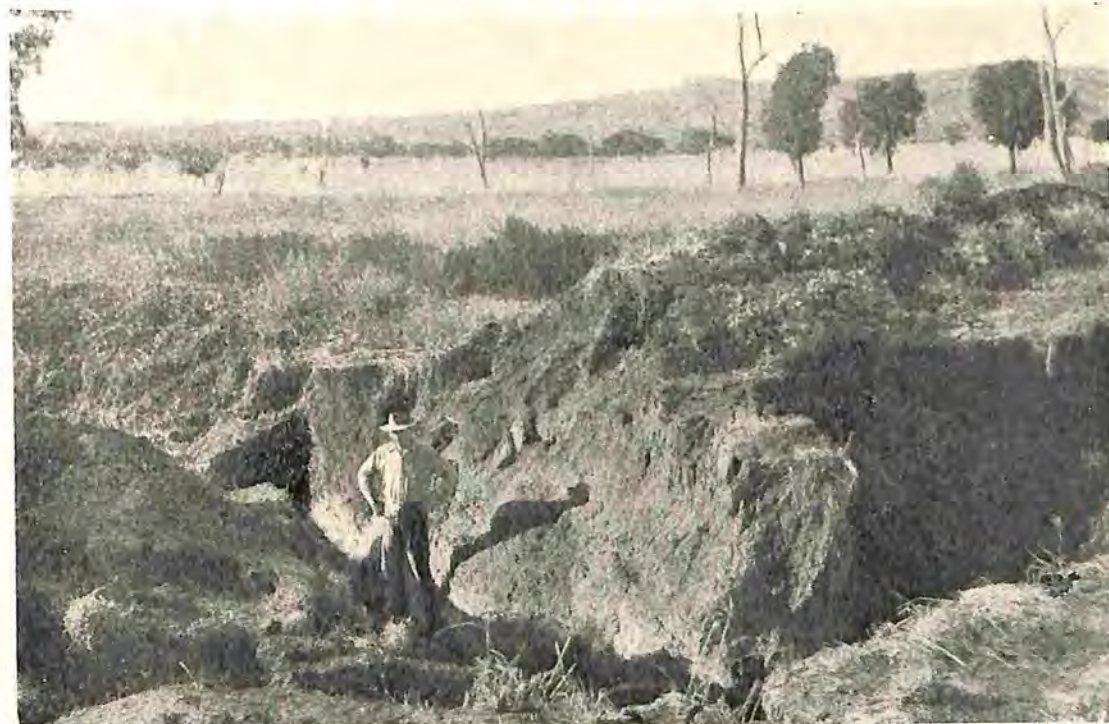
Fig. 4.—The damage to this absorption bank was caused by the water seeping through the bank, where it crossed a gully and eventually undermined it. This could have been prevented if the gully fill had been properly packed.

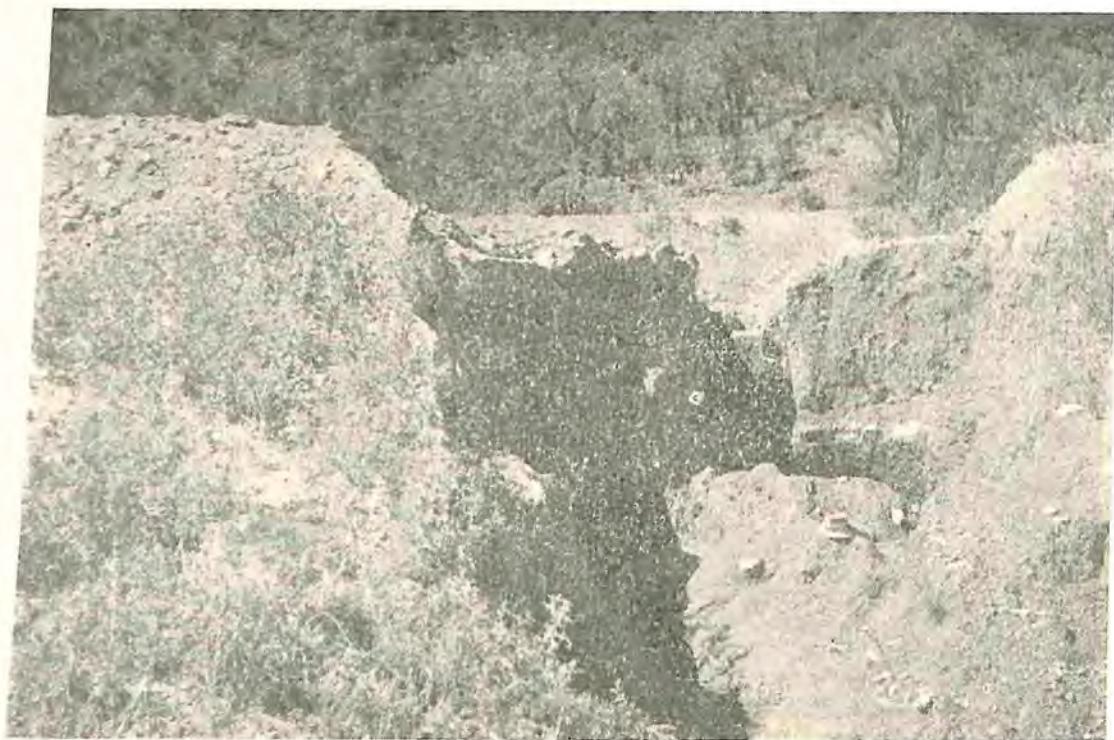
Fig. 5.—A badly-designed silt trap. Settling of the wall caused the water to flow over the top of the wall instead of through the outlet.

These remarks on settling of newly moved earth apply to a greater extent to silt traps and dams, as the amount of soil used is much larger. The damage to the silt trap shown in Fig. 5 was due to the settling of
