APPENDIX 10 – ABORIGINAL ARCHAEOLOGICAL REPORT

Lower Thredbo Valley Shared Path: Bullocks Flat to Curiosity Rocks, Snowy Mountains, NSW. Aboriginal cultural heritage assessment.

By
Sue Feary and Gerard Niemoeller
August 2015

Final report to NPWS and Snowy River Shire Council

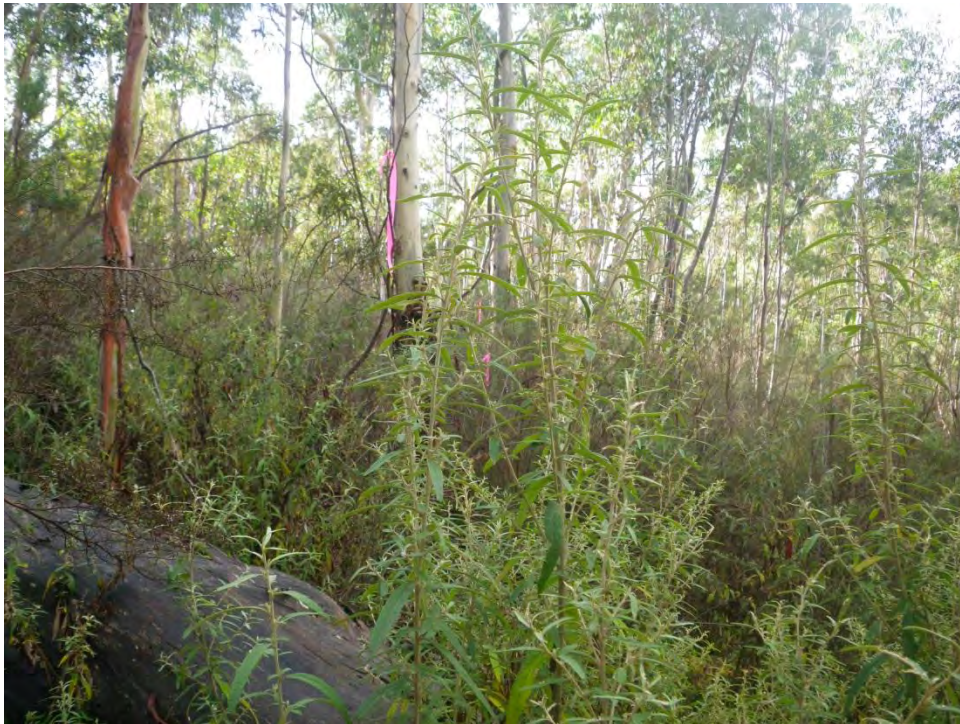
Figure 4: proposed path alignment, mid slope in lower Thredbo River valley

The landform of the study area is highly variable due to the length of the proposed track. In some sections the track follows the relatively flat river plain adjacent to Thredbo River while in other sections the landscape is very steep where the track deviates greater distances from the edge of Thredbo River. Some of these sections would have slopes greater than 25 degrees. The track crosses many small tributaries to Thredbo River most of which are very minor and most likely ephemeral or intermittent. At the higher elevations of the track, typically above about 1050 metres ASL, there was a distinct lack of surface rock and significant rock outcrops. Below this elevation there was a higher occurrence of rock outcropping and loose surface stone. Generally the surrounding landscape is steep to very steep (Figure 4). Adjacent to the proposal, slopes are consistently greater than 25 degrees. The study area is part of the east-west river valley of the Thredbo River, in between two significant east-west ridge lines with elevations of greater than 1500 metres asl to the north and 1400 metres asl to the south (EnviroKey, 2015). Thredbo River is impacted by seasonal changes in climate resulting in high flows during the spring snow melt and subject to snow and ice during the winter seasons.

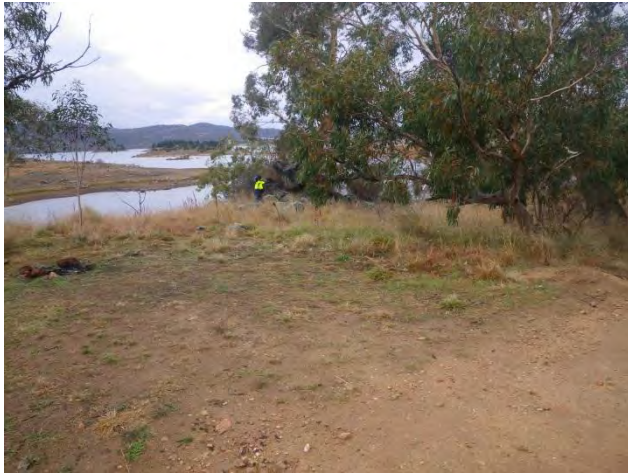
Figure 18: informal road on ridge with site WOLLONDIBBY1

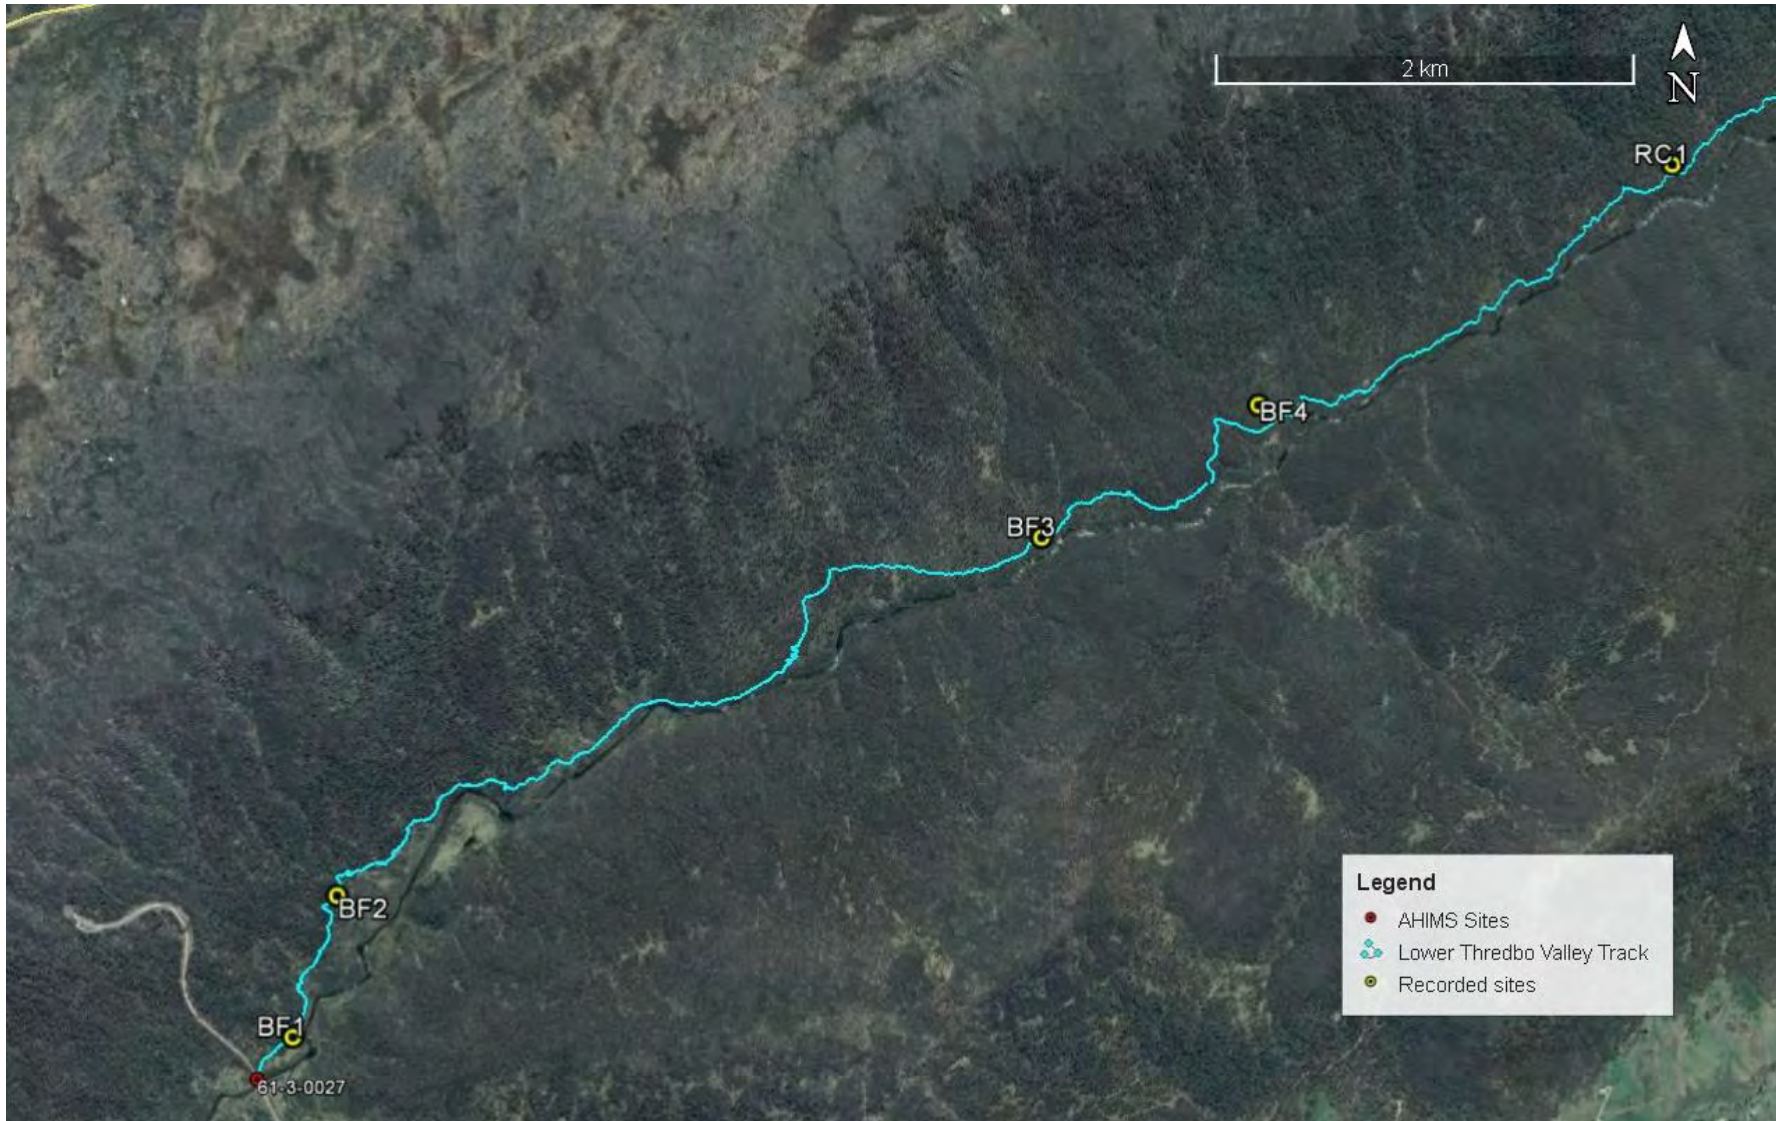
Figure 24: Recorded sites – Bullocks Flat to Pender Lea

Figure 23 shows the location of newly recorded sites along the alignment and the index for following figures (Figures 24 to 27), which provide more detail for each section of the alignment.

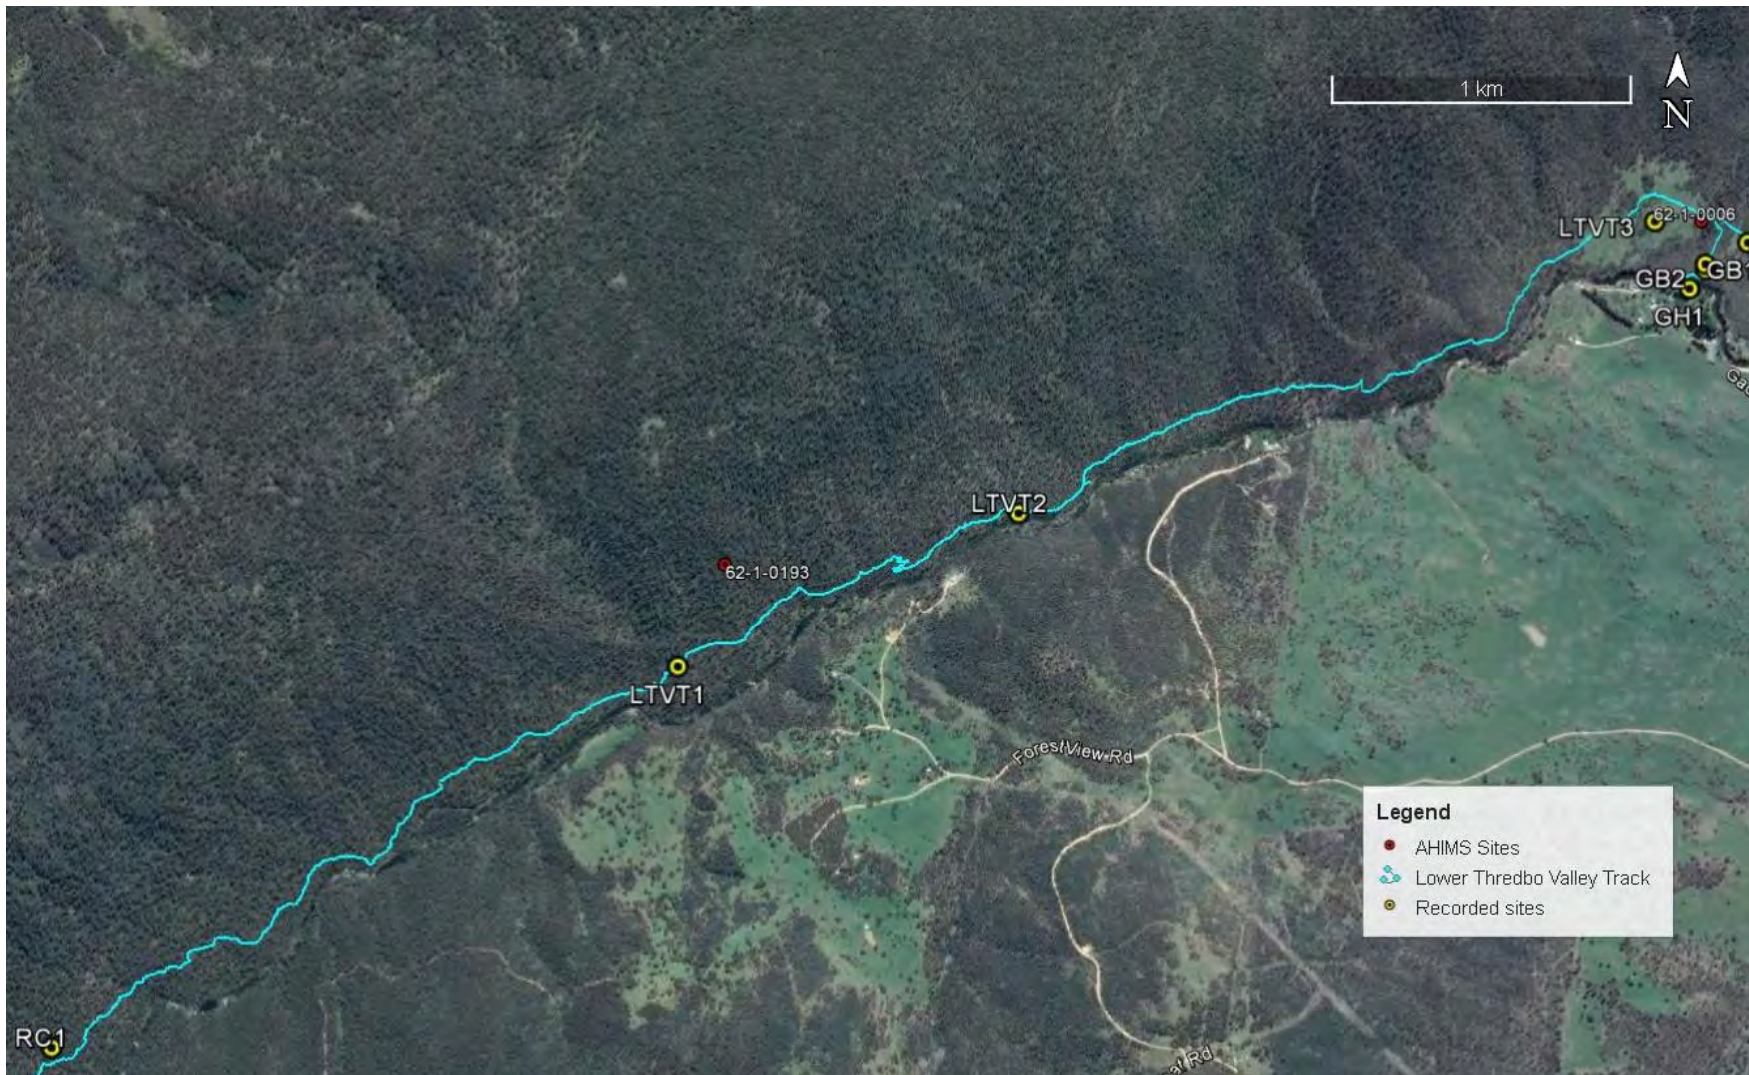
Figure 25: Recorded sites Penderlea to Robertsons Crossing

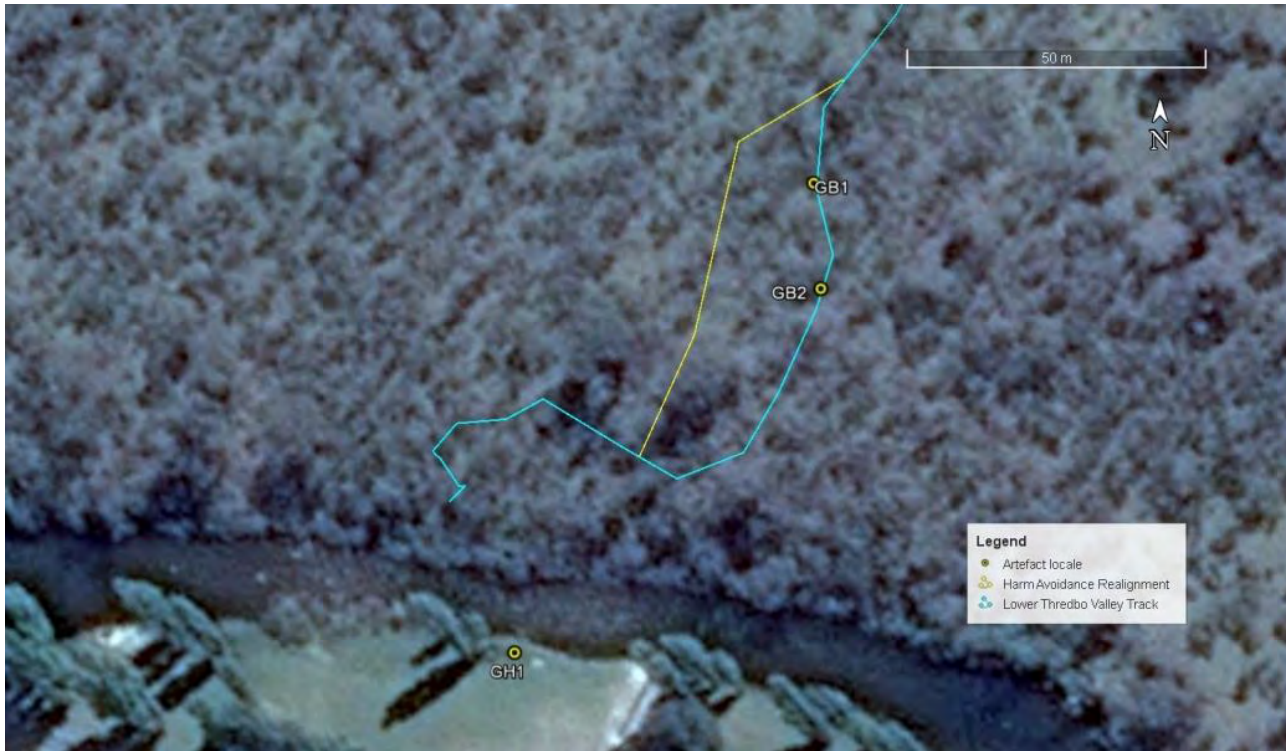
Figure 388: Location of site Gaden Hatchery 1 and proposed realignment (shown in yellow) to avoid harm to sites Gaden Bridge 1 and 2.

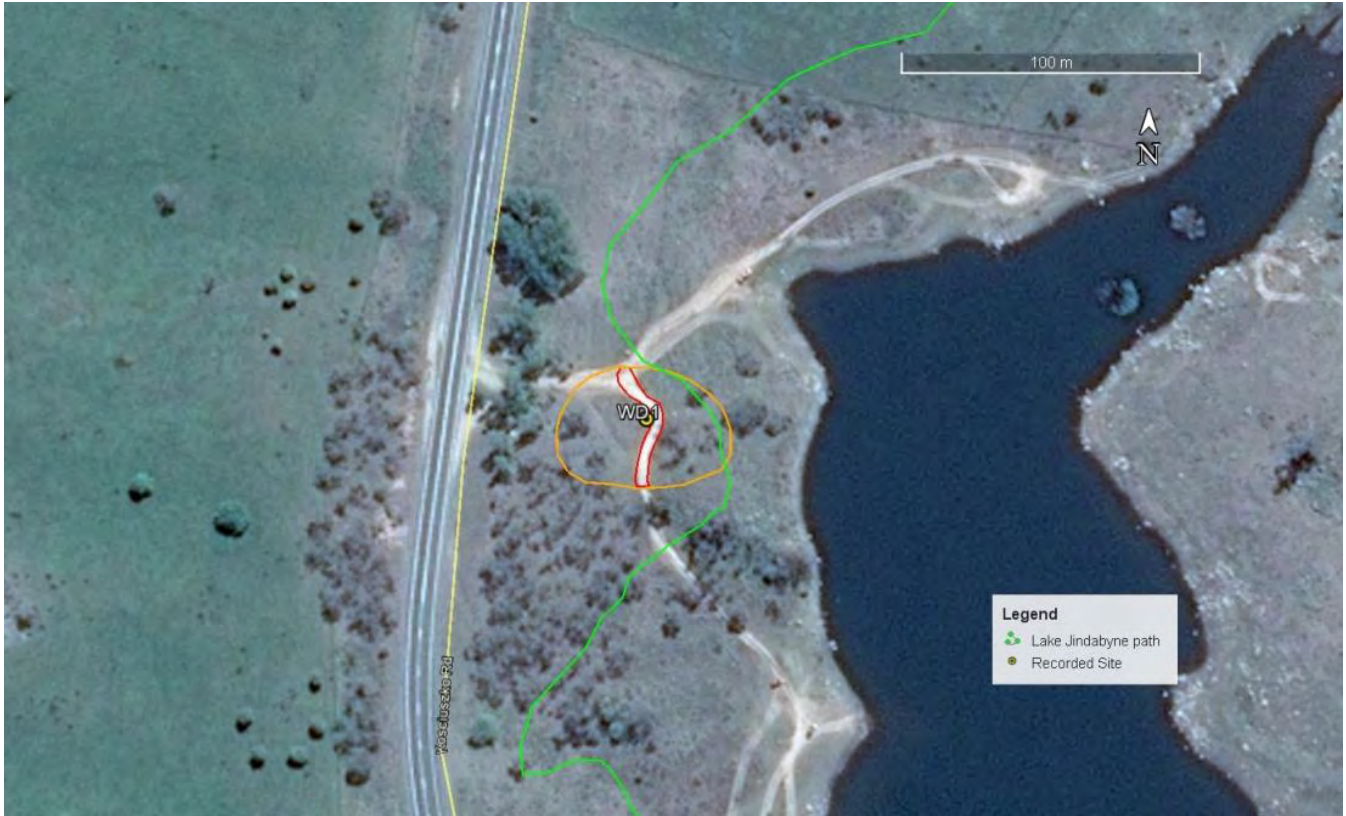
Figure 399: Visible extent of WOLLONDIBBY1 (in red) and estimated extent (orange) following the crest of the spur (approximate).

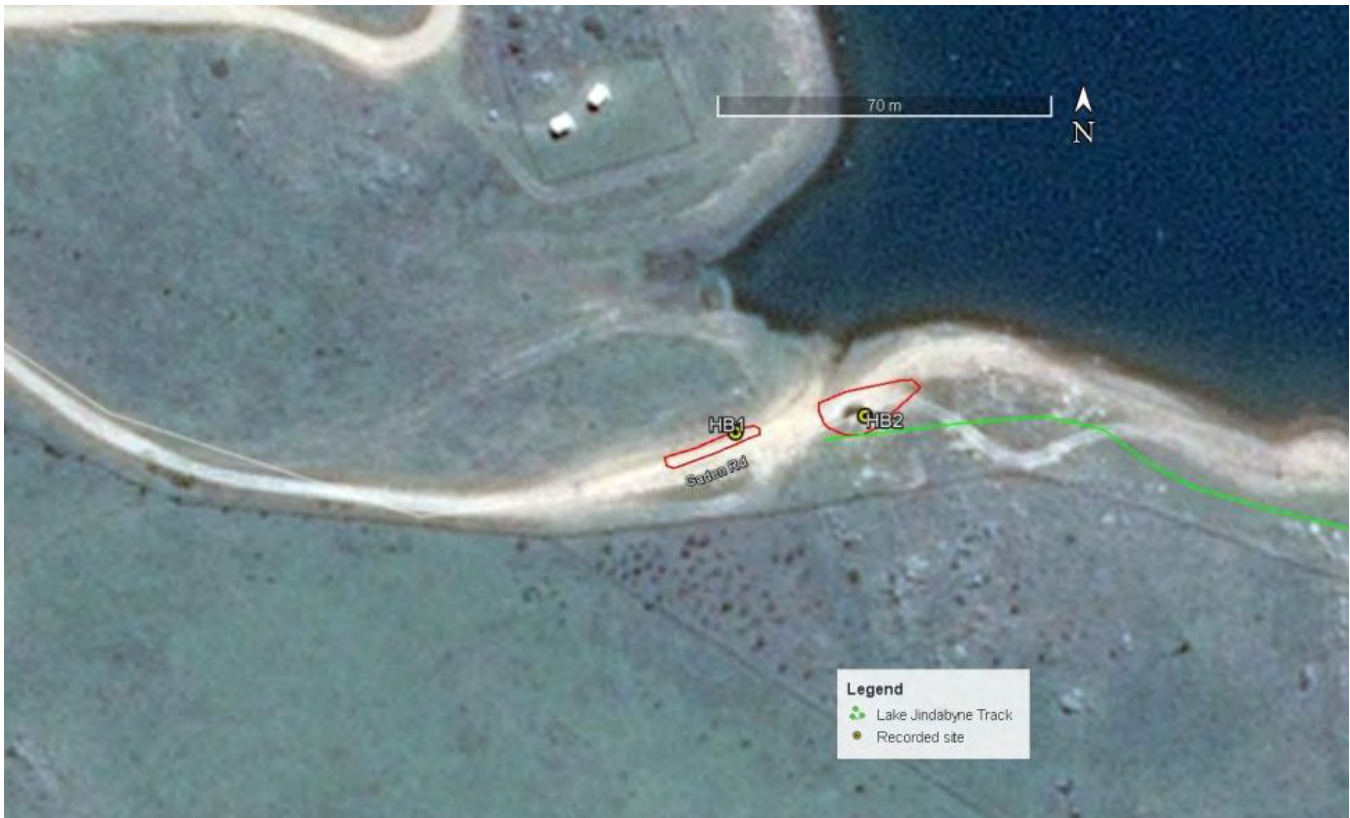
Figure 40: Possible extent of HATCHERY BAY2 and HATCHERY BAY1

The estimated extent of site **HATCHERY BAY1**, a dispersed artefact scatter on and beside the existing informal vehicle road is also shown in Figure 40. This road may be closed to vehicles and rehabilitated, which will result in impact to HATCHERY BAY1.
