Department of Planning and Environment

NSW Alpine Resorts Environmental Performance Report 2019–20

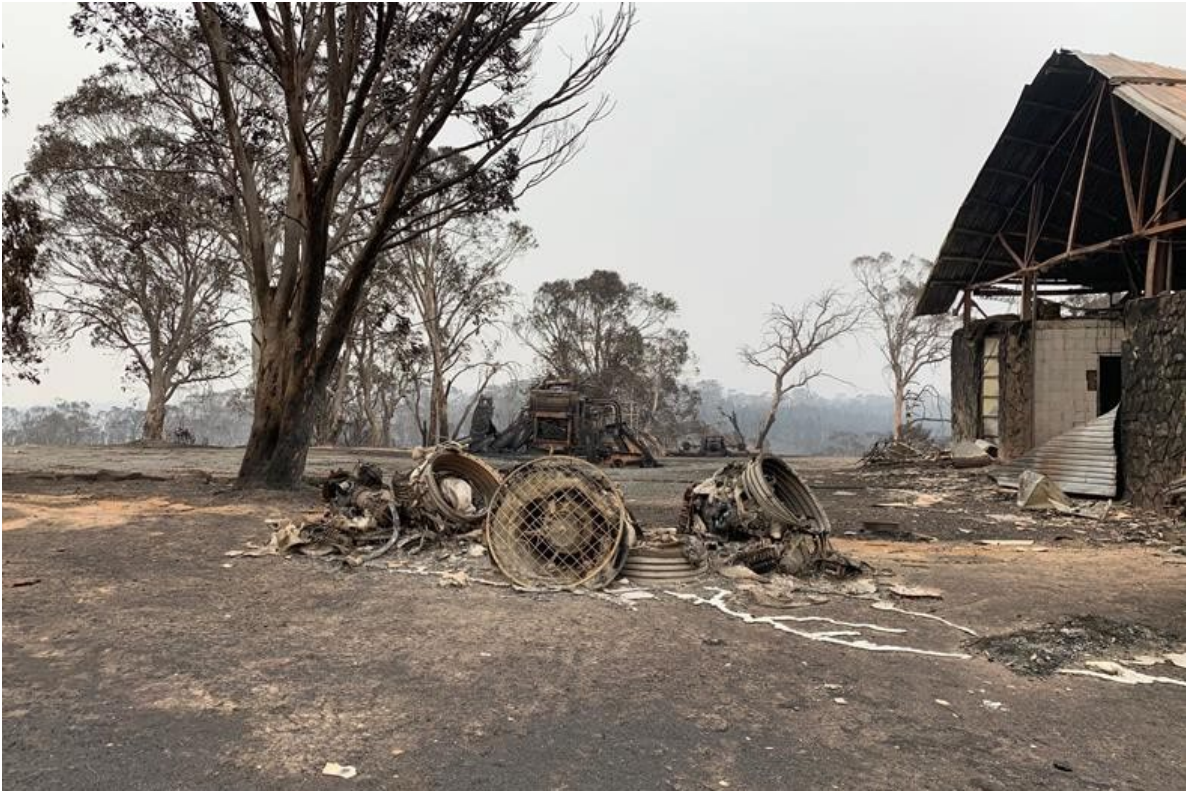
Figure 1 Selwyn Snow Resort after the 2020 bushfires
Photo: A Murdoch/Blyton Group

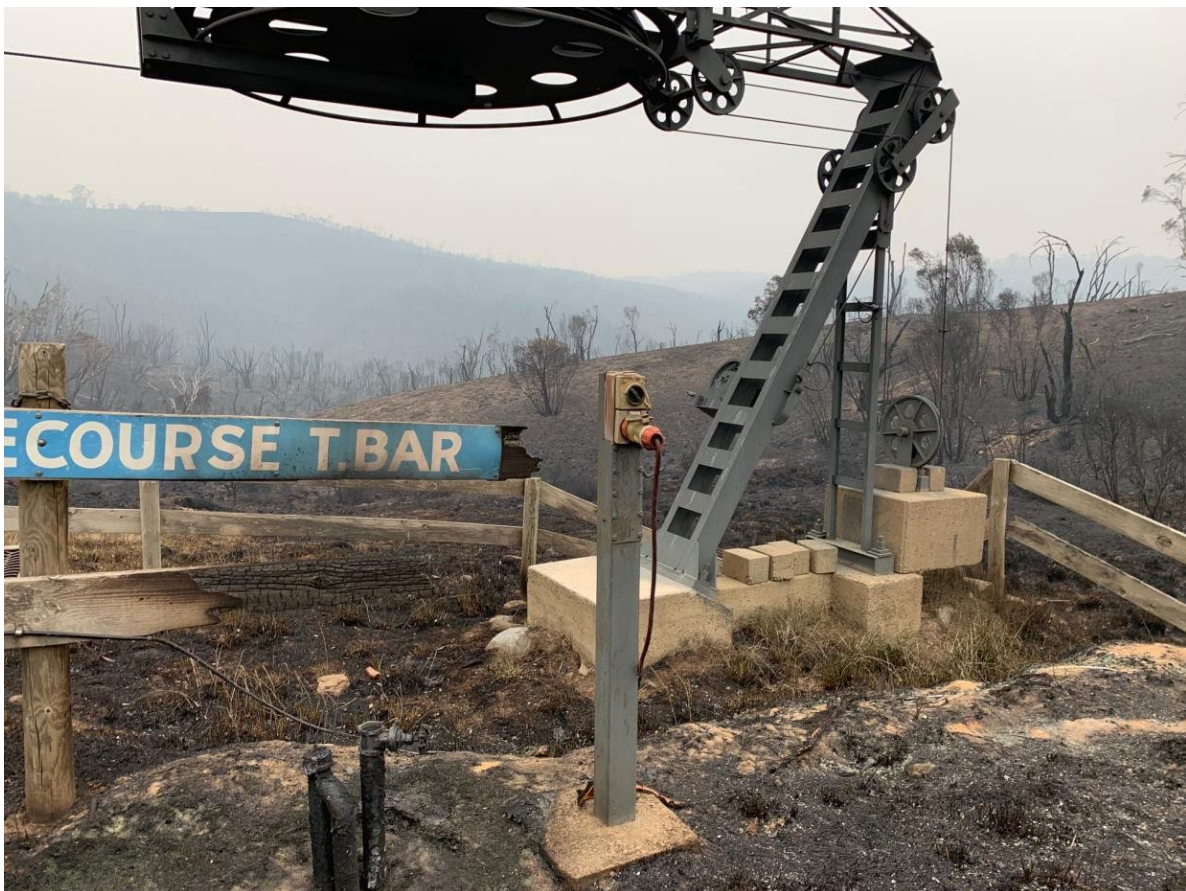
Figure 2 Damage to a Selwyn Snow Resort T-bar after the 2020 bushfires
Photo: A Murdoch/Blyton Group

Selwyn Snow Resort Pty Ltd has not submitted data for this report. This was due to the devastation caused to Selwyn Snow Resort by bushfires in January 2020. The resort suffered extensive damage to buildings, snow-making equipment, power, and water, as well as loss of records and data relating to environmental management system reporting.

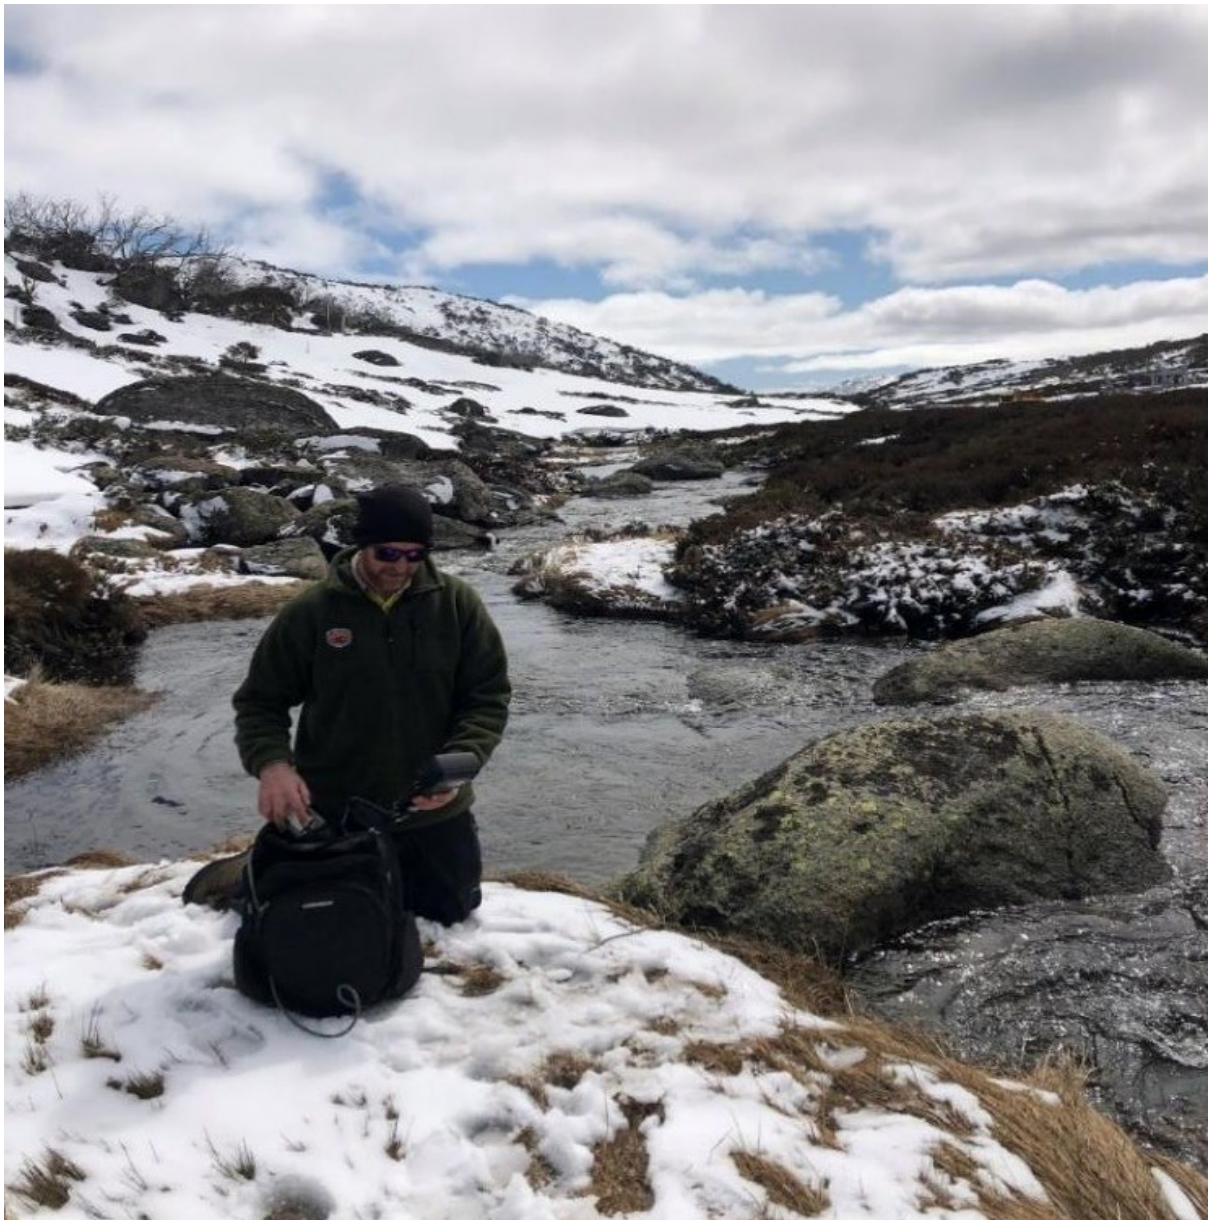
Figure 4 NPWS water quality monitoring program at Perisher Creek

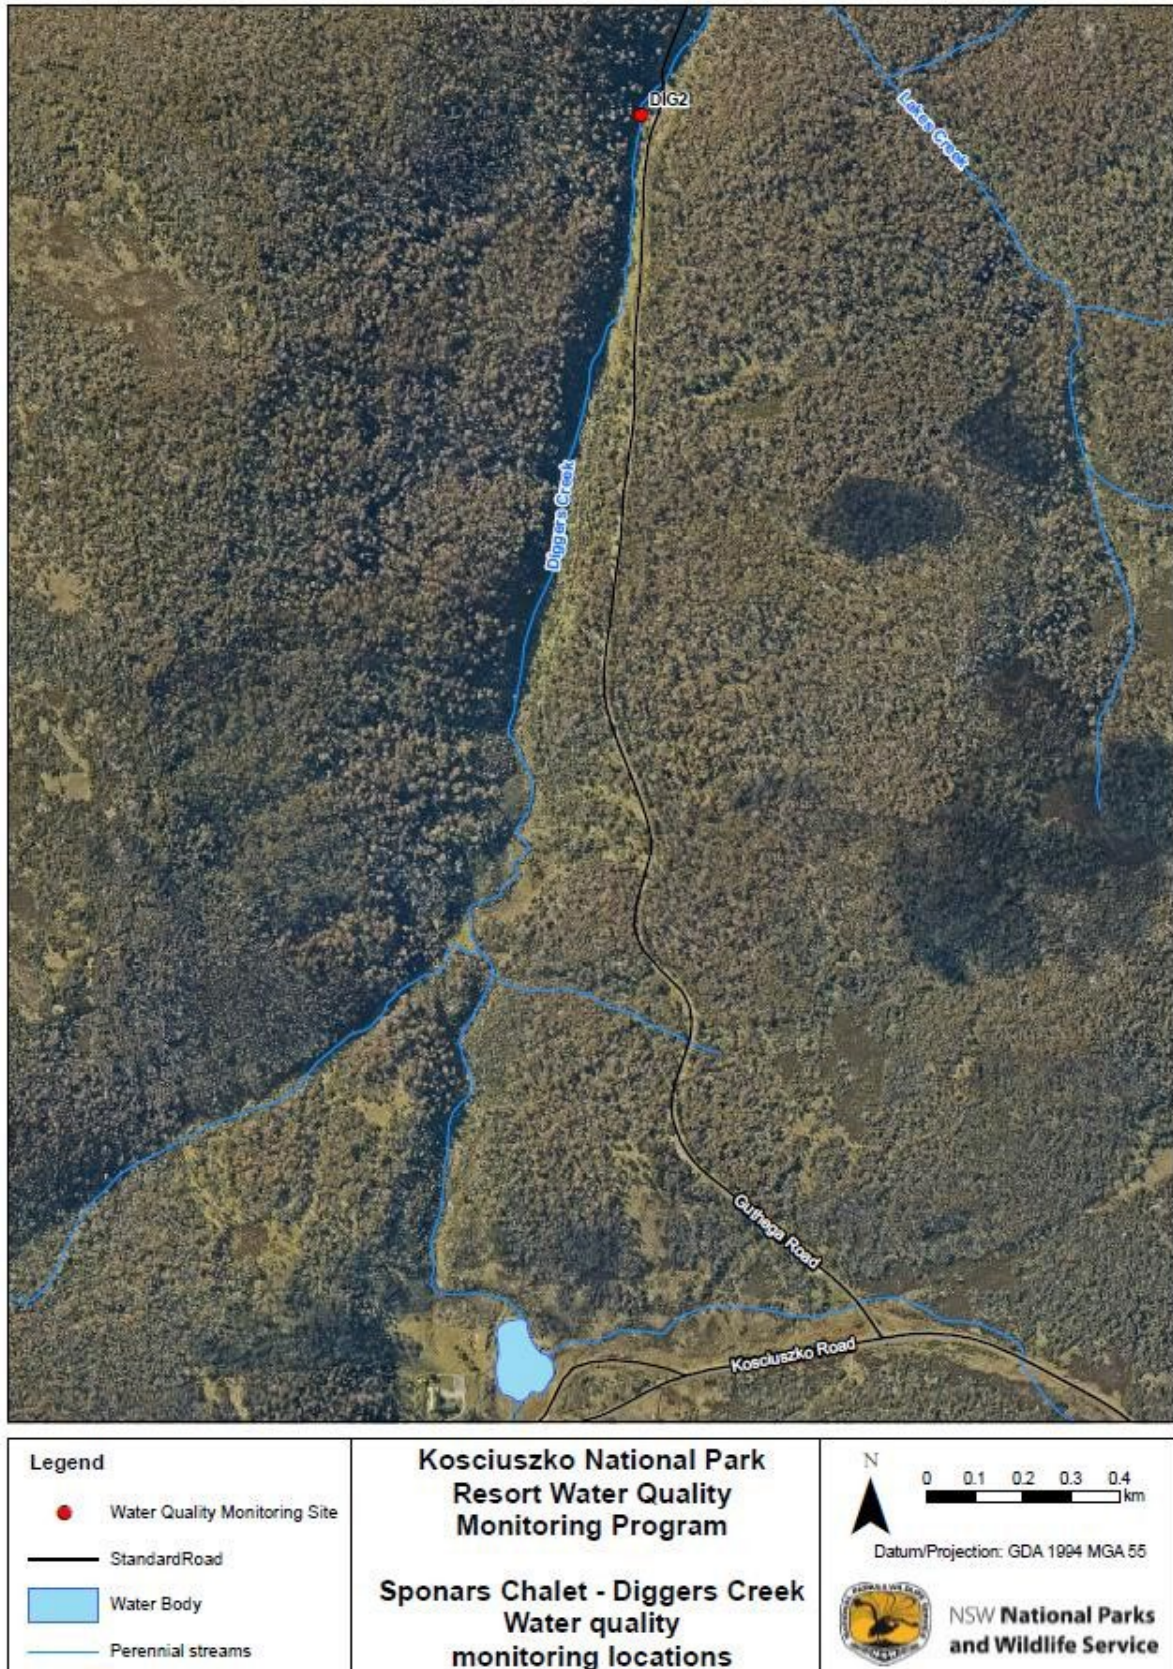
Figure 12 Water quality monitoring site near Sponars Chalet

Diggers Creek has one monitoring site which is part of the NPWS winter water quality monitoring program. During winter 2019, turbidity levels remained within the guideline but varied throughout the year. Higher turbidity generally coincided with precipitation events. Electrical conductivity was also within guideline levels, with elevated levels detected (still within guideline levels) during or immediately after precipitation events.

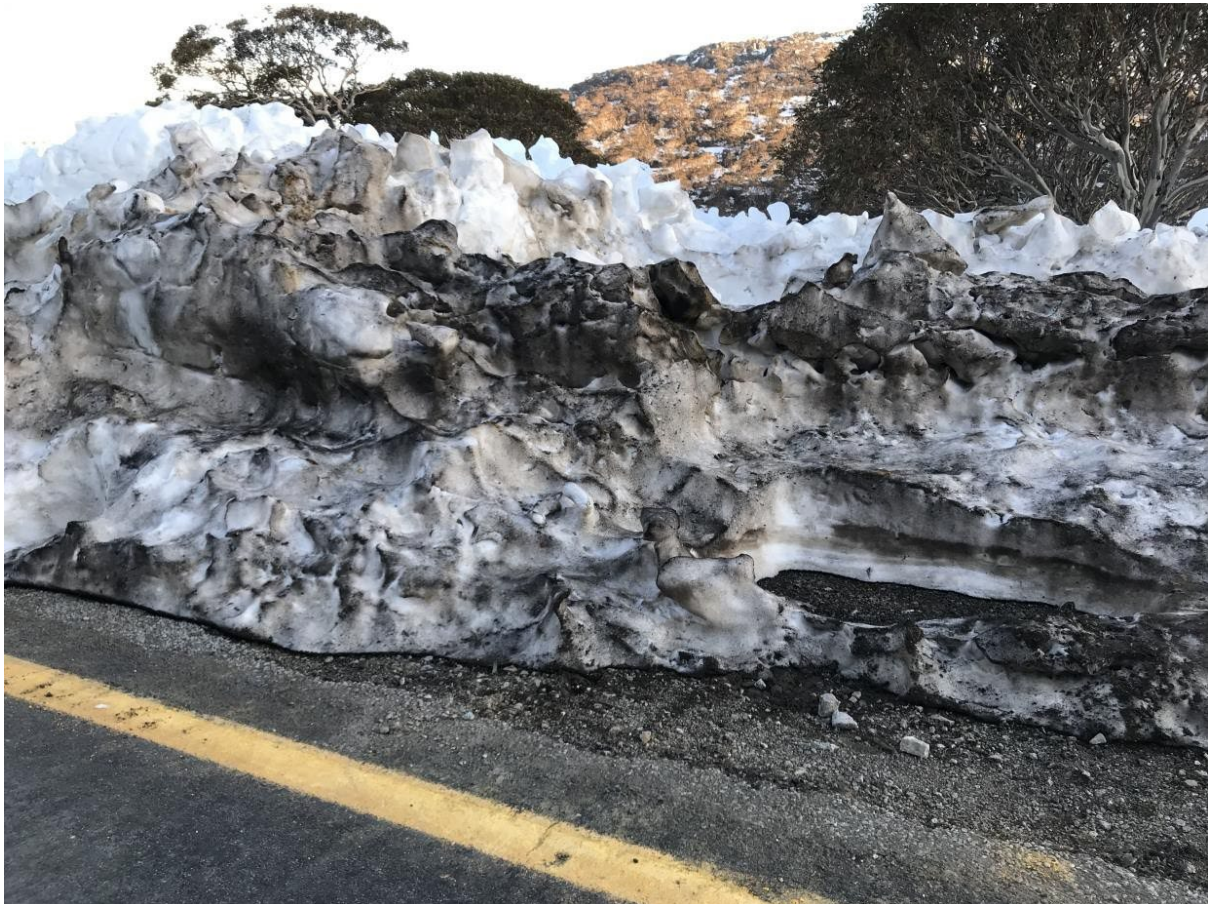
Figure 19 Contaminated snow near Charlotte Pass turning circle

Table 8 outlines the nature of pollution incidents across the reporting period. Most incidents were minor, involving a small amount of clean-up and no material harm to the environment.

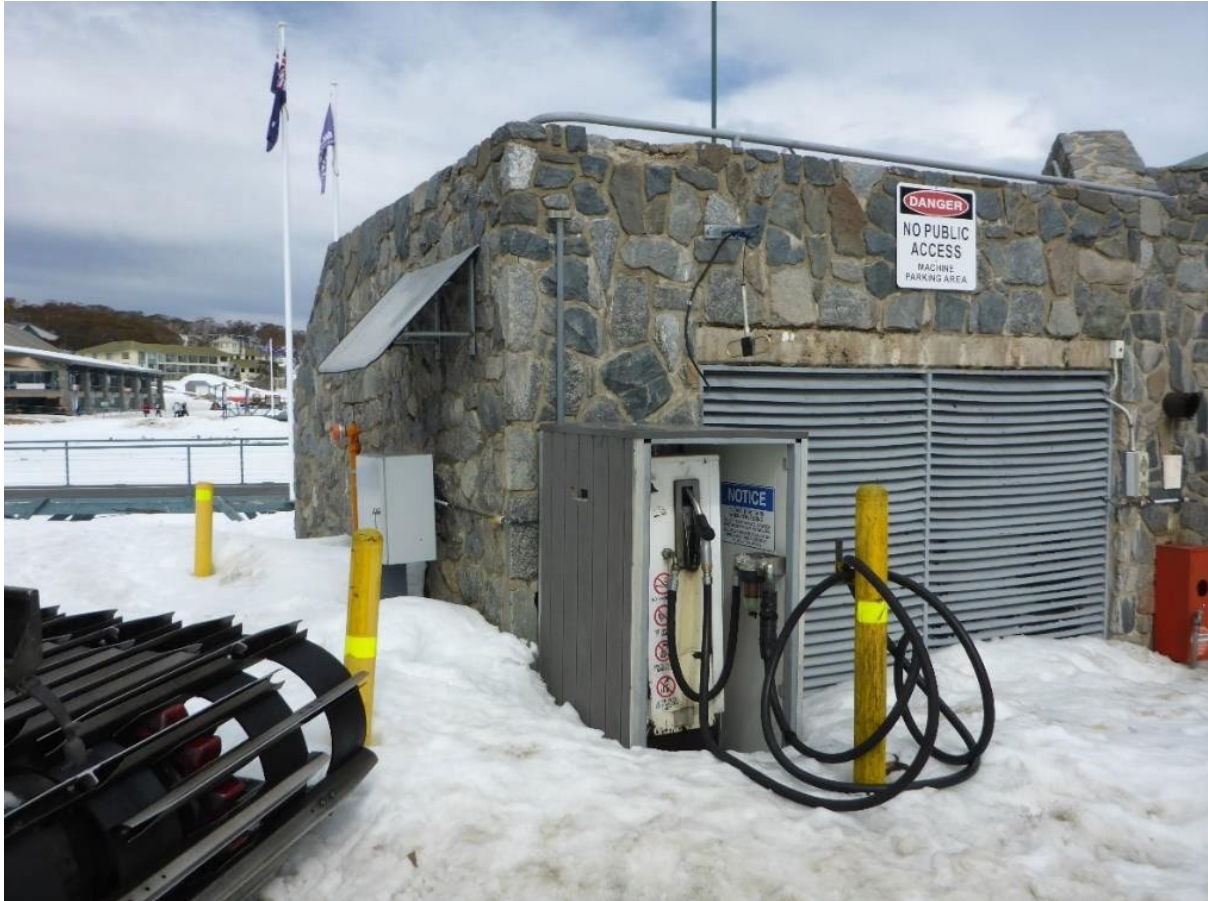
Figure 20 Snow mobile refuelling station, Perisher loading dock

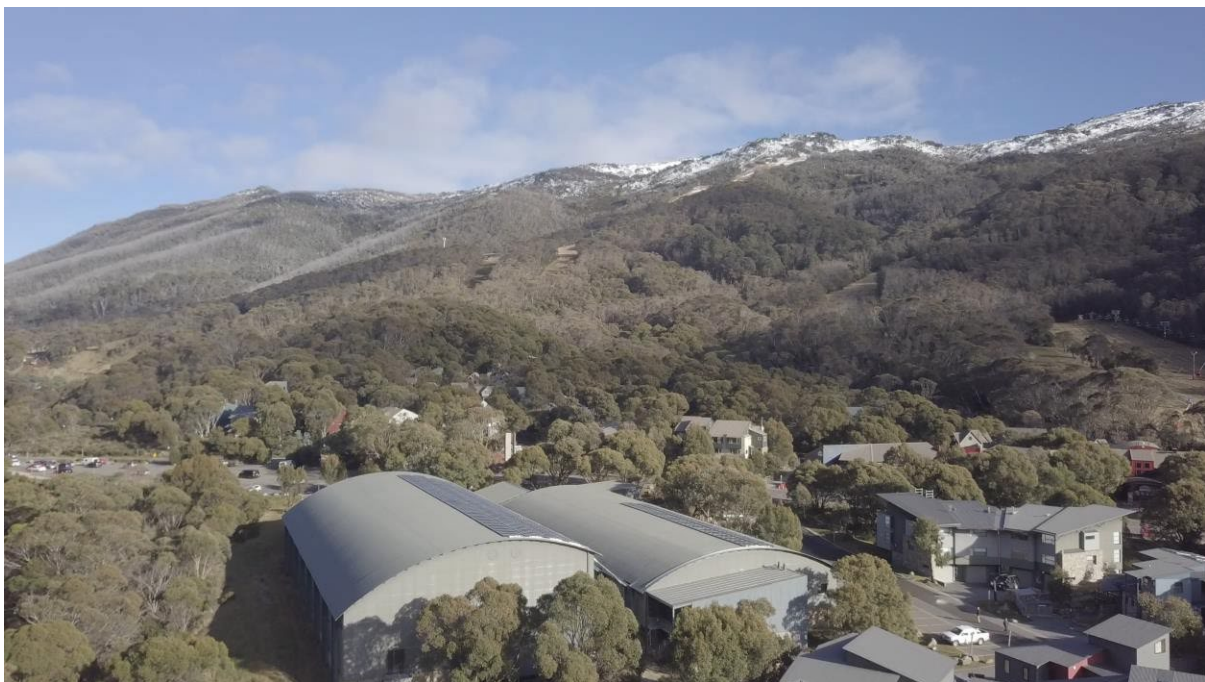
Figure 21 Solar panels on the Thredbo Leisure Centre

Solar panels on the Thredbo Leisure Centre generated 136,627 kWh of energy. This supplied the Thredbo Leisure Centre with 23.8% of its annual energy requirements. Kosciuszko Thredbo continues the incremental roll out of energy saving initiatives, for example energy saving devices are installed as and when old devices fail.

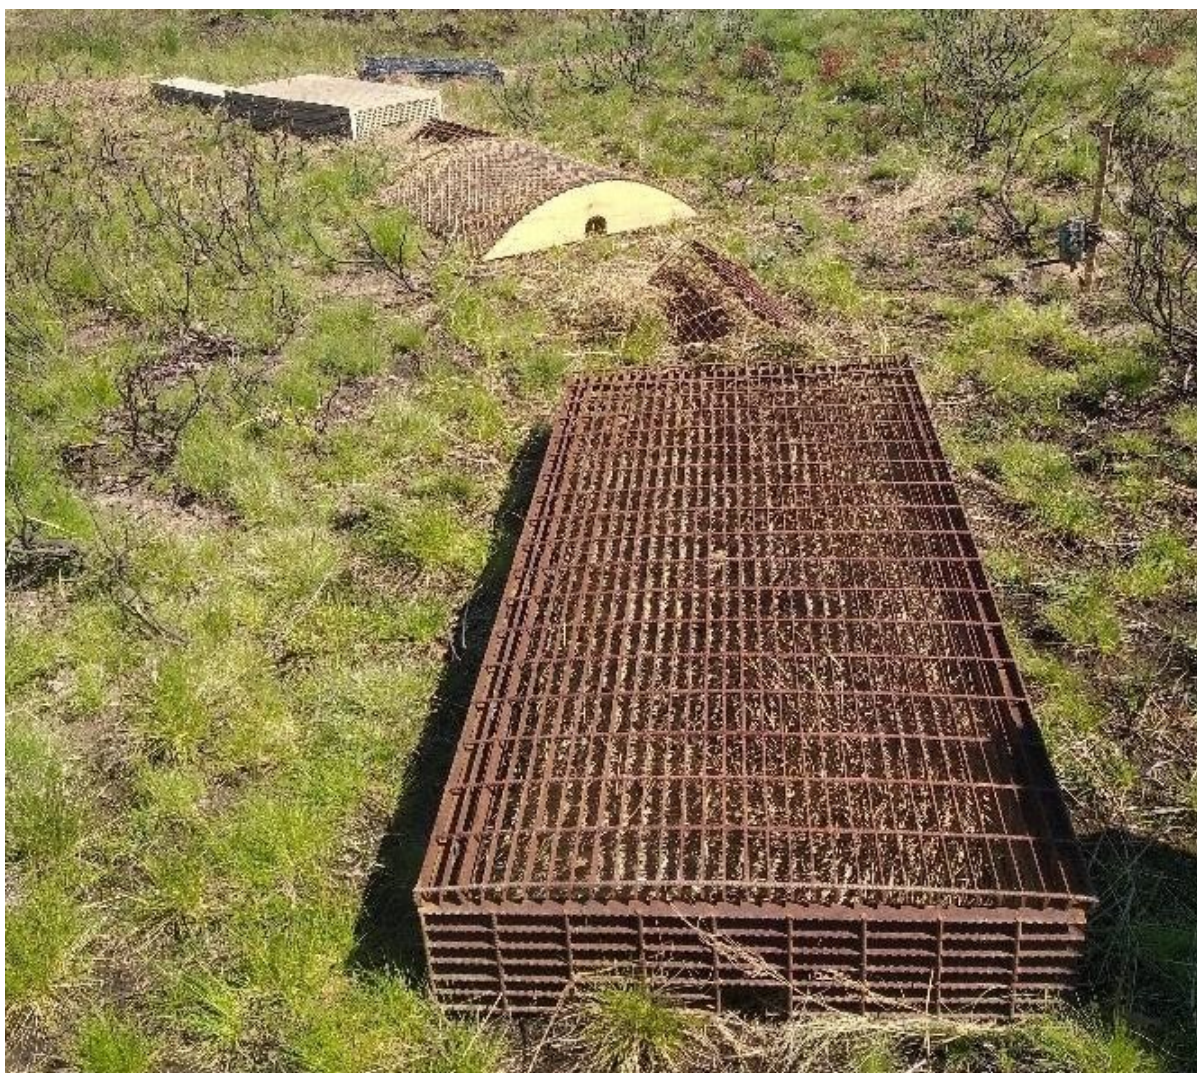
Figure 24 Artificial habitat structures for board-toothed rats

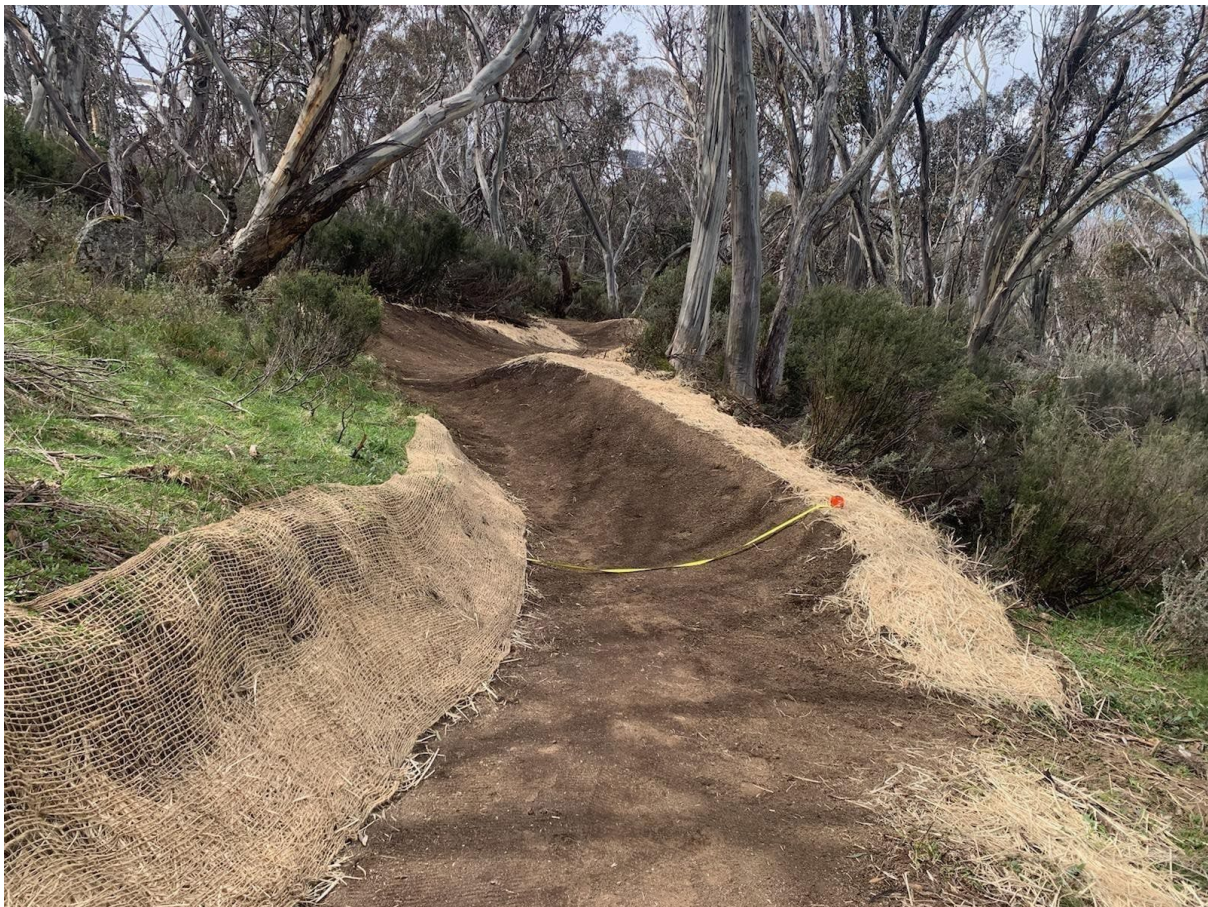
Figure 26 Recording monitoring points on a new gravity trail in the Thredbo Mountain Bike Park

NPWS endeavours to be as consistent as possible in its timing for pre- and post-season monitoring to allow better comparison of results. However, avoiding adverse weather is a key factor in determining exactly when this monitoring occurs. With assistance from Kosciuszko Thredbo, NPWS will also expand its biannual track monitoring program to encompass all gravity-focused trails within the Thredbo Mountain Bike Park.
