Site Assessment Proforma

SITE ASSESSMENT - HOTHAM CHALET

Lot 1 Higgi Drive, Mt Hotham Alpine Resort - November 2004

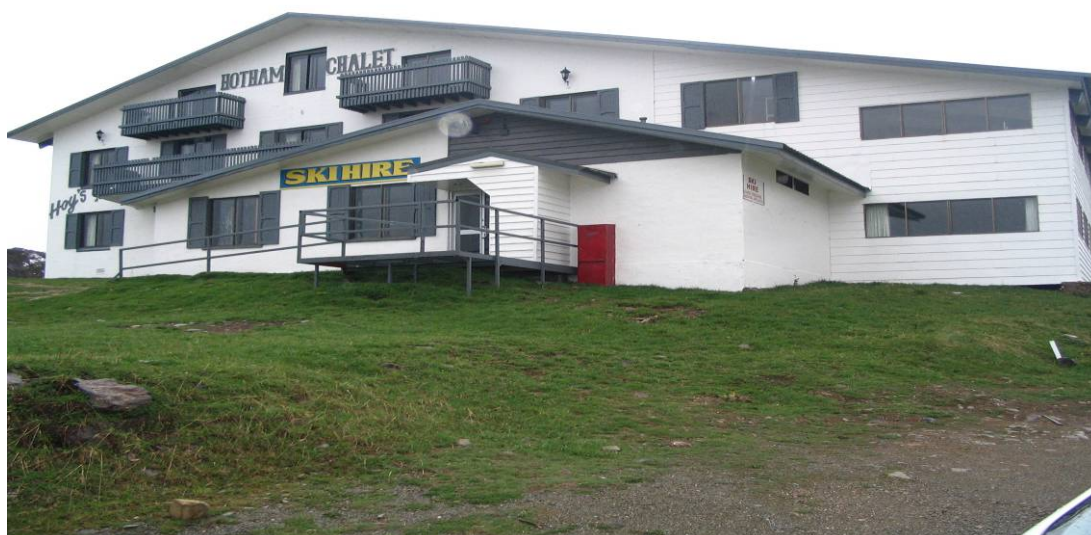
Figure A Current condition – Hotham Chalet, November 2004.

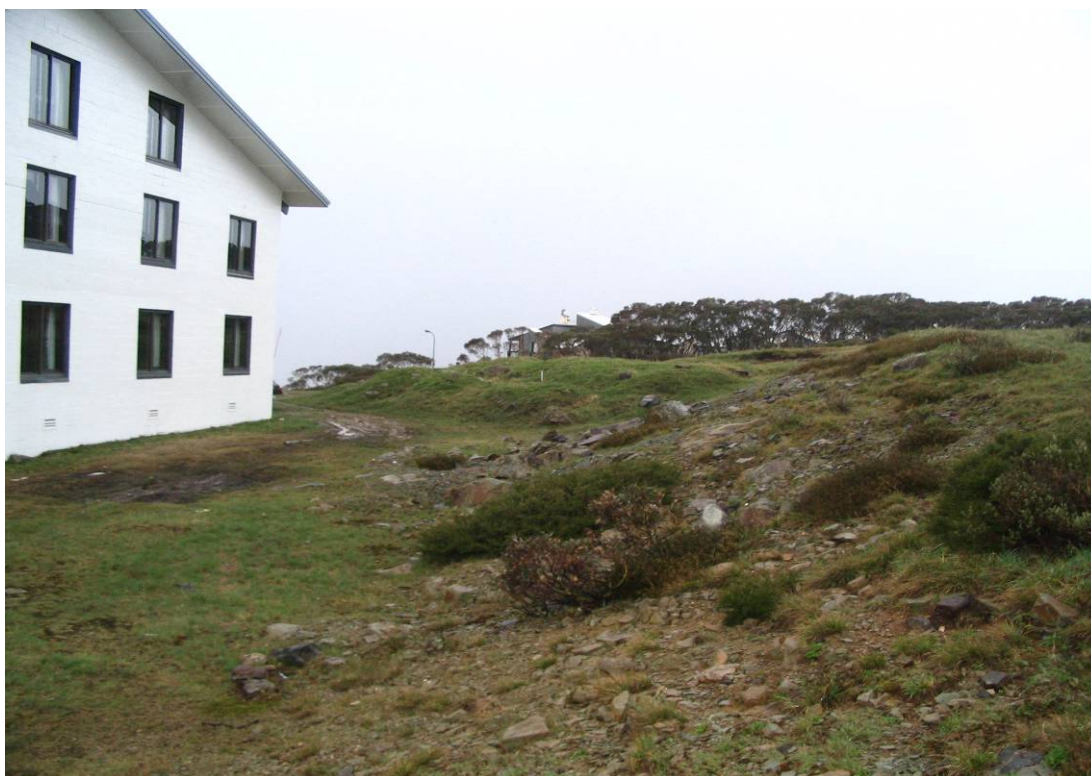
The only indigenous vegetation present on site is located on a small slope to the rear of the Chalet. This is illustrated in figure B. These plants have probably colonised from a remnant local seed bank. They include one plant of the *Hovea* species, one *Ozothamnus* and one small Snow Gum.

Figure B Indigenous vegetation on a small slope to the south east of the Chalet.
