# Soil investigation for the *Hibbertia* sp. Bankstown translocation project

Identifying favourable new sites for a critically endangered species

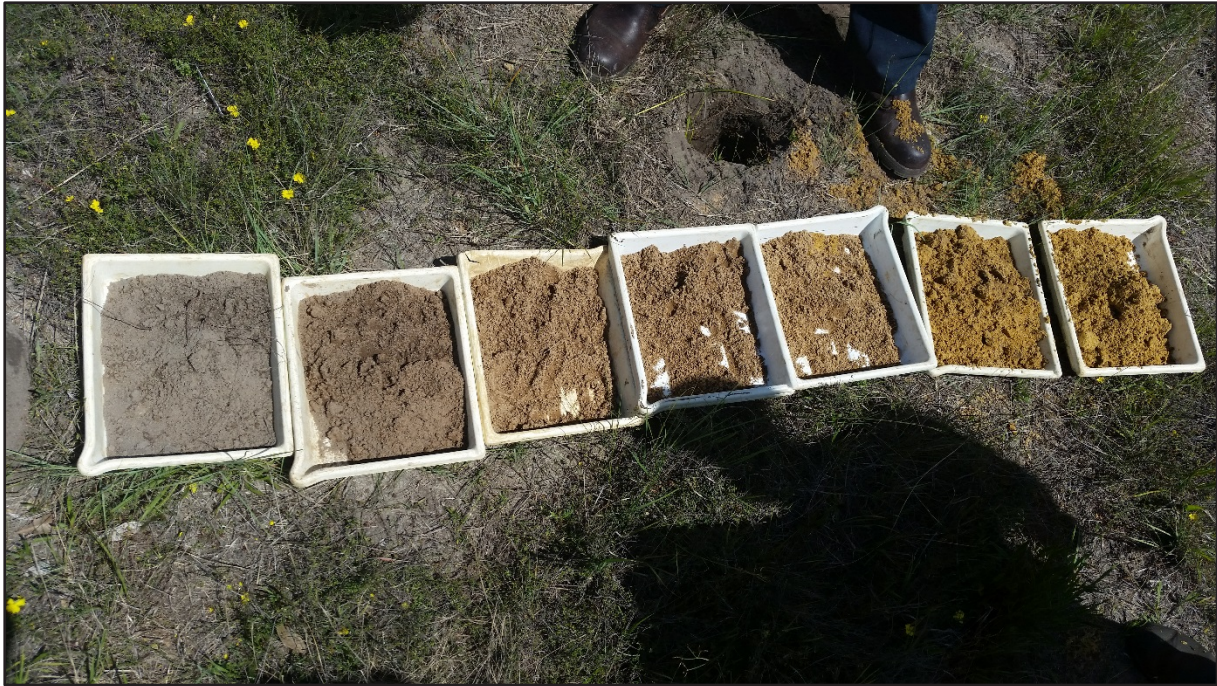
**Figure 5** Very deep, moist, sandy soils at the source area, typical of observation sites 1, 2 and 3. Photo: Greg Steenbeeke/OEH

Generally consistent, consisting of deep (>150 cm), well-drained Grey and Brown Orthic Tenosols (Earthy Sands) of low fertility (low CEC, cations, organic carbon, P and N) and with a slightly acidic to neutral pH. Topsoils are relatively deep (20 – 35 cm) consisting of coarse to medium textured loamy sands. These grade gradually into deep clayey sand-textured subsoils. As moisture increases, iron coloured mottles, of heavier texture (sandy clay loam), became prominent at >100 cm and occur within a pale grey clayey sand. Soils were generally moist beyond ~50 cm becoming very moist to wet between 80 – 150 cm. Soil moisture is likely to be due to run-on from adjoining shale-based landscapes and possibly lateral subterranean flow through the porous sandy soils from the drains to the north and south of the area.

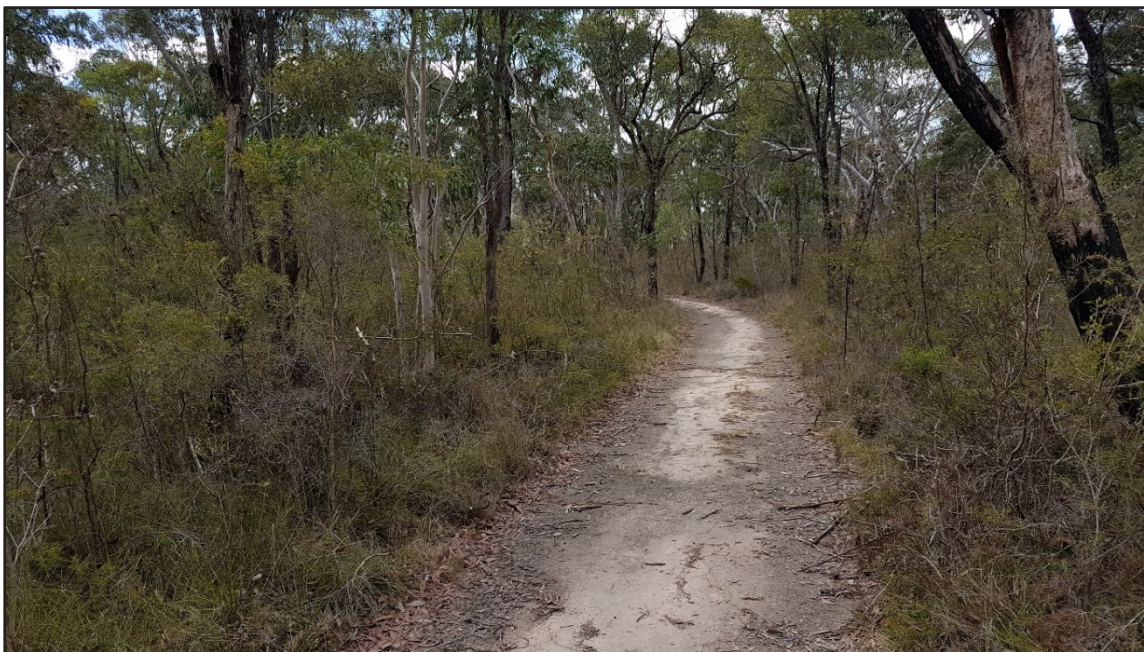
Figure 7 Imperfectly drained terrace plain at Voyager Point (site 4). Photo: Mark Young/OEH

Deep (100 cm) laterized Brown Kurosols (Brown and Yellow Podzolic Soils), comprising a thin (<10 cm) fine sandy clay loam topsoil overlying a brown light medium clay (observation site 5). This overlies a lateritic layer (with pisolithic ironstone gravels) at depth, observed at a gravel excavation site nearby and exposed along the walking track in various areas. These soils were not sampled for testing due to the constraints presented by the clayey subsoils. These are likely to present a major limitation for translocation.

Unlike the sandy soils at the Bankstown Airport source area, drainage on the terraces is expected to be slow, and the soils are imperfectly drained with areas of poorer drainage observed in some areas. The soils are very dissimilar physically to the source area and this soil is considered generally unsuitable for translocation.

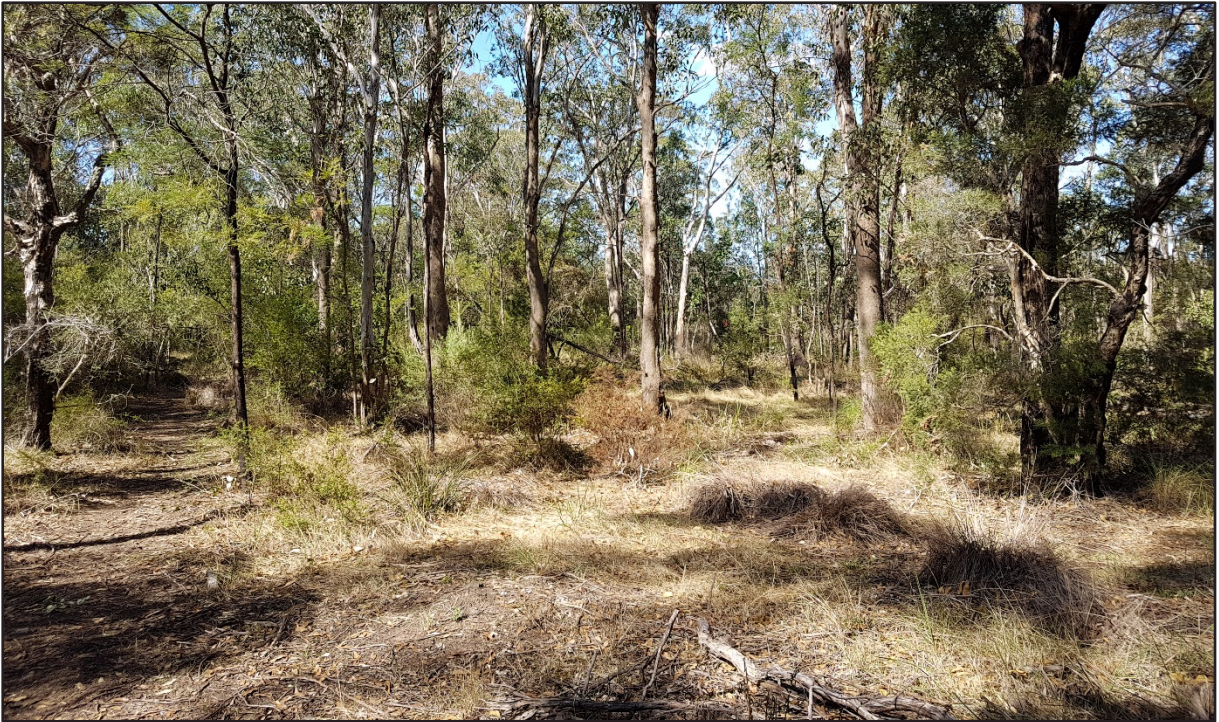
**Figure 8 Moderately well-drained levee at Voyager Point (sites 5 and 6).  
Photo: Mark Young/OEH**

Soils on the levee (site 5 and 6) consist of very deep (>150 cm), moderately well-drained Brown Kandosols. They are very high in fine sand and silt (with little coarse sand, unlike the source area) and are slightly acidic to neutral in pH with low fertility. Topsoil (A1 horizon) is brownish black, ~10 cm deep, fine sandy loam to loam, fine sandy. This overlies a paler A2 horizon to ~30 cm depth which then overlies yellowish-brown fine sandy clay loam subsoil. All boundaries are gradual.

The next most promising area is Voyager Point on the levee bank (sites 5 and 6) with its deep silty soils. Although the soils here have some constraints, being deep silts and fine sands instead of the deep sands of the source area, they are deep, are moderately well-drained and have more ability to hold soil moisture than the shallow sandstone-based soils.

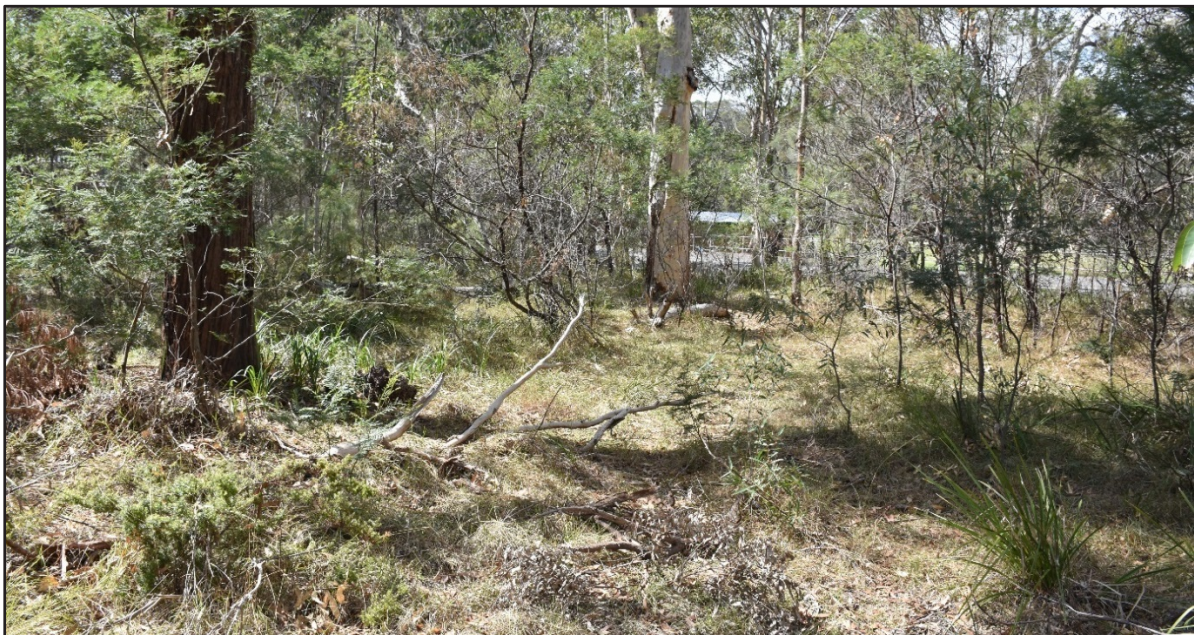
**Figure 10** Shallow, sandy soils with occasional sandstone rock outcrop occur at East Hills Reserve (sites 7 and 8). Photo: Casey Murphy/OEH

Shallow (up to 50 cm), rapidly to well-drained, sandy Leptic Tenosols (site 7) and Orthic Brown Tenosols (site 8) occur. These soils are slightly acidic, consist mainly of coarse and medium sands, and have low fertility. Topsoils range from 10 – 15 cm and consist of loamy sands (site 8) to sandy clay loams (site 7). These overlie brown clayey sands subsoils to 40 cm which overlie sandstone bedrock.

Texturally the soils at East Hills Reserve are most similar to the source area, however the most significant constraining difference is the shallow soil depth and available moisture. The shallow sandy soils are very well-drained with little capacity to hold onto moisture. If the site is chosen for translocation then it is suggested that micro-sampling of the soils with a spade should be undertaken to locate the deeper soils for planting.

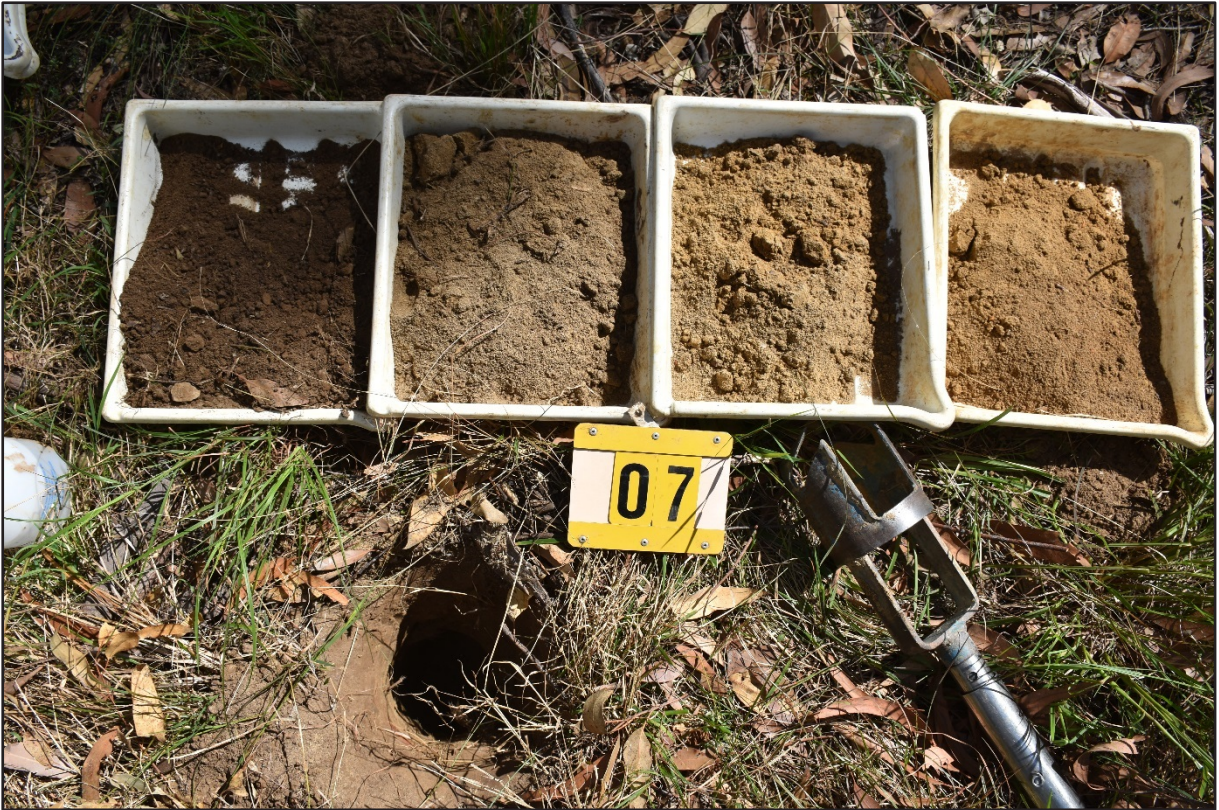
**Figure 11** Sandy clay loam topsoils (left) overlying paler A2 horizons (middle) and a clayey sand subsoil (right). Photo: Mark Young/OEH

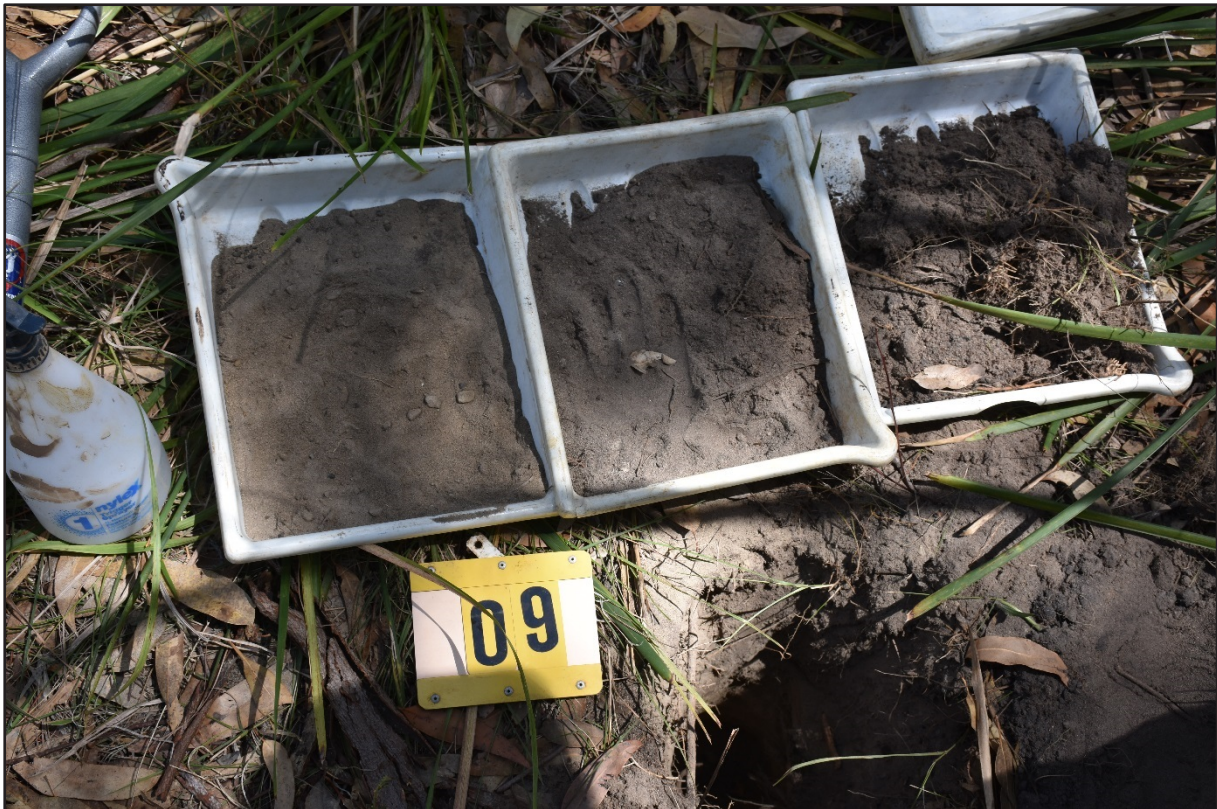
**Figure 14** Soil at site 9, showing weakly structured loamy sand topsoil (right) overlying a slightly paler and unstructured loamy sand (middle and left) to 45 cm depth. Photo: Mark Young/OEH

Discontinuous, very shallow to shallow (<50 cm), rapidly drained Leptic Tenosols (Siliceous Sands) (sites 9 and 10) which are very similar to sites 7 and 8 as they contain high levels of coarse sand, have slightly acid pH and low fertility. A typical profile consists of a very dark greyish brown coarse loamy sand A1 horizon with a weak structure overlying a dark greyish brown loamy sand A2 horizon, with no structure, which in turn overlies sandstone bedrock. Topsoils were noted as being hydrophobic (water repellent) in the field.

Discontinuous shallow, hydrophobic, sandy soils with areas of rock outcrop. No subsoils observed. Most limiting factor is soil depth and ability of the shallow sandy soils to retain soil moisture. Wetting of soils could also be a factor due to observed water repellence (hydrophobic).

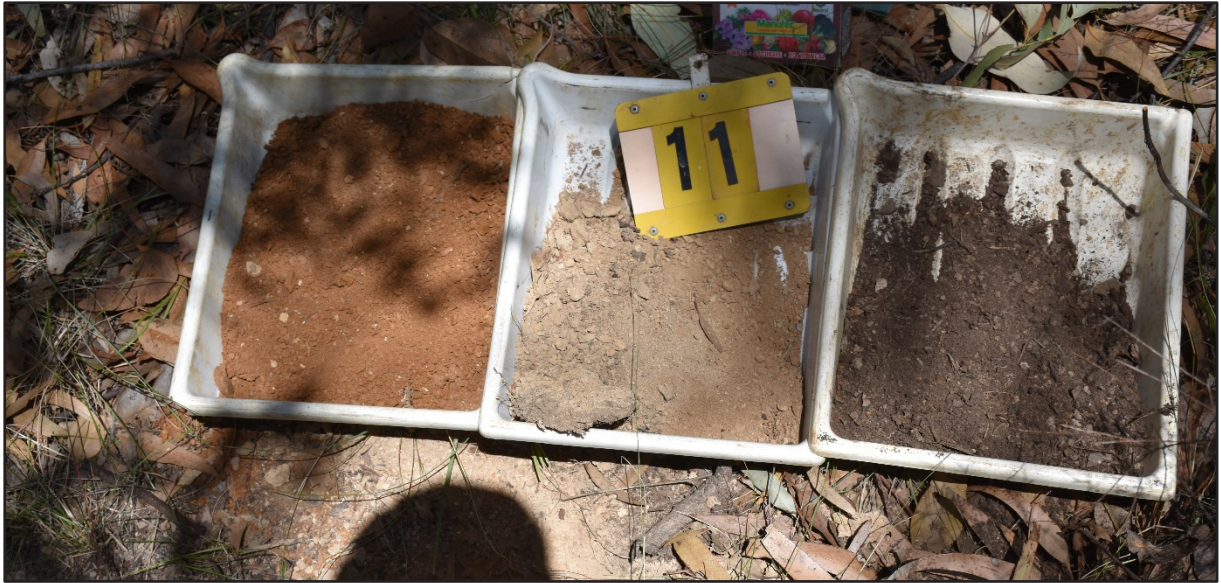
Figure 17 Soil at site 11, consisting of very thin sandy loam topsoil (right) overlying paler, hardsetting clay loam A2 horizon (middle) and a brown medium clay subsoil (left). Photo: Casey Murphy/OEH

With very thin A1 horizons overlying very hardsetting A2 horizons, and imperfectly drained clayey B horizons, the soils here are significantly different from the deep, moist, well-drained sandy soils of the source area, and it is not considered suitable for relocation. The pale A2 horizon indicates the soil is imperfectly drained with some lateral flow above the less permeable clayey B horizon.

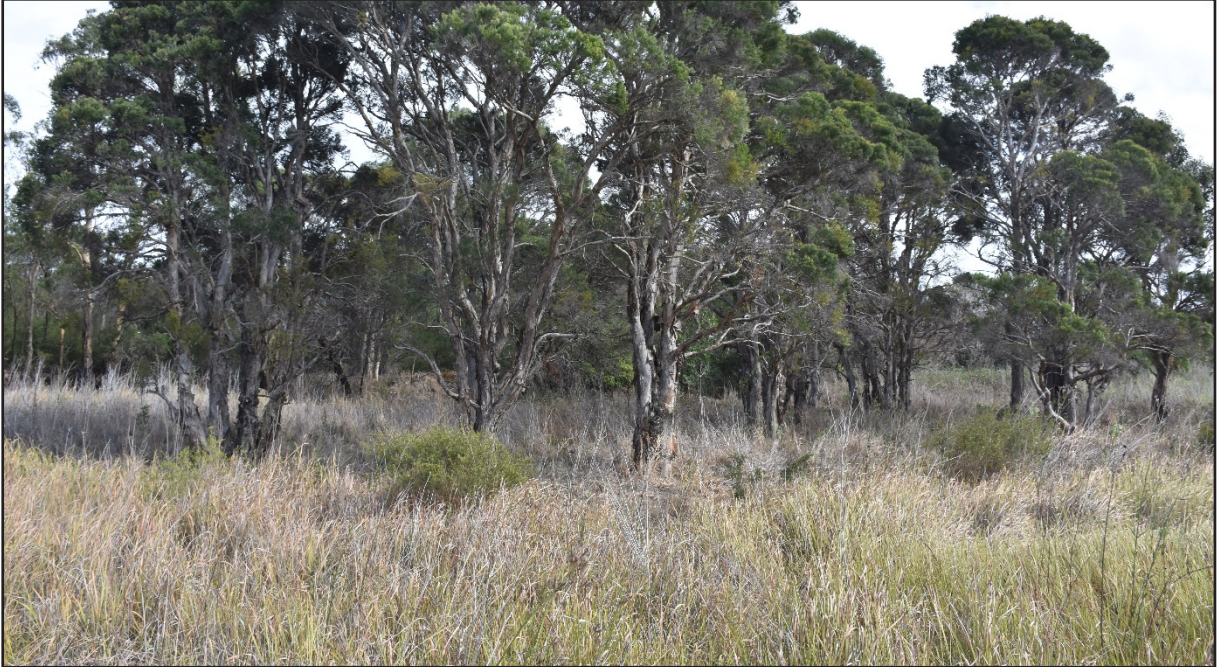
**Figure 20** Poorly drained central drainage plain at East Bankstown Airport, with *Melaleuca* spp.  
Photo: Casey Murphy/OEH

The soils of the central drainage plain (sites 12 and 13) are mainly Natric Brown and Yellow Kurosols (Soloths). They consist of 8 – 12 cm of A1 horizon topsoil, comprising a weak to moderate structured loam, overlying 12 – 26 cm of a massive structured, hardsetting, often bleached, silty clay loam A2 horizon. The A2 horizon overlies a yellowish brown medium clay B horizon >100 cm depth, with mottling indicating poor drainage. The B horizon tends to become redder upslope, indicating better drainage, as observed at site 15.

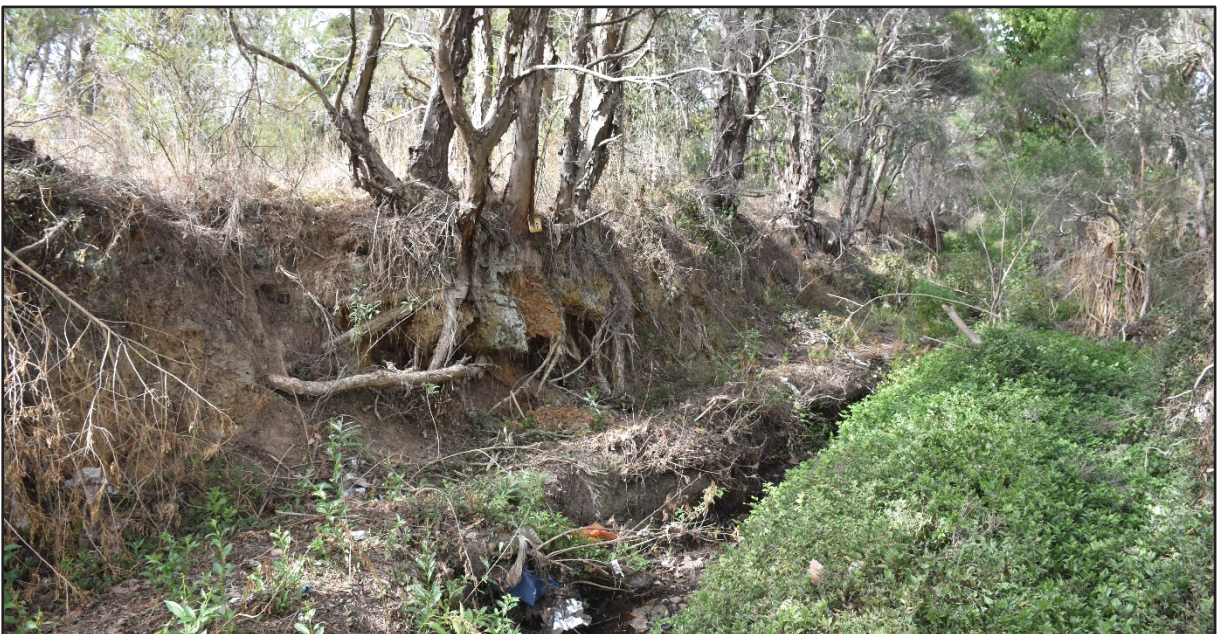
**Figure 21** Active gully erosion in the central drainage plain, caused by urban stormwater run-off.  
Photo: Casey Murphy/OEH

Although initially the central drainage plain (prior to urbanisation of the catchment) was likely to shed water via non-concentrated sheet flow, two gullies have now formed from the increase in urban stormwater run-off. One of the gullies (at site 17) is active and is up to 3 m deep in the northern area of the drainage plain below the netball courts. Slopes are < 5%, local relief is <10 m and elevation ranges between ~10 – 15 m.

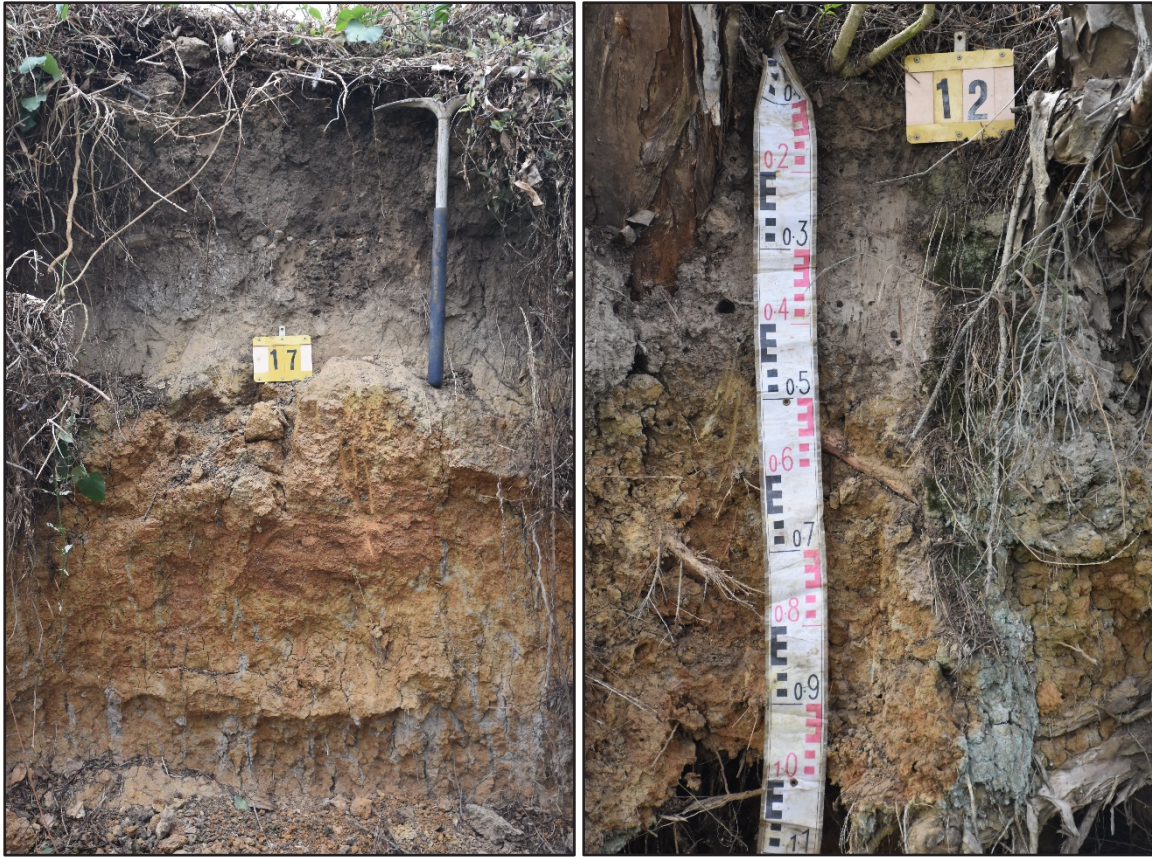
**Figures 22 and 23** To left, site 12 (Natric Kurosol), typical of the central drainage plain, showing bleached A2 horizon and poorly drained, mottled clayey B horizon. To right, site 17 (Anthrosol/Brown Sodosol), typical of the surrounding footslopes, showing a deep layer of fill above a bleached A2 and poorly-drained, mottled clayey B horizon. Photos: Mark Young/OEH

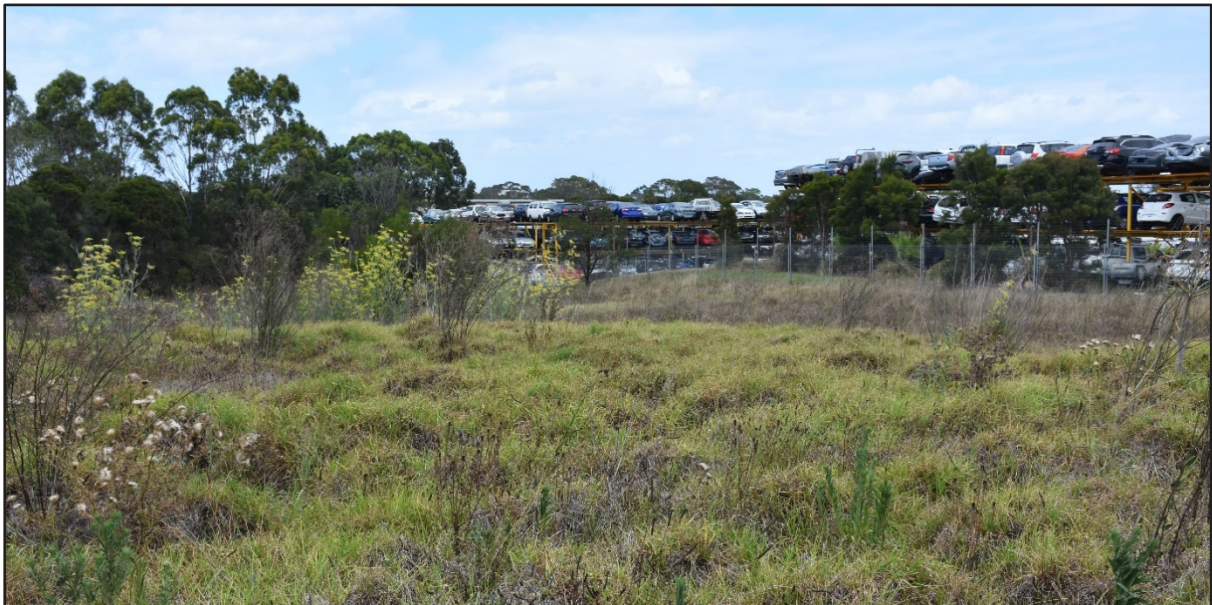
**Figure 24** Areas of fill (shown here at site 14) are found on elevated parts of both the western and eastern side of the area, adjoining industrial land. Photo: Casey Murphy/OEH

The more elevated areas, which adjoin the industrial land in the west and east of the central drainage plain, were observed to contain deposits of compacted stony-clayey fill (Anthrosols) which may overlie shale parent material at depth (sites 14, 16 and 17).

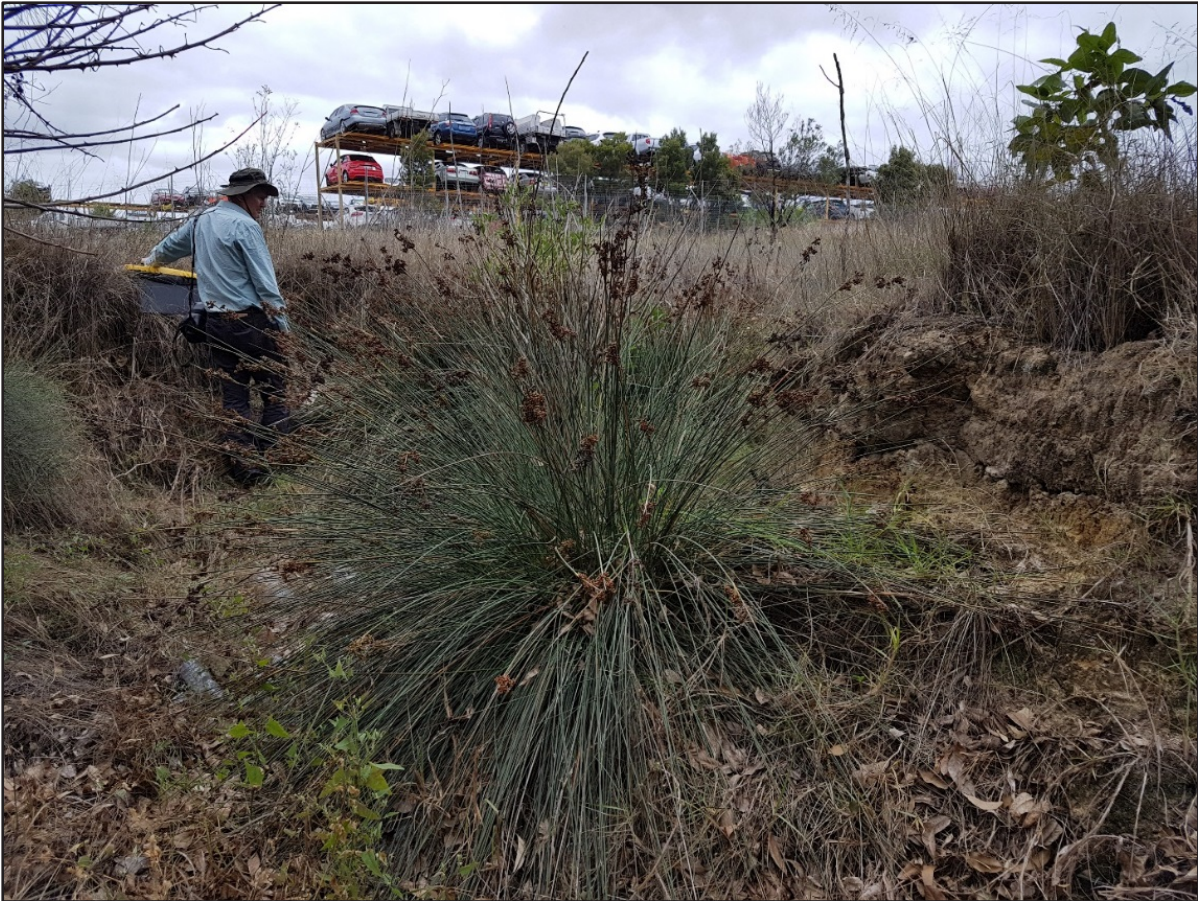
**Figure 25** Vegetation indicating salinity, observed at a gully head at site 18 on the lower slope/drainage plain boundary. Salt present on northern edge of gully. Photo: Mark Young/OEH

The main limitations are the disturbed, dense stony-clayey fill on the western and eastern areas and hardsetting topsoils, poor drainage and very slowly permeable subsoils of the central drainage plain. White salt on the ground and vegetation indicative of dryland salinity was also observed at a gully on the western edge of the drainage plain (see photo site 18).

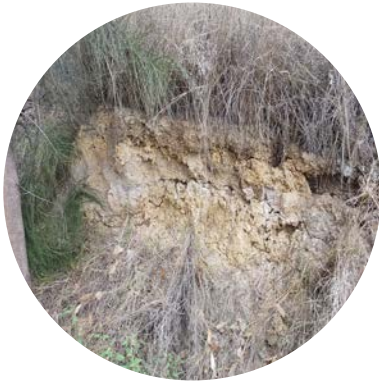
A sodic, salty soil in a gully at East Bankstown Airport.  
Photo: Mark Young/OEH
