Stage 1 Conservation Management Plan

SOUTH HEAD SYDNEY HARBOUR NATIONAL PARK

Volume 1 – Assessment of Significance

February 2008

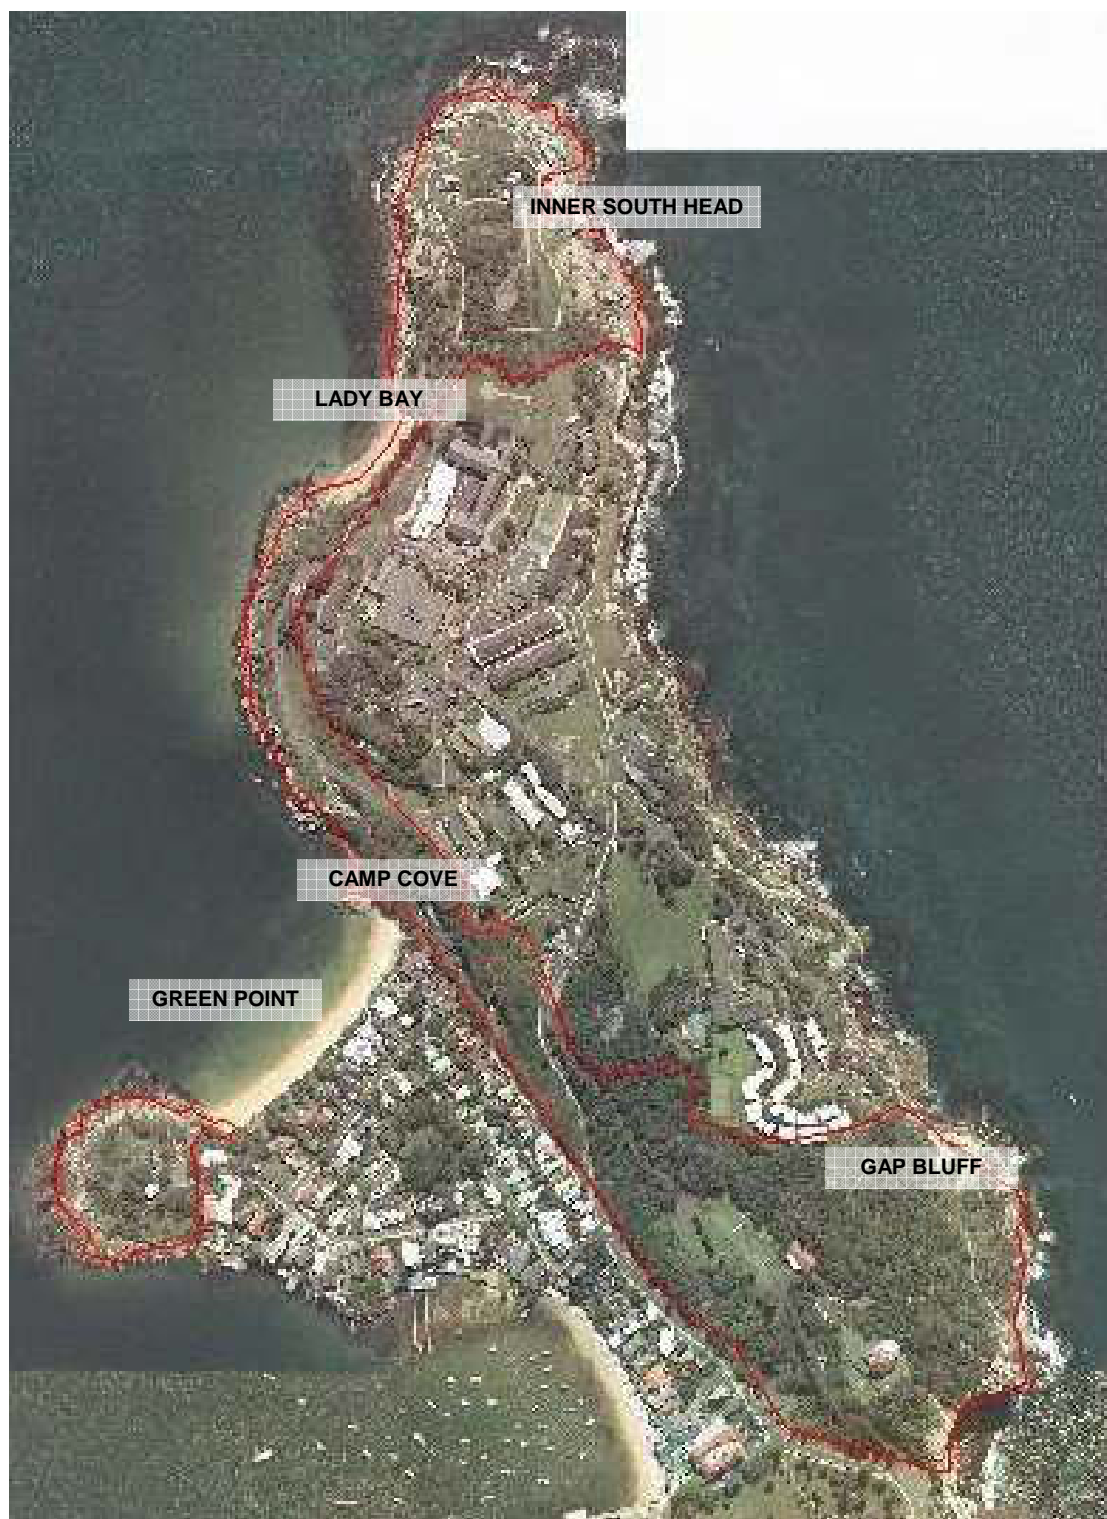
Figure 1.3. Aerial photograph of the north end of South Head showing the boundary of the two parts of the Sydney Harbour National Park at South Head, which comprise the study area (edged in red). The main precincts used in this CMP are identified. Source: DECC.

The study area is divided into five main precincts for the purposes of this report (see Figures 1.2 and 1.3):

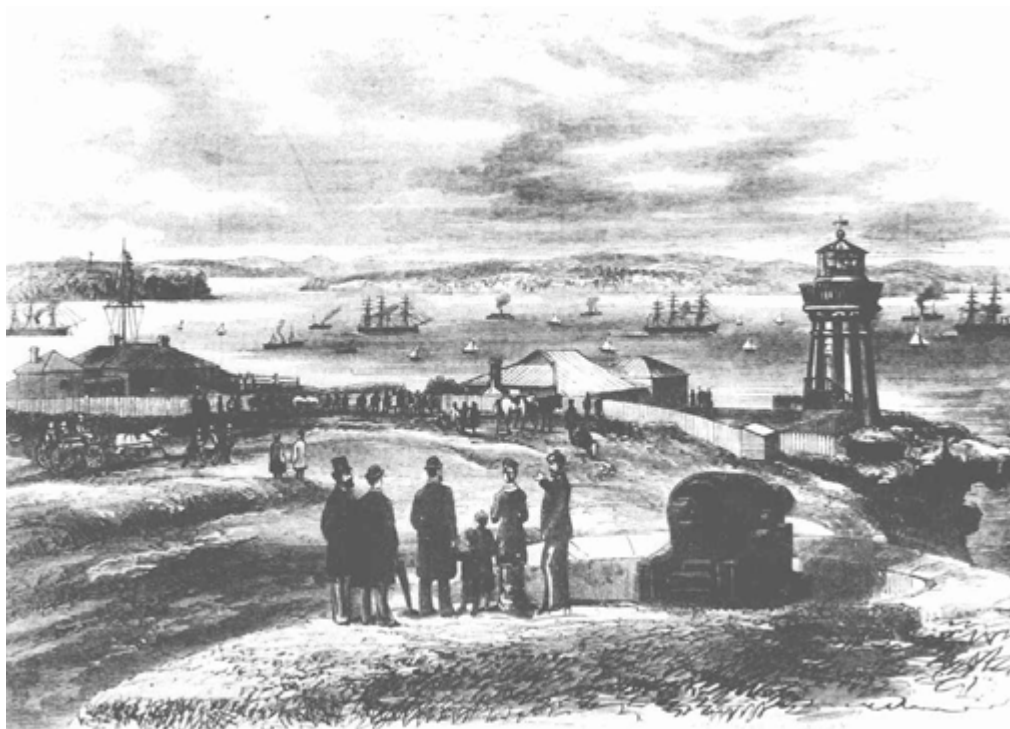
Figure 2.7. This engraving, originally published in the *Illustrated Sydney News*, shows spectators watching a fleet depart Port Jackson in December 1881. The group in the foreground is clustered beside a gun pit with gun mounted.

The mid ground shows the Hornby Light, and full complement of keepers' cottages surrounded by picket fences. The light station flagstaff is shown behind the head keeper's cottage on the left hand side of the picture (Source: *A Pictorial History of The Eastern Suburbs, Eastern Suburbs Newspapers, Randwick, 1977, p. 85*)

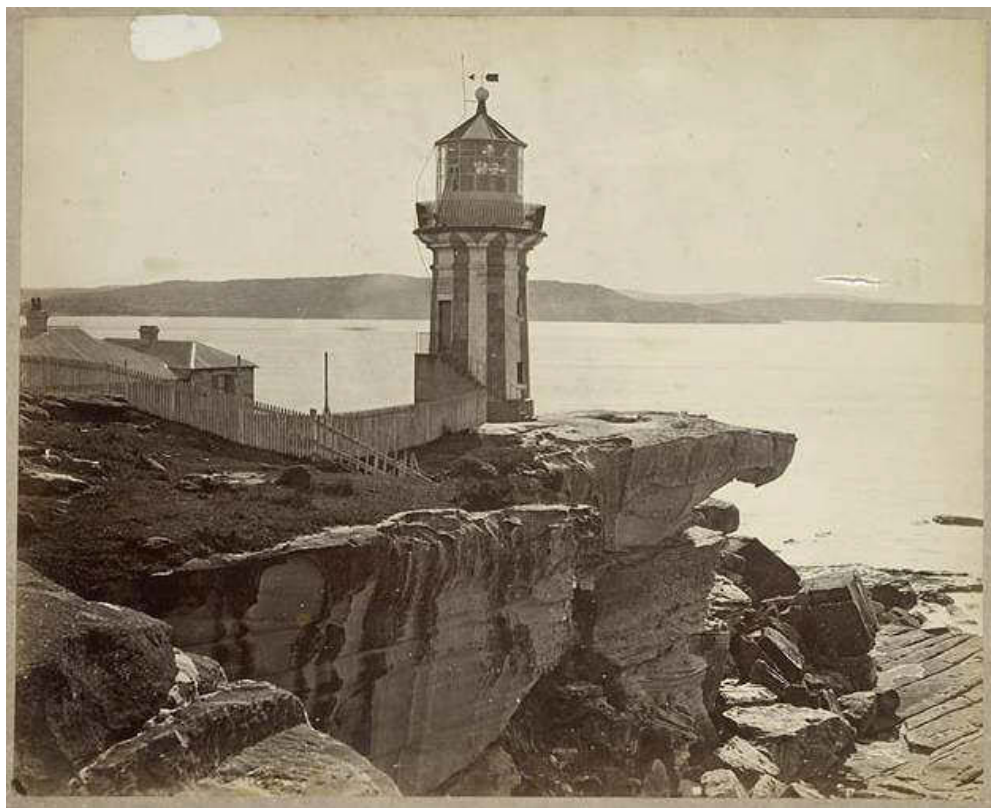
Figure 2.8. Hornby Light and cottage, 1884 (Source: *Album of photographic views of Sydney, Tronier, ca. 1879-1884, State Library of NSW, PXA 411*)

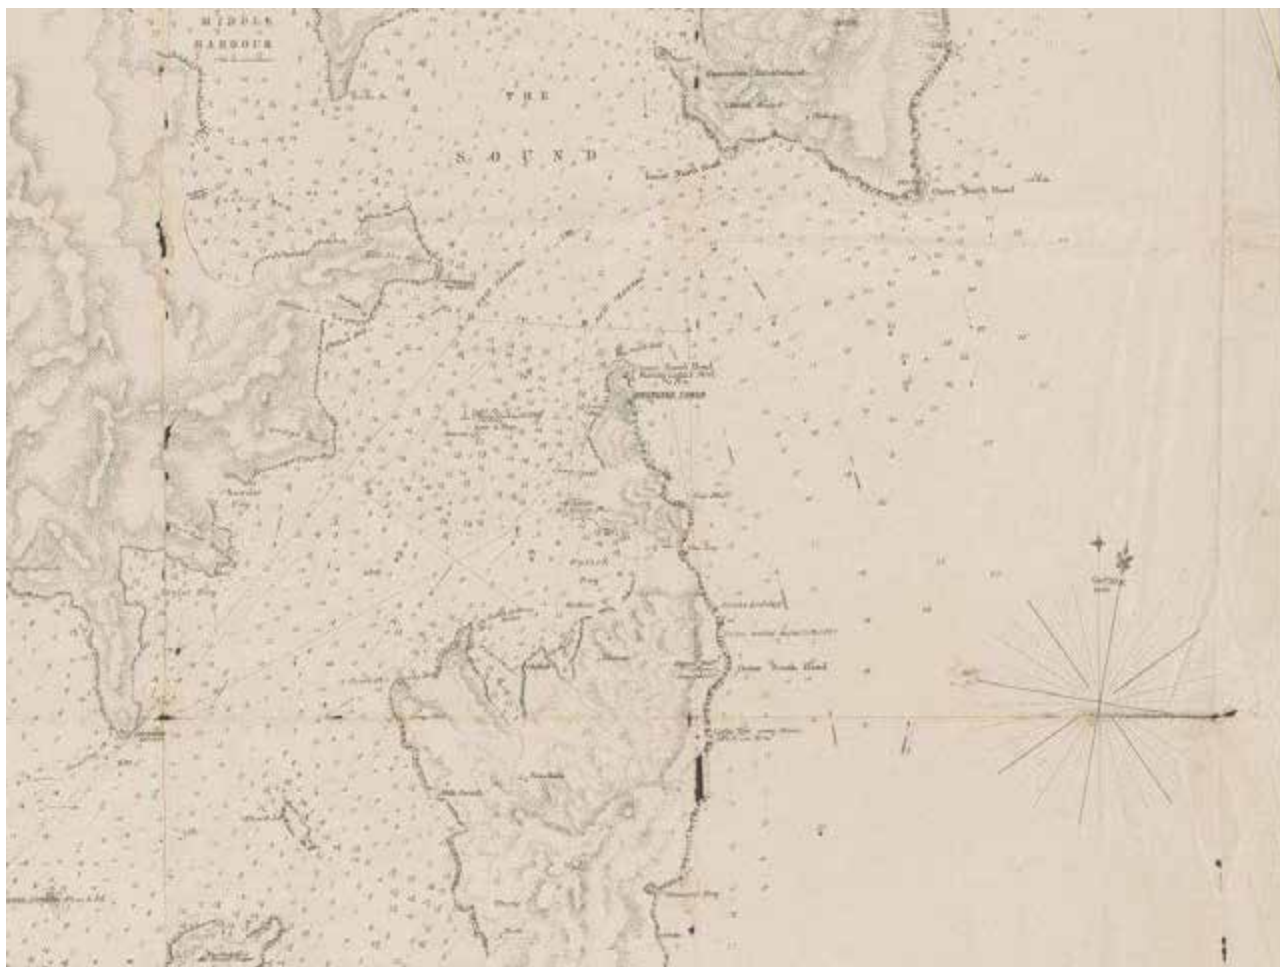
Figure 2.11. E W Ward, *Plan of portion of Port Jackson to illustrate Report on the Defences (of the City of Sydney)* dated 3rd January, 1863, NLA Map Rm 1401 <http://nla.gov.au/nla.mpa-rm1401>.

recommended batteries at Inner South Head and Middle Head, with a casemated tower on the Sow and Pigs reef (see map of defences, Figure 2.11). The scheme was to be made failsafe by the completion of the battery at Dawes Point and the construction of a tower for heavy guns on Pinchgut Island (now Fort Denison). The sites at Inner South Head and Middle Head were both to mount 30 heavy guns (with 15 mounted as soon as possible, and the rest to follow), and have barrack accommodation for 150 officers and men, stores, magazines and water tanks. Both were to be cut off from the ground behind with ditches and ramparts. He also mooted the idea of a boom across the navigable channels, but acknowledged that this would stifle maritime commerce. Gordon's recommendations were not enacted at the time, but did form the basis for the defence programme of the mid-1850s, discussed below.⁶¹

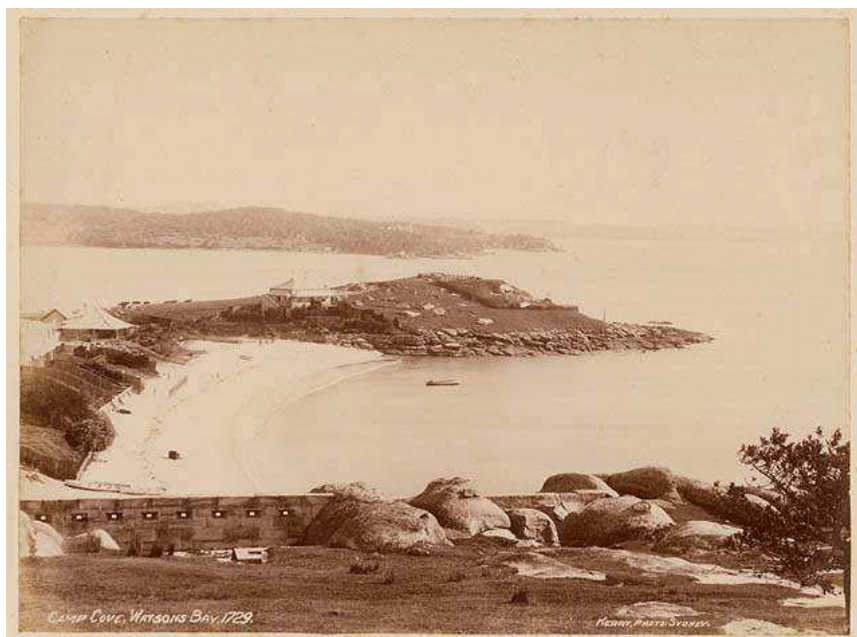
Figure 2.14. View across the rifle walls guarding the Cobblestone Road and delivery landing, Kerry and Co., n/d but probably c.1885–1895, showing the Marine Biological Station at centre. (Source: State Library of NSW, Small Pictures File, SPF/810)

Tension in Europe in 1876 prompted the NSW Government to seek the assistance of Sir William Jervis who had done much to reorganise the defences of Britain in the late 1860s. He joined Lt Col Peter Scratchley in 1877 to review NSW's coastal defences. Their activities led to the reorganisation of the batteries on Middle Head, Georges Head and South Head, and the development of new works on Green Point (see Figure 2.14) and Georges Heights. Jervis continued to advise the NSW Government until 1885.⁷⁰

A complex of complementary defence activities and facilities was developed at Green Point from the 1870s (see Figure 2.14). Some time between 1872 and 1885, a battery was constructed at Green Point, but little is known about it, and no physical remains of it have been identified. In 1878 a Submarine Miners Firing Station was built into the hillside at Green Point, consisting of a long access passage, two main rooms, and a passage leading into the harbour, to take out the electrical cable.⁷⁴ Two viewing ports allowed full views across to Middle Head. A minefield was installed across the shipping channels, and a similar firing station was built on the other side of the harbour at Georges Head. Jervois' idea was that '...an enemy's ship would first have to pass the electro-contact mines, then the mines fired by observation [from Green Point and Georges Head], he being at all times exposed to the converging fire of the batteries on Middle Head, South Head and Georges Head.'⁷⁵

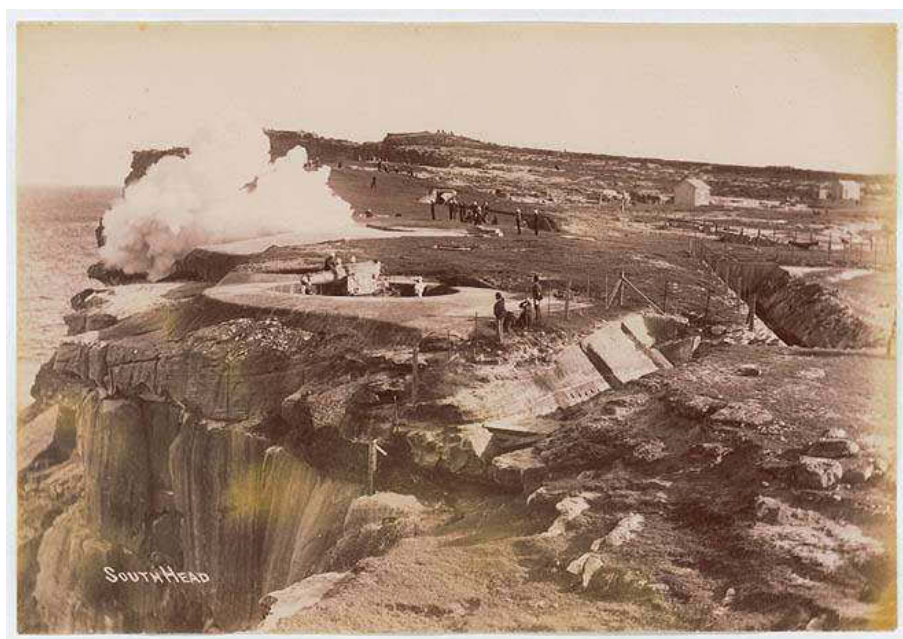
Figure 2.15. View of the South Head Fort c 1900–1910 (Hornby Battery), probably taken from inside the Hornby Light Tower, and showing the two gun emplacements (constructed 1876) inside the study area, and trench or moat to the rear of them on the right hand side of the photograph (see map above). It is possible that the smoke obscures the 6-inch HP ‘disappearing gun’. The 9-inch RML is in the foreground. (Source: State Library of NSW, Star Photo Co. - Unmounted views of NSW, [chiefly 1900–1910] PXE 711/23)

Historical photographs indicate that the entire headland has been cleared and modified (see Figures 2.15, 2.17, 2.26, 3.25). Some natural regrowth has occurred over the past forty years, supplemented by a planting program in 1997-2000. Remnant bushland consists of coastal heath namely *Melaleuca armillaris*/*Kunzea ambigua* scrub. There are high levels of weeds over much of the headland. There are no recorded threatened flora species.

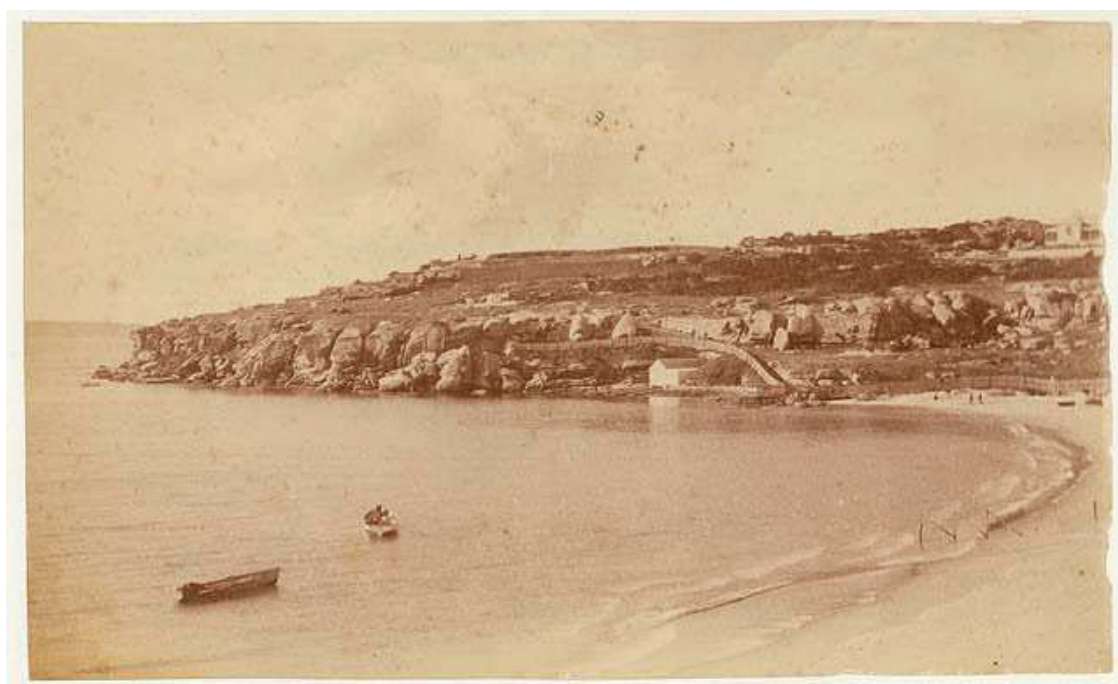
Figure 2.17. Camp Cove, Watsons Bay, c. 1880, showing the military boathouse and jetty area at the north end of Camp Cove, a fence possibly running along the line of the Cobblestone Road, and the stone rifle walls covering the jetty area. (Source: State Library of NSW, Small Pictures File, SPF/811)

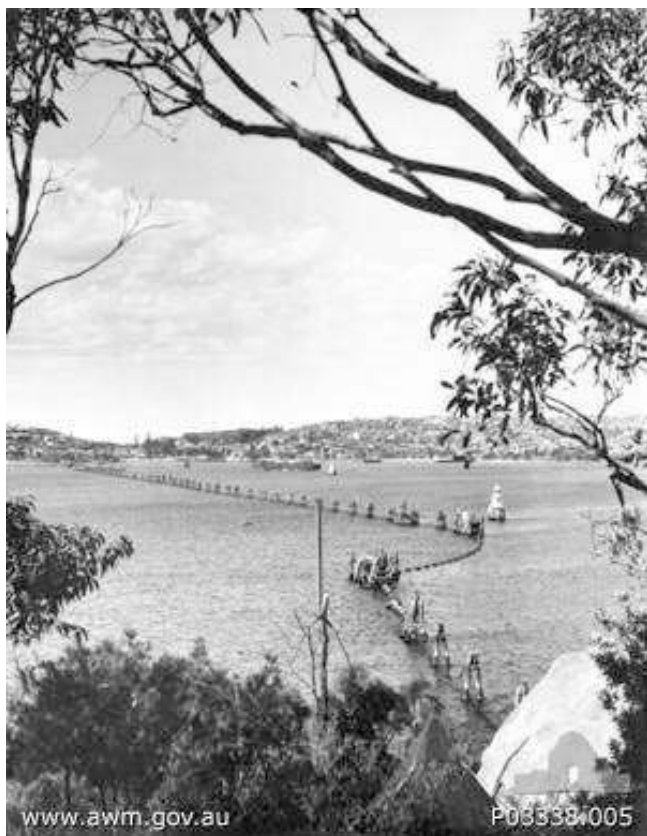
Figure 2.22. The Sydney Boom Defences Looking towards Green Point from Georges Head, 1942. (Source: The Australian War Memorial, id. P03338.005)

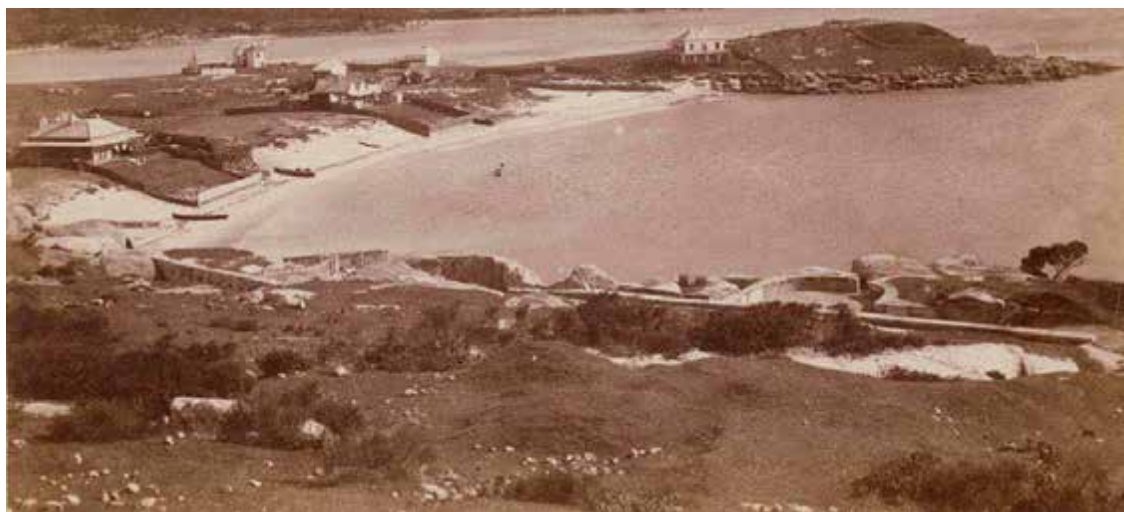
Figure 3.1. Part of a photograph taken in 1890s showing the open landscape in the foreground with the fortifications built in amongst the rocky outcrops (Battery not within the study area) and the denuded Green Point in the distance. Source: Mitchell Library, Small Pictures File Ref: SLSPF_749 1890

By the 1880s (see Figure 3.1) parts of the headland had been substantially cleared and by the 1930s (see Figure 3.2, aerial) only a few areas of low scrub remained. The dominant features at this time were the areas of grass and exposed rocky outcrops of sandstone. With the expansion of the Radar School in the 1940s and 50s, the density of built development increased.

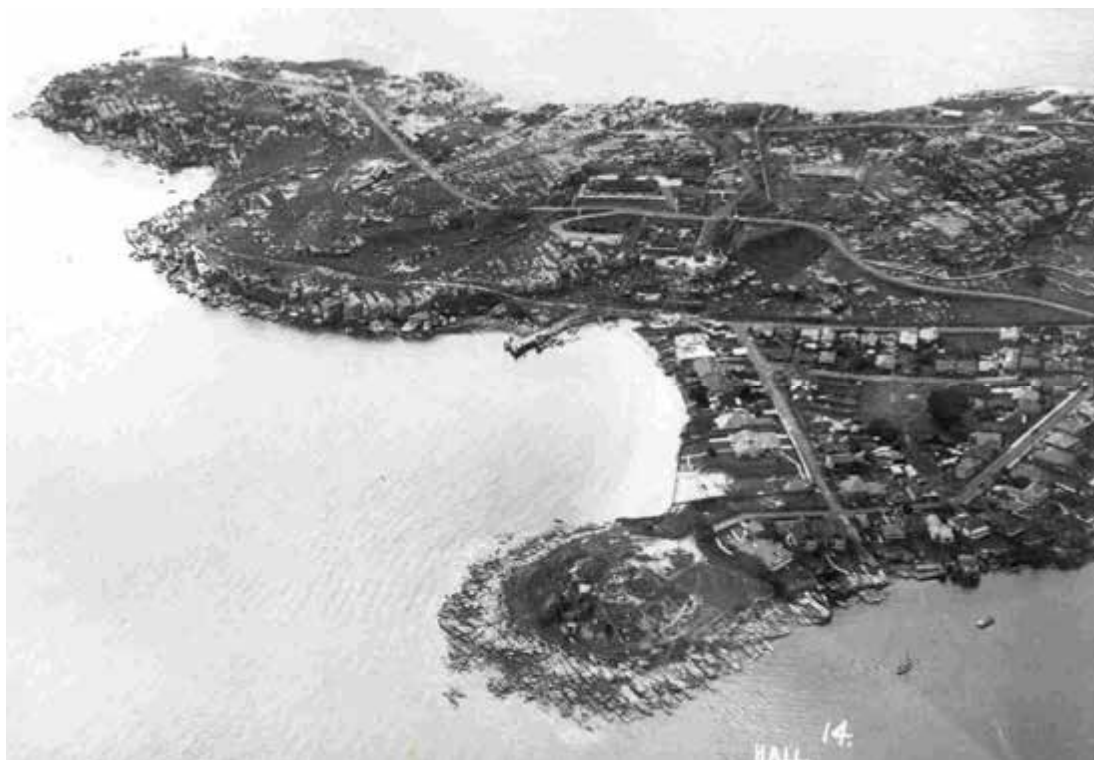
Figure 3.2. Aerial photograph taken in 1931 with South Head in the distance and Green Point in the foreground, Hall & Co. Source: State Library NSW GPO 1 07303 (Hall 014 Macleay Museum)

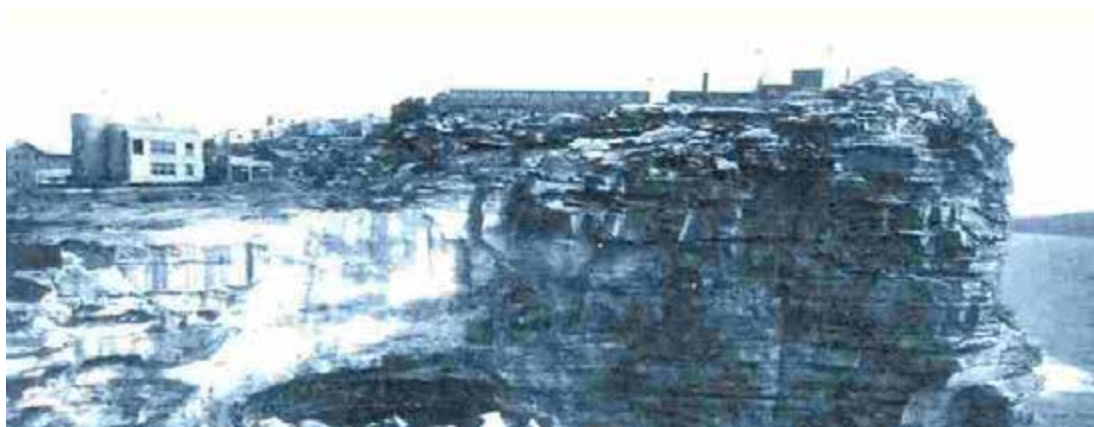
Figure 3.3. Part of a photograph taken in the 1940s of Gap Bluff showing the open exposed character of the landscape during the occupancy of the area by the Defence force. Sourced by DECC from the State Library of NSW Image Library.

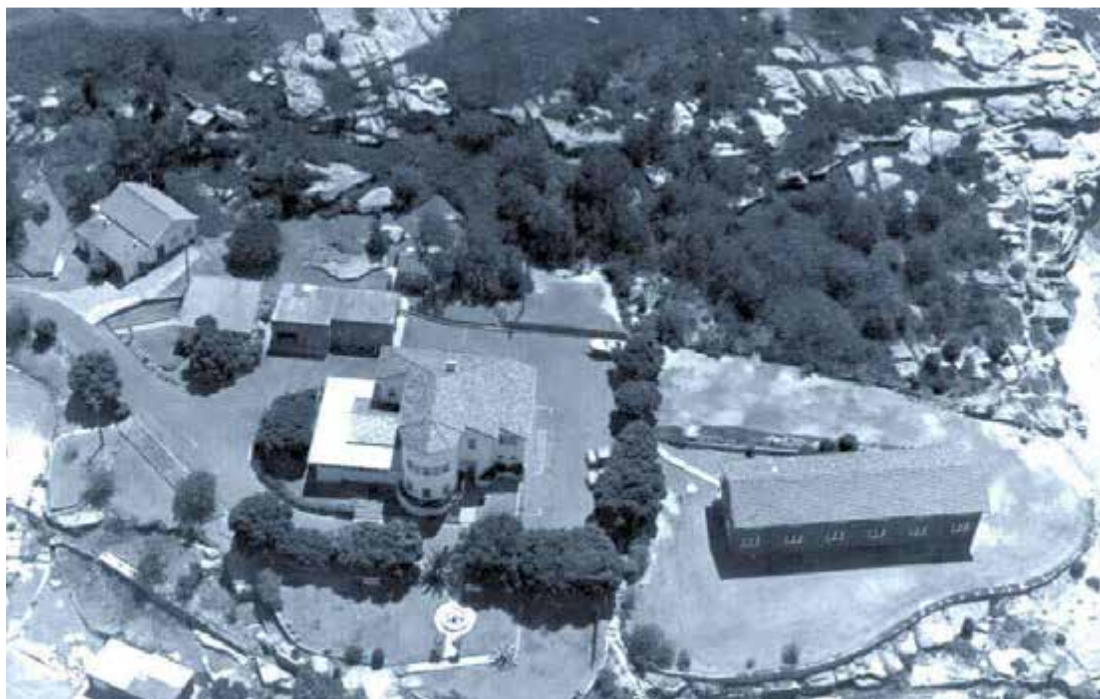
Figure 3.4. Aerial view of Gap Bluff in the 1955–60 showing the character of the open vegetation around the built up areas and the lawns, specimen trees and domestic scale gardens around the buildings. Source: HMAS Watson Library

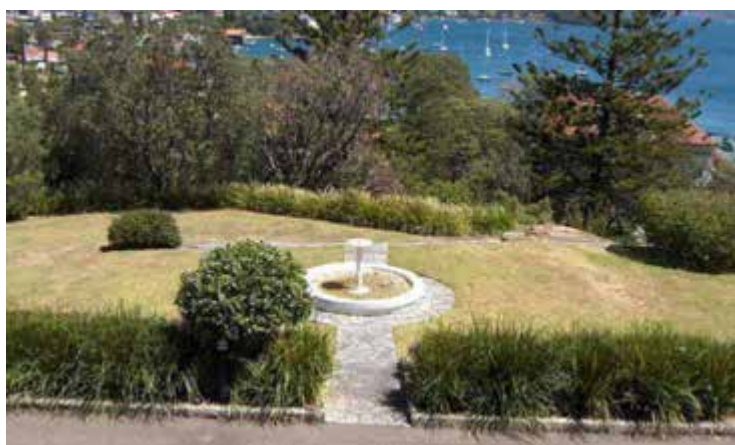
Figure 3.5. Domestic scale garden in front of the Officers' Mess [IS 4A.1]. October 2006.

Large asphalted areas for driveways and parking surround the building and are flanked by dense vegetation. There is a simple garden in a clearing to the west of the building centred on a small fountain with a stone "crazy paved" path and with remnant walling (Figure 3.5).

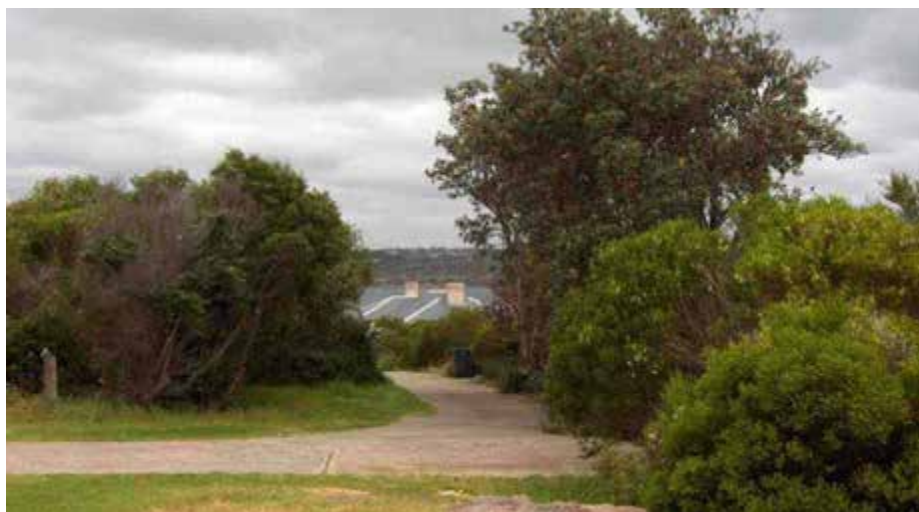
Figure 3.6. Dense revegetation around the Assistant Lightkeepers Cottage [IS 1.2]. Oct. 2006.

9. The visual relationships between both Lightkeepers' Cottages [1.1, 1.2] and the Hornby Light [1.0], currently partially obscured by scrub (Figure 3.6 and 3.11). Historically all the Lightstation buildings were situated in cleared grassland with only picket and paling fences between and views out to the ocean and Harbour (Figures 2.7, 2.8, 3.25).
10. Views from the accessible areas of the headland back to the Hornby Light [1.0] with its maritime setting beyond (Figure 3.9).
11. The open grassland setting of the fortifications on Inner South Head with views from and over the structures to the Harbour or ocean including the Hornby Battery [1.3], the 1854/55 gun emplacement [1.4], the WWII Searchlight [1.5], the 1890s gun emplacement [1.6] and the c1900 Directional Range Finder [1.9]. (See Figures 3.15, 3.16, 3.23, 3.24, 3.25).

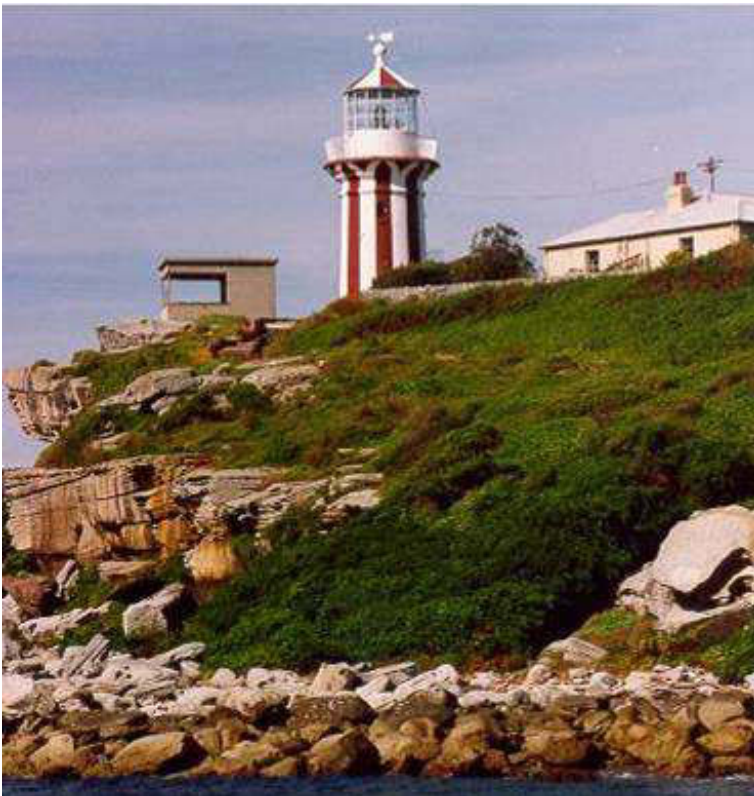
Figure 3.8. View of the tip of South Head from the Harbour. With (from left to right) the WWII Searchlight Shelter [1.5], the Hornby Light [1.0] and the Assistant Lightkeepers' Cottage [1.2]. (Source: Australian Heritage Database).

1. Views to South Head from sea going vessels on the ocean and on entering the heads toward the rocky headland topped with low heath and with the Hornby Light [1.0] dominant. At close range the WWII Searchlight Shelter [1.5] is also a dominant feature above the rocky ledges (Figure 3.8). This view has historic and contemporary significance as part of the symbolic gateway to Sydney and Australia.

6. Views to and from the Head Keeper's Cottage sitting across open grassland (Figure 3.8). This view is historically correct with the exception of the loss of the timber picket fences. The open setting assists in the interpretation of the heritage significance of the cottage (Figures 2.7 and 2.8).

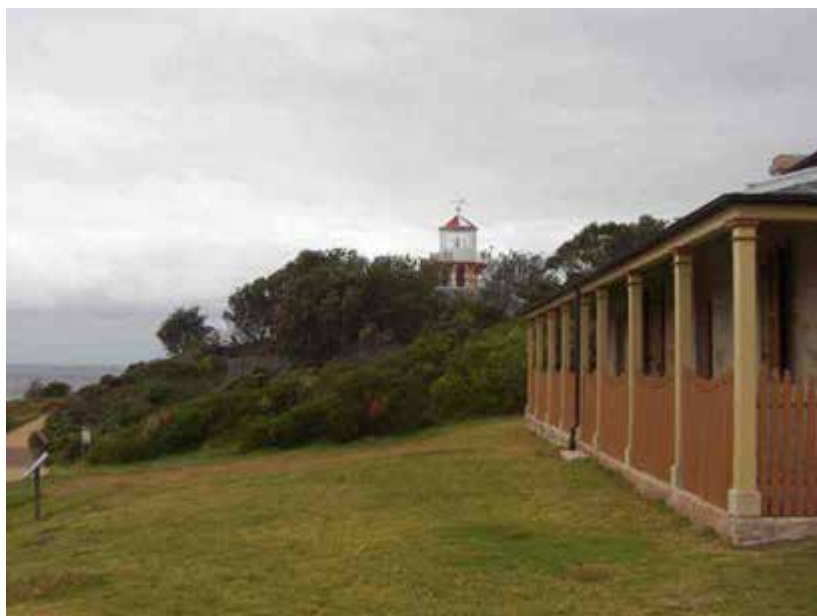
Figure 3.11. Looking to the east in front of the Head Lightkeeper's Cottage [1A.1] with the Hornby Light in the distance beyond. October 2006

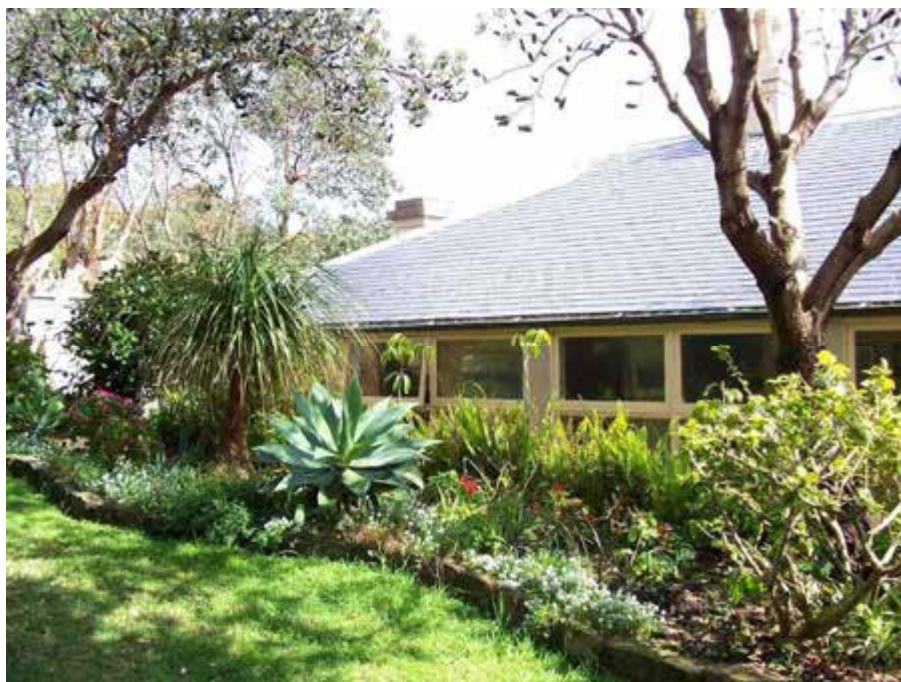
Figure 3.13. Looking at the south-east corner of the Assistant Lightkeepers Cottage with the cottages benched into the slope the verdant garden and showing the verandah enclosed in the 1940s and the recently installed slate roof. October 2006

The exterior of the Assistant Lightkeepers' Cottages features painted sandstone, painted timber joinery, roof slates and lead flashings. The building retains some fibrous cement sheeting from the 1940s work. The rear laundries are finished with painted bricks. The exterior and interiors of the cottages are in reasonable condition but have been altered since the nineteenth century works.

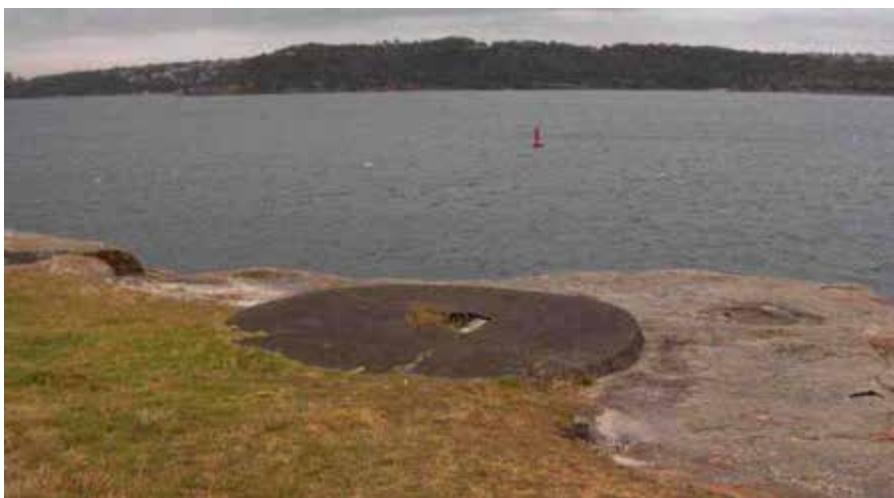
Figure 3.14. The concrete base of the flagstaff, looking south west over the harbour. October 2006

Directly to the west of the Head Lightkeeper's Cottage is a circular concrete base – this is likely the base of a flagstaff referred to in documents as being in-situ around 1902.¹²¹ The centre of the base has the remains of the housing for the timber staff. There is evidence of fixing points in the rock for the stays around the base some with iron fixings remaining.

The flagstaff was originally within the picket fence of the Head Lightkeeper's Cottage garden.

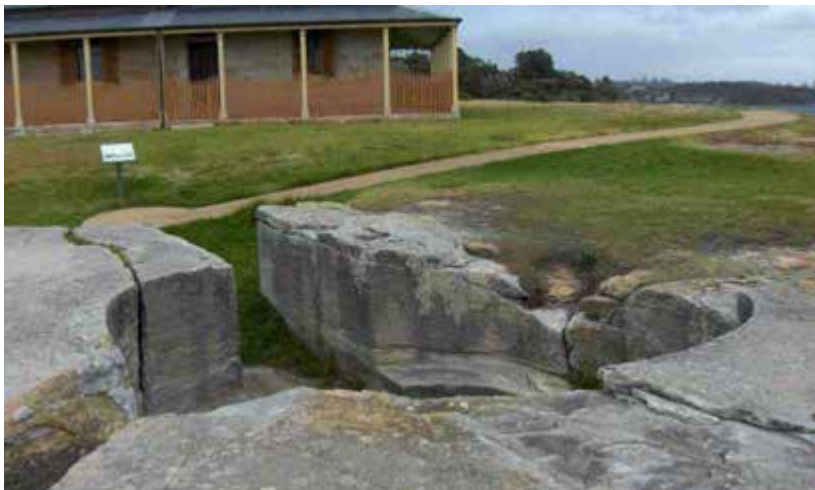
Figure 3.15. The 1854/55 gun pit [1.4] in the foreground with the Head Lightkeeper's Cottage [1.1] in the background. October 2006.

The earliest feature is the remains of an 1854–55 Gun Pit for a single gun, which was cut from a bluff in the rock for defence of the harbour prompted by the Crimean War. This pit was originally partnered with another to its east on which the Hornby Light was constructed. This pit is located close to the cliff edge, north of the Head Lightkeeper's Cottage. The pit has an unfinished appearance and was never armed. It still is in good

condition if a little weathered. It features a banquette, a distinctive rock apron and a flared opening with a short passage entering the pit from the south. A trench is cut on the northern side of the pit, which Gojak suggests was cut at a later date for an unknown purpose. The pit wall still has vestiges of its picked stone finish.

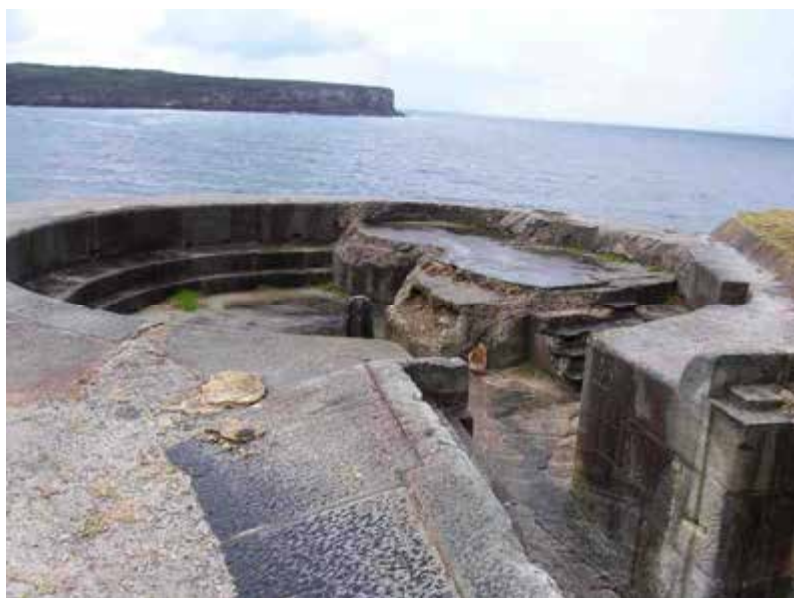
Figure 3.16. Looking north-east over the northern gun pit showing the 1876 work, the central pivot and the 1903 searchlight emplacement. October 2006.

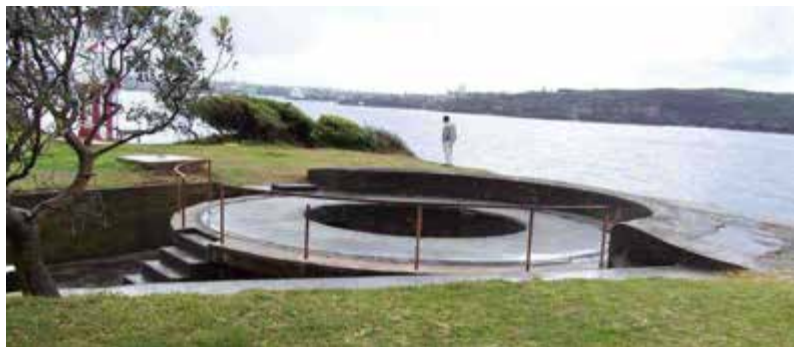
Figure 3.17. Looking north over the southern gun pit showing the 1889 and WWII works which substantially modified the emplacement to replace the 9-inch RML (fixed) gun with a 6-inch BL, MKV, and then with a 6-inch BL MKVII disappearing gun. October 2006.

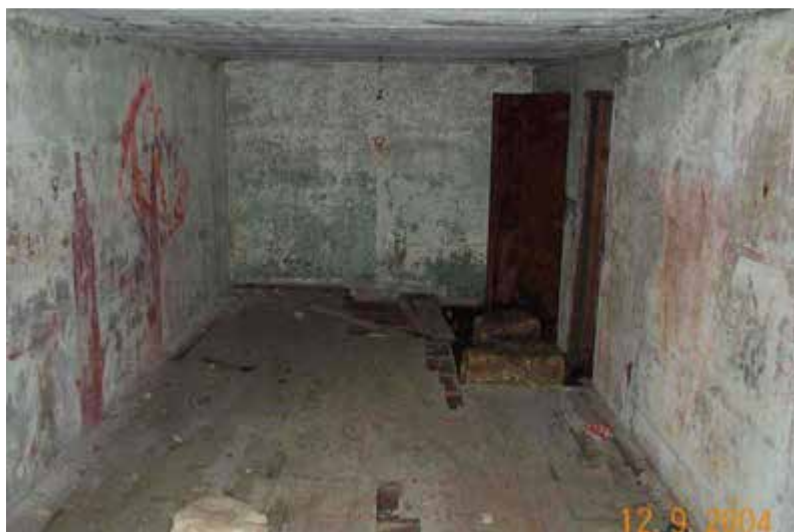
Figure 3.18. View of the interior of the Duty Room formed out of 1870s passage in 1939 showing the reinforced concrete ceiling, rendered walls and timber floor boards. Source: DECC 2004.

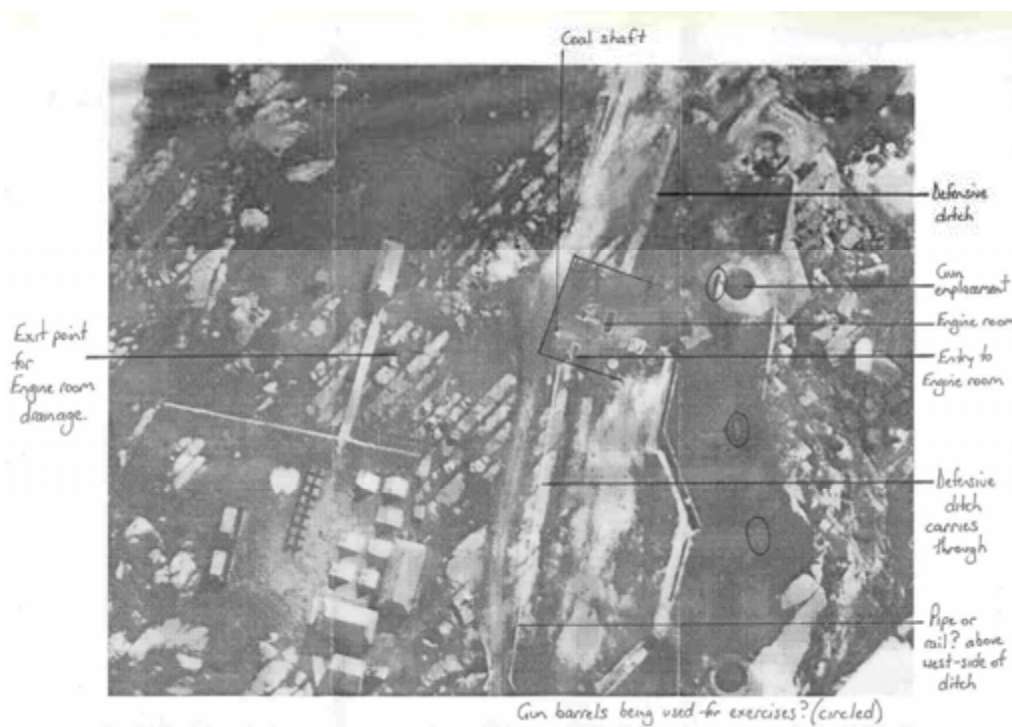
Figure 3.19. Copy of the 1929 Aerial Photograph, annotated to show the approximate location of the Engine Room [1.3B] in relation to the room's surface features that are still open at the surface. Source: DECC, annotated November 2006.

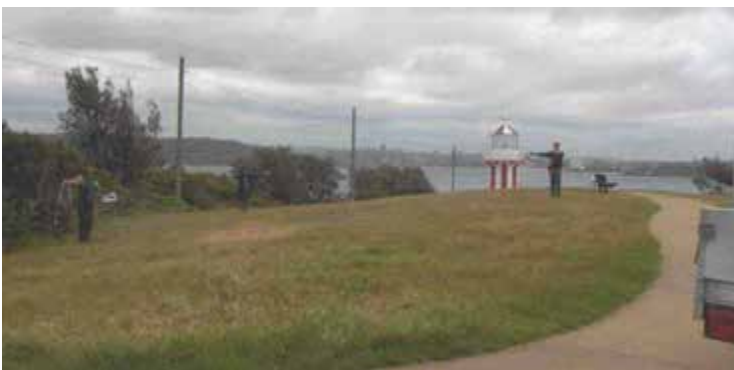
Figure 3.20. The approximate location of the Engine Room [1.3B] below the level area adjacent to the loop walking track is shown by PWD staff. October 2006

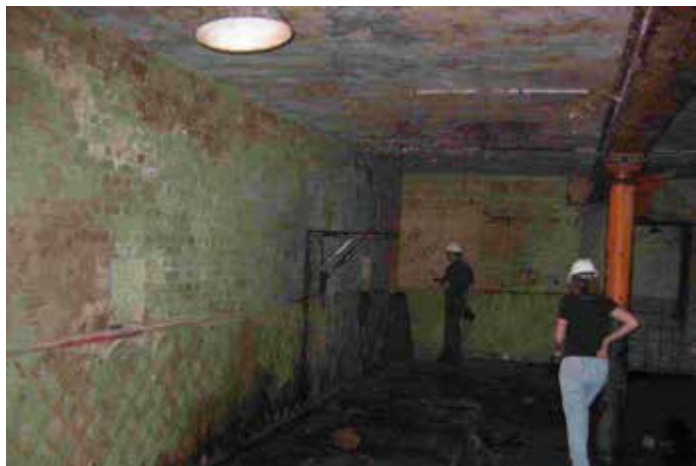
Figure 3.21. Interior of the Engine Room [1.3B] visited in 2006. Source: DECC 2006.

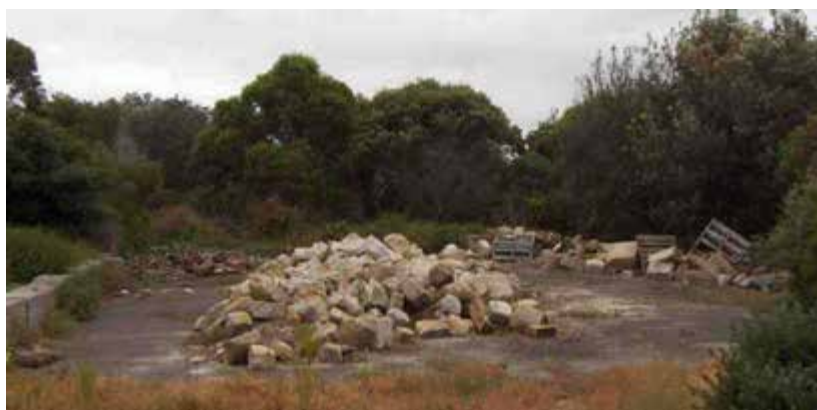
Figure 3.22. The rough asphalted open area, which corresponds with the location of c1940s army buildings around a parade ground [1.7]. October 2006

In the southern half of the area bounded by the walking track loop on the west side of the road to the Lightkeepers Cottages is a rough asphalted open area within a slight depression almost completely surrounded by revegetation and is used to store construction and landscape materials.

The area is believed to correspond with the location of c1940s Army buildings around a parade ground, although this may be further to the south closer to where there is now a helipad. In this case the asphalted landscape material storage area is likely to be part of a road or the floor of a former building (see Figures 3.25 & 3.26).

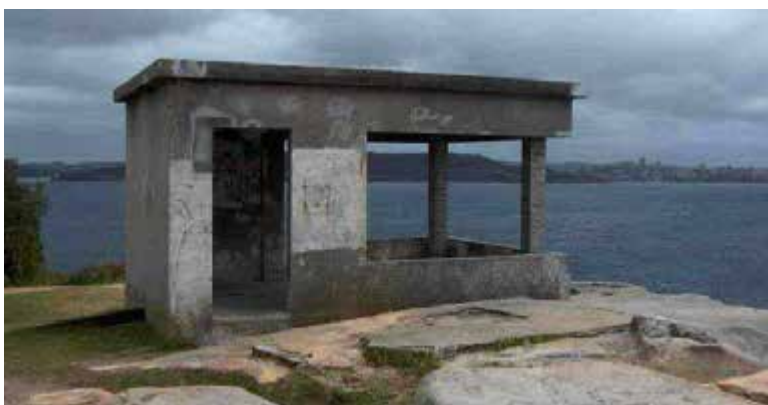
Figure 3.23. The WWII Searchlight Emplacement viewed from the southeast. October 2006

To the north of the Hornby Light is a reinforced concrete blockhouse, which is the shell of a WWII Searchlight Emplacement, which originally housed a carbon arc searchlight. No original fittings and fixtures survive. The blockhouse has a flat concrete roof with a large rectangular aperture for the searchlight taking up most of the front (north) seaward wall and part of the side (east and west) walls. Two brick piers support the concrete roof just inside the aperture. The block has a door opening in its east wall. A concrete slab and steel fixings to the east of the block may have been the base of a storage building. 124 Concrete remediation works were undertaken by NPWS in 2005.

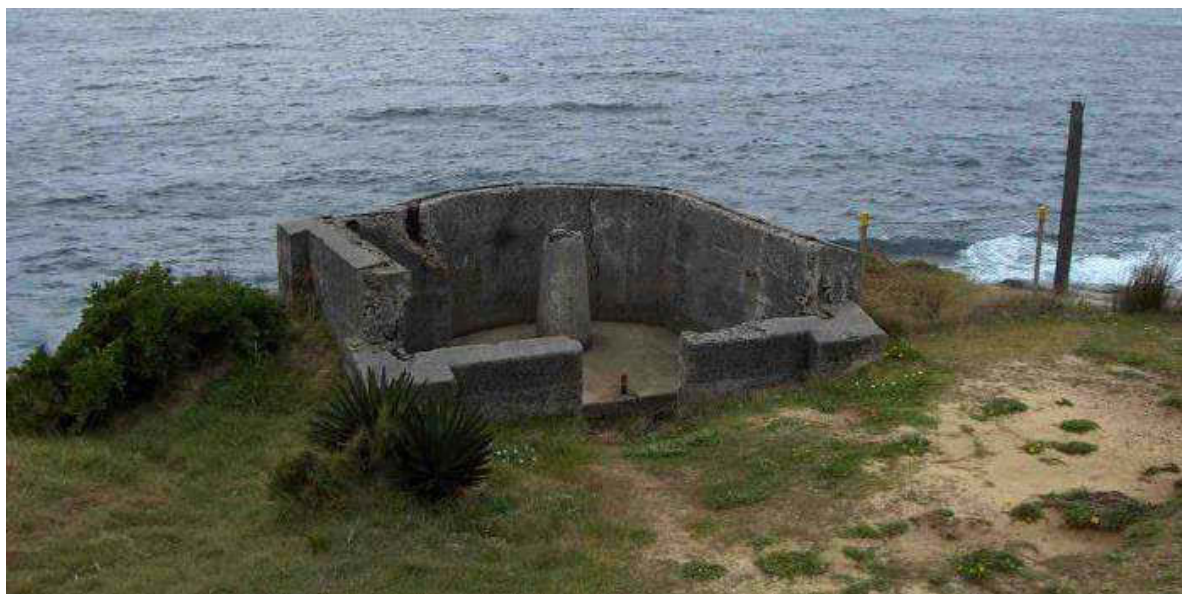
Figure 3.24. The Direction Range Finder on the cliff edge. October 2006

South of the Hornby Light is the remains of a smaller structure located at the precipitous cliff edge. The structure was used as a Directional Range Finder (DRF) from c1900 to about 1925 constructed to serve the 9-inch and 6-inch guns near the Hornby lighthouse.¹²⁵ The DRF is constructed in reinforced concrete with a central pillar mount for the range finder. The structure has no roof and no surviving fittings. The surviving concrete structure is partially deteriorated with rusting metal work but is stable overall.

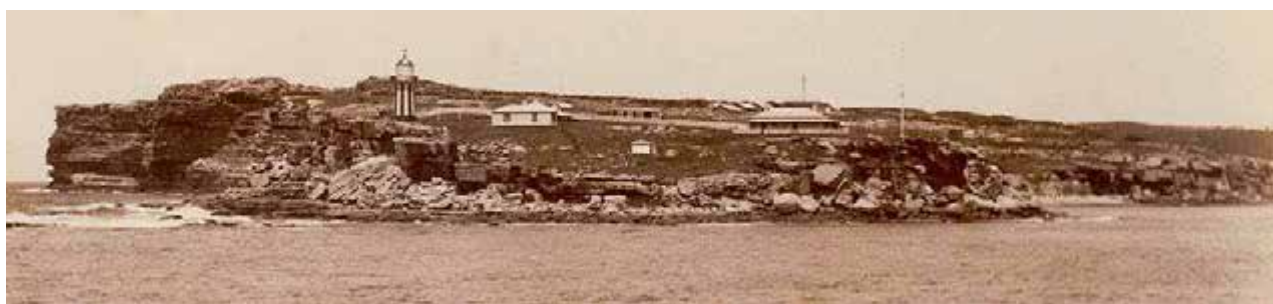
Figure 3.25. Inner South Head c.1900-1910. The stables can be seen in the centre of the image between the two lightkeeper's cottages. Three small buildings can also be seen behind this in the area (now site of landscape store [1.7]). Source: State Library of N.S.W., South Head c1900-10 Ref: PXE 711/8

3. Views to South Head from vessels in Sydney Harbour. The headland forms part of suite of undeveloped (many National Park) landscape features that give Sydney Harbour its unique qualities. The Head Lightkeeper's Cottage sitting in open grassland (as it has done historically) is visible. Historically all the Lightstation buildings would have been visible sitting in open grassland (Figure 3.25).

7. Views to and from the Assistant Lightkeepers' Cottage [1.2]. The views to the Cottage are now mostly obscured by medium height native scrub or by paling fences approximately 1.8 metres high. Although historically there was a tall picket fence around these cottages (Figures 2.7 and 2.8), views were possible through the fence, and the roof of the building was dominant over the fence. By the early 1900s there were only low picket fences (Figure 3.25).

Like other areas of the study area, this precinct is likely to contain evidence of historic services, particularly those related to the engine room and original power supply. A number of small buildings are also shown on c1900 plans and images in the vicinity of the parade ground (see Figure 3.25). They are likely to have been on brick or stone piers and are unlikely to have left substantial archaeological remains. A vegetated mound behind the lightkeeper's cottages has evidence of building debris in it. It is likely to be the site of the former stables and possibly also a domestic dump associated with the cottages.

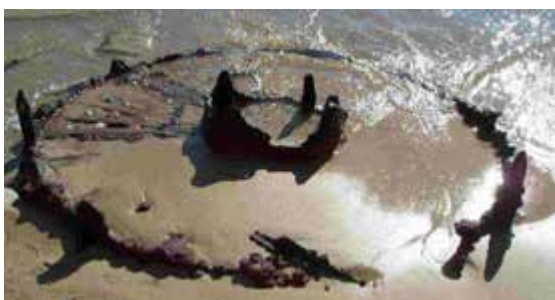
Figure 3.29. An artefact on the beach at Lady Bay [2.1] uncovered by tidal action. Source: DECC 2004.

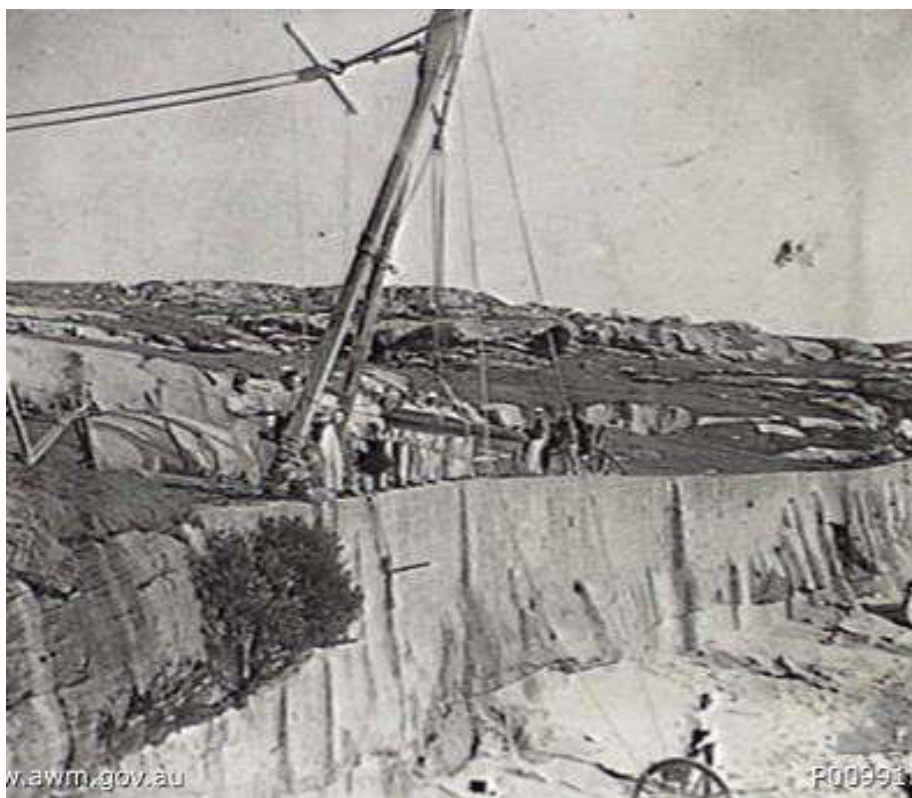
Figure 3.31: Sydney, NSW. 1898. Long course members of the south head NSW School of Artillery/Gunnery , after rafting a field gun to Lady Bay Beach, are shown using shear legs to lift the gun from the beach over the sea wall. Note the retaining wall built onto the natural bedrock (Source: AWM P991.074).

Immediately behind Lady Bay Beach itself is a retaining wall [2.11], seen in use by the School of Artillery/Gunnery in 1898 (Figure 3.31).

A sheltered walk and small chamber were built in behind it after this photograph was taken, possibly during WWII. The sheltered walk is now filled in and the chamber partially filled.
