Stage 1 Conservation Management Plan

SOUTH HEAD SYDNEY HARBOUR NATIONAL PARK

Volume 1 – Assessment of Significance

February 2008

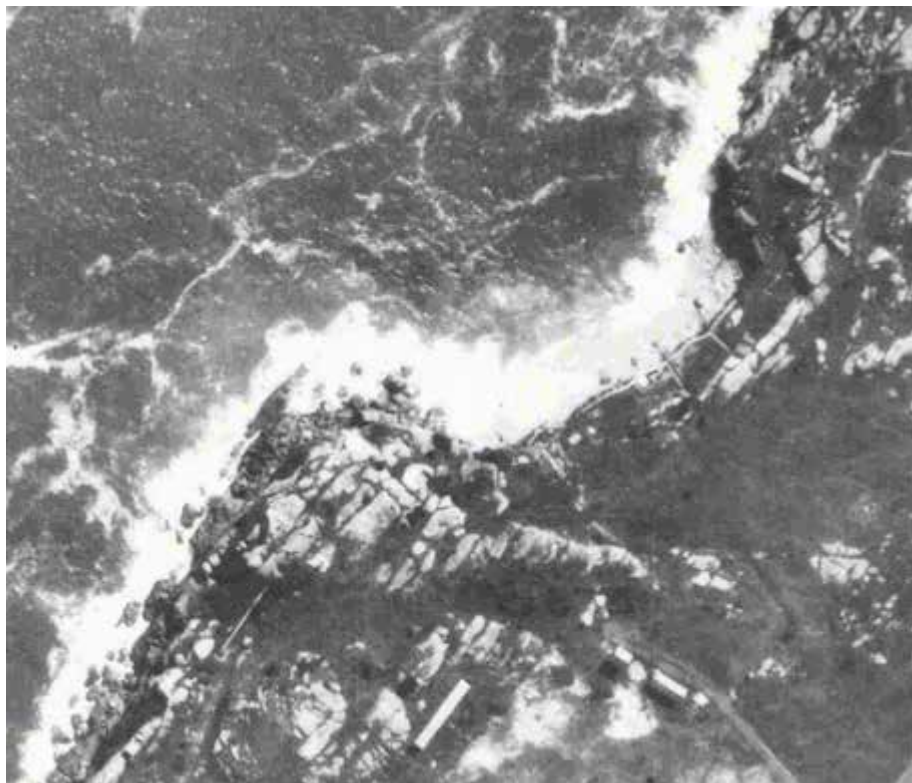
Figure 3.32. Part of the 1929 Aerial photograph showing Lady Bay. Source: DECC.

They now sit between the retaining wall and walking track. A large dish drain running from HMAS Watson is nearby. The wall and drain are visible on the 1920s aerial of the area (see Figure 3.32). The sheltered walk is not visible.

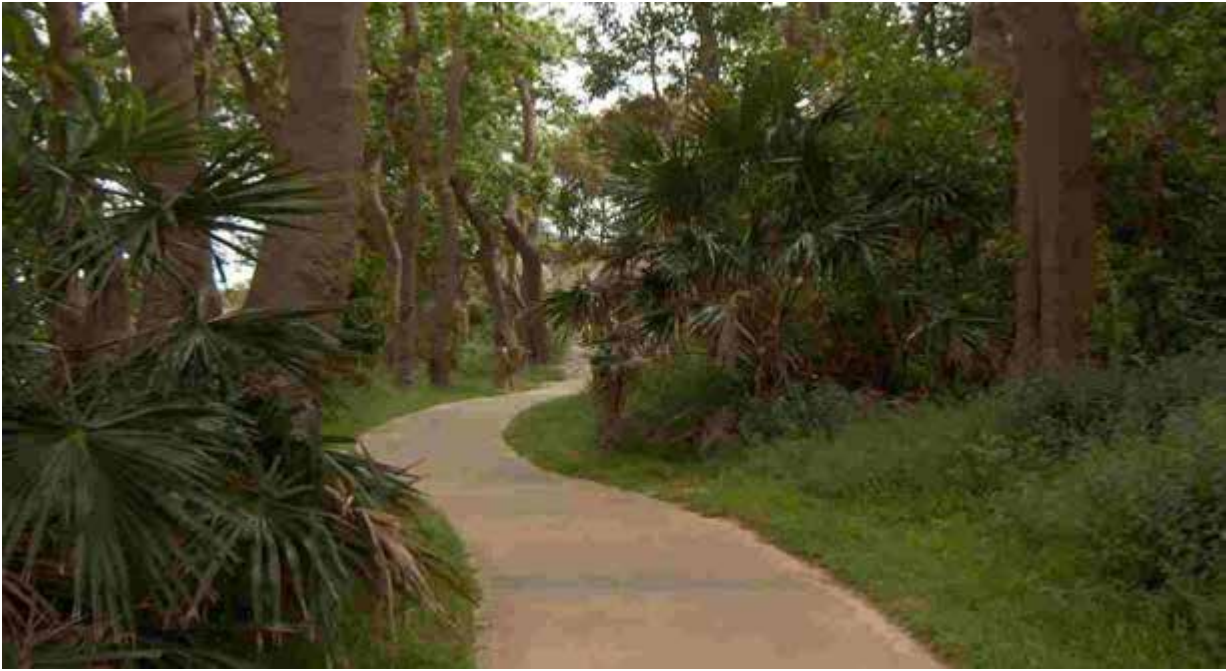
Figure 3.34. The walking track north of Camp Cove passing through stands of tall Coral trees. October 2006

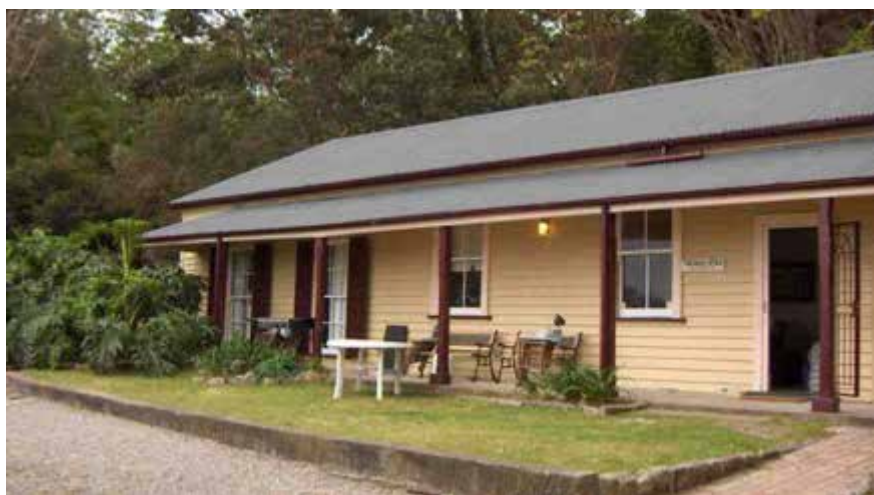
Figure 3.36. Constables Cottage. October 2006.

Nestled into the cliff in the southern part of the levelled Water Police area is a building, now referred to Constables Cottage. It was constructed between 1895 and 1903 as semi-detached residences for married military staff. In the 1950s the two residences were combined with doors pushed through the party wall in the main building and rear service wings. Other alterations were made to the buildings and it is now used as short let holiday accommodation. Constables Cottage is a single storey timber framed hipped roofed cottage fronted with a simple posted skillion verandah. The interior of the main part of the cottage's walls and ceilings are lined with the original fibrous plaster sheeting finished with cover battens. The cottage's details, linings, moulding and features are modest and typical of a simple Federation era cottage. The twentieth century changes and additions are typical of the time and are undistinguished except for the unusual pivoted wall vents in the rear, glazed passage. Overall the cottage is in excellent condition and the c1900 sections retain much of their original finishes and linings.

The rear area behind the cottage is covered by large concrete slabs, with wide spoon drains at the foot of the rock face. Of interest is a pair of brick external WCs let into the rock face of the cliff at the rear of the cottage. The WCs are in good condition with remnants of earlier services and the southern WC now houses the hot water cylinder. The cottage has an undistinguished low set garage added by NPWS.

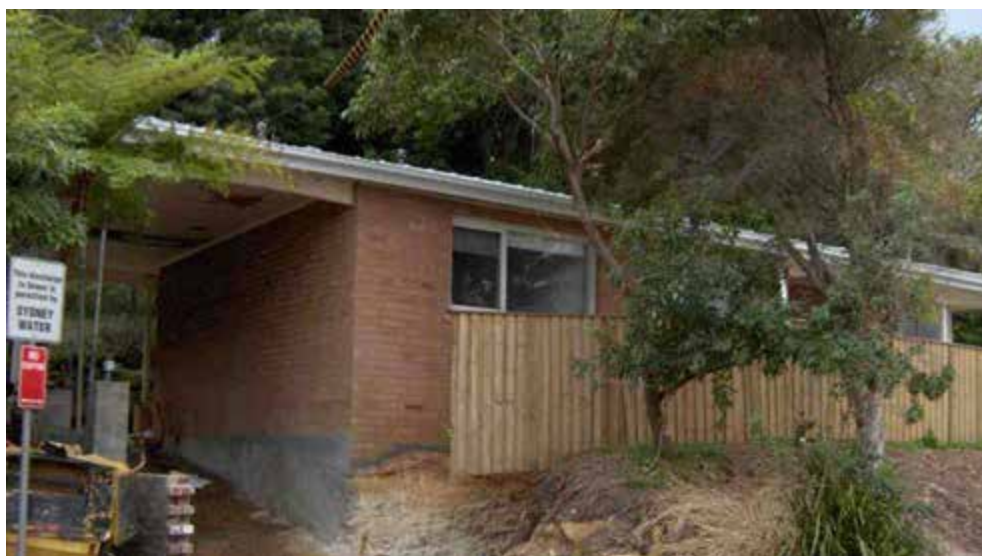
Figure 3.37. 33 Cliff Street during road and stormwater construction works undertaken by Woollahra Council. October 2006.

Immediately south of Constables Cottage is a mid-twentieth century residence at 33 Cliff Street. It is a single storey face brick residence with metal tiled roof and timber windows constructed sometime in the late 1950s on a site previously occupied by a late 1890s timber residence constructed for Staff Sergeants. The 1950s residence is positioned tight on its block with a single car carport on its northern end. The residence is in reasonable condition, is aesthetically undistinguished and is generally typical of its period with similar residences throughout Sydney's suburbs.

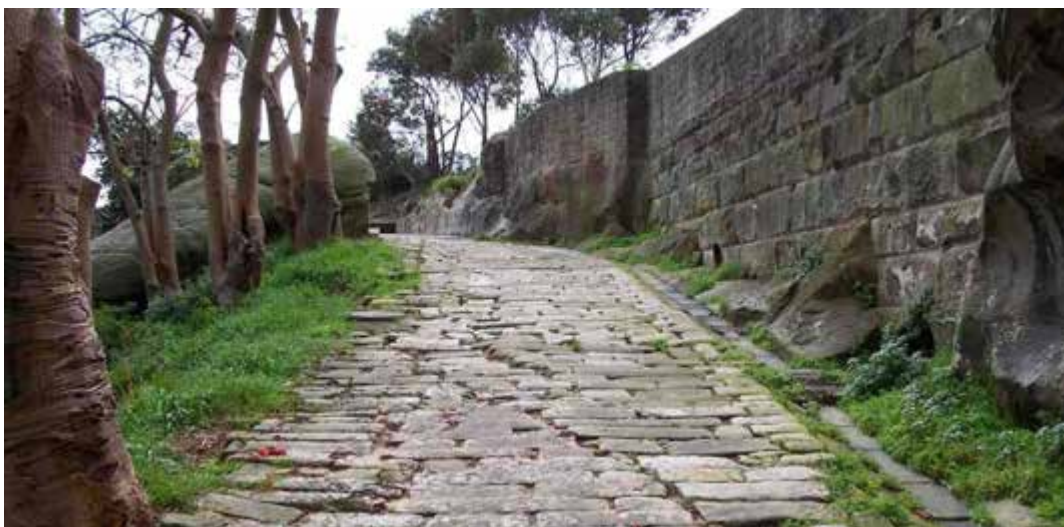
Figure 3.38. Looking north up the hill along the c1880s cobblestone road [IS 3.4] connecting the landing area and the Water Police at Camp Cove to South Head and the Hornby Light. The stone rifle walls flank the road on the east (right). October 2006.

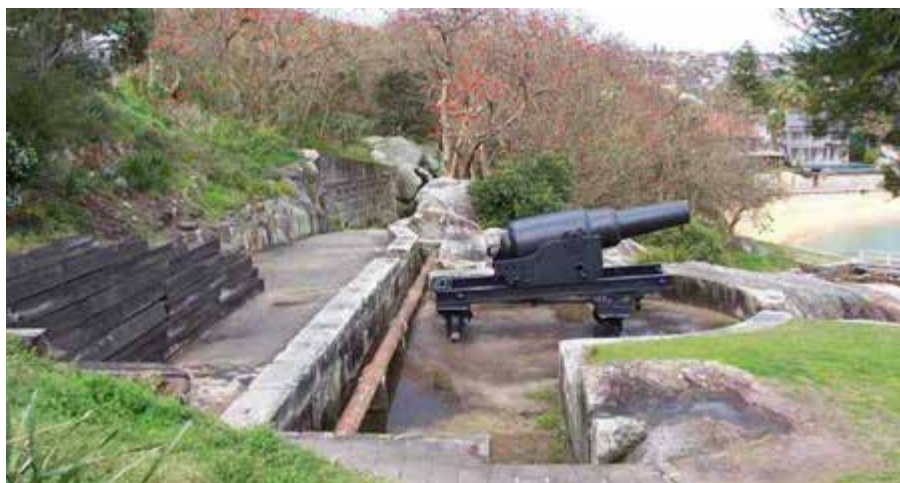
Figure 3.39. Looking south over the nineteenth century gun pit with Camp Cove in the distance. A 9-inch RML Mark V gun (on a carriage) relocated from elsewhere at South Head is housed at the pit. October 2006.

1. Views along the cobblestone road [3.4] with the rifle walls to the west (Figure 3.38).
2. View out to the Harbour from Gun Emplacement [3.3] (Figure 3.39).
3. Visual connections between the landing steps [1.6] and the slipways [1.5]
4. Views from the site of former water police buildings [2.1] to the beach and former jetty site [1.6] - now somewhat obscured by vegetation.
5. Views from the Harbour and Camp Cove to the rifle walls above the northern end of the Cove have great interpretive potential but are currently obscured by the grove of

Immediately on the west side of the road before Camp Cove are the remains of a gun emplacement excavated out of a rock bluff with low stone blocks walls. The pit currently accommodates a 9-inch RML Mark V gun (on a carriage) relocated from elsewhere at South Head. The emplacement consists of a U-shaped pit which faces west, accessed from the north by steps and a shallow open passage. Gojak noted that the pit had an unfinished appearance, there was no evidence of gun mounting and that the pit has no associated buildings or magazines.¹²⁸ The structure suggests that it was part of the late nineteenth century construction programs. Gojak iterates that there is some evidence to indicate that a 68-pounder gun was mounted at Camp Cove in 1891. The pit is associated with three narrow open passages, which lead from the road and pit to the base of the bluff and end at a sandstone block rifle wall. These features may indicate that the structure was abandoned and reused for another purpose. The pit and its associated structures are weathered with little evidence of original finish on the stonework but are in reasonable condition and are structurally stable. As the remains are close to the main walking path they are subject to intense visitor activity and the weathered surfaces are starting to be scoured.

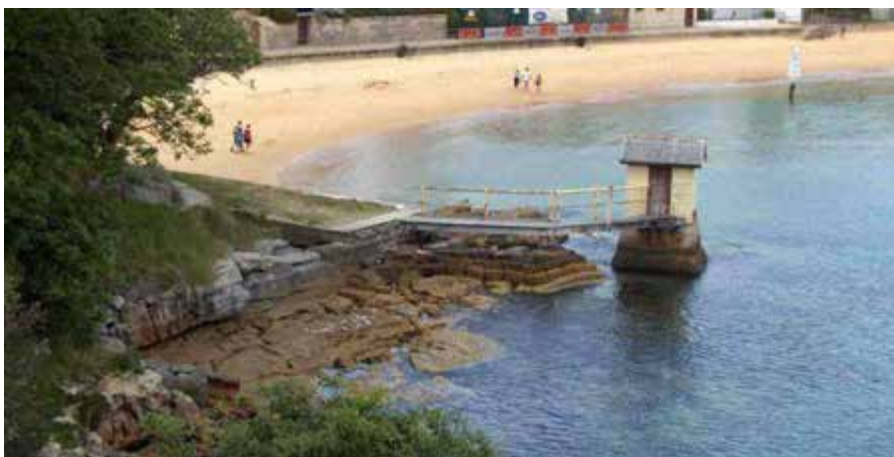
Figure 3.40. Looking southwest over Camp Cove with the remains of the Water Police slipways (site of former boatsheds, landing steps). The Tide Gauge and its walkway are the middle ground.

A wide timber jetty was constructed out into the Cove on the line of the stone steps, in the late nineteenth century, along with the stone retaining wall. The jetty was twice as long as the current timber walkway and stood until the 1970s when it seems to have been completely taken down as there is no evidence of it surviving. In 1931 the existing timber Tide Gauge on its concrete base was constructed at the end of the low rock shelf. The building initially was located hard against, and was accessed, from the nineteenth century jetty. The current timber framed walkway was constructed after the jetty was demolished to retain access to the Tide Gauge. The Tide Gauge is housed in a simple painted weatherboarded building with a gabled roof clad in corrugated asbestos. The Tide Gauge building is in reasonable condition.

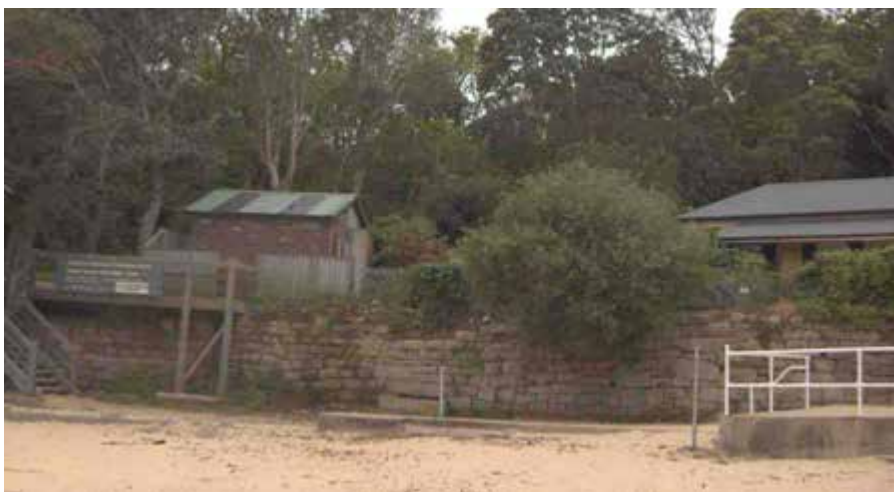
Figure 3.41. View of the north end of Camp Cove with the brick toilet block constructed in the late 1940s on the left, the late nineteenth century stone retaining wall within the National Park. The timber landing and stairs to the beach are outside the park. October 2006

Other structures at Camp Cove within the National Park includes the brick toilet block [3.7] constructed in the late 1940s. The adjacent timber landing and stairs that access the beach over the stone retaining wall are outside the Park boundary, but were constructed by NPWS and are maintained by DECC. The toilet block is a small rectangular gabled roofed building, which was originally constructed to serve the Defence Forces, but now is solely for public use. The block and its structure are in reasonable condition but its facilities are in need of upgrading.

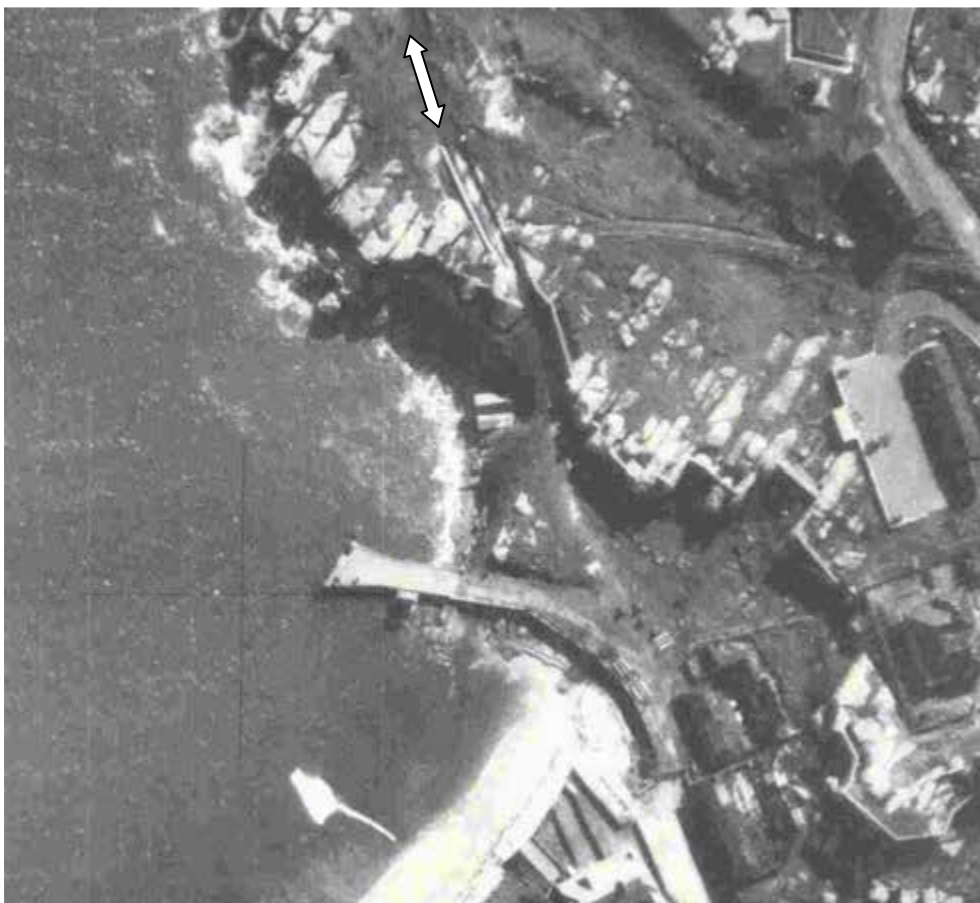
Figure 3.42. Part of the 1929 Aerial photograph showing Camp Cove in the bottom left, the timber jetty at its northern end, Constable Cottage to the east and the two timber boat sheds further north. The rifle walls are obvious, as is the c1880s road (indicated by the double-headed white arrow) from Camp Cove to the Hornby light. Source: DECC

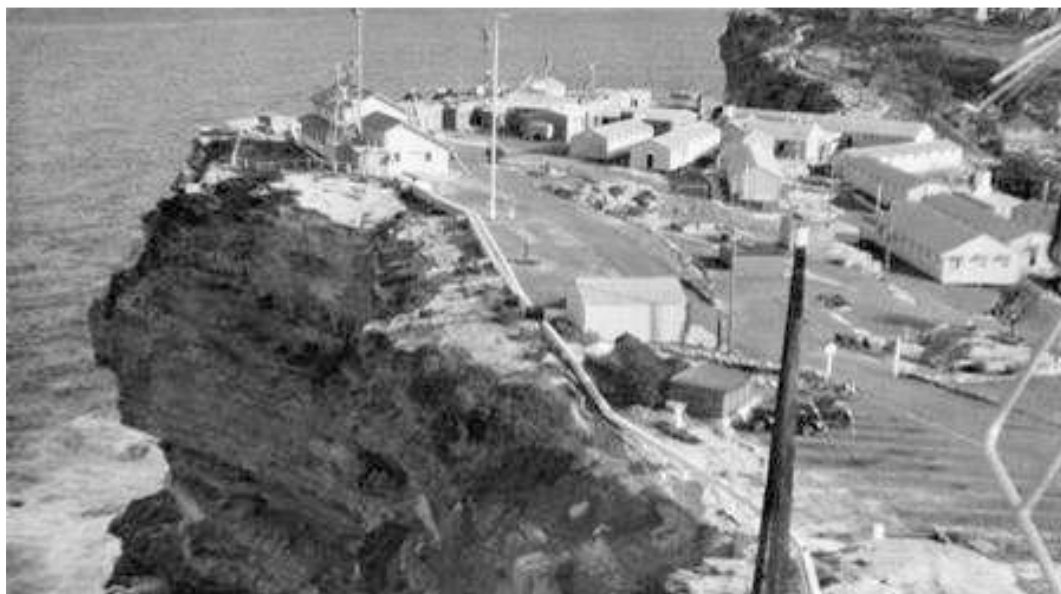
Figure 3.43. Part of a photograph taken of Gap Bluff showing the Royal Australian Navy radar training school in 1951. The buildings on the left at the top of the cliff are the Action Information Training Centre with a type 293 radar attached. Directly across the road are the maintenance and victualling areas with three mess buildings next to them. In front is the senior sailors mess, in the background is the Ratings mess hall and cook house and in between is the Ratings wet and dry canteen. The large buildings in the foreground are the Ratings living quarters and the small square building in front of them is the inflammable store. (Source: Australian War Memorial website www.awm.gov.au. Ref: P03815.006)

Upper Gap Bluff is now heavily vegetated with mainly native scrub and some weed infestation, although at the height of its use from the 1950s to 1980s it accommodated a dense array of masonry and timber structures interlinked by numerous roads and paths and set in a grassed landscape (see Figure 3.43). The current National Park lookouts [4B.1] are the only areas that retain this open setting with low native heath and spectacular maritime views. There are archaeological remains associated with defence uses throughout Upper Gap Bluff.

At the height of its use from the 1950s to 1980s the Upper Gap Bluff area [4B.0] accommodated a dense array of masonry and timber structures covering the mostly level north-eastern part of the area interlinked by numerous roads and paths (see Figure 3.43).

A basic and preliminary archaeological survey undertaken for this CMP identified a number of substantial structural remains and large areas of debris from the demolition of the buildings shown in Figure 3.43. Despite the heavy vegetation cover, it is still possible to see the various terraces and understand the arrangement of building, roads, equipment and terraced gardens. The development of the military landscape of training facilities from the 1870s to the 1980s is still readable although the sense of openness and connection between the different areas has been obscured.

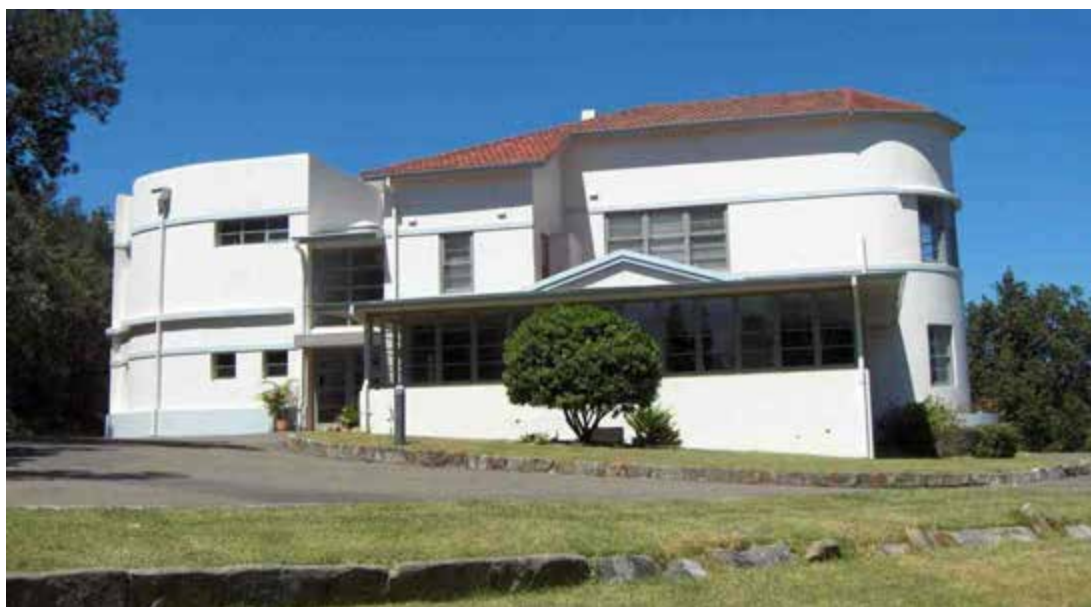
Figure 3.45. *The exterior of the Officers' Mess from the southwest with the verandah in the foreground, the 1930s block behind (with its 1950s roof and the 1990s rear extension on the left. October 2006*

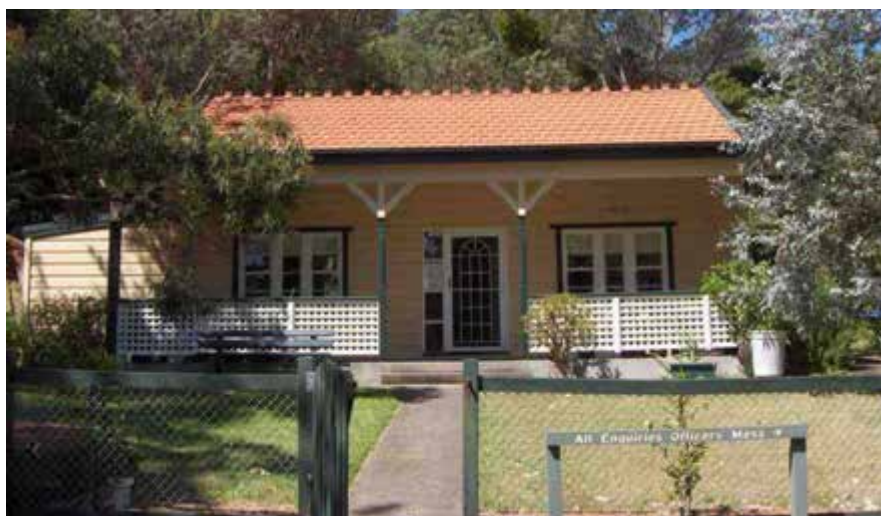
Figure 3.46. The front of the Workshop (now residence) from the west. October 2006

North west of the Officers' Mess is a small single storey, timber framed gabled building. The building was the first in the Gap Bluff area and was originally constructed as the workshop for the Practice Battery erected in 1895 on the top of the nearby eastern cliffs. The Workshop has been comprehensively altered and is now used as a residential cottage for National Parks staff.

The building is well presented within a small clearing in the revegetated bush alongside the road, which follows part of the alignment of the 1890s road connecting the workshop northwards to South Head. The road now continues on to the Officers' Mess. The rear of the building is benched into the hill, backed by a rough stone retaining wall. The building's site in the hill is protected by a wide, open stone drain, which wraps around the rear of the building at the top of the retaining wall to catch ground water and drain it down the north side of the building into the site's stormwater system. The revegetated bush now contains substantial trees. Some of the trees are perched precariously on top of the retaining wall with one large tree collapsed recently across the back of the site.

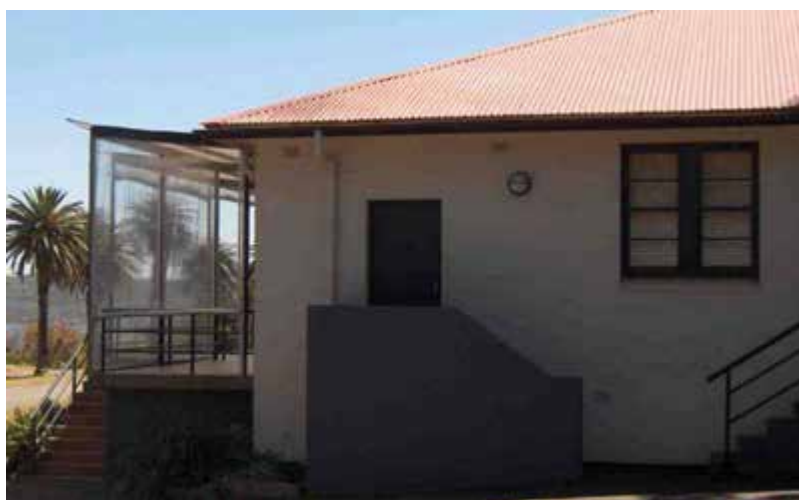
Figure 3.47. The exterior of the Armoury showing its end wall and the 1990s verandah looking from the southeast. October 2006.

The access road in front of the Workshop continues to the north-west and connects to the former Artillery Store constructed in 1938, now referred to as the Armoury. The Armoury building shares the Officers' Mess alignment (which was the alignment of most of the School of Artillery/Gunnery buildings) roughly parallel to Cliff Street whereas the workshop has its own tangential alignment. The Armoury is a wide and long single storey cavity brick building with a low hipped corrugated "Colorbond" steel roof. The construction of the

building as a utilitarian store is typical for its time. In the late 1980s the building was considered to be one of the most intact survivors of the School of Artillery.¹³⁰ However, in the 1990s the building was comprehensively altered as a function room as part of the works for the Simon University School of Business, at which time the building's interior was gutted and relined. The area at the rear of the building is drained with spoon drains cut into the rock shelf. Revegetated bush grows close to the top of the retaining wall and its large trees overhang the building. A set of concrete stairs rises north of the Armoury up the hill and links with a walking path to the cliffs to the east.

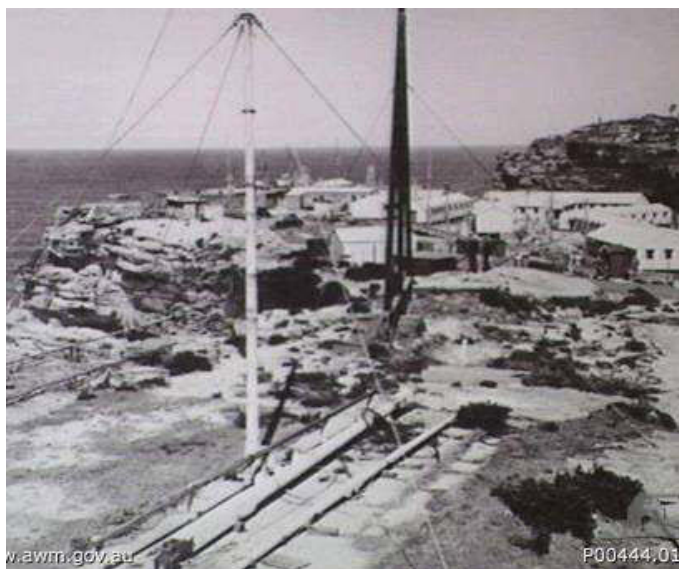
Figure 3.49. The RAN Radar Training School, looking south towards The Gap, c 1944.

Other potential archaeological evidence includes: footings, services, artefact deposits, demolition rubble, garden features, equipment platforms, fixings (for the types of activities shown below in Figure 3.49), rock-cut features, evidence of fence lines, terraces and walls and the remains of “Engine Room” shown on 1890 Telephone System Chart (reproduced in Mider 1998).

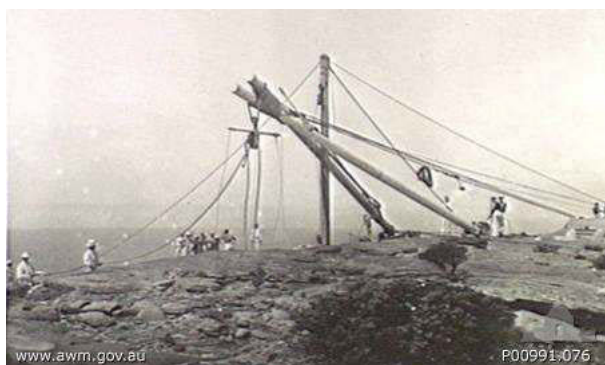
Figure 3.50: Sydney, NSW, 1898. Members Of The Long Course Of The NSW School of Artillery/Gunnery at South Head In The Process Of Erecting Shear Legs On A Cliff Top (Source: AWM P991.076).

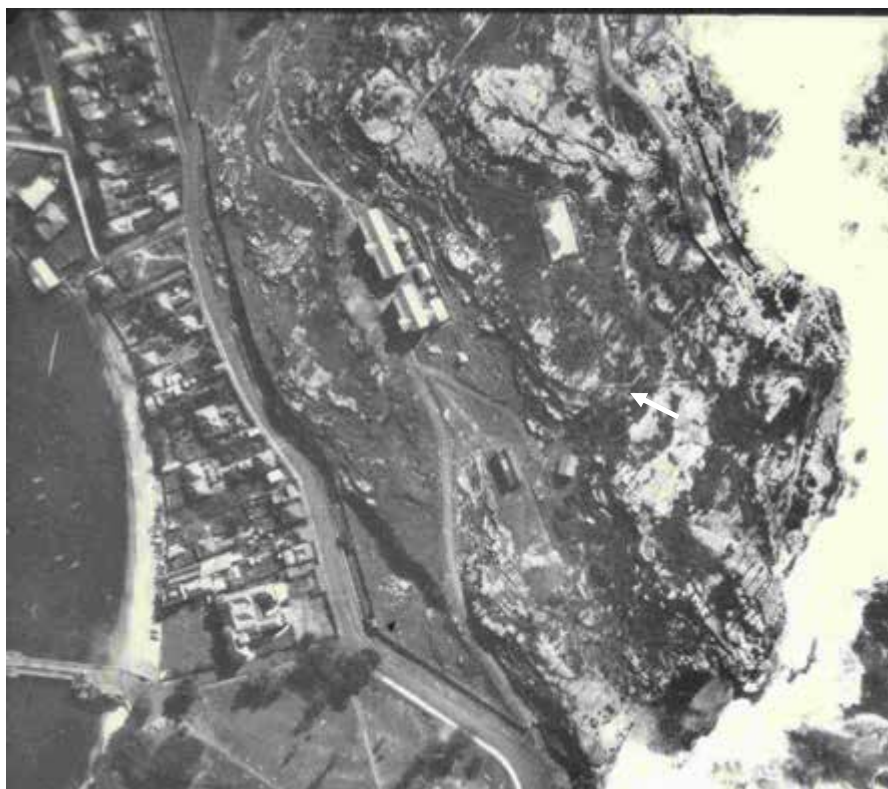
Figure 3.48. Part of the 1929 Aerial photograph showing Gap Bluff. The former Barrack buildings are clear, located in the north of the area and the Workshop is in the centre of the view with a vague line indicating the path to the Practice Battery in the northeast (top right). A wall bounds the area along Cliff Street. The remaining latrine is shown by the arrow. Source: DECC

North east of the Armoury, the School of Artillery/Gunnery /Artillery originally featured a pair of large two storey brick barracks constructed in 1912. A small hipped-roof Latrine was constructed at the same time between, and to the rear, of the two buildings. The larger buildings were demolished and are now only evidenced by the wide grassed area in front of the latrine and some exposed footings [4A.5 and 4A.6]. The latrine [4A.4A] still survives tucked in against the hill backed by a high, buttressed concrete retaining wall. The latrine is a single storey brick building on concrete slab, roofed with a rafter and collar tie timber frame and sheeted with corrugated “Colorbond” steel sheet. In the late 1980s the building had corrugated asbestos roof sheeting, which was replaced by the current “Colorbond” sheet.

The building is in reasonable condition, although the surface of the bricks on all elevations are weathered and have lost their case-harden faces. The current setting of the latrine, now standing solitary at the rear of the large open area created by the demolition of its larger neighbours accessed by a straight concrete path and fronted by a small garden, is very different to its original enclosed setting.

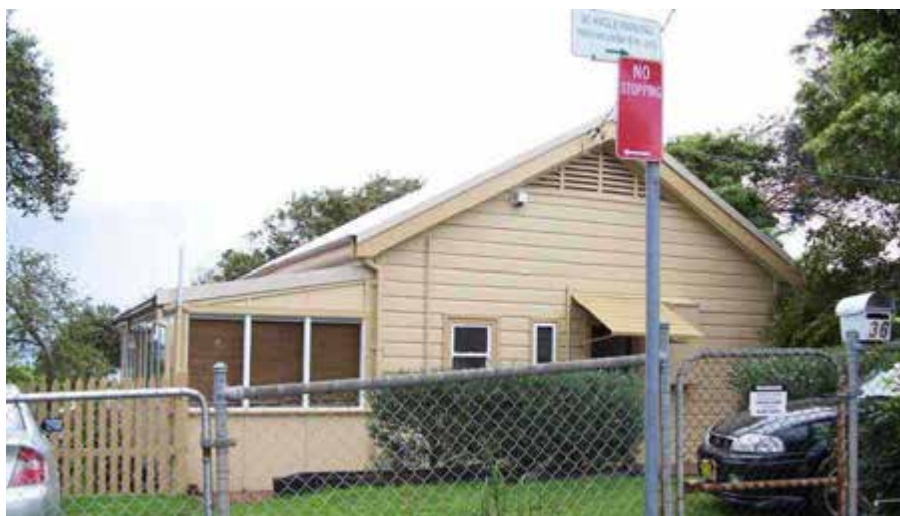
Figure 3.52. Green Point Cottage looking from the northeast. October 2006.

The areas immediately around the cottage are covered by a number of concrete slabs. The rear of the cottage is nestled into the rock outcrop, which is the highest point of the peninsula. The cottage and its garden are bounded on the front by a recently erected painted picket fence which is in good condition, a cyclone chain mesh fence and, at the rear, by a tall lapped and capped hardwood paling fence which is collapsing in some areas. The cottage has a undistinguished low set garage added by NPWS.

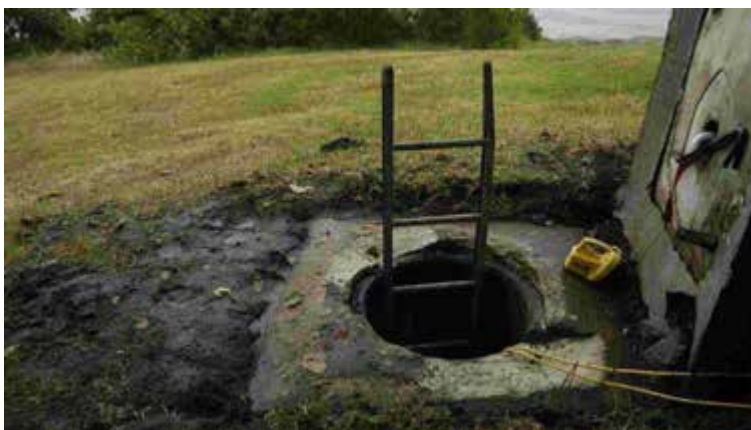
Figure 3.54. The current access to the Submarine Miners Firing Station opened for inspection in November 2006. Source: Paul Davies Pty Ltd November 2006

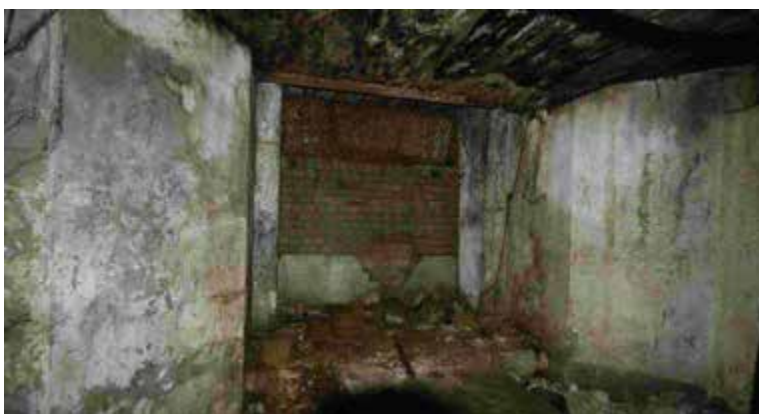
Figure 3.55. Interior of the Submarine Miners Firing Station. Source: Paul Davies Pty Ltd November 2006

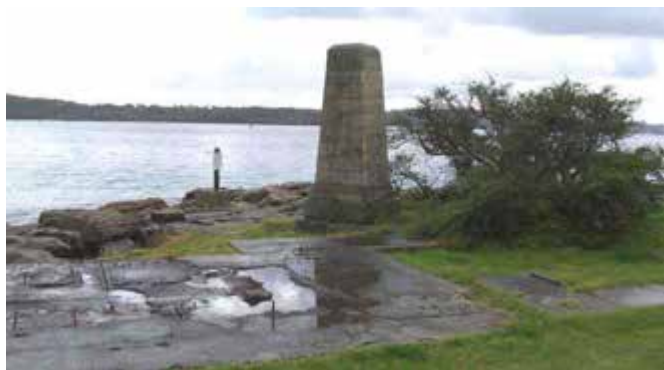
Figure 3.56. The stone navigation obelisk. The foundations of Searchlight No. 4 are in the foreground. October 2006.

North of the remains of Searchlight No. 4 (described under historical archaeology below) is a stone obelisk which is a navigational marker constructed in 1858. The obelisk consists of a simple 3 metre high, tapered shaft of dressed sandstone blocks with chamfered top. The shaft sits on a stepped sandstone base. The obelisk has fair-faced stone and its mortar joints are in good condition.

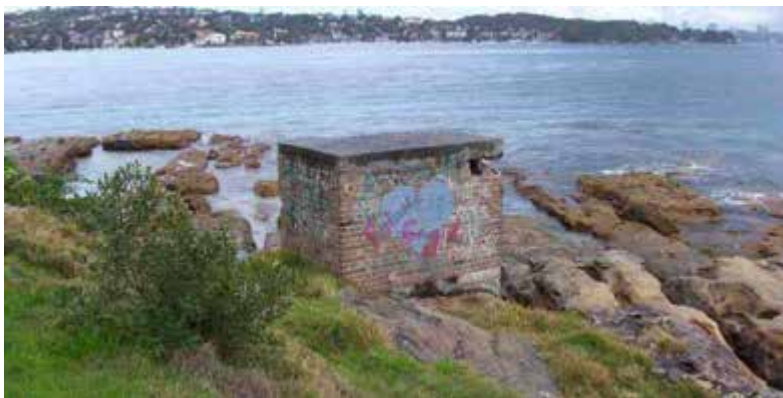
Figure 3.57. The 1940s Observation Post. October 2006

To the south of the remains of Searchlight No. 4 and west of Green Point Cottage is a small masonry rectangular block built in the 1940s as an **Observation Post**. Gojak advised that the observation post could have been used to cover the submarine net as a control station for the WWII guns mounted at Green Point.¹³⁴ The block is located on a small stone bluff above the rock reef looking west over the harbour. The brickwork is laid in English bond with a concrete slab floor and roof. The entrance and viewing window have been bricked up, mostly likely by the Council in the 1960s. The block is stable and in reasonable condition despite its exposed location. The external walls are heavily graffitied.

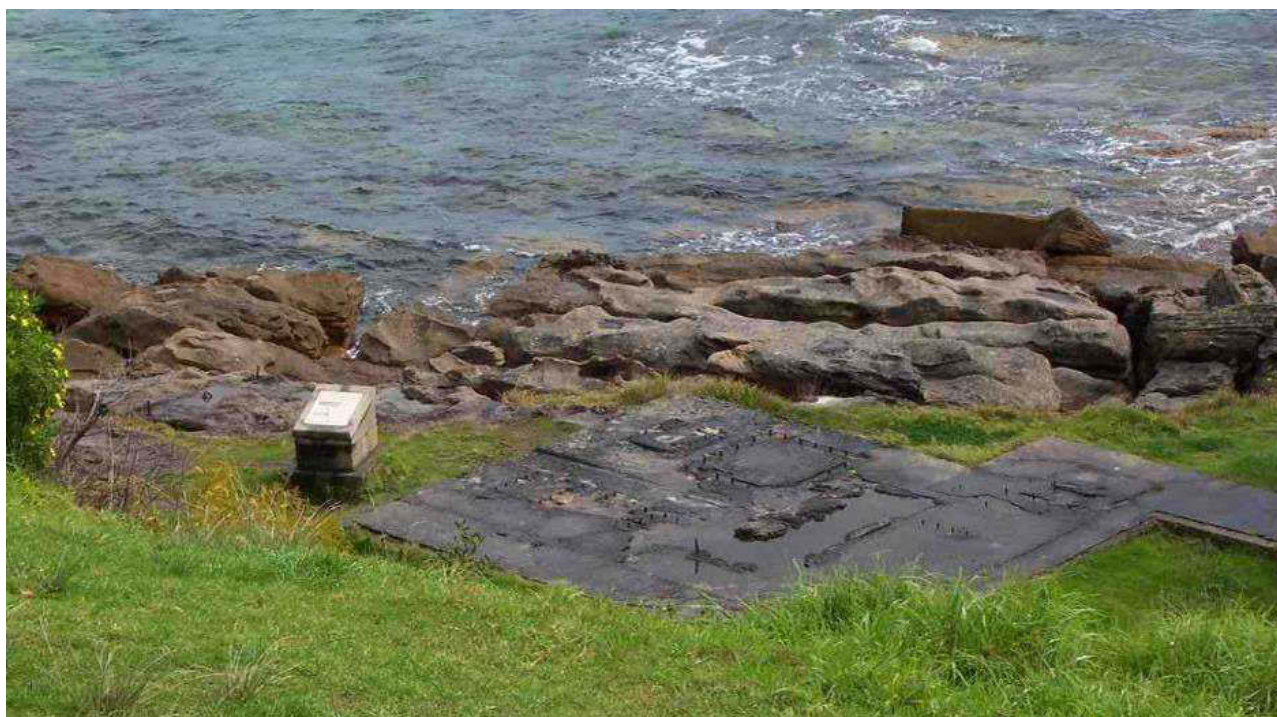
Figure 3.59. The foundations of Searchlight No. 4 (possibly also related to the boom net winch) are in the centre of the photograph alongside the memorial, which was erected in 1995 to record the World War Two Anti-Submarine and Torpedo Boom Net. October 2006

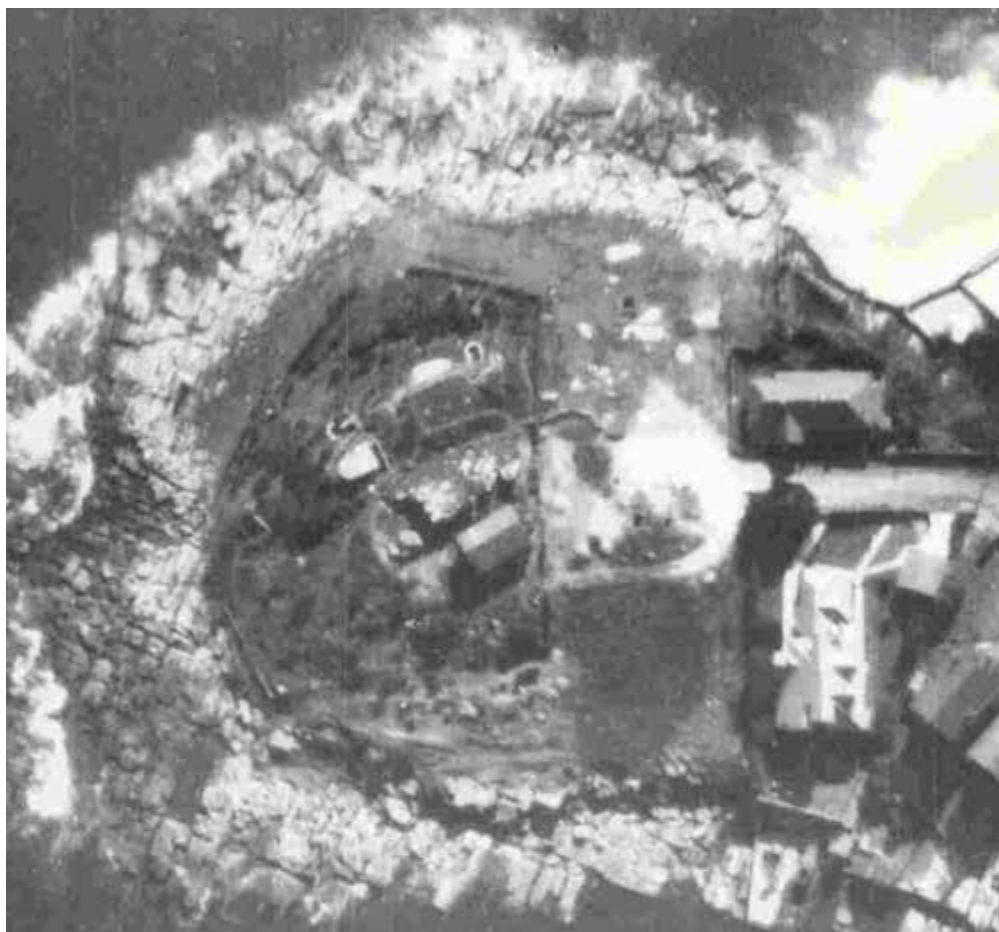
Figure 3.61. Part of the 1929 Aerial photograph showing Green Point with Green Point Cottage (former Officers Quarters) in the centre and the fortifications extant at the time around the headland. Source: DECC

number of emplacements on the peninsula at the time and possibly locates the Nordenfeld Emplacements (see Figure 3.60). Gojak noted that in 1985 there was no visible evidence of the QF 6-pounder 10-cwt twin guns at Green Point, which is still the case. Gojak surmised that the configuration of the battery most likely matched the surviving casemated emplacements at Obelisk Bay and Georges Head.¹³⁷ Sydney Fire Command data sheets record a Battery Control Station erected in the 1940s associated with the QF 6-pounder 10-cwt twin guns at Green Point. It was recorded as a three storey square tower and Gojak notes that oral information suggests that it was located on the sandstone outcrops above and north west of Green Point Cottage, which form the peninsula's highest point.

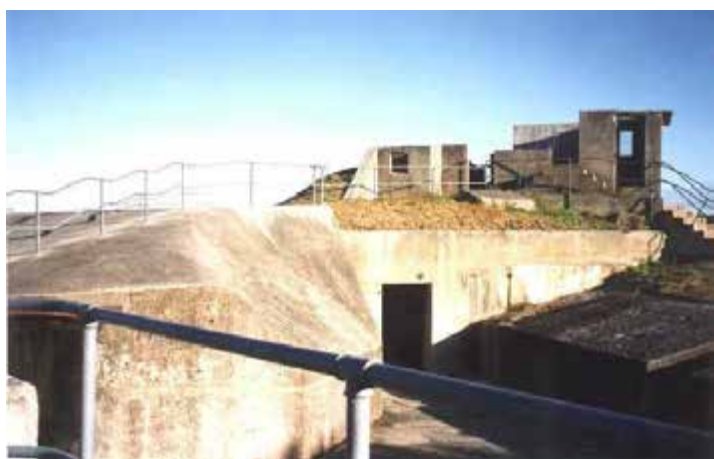
Figure 4.2. Photograph of Middle Head Fort Complex, Sydney Harbour National Park, Old Fort Road, taken in c1996. SHI Database 2060498

The Middle Head Fort Complex at Mosman is one of the most significant defence sites in Sydney with an outstanding collection of military fortifications and facilities, which date from first settlement through to the mid-twentieth century. Taken with other sites in Sydney, the technology and philosophy of military defence is demonstrated and recorded. The Middle Head defence sites are more complex and probably more intact than those at South Head.

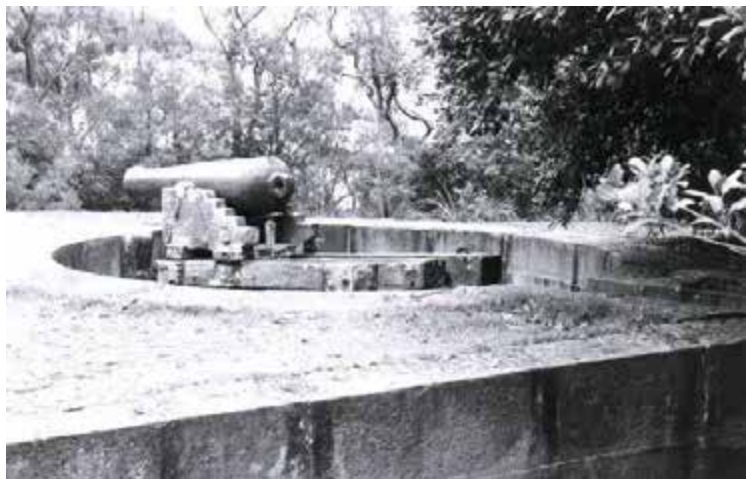
Figure 4.5. Part of the Bradleys Head Fortification Complex, Sydney Harbour National Park, Bradleys Head Road 1996. Photo from SHI 2060492

Associated with the forts at Bradleys Head is a sandstone wharf dating from the 1850s and a riflemen's gallery built with the extension of 1870. The mast of the Royal Australian Navy ship HMAS Sydney was erected over the 1840s fortification complex in 1934 as a memorial to WWI. The tripod mast is a prominent landmark and is in good condition. The area around the forts contains archaeological evidence of a larger group of buildings and structures which were once part of the fortification complex and the footings of a WWII anti-aircraft gun emplacement remain on the top of the ridge above the point.

The Bradleys Head Fort Complex at Mosman contains a collection of military fortifications and facilities, which date from 1839 through to the mid-twentieth century, and is part of one of the most significant historic areas in Sydney. The fortifications now feature as part of a popular recreation area and are probably the best known of Sydney's old forts.
