State of the beaches 2018-2019

Illawarra region

Beachwatch

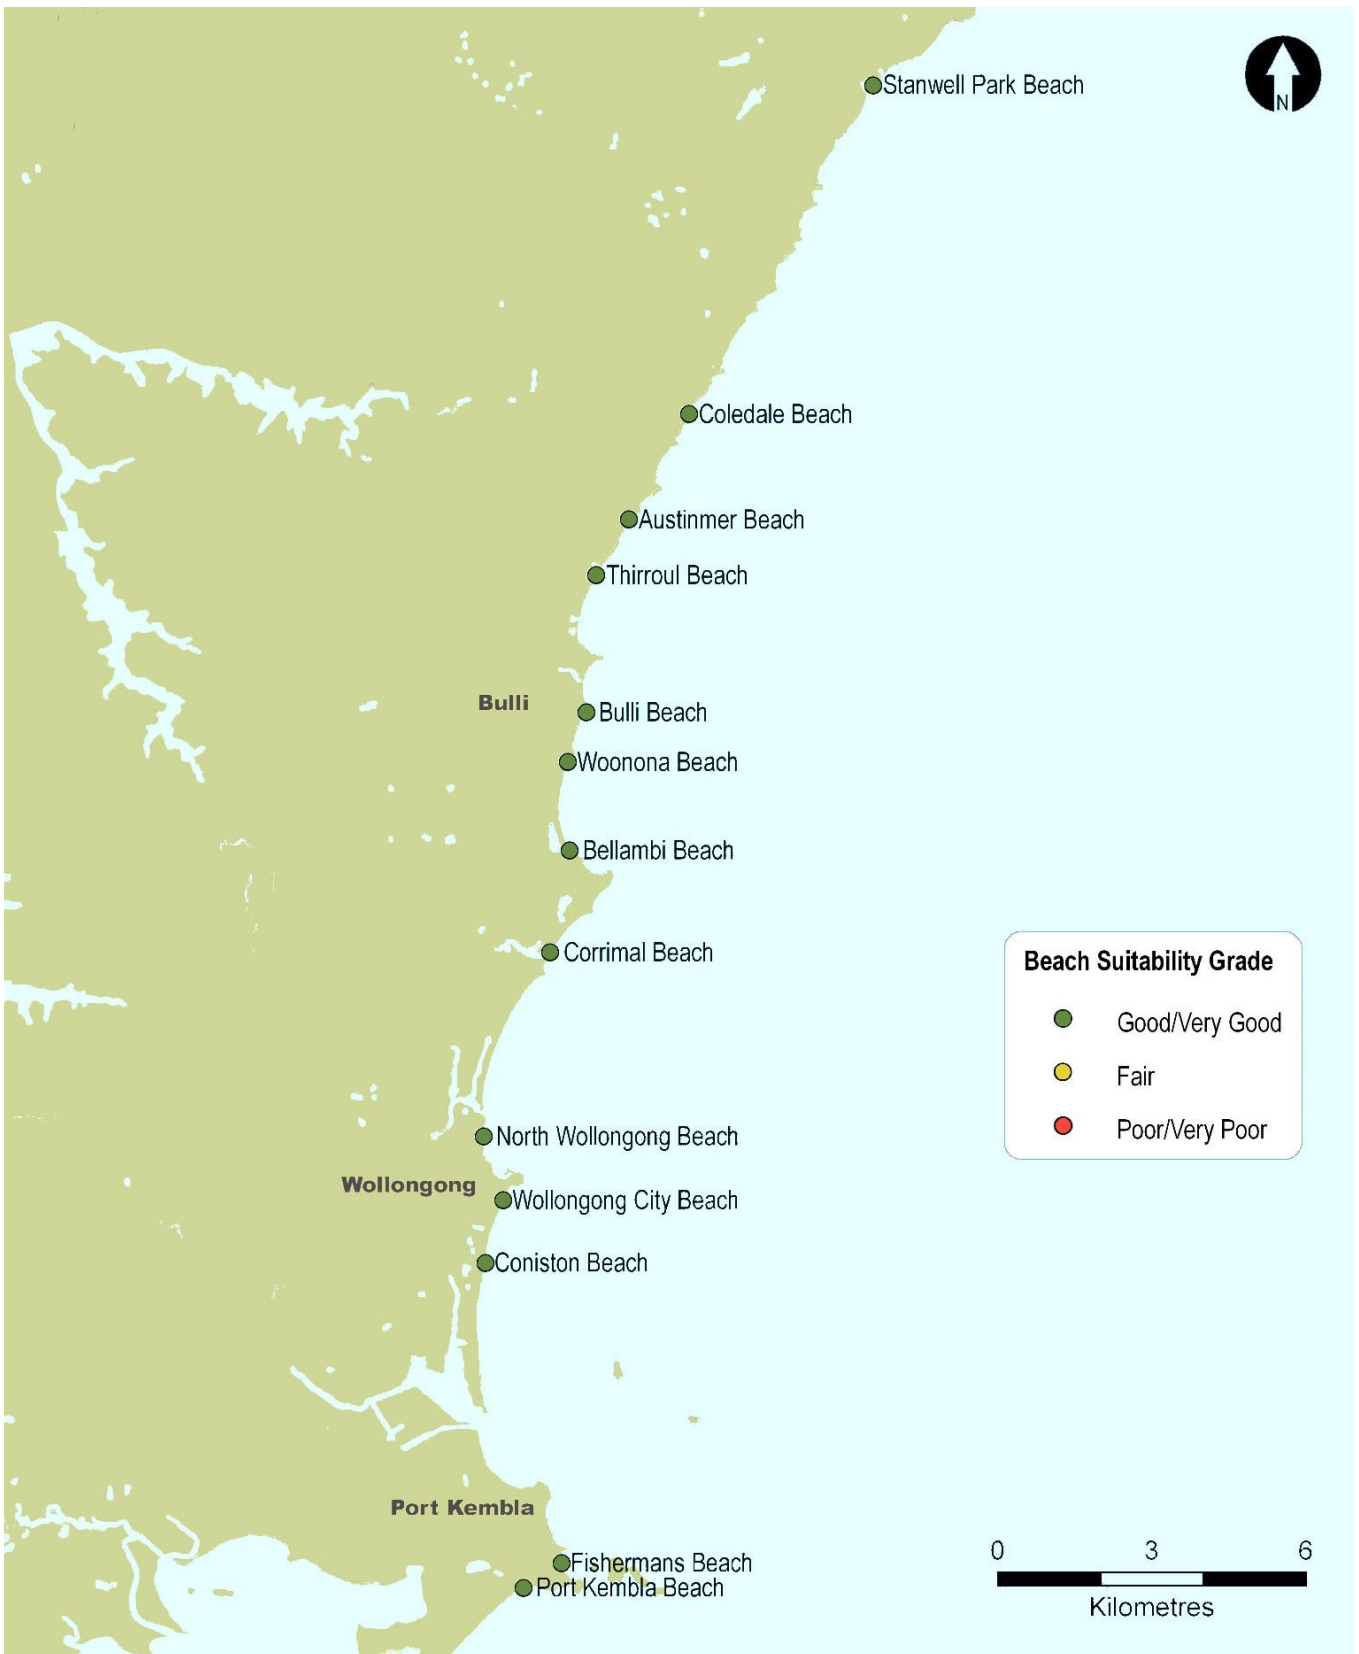
Sampling sites and Beach Suitability Grades in Wollongong City Council

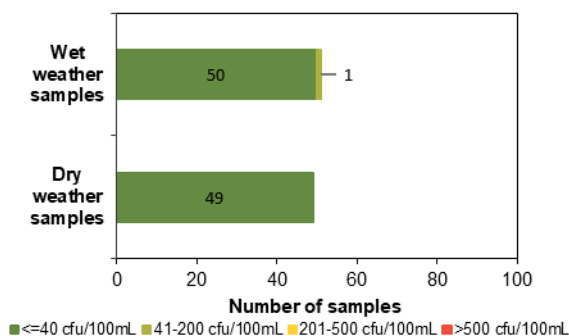
Dry and wet weather water quality

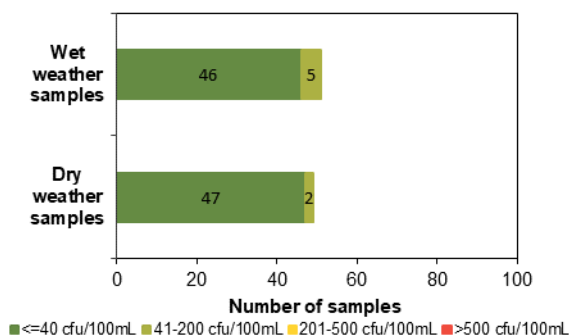
Dry and wet weather water quality

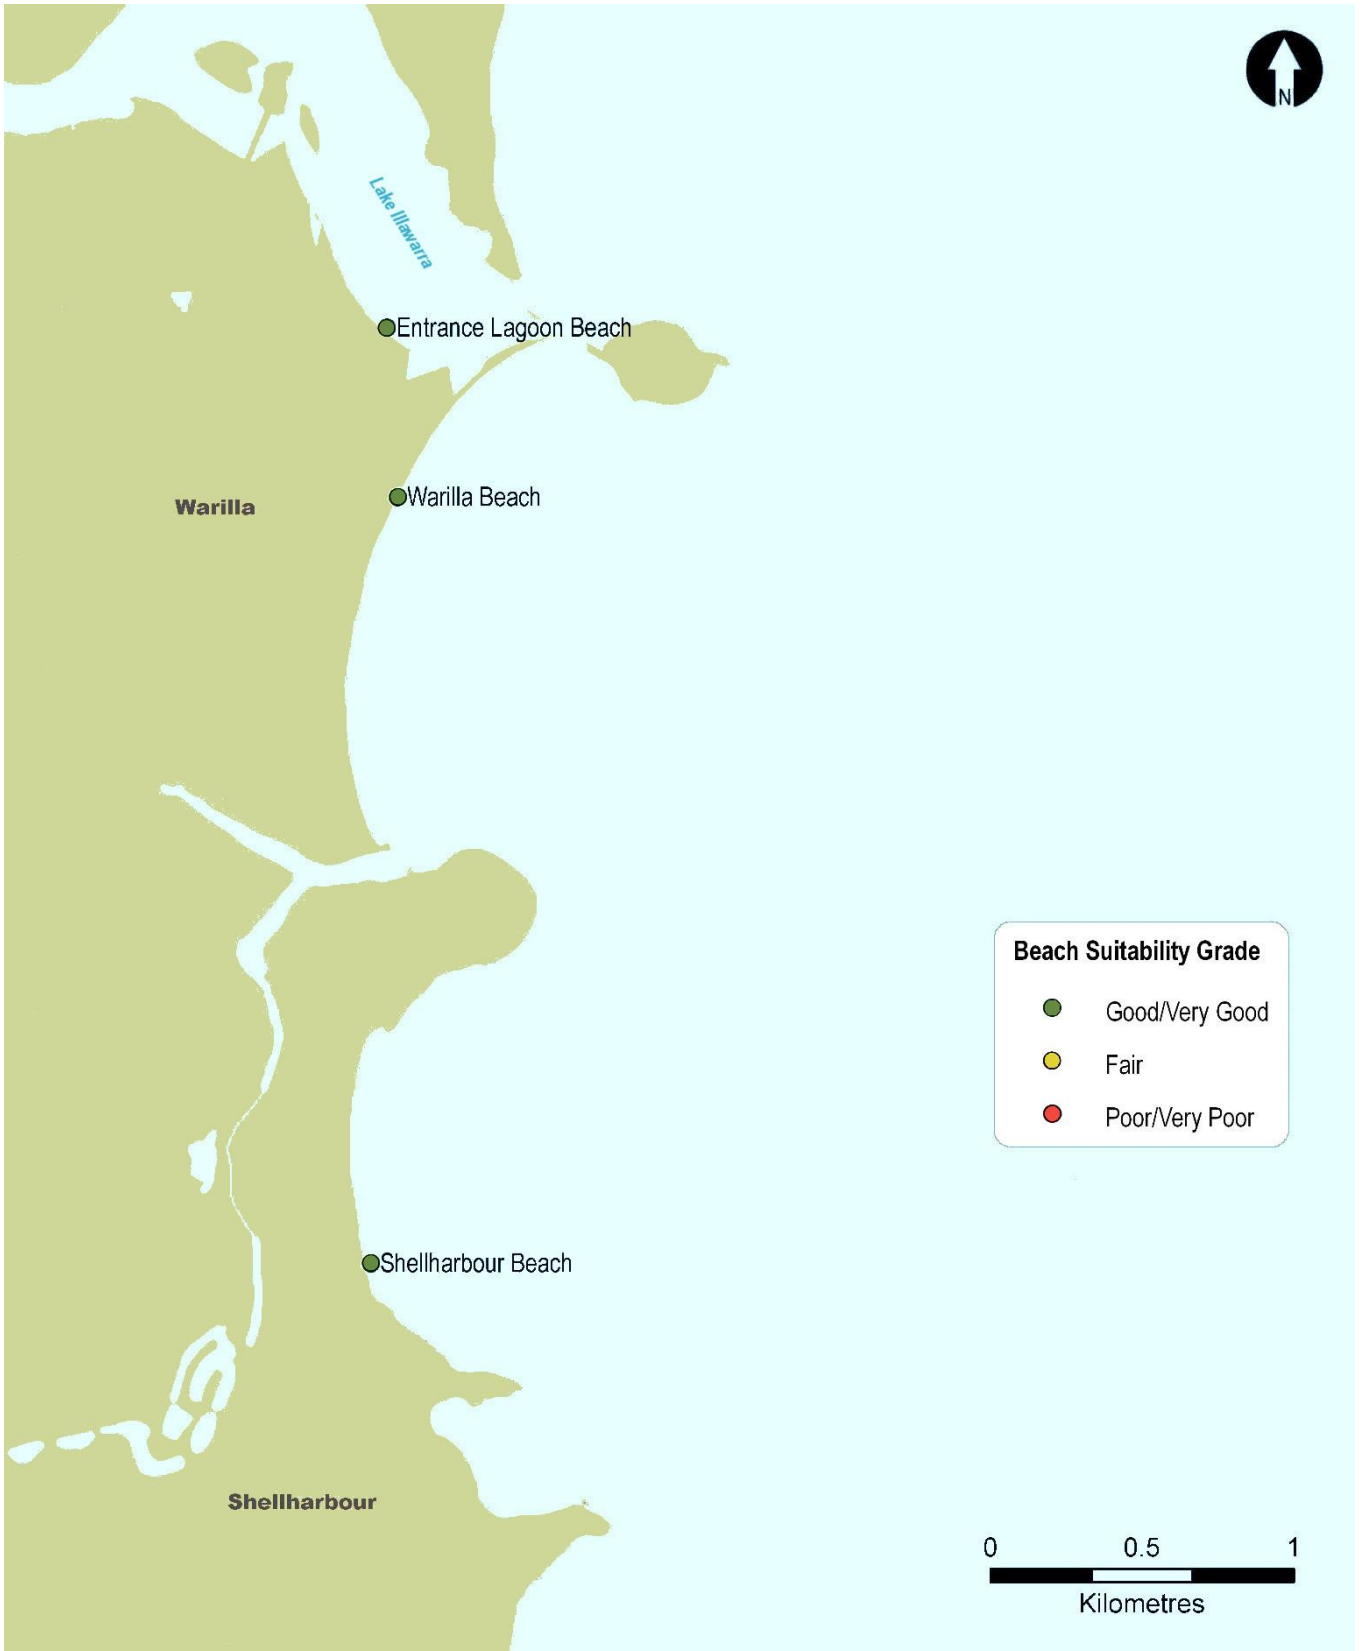
Sampling sites and Beach Suitability Grades in Shellharbour City Council

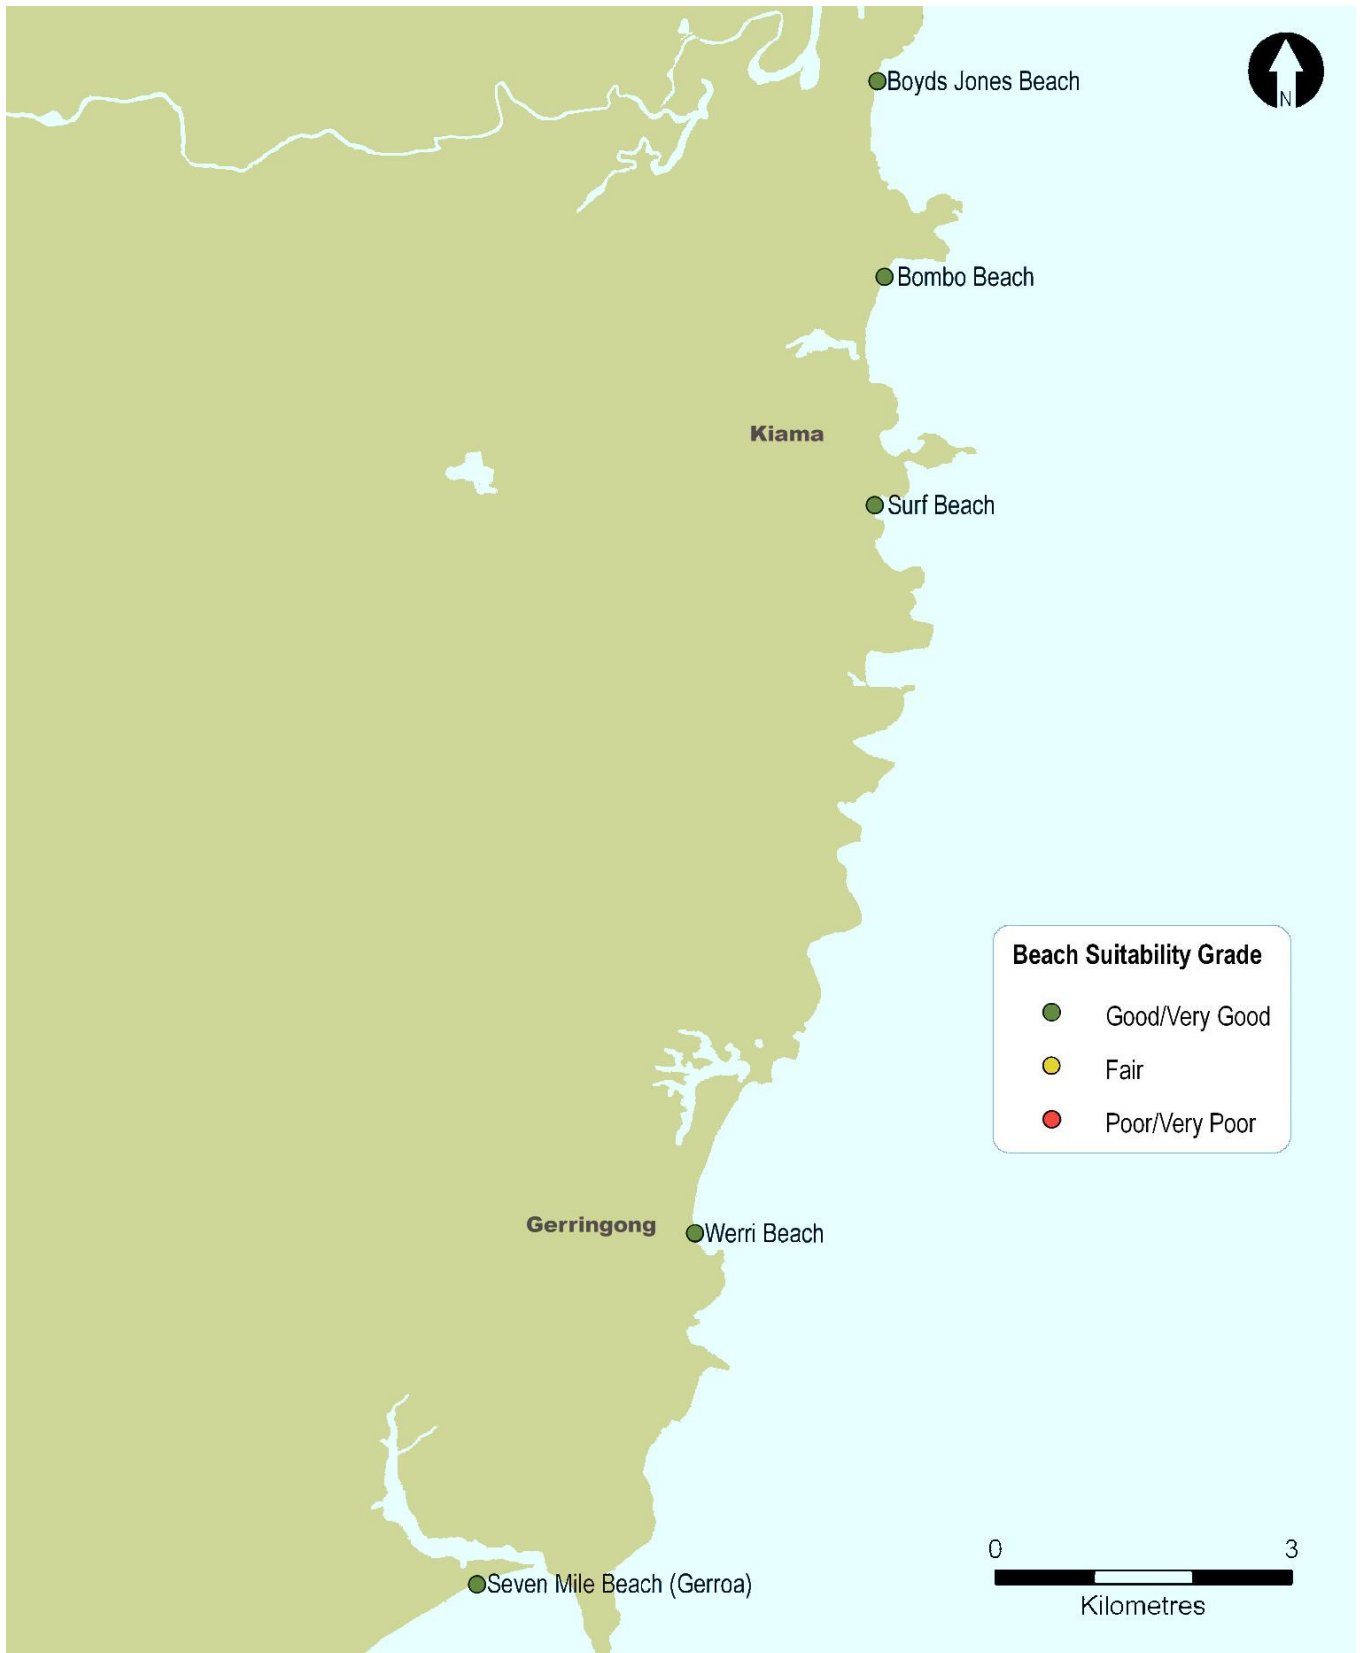
Sampling sites and Beach Suitability Grades in Kiama Municipal Council

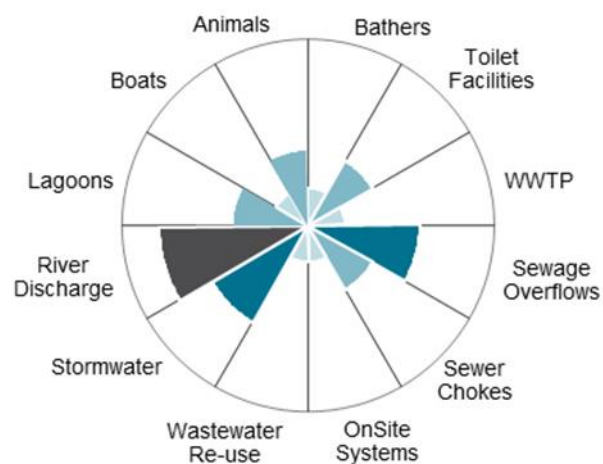
Sanitary Inspection Category (SIC) chart

The results of the sanitary inspection for each swimming location are presented in a radar pie chart. The chart shows the likelihood that each identified pollution source will contribute to faecal contamination at a swimming site, as indicated by the size and colour of the segment, ranging from very low (lightest colour) to very high (darkest colour) as shown below. The sum of these contributions is the overall likelihood, or Sanitary Inspection Category.

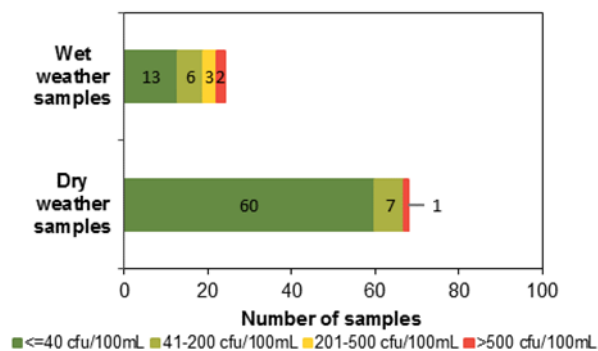
Wet and dry weather water quality chart

Enterococci levels in wet and dry weather conditions are presented for each swimming location as a bar graph. All data collected during the assessment period is included in the analysis. Dry weather is defined as no rainfall recorded in the previous 24 hours. Each bar is colour coded to show the number of enterococci results up to 40cfu/100mL, between 41 and 200cfu/100mL, between 201 and 500cfu/100mL and greater than 500cfu/100mL. These categories reflect the Microbial Assessment Category thresholds and are coloured on the graph as dark green, light green, amber and red respectively.

It is expected that swimming sites with lower levels of flushing show some elevated bacterial results in dry weather samples (no rainfall in the previous 24 hours) due to the longer time needed to recover from a rainfall event. At some estuarine and lake/lagoon swimming locations the impacts of stormwater pollution on beach water quality may be detected up to three days after rainfall.

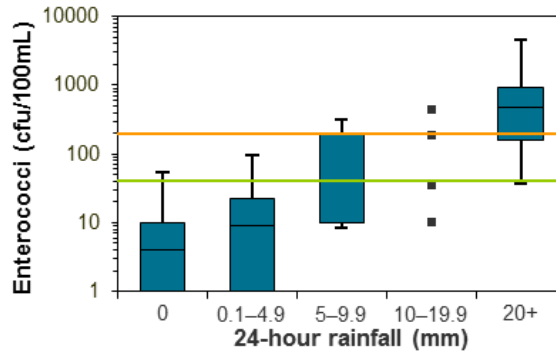
Water quality in response to rainfall

Trends in enterococci levels in response to rainfall are shown using a box plot. For reference, enterococci levels of 40cfu/100mL and 200cfu/100mL are indicated with a green and orange line, respectively. The 40cfu/100mL level is referred to as the 'safe swimming limit'. The enterococci data were obtained from the last five years of monitoring. Rainfall data were obtained from rain gauges situated close to the sample site and are 24-hour totals to 9am on the day of sampling. If there are fewer than five enterococci data points in a rainfall category, individual data points are presented instead of a box plot. At sites where many results are below the detection limit (1cfu/100mL), only the upper portion of the box plots will be visible.

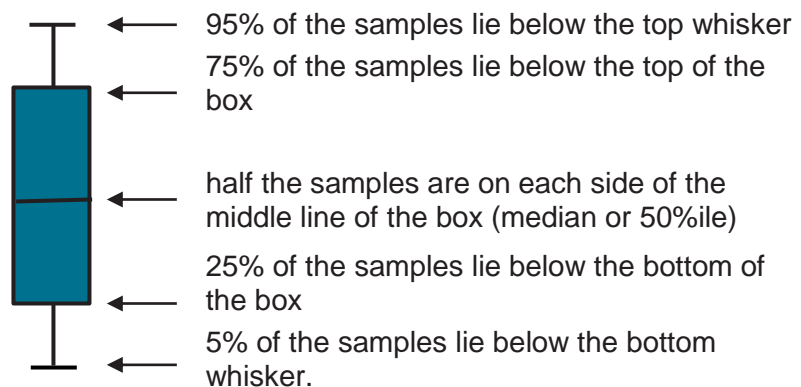
Each part of the box plot represents a significant percentile value of the sample population:
