State of the beaches 2019–2020

Central Coast region

Beachwatch

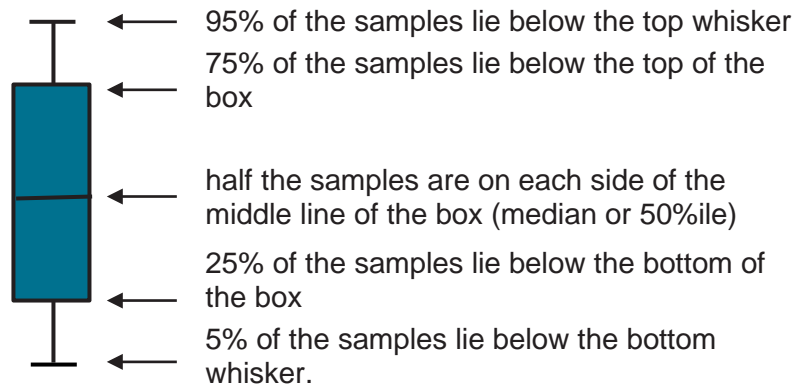
Each part of the box plot represents a significant percentile value of the sample population:
