State of the beaches 2019–2020

Illawarra region

Beachwatch

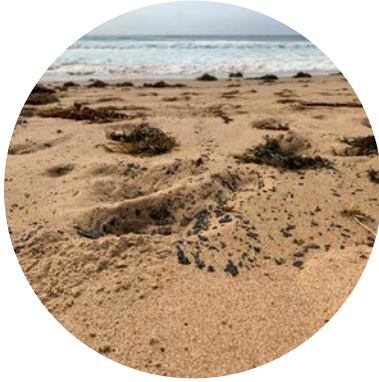
Bushfire ash and debris washed up on Stanwell Park Beach
Photo: Beachwatch/EES, DPIE

Catastrophic bushfires affected areas of the Illawarra region, particularly through the Southern Highlands, between October 2019 and January 2020. Despite the fires not directly impacting the coastal area, ash and debris were evident at many beaches.

Ash fallout from bushfires can add chemical contaminants to waterways and beaches. Rainfall-driven runoff from burnt areas can also impact water quality by washing suspended solids such as ash, charcoal, debris and soil particles, pathogens and dissolved materials into dams, streams and waterways. Dissolved materials can include nutrients, metals and organic matter. Increases in nutrients including phosphorus and nitrogen in the waterways can promote algal blooms.

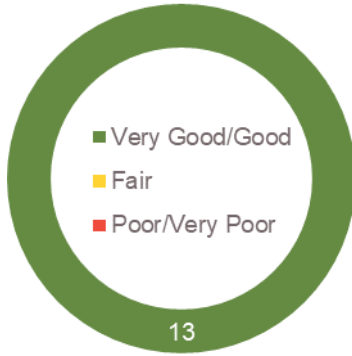
Beach Suitability Grades for Wollongong City Council ocean beaches

All ocean beaches continued to be graded as Very Good or Good in 2019–2020.

Six beaches were graded as Good: Thirroul Beach, Bulli Beach, Bellambi Beach, Corrimal Beach, North Wollongong Beach and Port Kembla Beach. Water quality at these sites was frequently suitable for swimming during dry weather conditions. Elevated enterococci levels were occasionally recorded following rainfall, and generally increased with increasing rainfall. Many of these sites have several, or more significant, potential sources of pollution such as stormwater drains or discharges from creeks or lagoons. Discharges from storm sewage treatment plants (SSTPs) at Bellambi and Port Kembla may also affect the water quality at nearby beaches Bellambi, Corrimal and Port Kembla following heavy rainfall.

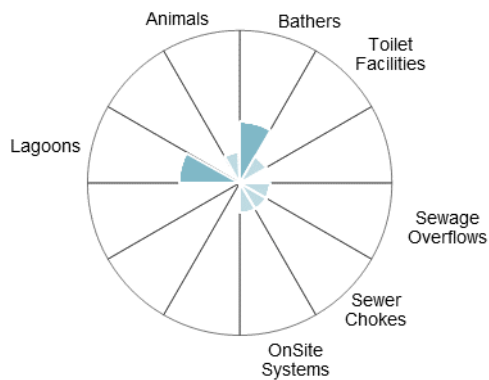
Sanitary inspection: Low

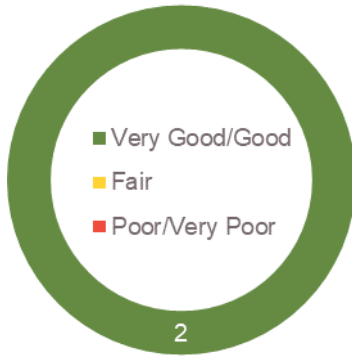
Beach Suitability Grades for Shellharbour City Council ocean beaches

Warilla and Shellharbour beaches have continued to be graded Very Good in 2019–2020 as in previous years. These beaches had excellent water quality and were suitable for swimming almost all of the time.

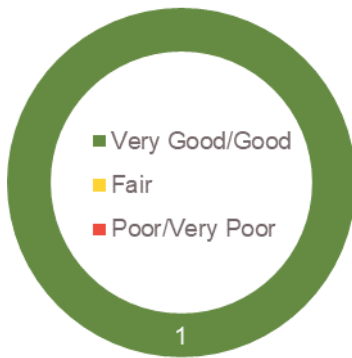
Beach Suitability Grades for Shellharbour City Council lake/lagoon swimming sites

Entrance Lagoon Beach was graded Good in 2019–2020, similar to previous years. Water quality at this site was mostly suitable for swimming during dry weather conditions, with 86% of dry weather samples within the safe swimming limit when there has been no rain in the previous 24 hours. Enterococci levels increased following rainfall, with levels often unsuitable for swimming after light rain. The swimming site is located within the entrance of Lake Illawarra and has lower levels of flushing. Due to this, the site can retain pollution inputs and take longer to recover from the impacts of stormwater. Water quality at this site may be impacted by contaminants discharged from Lake Illawarra, and stormwater during and following rainfall.

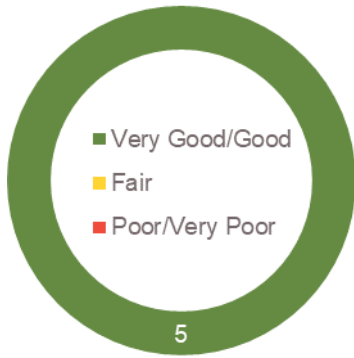
Beach Suitability Grades for Kiama Municipal Council ocean beaches

Boys Jones Beach, Bombo Beach, Werri Beach and Seven Mile Beach (Gerroa) were graded Very Good, consistent with previous years. Water quality at these sites was suitable for swimming almost all of the time.

Surf Beach Kiama was graded as Good, similar to previous years. While water quality at this beach is frequently suitable for swimming during dry weather conditions, elevated enterococci levels are occasionally recorded following light rainfall. It is recommended to avoid swimming during and for at least one day following rainfall or if there are signs of stormwater pollution such as discoloured water and floating debris.
