State of the beaches 2019–2020

North Coast region

Beachwatch

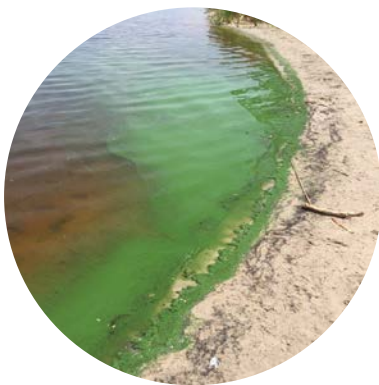
Blue-green algal bloom present in the water
Photo: Rachael Jenner/
Ballina Shire Council

Water NSW reported several occurrences of freshwater blue-green algal blooms impacting Lake Ainsworth in May 2019, and at times during November 2019 to March 2020. While freshwater algae occur naturally, there were times of heightened risk to recreational users due to rapid increases in abundance causing blooms.

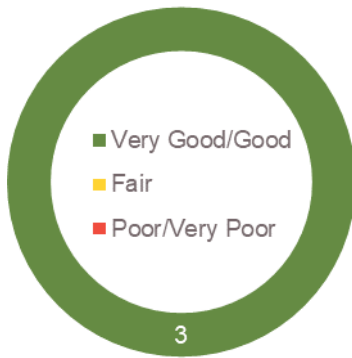
Beach Suitability Grades for Ballina Shire Council ocean beaches

Seven Mile Beach and Lighthouse Beach continued to be graded as Very Good, similar to previous years. These beaches had excellent water quality and were suitable for swimming almost all of the time.

Shelly Beach was graded as Good. Water quality at this site was of a high standard and suitable for swimming most of the time. While water quality at Shelly Beach has performed consistently well over the past five years, there are several potential sources of faecal contamination nearby.

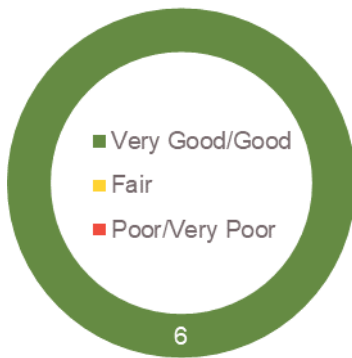
Beach Suitability Grades for Ballina Shire Council estuarine beaches

The estuarine swimming locations occasionally recorded elevated enterococci levels after light rainfall and more often after heavy rainfall. Water quality at these sites can be impacted by upstream sources and can take longer to recover due to lower levels of flushing.

It is recommended that swimming should be avoided during and for up to three days following rainfall at estuarine swimming sites, or if there are signs of pollution such as discoloured water or floating debris.

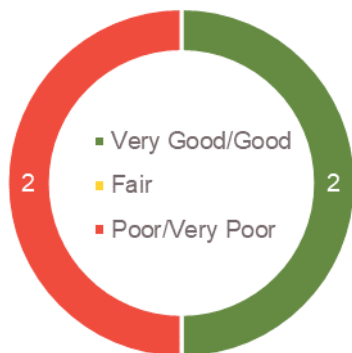
Beach Suitability Grades for Ballina Shire Council lake/lagoon swimming sites

Lake Ainsworth East and Lake Ainsworth South were graded as Good in 2019–2020.

Lake Ainsworth East was upgraded to Good from Poor in the previous year due to improved microbial water quality. The site was mostly suitable for swimming during dry weather, with 85% of dry weather samples within the safe swimming limit. Microbial water quality at this site remains close to the threshold between Good and Poor and has changed between the grades several times over the last five years. Water quality at Lake Ainsworth South was frequently

suitable for swimming during dry weather, with 97% of dry weather samples within the safe swimming limit. Elevated enterococci levels were regularly recorded at these sites after heavy rainfall.

Lake Ainsworth North and Lake Ainsworth West were graded as Poor, a similar result to the previous year. Elevated bacteria levels were recorded at these lake swimming sites during dry and wet weather conditions. Despite the poor grades, between 71% and 73% of dry weather samples were within the safe swimming limit. These sites may be impacted by a number of significant potential sources of faecal contamination including stormwater, and have low levels of flushing. Since 2019, council has been investigating the source of microbial contamination with additional samples collected for faecal sterol analysis at sites within Lake Ainsworth, to identify if elevated bacteria levels are from human or other animal sources.

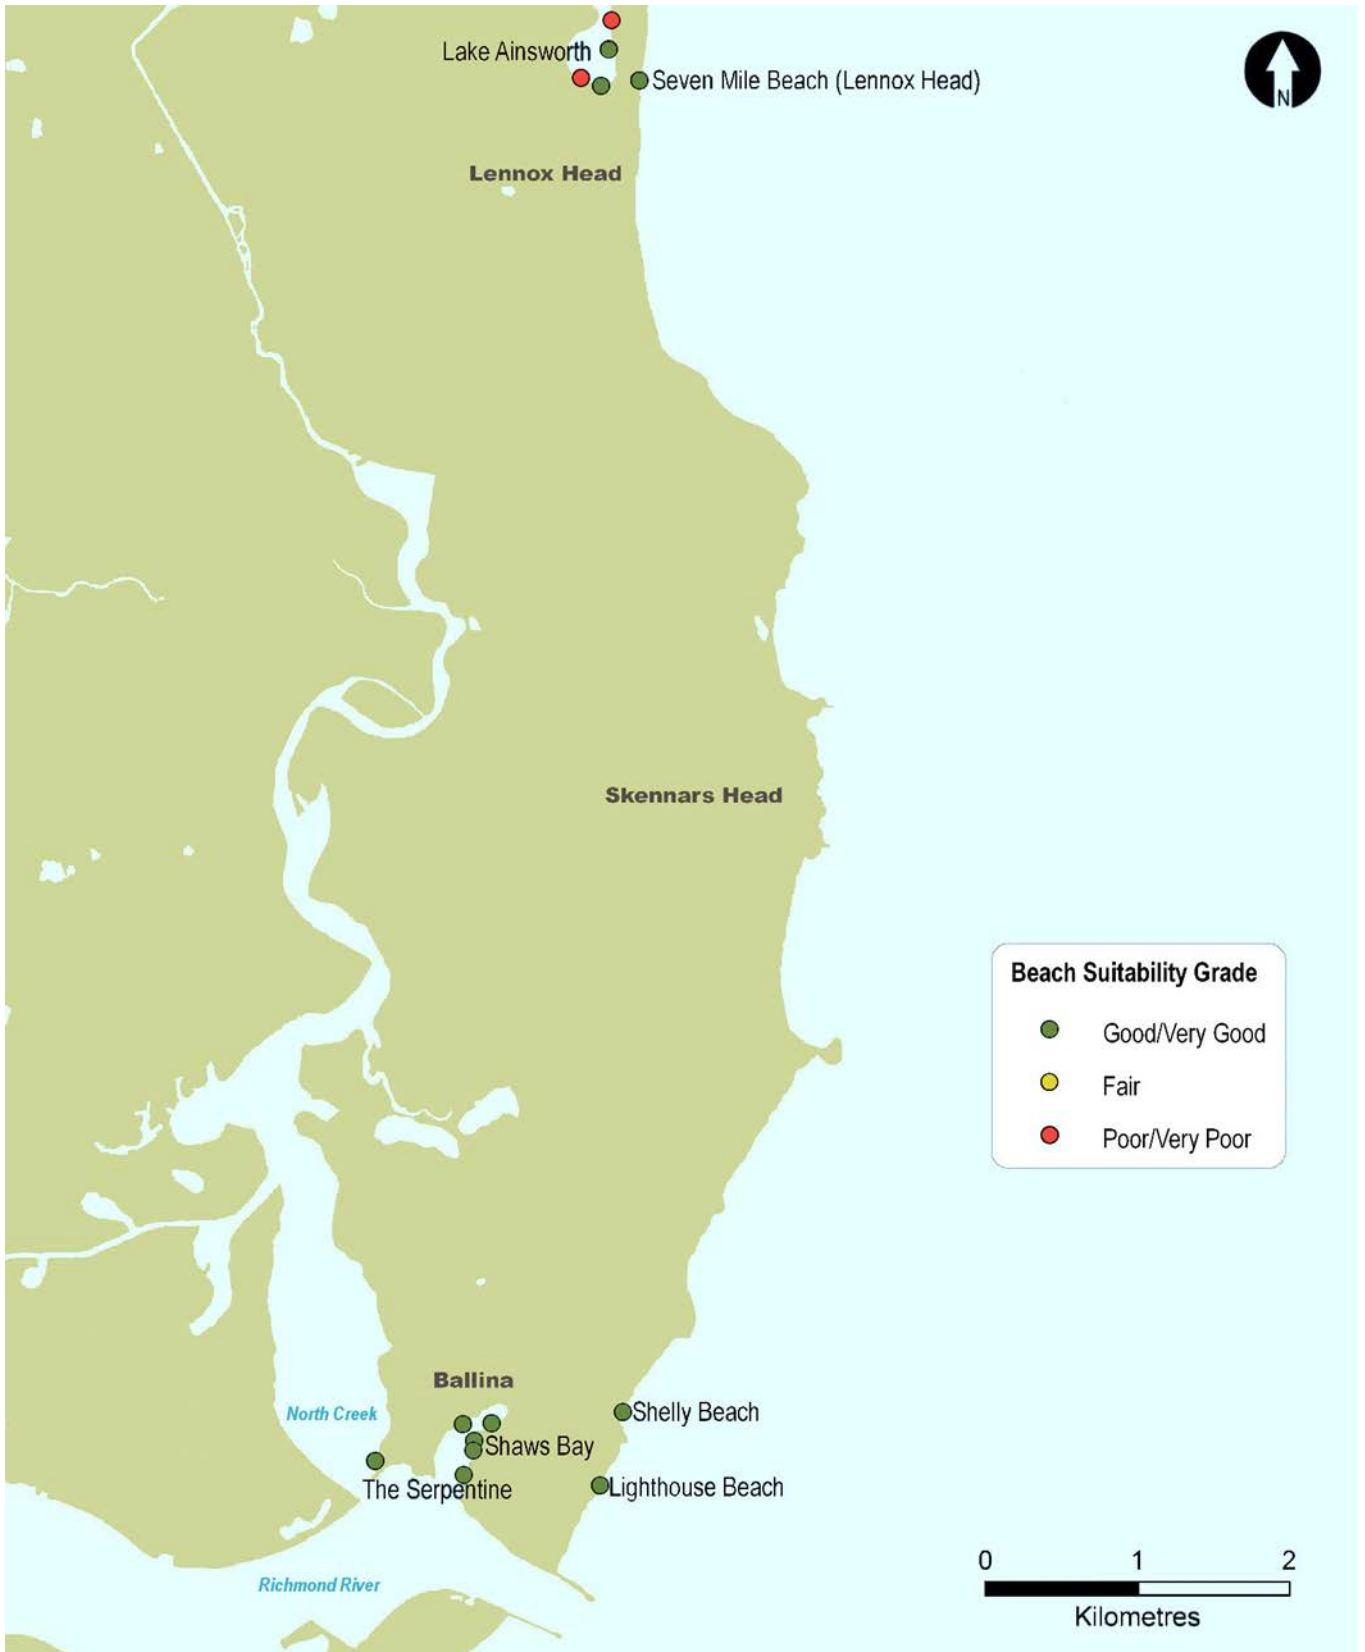
Sampling sites and Beach Suitability Grades in Ballina Shire Council

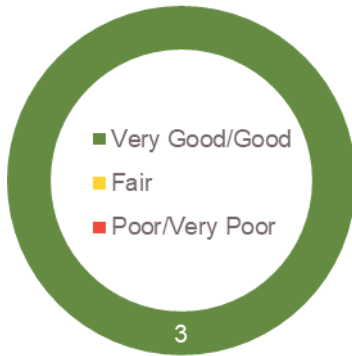
Beach Suitability Grades for Richmond Valley Council ocean beaches

All three ocean beaches were graded as Very Good: Airforce Beach, Main Beach and Shark Bay. Water quality at these beaches has been consistently excellent for many years and is suitable for swimming almost all of the time.

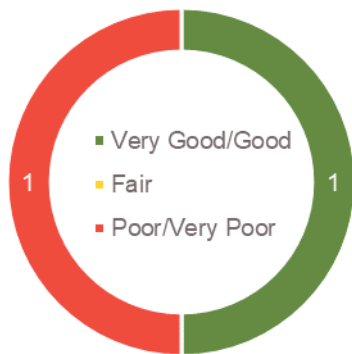
Beach Suitability Grades for Richmond Valley Council estuarine beaches

Elm Street Bridge North in the Evans River, continued to be graded as Good in 2019–2020, a similar result to the previous three years. Water quality was frequently suitable for swimming during dry weather, with 90% of samples within the safe swimming limit. Elevated enterococci levels were mostly recorded following rainfall.

Evans River, located downstream of Elm Street Bridge North, was graded as Poor in 2019–2020, the same as previous years. Water quality at this site was often suitable for swimming during dry weather conditions, with 59% of samples within the safe swimming limit. However, elevated enterococci levels were recorded in dry weather, and were regularly elevated during and following moderate to heavy rainfall. Discharge from a nearby large stormwater drain is also likely to impact water quality at this site when flowing. Further investigation is required to show the scale and extent of the problem, and the source of microbial contamination.

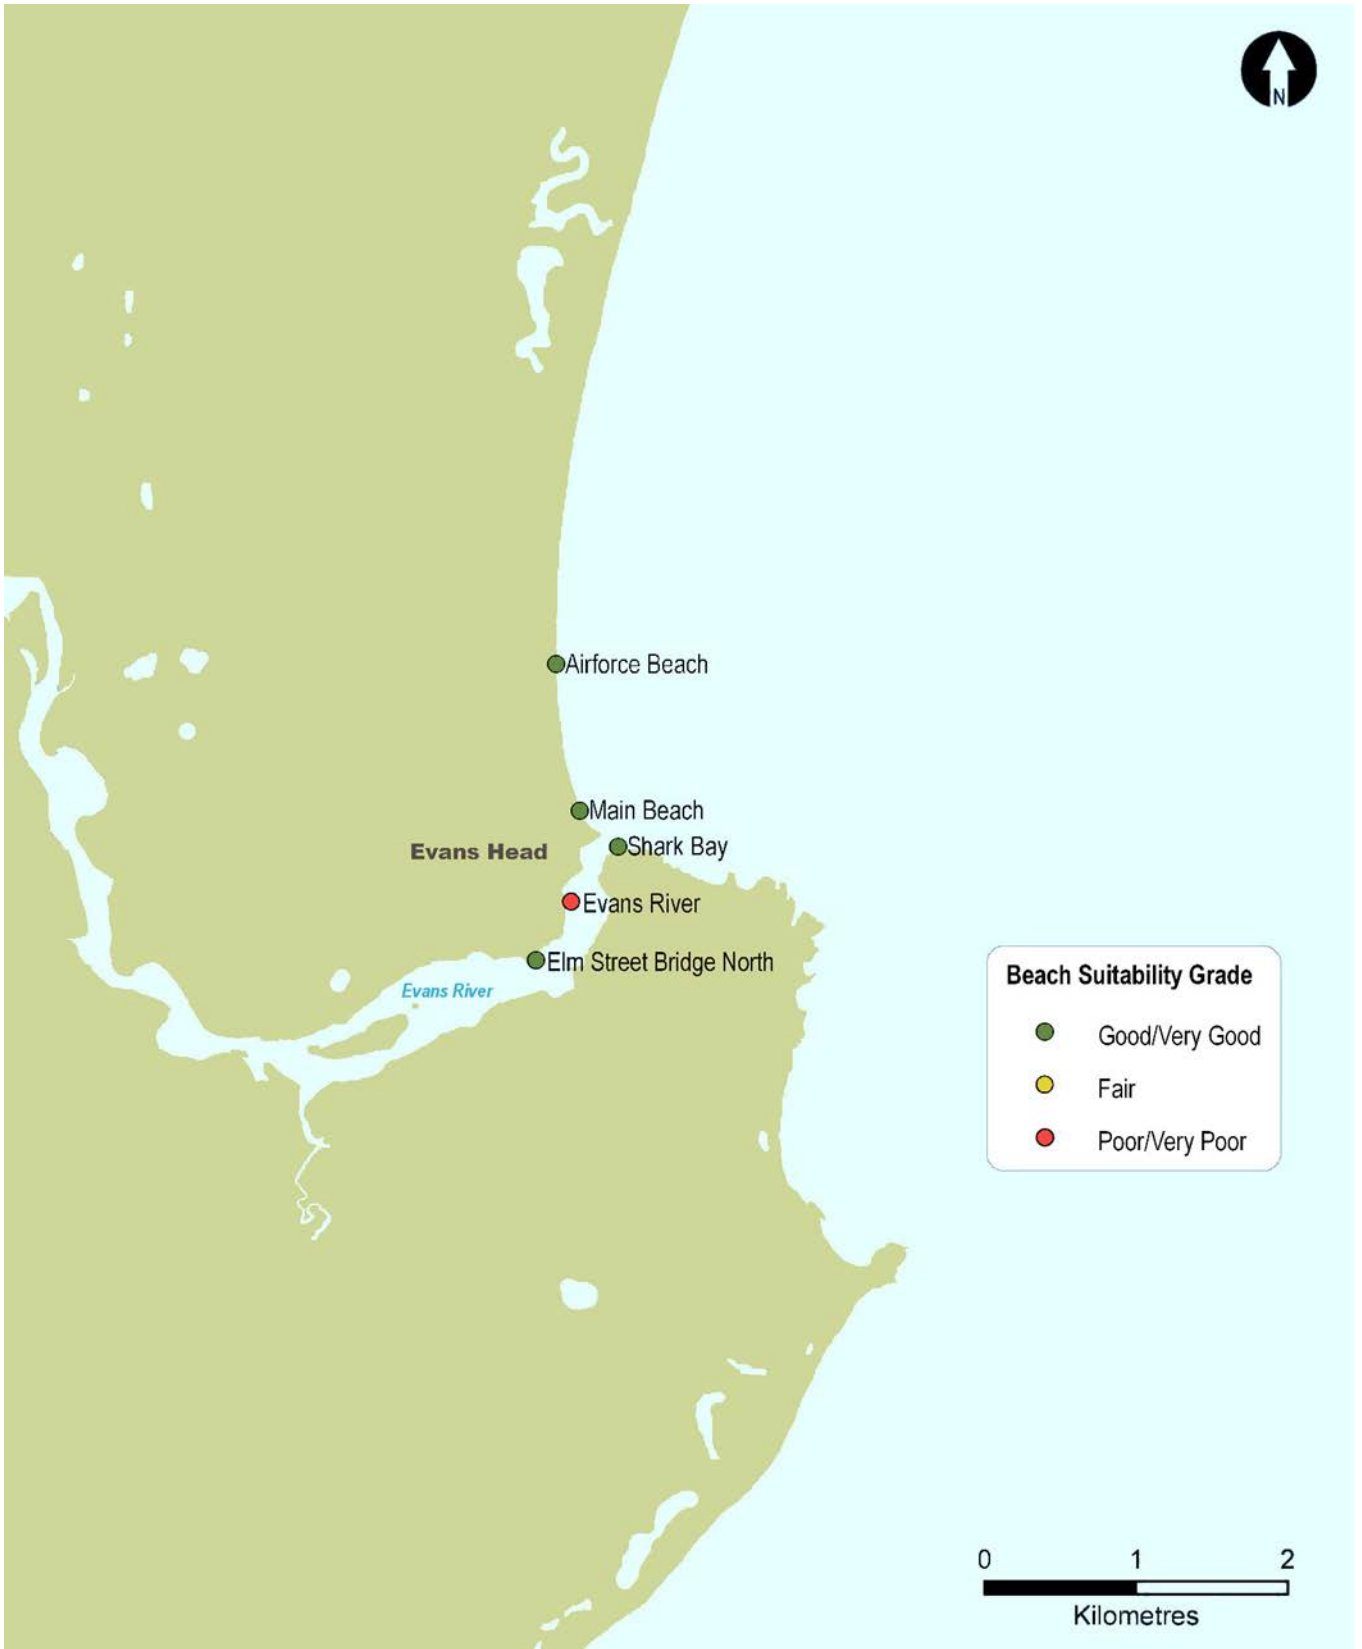
Sampling sites and Beach Suitability Grades in Richmond Valley Council
