State of the beaches 2019–2020

South Coast region

Beachwatch

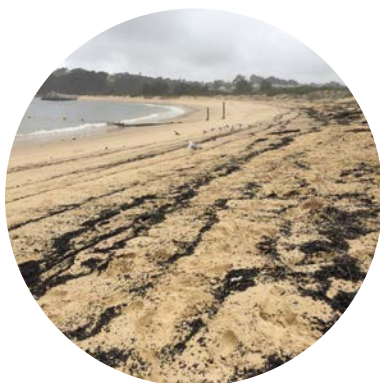
Bushfire ash and debris washed up at Wagonga Inlet
Photo: Adam Wethered/
EES, DPIE

Ash fallout from bushfires can add chemical contaminants to waterways and beaches. Rainfall-driven runoff from burnt areas can also impact water quality by washing suspended solids such as ash, charcoal, debris and soil particles, pathogens and dissolved materials into dams, streams and waterways. Dissolved materials can include nutrients, metals and organic matter. Increases in nutrients including

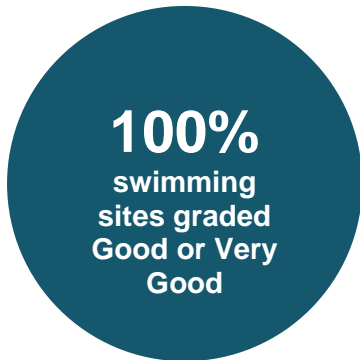
All 10 swimming sites were graded as Very Good or Good in 2019–2020. Excellent results were also recorded in previous years.

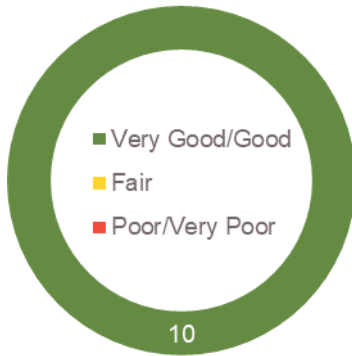
Beach Suitability Grades for Shoalhaven City Council ocean beaches

Nine of the 10 ocean beaches were graded as Very Good in 2019–2020: Shoalhaven Heads Beach, Tilbury Cove, Warrain Beach, Collingwood Beach, Cudmirrah Beach, Mollymook Beach, Rennies Beach, Bawley Point Beach and Merry Beach. Water quality at these sites has been of a high standard for several years and was suitable for swimming almost all of the time. These sites have few potential sources of faecal contamination.

Racecourse Beach was graded as Good, consistent with previous years. While the beach was frequently suitable for swimming during dry weather conditions, elevated enterococci results were recorded following moderate to heavy rainfall.

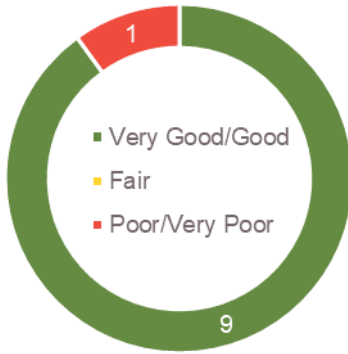
Beach Suitability Grades for Eurobodalla Shire Council ocean beaches

Five of the 10 ocean beaches were graded as Very Good in 2019–2020: Cookies Beach, Malua Bay Beach, Bengello Beach, Brou Beach and Narooma Main Beach. Water quality at these sites was suitable for swimming almost all of the time.

Caseys Beach, Broulee Beach, Shelley Beach and Tuross Main Beach were graded as Good, a similar result to the previous year. Water quality at these sites was suitable for swimming most of the time during dry weather conditions, however elevated enterococci levels sometimes exceeded the safe swimming limit following rain. Microbial water quality at Caseys Beach has continued to decline over the past several years, with significantly elevated bacterial levels more frequently measured, particularly following heavy rainfall.

Surf Beach was graded as Poor in 2019–2020, a similar result to the previous year. Elevated enterococci levels were often measured during dry weather conditions and after rainfall. In the last two years, the microbial water quality has continued to decline, and further investigation is recommended to show the scale and extent of the problem, and the source of microbial contamination. It is recommended to avoid swimming during and for at least one day following rainfall or if there are signs of stormwater pollution such as discoloured water and floating debris.

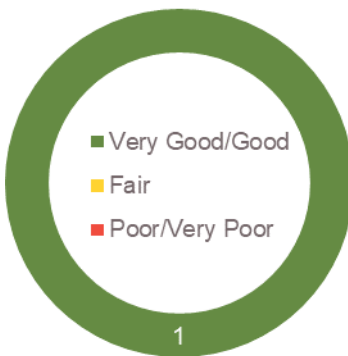
Beach Suitability Grades for Eurobodalla Shire Council estuarine beaches

Wagonga Inlet was graded as Good in 2019–2020, a similar result to the previous years. While water quality at this site was suitable for swimming most of the time, elevated enterococci results were occasionally recorded after little or no rain. Pollution inputs from elsewhere within Wagonga Inlet may impact water quality at this site. Swimming should be avoided during and for up to three days after rainfall, or if there are signs of pollution such as discoloured water or floating debris.

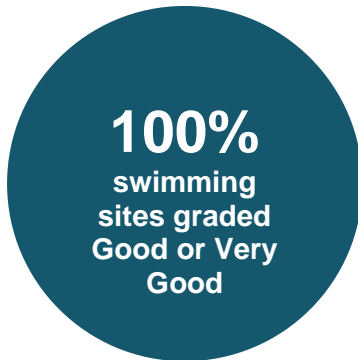
Fifteen swimming sites were monitored by Bega Valley Shire Council. Samples were collected weekly between November and March, and sampling and analysis was fully funded by the council.

All 15 swimming sites were graded as Very Good or Good in 2019–2020. This performance is consistent with previous years.

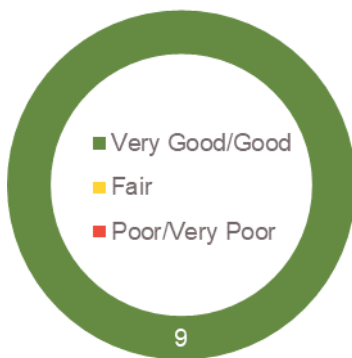
Beach Suitability Grades for Bega Valley Shire Council ocean beaches

Short Point Beach and Cocora Beach were graded as Good, similar to the previous year. While water quality at these sites was suitable for swimming most of the time, slightly elevated enterococci levels were occasionally recorded following rainfall, and sometimes during dry weather at Cocora Beach.

While water quality has been of a good standard at the ocean beaches, the grades are provisional as the assessment is based on limited bacterial data. Continued monitoring will provide a clearer indication of the water quality at these sites.

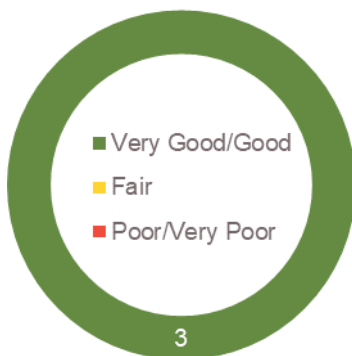
Beach Suitability Grades for Bega Valley Shire Council estuarine beaches

Bruce Steer Pool, Bar Beach and Pambula River Mouth continued to be graded as Good in 2019–2020. Water quality at these sites was suitable for swimming most of the time, with elevated enterococci levels occasionally recorded following rainfall. These sites can be impacted by upstream river sources and are not as well flushed as ocean beaches.

The grades are provisional at these sites as the assessment is based on limited bacterial data. Ongoing monitoring will continue to provide information about the water quality at the estuarine sites.

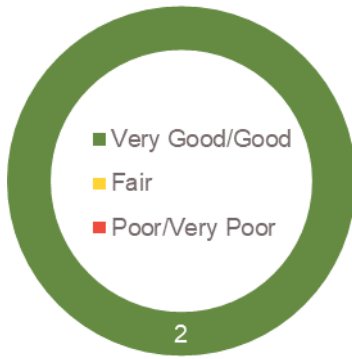
Beach Suitability Grades for Bega Valley Shire Council lake/lagoon swimming sites

Mogareeka Lions Park was graded as Very Good. Water quality was of a high standard, with all samples within the safe swimming limit. Sampling at Mogareeka Lions Park recommenced in late 2018; it was previously monitored from 2004 until 2010.

Mogareeka Inlet was graded as Good, consistent with previous years. While water quality at this site was suitable for swimming most of the time, slightly elevated enterococci levels were recorded on three occasions since 2016, with two of the results associated with rainfall in the previous three days. Water quality at this site can be impacted from upstream sources within the Bega River.

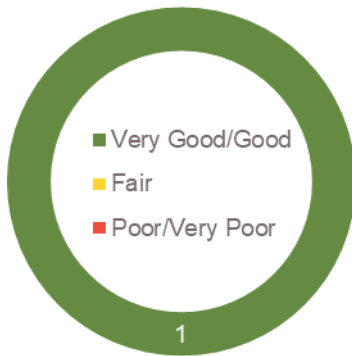
Beach Suitability Grades for Bega Valley Shire Council ocean baths

Big Blue Pool was graded as Good in 2019–2020, a similar result to the previous year. While water quality was suitable for swimming most of the time, slightly elevated results have been recorded on four occasions since 2016, with three of these associated with rainfall in the previous two days.

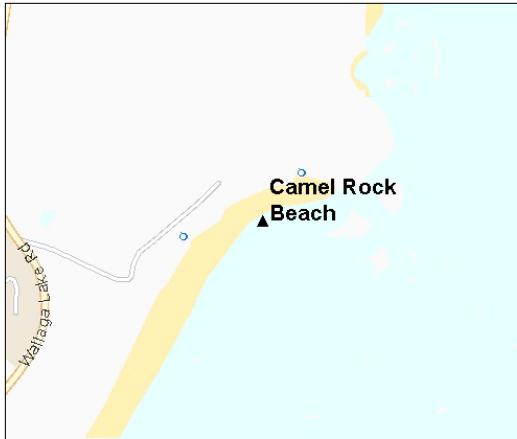
Camel Rock Beach is located to the north of Bermagui and is backed by a reserve.

The Beach Suitability Grade of Very Good indicates microbial water quality is considered suitable for swimming almost all of the time, with very few potential sources of faecal contamination.

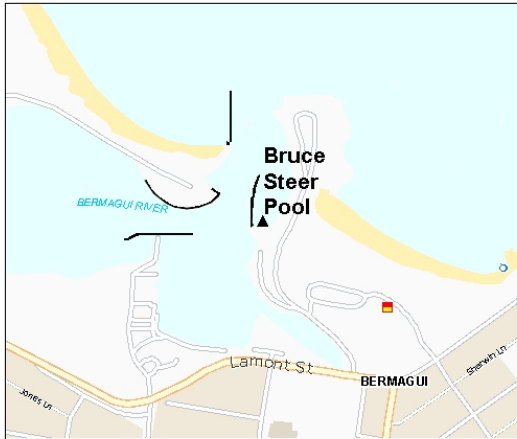
Bruce Steer Pool is a netted enclosure located in protected waters near the entrance to Bermagui Harbour.

The Beach Suitability Grade of Good indicates microbial water quality is considered suitable for swimming most of the time but may be susceptible to pollution after rain, with several potential sources of faecal contamination including river discharge.

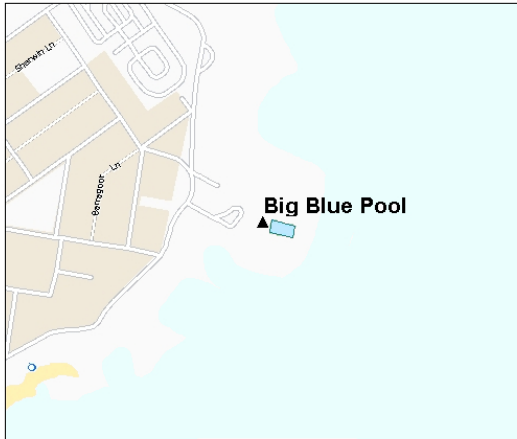
Big Blue Pool is a historic swimming area located on the headland to the south of Horseshoe Bay.

The Beach Suitability Grade of Good indicates microbial water quality is considered suitable for swimming most of the time but can be susceptible to pollution after rain, with several potential sources of faecal contamination.

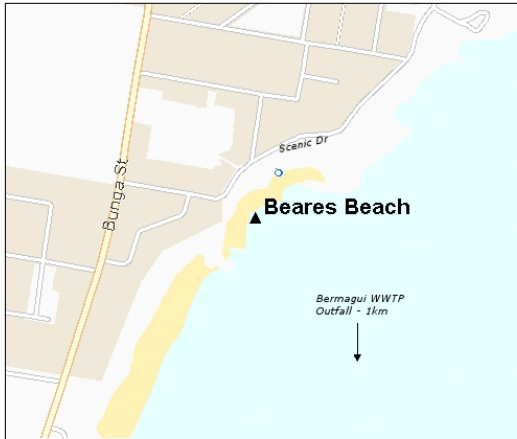
Beares Beach is a small, exposed beach located just south of the town of Bermagui.

The Beach Suitability Grade of Very Good indicates microbial water quality is considered suitable for swimming almost all of the time, with few potential sources of significant faecal contamination.

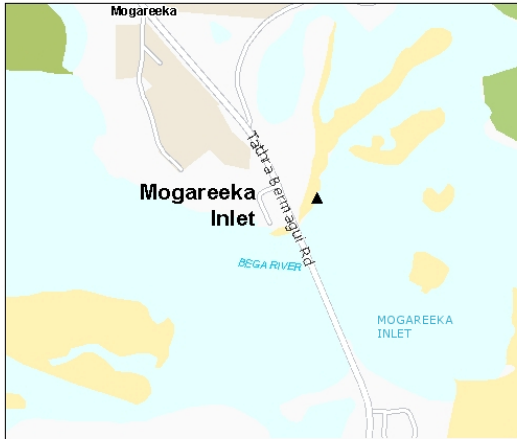
Mogareeka Inlet is on the northern side of the Bega River estuary, about 500 metres upstream of the entrance. The inlet is intermittently open to the ocean.

The Beach Suitability Grade of Good indicates microbial water quality is considered suitable for swimming most of the time but may be susceptible to pollution after rain, with several potential sources of faecal contamination.

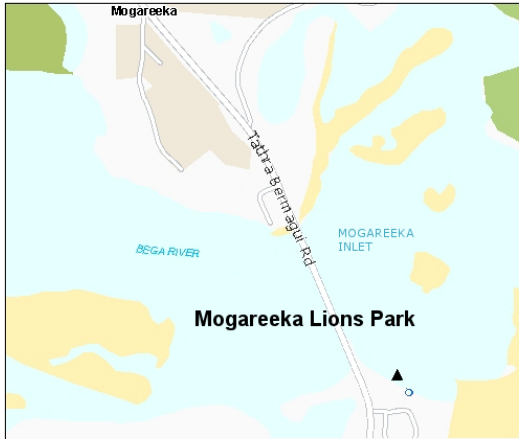
Mogareeka Lions Park is located on the southern side of the Bega River estuary, about 500 metres upstream of the entrance. The inlet is intermittently open to the ocean.

The Beach Suitability Grade of Very Good indicates microbial water quality is considered suitable for swimming almost all of the time, with few potential sources of significant faecal contamination.

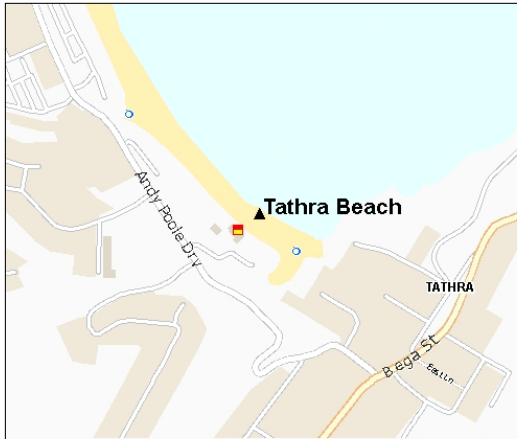
Tathra Beach is a popular beach stretching for approximately five kilometres. The beach is patrolled during the summer months.

The Beach Suitability Grade of Very Good indicates microbial water quality is considered suitable for swimming almost all of the time, with few potential sources of significant faecal contamination.

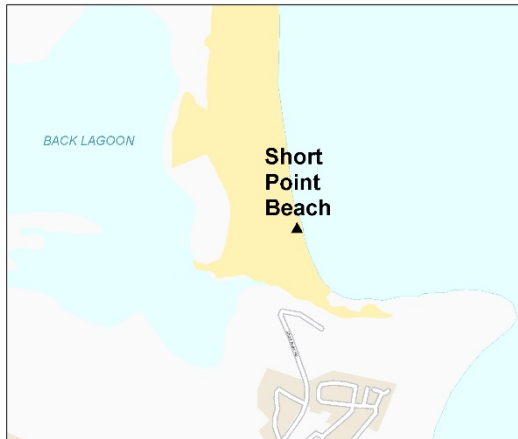
Short Point Beach is located between the towns of Merimbula and Tura. It is patrolled during summer holidays.

The Beach Suitability Grade of Good indicates microbial water quality is considered suitable for swimming most of the time but can be susceptible to pollution after rain, with several potential sources of minor faecal contamination.

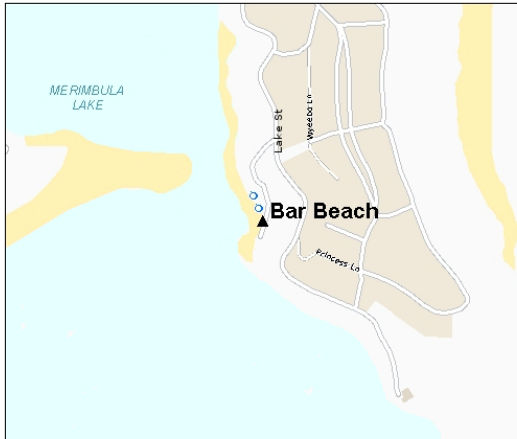
Bar Beach is located on the northern side of the inlet to Merimbula Lake. The beach is patrolled during the summer holidays.

The Beach Suitability Grade of Good indicates microbial water quality is considered suitable for swimming most of the time but may be susceptible to pollution after rain, with several potential sources of faecal contamination including outflow from Merimbula Lake.

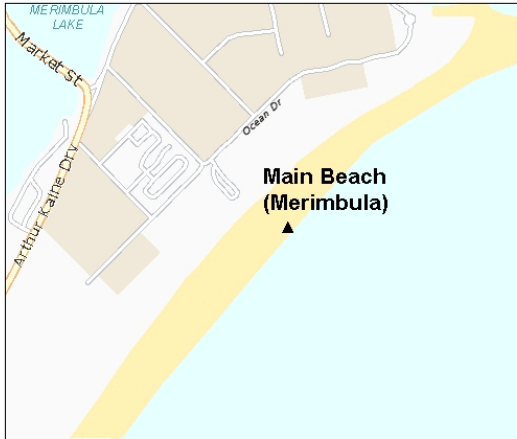
Main Beach (Merimbula)

Merimbula Main Beach is located on the southern side of Merimbula Lake. It is patrolled during the summer holidays.

The Beach Suitability Grade of Very Good indicates microbial water quality is considered suitable for swimming almost all of the time, with few potential sources of faecal contamination.

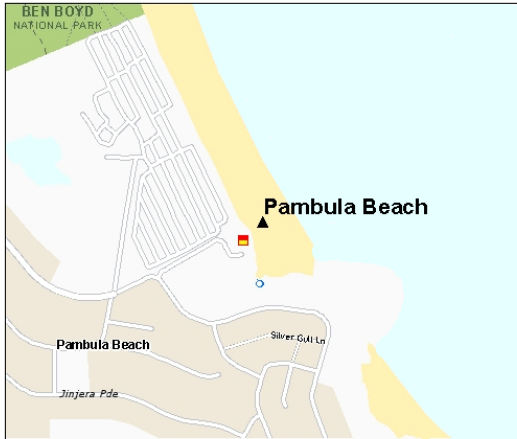
Pambula Beach is located to the north of Pambula River and is patrolled during the summer months.

The Beach Suitability Grade of Very Good indicates microbial water quality is considered suitable for swimming almost all of the time, with few potential sources of significant faecal contamination.

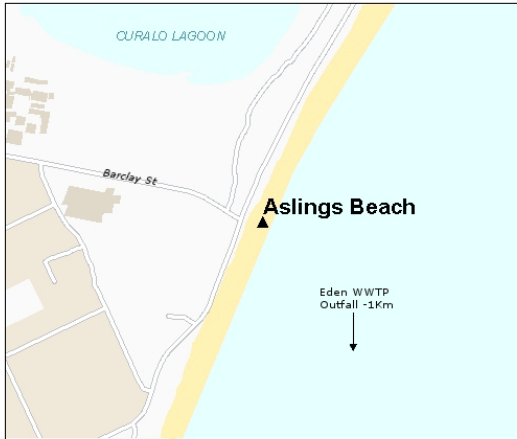
Aslings Beach is the main surf beach in Eden. The southern end of the beach is patrolled during the summer months.

The Beach Suitability Grade of Very Good indicates microbial water quality is considered suitable for swimming almost all of the time, with several potential sources of minor faecal contamination.

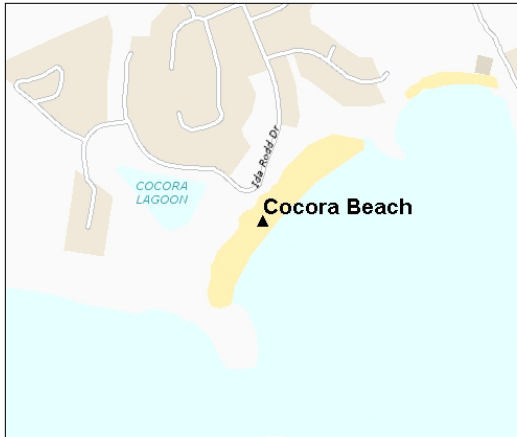
Cocora Beach is a protected ocean beach in the north of Twofold Bay.

The Beach Suitability Grade of Good indicates microbial water quality is considered suitable for swimming most of the time but may be susceptible to pollution after rain, with several potential sources of faecal contamination, including outflow from Cocora Lagoon.

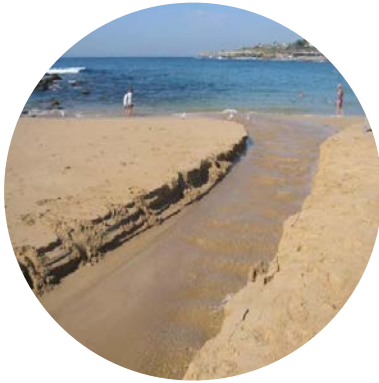
Stormwater at Coogee Beach
Photo: Beachwatch/EES, DPIE

Stormwater in urban areas often contains sewage from leakages, overflows or sewer chokes when the sewerage system fails.

Sewage overflows can occur in wet weather when the network has exceeded capacity due to rainwater entering the system. The mix of sewage and rainwater discharges from designated overflow points and drains to waterways, usually via the stormwater system. Overflows from the sewerage system can also occur in dry weather due to mechanical failure or power outage.

Sewer chokes occur due to blockages in the pipes usually due to tree roots, oil, grease or debris. This causes sewage to back up and escape via sewer inspection points, designed overflow structures or cracks in the pipes, then drain to waterways, usually via the stormwater system.

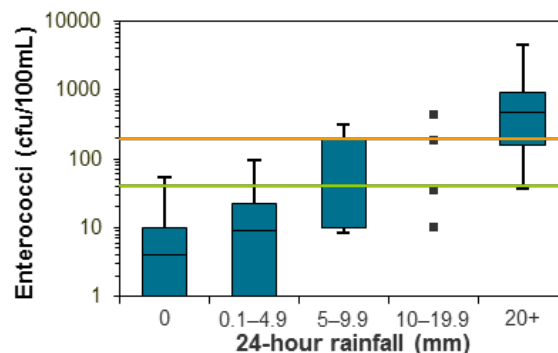
Trends in enterococci levels in response to rainfall are shown using a box plot. For reference, enterococci levels of 40 cfu/100 mL and 200 cfu/100 mL are indicated with a green and orange line, respectively. The 40 cfu/100 mL level is referred to as the 'safe swimming limit'. The enterococci data were obtained from the last five years of monitoring. Rainfall data were obtained from rain gauges situated close to the sample site and are 24-hour totals to 9am on the day of sampling. If there are fewer than five enterococci data points in a rainfall category, individual data points are presented instead of a box plot. At sites where many results are below the detection limit (1 cfu/100 mL), only the upper portion of the box plots will be visible.

Each part of the box plot represents a significant percentile value of the sample population:
