State of the beaches 2019–2020

Sydney region

Beachwatch

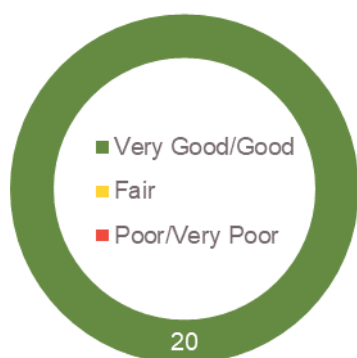
Beach Suitability Grades for Northern Sydney ocean beaches

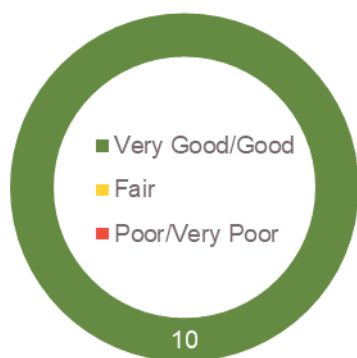
Beach Suitability Grades for Northern Sydney estuarine beaches

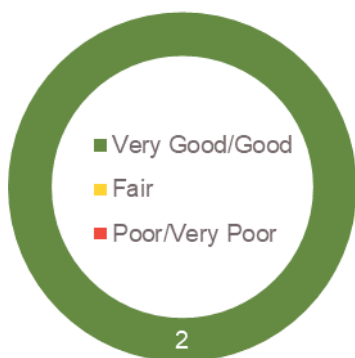
Beach Suitability Grades for Northern Sydney lake/lagoon swimming sites

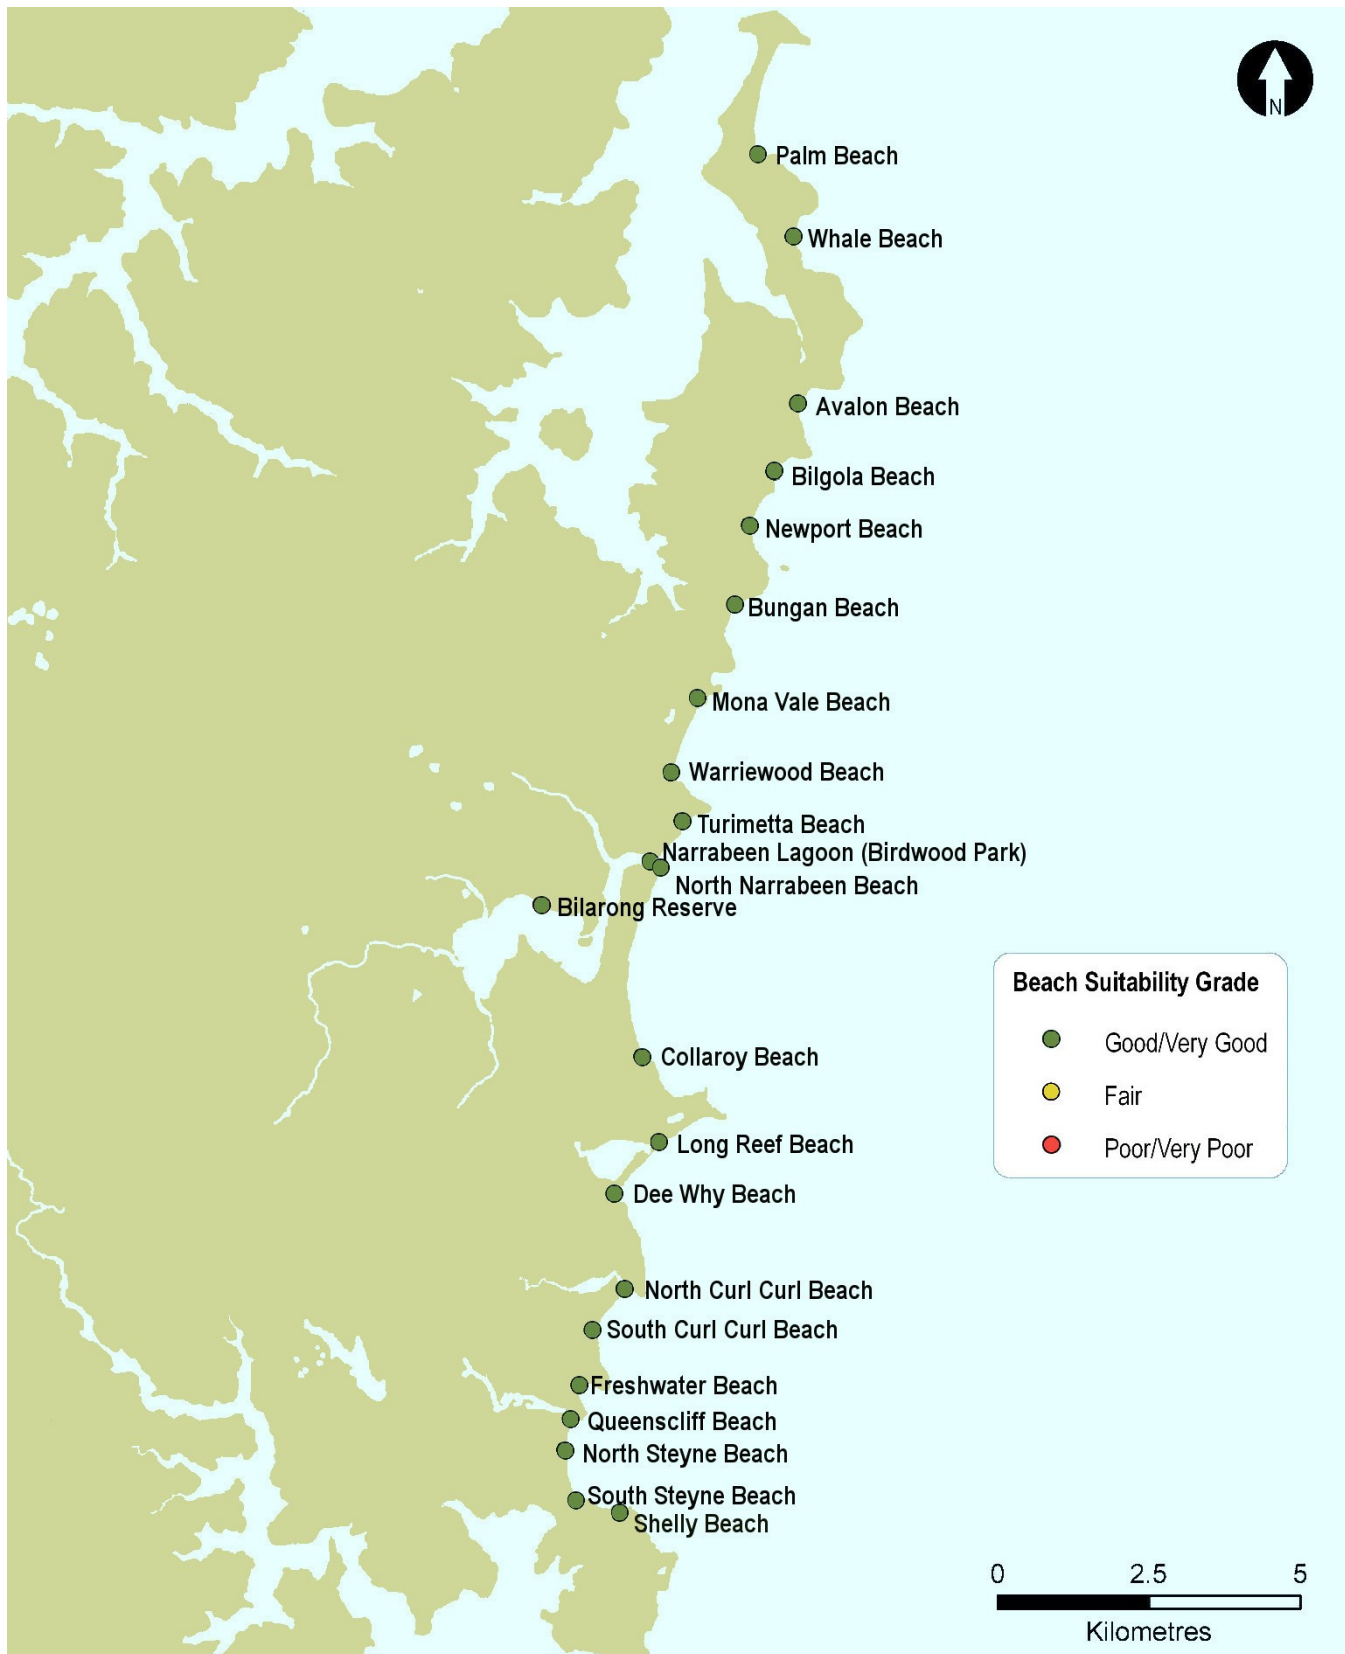
Sampling sites and Beach Suitability Grades at Sydney's Northern Beaches

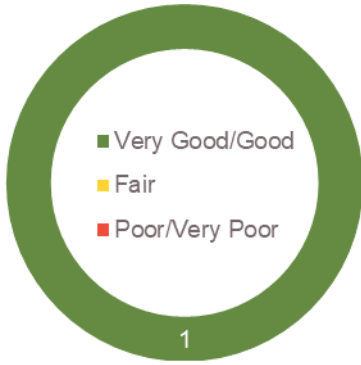
Beach Suitability Grades for Central Sydney ocean baths

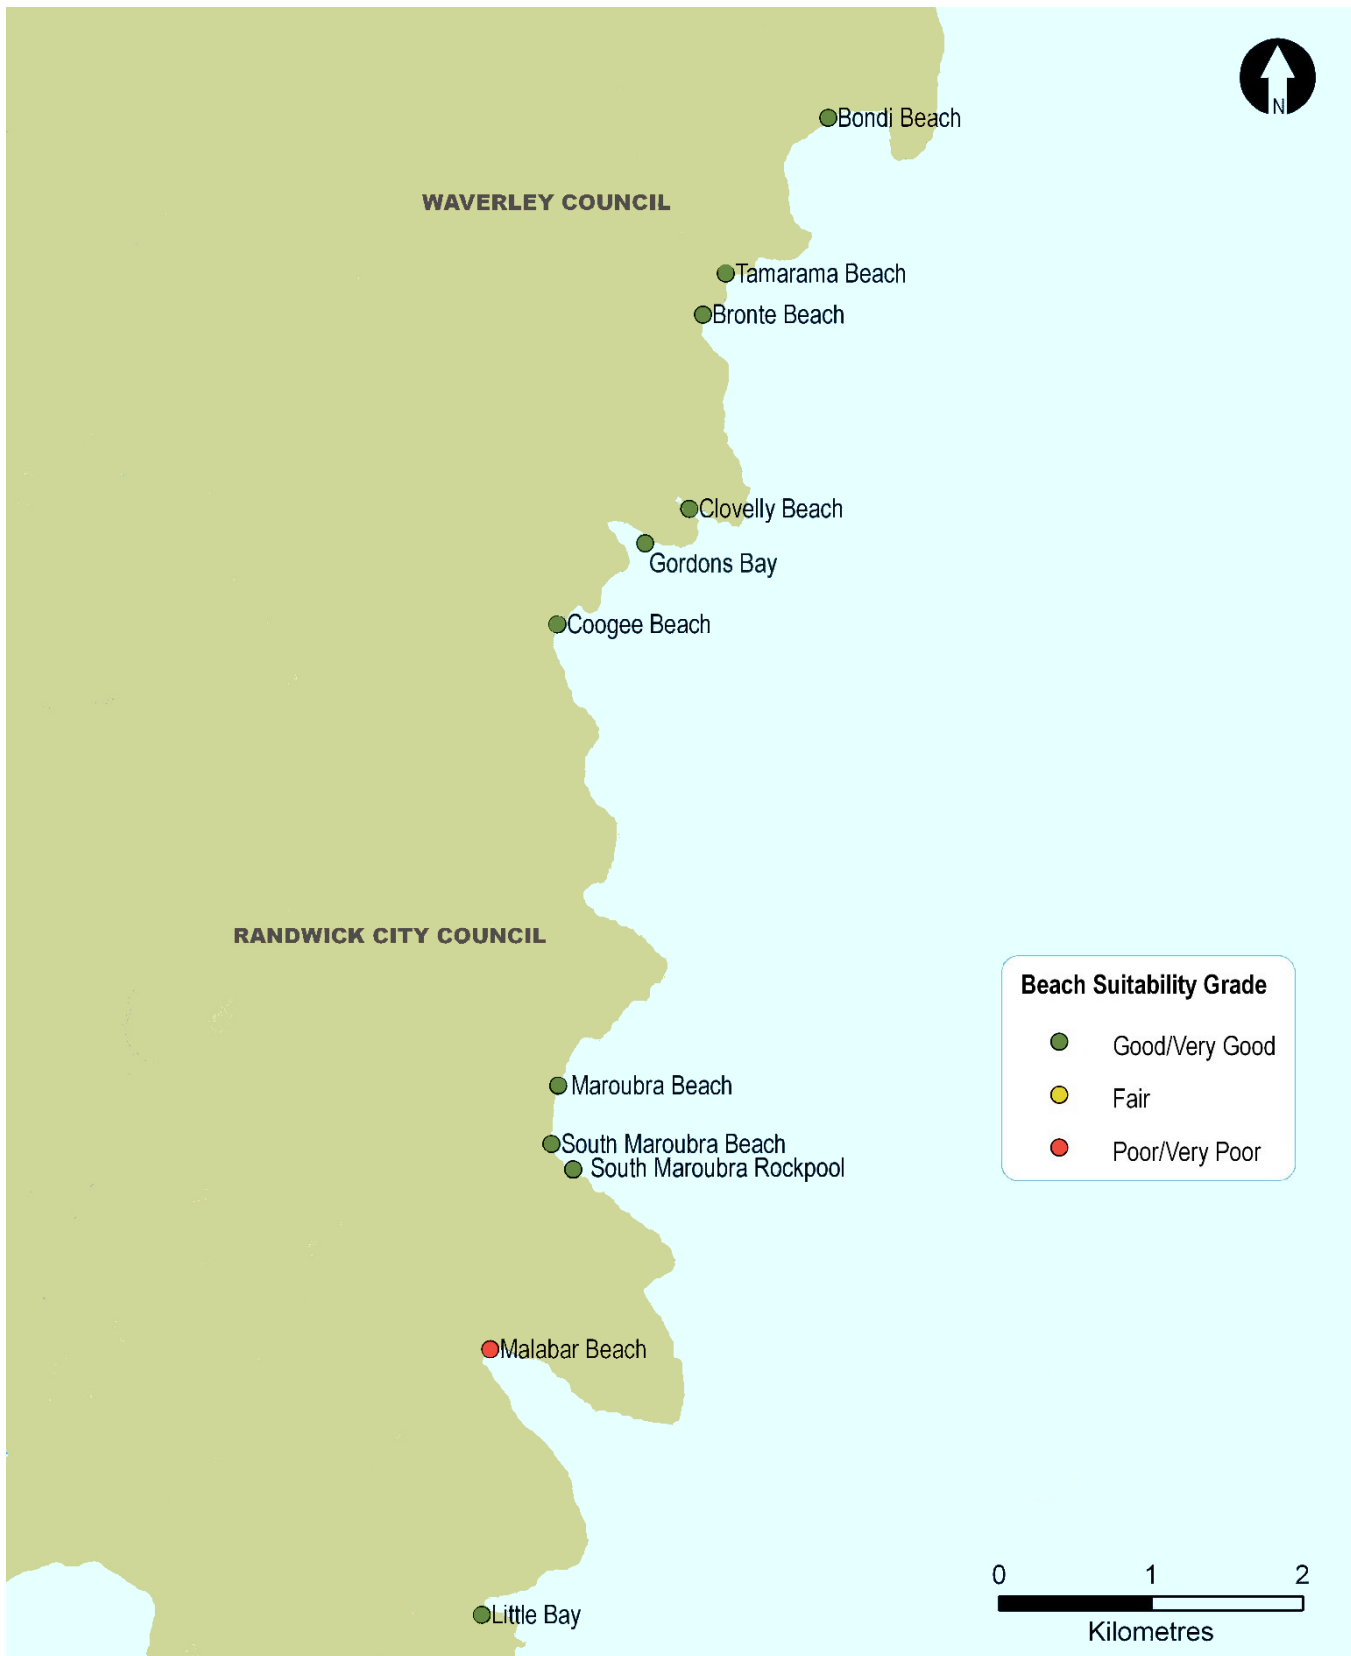
Sampling sites and Beach Suitability Grades at Sydney's central beaches

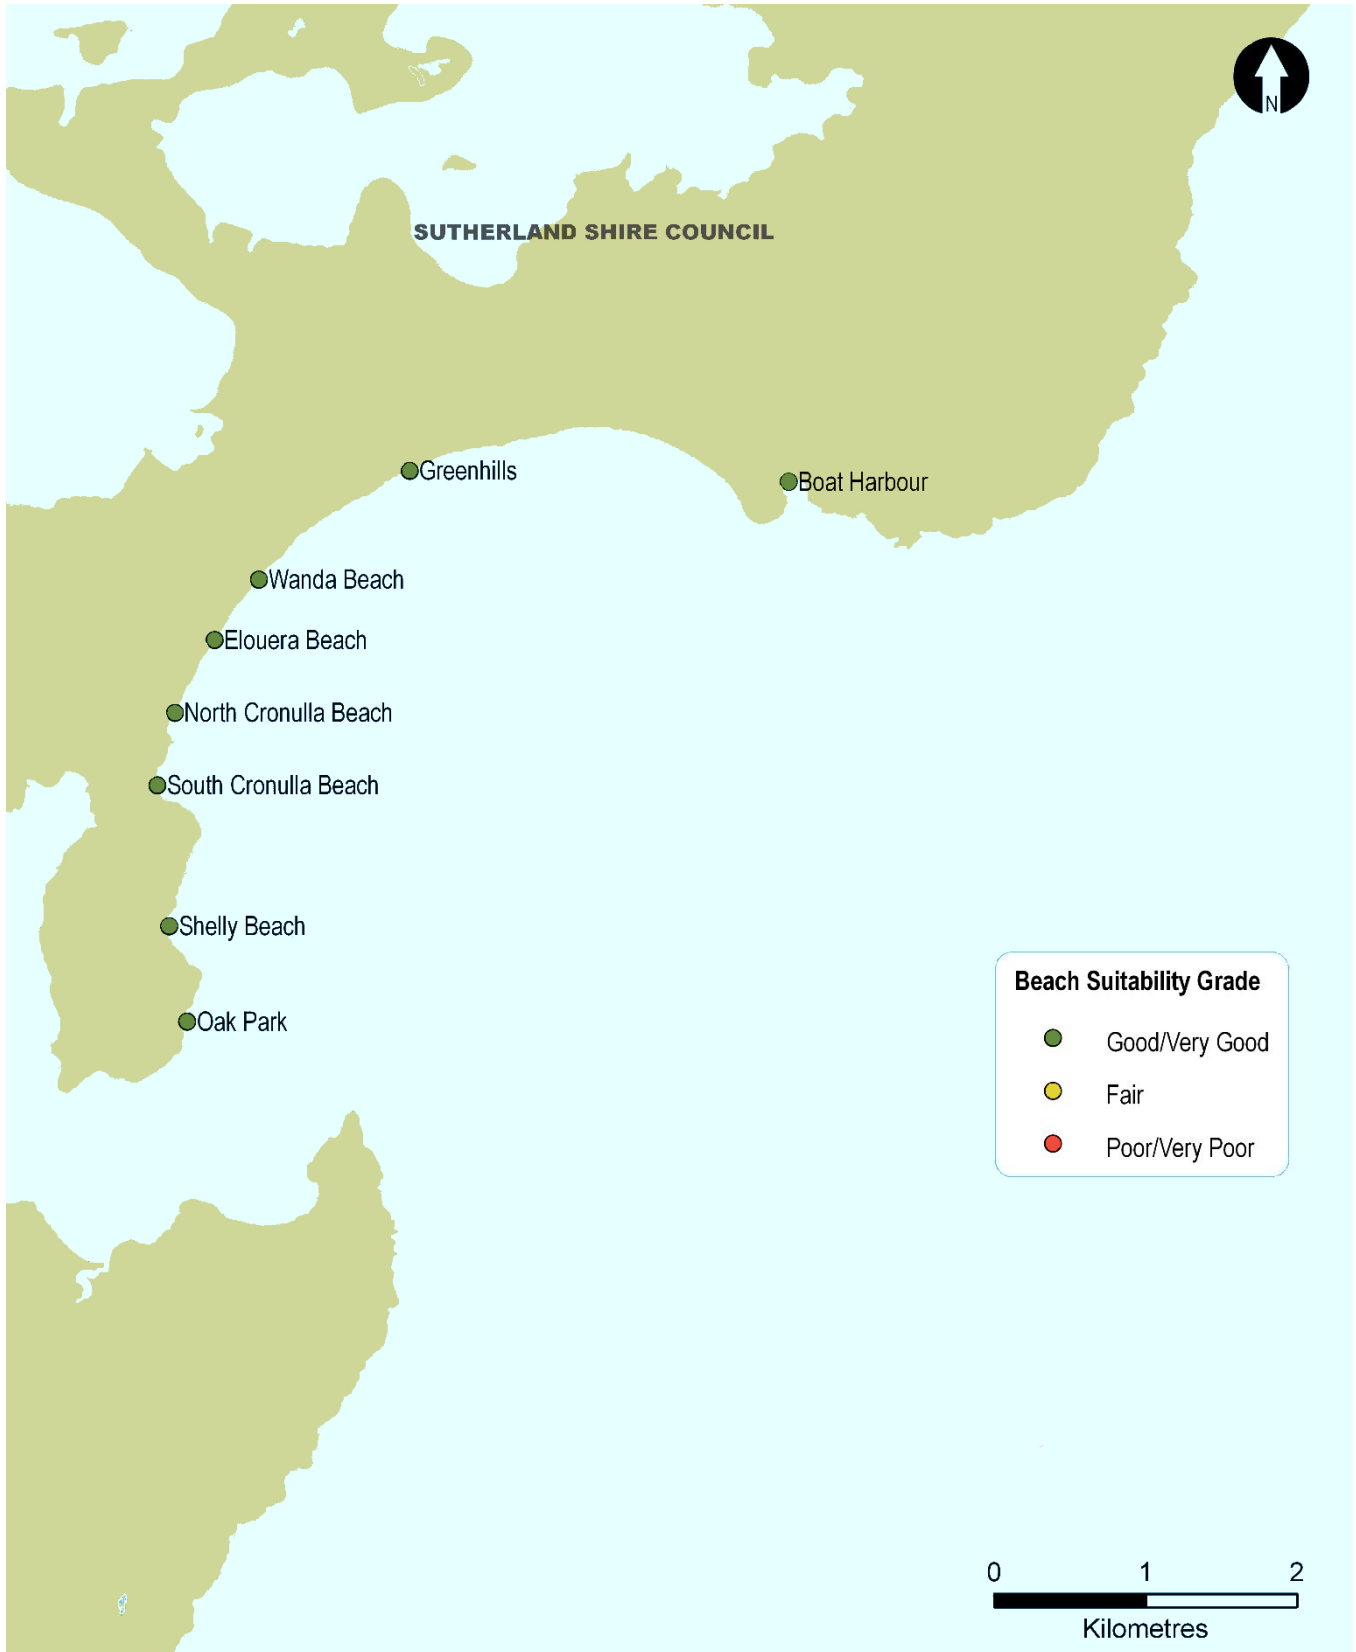
Sampling sites at Beach Suitability Grades at Sydney's Southern beaches

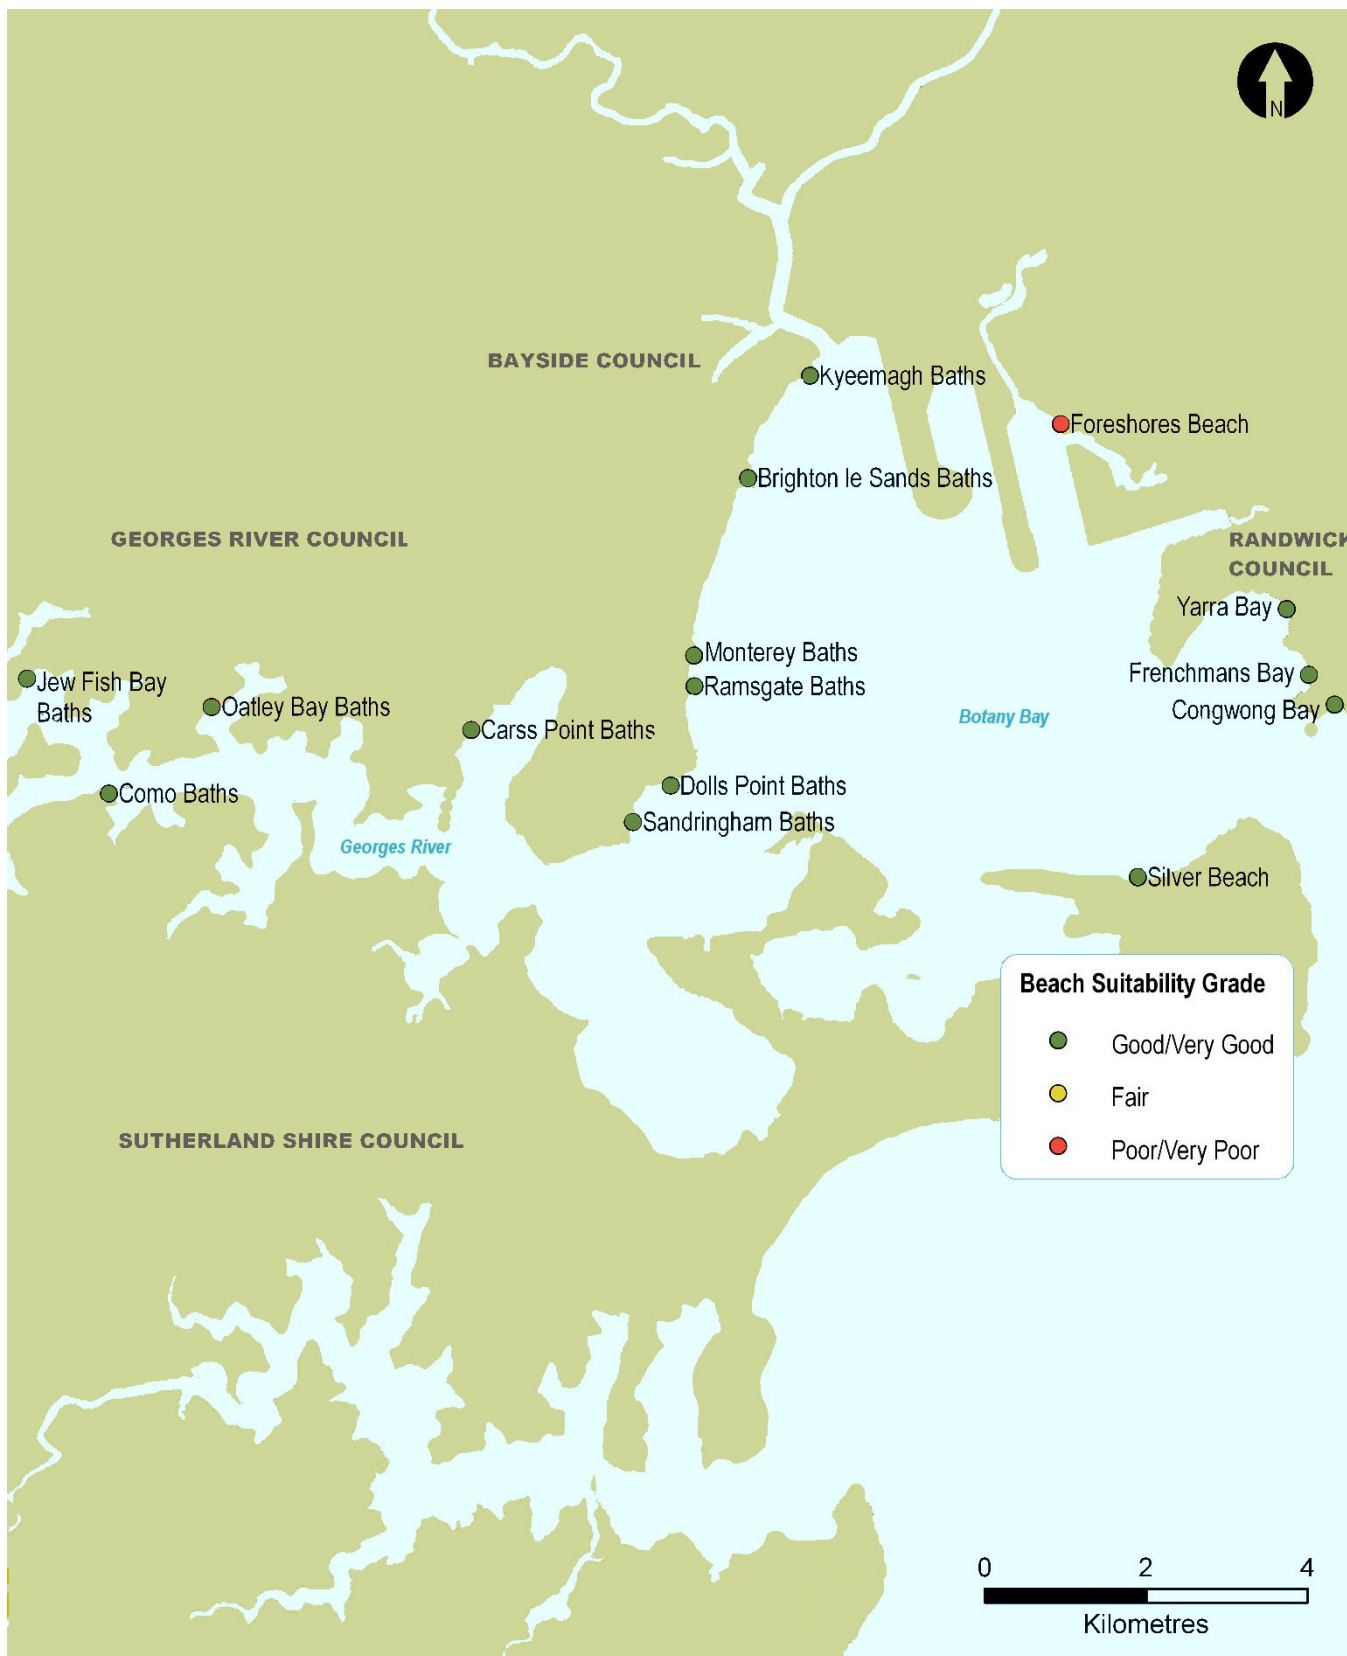
Sampling sites and Beach Suitability Grades in Botany Bay and lower Georges River

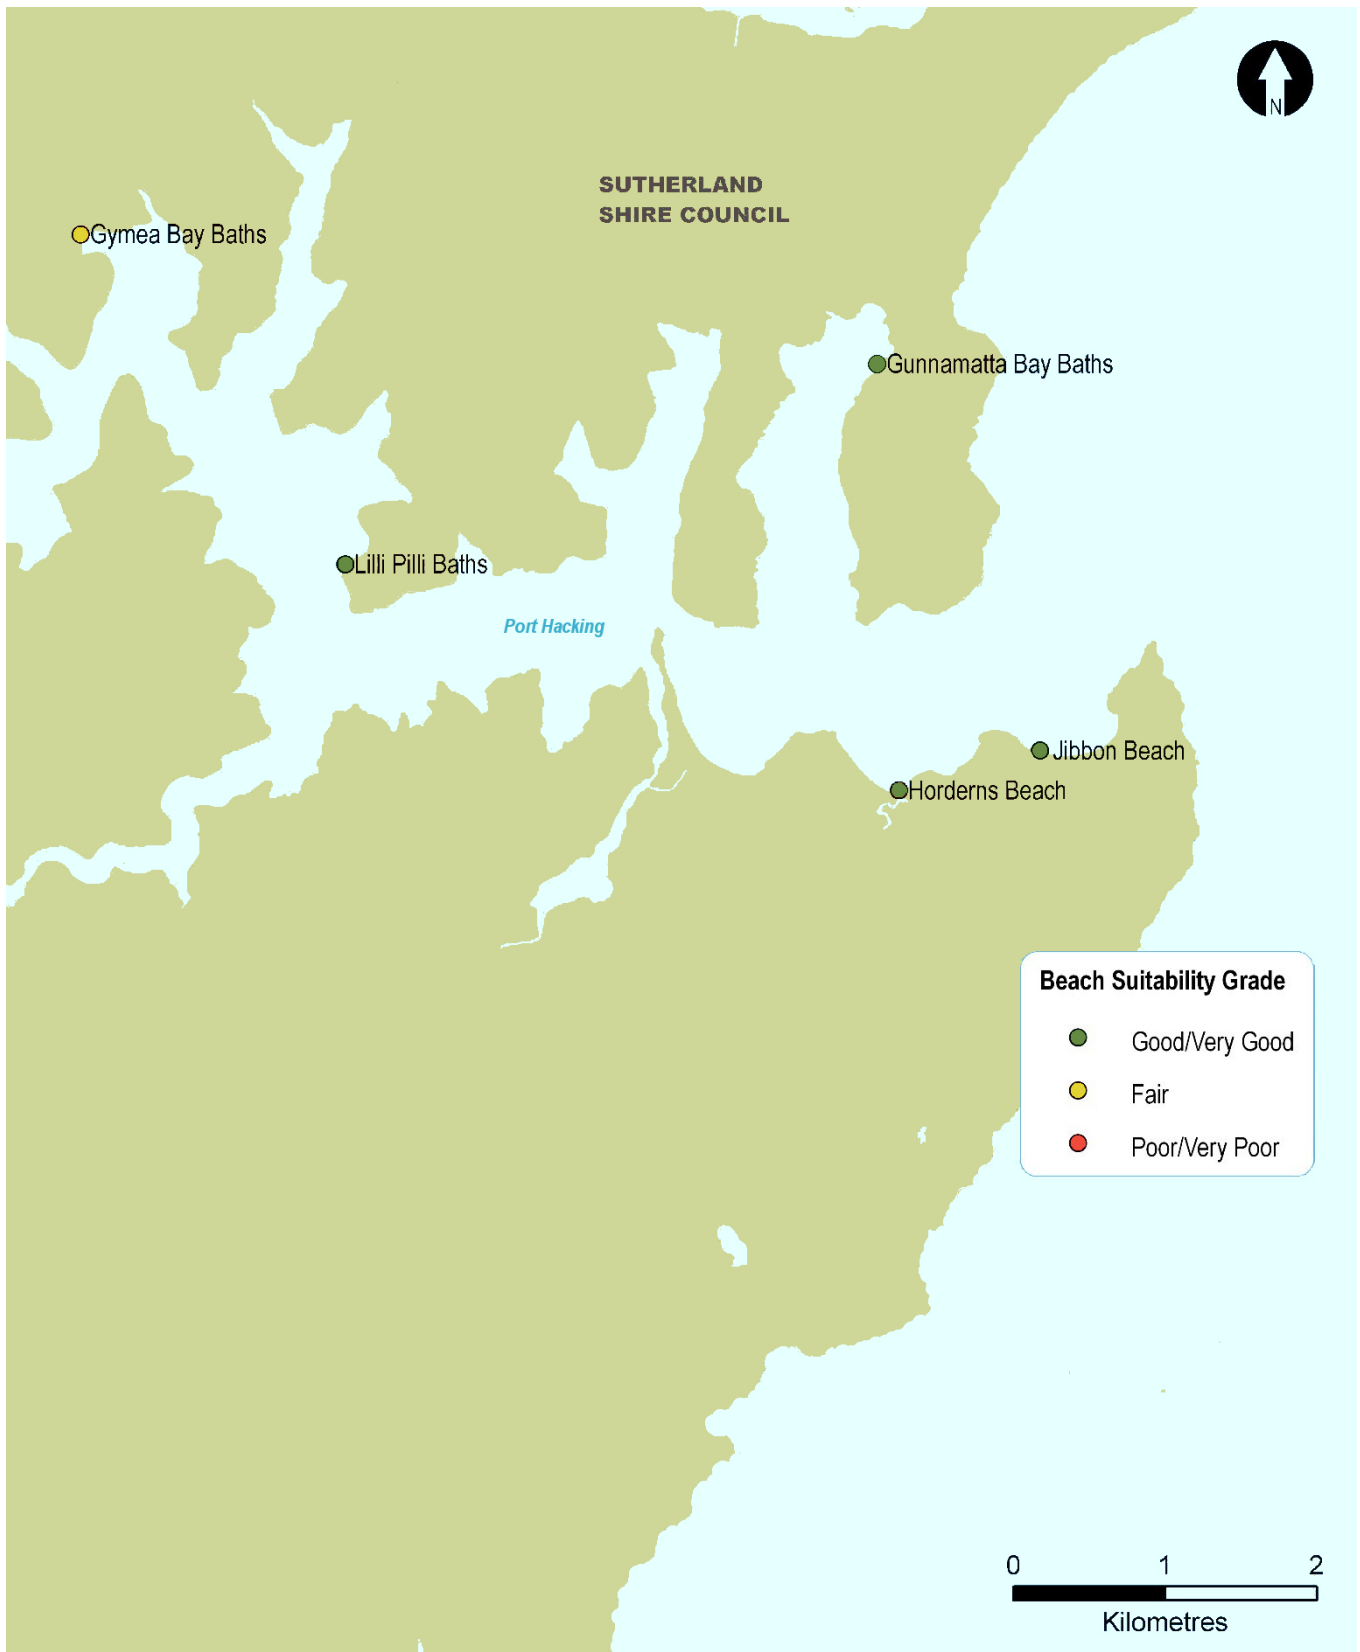
Sampling sites and Beach Suitability Grades in Port Hacking
