# State of the beaches 2020-2021

Central Coast region

## Beachwatch

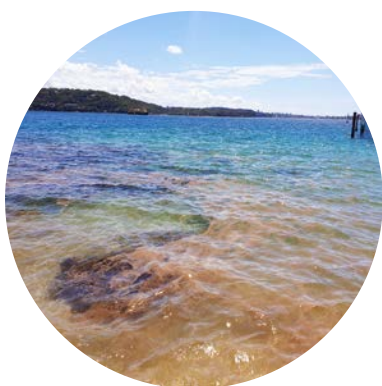
Marine algal bloom present in the water

The appearance of **marine algae** is sometimes mistaken for **sewage contamination** or **oil slicks**, due to a strong odour and red or brown discolouration in the water caused by the blooms.

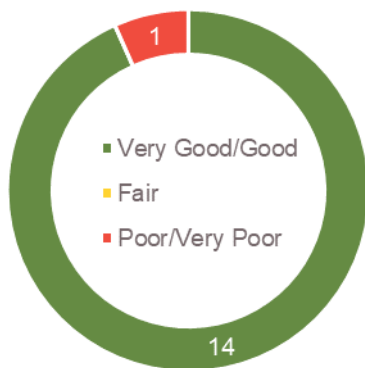
**Beach Suitability Grades for Central Coast ocean beaches**

Fourteen of the 15 ocean beaches were graded as Good: Lakes Beach, Soldiers Beach, North Entrance Beach, The Entrance Beach, Toowoan Bay, Shelly Beach, Wamberal Beach, North Avoca Beach, Avoca Beach, Copacabana Beach, MacMasters Beach, Killcare Beach, Ocean Beach and Umina Beach. Soldiers Beach, MacMasters Beach, Killcare Beach and Umina Beach declined to Good from Very Good in 2019–2020. Water quality at these sites is suitable for swimming most of the time but can be susceptible to pollution following rainfall.

Terrigal Beach was graded as Poor, a decline from Good in the previous year. Water quality at this beach was mostly suitable for swimming in dry weather conditions, with 87% of dry weather samples within the safe swimming limit. However, elevated enterococci levels were occasionally recorded after little or no rain, and often after light rain. While the microbial water quality at Terrigal Beach has shown a decline in performance this year, it remains close to the threshold between Good and Poor, and the site has fluctuated between Good and Poor for several years. The decline in water quality reflects a higher proportion of samples collected at Terrigal Beach during wet weather compared to the 2019–2020 assessment period.

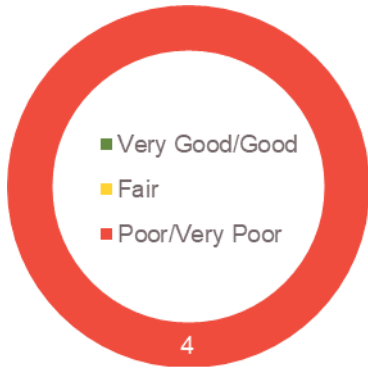
**Beach Suitability Grades for Central Coast estuarine beaches**

Microbial water quality at Yattalunga Baths was mostly suitable for swimming during dry weather conditions, with 79% of samples within the safe swimming limit when no rain had fallen in the previous 24 hours. Elevated enterococci levels were often recorded following light rainfall, and generally increased in response to increasing rainfall.

Microbial water quality at Davistown Baths, Pretty Beach Baths and Woy Woy Baths was often elevated during dry and wet weather conditions. At these sites, the bacterial levels continued to increase significantly in response to increasing rainfall.

The estuarine beaches may be impacted by several significant potential sources of faecal contamination including stormwater and other sources within Brisbane Water, and have low levels of flushing. Further investigation is required to show the scale and extent of the problem, and the source of microbial contamination.

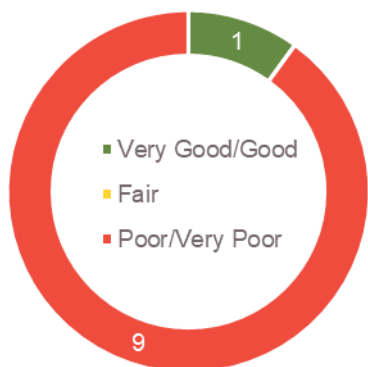
**Beach Suitability Grades for Central Coast lake/lagoon swimming sites**

Summerland Point Baths was graded as Good, a similar result to the previous year. Water quality at this site was mostly suitable for swimming during dry weather conditions, with 85% of samples within the safe swimming limit when no rain had fallen in the previous 24 hours.

Microbial water quality at Gwandalan, Chain Valley Bay, Mannering Park Baths and Canton Beach was often unsuitable for swimming during dry and wet weather conditions, with enterococci levels increasing significantly with increasing rainfall. Further investigation is required to show the scale and extent of the problem, and the source of microbial contamination at poorer performing sites.

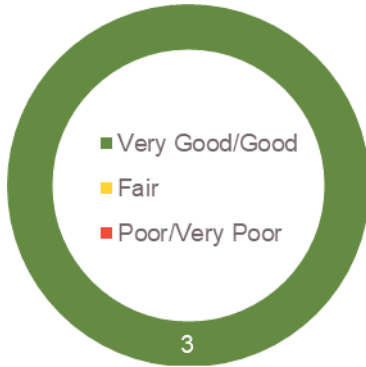
**Beach Suitability Grades for Central Coast ocean baths**

Cabbage Tree Bay Rockpool, The Entrance Ocean Baths and Pearl Beach Rockpool were graded as Good in 2020–2021, consistent with the previous year. Water quality at these sites was suitable for swimming most of the time but can be impacted by pollution following rain.

The Entrance Ocean Baths was generally suitable for swimming during dry and wet weather conditions. Cabbage Tree Bay Rockpool and Pearl Beach Rockpool were mostly suitable for swimming after little or no rain, with elevated levels of enterococci mostly recorded following heavy rainfall.

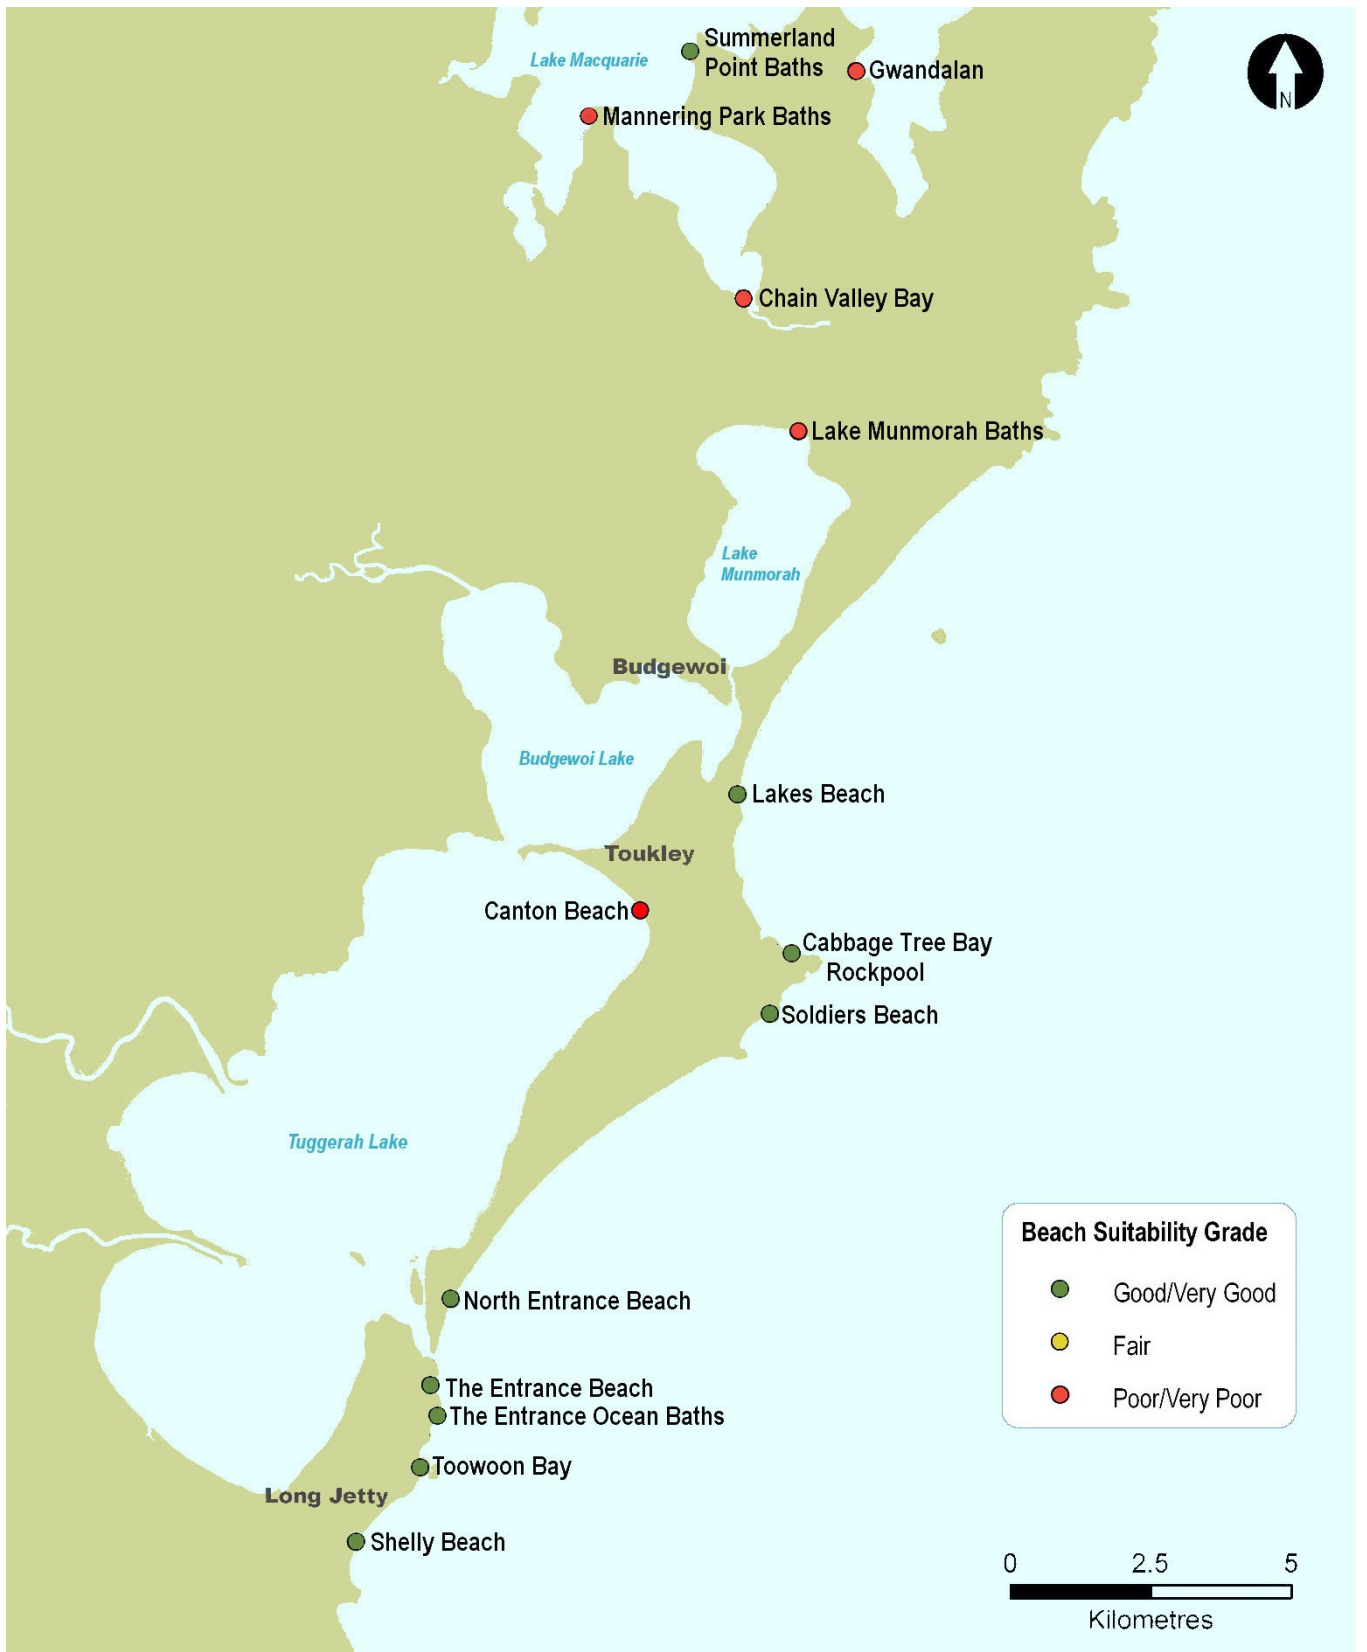
Sampling sites and Beach Suitability Grades in Central Coast Council (northern)

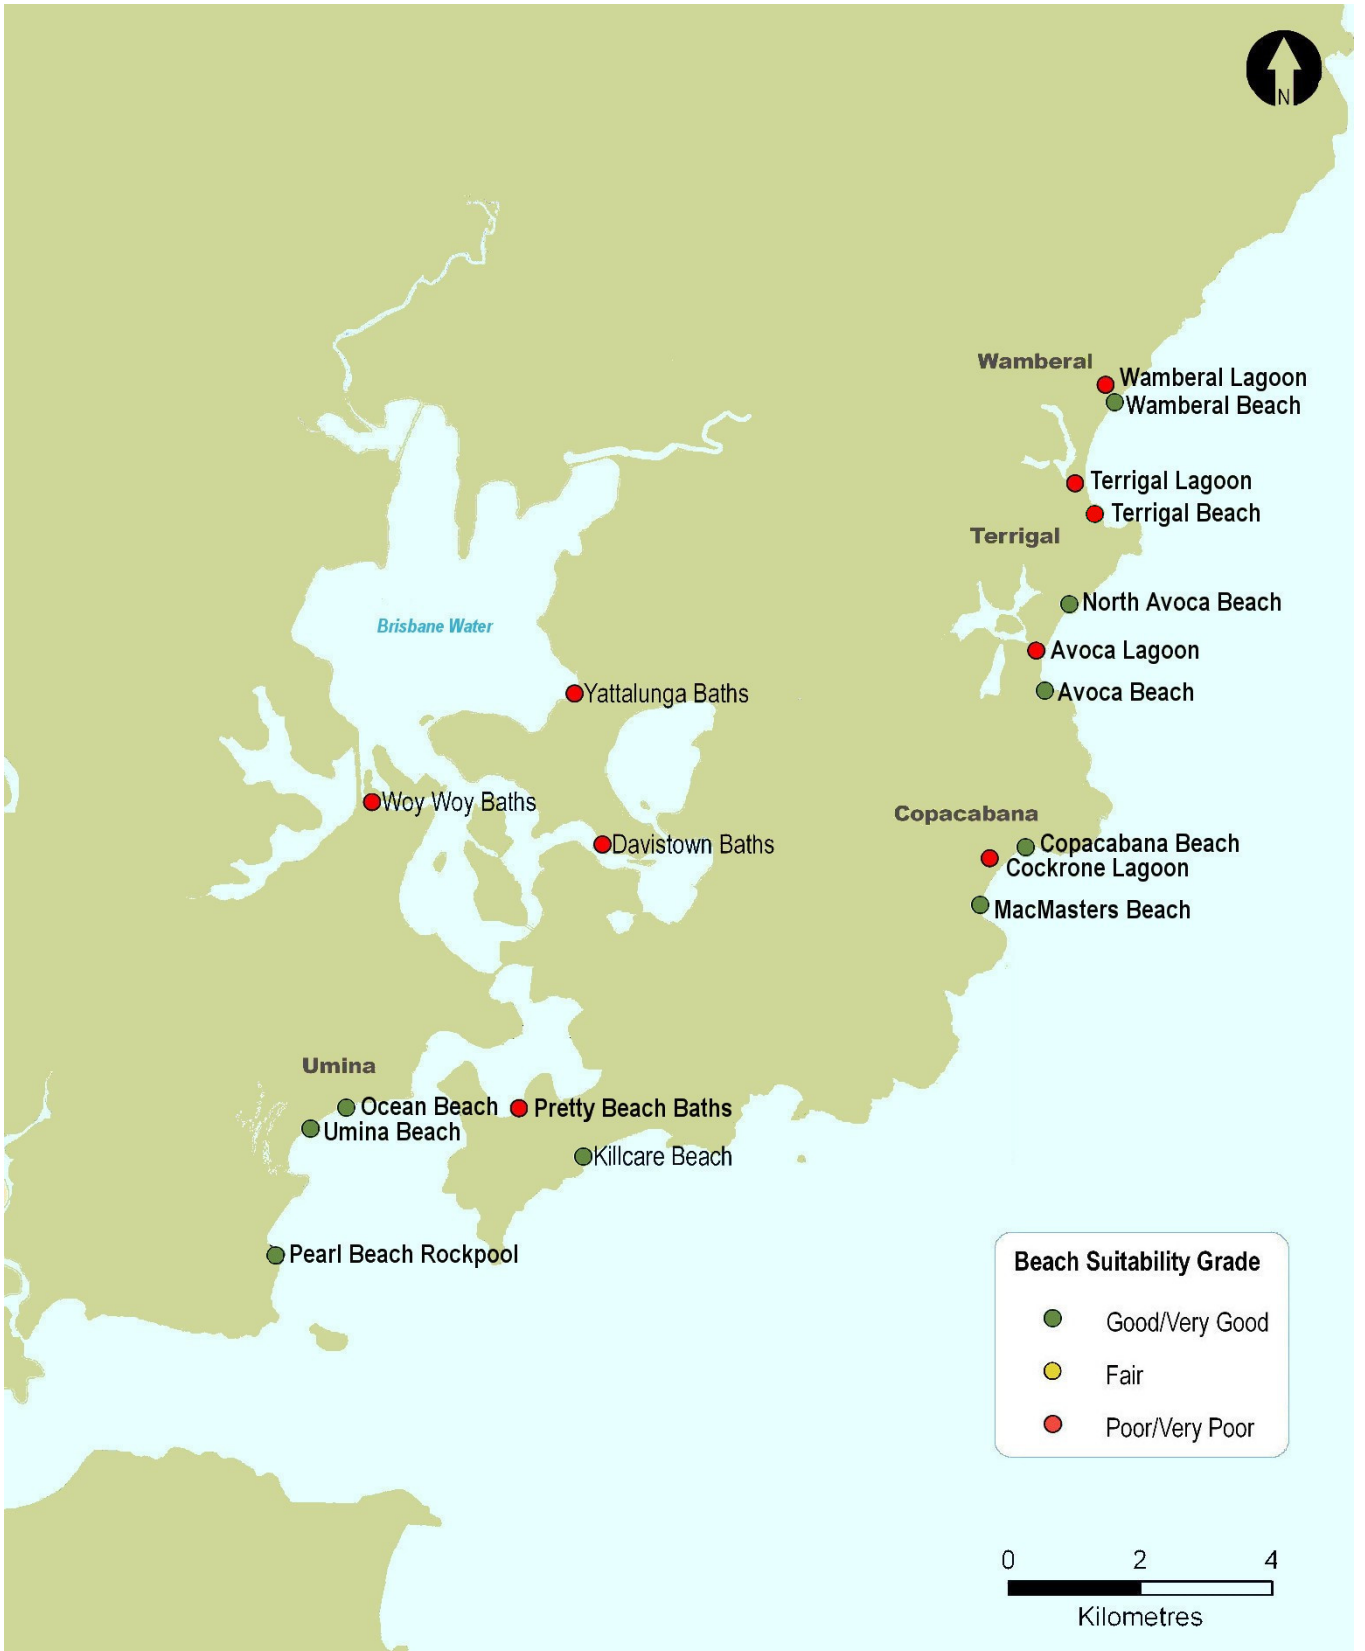
Sampling sites and Beach Suitability Grades in Central Coast Council (southern)

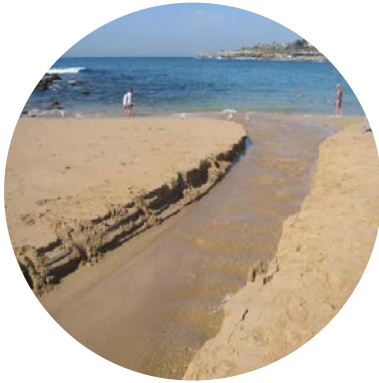
Stormwater at Coogee Beach  
Photo: Beachwatch/EES, DPIE

Stormwater in urban areas often contains sewage from leakages, overflows or sewer chokes when the sewerage system fails.

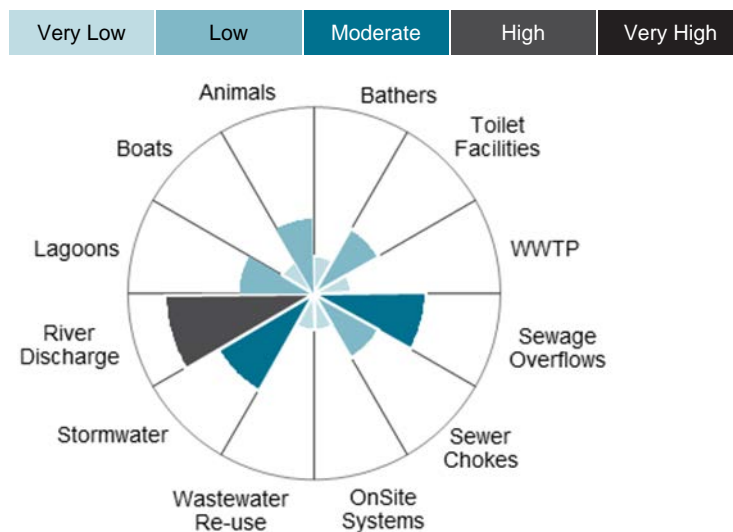
### Sanitary Inspection Category (SIC) chart

The results of the sanitary inspection for each swimming location are presented in a radar pie chart. The chart shows the likelihood that each identified pollution source will contribute to faecal contamination at a swimming site, as indicated by the size and colour of the segment, ranging from very low (lightest colour) to very high (darkest colour) as shown below. The sum of these contributions is the overall likelihood, or Sanitary Inspection Category.

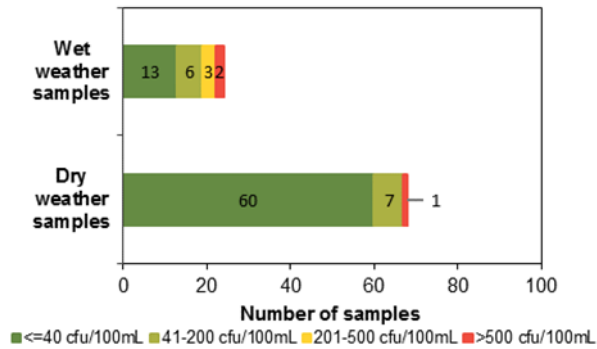
### Wet and dry weather water quality chart

coloured on the graph as dark green, light green, amber and red respectively.

It is expected that swimming sites with lower levels of flushing will show some elevated bacterial results in dry weather samples (no rainfall in the previous 24 hours) due to the longer time needed to recover from a rainfall event. At some estuarine and lake/lagoon swimming locations the impacts of stormwater pollution on beach water quality may be detected up to three days after rainfall.

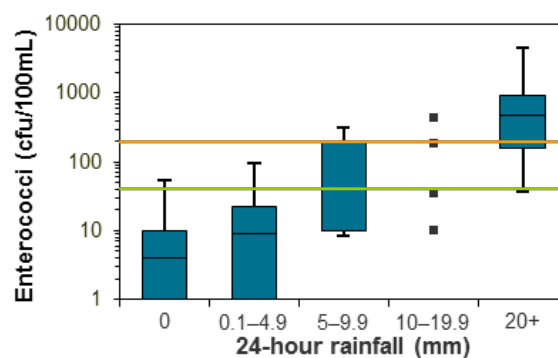
### Water quality in response to rainfall

Trends in enterococci levels in response to rainfall are shown using a box plot. For reference, enterococci levels of 40 cfu/100 mL and 200 cfu/100 mL are indicated with a green and orange line, respectively. The 40 cfu/100 mL level is referred to as the 'safe swimming limit'. The enterococci data were obtained from the last five years of monitoring. Rainfall data were obtained from rain gauges situated close to the sample site and are 24-hour totals to 9am on the day of sampling. If there are fewer than five enterococci data points in a rainfall category, individual data points are presented instead of a box plot. At sites where many results are below the detection limit (1 cfu/100 mL), only the upper portion of the box plots will be visible.

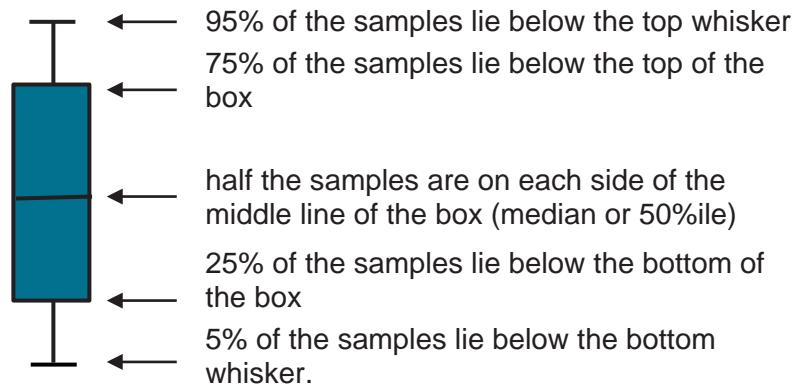
Each part of the box plot represents a significant percentile value of the sample population:
