Department of Planning, Industry and Environment

State of the beaches 2020-2021

Hunter region

Beachwatch

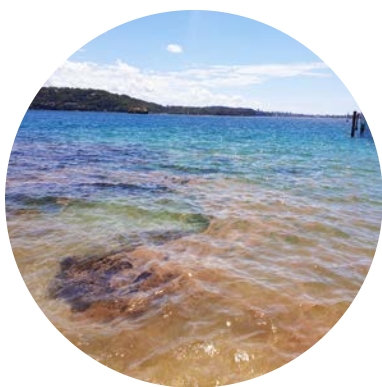
Marine algal bloom present in the water
Photo: Chad Weston/NPWS, DPIE

Water NSW received reports of widespread marine algal blooms from Newcastle to The Entrance in early November 2020 that may have impacted beaches in the Hunter region. The blooms' appearance was consistent with the genus *Trichodesmium*. Marine algae advisories were issued on the Water NSW website.

The appearance of **marine algae** is sometimes mistaken for **sewage contamination** or **oil slicks**, due to a strong odour and red or brown discolouration in the water caused by the blooms.

As a precaution, direct contact with algae should be avoided as it can cause skin and eye irritations. The marine algal blooms dissipated with changes in tide and wind conditions.

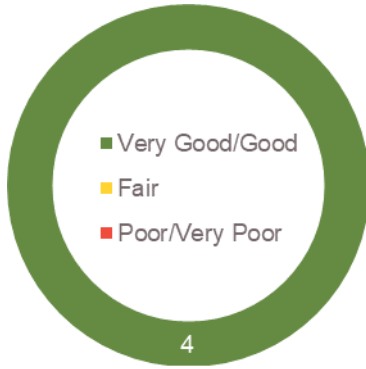
Beach Suitability Grades for Port Stephens Council ocean beaches

All four ocean beaches were graded as Very Good in 2020–2021: Zenith Beach, Box Beach, Fingal Beach and One Mile Beach. Water quality at these sites has continued to be of a high standard and was suitable for swimming almost all of the time.

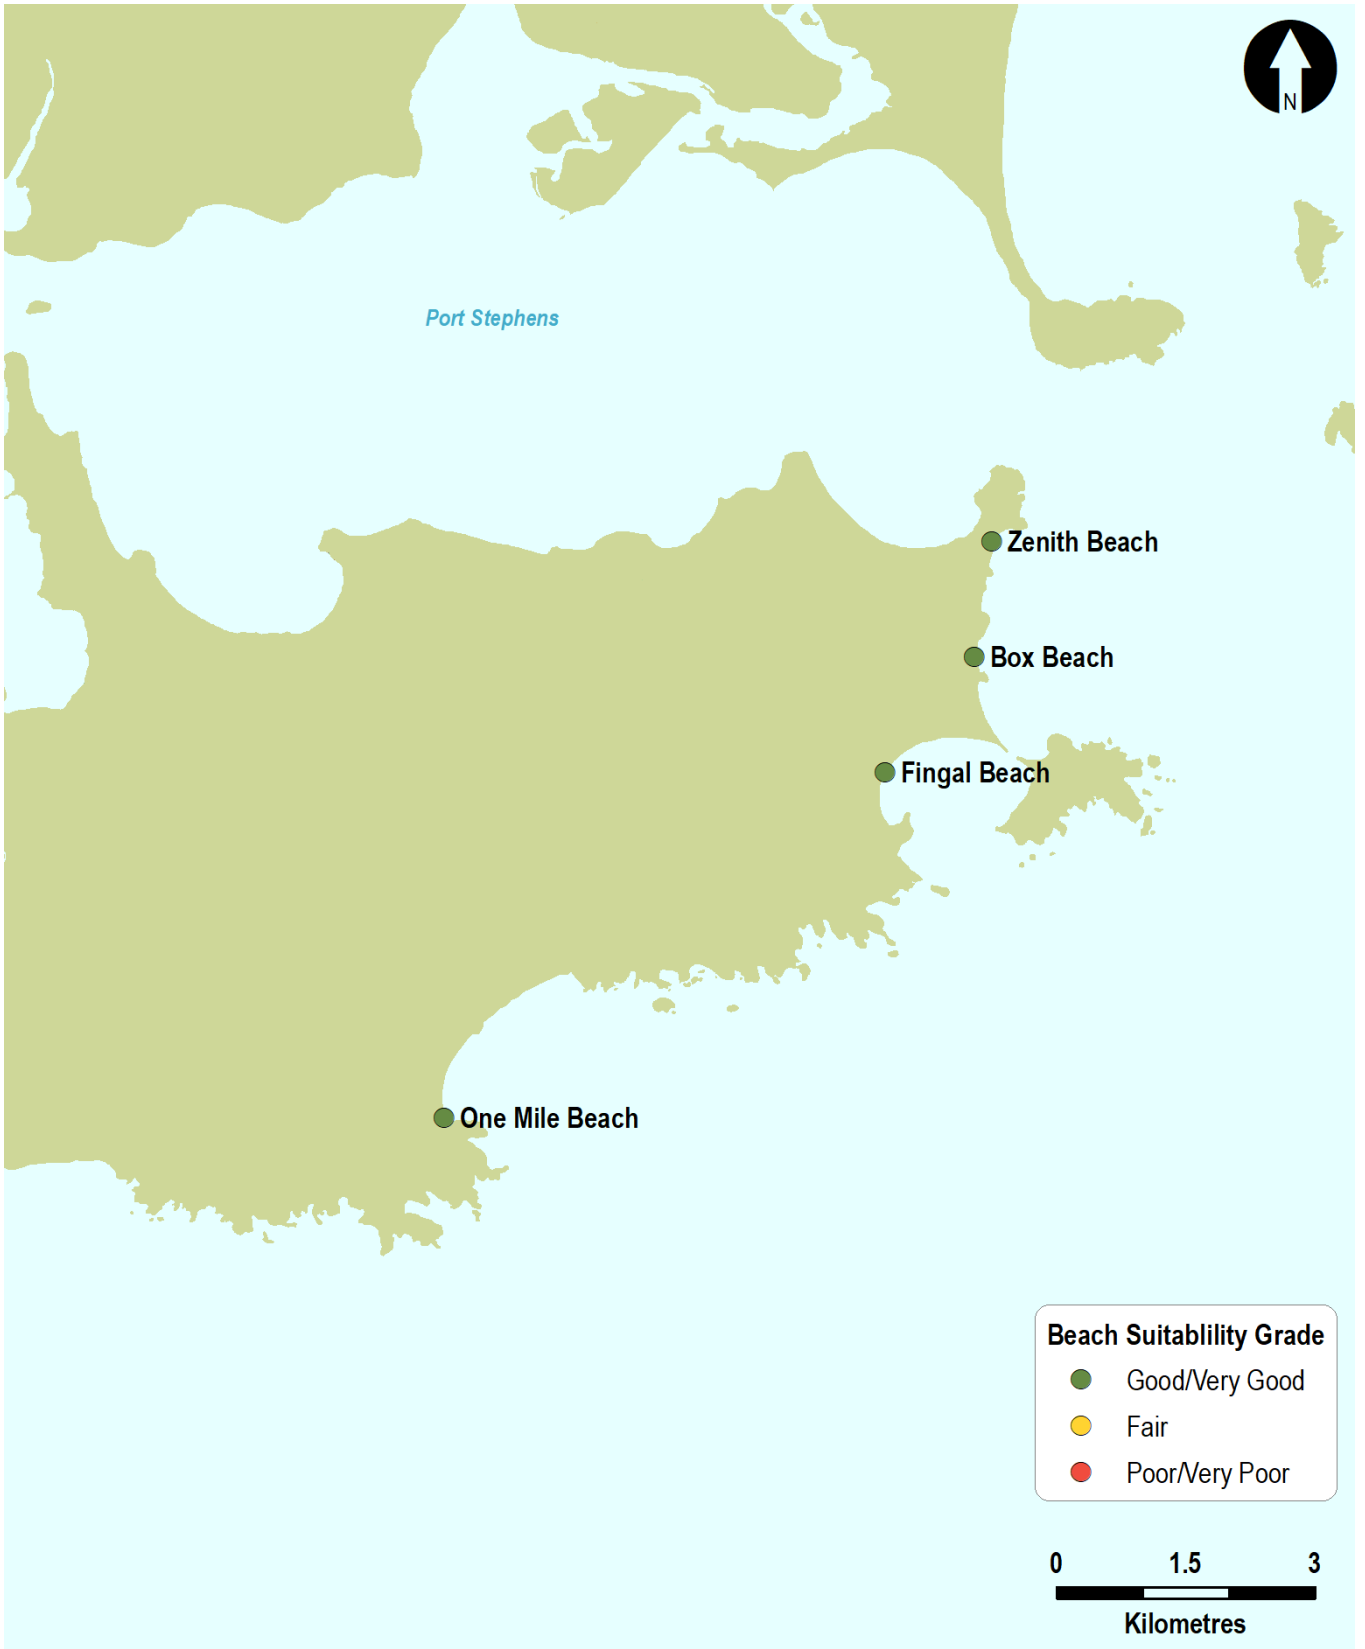
Sampling sites and Beach Suitability Grades in Port Stephens Council

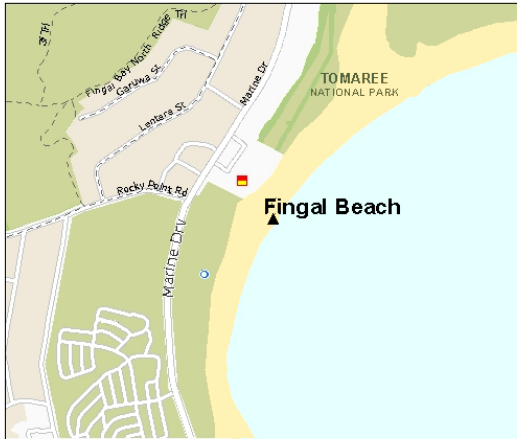
Fingal Beach is approximately 2.7 kilometres long and within Fingal Bay. The beach is patrolled from September to April.

The Beach Suitability Grade of Very Good indicates microbial water quality is considered suitable for swimming almost all of the time, with few potential sources of faecal contamination.

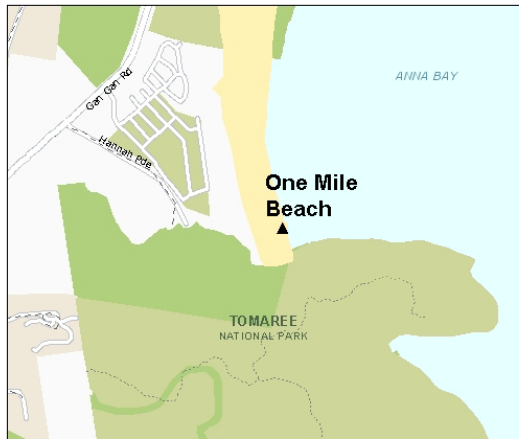
One Mile Beach

This 1.3 kilometre stretch of beach is at the southern end of Anna Bay and is patrolled from September to April.

The Beach Suitability Grade of Very Good indicates microbial water quality is considered suitable for swimming almost all of the time, with few potential sources of faecal contamination.

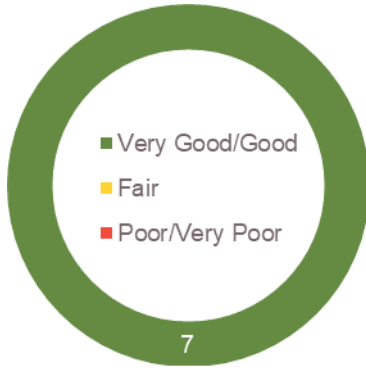
Beach Suitability Grades for City of Newcastle Council ocean beaches

Five of the seven ocean beaches were graded as Very Good in 2020–2021: South Stockton Beach, Nobbys Beach, Newcastle Beach, Bar Beach and Burwood North Beach. Water quality at these sites has been consistently excellent for many years and is suitable for swimming almost all of the time.

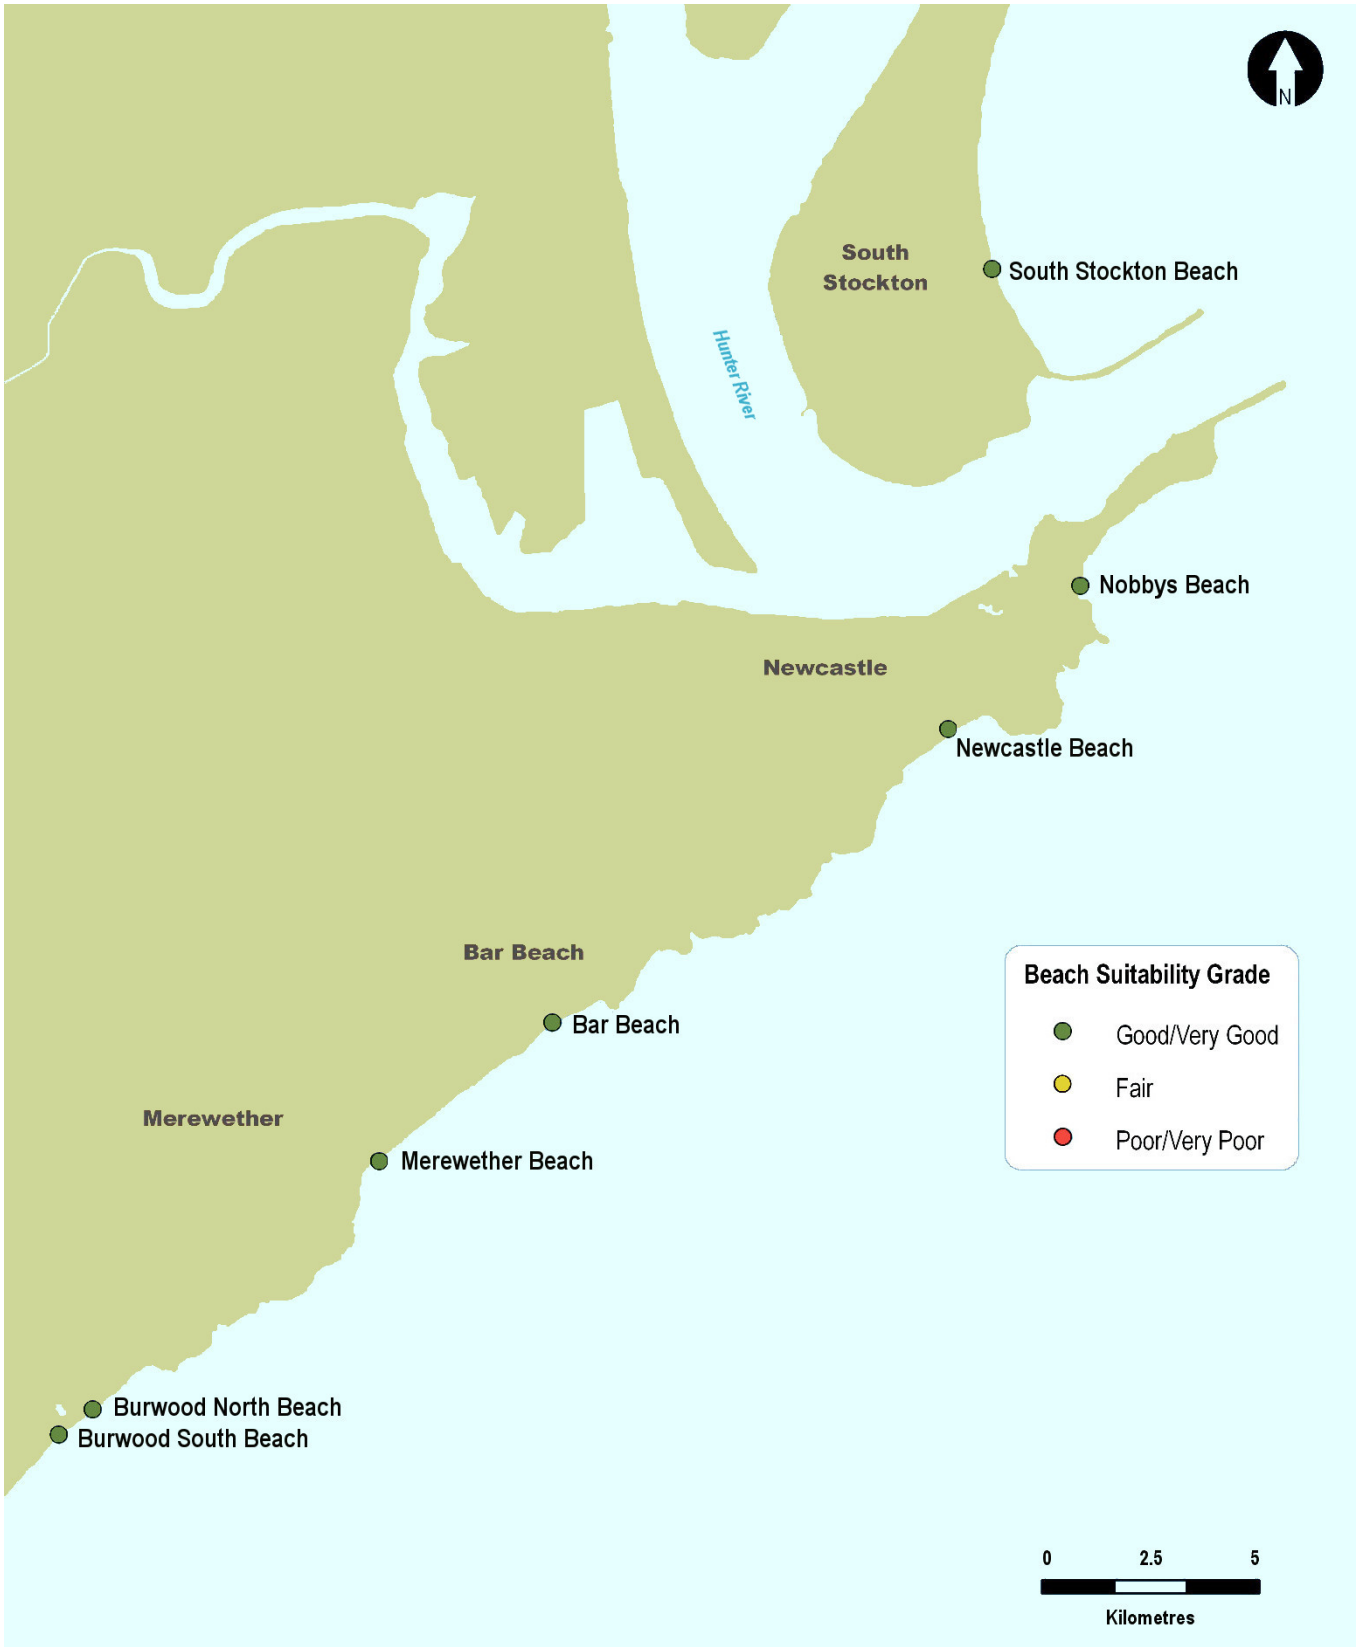
Sampling sites and Beach Suitability Grades in City of Newcastle Council

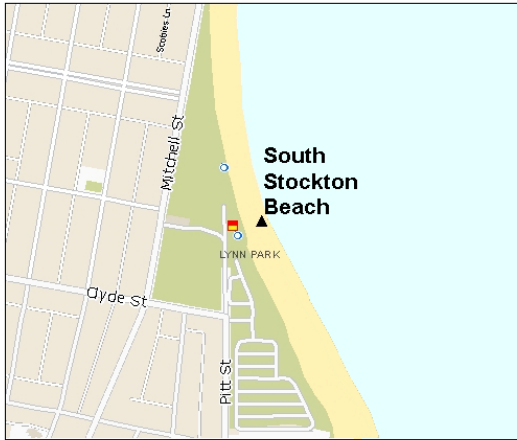
South Stockton Beach is at the southern end of a 32 kilometre stretch of beach and is patrolled from September to April.

The Beach Suitability Grade of Very Good indicates microbial water quality is considered suitable for swimming almost all of the time, with few potential sources of significant faecal contamination.

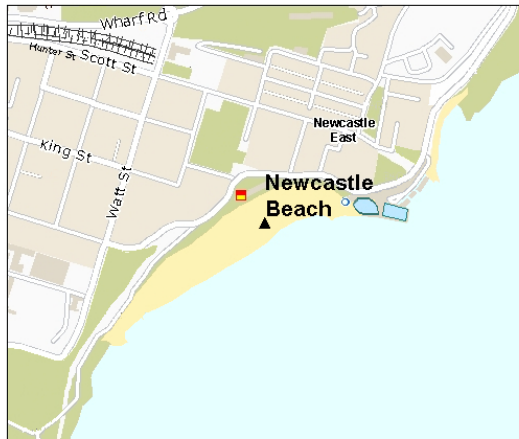
Newcastle Beach is approximately 650 metres long and is patrolled from September to April.

The Beach Suitability Grade of Very Good indicates microbial water quality is considered suitable for swimming almost all of the time, with few potential sources of faecal contamination.

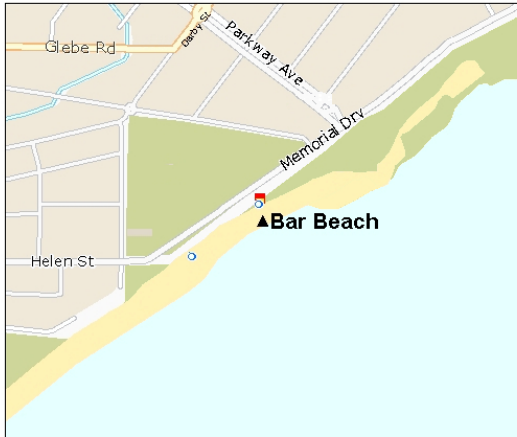
Bar Beach is approximately 500 metres long and is patrolled all year round.

The Beach Suitability Grade of Very Good indicates microbial water quality is considered suitable for swimming almost all of the time, with few potential sources of faecal contamination.

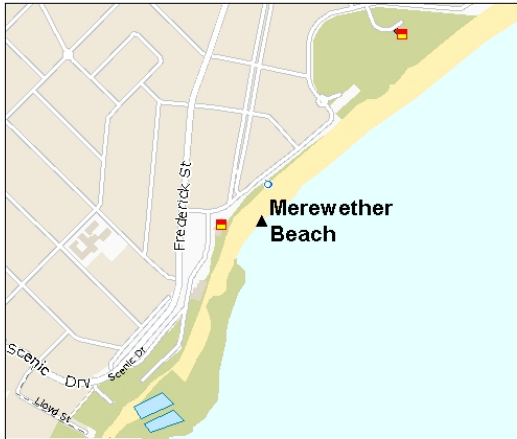
Merewether Beach is at the southern end of a 900 metre stretch of beach and is patrolled year round.

The Beach Suitability Grade of Good indicates microbial water quality is considered suitable for swimming most of the time but can be susceptible to pollution after heavy rain, with several potential sources of minor faecal contamination.

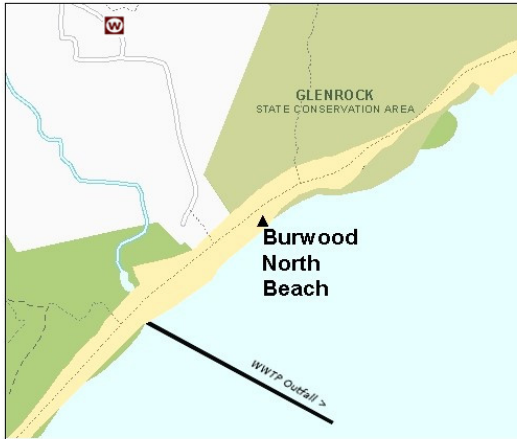
Burwood North Beach is at the northern end of an 800 metre stretch of beach and is not patrolled by lifeguards.

The Beach Suitability Grade of Very Good indicates microbial water quality is considered suitable for swimming almost all of the time with few potential sources of faecal contamination.

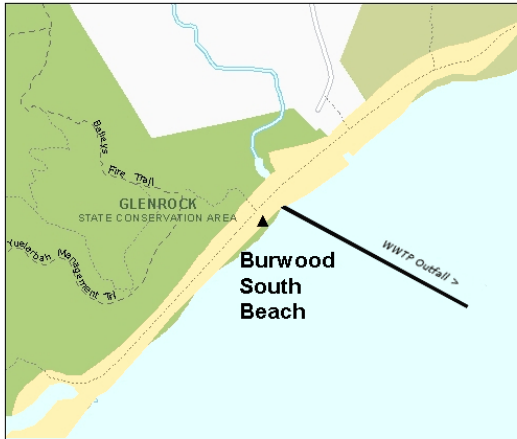
Burwood South Beach is located at the southern end of an 800 metre stretch of beach and is not patrolled by lifeguards.

The Beach Suitability Grade of Good indicates microbial water quality is considered suitable for swimming most of the time but can be susceptible to pollution after heavy rain, with several potential sources of faecal contamination.

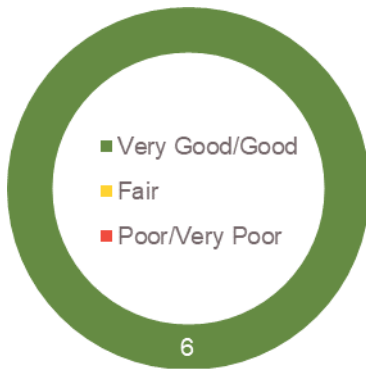
Beach Suitability Grades for Lake Macquarie City Council ocean beaches

Four of the six ocean beaches were graded as Very Good in 2020–2021: Dudley Beach, Redhead Beach, Blacksmiths Beach and Caves Beach. The water quality at these beaches is suitable for swimming almost all of the time.

Swansea Heads Little Beach improved to Good in 2020–2021 from a Poor grade the previous year. While the water quality was mostly suitable for swimming during dry weather conditions, with 90% of dry weather samples within the safe swimming limit, elevated levels occasionally exceeded the safe swimming limit in dry weather conditions and often following light rainfall.

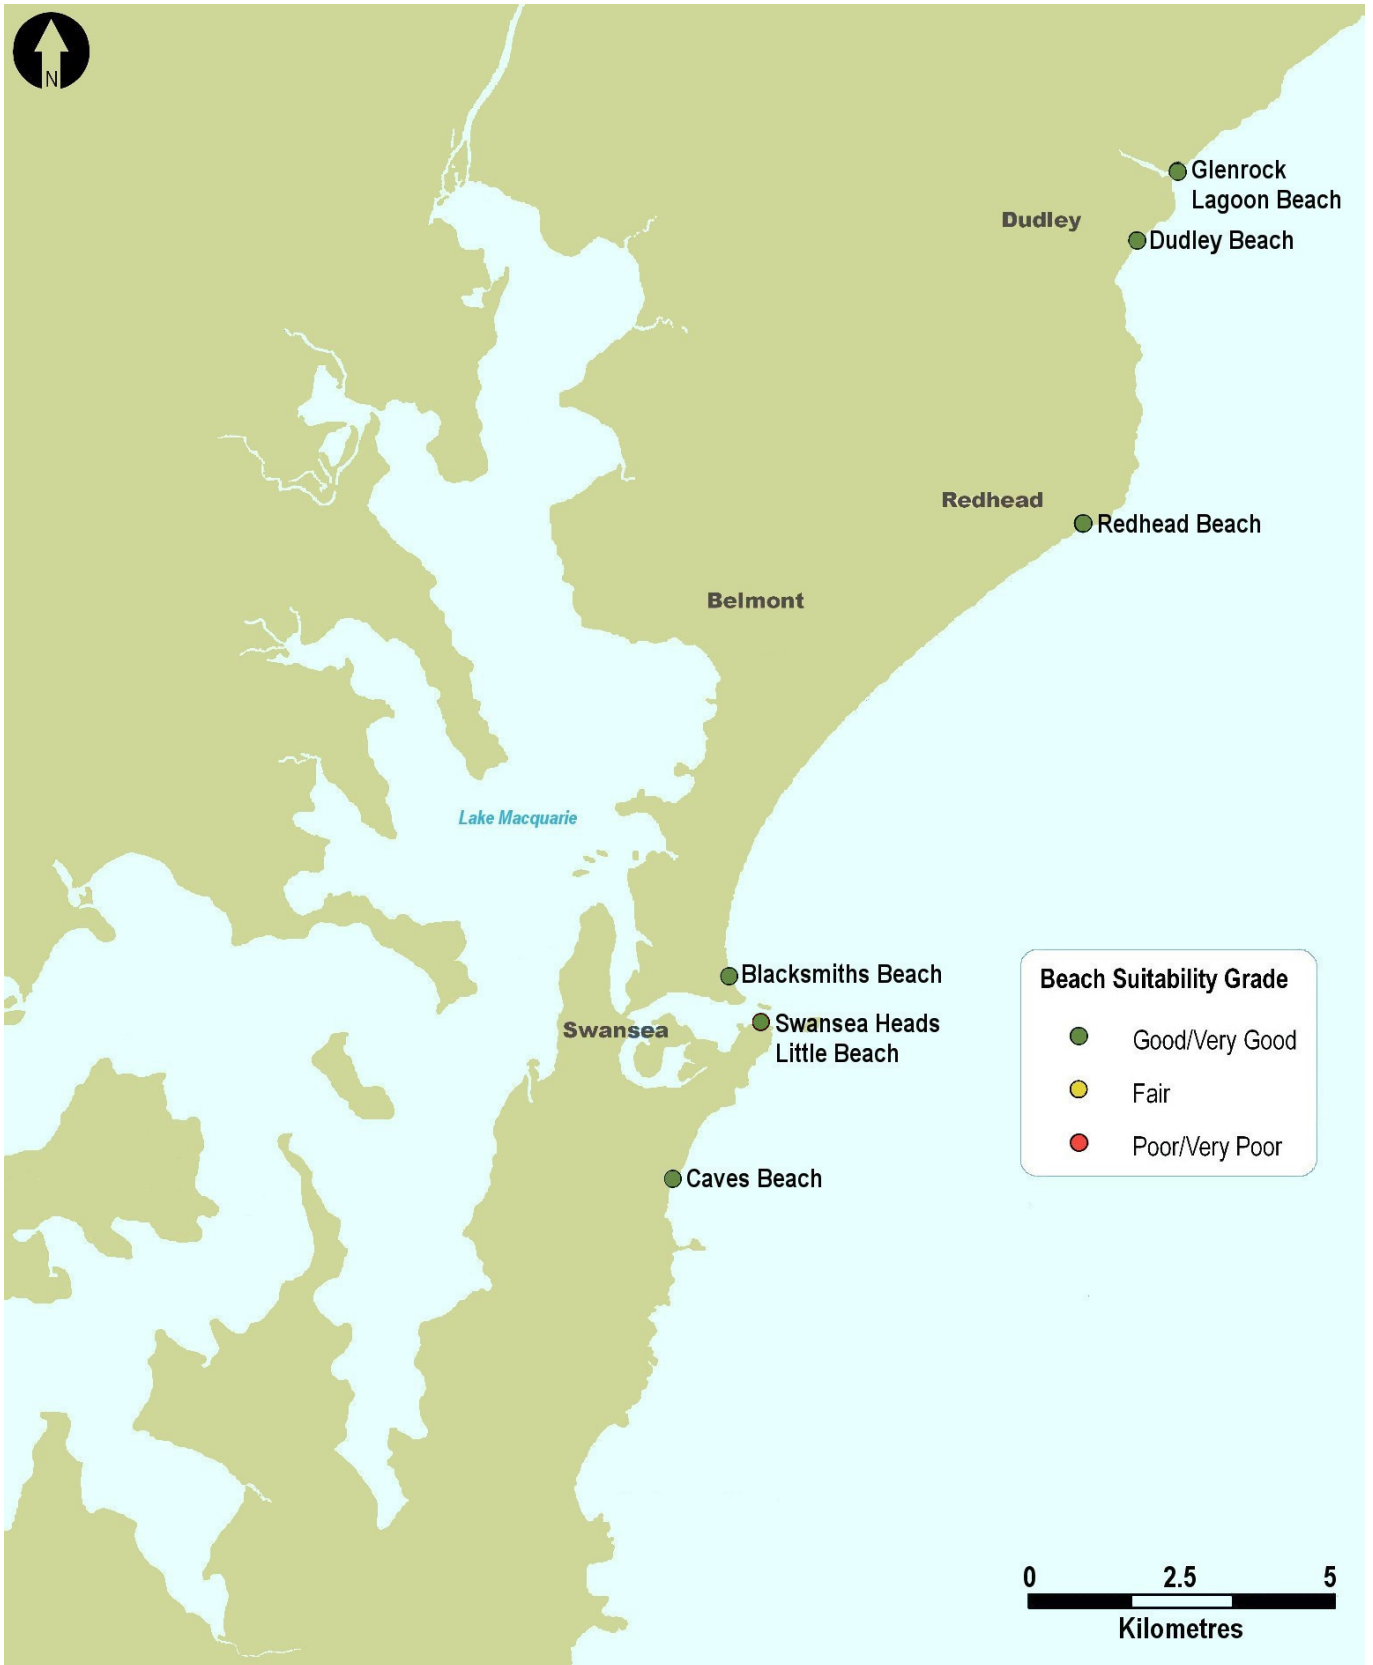
Sampling sites and Beach Suitability Grades in Lake Macquarie City Council

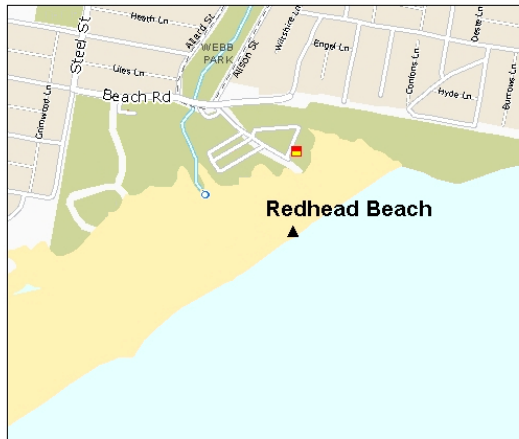
Redhead Beach is located at the northern end of a 10 kilometre stretch of beach and is patrolled between September and April.

The Beach Suitability Grade of Very Good indicates microbial water quality is considered suitable for swimming almost all of the time, with few potential sources of faecal contamination.

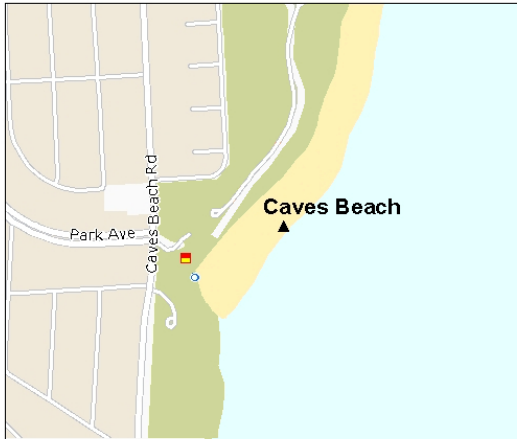
Caves Beach is located at the southern end of a 1.8 kilometre beach and is patrolled between September and April.

The Beach Suitability Grade of Very Good indicates microbial water quality is considered suitable for swimming almost all of the time, with few potential sources of significant faecal contamination.
