# State of the beaches 2020-2021

North Coast region

## Beachwatch

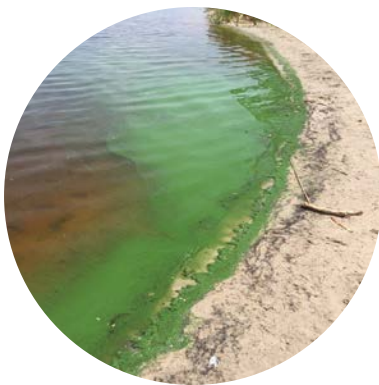
Blue-green algal bloom present in the water  
Photo: Rachael Jenner/  
Ballina Shire Council

Water NSW reported several occurrences of freshwater blue-green algal blooms, *Dolichospermum circinale* impacting Lake Ainsworth in October and November 2020, and during February and March 2021. Water NSW also issued a caution alert for marine algae, *Alexandrium* sp. at South Ballina Beach in October 2020.

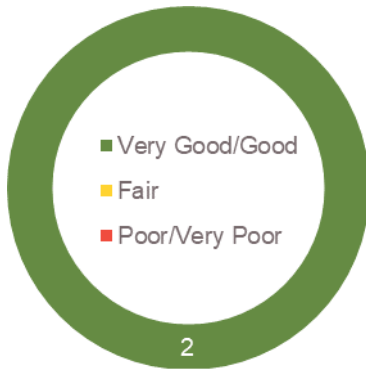
**Beach Suitability Grades for Byron Shire Council ocean beaches**

The two ocean beaches were graded as Very Good in 2020–2021: Main Beach (Byron Bay) and Tallow Beach (Suffolk Park). These beaches had excellent water quality and were suitable for swimming almost all of the time.

While water quality has been of a good standard, the grades are provisional as the assessment is based on limited bacterial data.

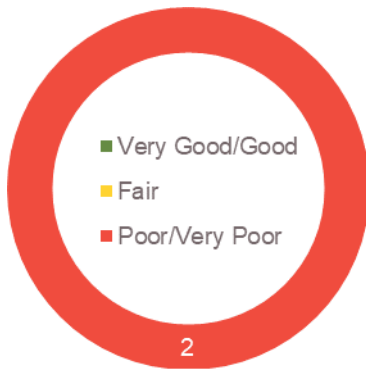
**Beach Suitability Grades for Byron Shire Council estuarine beaches**

Torakina Beach, located within the entrance of the Brunswick River, and Simpsons Creek were graded as Poor in 2020–2021. Elevated bacteria levels were recorded at these sites during dry and wet weather conditions. These sites may be impacted by several potential sources of faecal contamination including stormwater and upstream sources in the Brunswick River and Simpsons Creek.

While these results are provisional due to limited bacterial data, swimming is not recommended at these sites during and for up to three days after rainfall, or if there are signs of stormwater pollution such as discoloured water or floating debris.

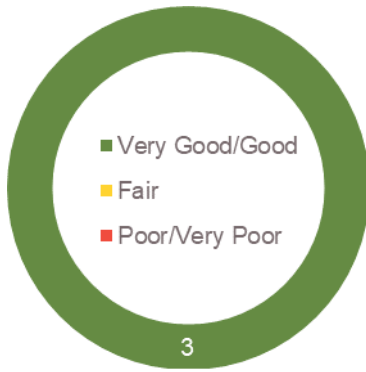
**Beach Suitability Grades for Ballina Shire Council ocean beaches**

Seven Mile Beach, Shelly Beach and Lighthouse Beach were graded as Very Good in 2020–2021. These beaches had excellent water quality and were suitable for swimming almost all of the time.

While Seven Mile Beach and Lighthouse Beach have continued to be graded as Very Good as in previous years, Shelly Beach was upgraded from Good in the previous year due to improved microbial water quality.

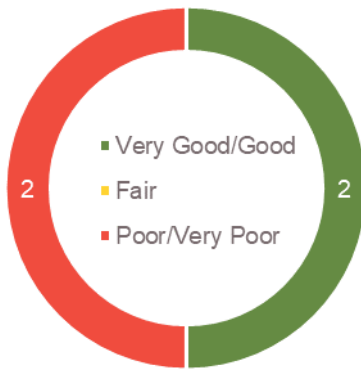
**Beach Suitability Grades for Ballina Shire Council lake/lagoon swimming sites**

Lake Ainsworth East and Lake Ainsworth South continued to be graded as Good in 2020–2021. These sites were mostly suitable for swimming during dry weather, with 86% and 95% of dry weather samples within the safe swimming limit respectively. Elevated enterococci levels were regularly recorded at these sites after heavy rainfall.

Lake Ainsworth North and Lake Ainsworth West were graded as Poor, a result consistent with the previous year. Elevated bacteria levels were recorded at these lake swimming sites during dry and wet weather conditions. Despite the poor grades, between 71% and 73% of dry weather samples were within the safe swimming limit. These sites may be impacted by a number of significant potential sources of faecal contamination, including stormwater, and have low levels of flushing. Since 2019, council has been investigating the source of microbial contamination with additional samples collected for faecal sterol analysis at sites within Lake Ainsworth. Preliminary results have found that the main contributors to elevated bacteria levels are from avian (bird) sources.

In 2019, Ballina Shire Council collected additional samples from several locations within Lake Ainsworth. The samples have been tested for faecal sterols to identify if elevated enterococci counts are from human or animal sources. Preliminary results from the sampling identified that human faecal compounds were not detected in the samples and that avian (bird) faecal matter is the main contributor. It is thought that Beachwatch samples collected at the lake may be significantly influenced by waterbird faecal matter rather than bathers.

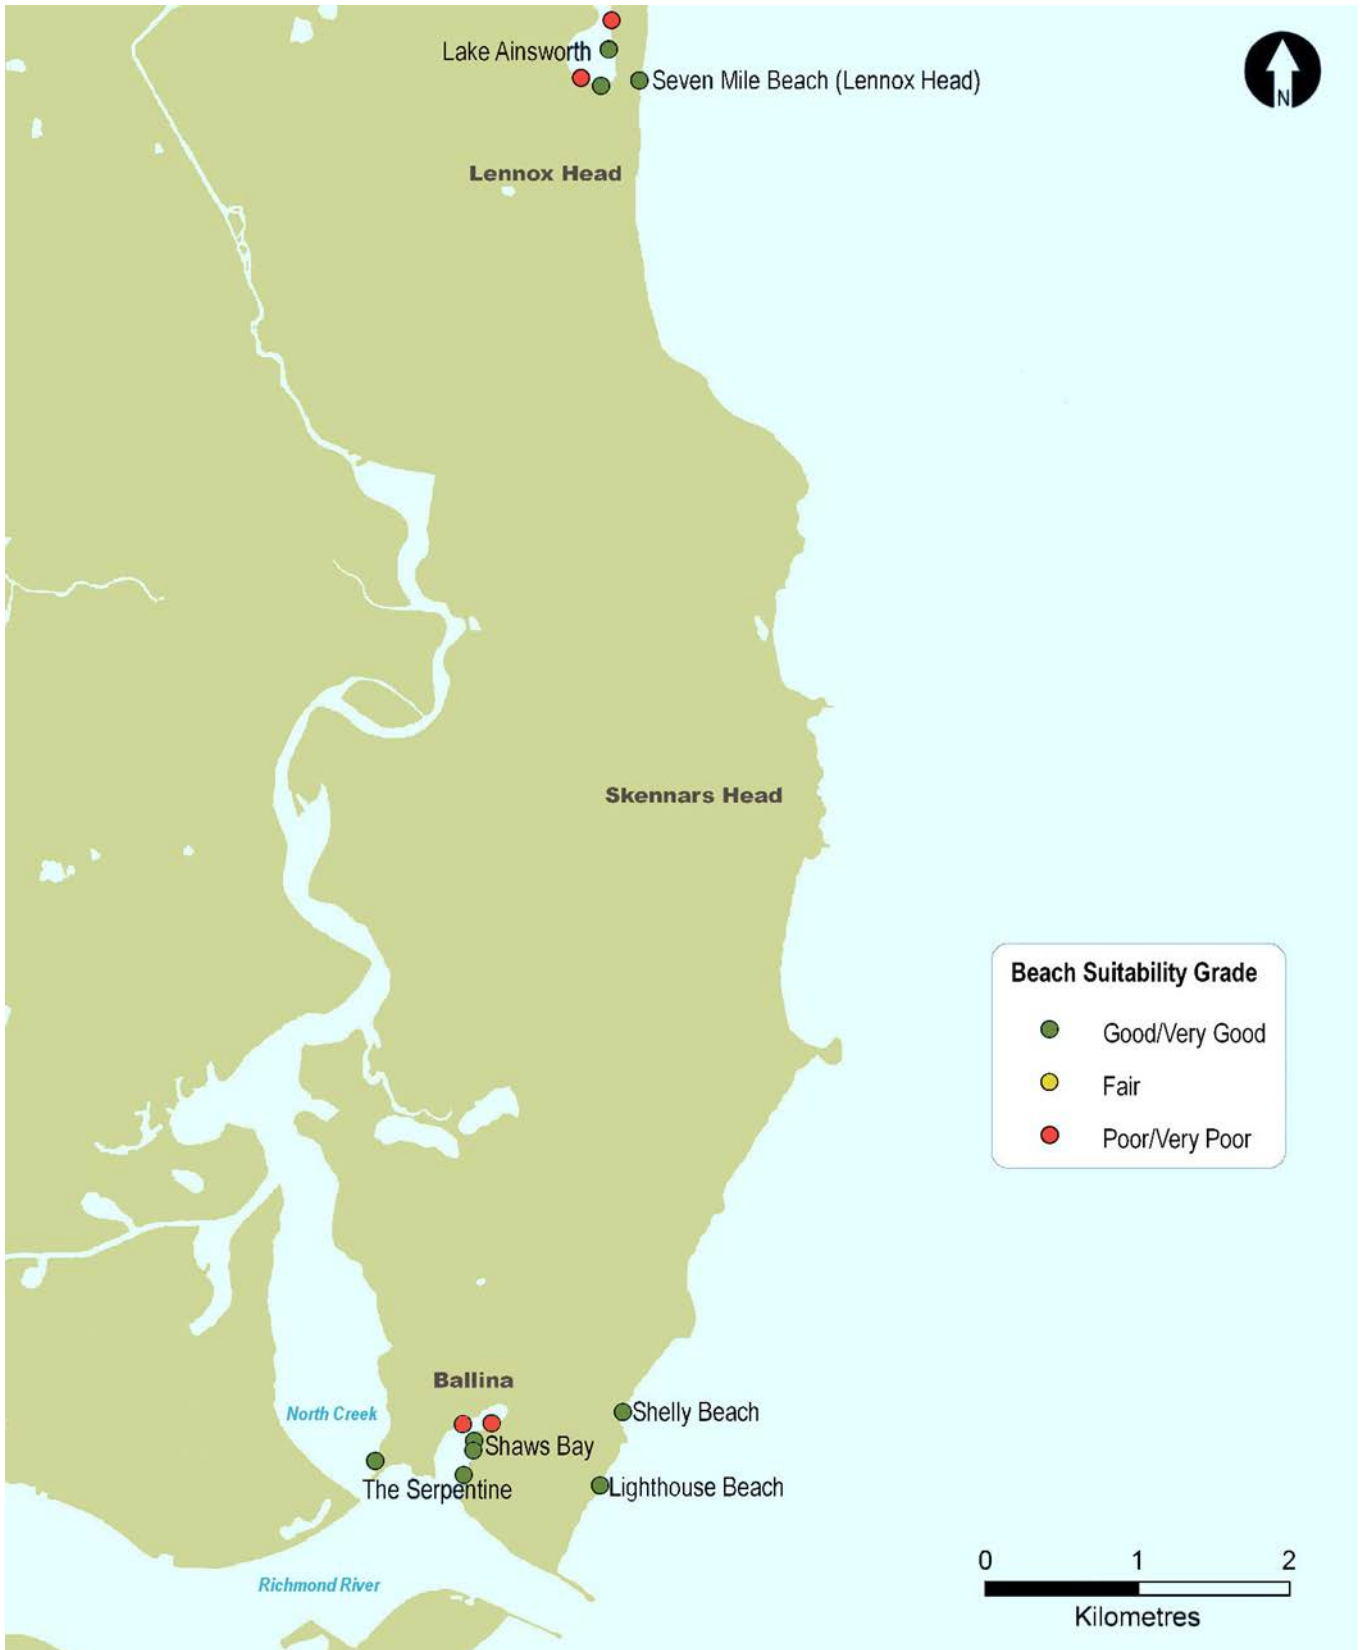
**Sampling sites and Beach Suitability Grades in Ballina Shire Council**

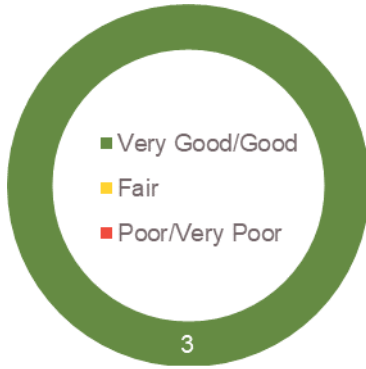
**Beach Suitability Grades for Richmond Valley Council ocean beaches**

Shark Bay continued to be graded as Very Good in 2020–2021. Water quality at this beach has been consistently excellent for many years and is suitable for swimming almost all of the time.

Airforce Beach and Main Beach were graded as Good, downgraded from Very Good in the previous year due to a decline in microbial water quality. While water quality at these beaches was suitable for swimming most of the time, elevated results were often recorded following heavy rainfall.

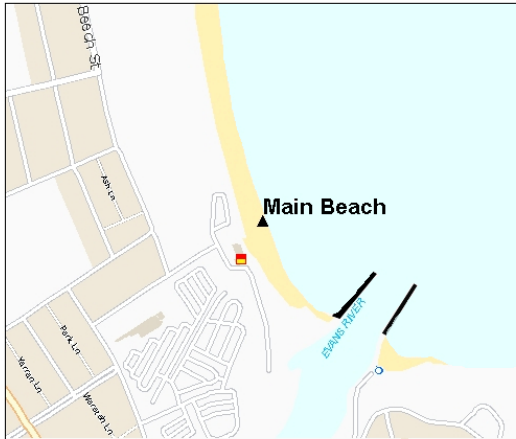
Main Beach is located at the southern end of a 31 kilometre stretch of beach and is patrolled during holiday periods.

The Beach Suitability Grade of Good indicates microbial water quality is considered suitable for swimming most of the time but may be susceptible to pollution after rain, from several potential sources of faecal contamination including stormwater.

Enterococci levels increased slightly with increasing rainfall, occasionally exceeding the safe swimming limit after light rain, and often after 20 mm or more of rain.
