Department of Planning, Industry and Environment

State of the beaches 2020-2021

Sydney region

Beachwatch

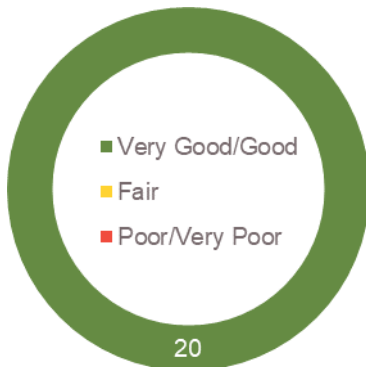
Beach Suitability Grades for Northern Sydney ocean beaches

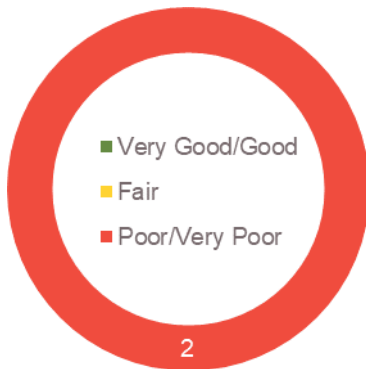
Beach Suitability Grades for Northern Sydney lake/lagoon swimming sites

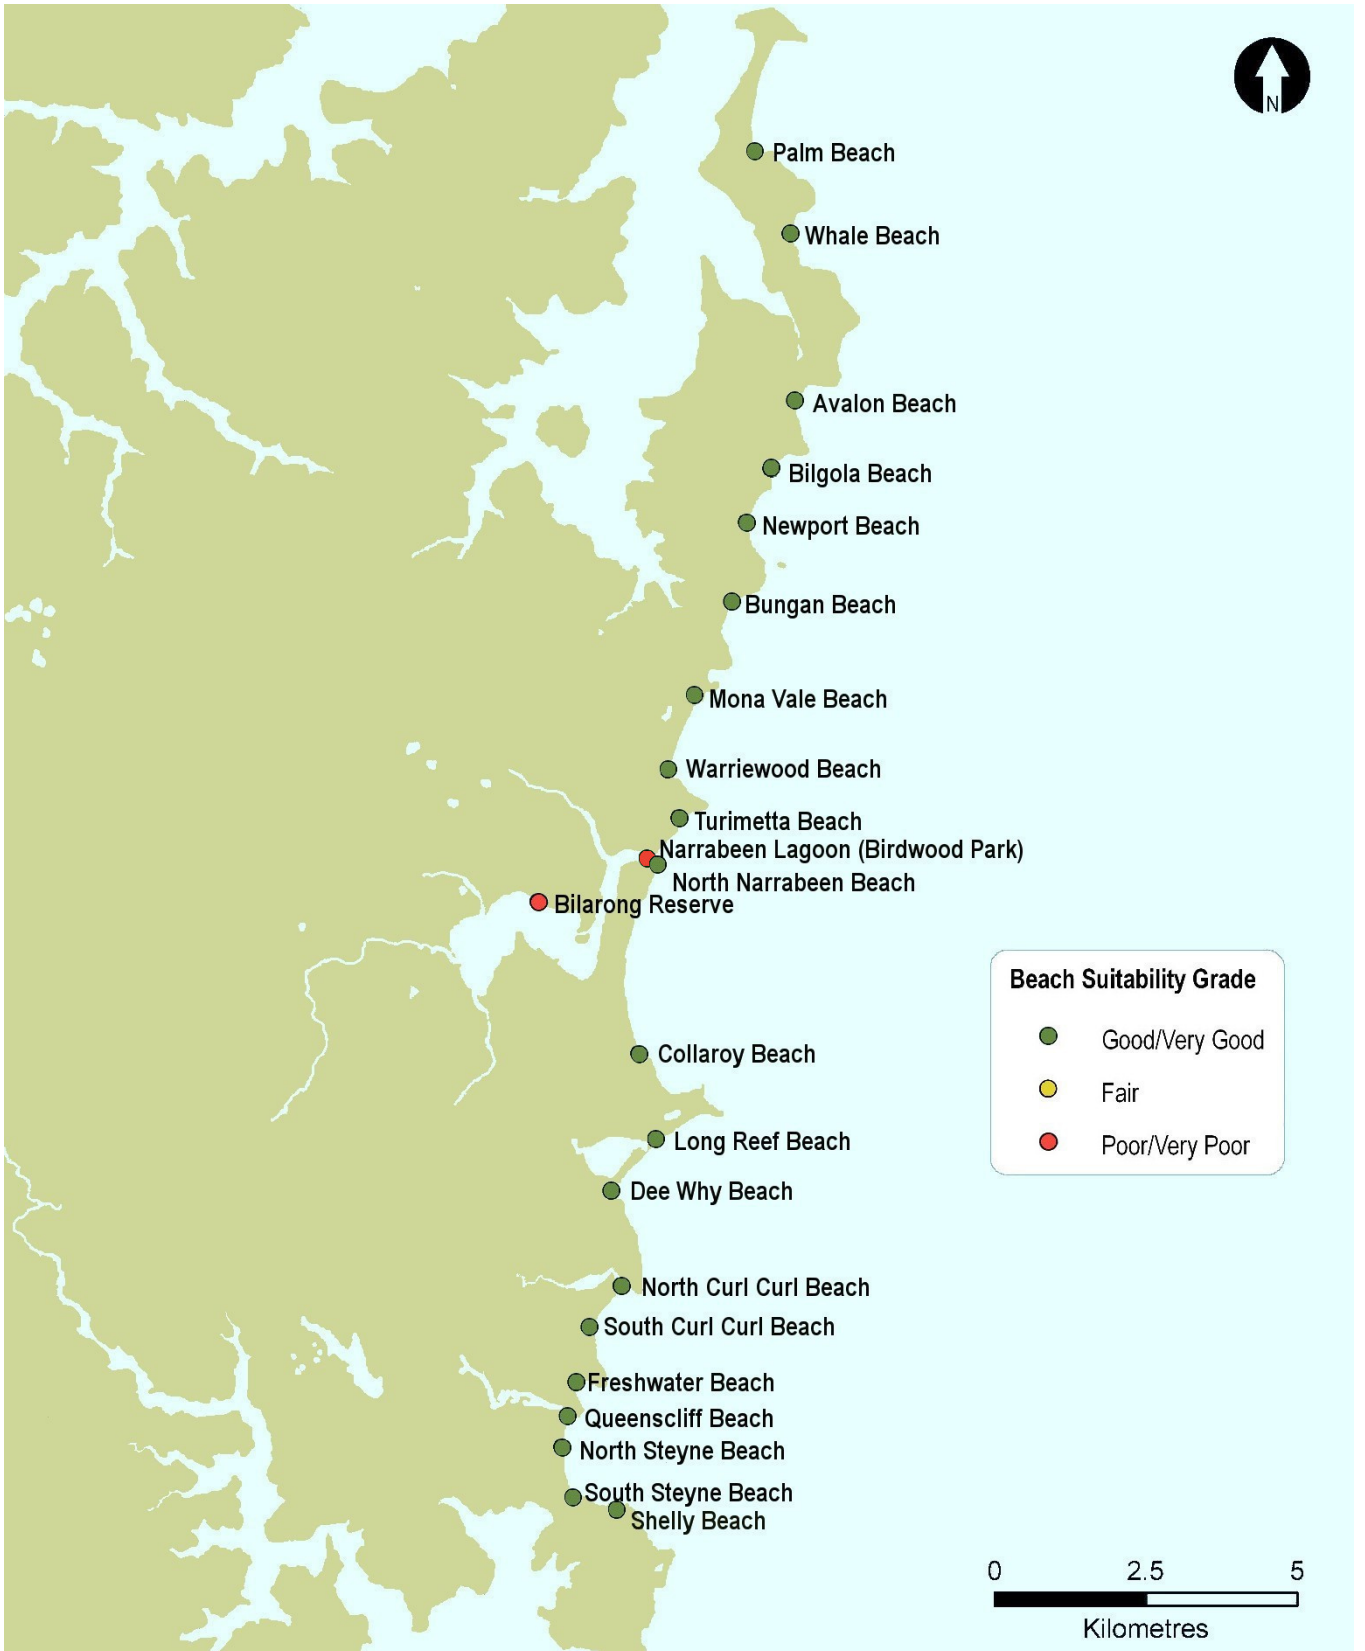
Sampling sites and Beach Suitability Grades at Sydney's Northern Beaches

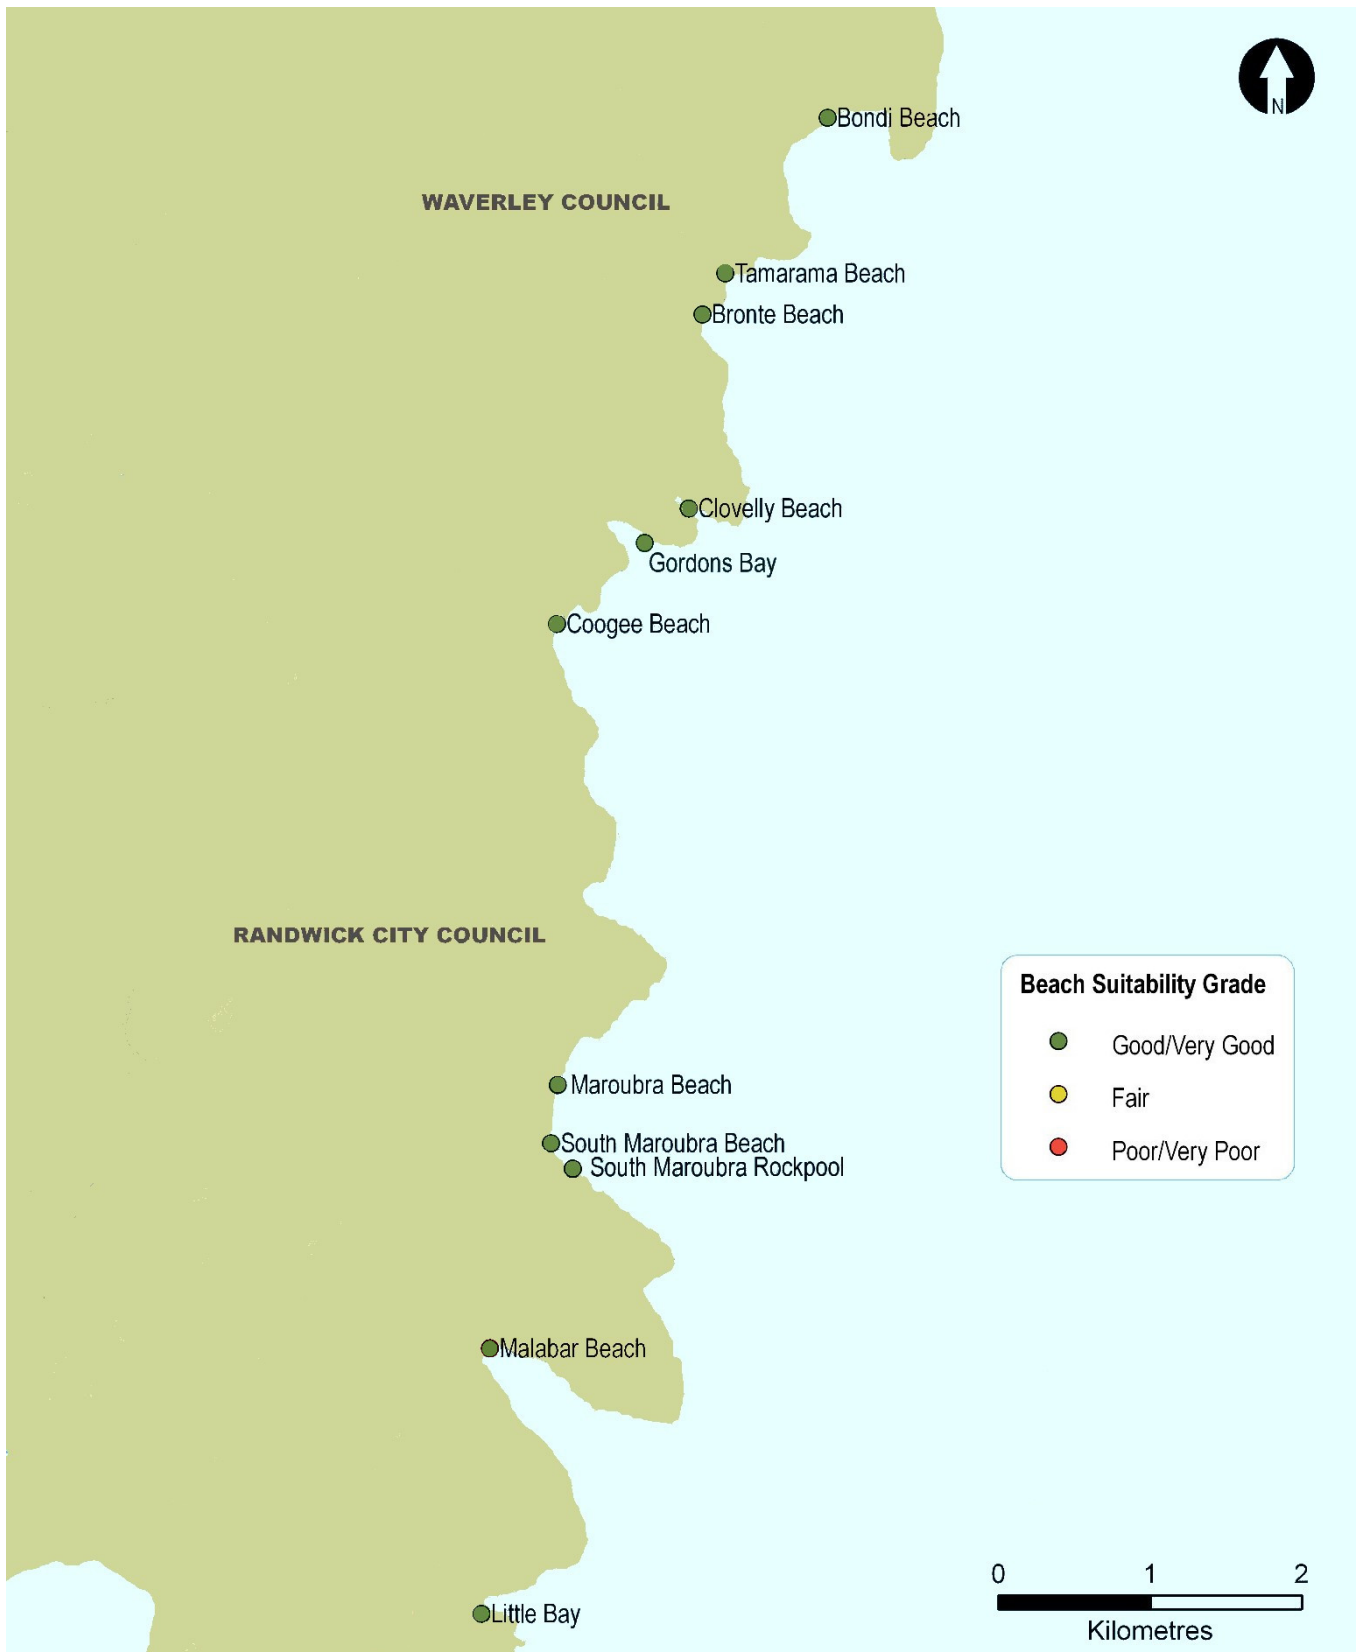
Sampling sites and Beach Suitability Grades at Sydney's central beaches

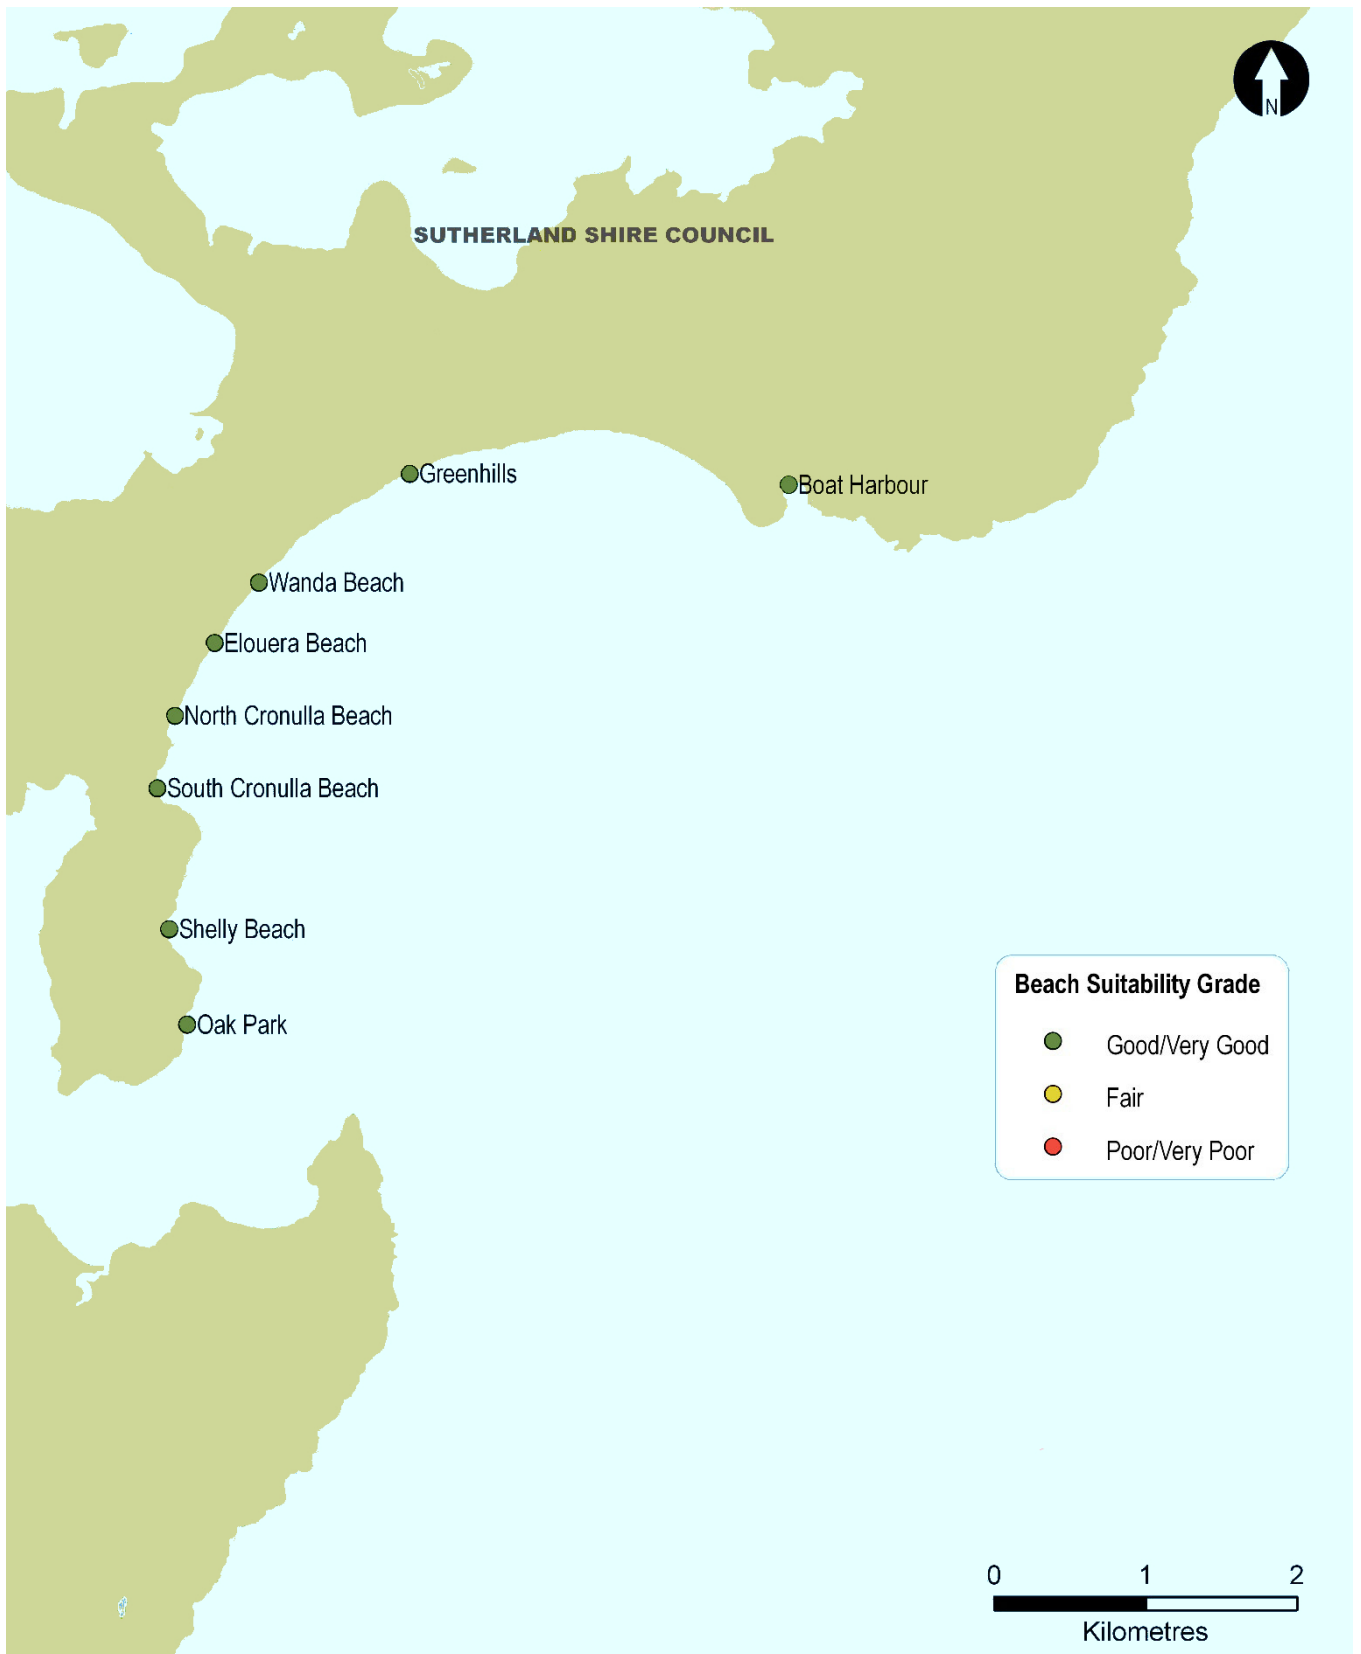
Sampling sites at Beach Suitability Grades at Sydney's Southern beaches

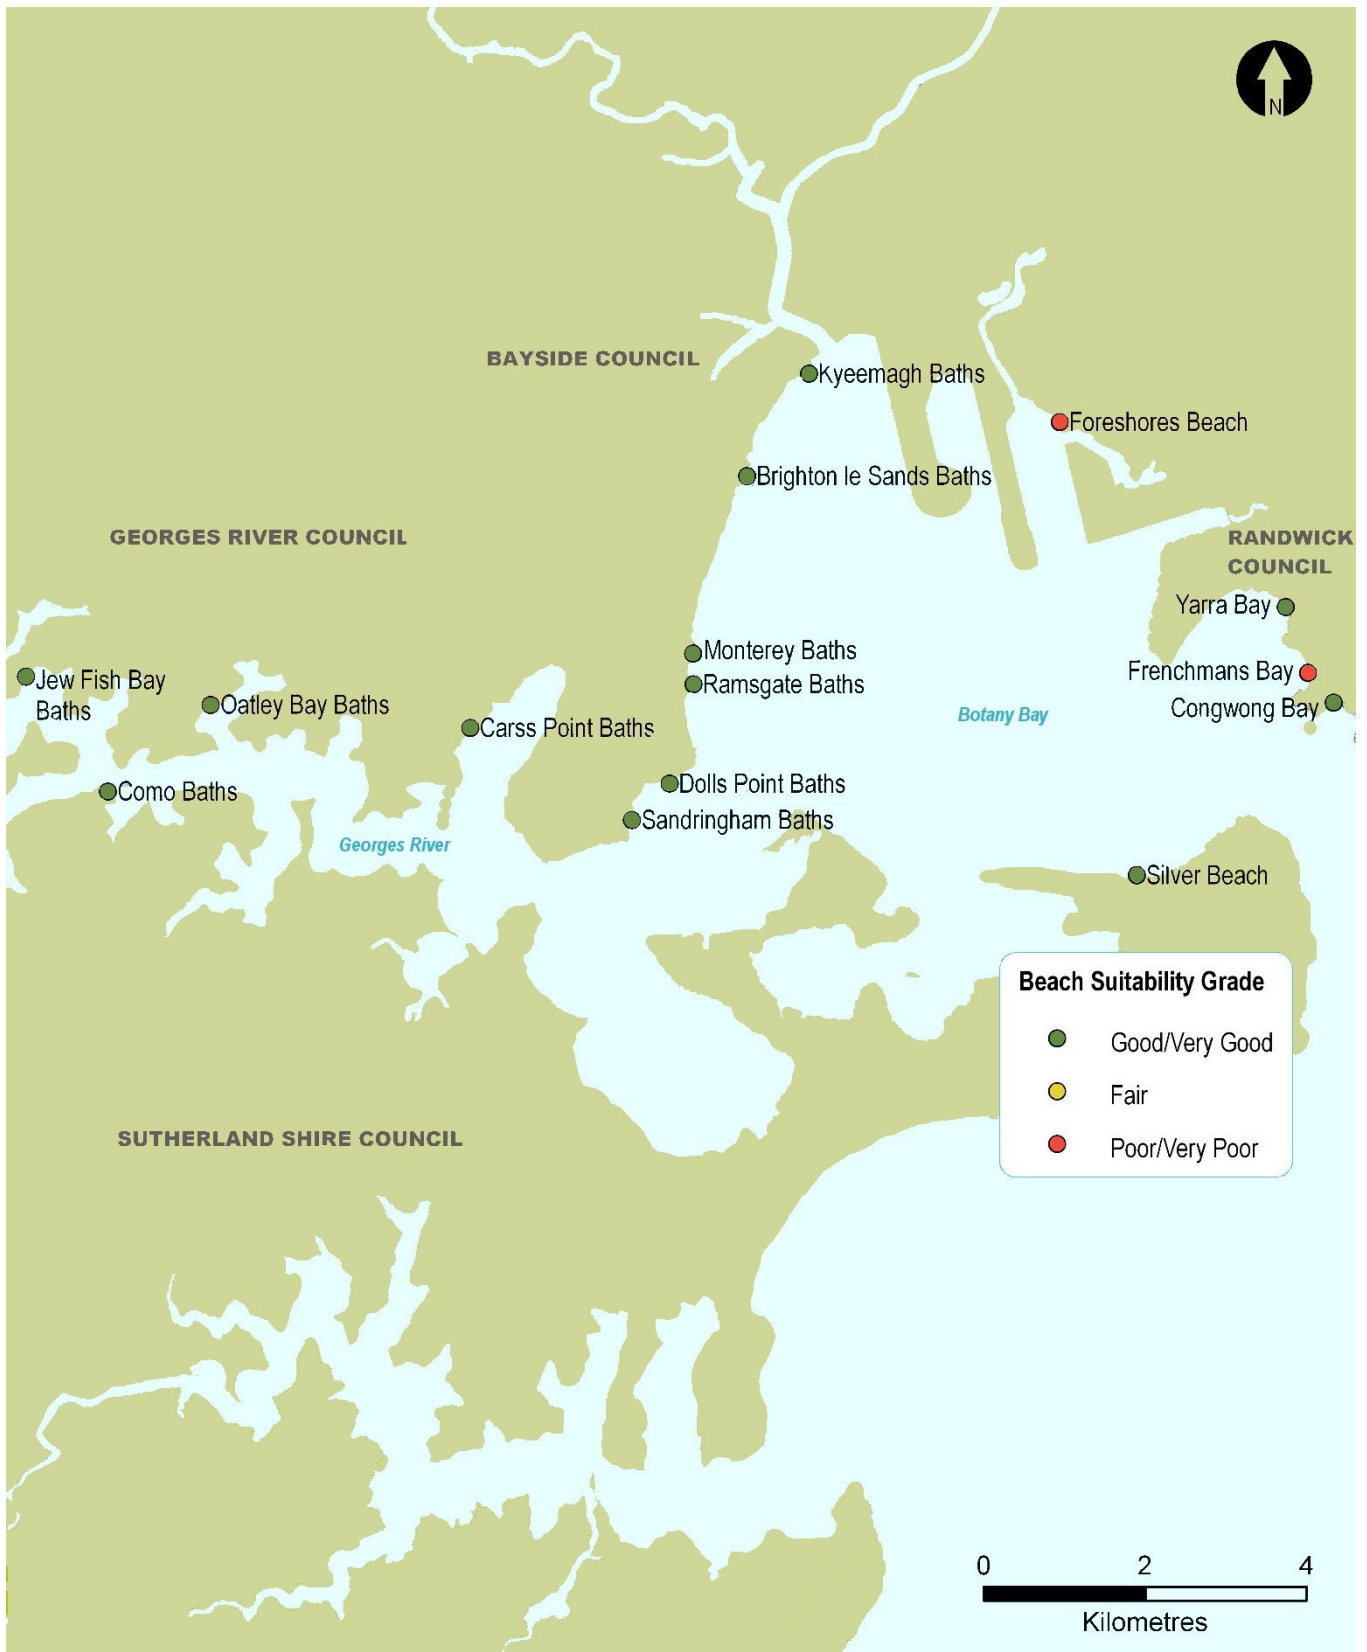
Sampling sites and Beach Suitability Grades in Botany Bay and lower Georges River

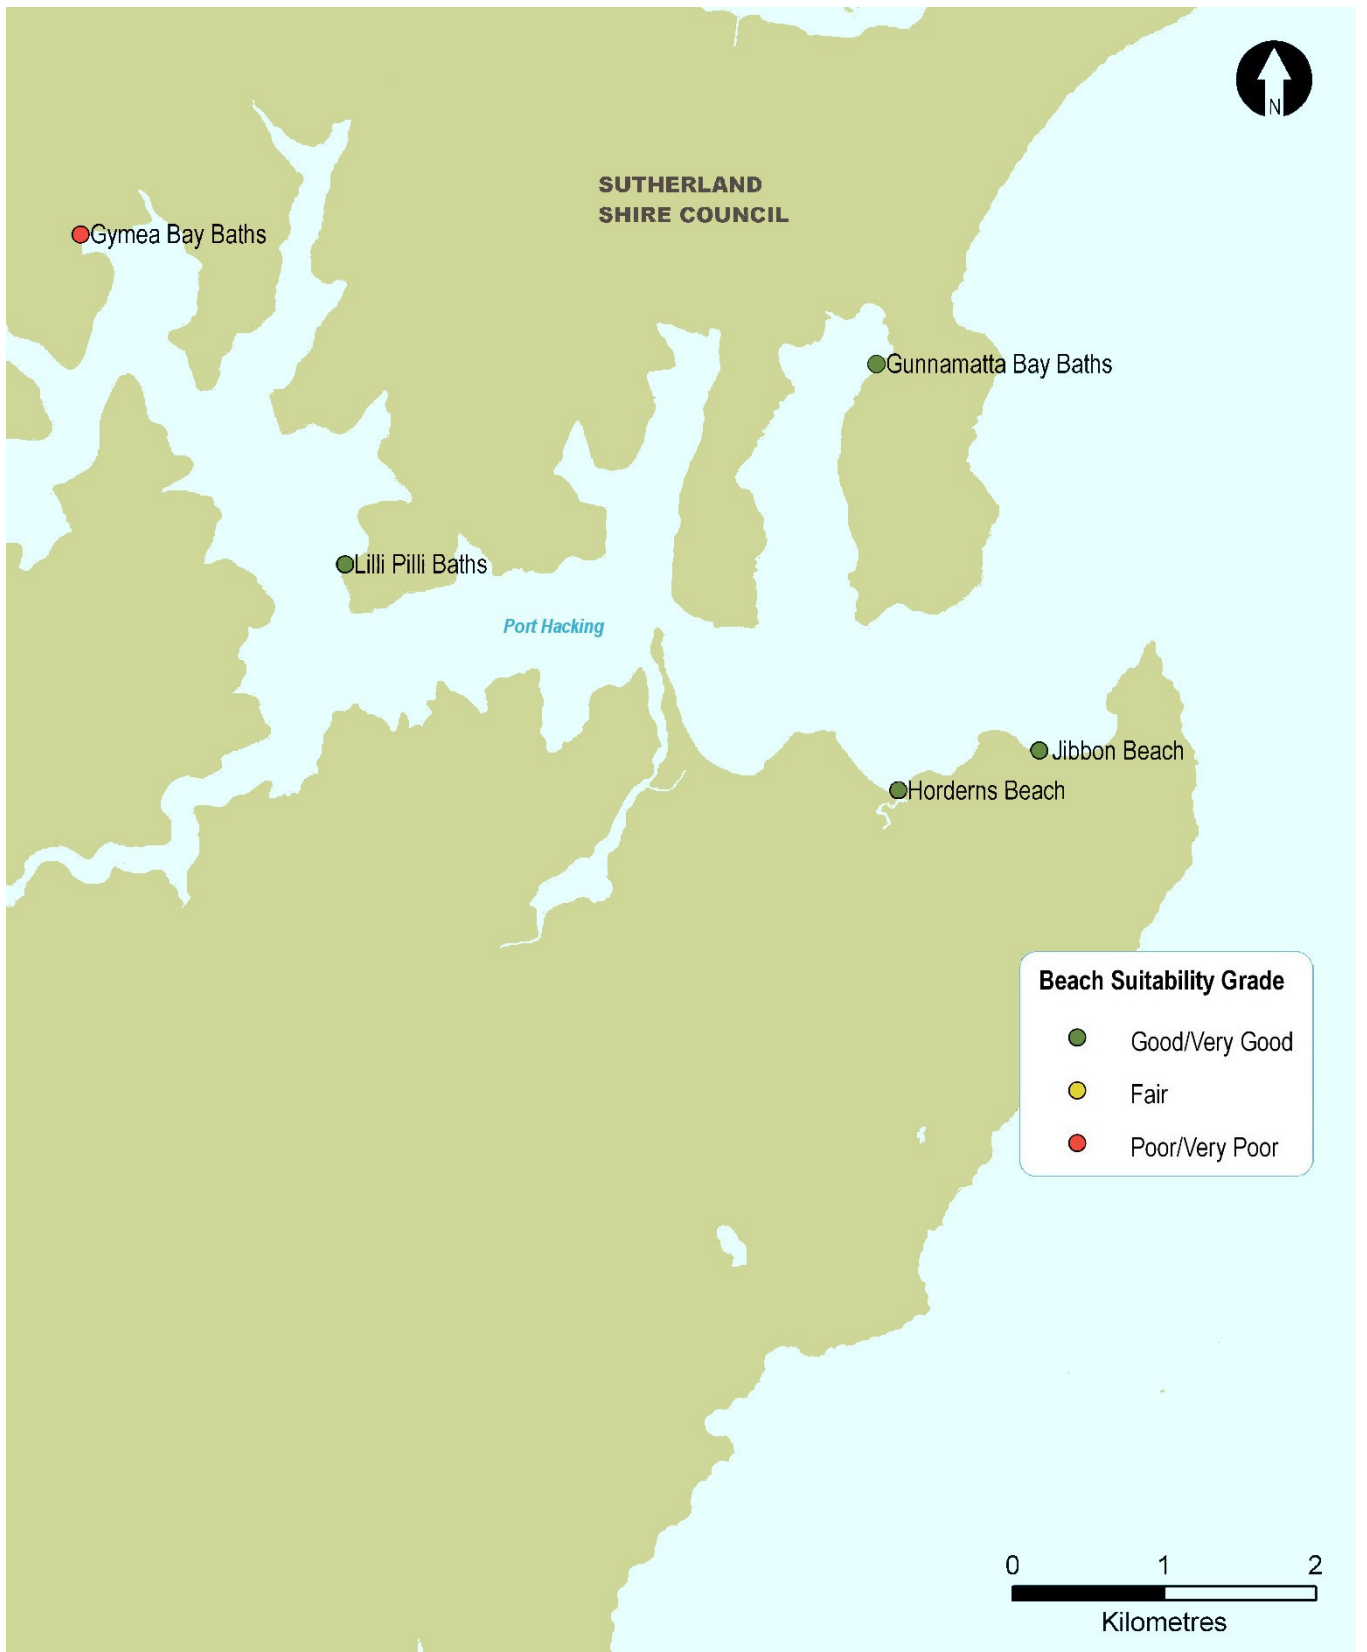
Sampling sites and Beach Suitability Grades in Port Hacking
