## Beachwatch

# State of the beaches 2022–23

Mid-North Coast Region

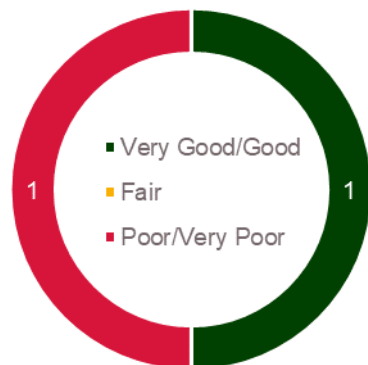
Beach Suitability Grades for Bellinghen Shire Council ocean beaches

The Beach Suitability Grades provided for monitored sites in Bellinghen Shire are provisional due to limited bacterial data. It is recommended that swimming should be avoided during and for up to one day after rainfall at ocean beaches or if there are signs of stormwater pollution such as discoloured water, flowing drains or outflow from creeks or lagoons, due to the possibility of pollution.

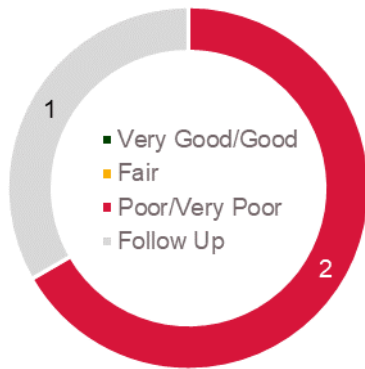
**Beach Suitability Grades for Bellingen Shire Council estuarine sites**

Lavenders Bridge and Urunga Lido were graded as Poor in 2022–2023. These grades are provisional and subject to change as the assessment is based on limited bacterial data.

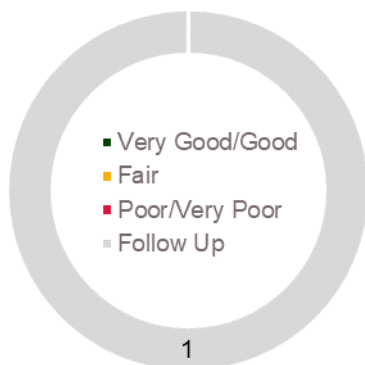
**Beach Suitability Grades for Bellingen Shire Council lagoon site**

Dalhousie Creek is in a small lagoon with an intermittently closed/open entrance. The lagoon entrance was open 4 times during the assessment period: 23 January, 13 February, 27 March and 3 April 2023. The sanitary inspection and water quality data at Dalhousie Creek produce potentially incongruent results, and further assessment will be required.

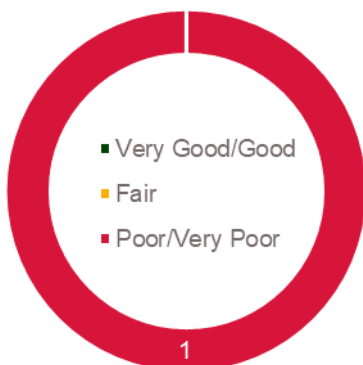
**Beach Suitability Grades for Bellingen Shire Council freshwater site**

Arthur Keough Reserve was graded as Poor in 2022–2023. This grade is provisional and subject to change as data available for the microbial assessment is incomplete.

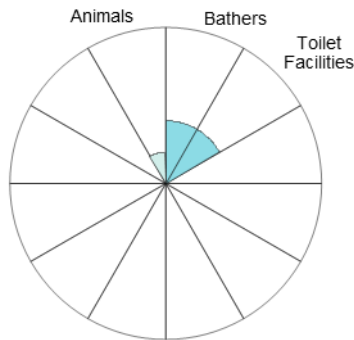
### Sanitary inspection: Low

The Beach Suitability Grade of Good indicates microbial water quality is considered suitable for swimming most of the time, with few potential sources of faecal contamination.

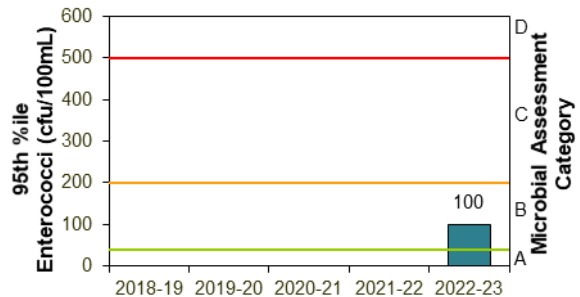
### Microbial Assessment Category: B

Site type	Assessment period	Dry weather samples suitable for swimming	Water samples	Beach grade status
Ocean beach	Sep 2022 to Apr 2023	88%	27	Provisional

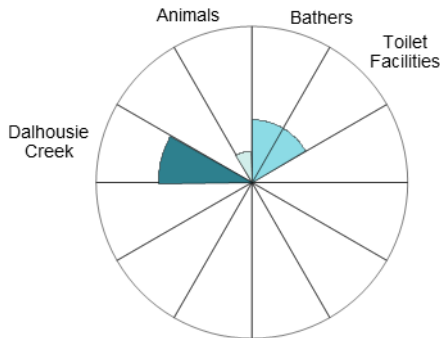
## Sanitary inspection: Moderate

The Beach Suitability Grade of Poor indicates microbial water quality is susceptible to faecal pollution, particularly after rainfall, with potential contamination from Dalhousie Creek when the lagoon entrance is open.

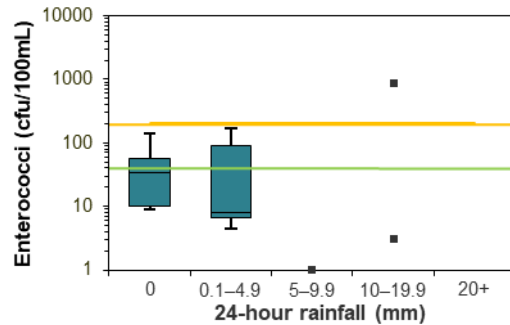
## Water quality in response to rainfall

Enterococci levels increased slightly with increasing rainfall, occasionally exceeding the safe swimming limit in dry weather conditions.

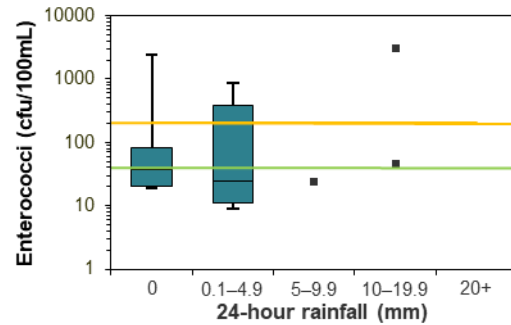
## Water quality in response to rainfall

Enterococci levels generally increased with increasing rainfall, occasionally exceeding the safe swimming limit in dry weather conditions.

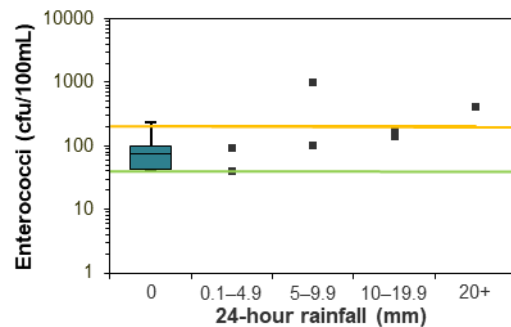
## Water quality in response to rainfall

Enterococci levels increased with increasing rainfall, frequently exceeding the safe swimming limit in dry weather conditions and across all rainfall categories.

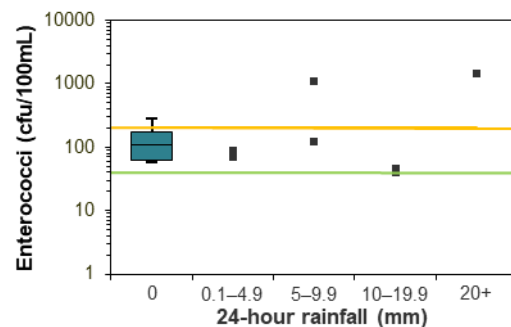
## Water quality in response to rainfall

Enterococci levels increased with increasing rainfall, frequently exceeding the safe swimming limit in dry weather conditions and across all rainfall categories.

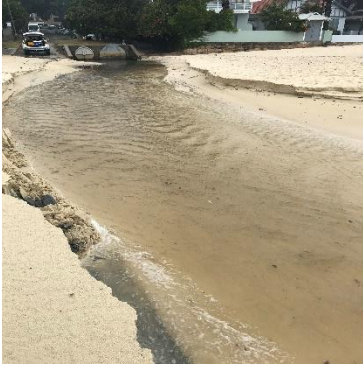
Stormwater drain flow  
Photo: Beachwatch/DPE

Stormwater in urban areas often contains sewage from leakages, overflows or sewer chokes when the sewerage system fails.

Sewage overflows can occur in wet weather when the network has exceeded capacity due to rainwater entering the system. The mix of sewage and rainwater discharges from designated overflow points and drains to waterways, usually via the stormwater system. Overflows from the sewerage system can also occur in dry weather due to mechanical failure or power outage.

Sewer chokes occur due to blockages in the pipes usually due to tree roots, oil, grease or debris. This causes sewage to back up and escape via sewer inspection points, designed overflow structures or cracks in the pipes, then drain to waterways, usually via the stormwater system.

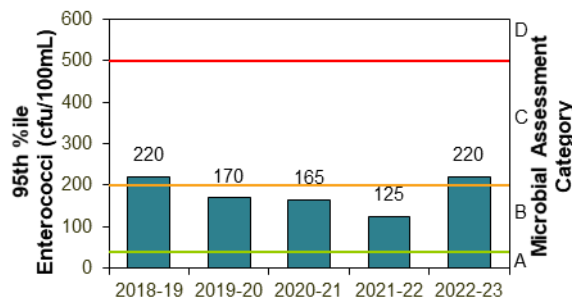
On each beach page, the MACs for the last 5 years are displayed on a simple bar chart. The MAC for the current year is based on enterococci data collected during the assessment period. The bars are labelled with the 95th

percentile value for each year and the thresholds dividing the A, B, C and D categories are marked in green, amber and red for reference.

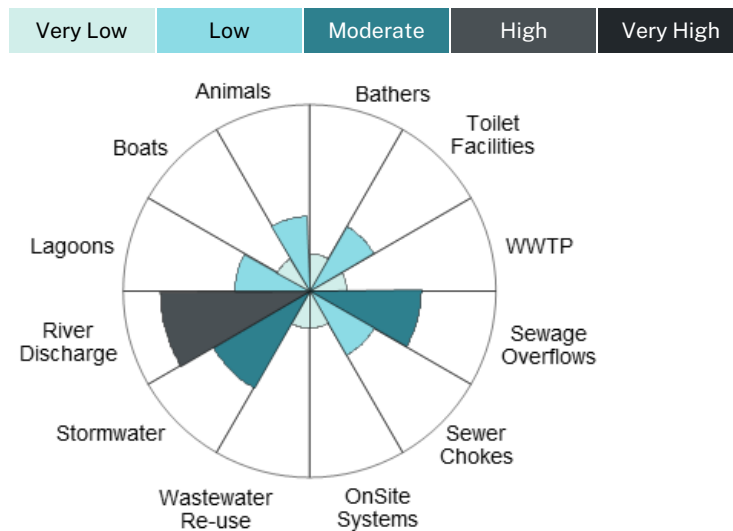
### Sanitary Inspection Category (SIC) chart

The results of the sanitary inspection for each swimming location are presented in a radar pie chart. The chart shows the likelihood that each identified pollution source will contribute to faecal contamination at a swimming site, as indicated by the size and colour of the segment, ranging from very low (lightest colour) to very high (darkest colour) as shown below. The sum of these contributions is the overall likelihood, or Sanitary Inspection Category.

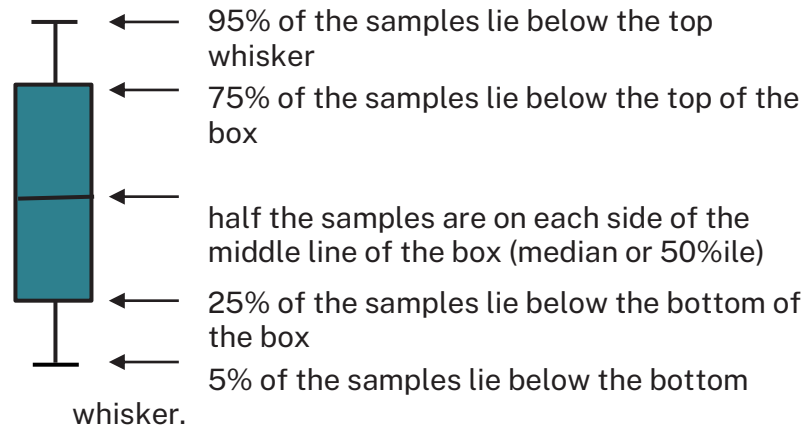
Each part of the box plot represents a significant percentile value of the sample population:
