Beachwatch

State of the beaches 2022–23

North Coast Region

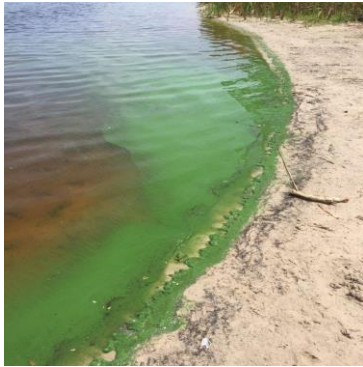
Blue-green algal bloom present in the water
Photo: Rachael Jenner/
Ballina Shire Council

Water NSW and Ballina Shire Council reported the occurrence of freshwater blue-green algal blooms, *Dolichospermum circinale* impacting Lake Ainsworth in February to March 2023. Water NSW also issued a caution alert for *Trichodesmium* sp. in the Richmond River and The Spit and Missingham Beach in December 2022, and for several places along the coastline including lower reaches of Cudgen Creek at Kingscliff, lower reaches of Richmond River and North Creek near Missingham Beach, and lower reaches of Evans River in January to February 2023.

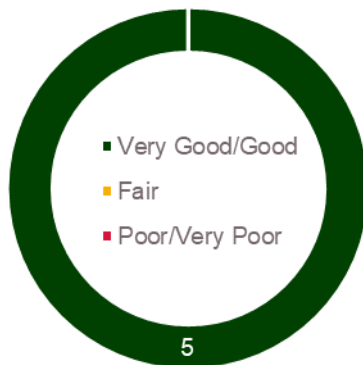
Beach Suitability Grades for Byron Shire Council ocean beaches

The 5 ocean beaches were graded as Good in 2022–2023: South Golden Beach, New Brighton Beach, Main Beach (Byron Bay), Clarkes Beach and Tallow Beach (Suffolk Park). These sites had good water quality and were suitable for swimming most of the time.

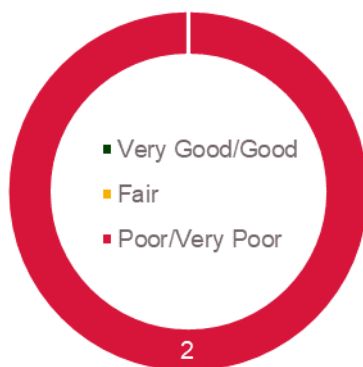
Beach Suitability Grades for Byron Shire Council estuarine beaches

Torakina Beach, located within the entrance of the Brunswick River, and Simpsons Creek were graded as Poor in 2022–2023. Elevated bacteria levels were recorded at these sites during dry and wet weather conditions. These sites may be impacted by several potential sources of faecal contamination including stormwater and upstream sources in the Brunswick River and Simpsons Creek.

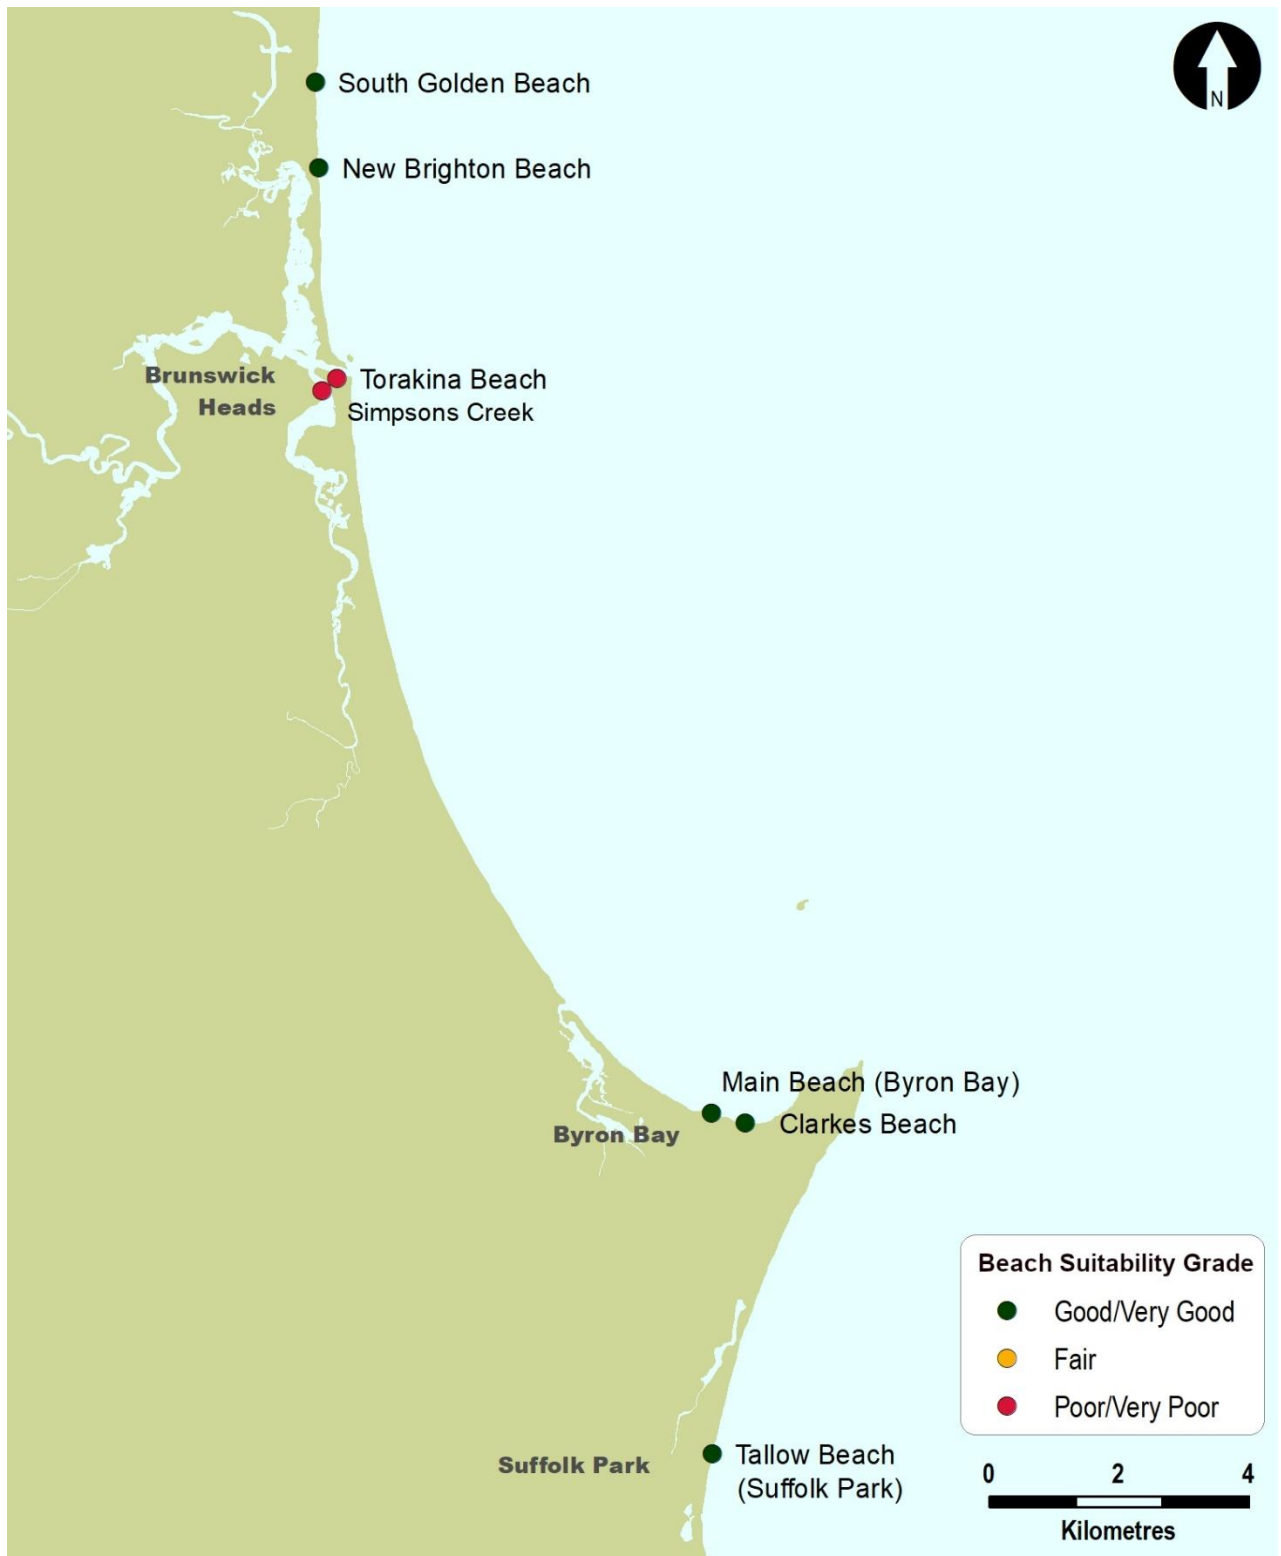
Sampling sites and Beach Suitability Grades in Byron Shire Council

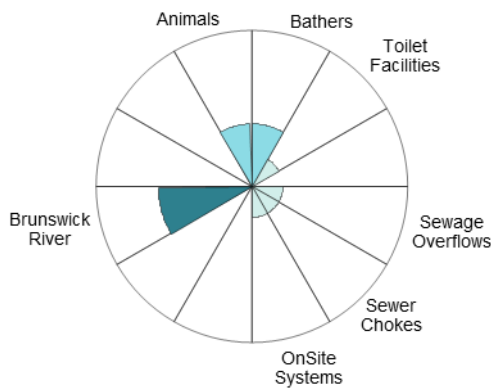
Sanitary inspection: Moderate

Microbial Assessment Category: B

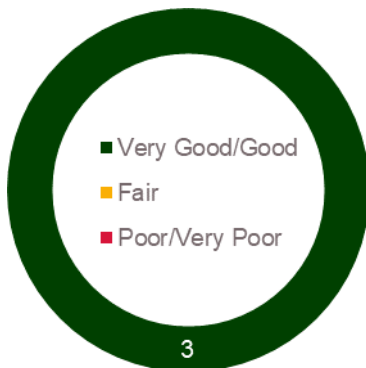
Beach Suitability Grades for Ballina Shire Council ocean beaches

Seven Mile Beach, Shelly Beach and Lighthouse Beach continued to be graded as Very Good in 2022–2023. These beaches had excellent water quality and were suitable for swimming almost all of the time.

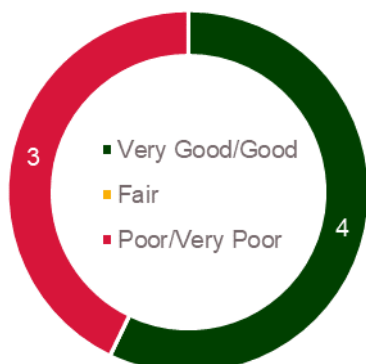
Beach Suitability Grades for Ballina Shire Council estuarine beaches

Four of the 7 estuarine swimming locations were graded as Good in 2022–2023: Shaws Bay East, Shaws Bay East Arm, Shaws Bay East Beach and The Serpentine. Water quality at these sites was frequently suitable for swimming in dry weather, with 87% or greater of dry weather samples within the safe swimming limit.

Shaws Bay North and Shaws Bay West were graded Poor in 2022–2023, similar to the previous year. While these sites were mostly suitable for swimming during dry weather, elevated bacterial levels were regularly recorded following light rainfall. Monitoring at Missingham Beach commenced in November 2022. Missingham Beach was graded as Poor in 2022–2023, however the grade is provisional as the assessment is based on limited bacterial data.

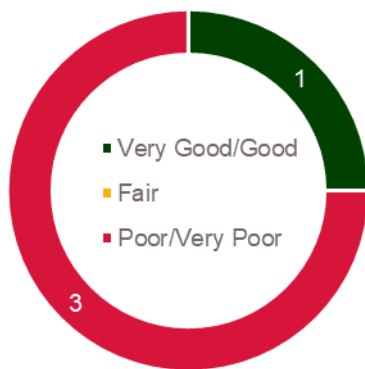
Beach Suitability Grades for Ballina Shire Council lake/lagoon swimming sites

Lake Ainsworth South continued to be graded as Good in 2022–2023. This site was frequently suitable for swimming during dry weather, with 88% of dry weather samples within the safe swimming limit. Elevated enterococci levels were regularly recorded at this site after heavy rainfall.

Lake Ainsworth North and Lake Ainsworth West were graded as Poor, a result consistent with previous years. Elevated bacteria levels were recorded at these lake swimming sites during dry and wet weather conditions. Despite the poor grades, between 79% and 70% of dry weather samples were within the safe swimming limit. Lake Ainsworth East was downgraded to Poor in 2022–2023, from Good in the previous year. These sites may be impacted by a number of significant potential sources of faecal contamination, including stormwater, and have low levels of flushing.

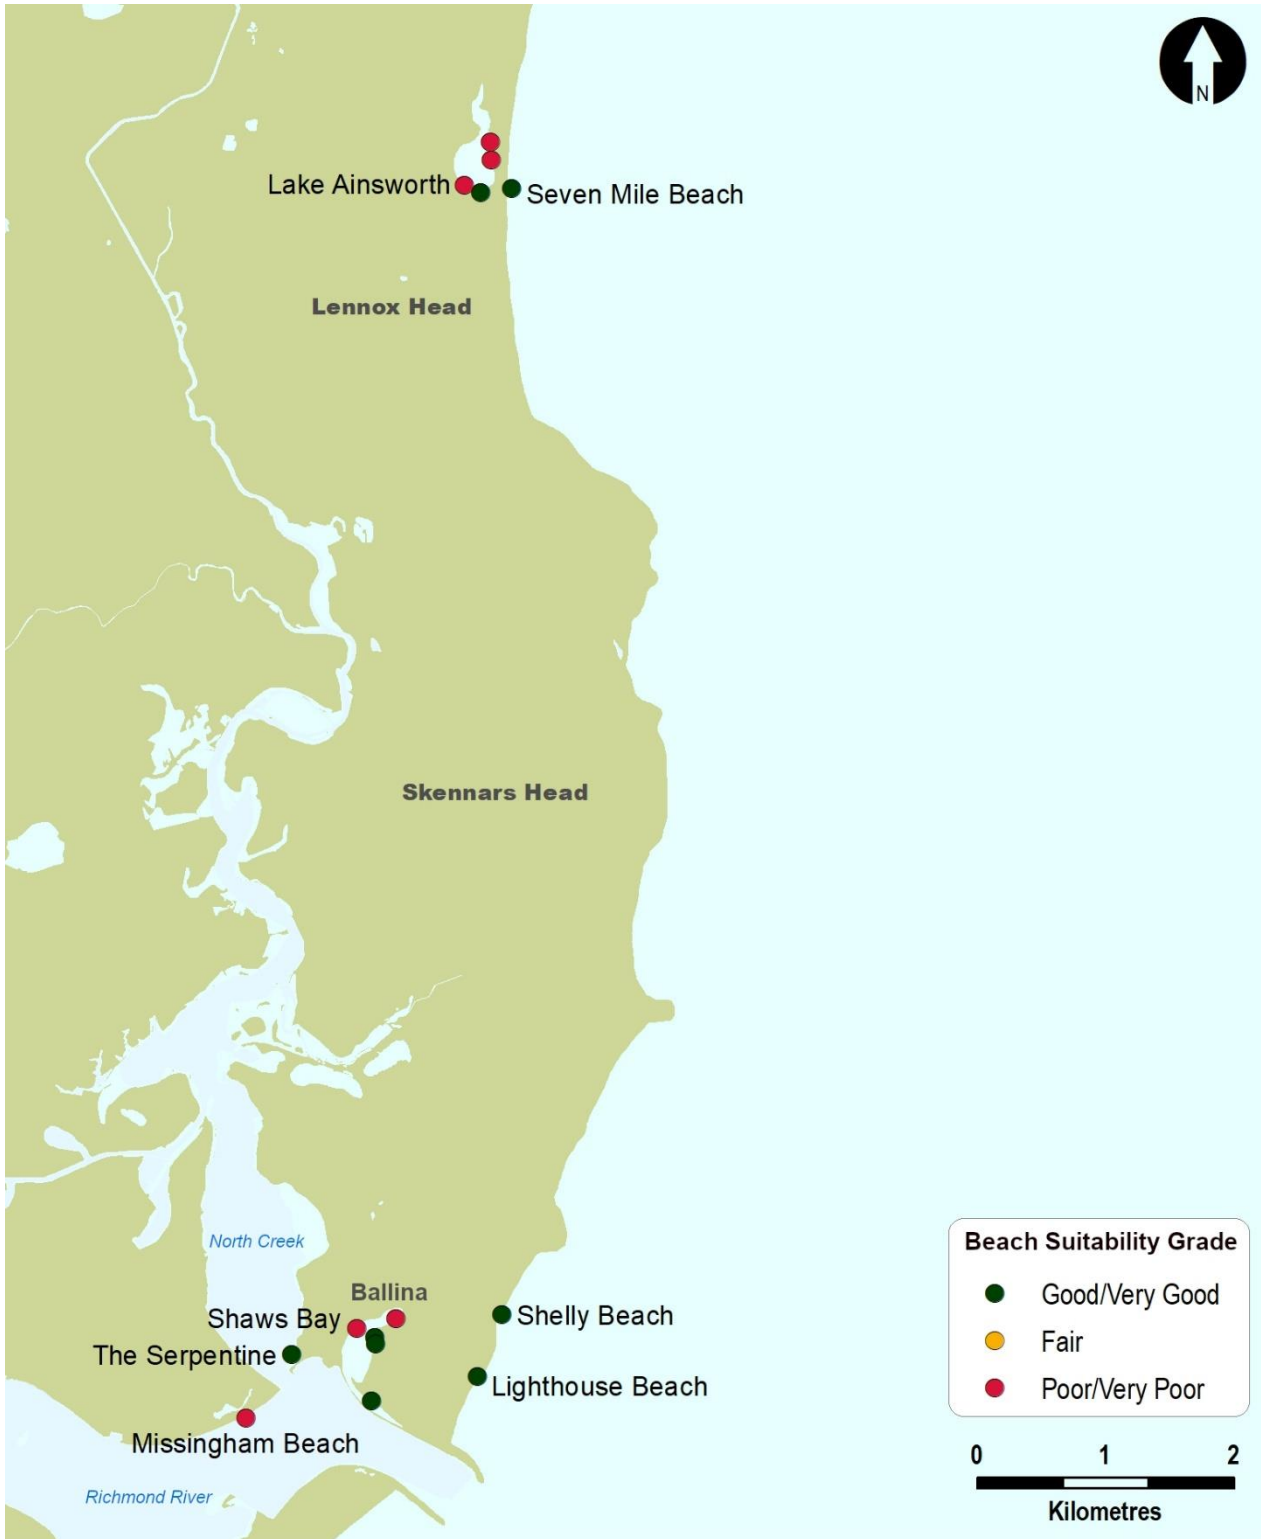
Sampling sites and Beach Suitability Grades in Ballina Shire Council

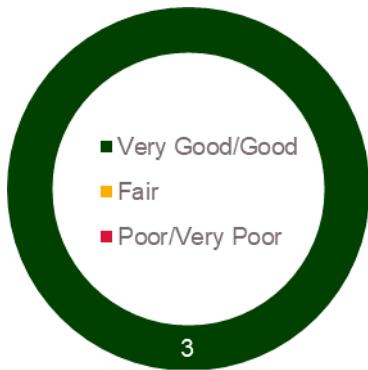
Beach Suitability Grades for Richmond Valley Council ocean beaches

Shark Bay was graded as Very Good in 2022–2023. Water quality at this beach has been consistently excellent for many years and is suitable for swimming almost all of the time.

Airforce Beach and Main Beach continued to be graded as Good in 2022–2023, a similar result to the previous year. While water quality at these beaches was suitable for swimming most of the time, elevated enterococci results were occasionally recorded in dry and wet weather conditions.

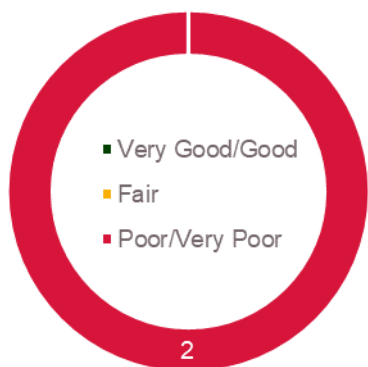
Beach Suitability Grades for Richmond Valley Council estuarine beaches

Evans River, located downstream of Elm Street Bridge North, continued to be graded as Poor in 2022–2023, consistent with previous years. Elevated bacterial levels were recorded in dry weather and were regularly elevated during and following moderate to heavy rainfall. Despite this, water quality was often suitable for swimming during dry weather, with 60% of dry weather samples within the safe swimming limit. Discharge from a nearby large stormwater drain is also likely to impact water quality at this site when flowing.

Elm Street Bridge North in the Evans River was graded as Poor in 2022–2023, downgraded from Good in the previous year. Water quality was mostly suitable for swimming during dry weather, with 79% of samples within the safe swimming limit. Elevated bacterial levels were often recorded following rainfall.

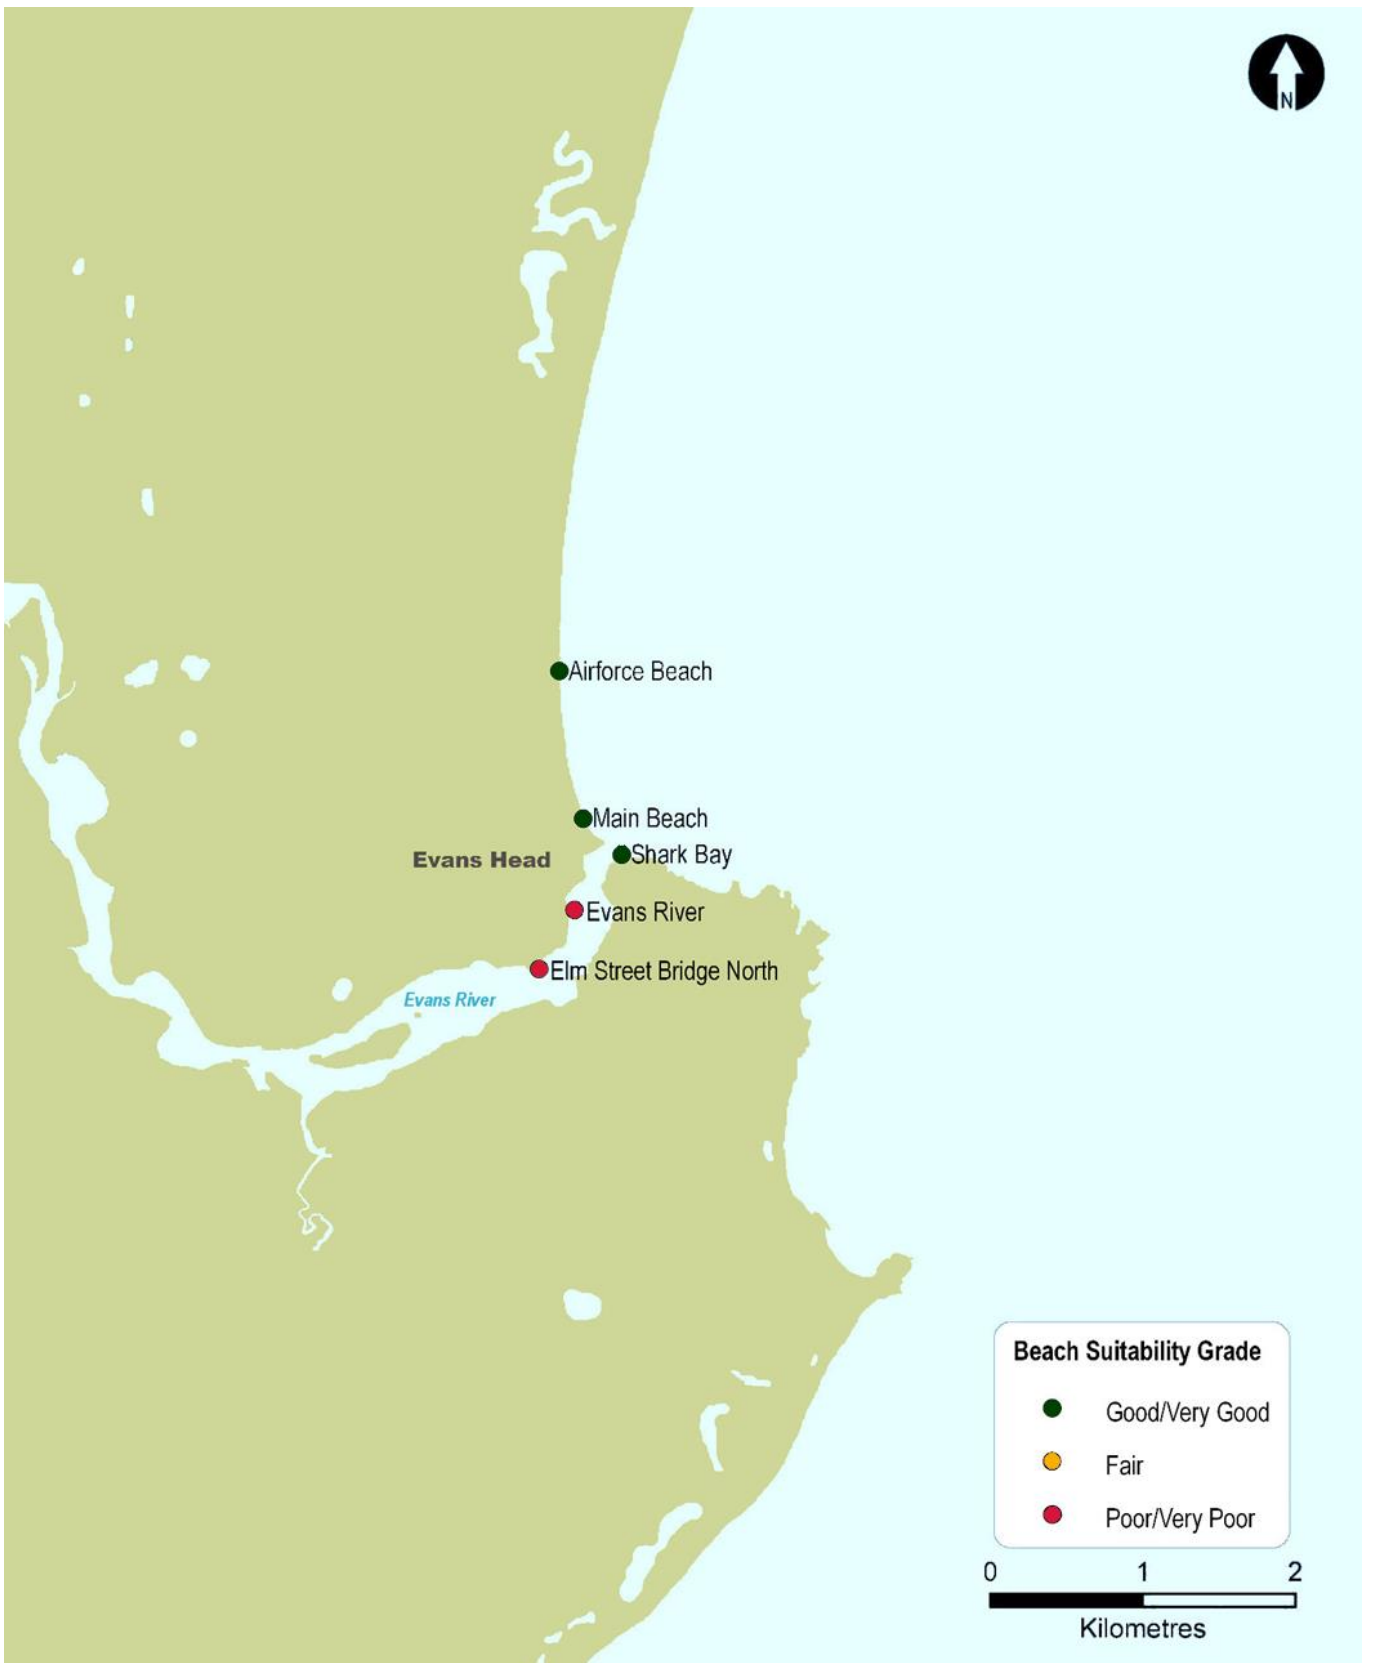
Sampling sites and Beach Suitability Grades in Richmond Valley Council

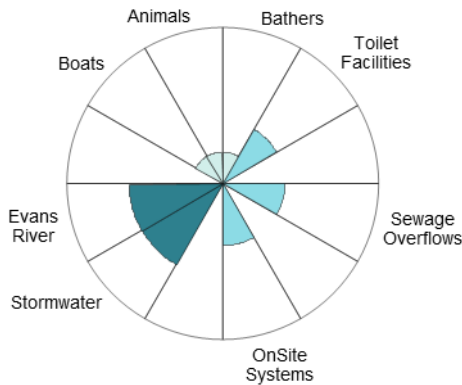
Sanitary inspection: Moderate

Microbial Assessment Category: D

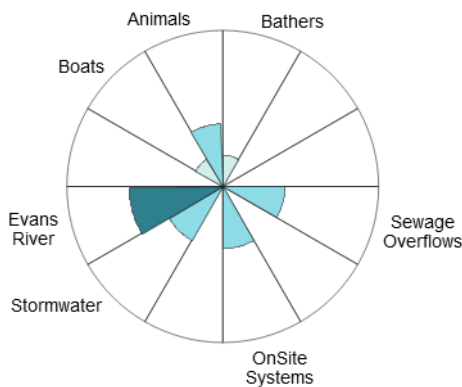
Sanitary inspection: Moderate

Microbial Assessment Category: C
