## Beachwatch

# State of the beaches 2022–23

South Coast Region

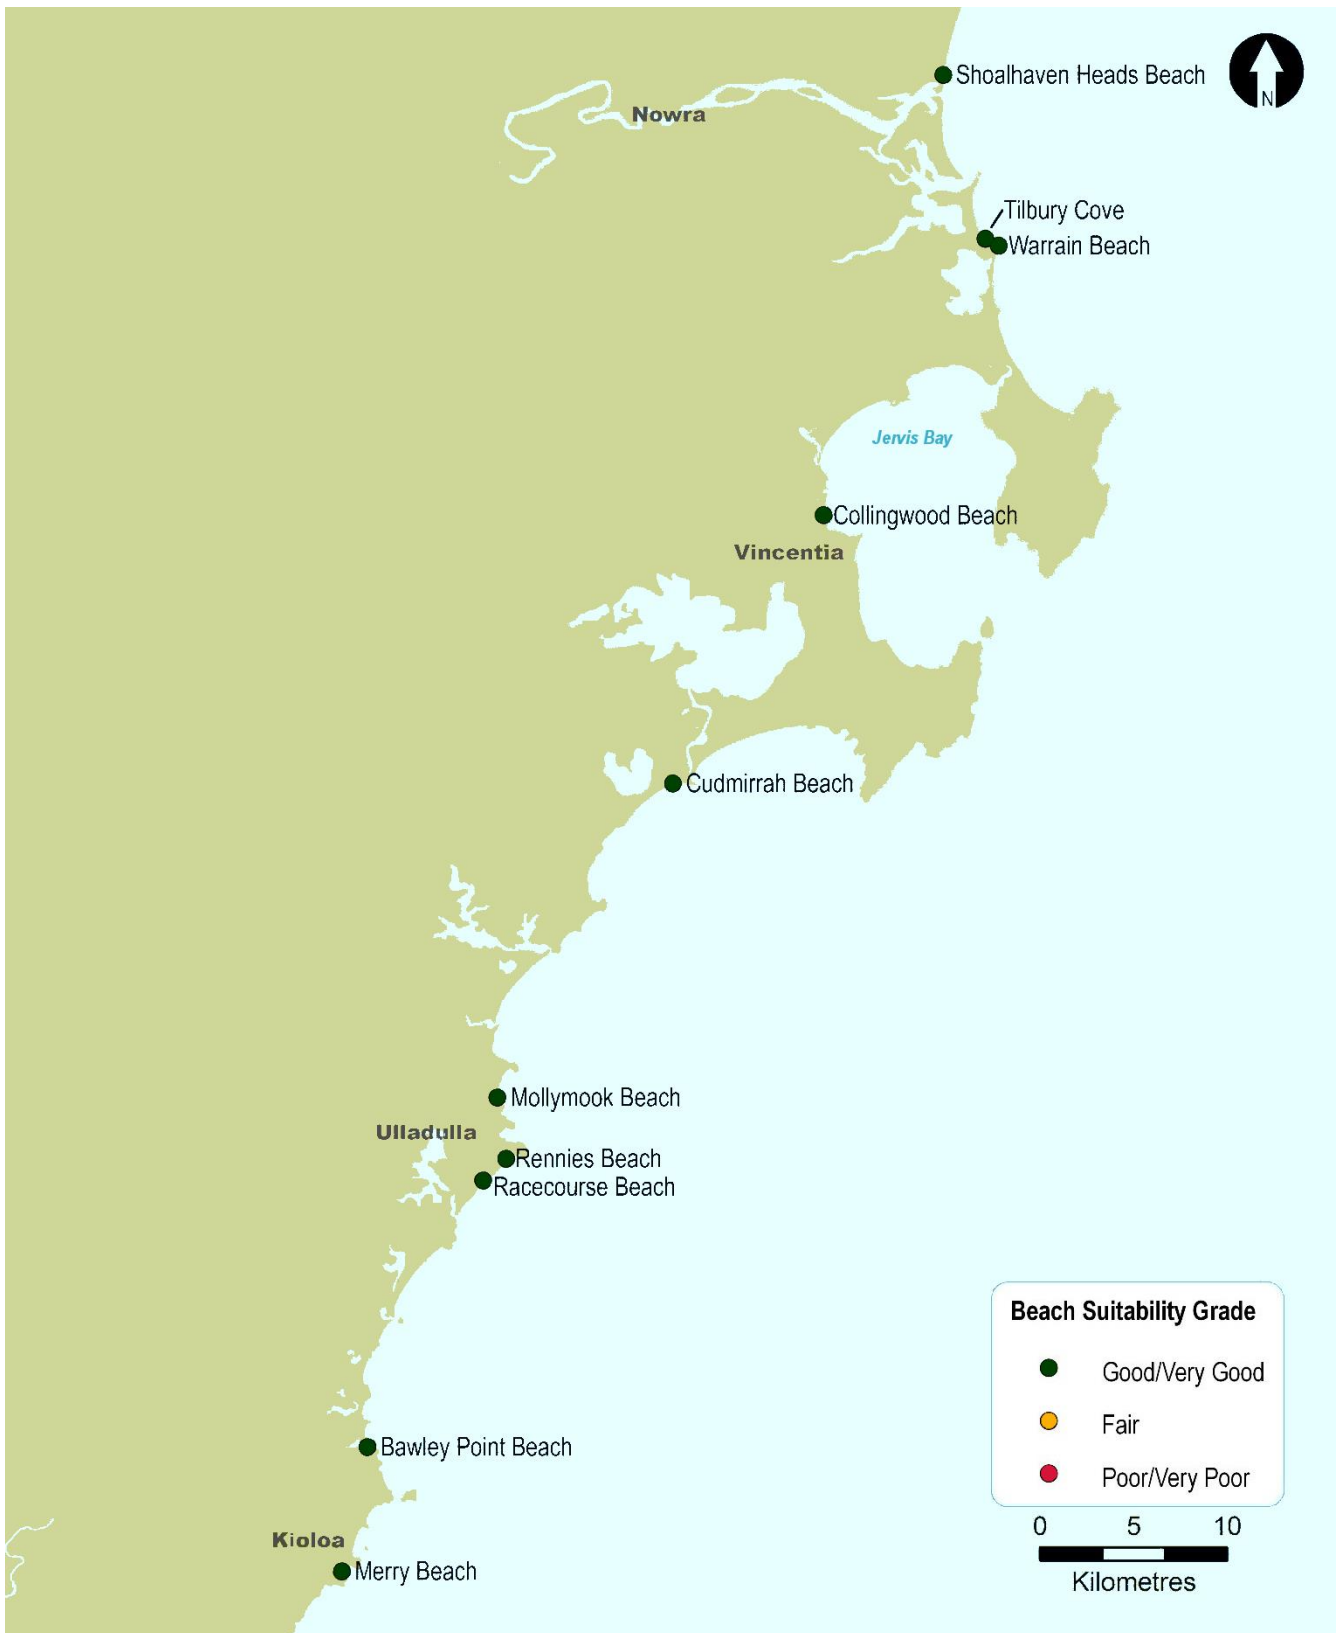
**Sampling sites and Beach Suitability Grades in Shoalhaven City Council**

While water quality at these sites was suitable for swimming almost all of the time, elevated bacterial levels were occasionally recorded at some of the beaches following heavy rainfall.

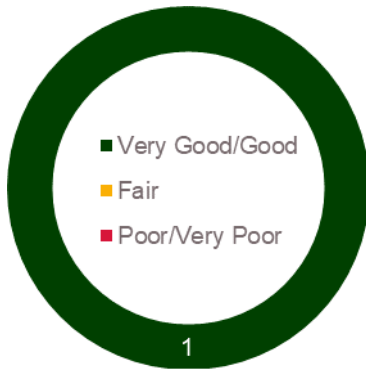
**Beach Suitability Grades for Eurobodalla Shire Council estuarine beaches**

Wagonga Inlet continued to be graded as Good in 2022–2023, similar to previous years. While water quality at this site was mostly suitable for swimming, elevated enterococci results were occasionally recorded after light rain, and regularly after heavy rainfall. Pollution inputs from elsewhere within Wagonga Inlet may impact water quality at this site.

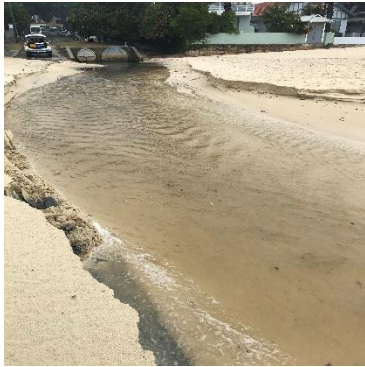
Stormwater drain flow  
Photo: Beachwatch/DPE

Stormwater in urban areas often contains sewage from leakages, overflows or sewer chokes when the sewerage system fails.

Sewage overflows can occur in wet weather when the network has exceeded capacity due to rainwater entering the system. The mix of sewage and rainwater discharges from designated overflow points and drains to waterways, usually via the stormwater system. Overflows from the sewerage system can also occur in dry weather due to mechanical failure or power outage.

Sewer chokes occur due to blockages in the pipes usually due to tree roots, oil, grease or debris. This causes sewage to back up and escape via sewer inspection points, designed overflow structures or cracks in the pipes, then drain to waterways, usually via the stormwater system.

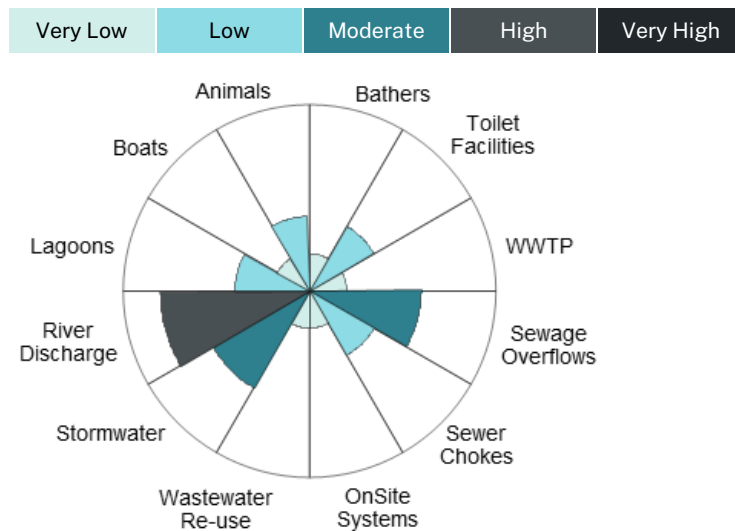
The results of the sanitary inspection for each swimming location are presented in a radar pie chart. The chart shows the likelihood that each identified pollution source will contribute to faecal contamination at a swimming site, as indicated by the size and colour of the segment, ranging from very low (lightest colour) to very high (darkest colour) as shown below. The sum of these contributions is the overall likelihood, or Sanitary Inspection Category.

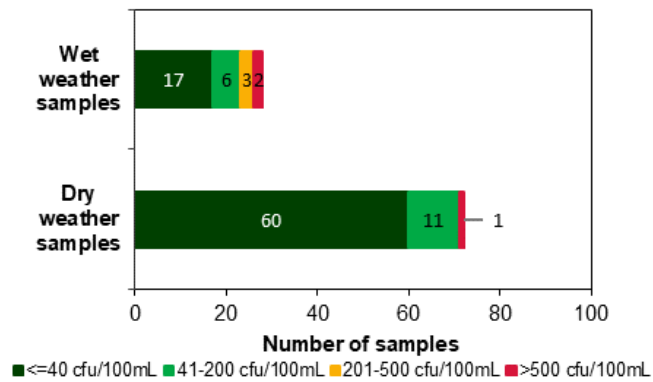
### Wet and dry weather water quality chart

Enterococci levels in wet and dry weather conditions are presented for each swimming location as a bar graph. All data collected during the assessment period is included in the analysis. Dry weather is defined as no rainfall recorded in the previous 24 hours. Each bar is colour coded to show the number of enterococci results up to 40 cfu/100 mL, between 41 and 200 cfu/100 mL, between

201 and 500 cfu/100 mL and greater than 500 cfu/100 mL. These categories reflect the Microbial Assessment Category thresholds and are coloured on the graph as dark green, light green, amber and red respectively.

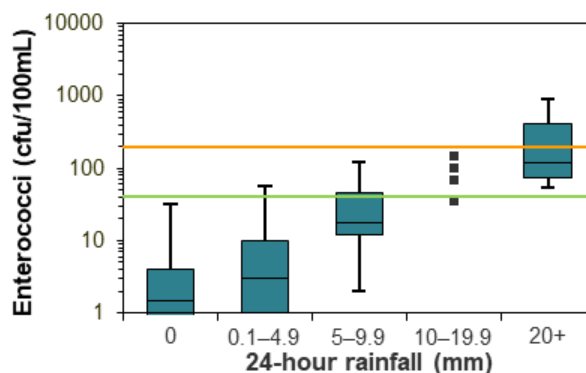
Trends in enterococci levels in response to rainfall are shown using a box plot. For reference, enterococci levels of 40 cfu/100 mL and 200 cfu/100 mL are indicated with a green and orange line, respectively. The 40 cfu/100 mL level is referred to as the ‘safe swimming limit’. The enterococci data were obtained from the last 5 years of monitoring. Rainfall data were obtained from rain gauges situated close to the sample site and are 24-hour totals to 9 am on the day of sampling. If there are fewer than 5 enterococci data points in a rainfall category, individual data points are presented instead of a box plot. At sites where many results are below the detection limit (1 cfu/100 mL), only the upper portion of the box plots will be visible.
