Beachwatch

State of the beaches 2022–23

Sydney Region

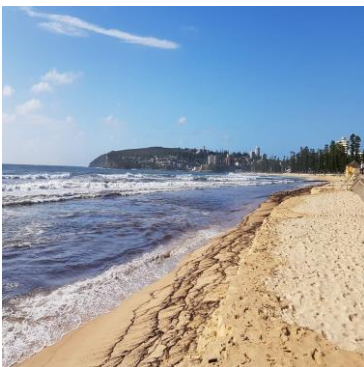
Debris and discoloured water at Queenscliff Beach following extreme wet weather and flooding
Photo: Beachwatch/DPE

As microbial levels returned to normal at swim sites monitored by Beachwatch there was still a large amount of debris or other hazards, such as murky water, which posed a risk to recreational activities.

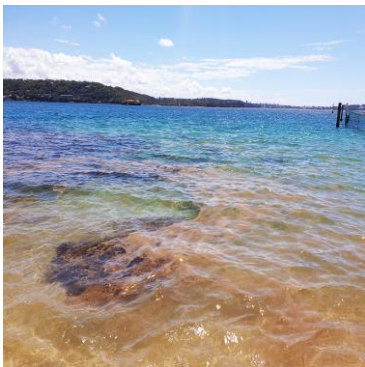
Marine algal bloom present in the water

WaterNSW reported several occurrences of marine algal blooms along the Sydney coast in 2022–2023. Blooms of *Alexandrium pacificum* occurred in a number of estuaries including Broken Bay and Pittwater during October 2022 to February 2023. *Noctiluca* sp. were reported at Coogee Beach in March 2023. Marine algae advisories were issued on the Beachwatch and WaterNSW websites.

The appearance of **marine algae** is sometimes mistaken for **sewage contamination** or **oil slicks**, due to a strong odour and red or brown discolouration in the water caused by the blooms.

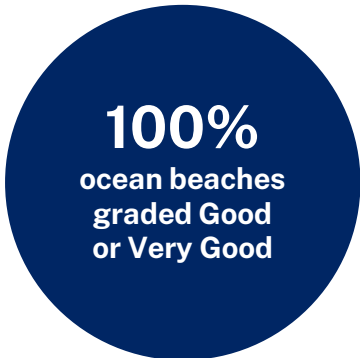
Percentage of sites graded as Very Good or Good

Twenty-nine of the 32 swimming sites were graded as Very Good or Good in 2022–2023. This is a very good result and a similar performance to the previous year.

2020–2021	2021–2022	2022–2023	Trend
Ocean beaches (20 sites)	100%	100%	100%	
Estuarine sites (10 sites)	100%	90%	90%	
Lake/lagoon sites (2 sites)	0%	0%	0%

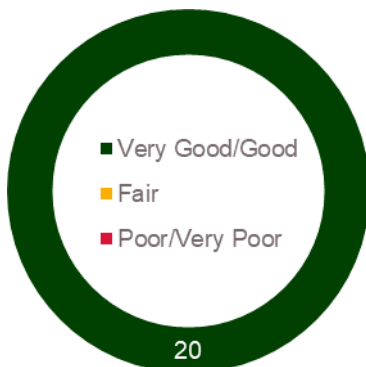
Beach Suitability Grades for Northern Sydney ocean beaches

Bilgola Beach, Newport Beach, Bungun Beach, Mona Vale Beach, Warriewood Beach, Turimetta Beach, North Narrabeen Beach, Collaroy Beach, Long Reef Beach, Dee Why, North Curl Curl Beach, South Curl Curl Beach, Freshwater Beach, Queenscliff Beach, North Steyne Beach, South Steyne Beach and Shelly Beach were graded as Good. Water quality was frequently suitable for swimming during dry weather conditions, with elevated levels of enterococci recorded following heavy rainfall.

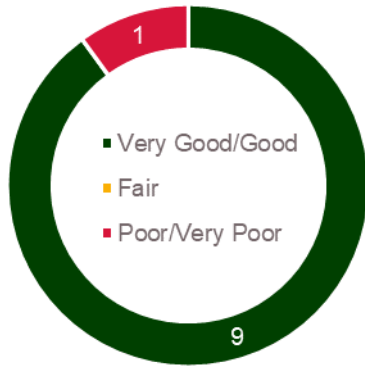
Beach Suitability Grades for Northern Sydney estuarine beaches

Nine of the 10 estuarine swimming sites in Pittwater were graded as Very Good or Good in 2022–2023.

Barrenjoey Beach, Paradise Beach Baths, Clareville Beach, Taylors Point Baths, North Scotland Island, South Scotland Island and Elvina Bay were graded as Good. Water quality at these sites was suitable for swimming most of the time, with elevated levels of enterococci mostly recorded following rainfall. Bacterial levels were occasionally elevated at Barrenjoey Beach during dry weather conditions.

Bayview Baths was graded as Poor, a similar result to the previous year. Elevated enterococci levels were occasionally recorded during dry weather conditions, and regularly after moderate to heavy rainfall. Water quality at this site can take longer to recover from stormwater events than at other Pittwater swimming sites due to lower levels of flushing.

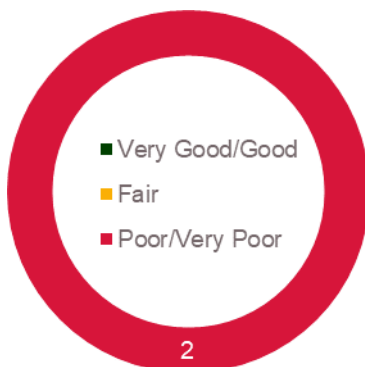
Beach Suitability Grades for Northern Sydney lake/lagoon swimming sites

The 2 swimming sites in Narrabeen Lagoon, Birdwood Park and Bilarong Reserve, continued to be graded as Poor in 2022–2023, as in the previous year. Water quality at these sites was mostly suitable for swimming during dry weather, with 82% and 73% of dry weather samples within the safe swimming limit for Birdwood Park and Bilarong Reserve, respectively. However, enterococci levels increased with increasing rainfall, and often exceeded the safe swimming limit after light rainfall.

The amount of time the lagoon is open or closed influences water quality at Birdwood Park and Bilarong Reserve lagoon sites. During periods of entrance closure, water quality is likely to decline as pollution inputs are not as readily dissipated or flushed. The lagoon entrance will open and close naturally depending on how much rainfall has occurred and how much sand has accumulated in the mouth. When there are very large accumulations of sand, the entrance will often close and stay closed until the sand is removed by Northern Beaches Council. Historically this process happens every 4–5 years, with the last sand clearance operation being completed in December 2021. With the adoption of the Narrabeen Lagoon Entrance Management Strategy in September 2022, council will be trialling more frequent but smaller sand clearance operations (every 2–3 years rather than 4–5 years).

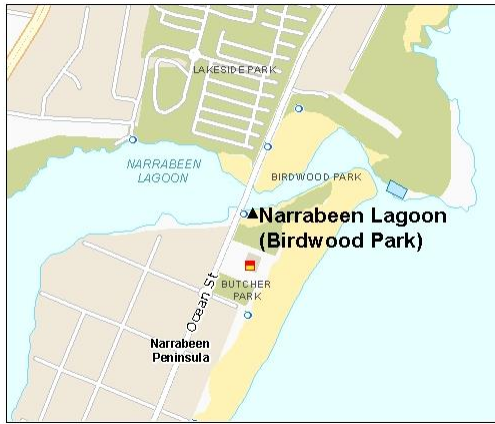
Narrabeen Lagoon (Birdwood Park)

See 'How to read this report' for key to map.

The Birdwood Park swimming site is a sandy beach on the southern side of the entrance to Narrabeen Lagoon. The lagoon entrance has been periodically open and closed at times.

The Beach Suitability Grade of Poor indicates microbial water quality is susceptible to faecal pollution, particularly after rainfall and occasionally during dry weather conditions, with several potential sources of faecal contamination including from elsewhere within the lagoon.

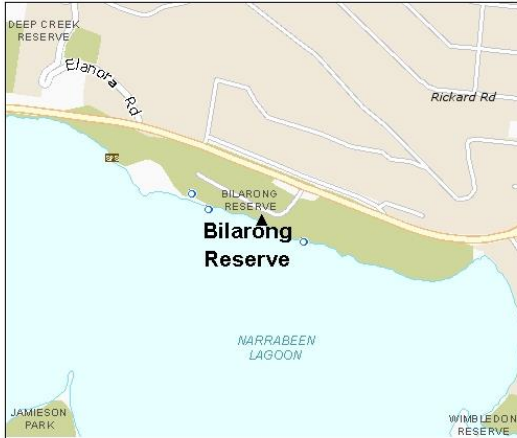
Bilarong Reserve is located on the northern shoreline of Narrabeen Lagoon.

The Beach Suitability Grade of Poor indicates microbial water quality is susceptible to faecal pollution, particularly after rainfall and occasionally during dry weather conditions, with several potential sources of faecal contamination including from elsewhere within the lagoon.

Bilarong Reserve in Narrabeen Lagoon retains pollution inputs because it is located away from the lagoon entrance and is not well flushed by clean ocean water. A significant source of faecal contamination is stormwater runoff to the lagoon.

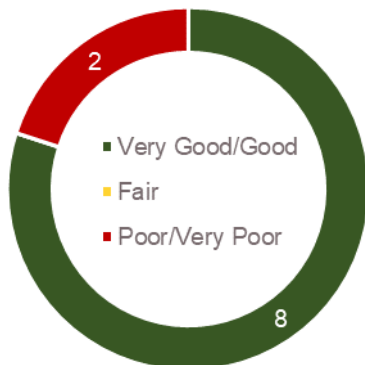
Beach Suitability Grades for Central Sydney ocean beaches

Bondi Beach, Tamarama Beach, Bronte Beach, Clovelly Beach, Gordons Bay, Maroubra Beach, South Maroubra Beach and Little Bay Beach were graded as Good. Clovelly Beach and South Maroubra Beach were downgraded to Good from Very Good in the previous year, due to a decline in microbial water quality. These sites were frequently suitable for swimming during dry weather conditions but recorded elevated enterococci levels following rainfall. Elevated enterococci levels were occasionally recorded at Little Bay Beach in dry weather conditions.

Coogee Beach and Malabar Beach were graded as Poor. Malabar Beach was downgraded to Poor from Good in the previous year. Microbial water quality at these sites is frequently suitable for swimming during dry weather conditions, with 86% and 88% of dry weather samples within the safe swimming limit, respectively. However, enterococci levels increase following rainfall.

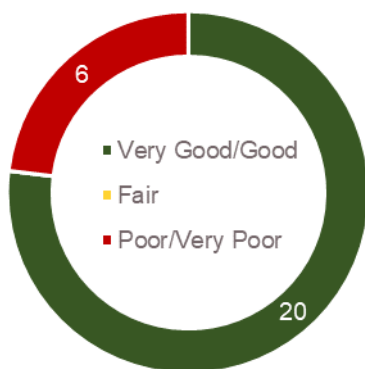
Beach Suitability Grades for Central Sydney estuarine beaches

Six estuarine swimming sites in Sydney Harbour were graded as Poor in 2022–2023: Rose Bay Beach, Tambourine Bay, Woolwich Baths, Northbridge Baths, Gurney Crescent Baths and Davidson Reserve. Water quality at these swimming sites was mostly suitable for swimming during dry weather conditions, with elevated bacterial levels recorded following rainfall.

While Tambourine Bay in Lane Cove River, Davidson Reserve in Middle Harbour, Rose Bay Beach in Port Jackson and Northbridge Baths in Middle Harbour continued to be graded as Poor from the previous year, Woolwich Baths in lower Lane Cove River and Gurney Crescent Baths in Middle Harbour were downgraded to Poor from Good and Fair grades, respectively, due to a decline in microbial water quality. Microbial water quality at Woolwich Baths and Gurney Crescent Baths is frequently suitable for swimming during dry weather conditions, with 83% and 93% of dry weather samples within the safe swimming limit, respectively. However,

enterococci levels increase following rainfall. These sites are more susceptible to wet weather impacts and have several significant sources of faecal contamination including upstream sources, stormwater and sewage overflows.

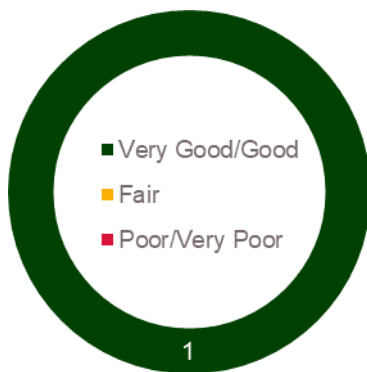
Beach Suitability Grades for Central Sydney ocean baths

South Maroubra Rockpool was graded as Good in 2022–2023, similar to previous years. Water quality is frequently suitable for swimming during dry weather conditions, with 88% of dry weather samples within the safe swimming limit. Enterococci levels increased with increasing rainfall. Swimming should be avoided during and for up to one day following rainfall, or if there are any signs of pollution such as the stormwater drain discharging to the site, discoloured water or floating debris.

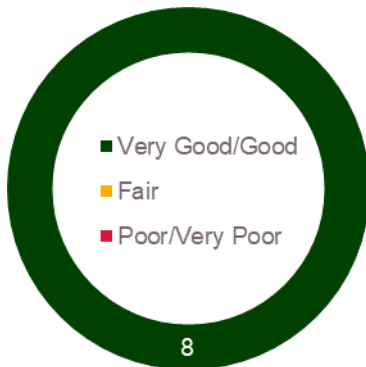
Beach Suitability Grades for Southern Sydney ocean beaches

Greenhills Beach, Wanda Beach, Elouera Beach, North Cronulla Beach, Shelly Beach and Oak Park were graded as Very Good. Water quality at these sites has been consistently excellent for many years and is suitable for swimming almost all of the time.

Boat Harbour and South Cronulla Beach were graded Good as in the previous year. Water quality at these sites is mostly suitable for swimming during dry weather conditions, but can be susceptible to pollution, with elevated enterococci levels occasionally recorded during dry weather or after light rainfall.

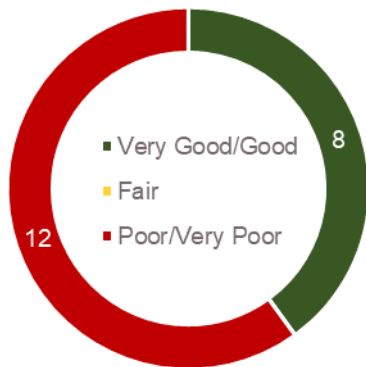
Beach Suitability Grades for Southern Sydney estuarine beaches

Eight of the 20 estuarine sites were graded as Good in 2022–2023: Silver Beach, Sandringham Baths, Ramsgate Baths, Monterey Baths, Congwong Bay, Jibbon Beach, Horderns Beach and Lilli Pilli Baths. Water quality at these sites was suitable for swimming most of the time, with elevated levels of enterococci mostly recorded following rainfall.

Ten estuarine swimming sites were graded as Poor in 2022–2023: Jew Fish Bay Baths, Oatley Bay Baths, Como Baths and Carss Point Baths in the lower Georges River, Brighton-Le-Sands Baths, Dolls Point Baths, Kyeemagh Baths, Frenchmans Bay and Yarra Bay in Botany Bay, and Gunnamatta Bay Baths in Port Hacking. Microbial water quality at these sites was mostly suitable for swimming during dry weather conditions, with between 63% and 92% of dry weather samples within the safe swimming limit. However, bacterial levels increased significantly with increasing rainfall.

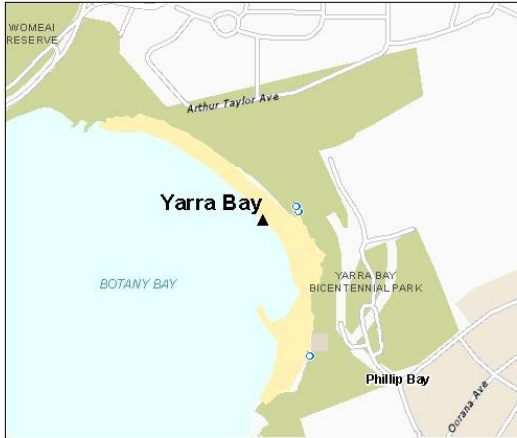
Yarra Bay is a 750 m long sandy beach in Botany Bay. The swimming area is not netted and has a rock groyne at the southern end.

The Beach Suitability Grade of Poor indicates microbial water quality is susceptible to faecal pollution, particularly after rainfall and occasionally during dry weather conditions, with several potential sources of faecal contamination including stormwater that ponds in the middle of the beach.

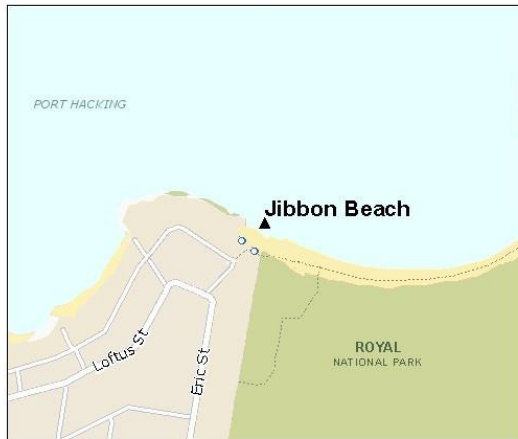
Jibbon Beach is located at the entrance to Port Hacking. The beach is backed by the Royal National Park and accessed from Bundeena.

The Beach Suitability Grade of Good indicates microbial water quality is considered suitable for swimming most of the time but may be susceptible to pollution after rain, with several potential sources of faecal contamination.

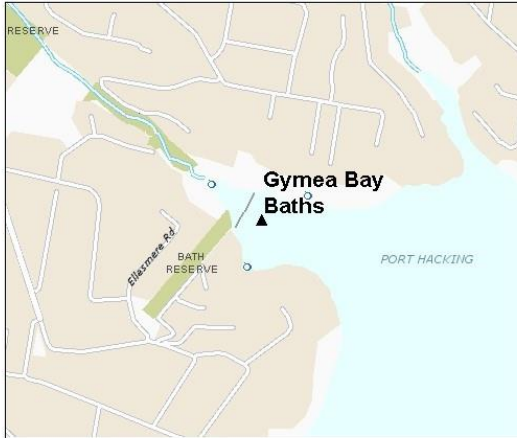
GyMEA Bay Baths is an enclosed tidal swimming area backed by a narrow sandy beach in the upper reaches of Port Hacking.

The Beach Suitability Grade of Very Poor indicates microbial water quality is very susceptible to faecal pollution with many potential sources of faecal contamination including stormwater.

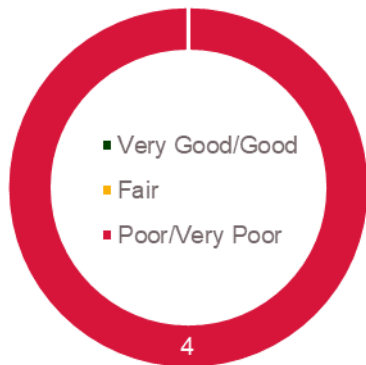
Beach Suitability Grades for Western Sydney

All 4 Western Sydney freshwater sites were graded as Poor or Very Poor in 2022–2023.

Megalong Creek, Wentworth Falls Lake – Jetty and Wentworth Falls Lake – Beach were graded as Poor. These sites are susceptible to pollution after rainfall, with a larger proportion of samples collected during wet weather conditions contributing to the Poor grades.

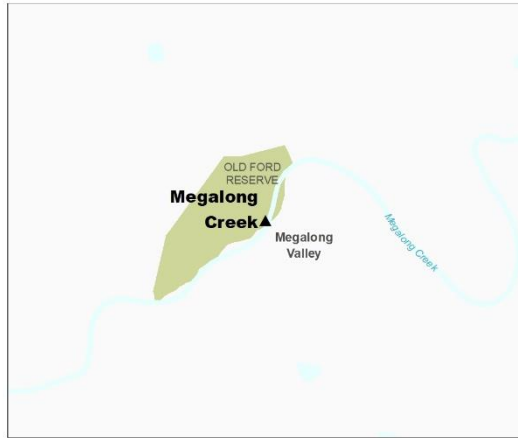
Megalong Creek swim site is a group of pools along a 150 m stretch of Megalong Creek, adjacent to Old Ford Camping Reserve.

The Beach Suitability Grade of Poor indicates microbial water quality is susceptible to faecal pollution, particularly after rainfall and occasionally during dry weather conditions, with potential faecal contamination from upstream sources in the creek.

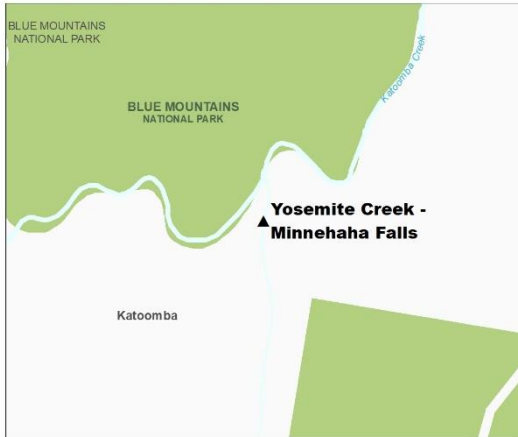
Yosemite Creek – Minnehaha Falls swim site is a small, shallow pool in Yosemite Creek, at the edge of the Blue Mountains National Park and is near the popular Minnehaha Falls.

The Beach Suitability Grade of Very Poor indicates microbial water quality is very susceptible to faecal pollution with many potential sources of faecal contamination.
