Beachwatch

State of the beaches 2023–24

Central Coast region

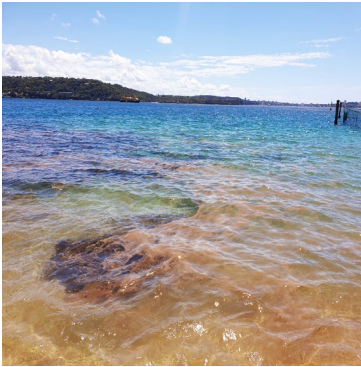
Marine algal bloom present in the water

The appearance of **marine algae** is sometimes mistaken for **sewage contamination** or **oil slicks**, due to a strong odour and red or brown discolouration in the water caused by the blooms.

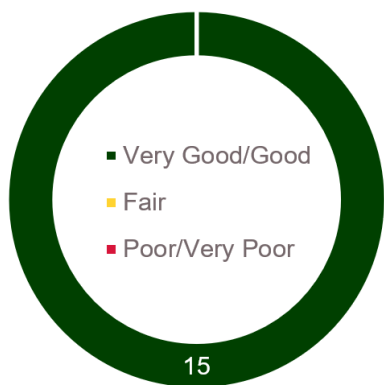
Beach Suitability Grades for Central Coast ocean beaches

Lakes Beach, Soldiers Beach and North Entrance Beach were graded as Very Good in 2023–2024. While the grade for North Entrance Beach was consistent with the previous year, Lakes Beach and Soldiers Beach grades improved from Good in the previous year due to improved microbial water quality. Water quality at these sites was suitable for swimming almost all of the time.

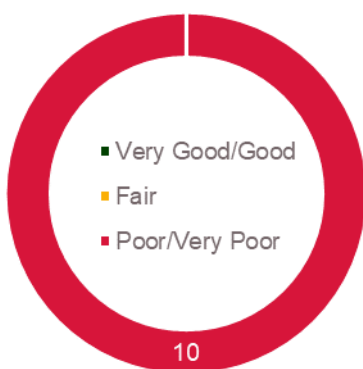
Beach Suitability Grades for Central Coast lake/lagoon swimming sites

Summerland Point Baths, Gwandalan, Chain Valley Bay, Mannering Park Baths, Lake Munmorah Baths and Canton Beach were graded as Poor in 2023–2024, consistent with the previous year.

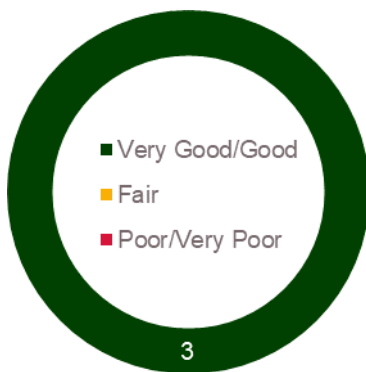
Beach Suitability Grades for Central Coast ocean baths

The Entrance Ocean Baths was frequently suitable for swimming during dry weather conditions with 100% of dry weather samples within the safe swimming limit. Elevated enterococci were occasionally recorded following heavy rain.

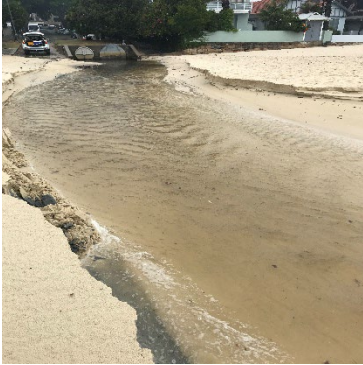
Stormwater drain flow

Stormwater in urban areas often contains sewage from leakages, overflows or sewer chokes when the sewerage system fails.

Sewage overflows can occur in wet weather when the network has exceeded capacity due to rainwater entering the system. The mix of sewage and rainwater discharges from designated overflow points and drains to waterways, usually via the stormwater system. Overflows from the sewerage system can also occur in dry weather due to mechanical failure or power outage.

Sewer chokes occur due to blockages in the pipes usually due to tree roots, oil, grease or debris. This causes sewage to back up and escape via sewer inspection points, designed overflow structures or cracks in the pipes, then drain to waterways, usually via the stormwater system.
