# Wantiool Land and Water Management Plan

Prepared for the Wantiool Landcare Group, Junee NSW

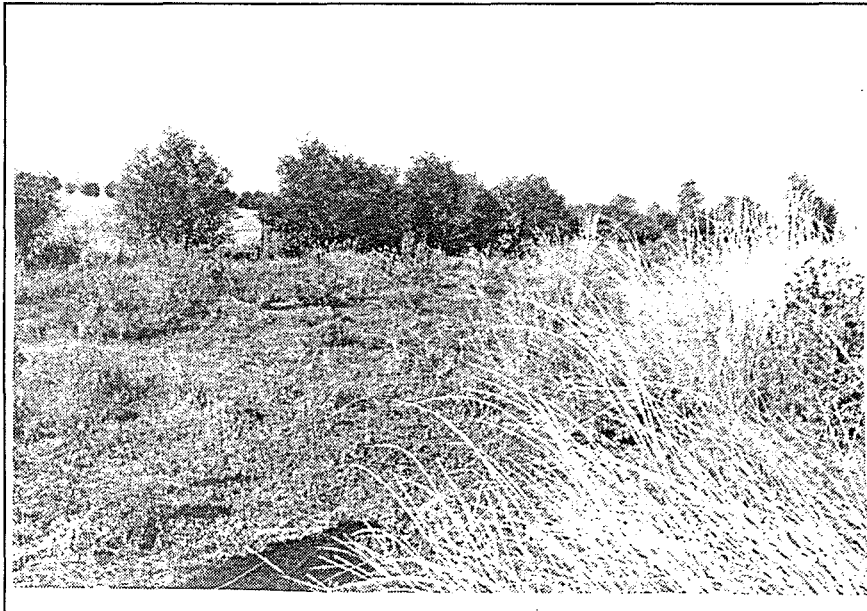
*A salt reclamation project on "Wirega" using Tall Wheat Grass, Strawberry clover and trees established from tubestock.*

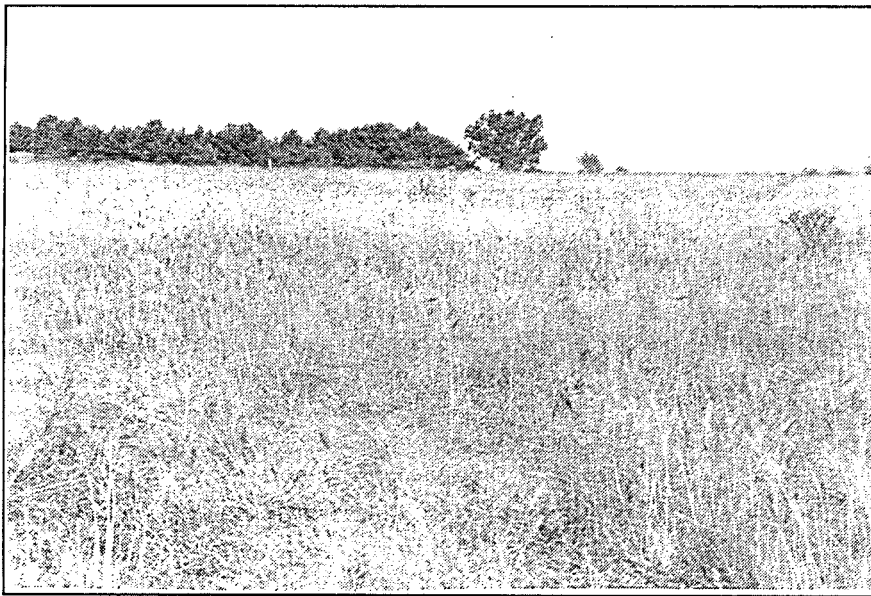
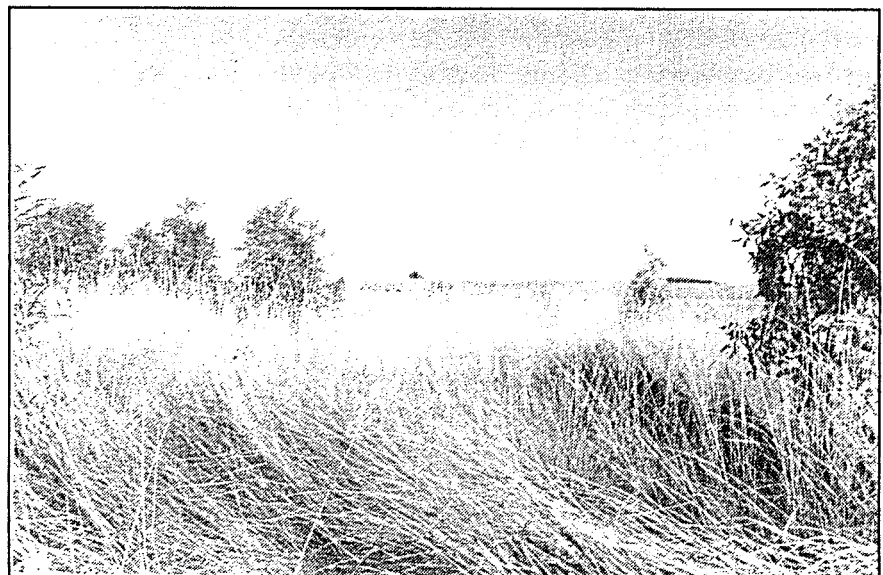
*Pastures being used to control salinity (top) Consol lovegrass and Tall Wheat Grass (at right).*
