# **Statement of Heritage Impact**

Demondrille Signal Box

October 2023

Project Number: 210458

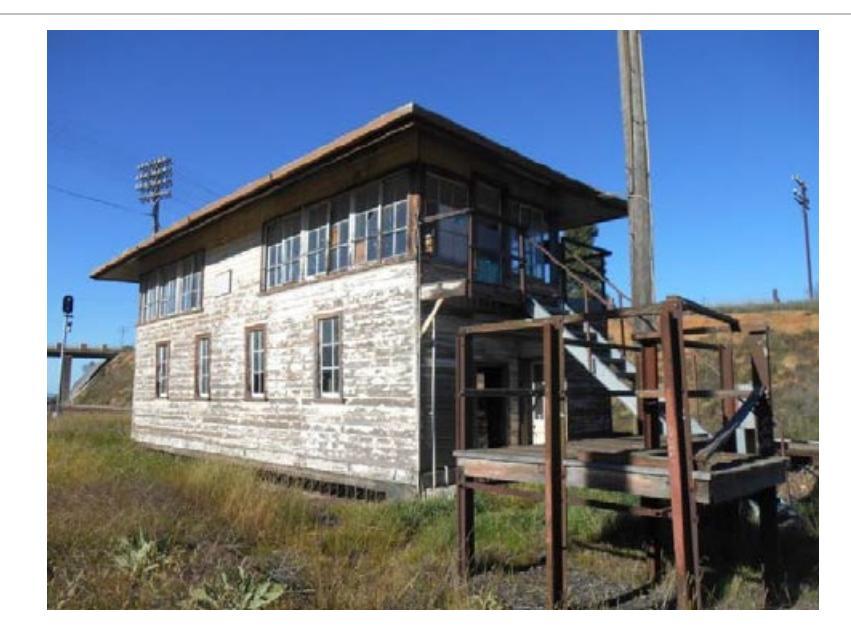
Figure 3-10 Demondrille signal box in c.2014 (2014 Asbestos Register)

The building was provided to ARTC in 2004 as redundant infrastructure and was classed by ARTC as already being in a dilapidated state. The SHI database assessment of condition in 2009 is that the signal box was in a derelict state. It is noted in the BCS (2010) strategy that there were OH&S issues accessing the building. Photos from the 2014 Asbestos Register display the condition of the building as dilapidated and it was noted that the structure was high risk due to the ACM and presented significant OH&S issues (Figure 3-10).

Between 2014 and 2019, access to the structure was restricted when the external stairs collapsed. In order to prevent further collapse of the structure, ARTC installed external bracing columns to hold the structure in place (Figure 3-10).

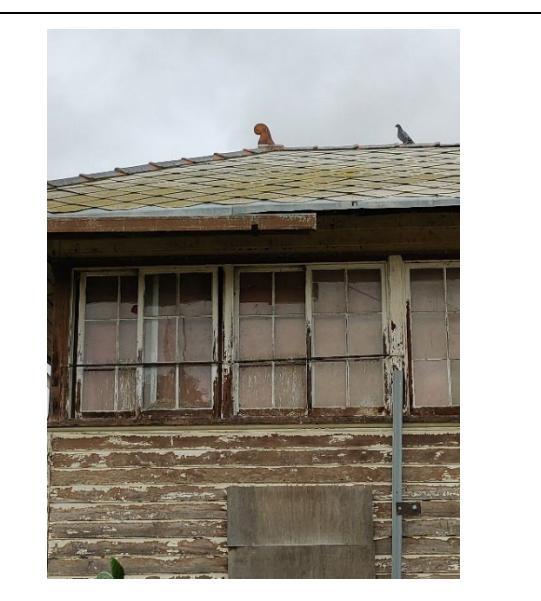
Plate 3-2 Upper storey windows and roof of signal box. Some details remain, including the terracotta finials

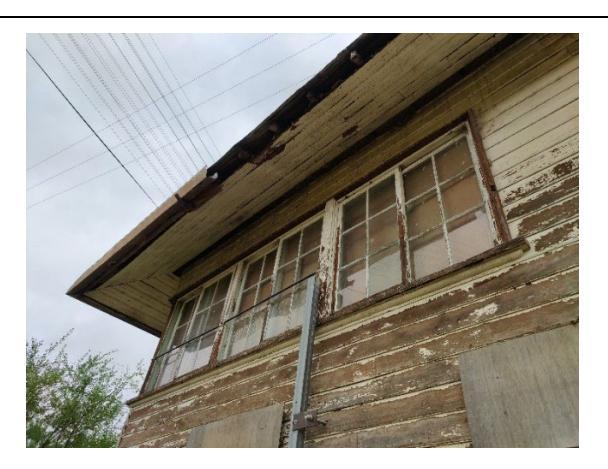
Plate 3-4 Upper storey windows and eaves

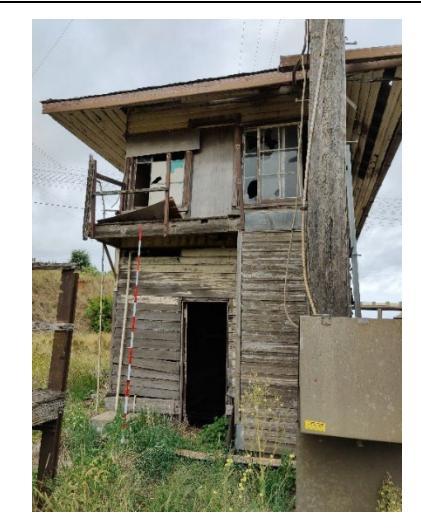
Plate 3-5 External stairs to reach the second storey originally located on the northern side of the structure have been mostly removed

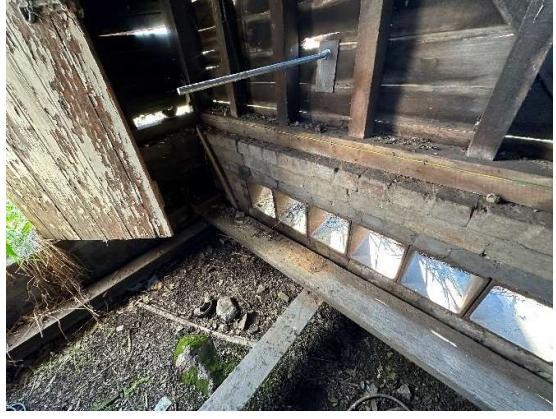
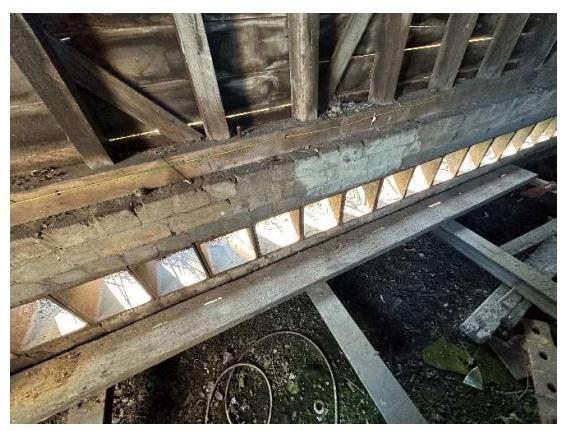
- Timber frame supported on foundation masonry and open steel "blocks" refer photo 01 & 02.
- Floor supports consist of rail iron joists supported by lower masonry. Majority of floorboards have been dislodged – refer photo 03 & 04.

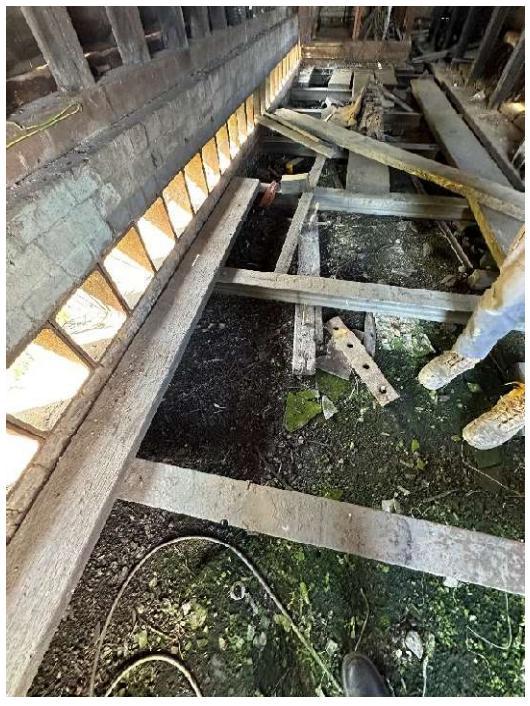
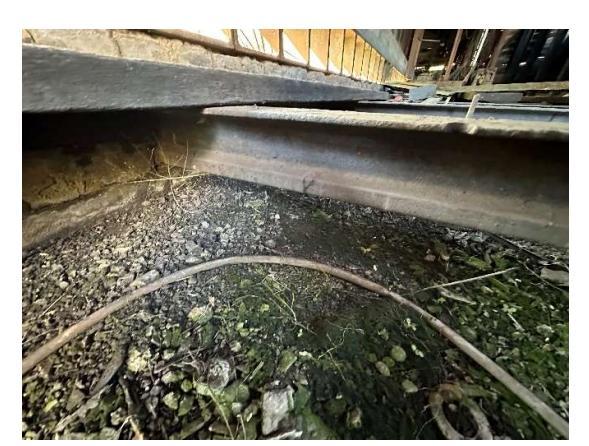
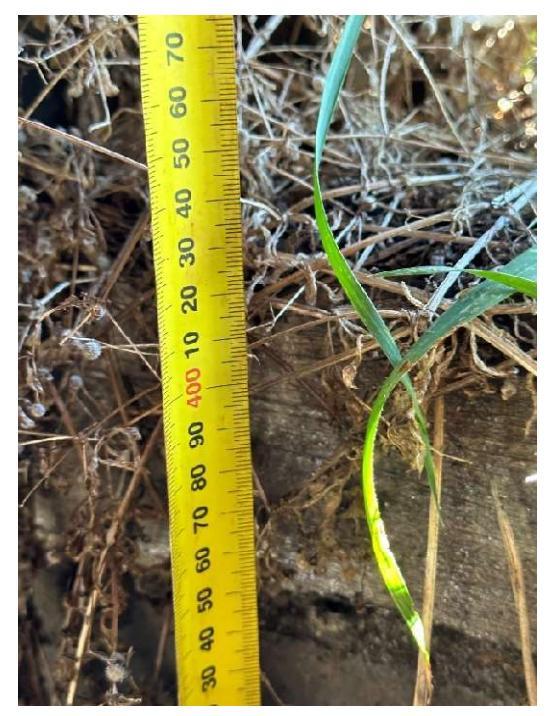
- Ground surface to the underside of the floor is damp and sits approximately 400mm lower than the surrounding ground levels refer photo's 05 to 07.
- Previous remedial works have been undertaken to external wall, however, fixed to the external cladding only and not the structural frame refer photo 08.

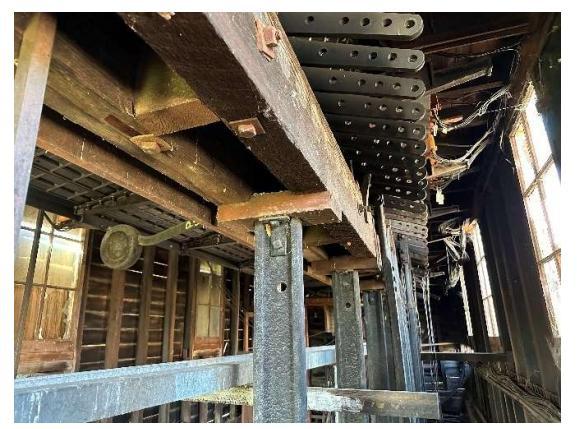
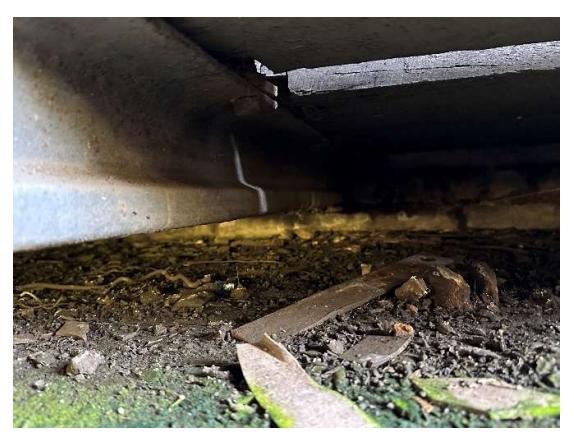
- Main double bearers for lever arms supported by rail iron columns. Columns are supported by joists at floor level refer photo 09 & 10.
- First floor bearer is supported by struts to lower bearer for lever arms refer photo 11 & 12.

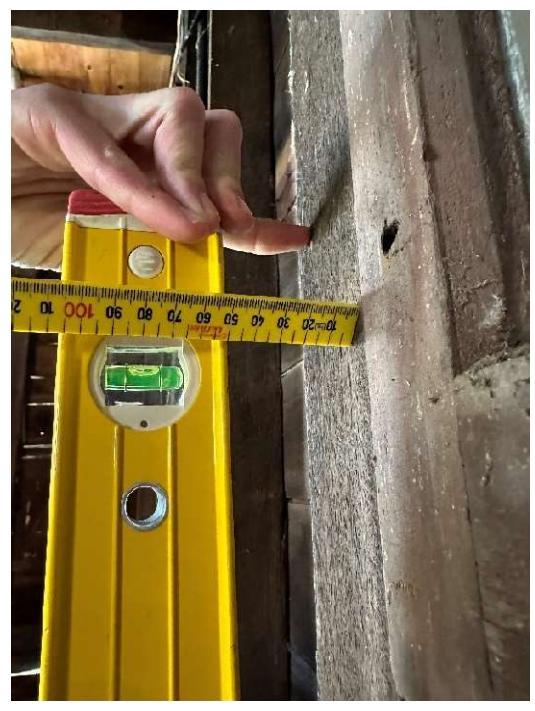
Photo 13.

- Timber frame on the northern side is approximately 50mm out of plumb over the length of a 1200mm level refer photo 13.
- Rotation and separation of the stud connections are evident refer photo 14.

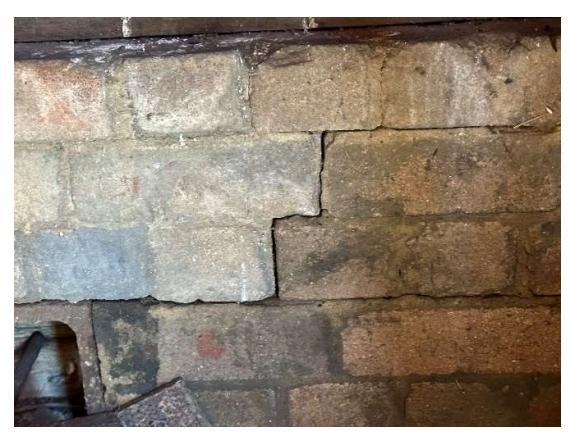
Photo 16.

- Masonry supports at tie down location has deteriorated refer photo 15.
- Cracking to sub-floor masonry wall refer photo 16.

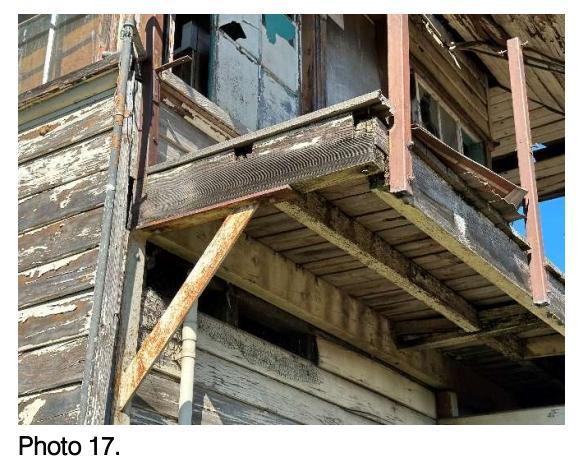
- External landing timbers are extremely weather damaged with connections compromised. Stair access • has been removed – refer photo's 17 to 19.
- Steel posts have been installed as an attempt to stabilise the building, however, the tension rods have ٠ been fixed to the cladding only - refer photo's 20 to 22.
- Eaves lining board are weather damaged and are out of plane with separation from the underside of the • rafters - refer photo's 23 to 25.
- Ends of timber rafters appear weather damaged with guttering dislodged refer photo 26. ٠
- Gutters are full of debris and have rotated outwards refer photo 27.
- Timber weather boards are extremely weather damaged and are dislodged at some locations refer ٠ photo 28 & 29.
- There is an overall lack of maintenance and adequate site surface drainage to the surrounds of the • building - refer photo 30 & 31.
