### 3.4 Detailed Descriptions of Principal Buildings - Homestead Group

#### 3.4.1 The Homestead Group Generally

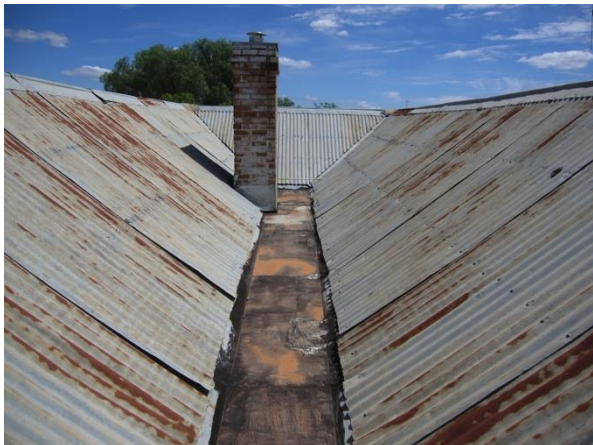
The box gutter is supported on timbers fixed to the rafters which support a gutter board. This is generally intact with some deterioration near the chimneys. The gutter lining is galvanised steel sheet soldered at the joins and has been patched externally and coated in bitumen in places. Water ponds adjacent to the chimneys.

Central roof valley looking north.

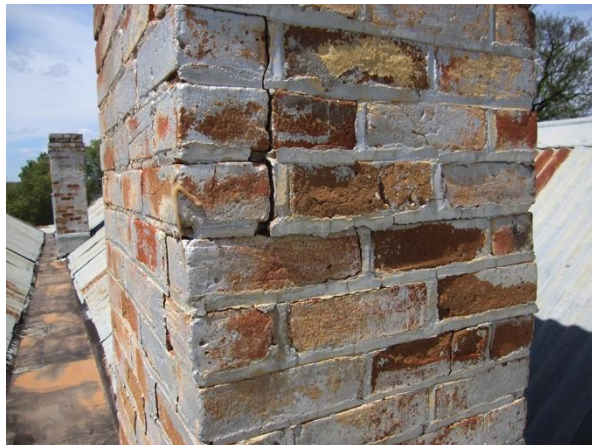
The chimneys are brick structures with two flues in each chimney rising towards the west side of the box gutter. The bricks are soft red dry pressed bricks set in lime mortar. There is mortar loss on the exterior and some joints have been repointed in cement leading to the deterioration of the bricks. A third chimney near the south end of the house has been removed.

Detail of chimney.

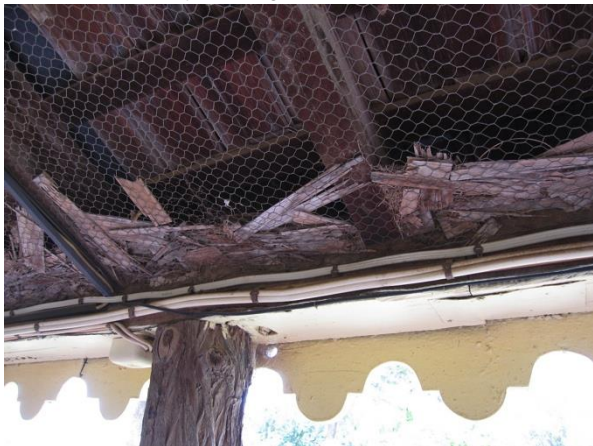
Underside of verandah shingles and chicken wire.

The verandah has closely spaced battens and timber shingles. These are exceptionally thin and long (720mm) but appear to be split hardwood. Mountain ash is the only timber capable of being split in this thickness and length and this is not available locally and would have been imported. The shingles have battens over them and are clad in corrugated iron, in two lengths. It may be that this was the original configuration as the roof pitch is too low for shingles and the shingles are in very good condition. Such a configuration would have provided insulation. The underside is now lined with chicken wire.

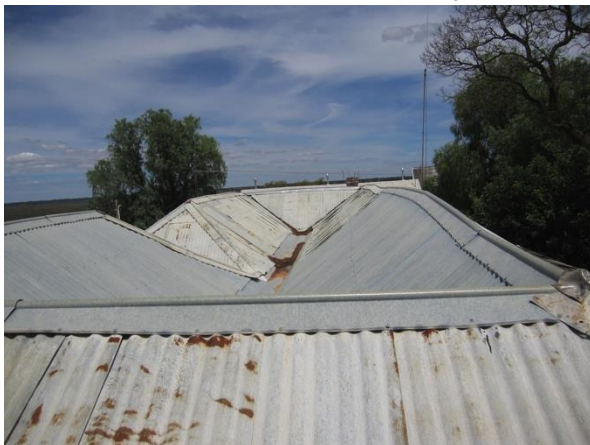
Roof looking west showing central valley.

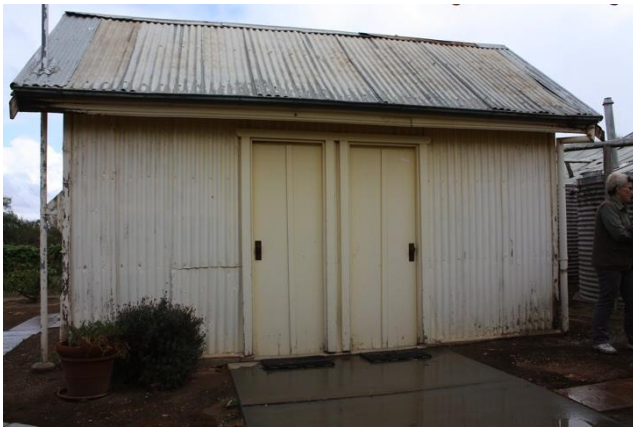
The ridge and some of the roof sheets are loose and need refixing. The ogee gutter (NW corner) and some of the downpipes are corroded, some of the fascia board deteriorated (NW corner). The soffits and fascias of the skillion are sagged and the downpipe is missing. There are holes in the cladding where earlier plumbing pipes were. There are vent pipes on each side of the building.

North wall.

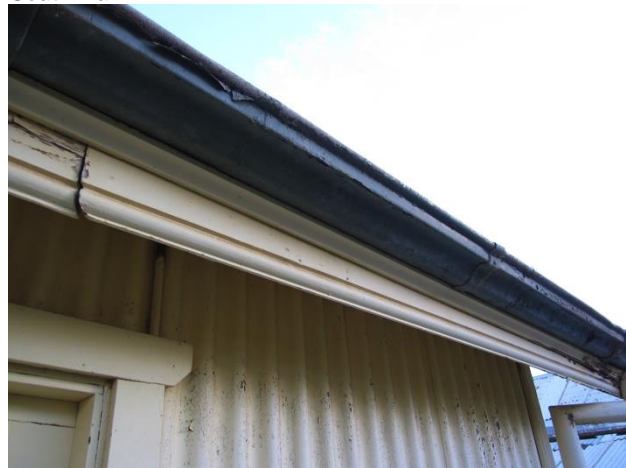
Eave detail.

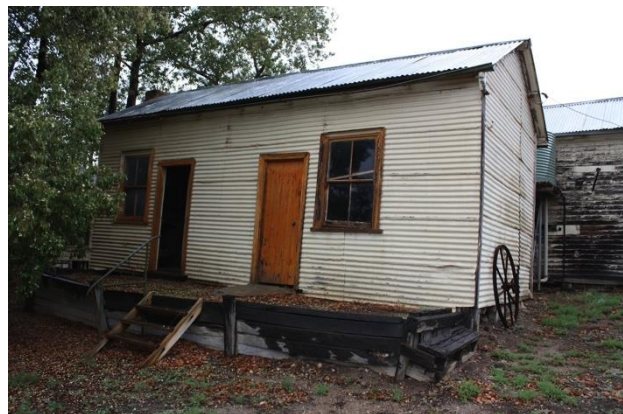
The building is generally in poor condition. The earth verandah is collapsing and the earth built up against the timber floor structure as well as the interior slab provide paths for termite entry. Erosion along the north wall is also undermining the internal concrete slab and causing it to collapse. Some roof and wall sheeting is loose and needs refixing and the flashing repaired on the flue from the copper. The gutters have failed and downpipes are missing or corroded. The exterior, the joinery and interior south room were formerly painted. leaf litter should be cleared from between the chimney and south wall and the chimney capped. A timber cover board needs to be refixed at the base of the south wall adjacent the chimney. The north-east window is collapsing and needs remaking and all the windows and doors need repair and repainting. Part of the ceiling in the south room is sagging and needs renailing.

*East wall and earth verandah.*

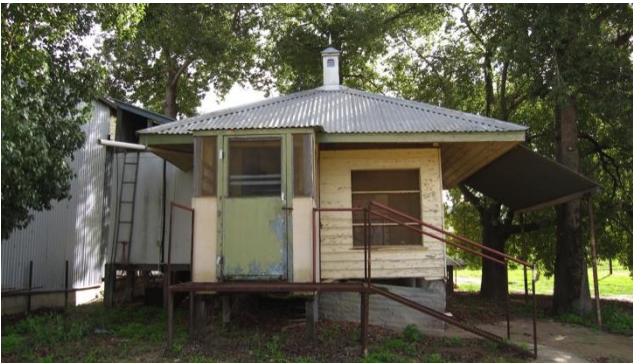
The building is generally in good condition. The cool room compromises the original structure. A side panel is missing from the southside of the cool room roof. Some of the fly wire has holes and some of the wire mesh enclosing the sub-floor is missing. The window sill to the south window is damaged and needs repair and some soffit lining boards are missing at the north-west corner. The top plate is damaged on the north and east sides and may need replacement. A hole in the fibro sheet to the porch west wall needs repair. There is termite damage to the centre stump on the east wall. The building needs repainting.

View from south.

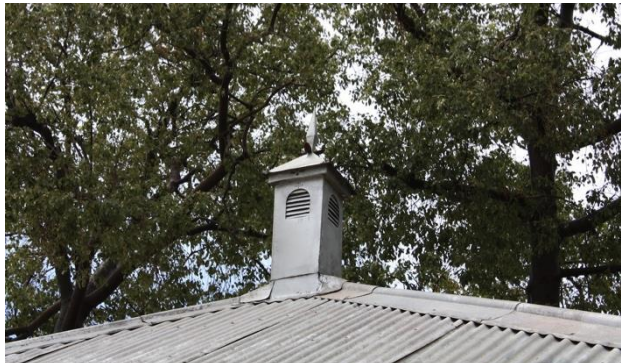
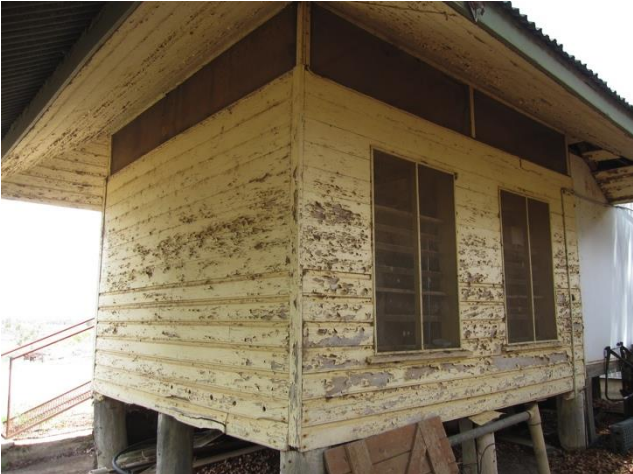
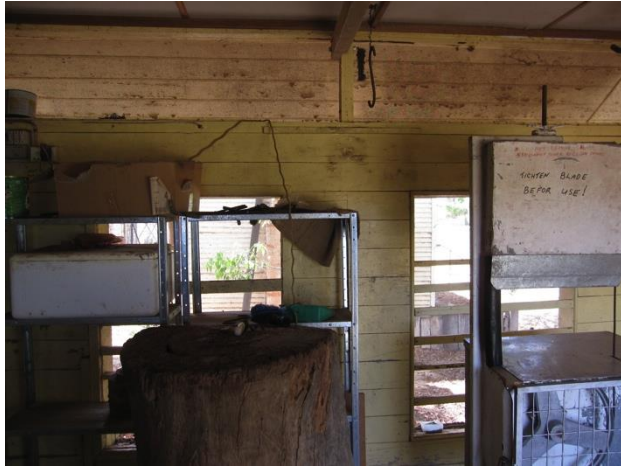
Roof vent.

Northeast view of walls and eaves.

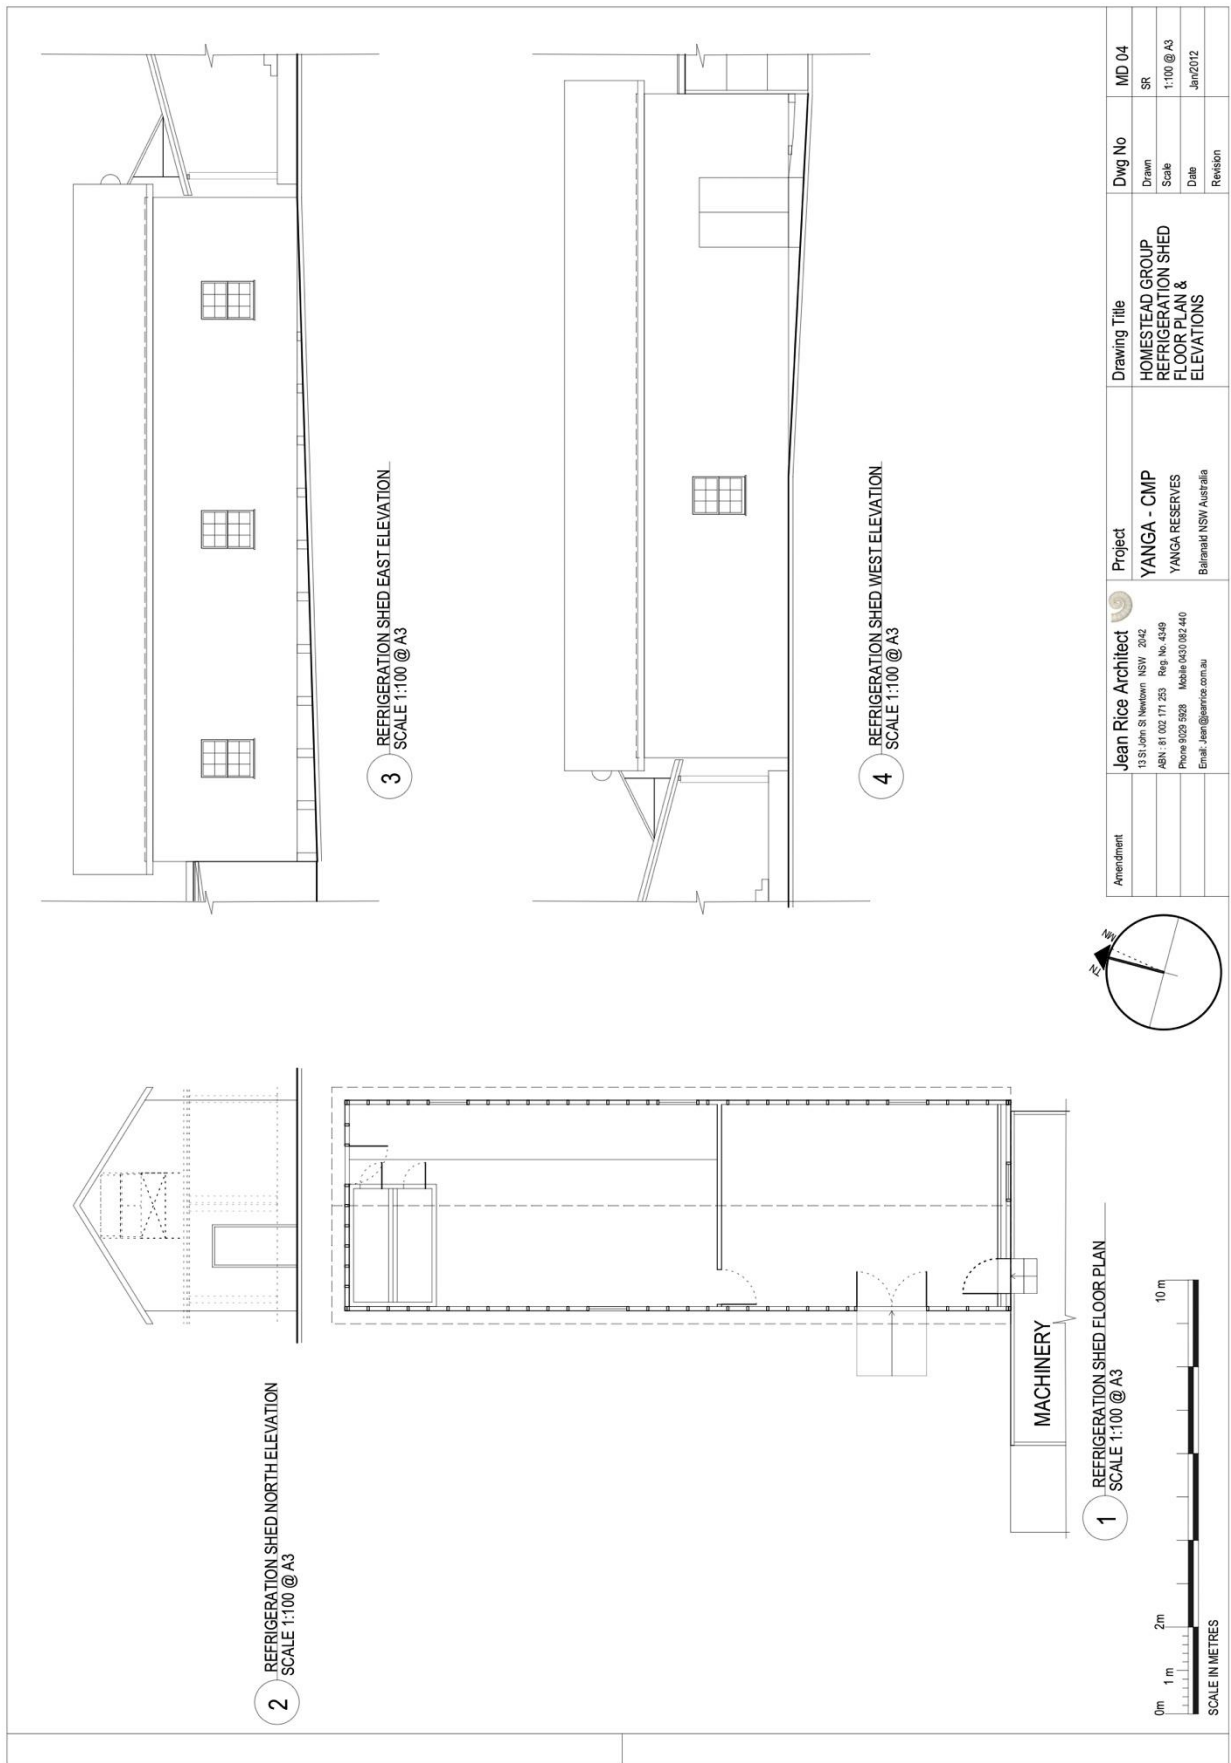
Figure 3.4.27 Homestead Group Refrigeration Shed floor plan & elevations and elevations. Jean Rice Architect, site assessment 2009.

There is some damage to the roof sheeting adjacent to the solar collector which is on the kitchen verandah roof, to the north. The east gutter has failed with the gutter straps coming off but it is a new gutter and could be repaired easily. There is a gutter from the verandah of the kitchen wing discharging onto the ground near the eastern wall and the water would be running under the building. On the western side there are some holes in the corrugated iron roof in the eaves. The gutter on west side is not intact and has tipped forward. The down pipe goes onto the roof of the modern machinery shed adjacent to the south.

On the east wall several of the timber weatherboards have split and some are missing. Most of the damage is to the lower part of the wall. The north wall has damage to the timber boarding at the base and at the western wall where a down pipe is leaking and running down the wall. On the western wall the boards have deteriorated at the base and there is some rot in the stud frame. The section of the west wall south of the double doors is badly damaged by termites and the timber boarding is missing. The wall has subsided off the bottom plate at this point. The internal concrete slabs make the timber structure vulnerable to termites.

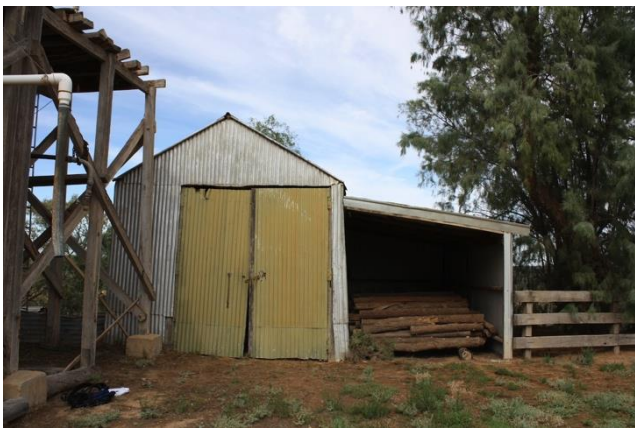
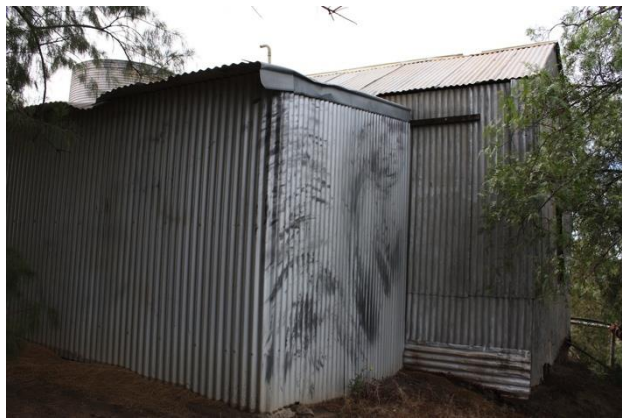
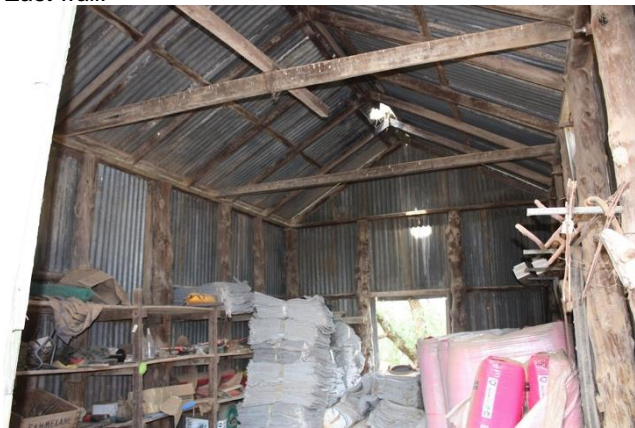
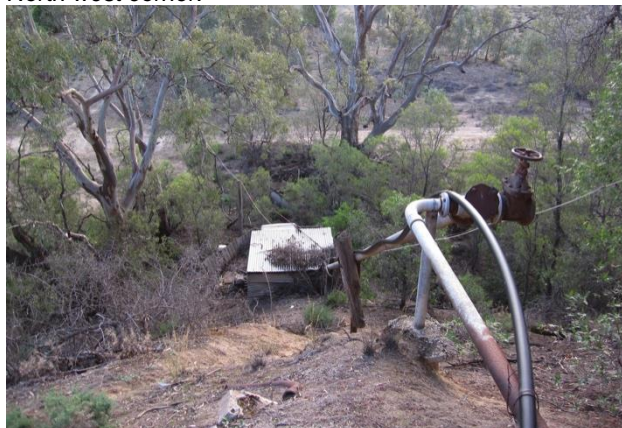
The building is in good condition though was not inspected internally. The westmost edge of the floor is undermined or eroded. The double doors are sagging and there is a tear in the cgi at the top of one leaf. There are no eaves nor gutters. The cgi is corroded from the floor level to the ground on the west wall and south wall at the west end. The north west corner post of the main space is missing at the base. The top of a cgi sheet needs refixing on the north wall, west end. The top of the skillion north wall has been damaged by a tree.

East wall.

North west corner.

Interior looking west.

Pipe linking to lake bed (dry in this photo)

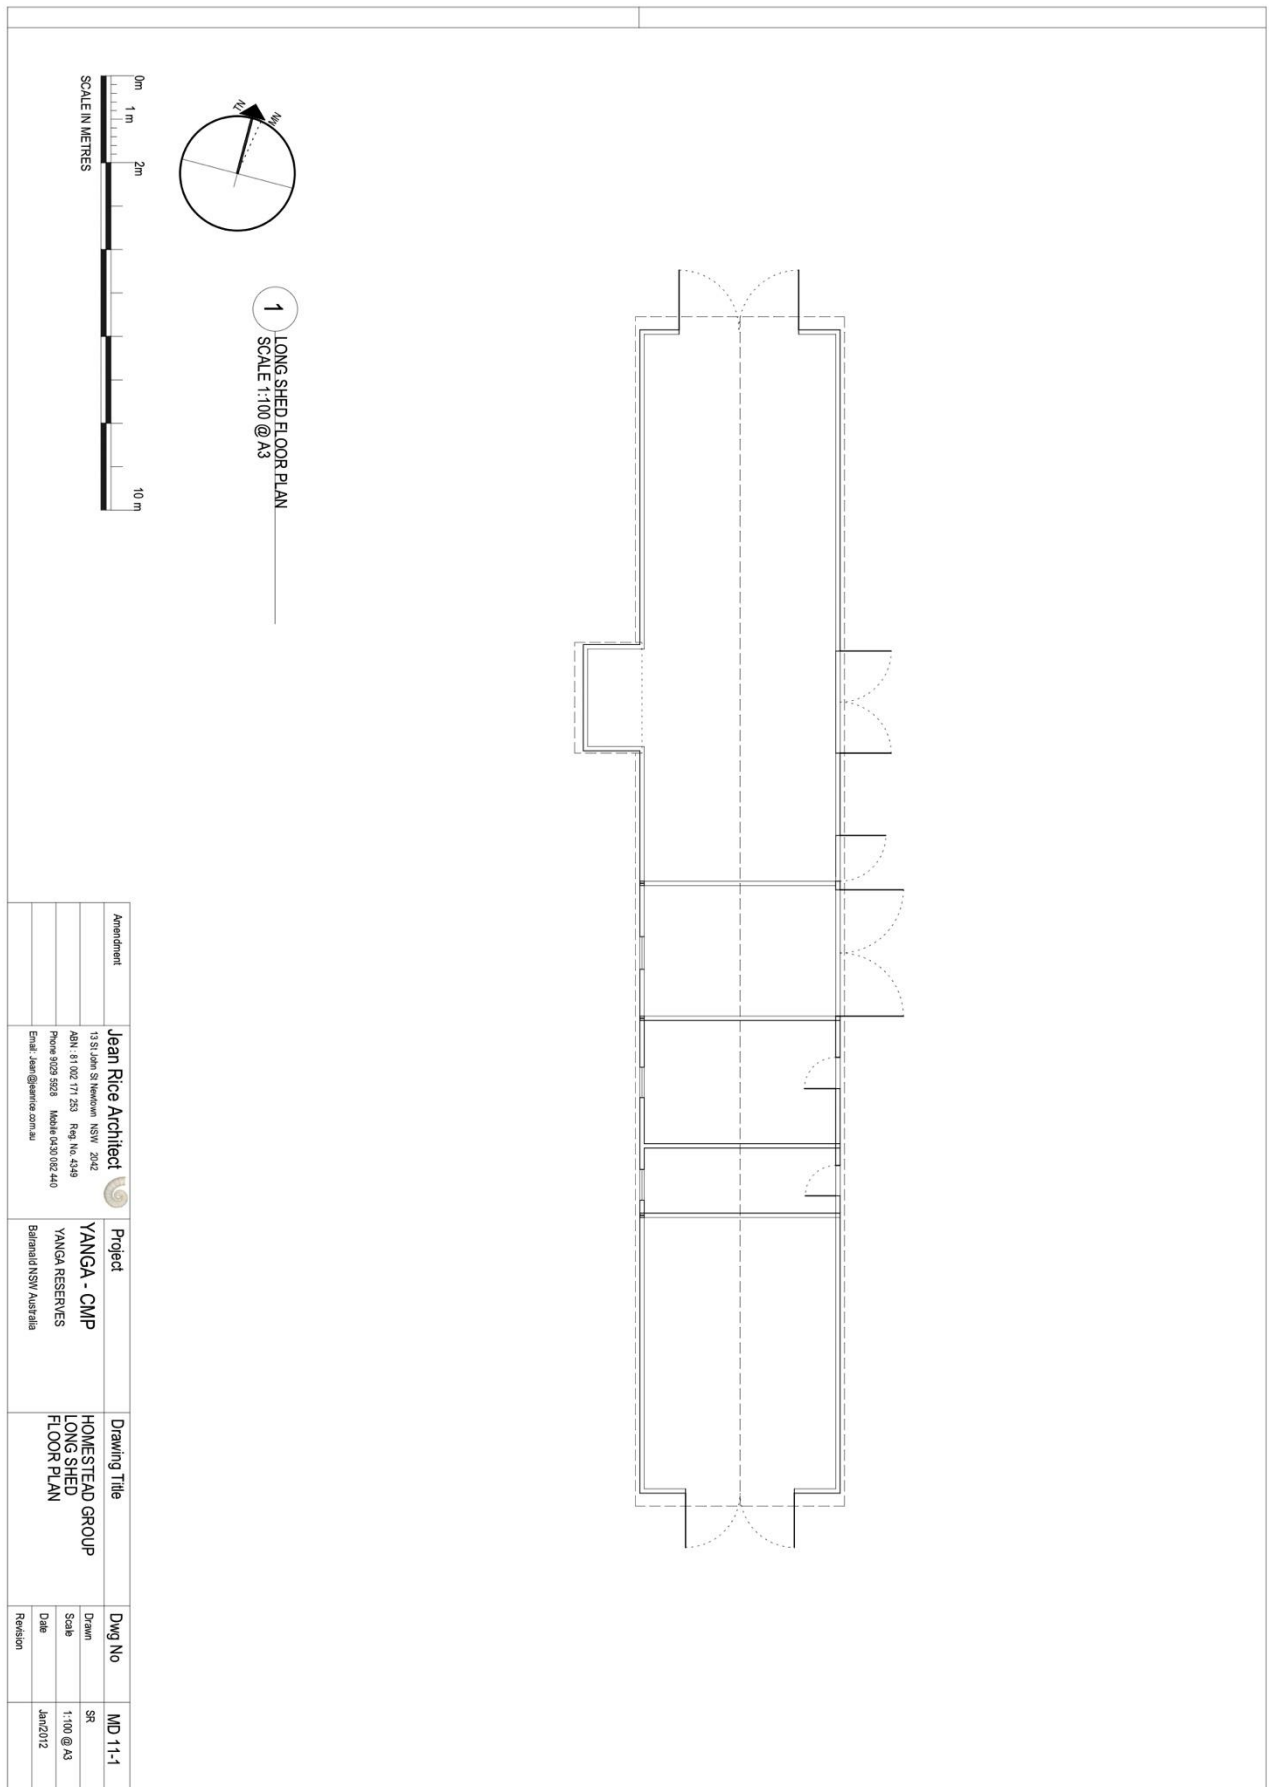
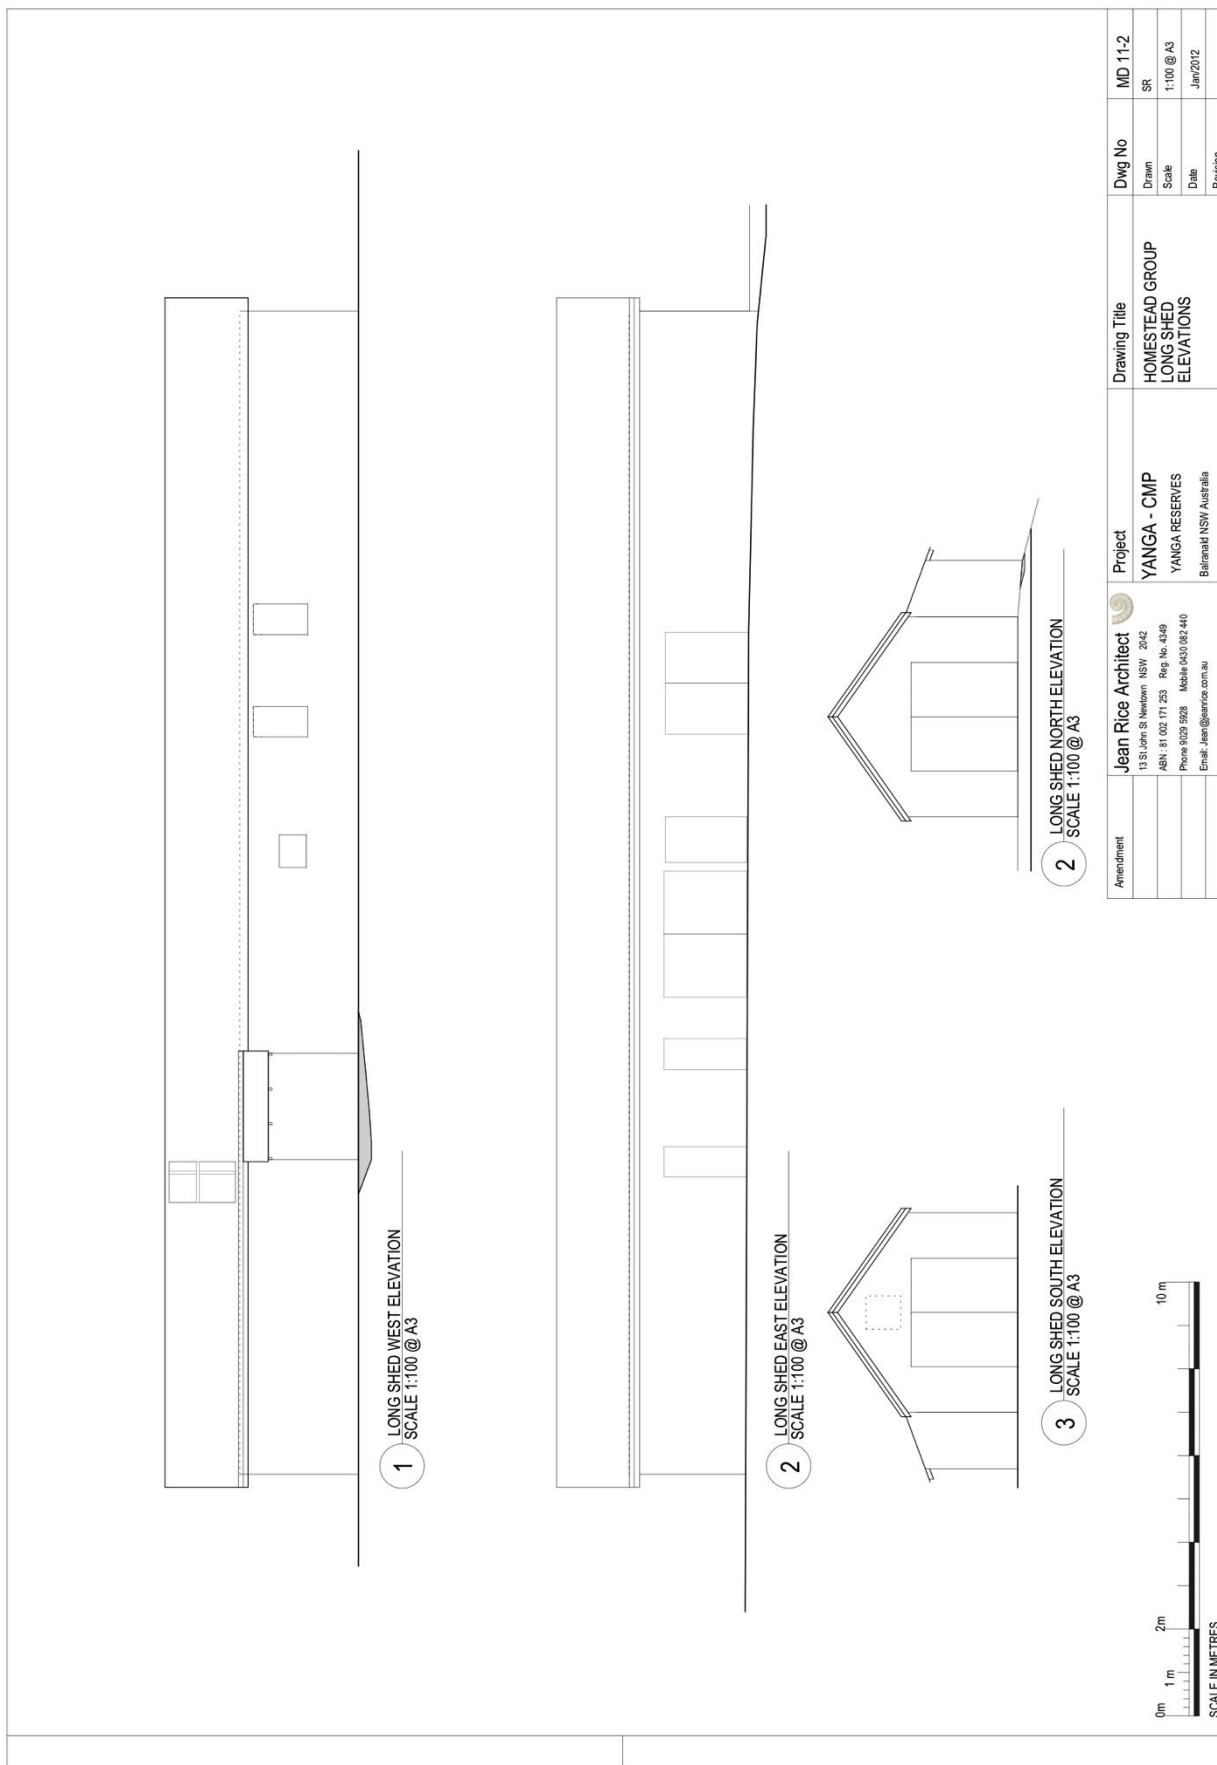
Figure 3.4.36 Homestead Group Long Shed floor plan.. Jean Rice Architect, site assessment 2009.

The building is generally in good condition. There are missing sheets of iron at the centre on the west side of the roof and the edge of some roof sheets are loose. There are missing wall sheets at the north west corner and loose sheets at each corner. As the building has little bracing it relies on the cgi sheeting to provide these and secure fixings are important for building stability. Some of the cgi sheets on the east doors are also loose. There is corrosion to the cgi walling to the west skillion and nearby, especially at the base. The base of cgi wall cladding is corroded in several locations and has already under sheeted in some locations.

The fascia and gutter is missing for a large part of the west side and the west downpipes are missing. One section of concrete slab has subsided and cracked in the small central room with the double doors. The window sills are rotted and the fly wire missing. There are no window sashes and it is not noted whether there was evidence of former sashes. The south gable previously had a louvred vent which has been removed. The north gable framing does not indicate a vent.

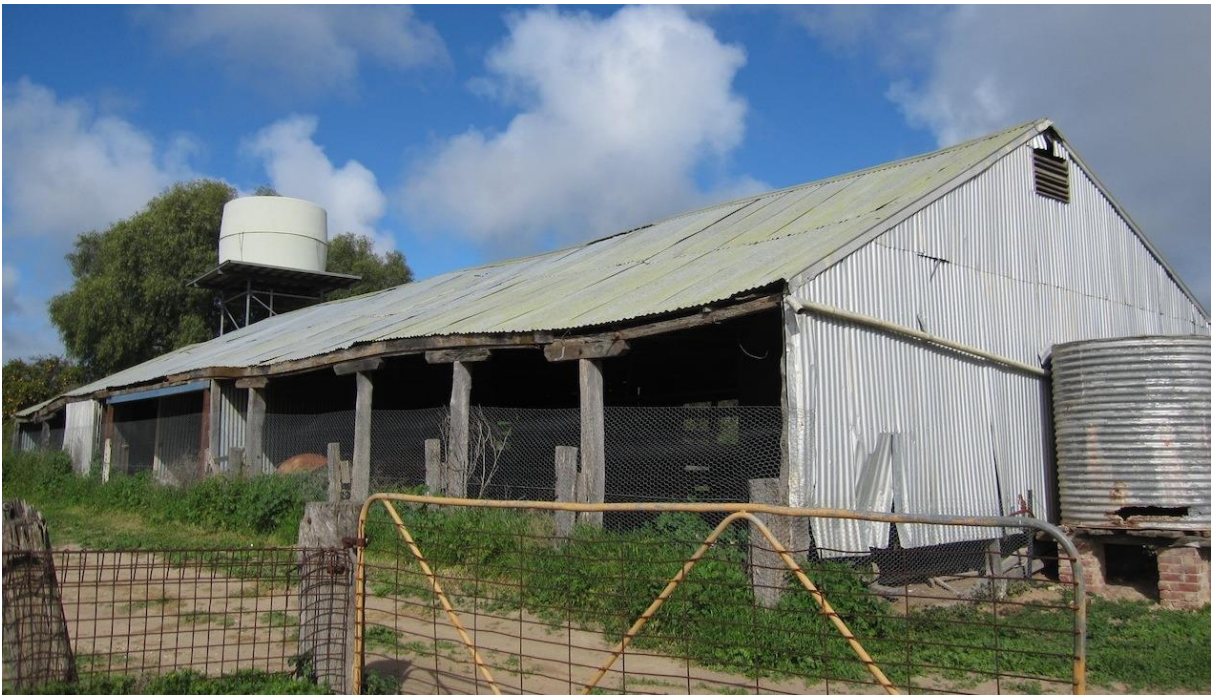
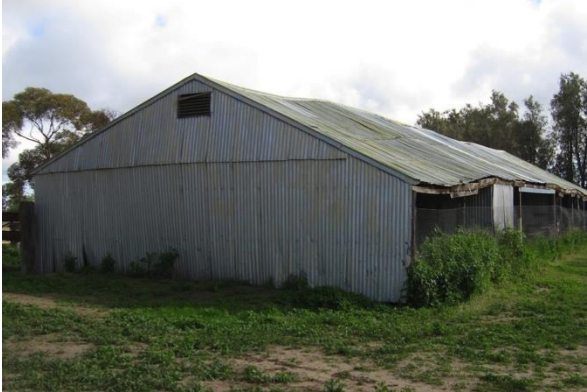
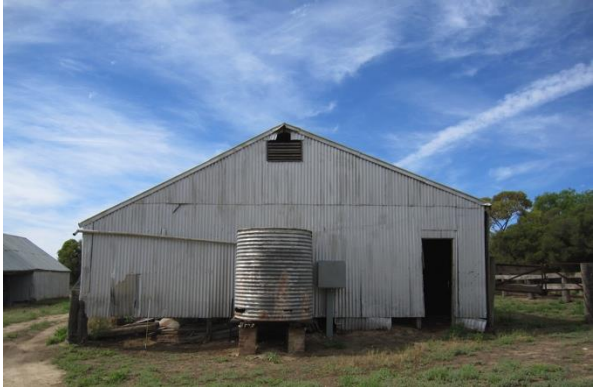
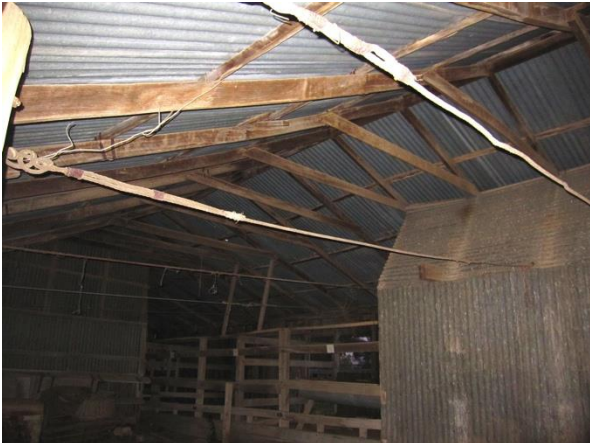
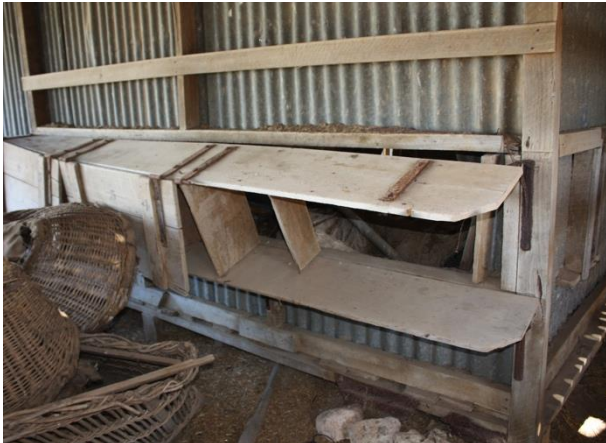
The post layout in the east wall has been altered so the steel cables tying the rafters do not always coincide with posts. The posts are generally at the junction of the top plates indicating that both have been replaced or altered and the original configuration is not clear. Towards the north end the ridge has dropped and the junctions of the rafters at the ridge board have opened up at the base. Some have pulled away from the ridgeboard at the north end and on the east side rafter has dropped but is still bearing against the ridgeboard.

View of east wall from north.

South wall.

North wall.

View of interior of roof.

Pigeon holes on north wall of grain store.

This building requires a lot of work to be stabilised, primarily the east wall with most of the elements in the east wall needing to be replaced. The roof structure is also under-sized for the spans. It could be stabilised by having an additional structure supporting it at mid span. The space is open enough for such a structure to be inserted. There is also little bracing in any direction. The steel the cables tying the ends of the rafters are in principal a good system, but the top plates are not in good enough condition to take the structural loads and the ties are not fixed securely enough to the posts or rails to bear those loads.

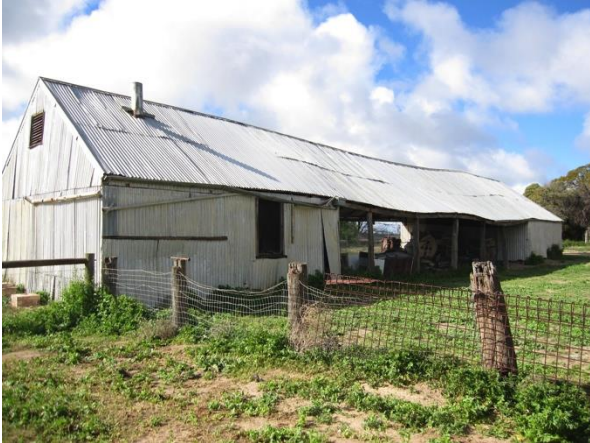
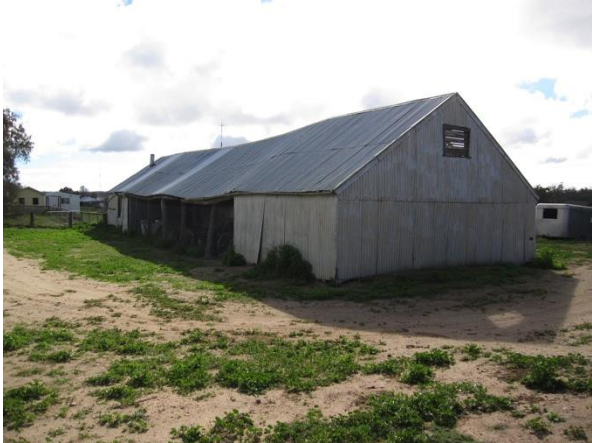
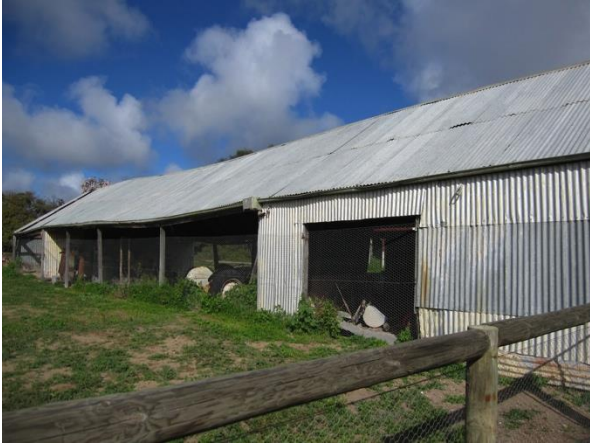
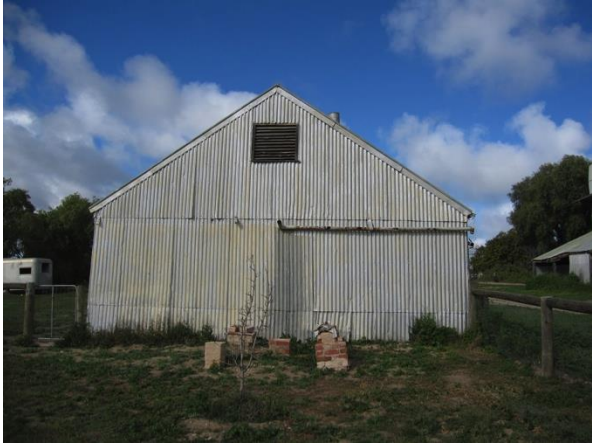
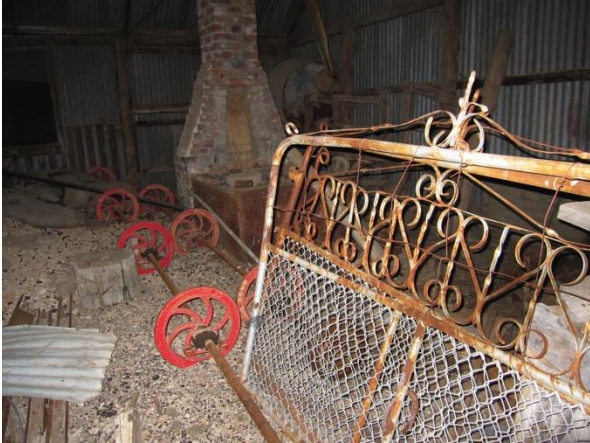
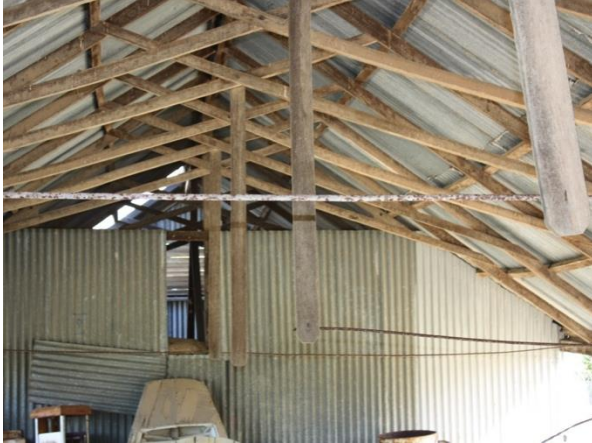
The east wall has been altered and posts removed. New posts are at larger spacings with top plates with larger spans. This has compromised the truss system leading to the sagging and collapse of some parts and the original structural system being compromised. The system also relies on the round posts being a cantilever out of the ground and where posts have tipped over or rotted the roof structure has also failed.

West wall viewed from north.

East wall viewed from north.

North wall.

Interior showing Blacksmiths forge and chimney.

Coach shed interior showing roof structure.

This building need stabilised, primarily the resupport and reinstatement of the roof truss system. Some posts need replacement and the end wall braces refixing. The top plate needs leveling so gutters can be reinstalled to take water away from the building. Similarly ground levels need adjustment, where built up, so water drains away from the building.

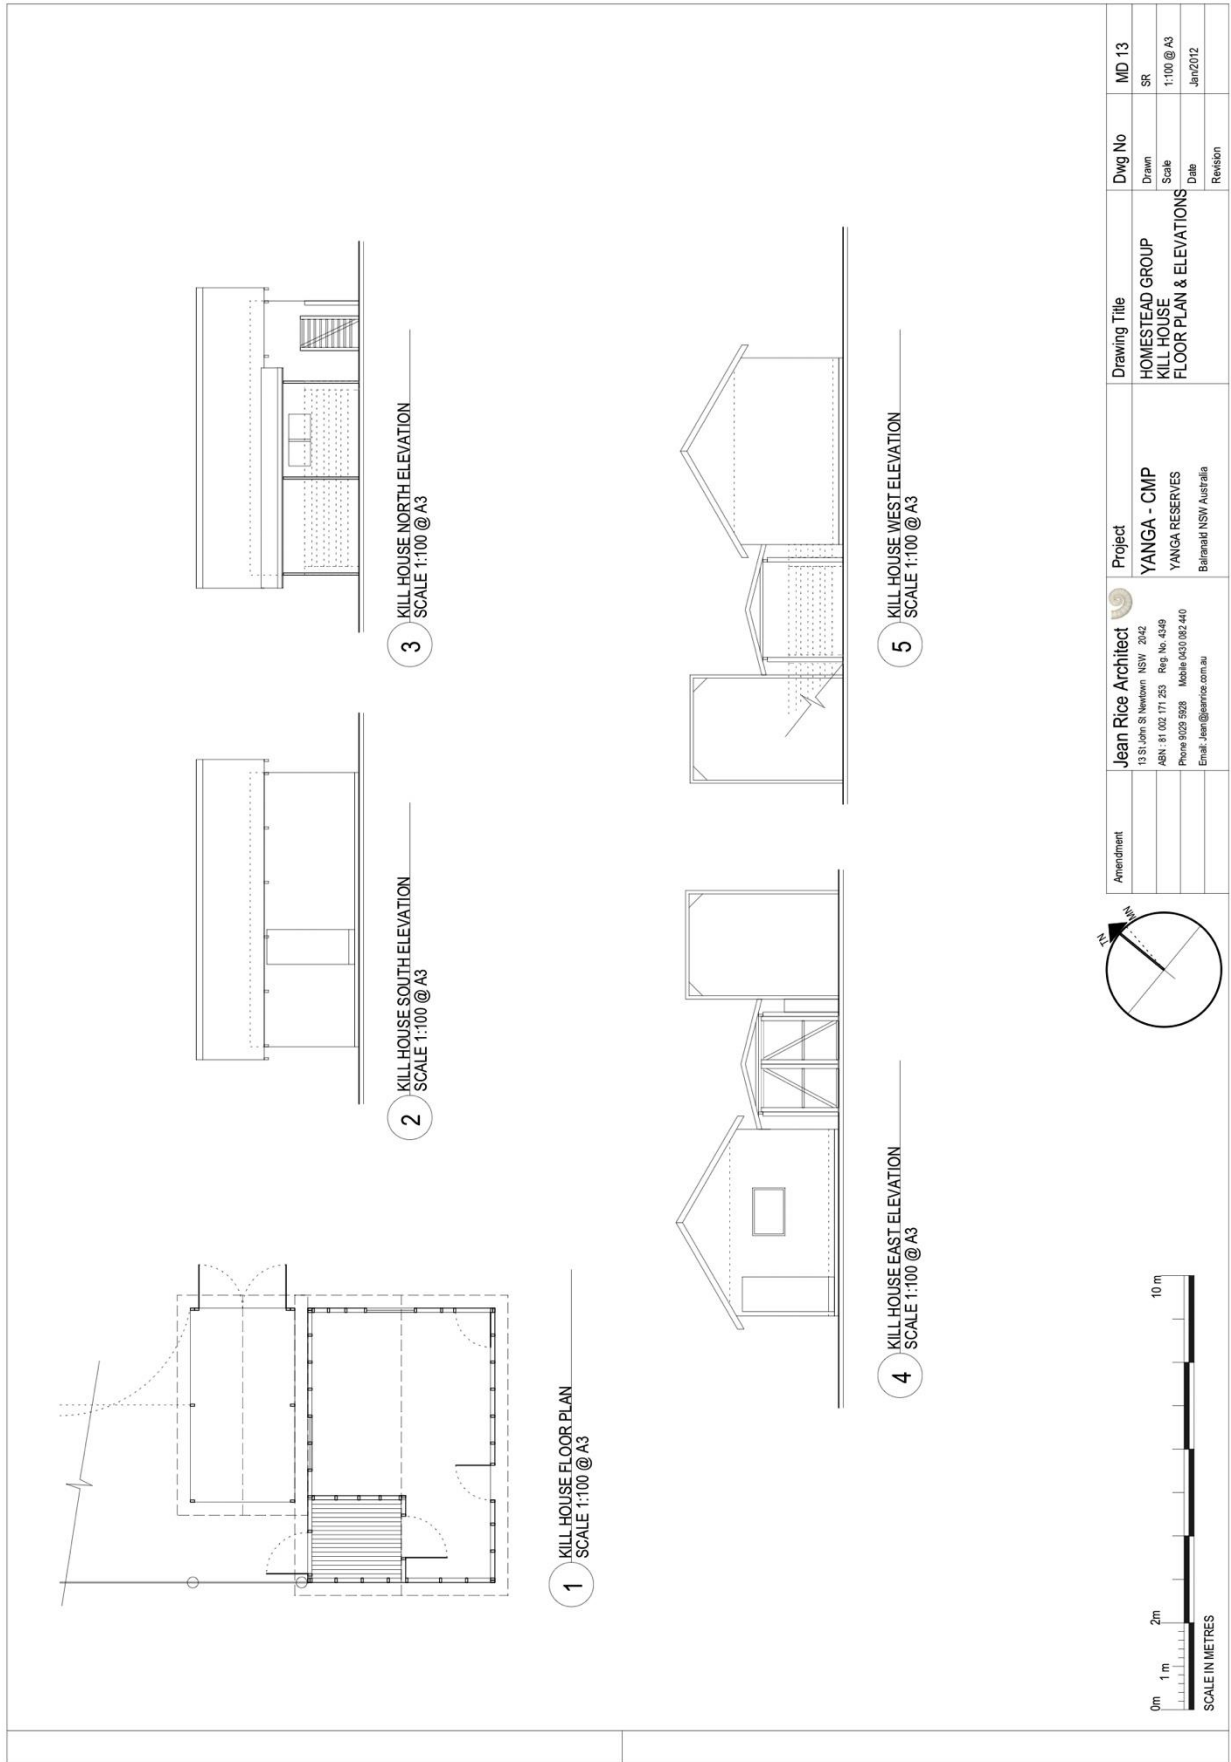
Figure 3.4.44 Homestead Group Kill House plan & elevations. Jean Rice Architect, site assessment 2009.

The building is generally in fair condition. There are loose fixings to sheets of iron generally and especially to the base of the roof sheets at the centre of the both sides. These fixings are necessary to provide bracing. The roof barge flashing is missing to part of the west end of the Killing shed and of the attached structure. The base of cgi wall cladding is corroded in several locations. The concrete slab floor is undermined in several locations where the soil has been washed away. The concrete step to the east door is also undermined and collapsing. The lack of gutters and downpipes may be contributing to this.

The attached structure to the north has no bracing and is leaning to the north. The top plate in the NW corner has been pushed off the posts. Refixing is needed and addition of wire or hoop iron bracing and ties. The gates are collapsing and need rebuilding.

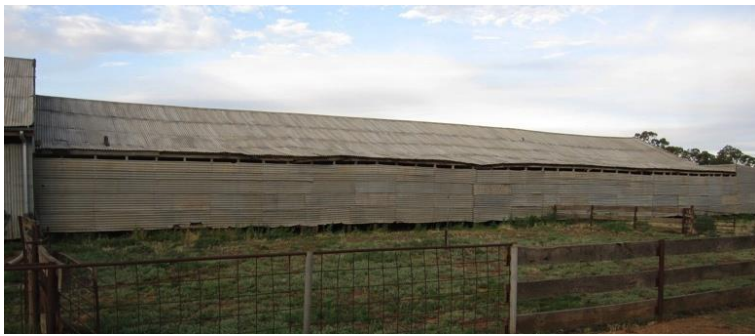
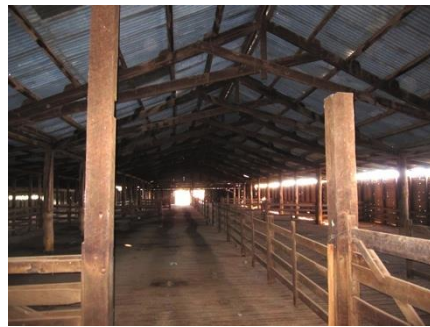
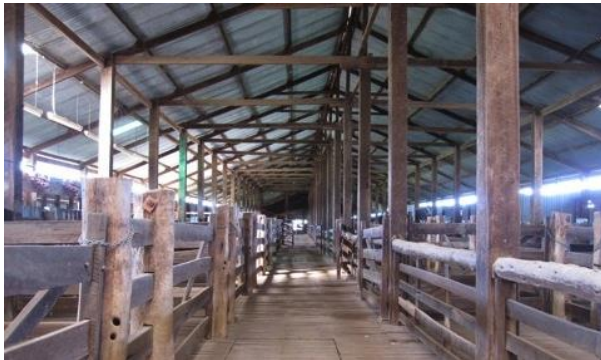
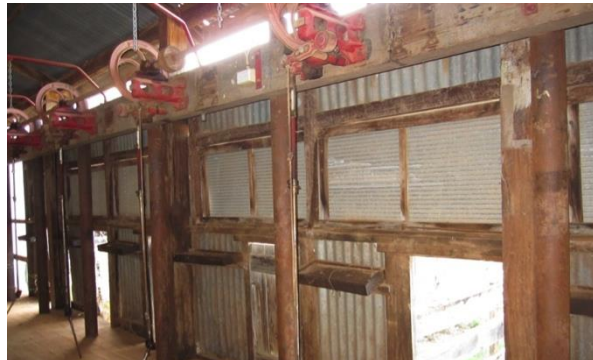
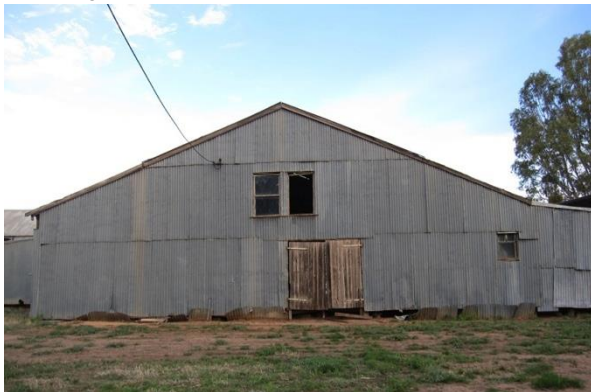
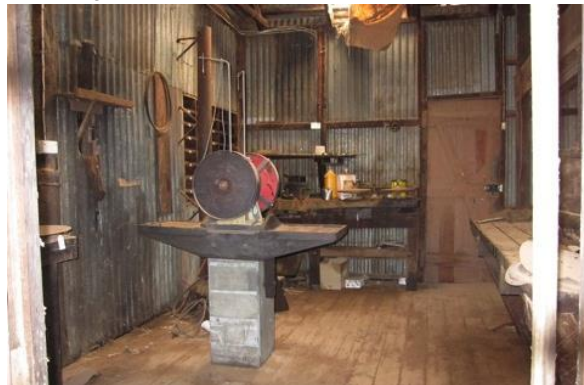
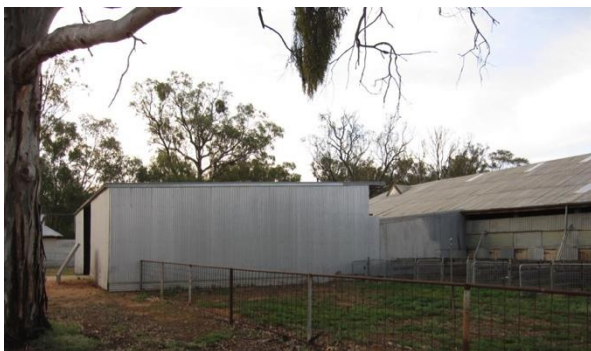
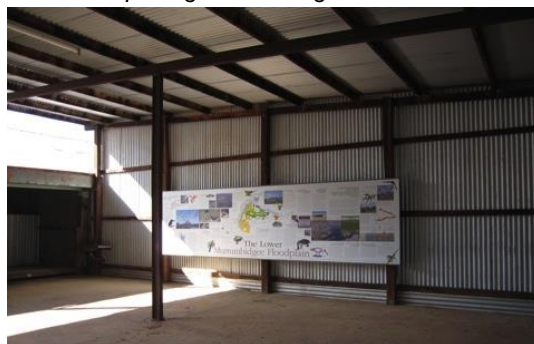
Figure 3.5.3 Views of Woolshed. Photos by CMP authors, 2009

Generally the building is structurally sound, in fair to good condition and the roof is mostly water tight. In some limited areas there is water entry and termite and damp damage. In particular the east end is poorly built and is failing. Many cgi roof and wall sheets are loose and need refixing. Some areas have termite damage or a sunken suggesting such damage. Heavy wool baling machinery in the west end should be moved onto the concrete bases and restumping or replacement of post bases may be needed in these and other sunken areas. Replacement of post bases done recently on the south side is well done with halved joints and bolted connections. Downpipes have been installed on part of the south side discharging water away from the building but most other gutters and downpipes have failed and water drains under the building in several locations. Sheep dung is built up under the floor in some places to the underside of the floor structure restricting ventilation and should be reduced.

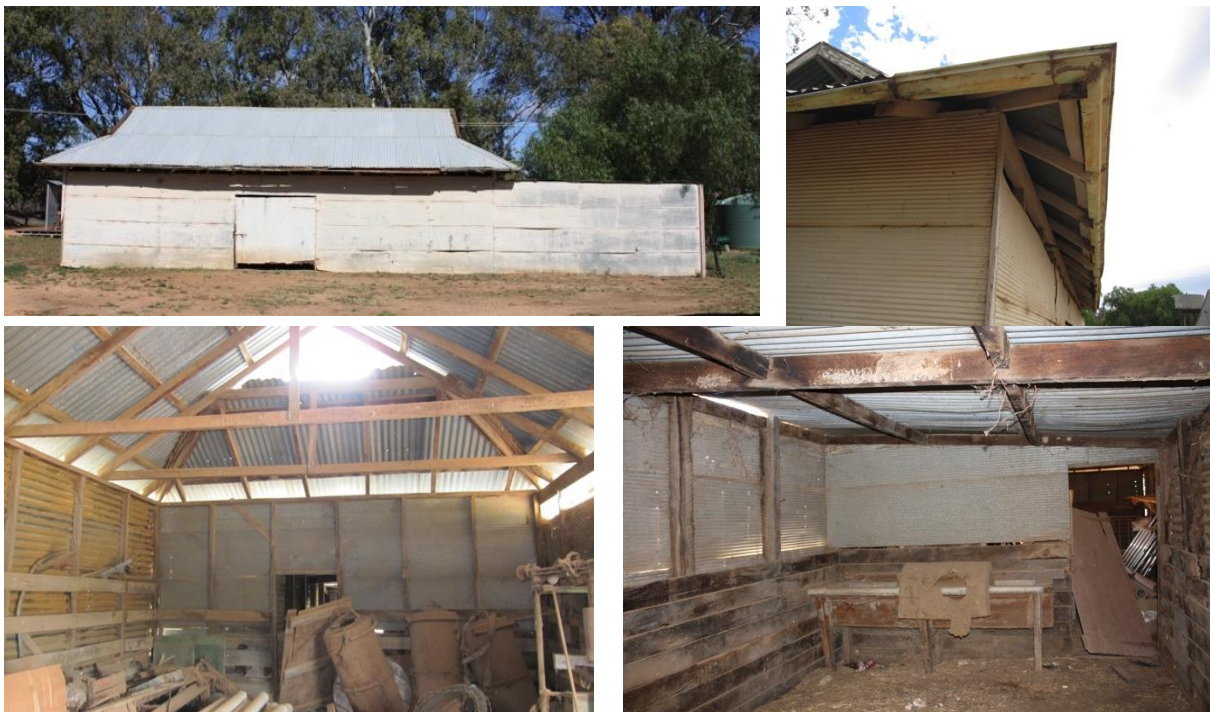
Figure 3.5.12 Views of Stable. CMP authors, 2009

Much of the cgi sheeting has loose fixings. Some is damaged on the north face of the main roof. The sheets are off to some of the west wall of the addition and need refixing or replacing. At least half of the guttering has failed and needs replacing and there are no downpipes. There is a pepper tree very close to the north east corner of the addition that is damaging the structure and should be removed.

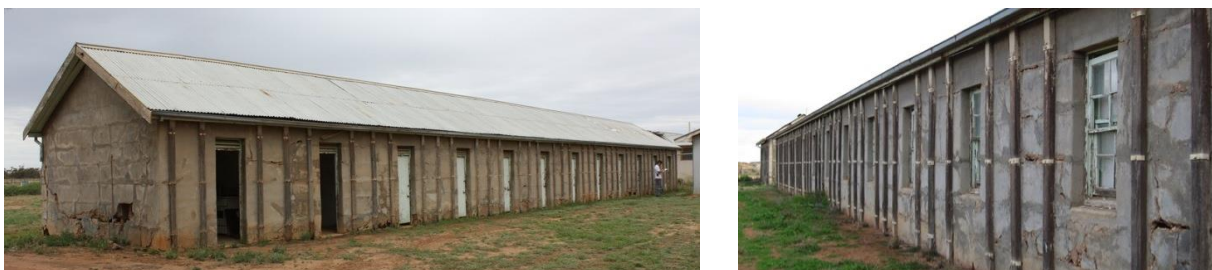
Figure 3.5.14 West and east view of Old Shearers Quarters. CMP authors, 2009

There is severe deterioration of parts of the masonry walls. There is some settlement, erosion of the blocks at the base and cracking in some locations especially over the openings. The north wall is much worse than elsewhere. The whole base of the wall is loose and friable with large holes in it. The failure is similar to how mud brick fails. This coincides with where the gutters (downpipes) discharge. The down pipes here are missing water is lying on the ground in a depression at the north end of the building. Similarly elsewhere the damage is concentrated at the base of the wall where the masonry is not protected by the eave. Water damage is the likely major cause of the deterioration. This may include flood damage. The cracking at the corners indicates the lower part of the north wall is moving out and down. This indicates foundation movement - possibly the wall and footing subsiding into the soft ground. The roof is in good condition except the eaves lining which is sagging. The internal walls at the north end also have cracks and the ceilings in these rooms have sagged and are partly falling in.
