### 3.4 Detailed Descriptions of Principal Buildings - Homestead Group

#### 3.4.1 The Homestead Group Generally

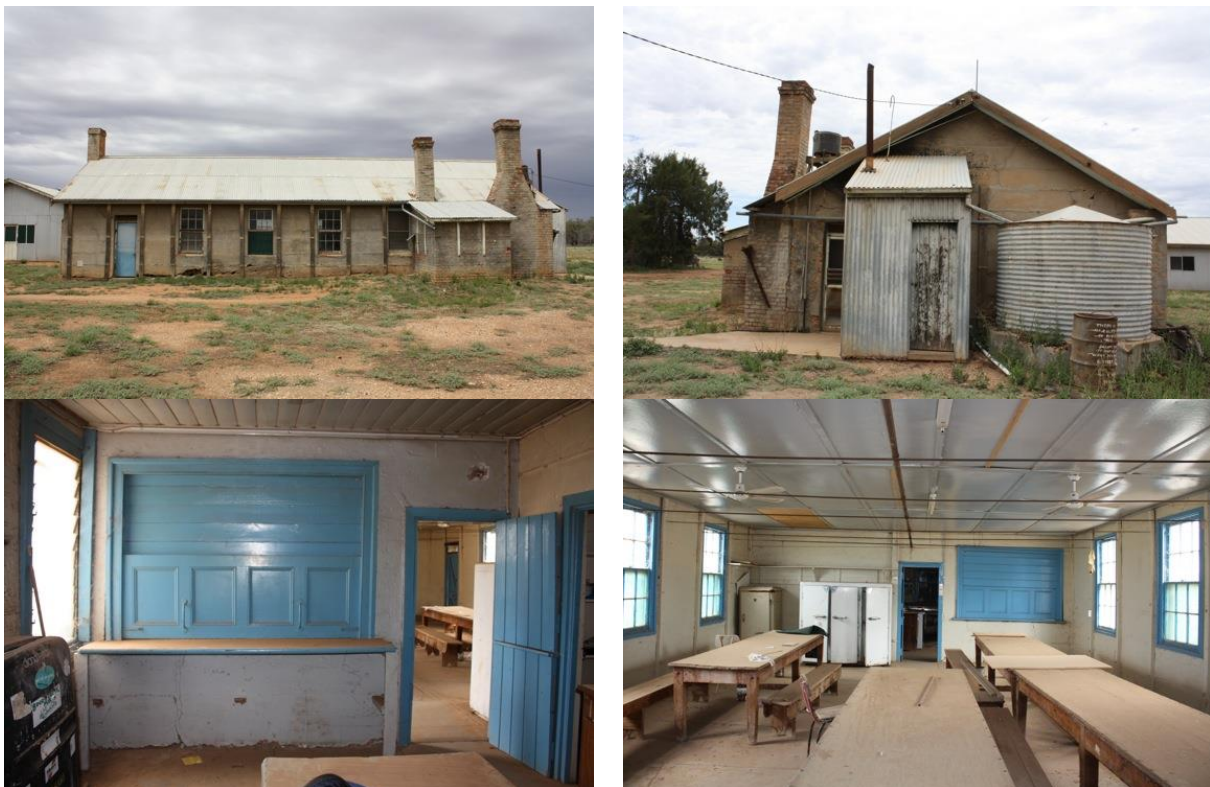
Figure 3.5.17 Views of Cookhouse and Mess Room. CMP authors, 2009

The masonry block structure is deteriorated at the base particularly on the north side but otherwise the building is in good condition. There is some rusting of ferrous metal reinforcing (straps and bars) in the window sill areas. There are settlement cracks in many locations. There is one bay on north wall where the bricks have failed there is an opening at floor level. Some cracking was evident in the internal walls, particularly under the servery where the cracks indicate settlement to the outside and to the east. There are open joints and rising damp evident in the brick fireplaces likely a result of inadequate stormwater disposal.

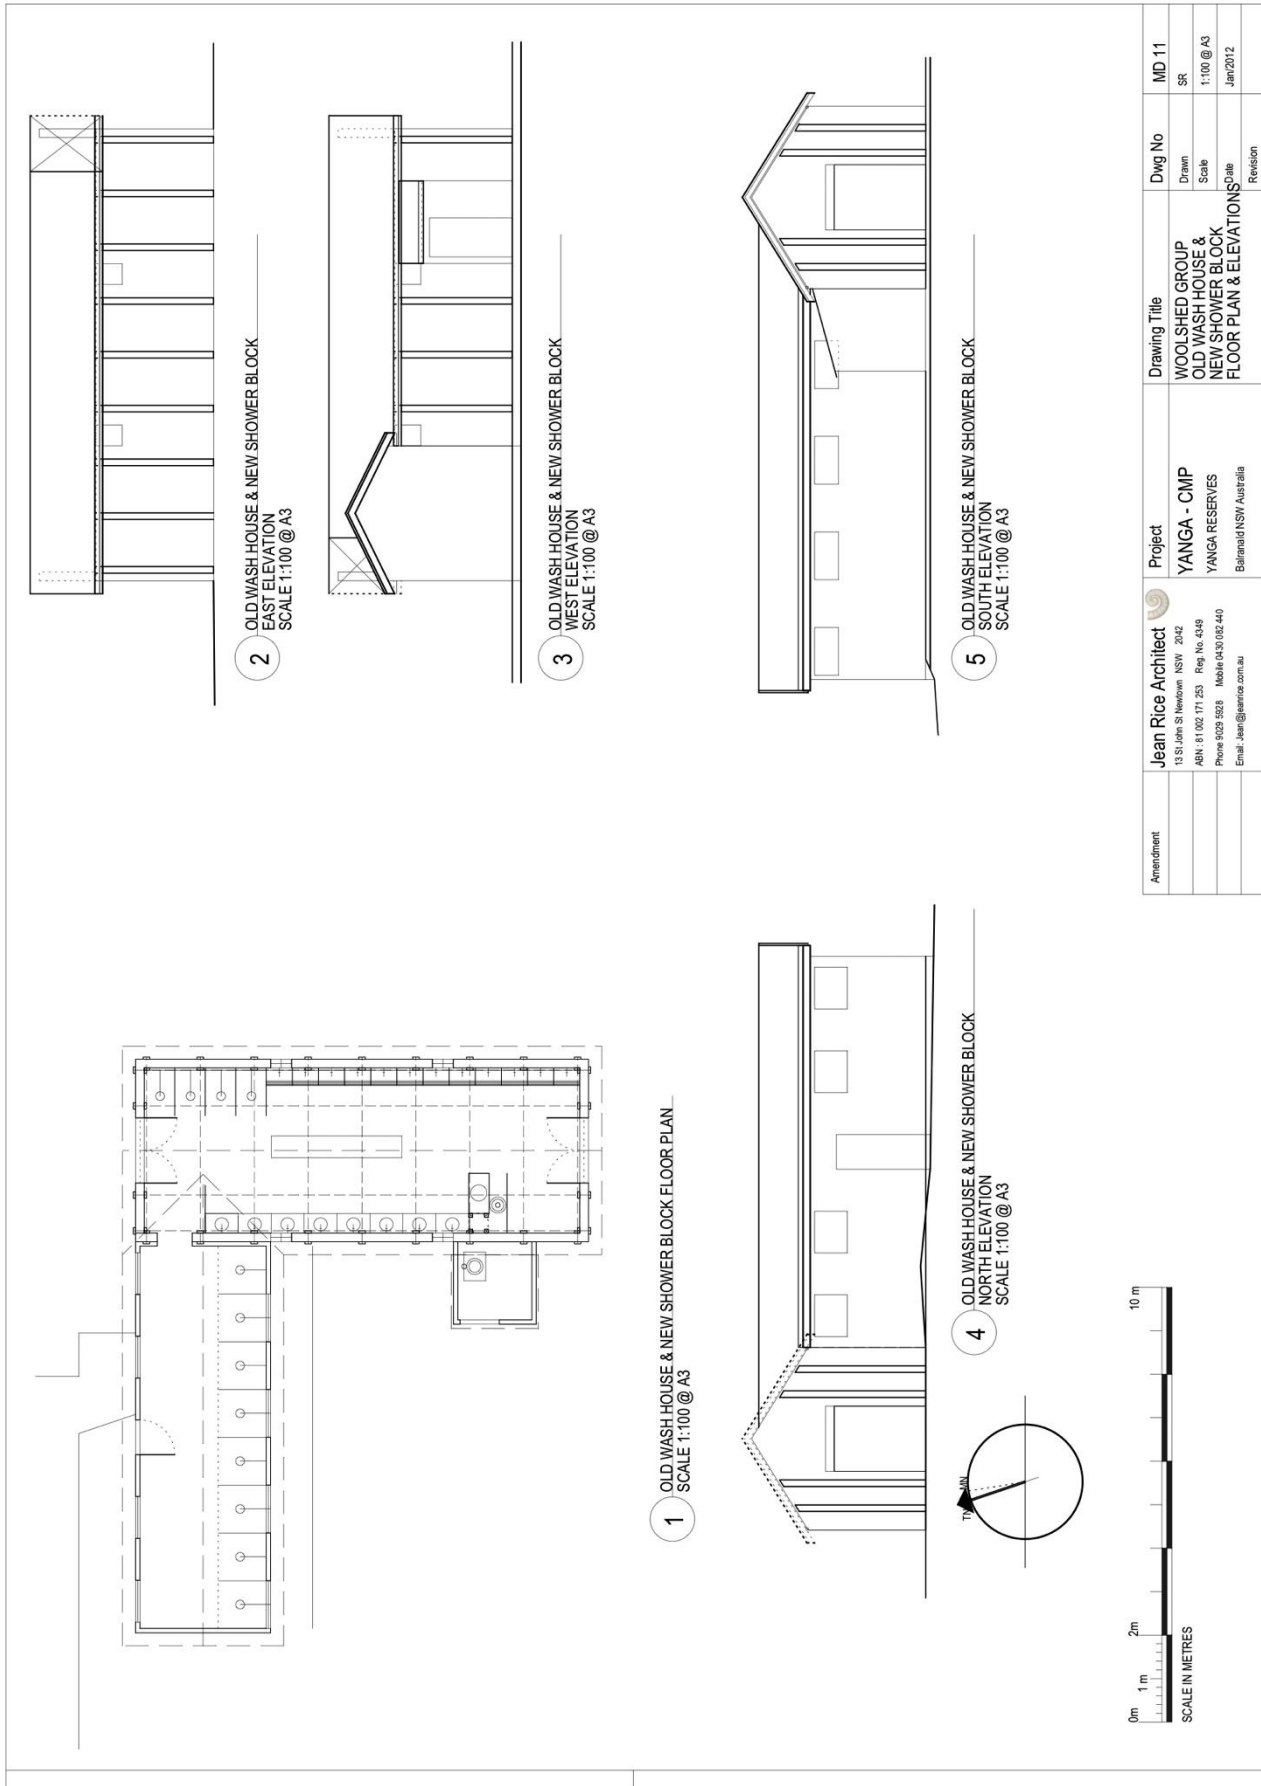
Figure 3.5.23 Woolshed Group, Wash House and New Shower Block floor plan and elevations. Jean Rice Architect, site assessment 2009.

The Wash House is in much worse condition than the other similar buildings with severe termite damage to the roof which is propped. The damage is worst at the junctions with the New Shower Block which is clad with fibre cement and cannot be fully inspected. The wall to the old wash room is collapsing in this area and the roof at the north end has collapsed to the extent that the roofing has failed, blown off and is missing. There is also termite damage along the west wall, in the central area of the building. The section of the wall on the west side is badly deteriorated with a hole on the exterior under the window, just to the north side of the lean-to. The gutter on the west side is collapsing because the supporting structure has failed. There is some cracking on the walls on the west side, the base has been patched with cement but it has failed again in the same location. There is a blob of cement on the ground with 1985 scratched into it suggesting the cement repair was done at this time or it may be from the construction of the new shower wing which was added onto the old block on the west side. The damage concentrated on the north west corner is probably related to a down pipe that discharges here from the New Quarters and from the valley gutter. The floor slab junctions have also provided a path for termites. There is also deterioration at the back of the showers in areas where the masonry would have been wet. There is a flue from the copper inside which may be asbestos.

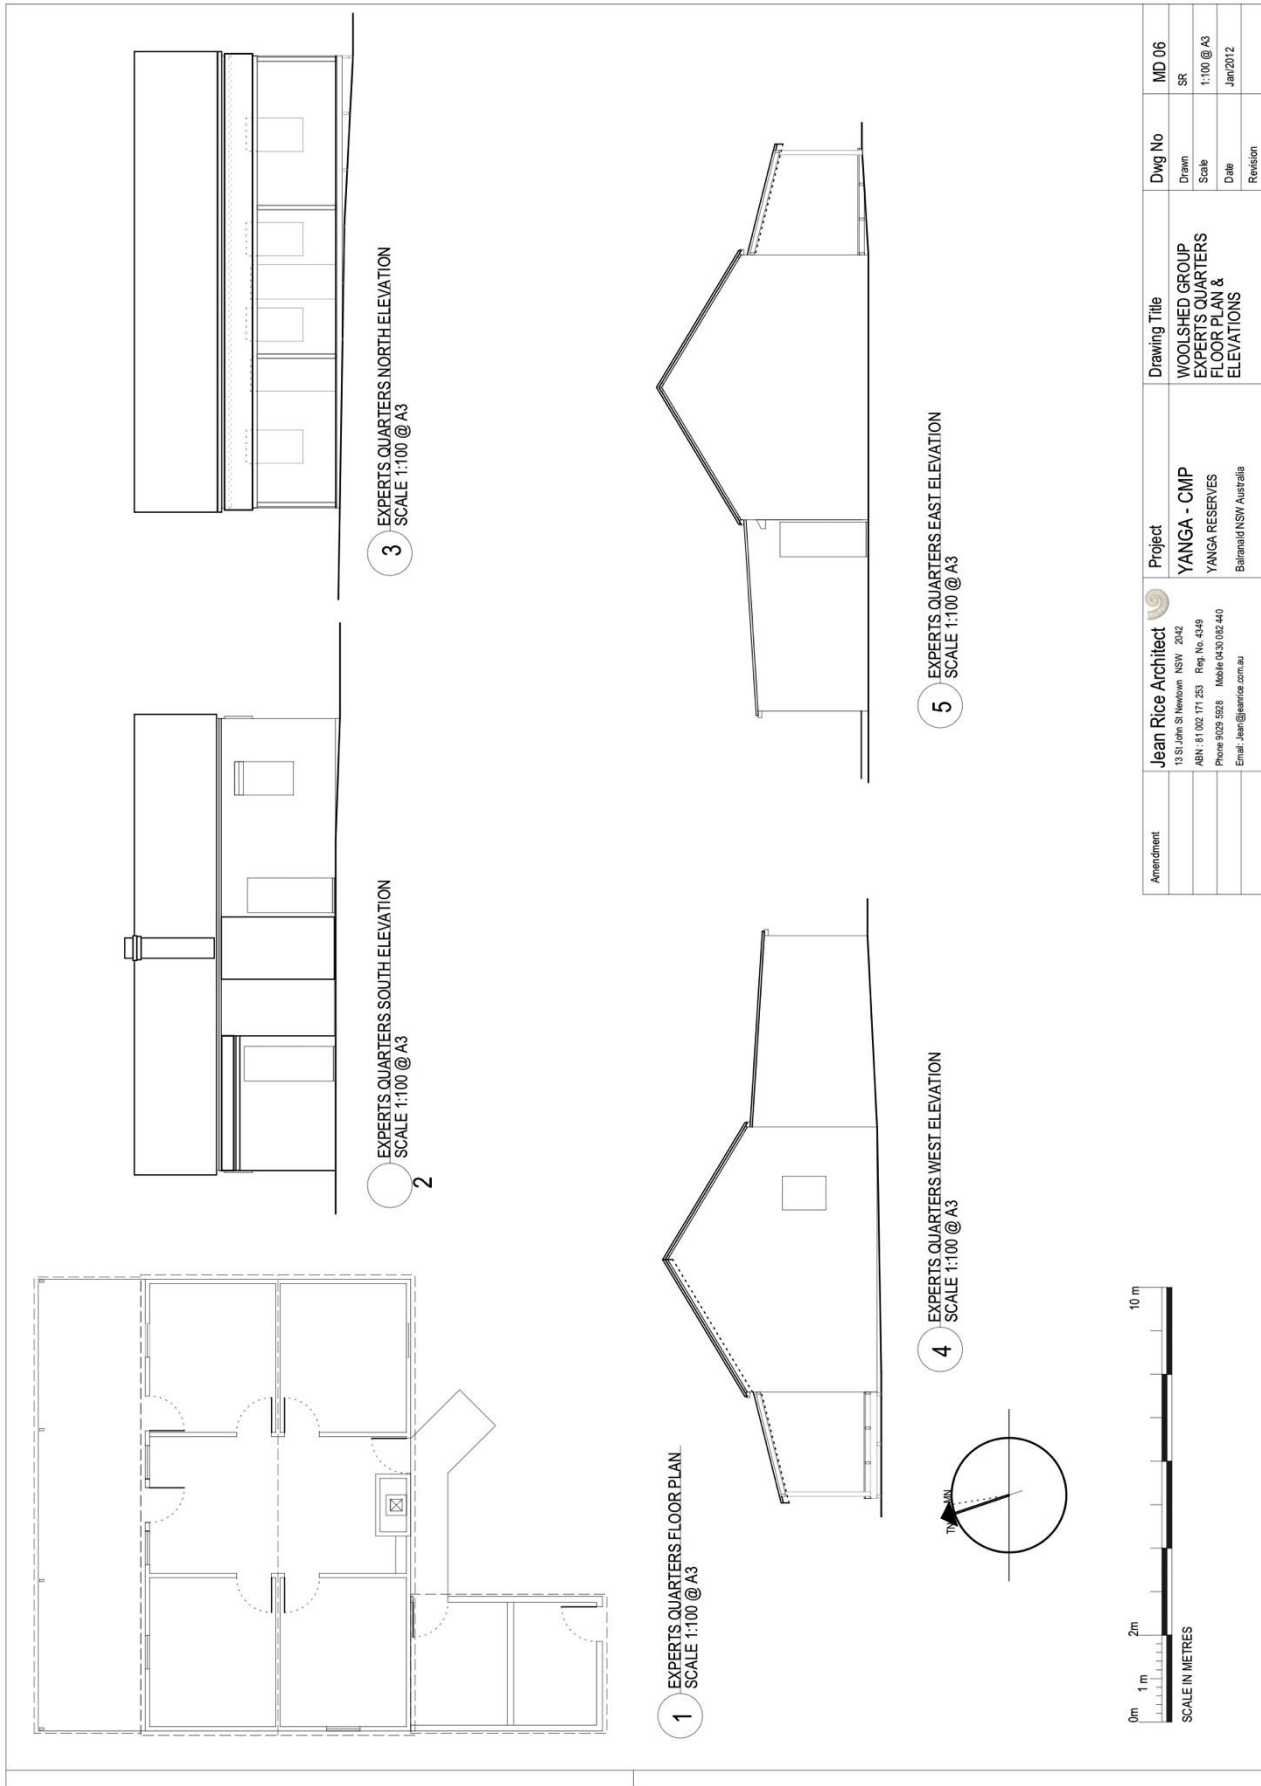
Figure 3.5.24 Woolshed Group, Experts Quarters floor plan and elevations. Jean Rice Architect, site assessed 2009.

The building is in fair condition with subsidence evident and termite damage to the north-east corner of the building. The butt jointed board in the north-east room may be replacements and indicate former termite damage. The subsidence may indicate termite damage or deterioration from damp. The gutter generally have failed and do not discharge away from the building. The bargeboards are missing (except the north-west corner) and the rear fascia. The front verandah posts have dropped.

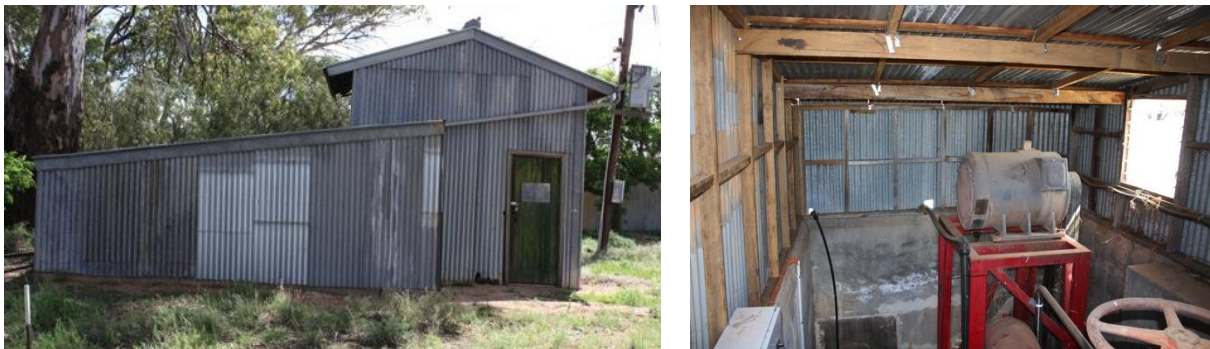
Figure 3.5.26 South west and interior views of Irrigation Pump House. CMP authors, 2009

The Irrigation Pump House is a small building on the river bank west of the Cookhouse and it is oriented towards the river. The main part is a square shed with a gabled roof, a ridge vent and all clad in cgi. There is a skillion section to the south towards the river that has a deep pit with modern concrete sides and a concrete stair. There are engines and pumps installed in the pit and upper level and associated pipes. The frame is of timber and metal and is clad in secondhand corrugated iron. The simple windows have glass louvres, many broken. The doors are from the east side and are timber and a sign on the main door says "Danger, No Admittance". Large steel pipes and plastic pipes lead to the river. The building is in good condition apart from some damage to the roof from tree branches, broken glass and the timber doors need repainting.

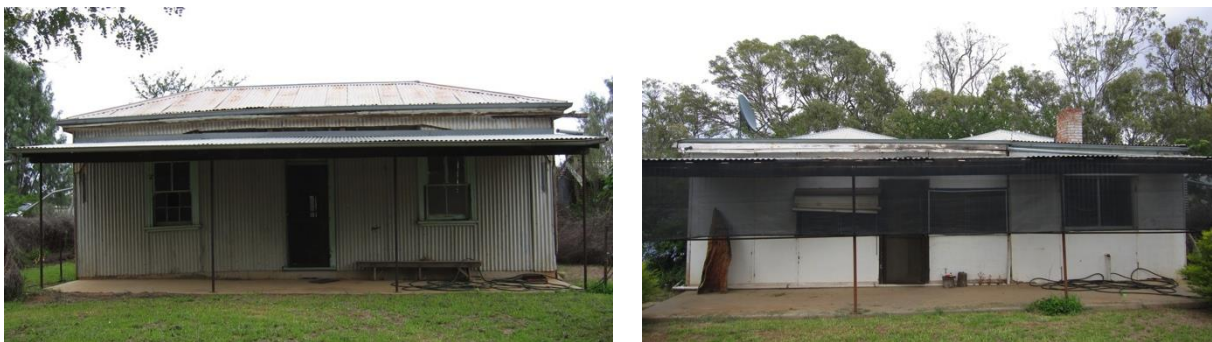
Figure 3.5.28 Front and rear of Woolshed Cottage. Photos by CMP authors, 2009

The building is in poor condition. The floor has dropped in several locations and the internal wall cladding cracked. Some of the ceiling lining has fallen. The cgi roofing is in good condition but some sheets are loose and need refixing. Some of the windows are nailed shut and some sashes are failing. Some guttering is sagged or damaged and some flashings missing as well as coverstrips to cladding junctions.

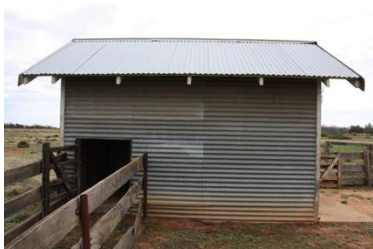
Views of Slaughterhouse

The building is generally in good condition. There are loose fixings to some sheets of iron. The roof barge flashing is missing over the door. There is some subsidence to the concrete slab and evidence of rabbits undermining the northeast corner of the sheep pen. Some timber slats are missing.
